### INSPECTION REPORT

| Inspection Date(s): | 02/25/2020 | |
| Facility Name: | <b>Artesia Wastewater Treatment Plant</b> | |
| Identification/Permit Number: | NM0022268 | |

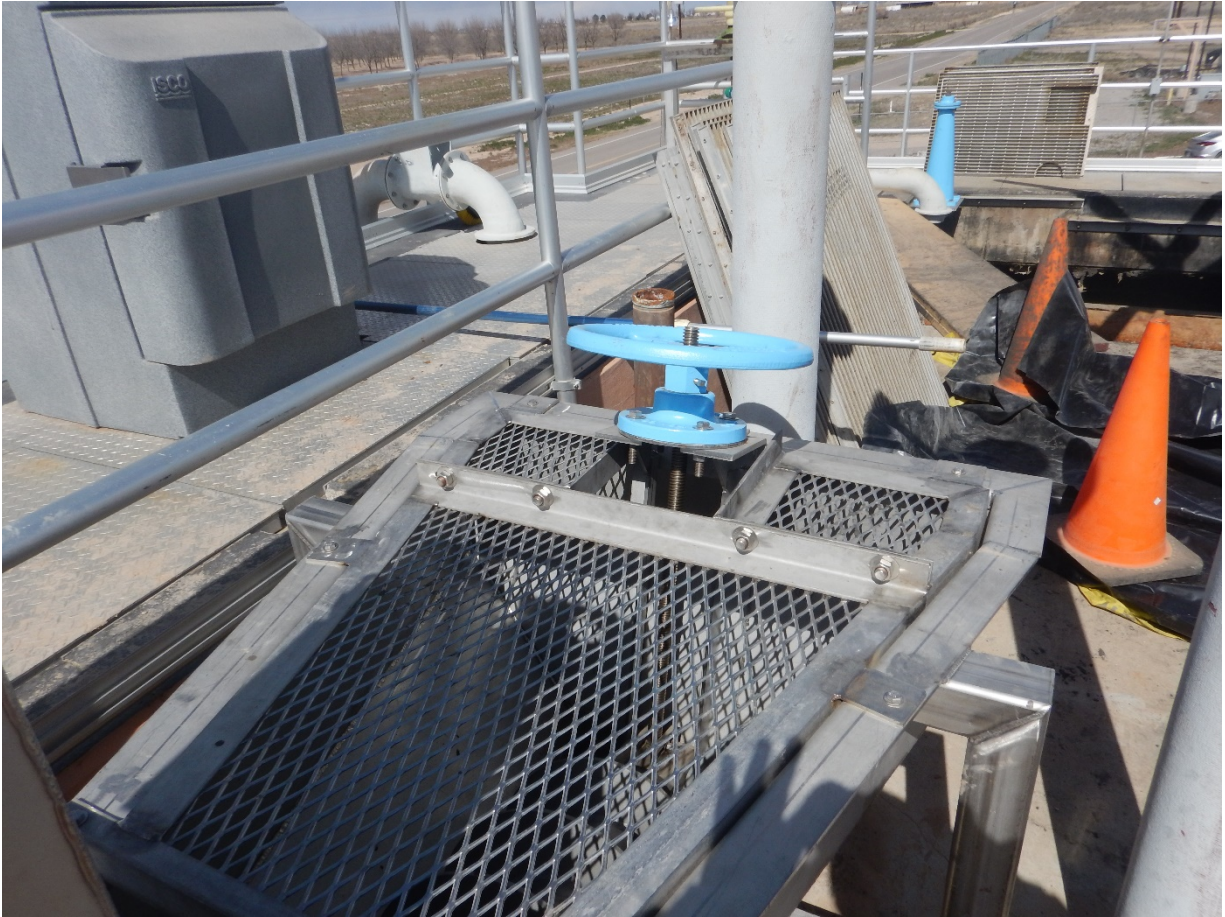
Photo File Name: City of Artesia (COA) WWTP (DSCN1726)

Description: View of the WWTP bar screen/headworks prior to entering the grit chamber.

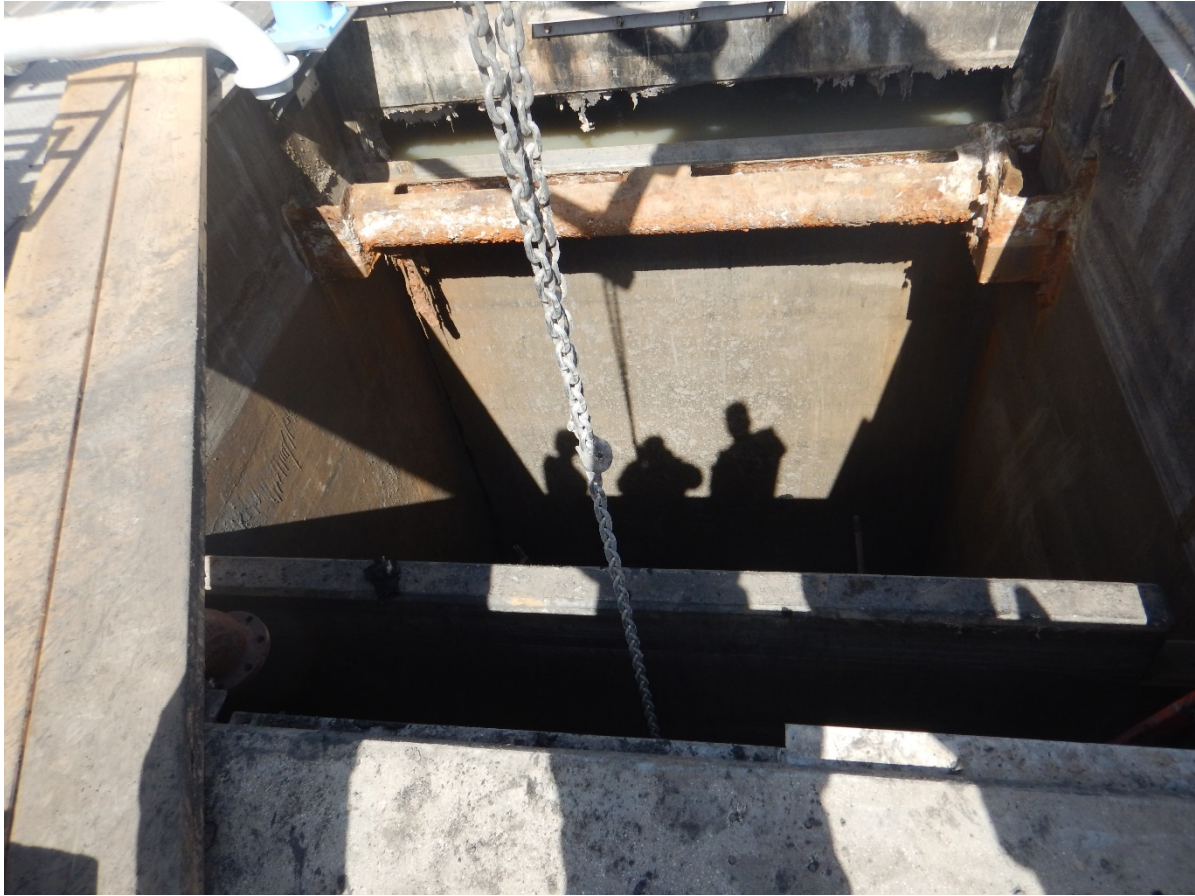
Photo File Name: City of Artesia WWTP (DSCN1727)

Description: View of a portion of the grit chamber and some of the piping undergoing rehabilitation.

- The WWTP's existing grit chamber identified for rehabilitation in the completed Smith Engineering Preliminary Engineering Report (PER) commenced on January 6, 2020 (Beginning of Project-BOP) by the issuance of the Notice to Proceed (NTP) under project number COA-PS-18-0005 for a scheduled completion date (End of Project-EOP) of 180-days, or approximately June 6, 2020.

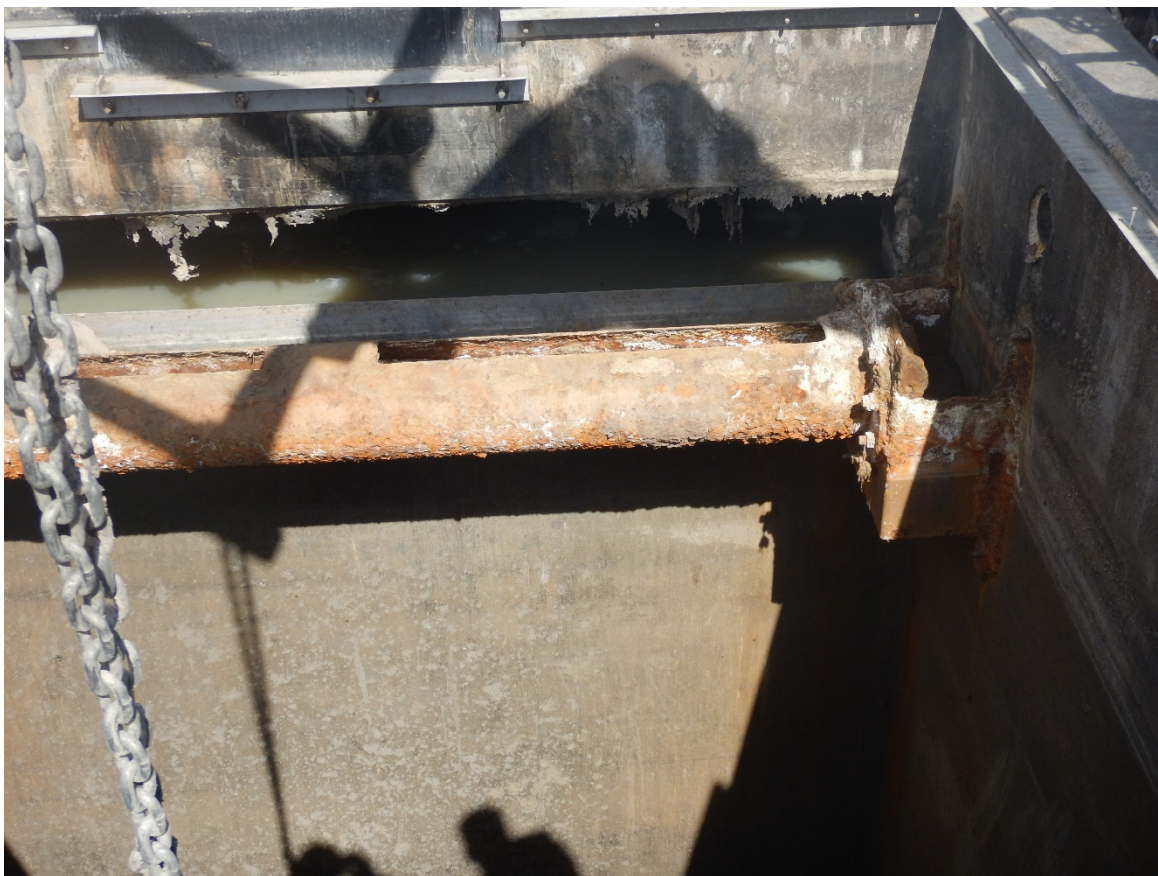
Photo File Name: City of Artesia WWTP (DSCN1728)

Description: A more detailed view of some of the piping within the grit chamber undergoing rehabilitation under project number COA-PS-18-0005.

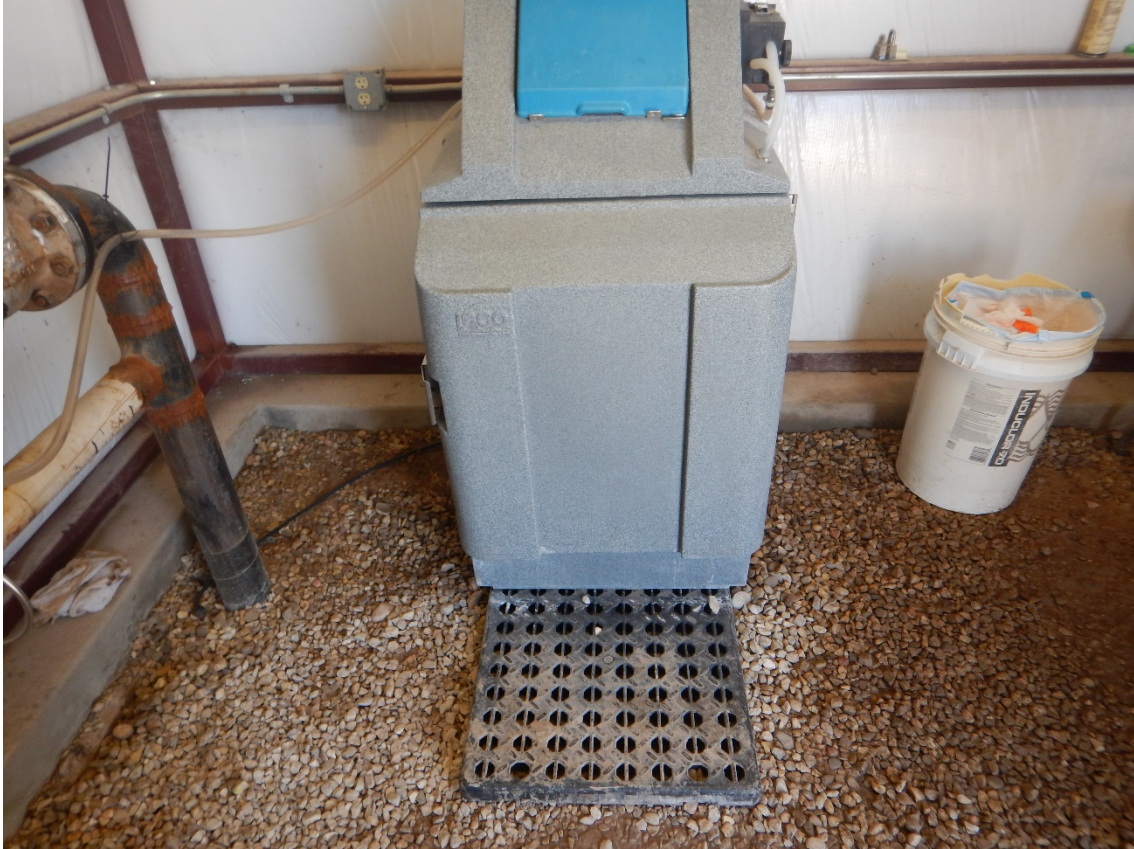
Photo File Name: City of Artesia WWTP (DSCN1724)

Description: View of automatic sampler (auto sampler) installed in accordance with the City of Artesia and Navajo Refining wastewater agreement. The auto sampler is located within a locked building at the approximate southwest corner of North Freeman and East Logan. Note: Only WWTP personnel have access to this building.

- In accordance with conditions of the Navajo and COA Agreement, a WWTP (access only) sampling point and totalizing meter were installed within a locked building situated at the approximate southwest corner of North Freeman and East Logan Streets (Latitude/Longitude 32° 51' 11.305" North 104° 23' 45.142" West). WWTP personnel collect samples daily for pH and chlorine (CL) analysis. The observed Omega® type C7.00 meter (serial number 56448/17) was a replacement due to the previous meters' failure. This observed meter is scheduled for calibration/certification by Yukon on March 19, 2020.

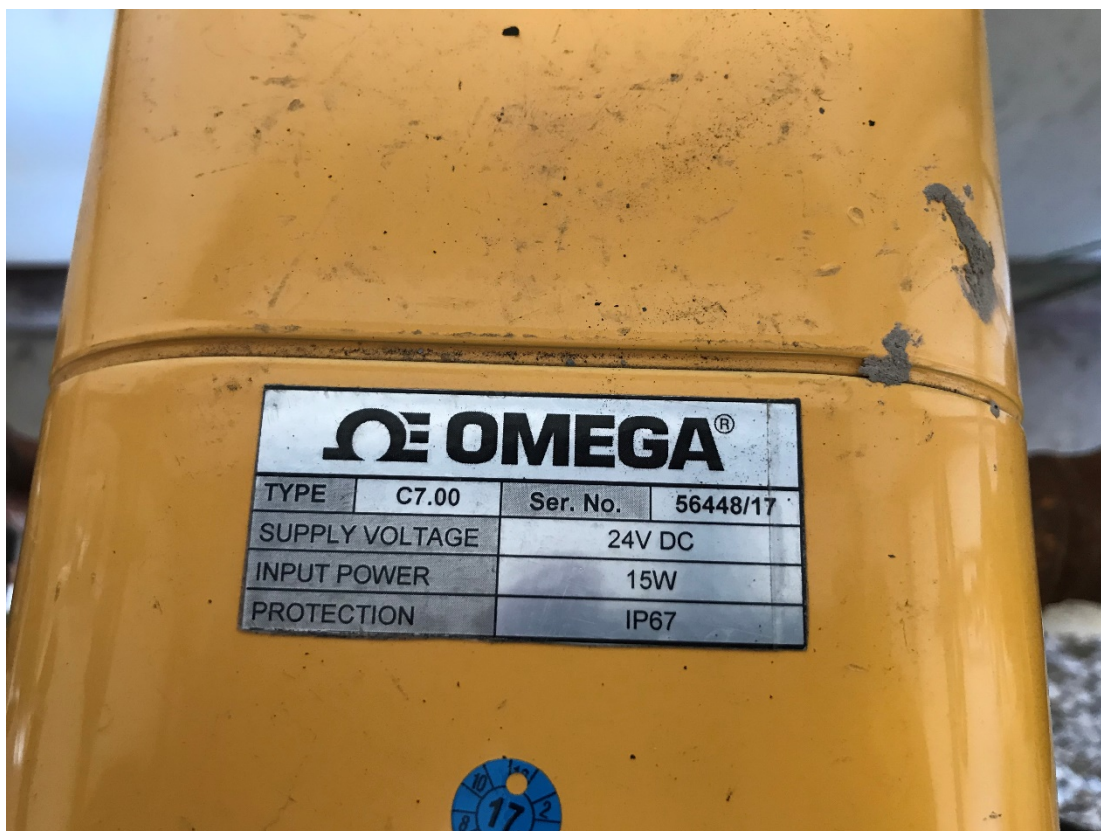
Photo File Name: City of Artesia WWTP (IMG\_0168)

Description: View of Omega® meter model specifications within the locked building to record Navajo Refining discharge flow volumes delivered to the WWTP.

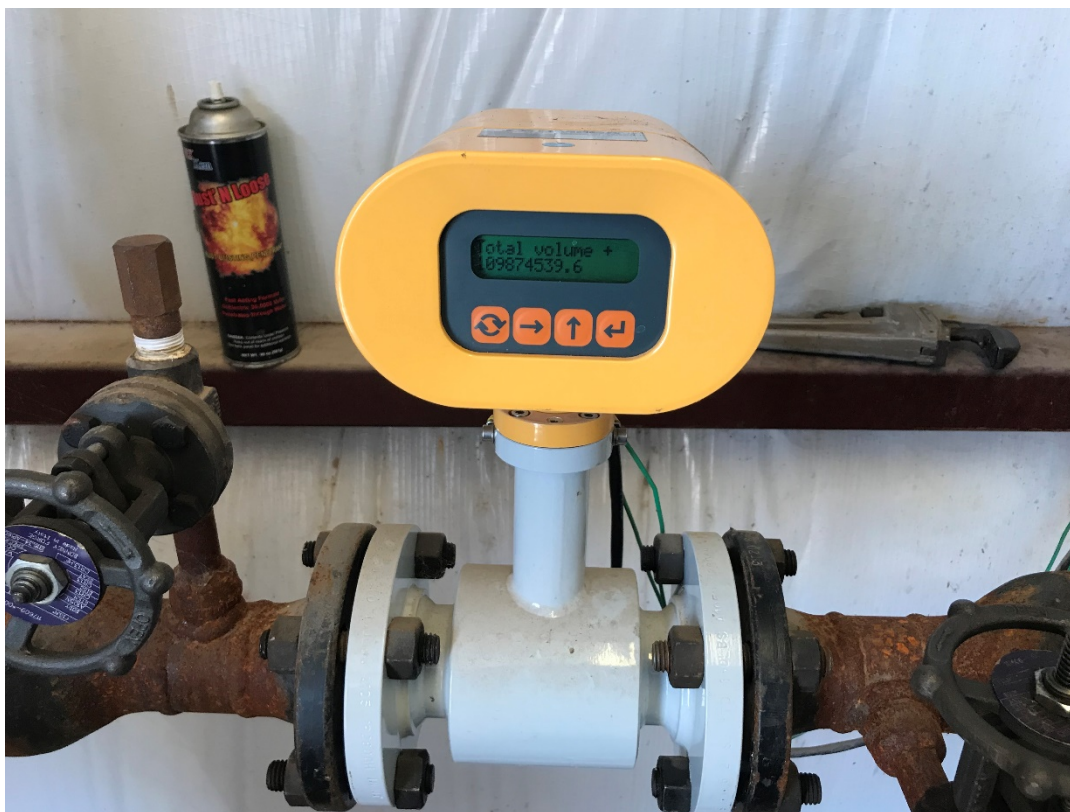
Photo File Name: City of Artesia WWTP (IMG\_0167)

Description: View of Omega® type C7.00 totalizing meter digital display installed in-line.  
Note: This meter was scheduled for calibration/certification by Yukon on March 19, 2020.
