# Releasability of Asbestos Fibers From Asbestos-Containing Gaskets

James R. Millette<sup>A</sup>, Michael D. Mount<sup>A</sup> and Steve M. Hays<sup>B</sup>

<sup>A</sup>MVA, Inc. 5500 Oakbrook Pkwy., Suite 200, Norcross, GA 30093

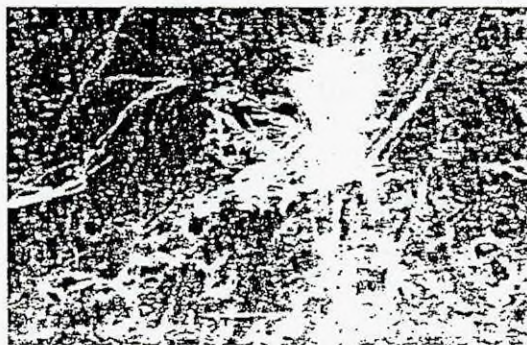
Fig. 3. Close-up view of the surface of the gasket material from Fig. 2 showing uncoated chrysotile asbestos fibers protruding.

The question of whether or not all asbestos fibers are completely bound or encapsulated in gasketing material is one that has been studied by microscopy.<sup>7</sup> A close examination of the surfaces of four unused gaskets showed that although most of the asbestos is indeed bound within an organic binder, uncoated asbestos fibers were present on the surface and on the edges of the gaskets which would be released as free fibers with mild abrasion. Additional work examining gaskets from a number of manufacturers showed similar results. A portion of a John Crane, Crane Packing Company, sheet gasket labeled 333 HEAVY DUTY is shown in Figure 2. A magnified view of the surface of the top of the gasket is shown in Figure 3. The

chrysotile fibers are uncoated and protruding from the gasket surface.

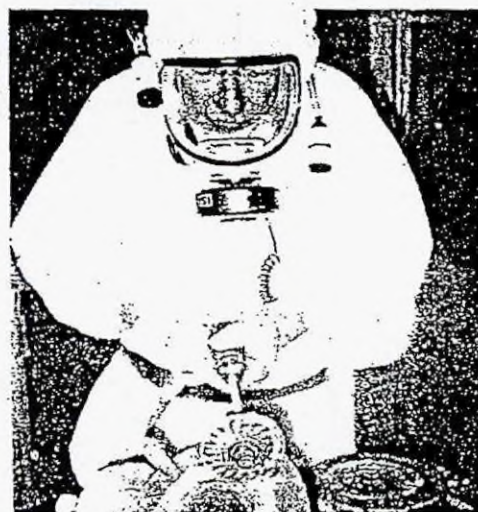
Fig. 5 (left): Power wire brushing of a pipe flange after removal of the gasket during Study 1.

| Activity | PCM* (f/cc) | TEM** (s/cc) |
|---|---|---|
| Power wire brushing | 6.8 | 62 |
