INSPECTION REPORT

| Type of Inspection | Compliance Evaluation Inspection (CEI) | |
| Facility or Site Name | Glorieta Camps Wastewater Treatment Plant | |
| Permit Number(s) (If Applicable) | NM0028088 | |

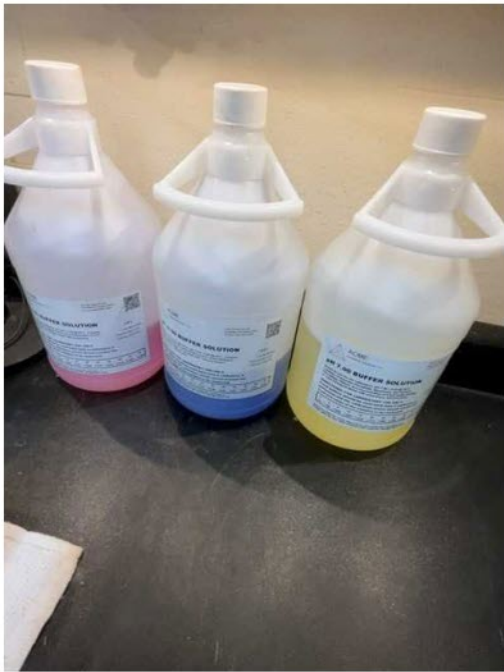
| [Title] | | | IMG-20240506113018301862847.jpg |

The pH buffers have written opened-on date, and an expiration date calculated based on the earliest of 1-year from opened-on date, or the manufacturer's printed expiration date. However, pH buffer solutions begin to oxidize when opened and most do not last a full year – inspector was unable to verify the solutions' validity after opening from this manufacturer. Inspector recommends facility personnel contact the manufacturer to determine appropriate expiration time of solutions after they are opened or find a different manufacturer.

| pH buffer solutions showing opened-on date and expiration date calculated from the earliest of 1-year from opening, or manufacturer's printed expiration date. | | | |

| Location: | Area: | Sub-area: |
|---|---|---|
| Inspector recommends facility personnel contact the manufacturer to determine appropriate expiration time of solutions after they are opened or find a different manufacturer. | | |

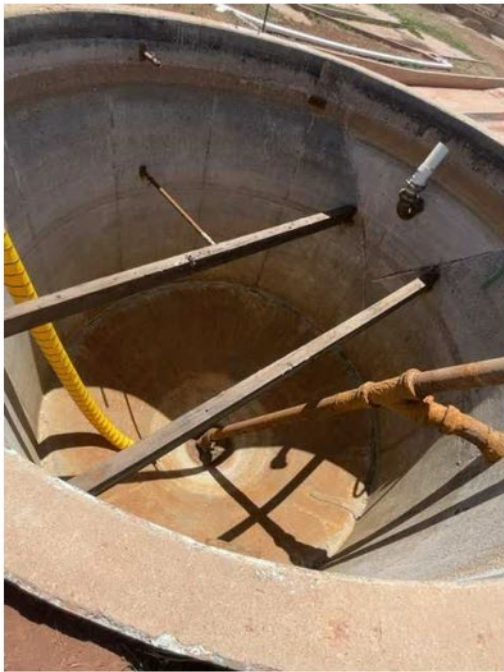
| [Title] | | | IMG-202405061159215921102186.jpg |

The original influent pipe was corrugated steel, but has been replaced with PVC, and an added a grit basin. There is no staff gauge for the influent flow meter.

The outer ring of aeration basins is not currently in use, but is available for extra storage, if needed. The aeration basin is currently watertight, but engineers have stated that catastrophic failure of aeration basin concrete walls is possible (horizontal cracks are visible in basin walls) due to freeze thaw damage and vibrations from blades.

Smith Engineering has been retained for concrete and process engineering design.

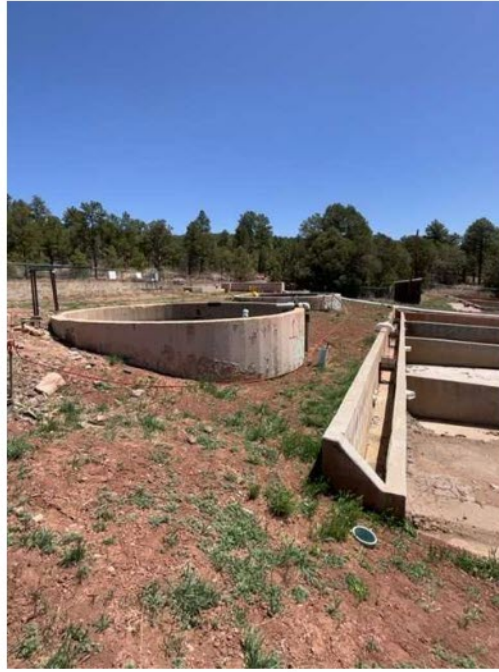
| [Title] | | | IMG-20240506120417417115740.jpg |

The Imhoff sludge tanks have problems with the sludge plugs in the bottom, so someone must clean them out regularly. This is a permitted confined space. The tanks have a relatively low wall with respect to the ground, which could allow someone to trip and fall into the tank. These tanks need a barrier to be OSHA compliant. The wall above the drying beds is also low and needs a barricade to prevent fall hazards and the fence around the compost bin was observed to need repair. Facility personnel stated that there are not many pedestrians in the area, fences keep out the campers from the WWTP area.

| AOC Reference #: AA2-OB-006 | Location: 8 - Sludge and Biosolids |
|---|---|
| <b>AOC:</b><br><br>The tanks have a relatively low wall with respect to the ground, which could allow someone to trip and fall into the tank. These tanks need a barrier to be OSHA compliant. The wall above the drying beds is also low and needs a barricade to prevent fall hazards and the fence around compost bin isn't in great shape. | |

| Sludge tanks and drying bed wall present falling safety hazard. | | | |

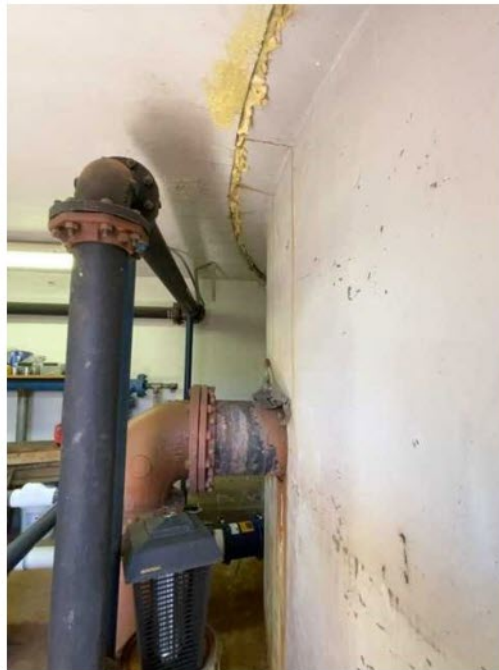
| [Title] | | | IMG-20240506121919191959601.jpg |

Denitrification was observed occurring in clarifier. Clarifier is leaning away from building; separation was observed in the concrete and the weirs aren't level. The clarifier is cleaned in March (once a year, although facility personnel say they try to clean it twice a year).

| AOC Reference #: AA2-OB-004 | Location: 2 - Primary and Secondary Treatment |
|---|---|
| <b>AOC:</b><br><br>Denitrification is occurring in clarifier. Clarifier is leaning away from building, can see separation in concrete and weirs aren't level. The clarifier is cleaned in March (once a year, although facility personnel say they try to clean it twice a year). | |

| Crack between building and settling clarifier has been sealed with expanding spray foam. | | | |
