## **RCRA Inspection Report**

Dart Polymers, Inc.  
2400 Harbor Road  
Owensboro, Kentucky 42301

December 5, 2023, at 8:30 a.m.

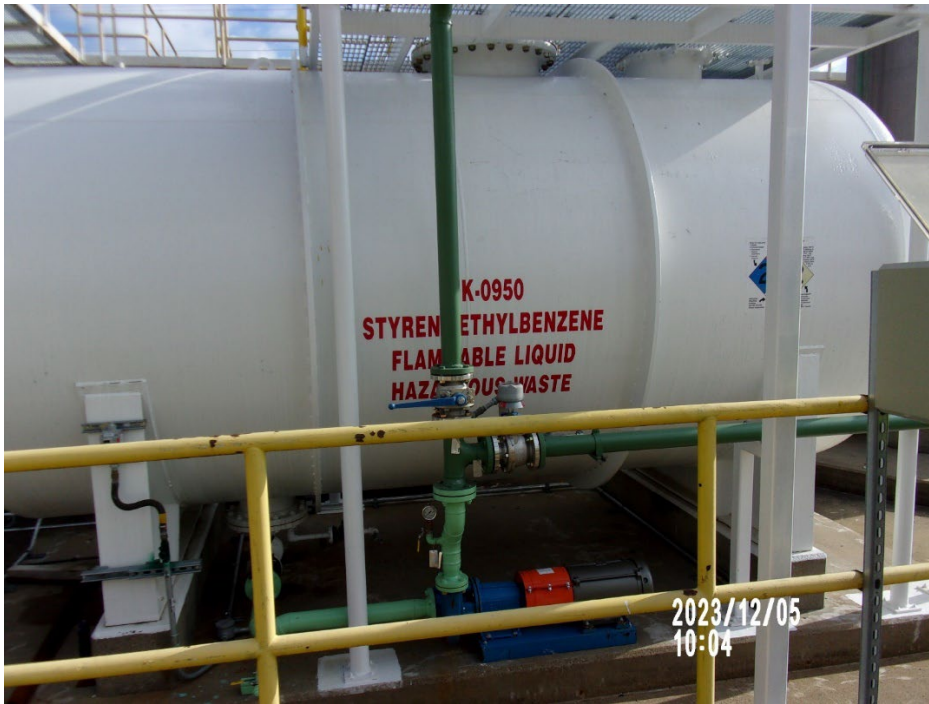
The 6,500-gallon tank appeared to be well maintained and no areas of corrosion or any leaks were observed. The associated piping, pumps, and valves also appeared to be well maintained and no evidence of corrosion or leaks were observed. The tank is a fixed-roof tank. The tank is in a tank farm with numerous other production (non-waste) tanks. The entire tank farm has a walled concrete secondary containment system. The secondary containment system for this area was a liner system per 401 KAR 39:090, Section 2(1) [40 C.F.R. § 265.193(e)(1)].

Photo 1: Hazardous Waste Accumulation Tank.

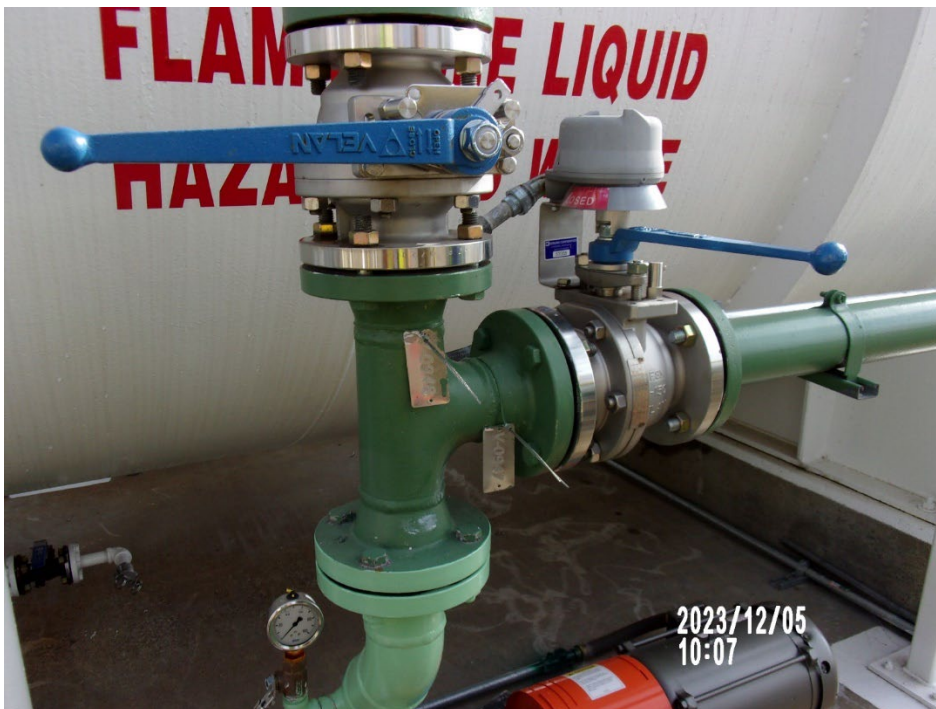
The new hazardous waste tank system is covered under the facility's Title V Air permit. The inspectors did view the marking tags on the piping. The facility has installed metal tags at the monitoring points that the facility is monitoring for their Title V permit. The facility maintains a Leak Detection and Repair (LDAR) program per the facility's Title V air permit. The facility has several thousand inspection points in their production process (non-waste), and the facility performs LDAR on their single Hazardous Waste tank system that is designated for styrene/ethylbenzene. Each test point has a unique identifier tag attached to it. Any component associated with the Hazardous Waste tank contains a "09" designation on the tag.

Photo 2: Air Monitoring Tags on the Hazardous Waste Pump Ancillary Equipment.

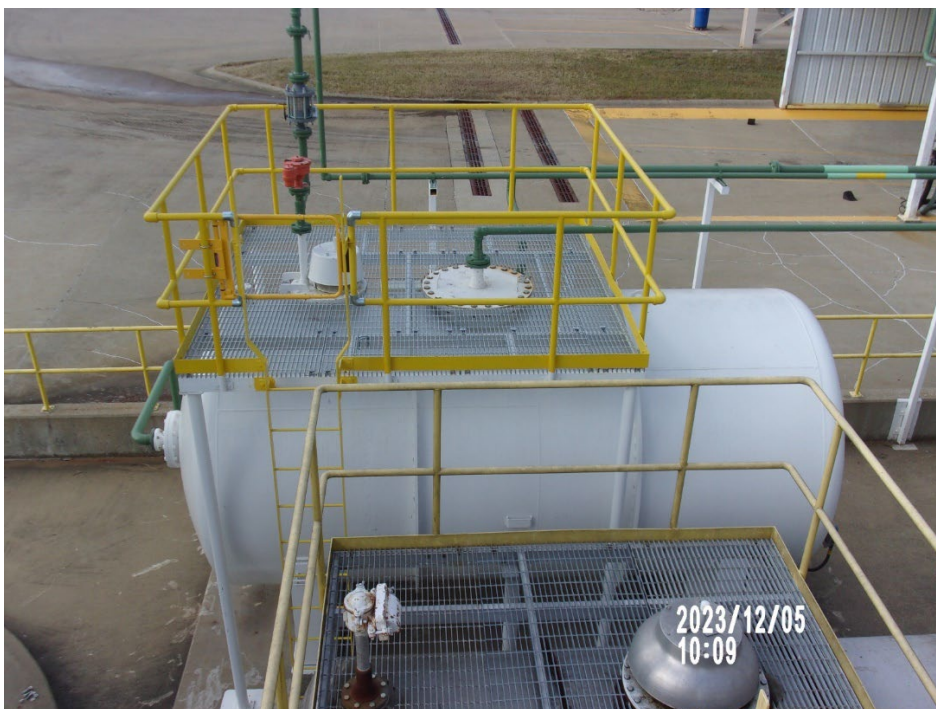
Photo 3: Top of the hazardous waste accumulation tank.

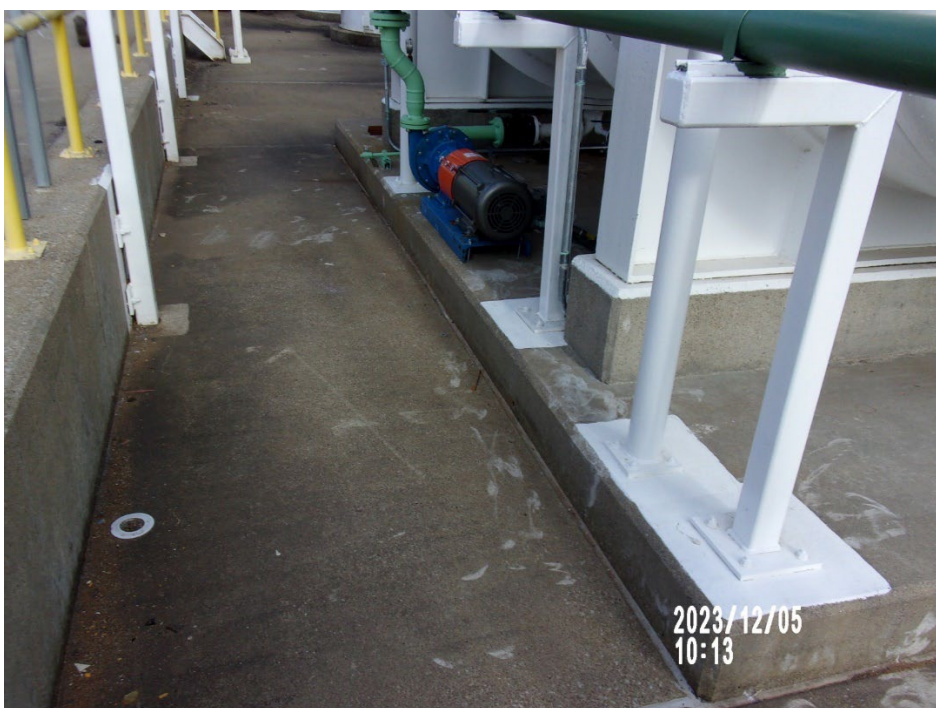
Some limited cracks were observed in the vicinity of the hazardous waste tank (Photos 5-9). It was also observed that the concrete was not coated with an impervious type of sealant or coating (Photos 4-9). Concrete secondary containment for hazardous waste accumulation tanks

is required to have an impermeable liner or impermeable coating and to be free of cracks and gaps in the structure.

Photo 4: Secondary containment under the hazardous waste accumulation tank. The concrete is not coated.

The facility reported, on 1/4/2024, that the tank inspection company would be able to work with a Professional Engineer to provide an assessment and certification. The facility also reported that they were in the process of obtaining quotes on a coating for their secondary containment system. In their 1/4/2024 letter, the facility also provided information, as noted above in the Recycling Review section, supporting that the styrene/ethylbenzene characteristic byproduct was being managed as a commercial product.

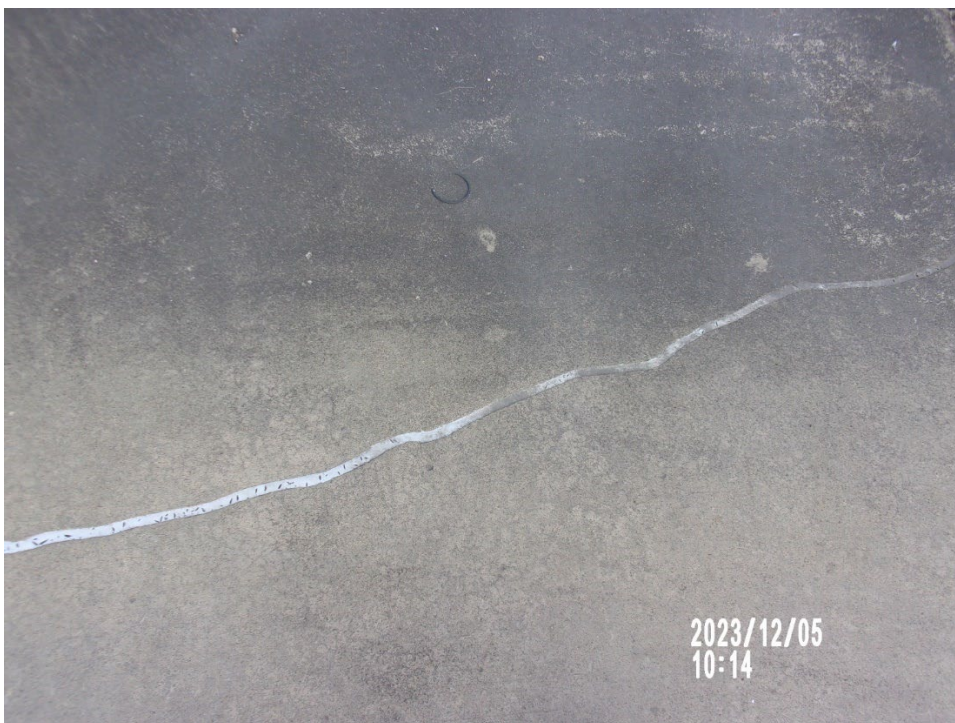
Photo 5: Repaired crack in the secondary containment in the vicinity of the hazardous waste accumulation tank.

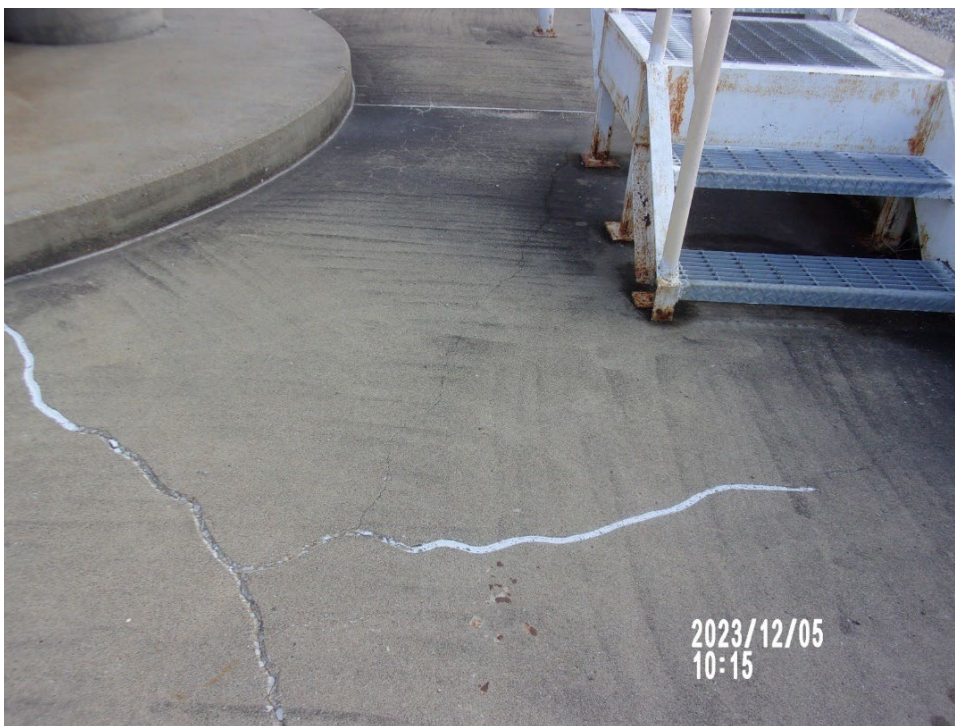
Photo 6: Cracks near the hazardous waste accumulation tank.

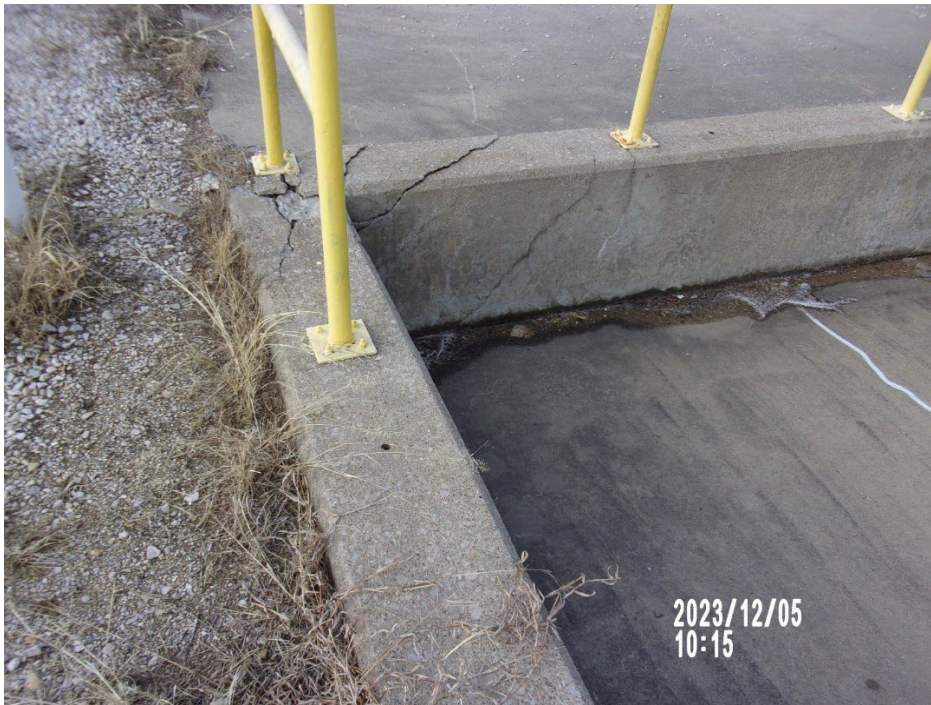
Photo 7: Cracks in the concrete containment wall in the area adjacent to the hazardous waste accumulation tank.

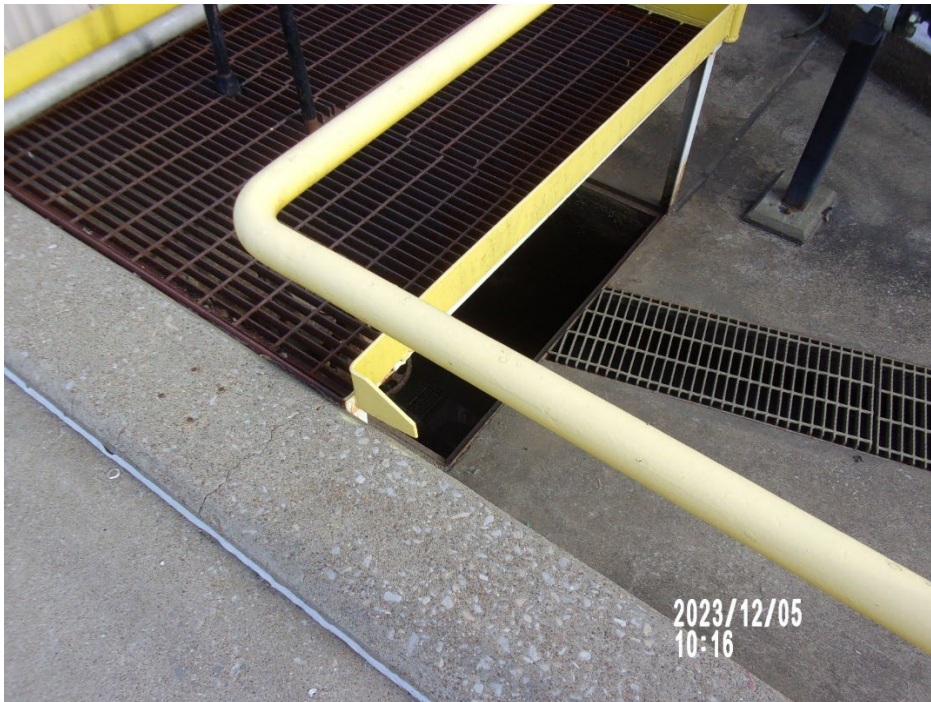
Photo 8: Small hairline crack in the containment wall near the hazardous waste accumulation tank. The concrete is not coated.

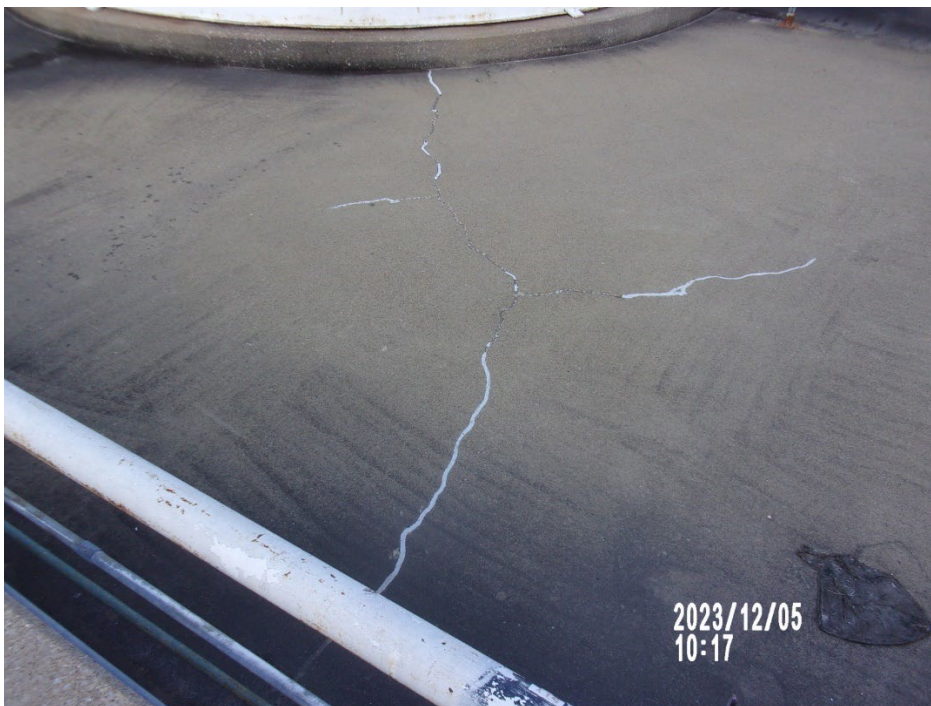
Photo 9: Partially repaired cracks in the secondary containment concrete.

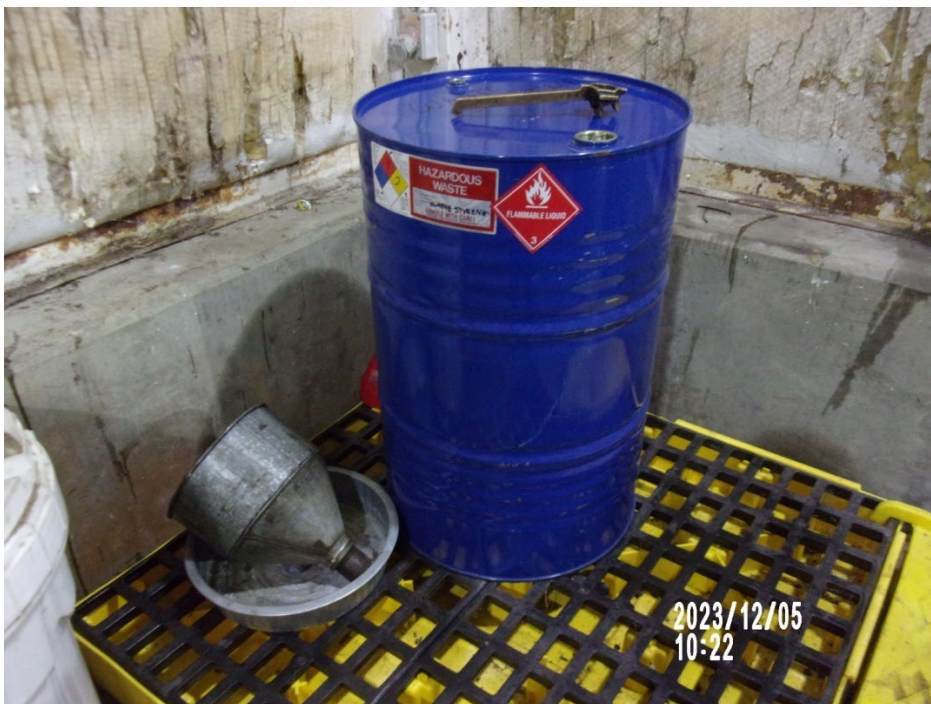
This area has pumps for transferring materials from raw material tanks to the production area. A single satellite accumulation area had a 55-gallon metal container of hazardous waste (Waste Styrene) present (Photo 10). The container was labeled as hazardous waste and had a Class 3 DOT marking to indicate the hazard. The container was on a plastic pallet that provided secondary containment. The container was closed and appeared to be in good condition.

Photo 10: Hazardous Waste SAA Metal 55-Gallon Container in the Pump House.

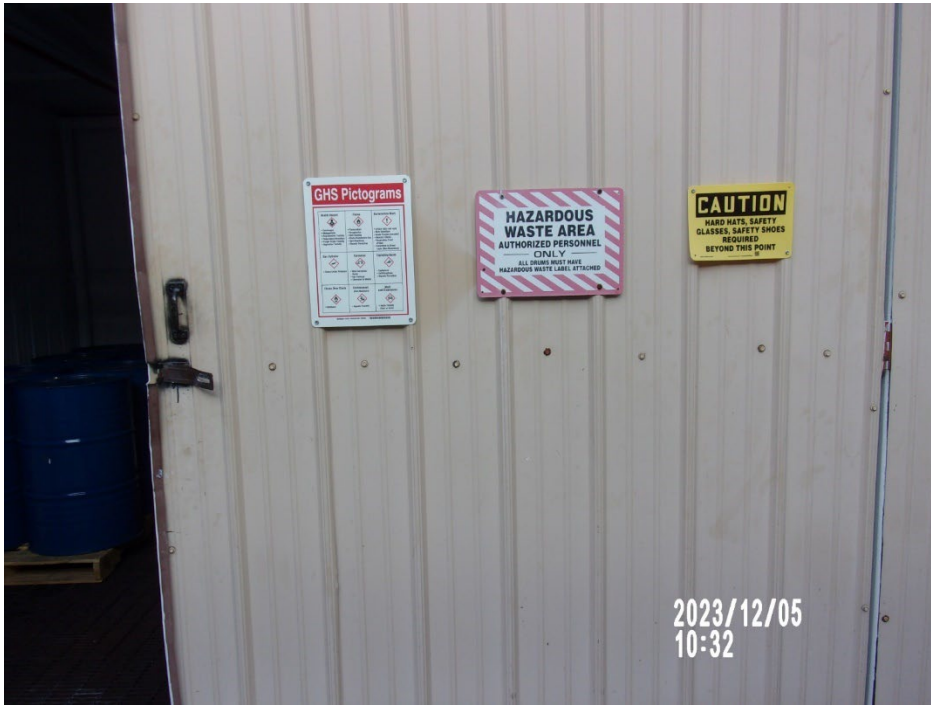
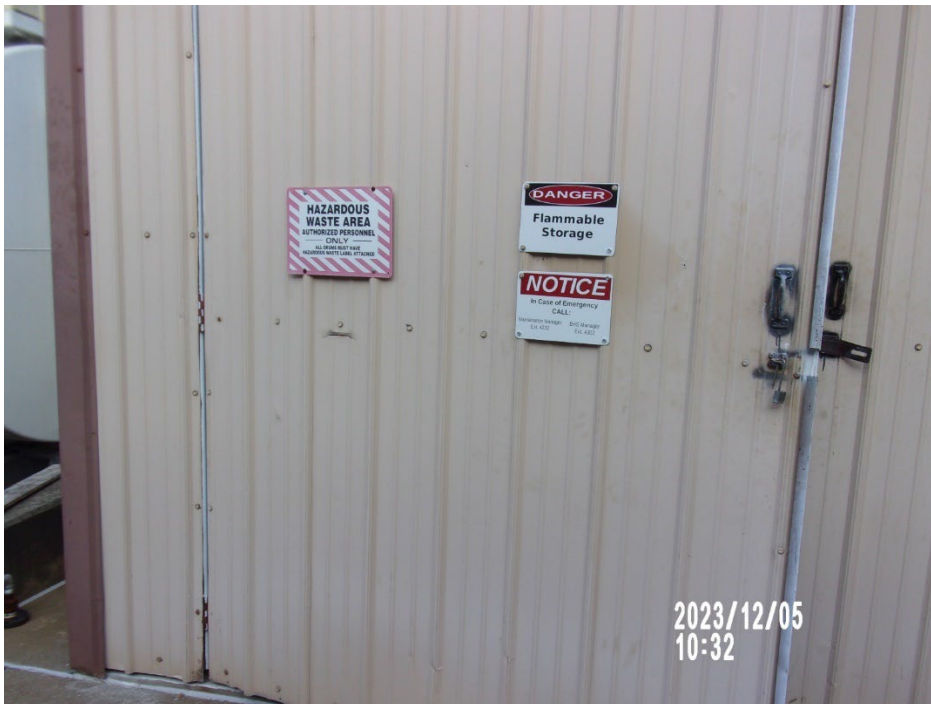
The Central Accumulation Area (CAA) was inspected. The area was identified with a sign which read "Hazardous Waste Area, Authorized Personnel Only." A sign stating "Danger – Flammable Storage" was also present (Photos 11 and 12). Dart Polymer manages ignitable wastes in this CAA, and there was no "No Smoking" sign present, although the Flammable Storage sign was present. During the inspection the facility personnel did put up a "No Smoking" sign on the building.

Photo 11: Signs on the Hazardous Waste Central Accumulation Area (CAA).

Photo 12: Additional signage on the hazardous waste CAA.

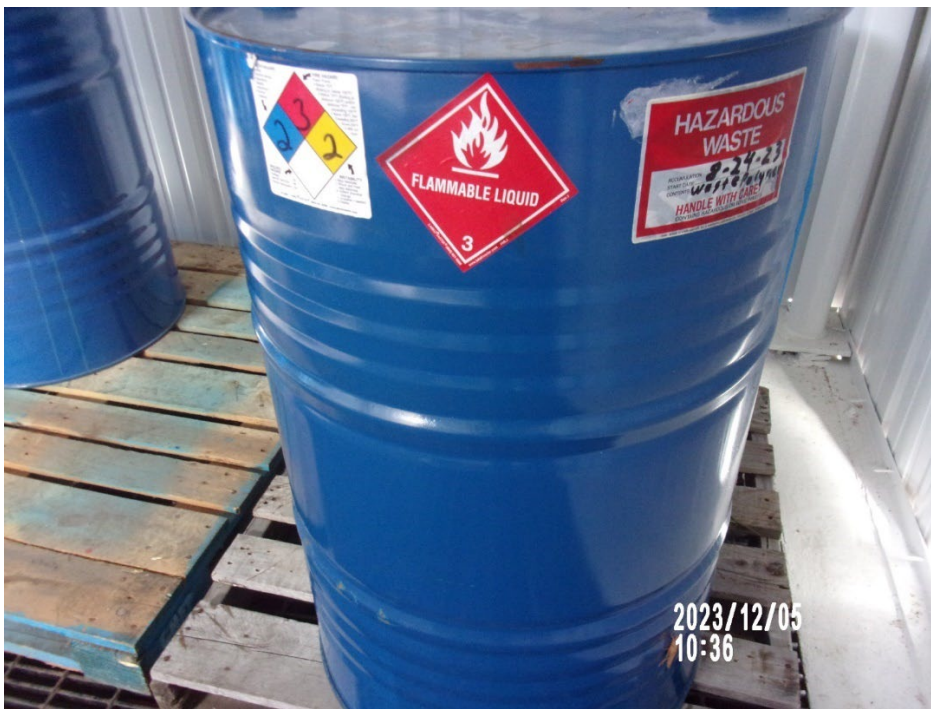
The CAA had ten 55-Gallon, one 30-gallon, and one 15-gallon containers of hazardous waste present at the time of the inspection (Photos 13-18). Nine of the 55-gallon containers (D001 wastes) were dated 11/9/2023, 11/13/2023, 11/15/2023, 11/16/2023, 11/18/2023, 11/22/2023, 11/27/2023, 12/1/2023, and 12/3/2023. The 15-gallon metal container (D001) was dated 11/15/2023. Two containers, a metal 55-gallon (Waste Polymer), dated 8/24/2023, and 30-gallon plastic container (Waste Initiator), dated 7/31/2023, were past the 90-day limit. The facility had requested an accumulation extension on these two containers and had received an approved extension from KYDEP on 11/21/2023. The extension was granted due to a backlog at the incinerator where the wastes would be shipped. All containers in the CAA were labeled as hazardous waste, had a hazard indicator marking, were closed, and were in good condition.

Photo 13: Metal 55-Gallon Container in the CAA. The container is dated 8/24/2023 but received an accumulation variance from KYDEP.

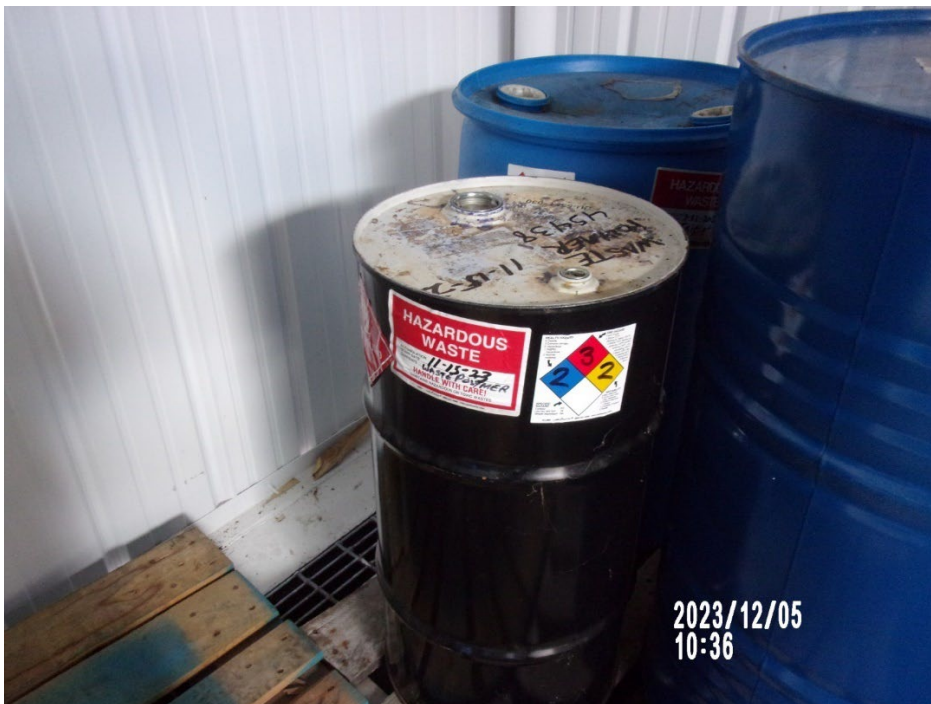
Photo 14: Metal 16-Gallon Hazardous Waste Container in the CAA. Plastic 30-Gallon Hazardous Waste Container is dated 7/31/2023 but has received an accumulation variance from KYDEP.

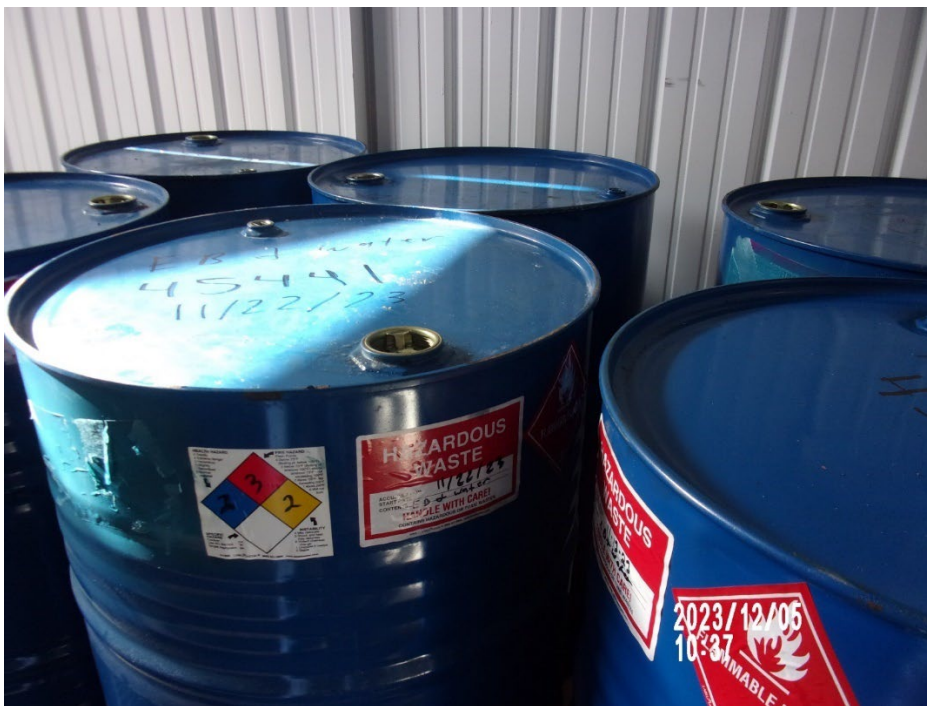
Photo 15: Metal 55-Gallon Container, Dated 12/1/203 in the CAA.

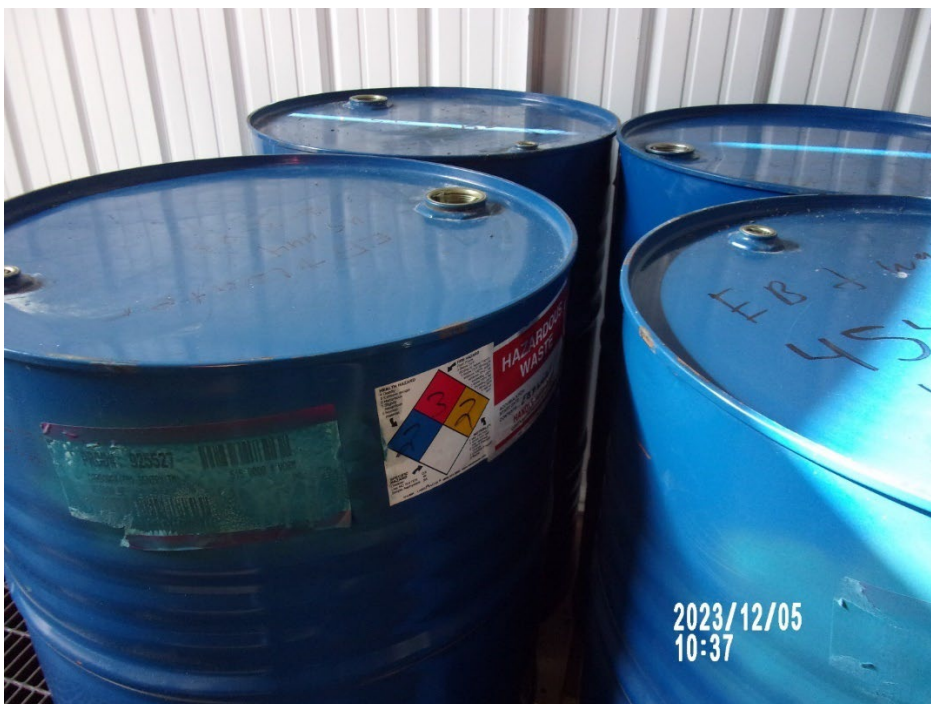
Photo 16: Group of Metal 55-Gallon Containers in the CAA.

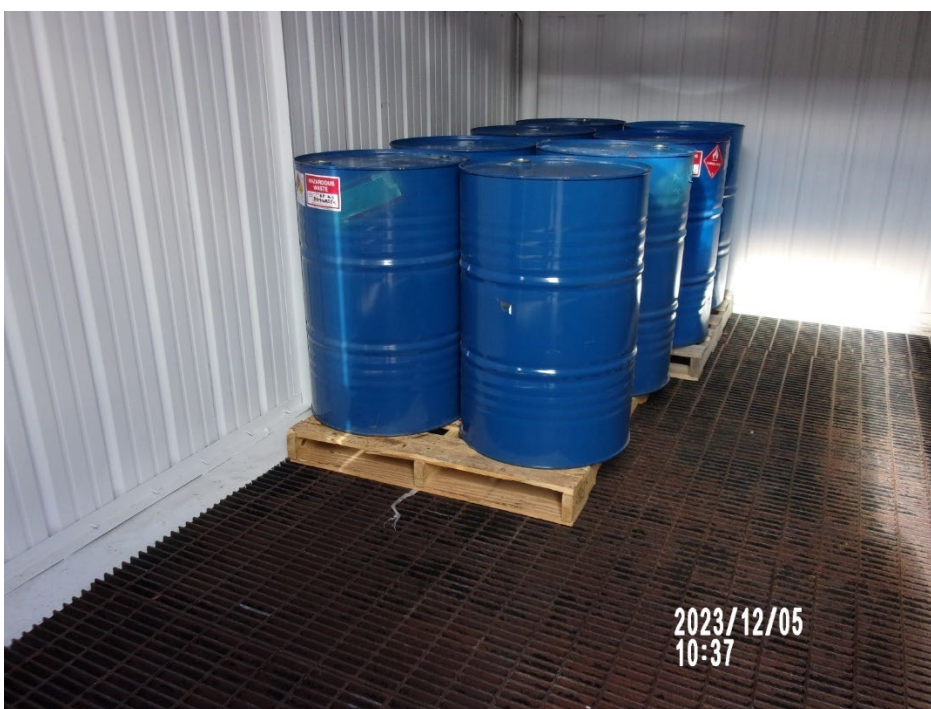
Photo 18: Third photo of the eight grouped metal 55-Gallon containers in the CAA. The inspectors were able to see the labels and markings but advised the facility to consider moving the containers away from the wall.

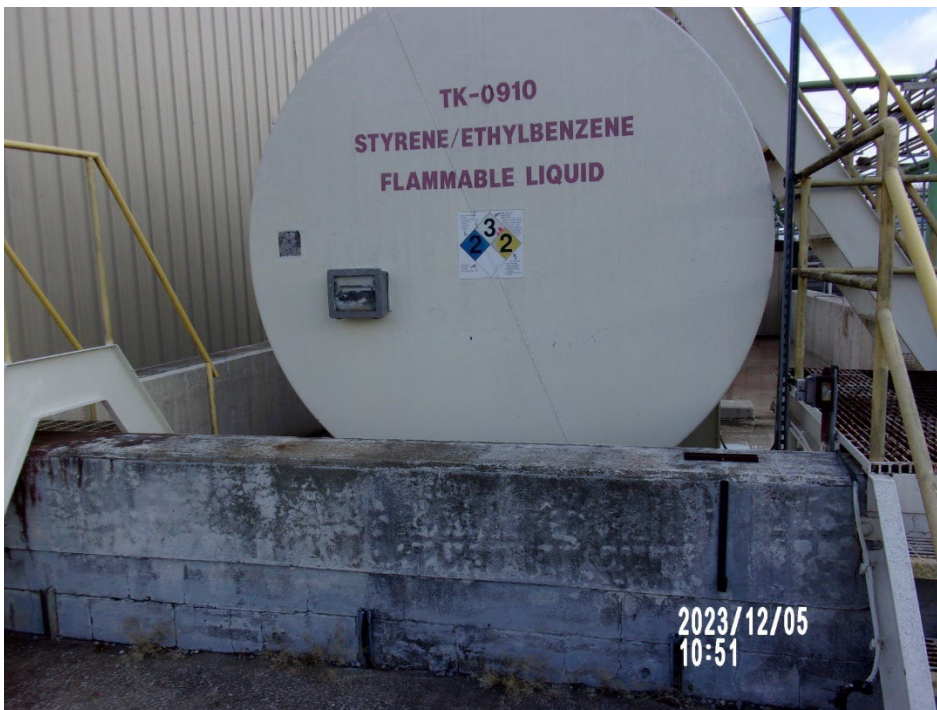
The former hazardous waste tank was converted to a product tank in the summer of 2022 (Photos 20-22). It was managing the same material that was formerly a hazardous waste but a portion of this Styrene/Ethylbenzene mixture is now being sold as a raw material for another manufacturer to utilize as a raw material in their production process. Mr. Frizzell briefed that when the product cannot all be sold it is sent to the hazardous waste tank and is shipped as a hazardous waste. This initial briefing and information provided by Dart Polymers, and observations from the inspection, supported that the material could potentially qualify for the exclusion under 401 KAR 39:060, Section 3(1) [40 C.F.R. § 261.2(e)(1)(ii)] for materials being used as effective substitutes for commercial products, and/or possible other related/similar exclusions. More information to further review this topic was discussed later in the inspection and subsequently discussed on 12/20/2023 (see below in the “Recycling Review” section).

Photo 20: Former 90-Day Hazardous Waste Accumulation Tank Converted to a Product Tank.

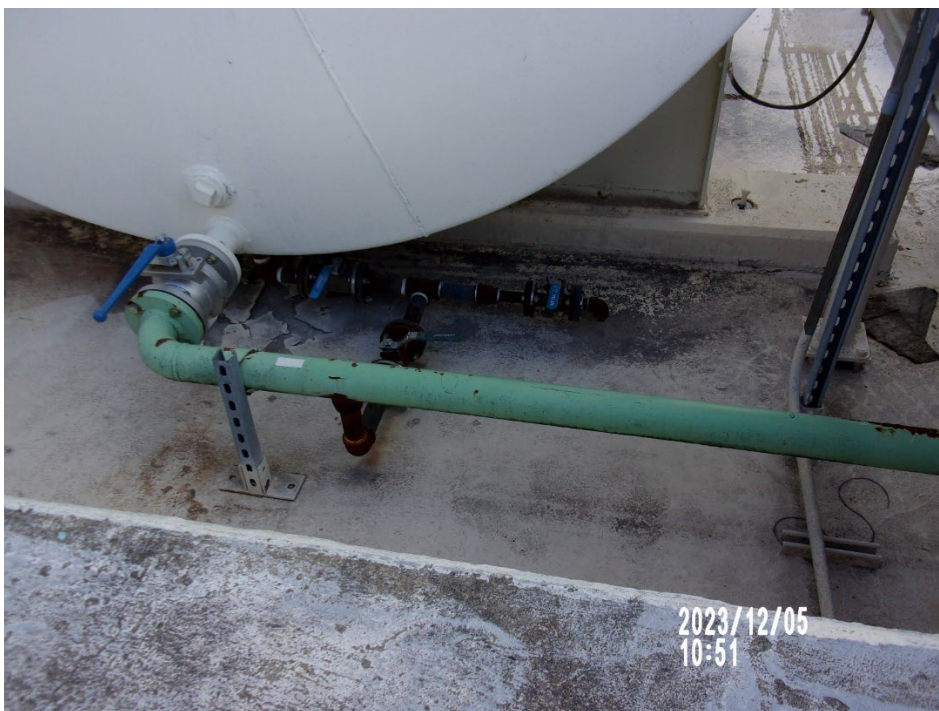
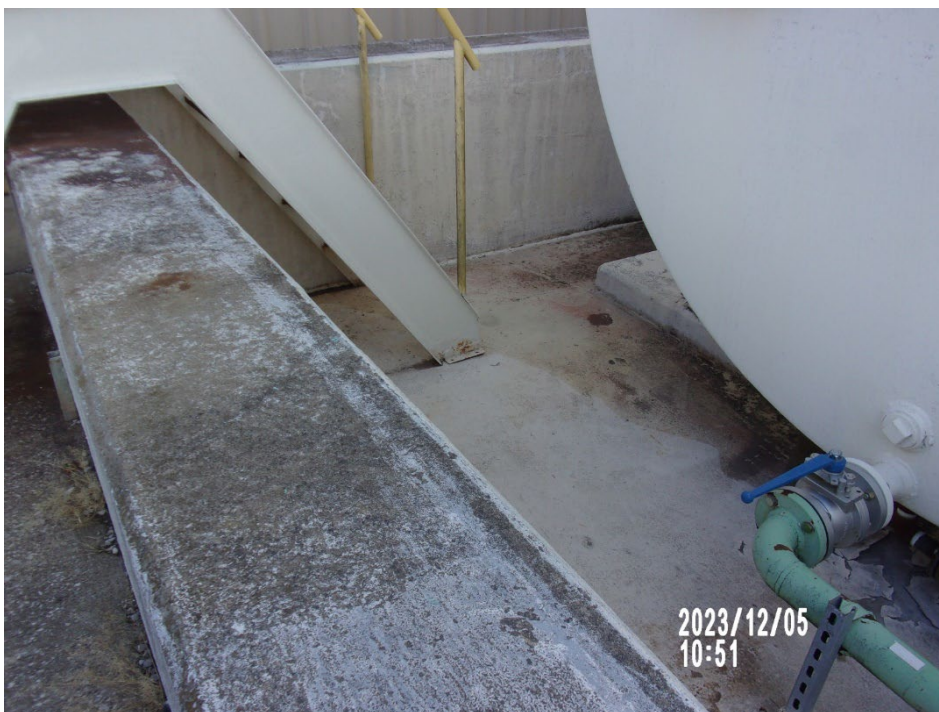
Photo 21: Secondary Containment for the Former 90-Day Hazardous Waste Accumulation Tank. The concrete in this area had been coated.

Photo 22: Secondary Containment for the Former 90-Day Hazardous Waste Accumulation Tank. The concrete in this area had been coated.

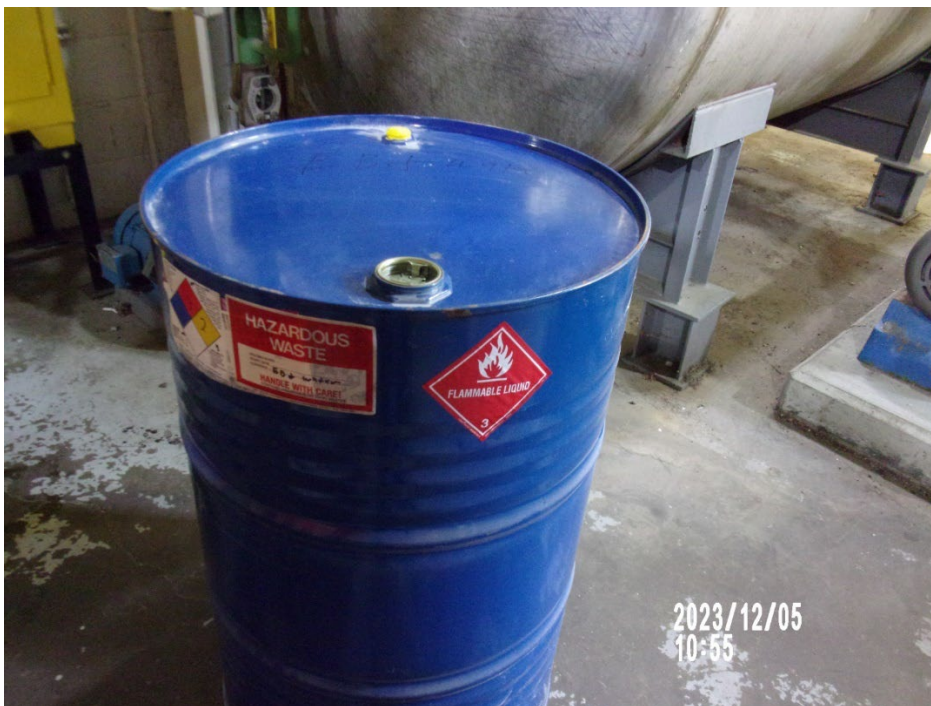
The first SAA had a single 55-gallon container for waste Ethylbenzene & Water (D001, D018) from Reactor Building maintenance operations (Photos 23 and 24). The next SAA was for operations associated with filter draining operations. There was a plastic 30-gallon container of (Waste Initiator Peroxide, D001), and a metal 20-gallon container for Waste Polymer, D001 (Photos 25 and 26). The containers were all closed, in good condition, labeled as hazardous waste, and had the appropriate hazard markings.

Photo 24: Metal 55-Gallon SAA Container in the Plant 1 Containing Waste Ethylbenzene and Water.

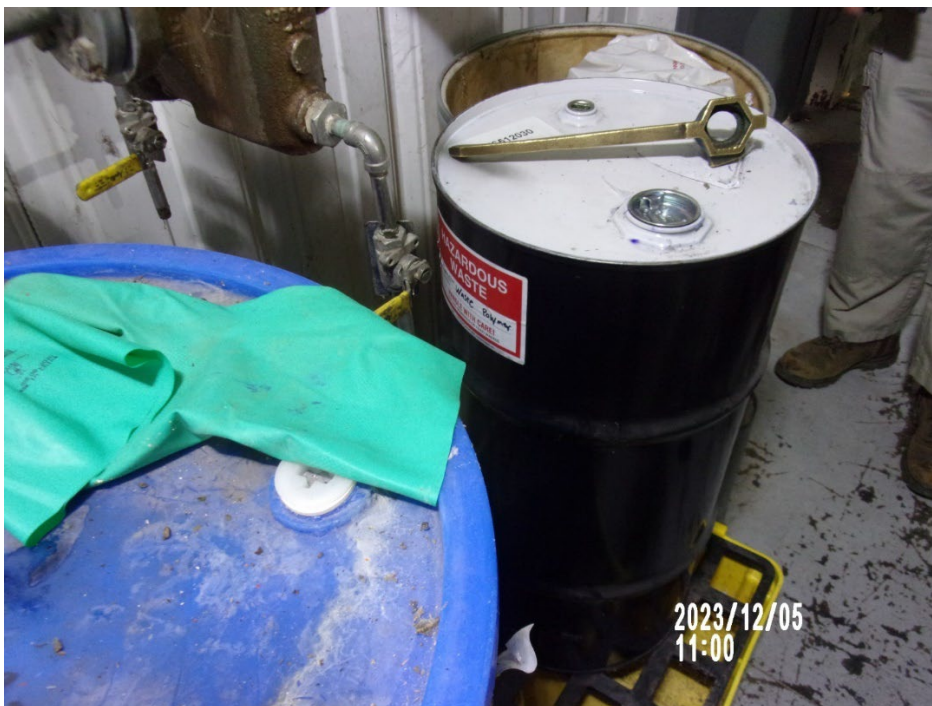
Photo 25: SAA Containers in Plant 1 Containing Waste Initiator and Waste Polymer.

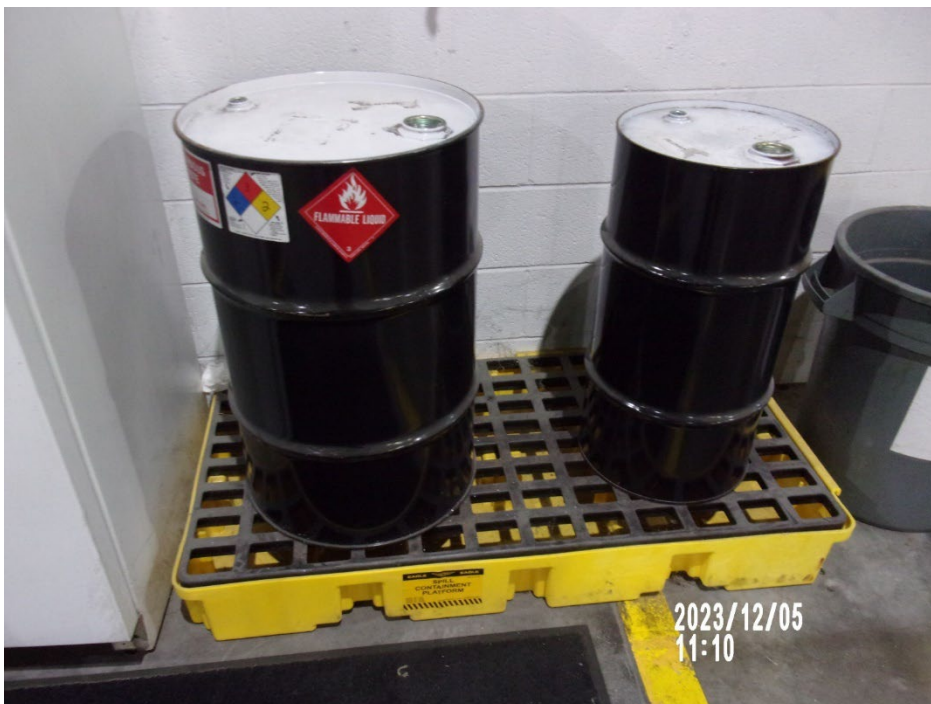
The facility had established different SAAs for different laboratory waste streams. The laboratory performs quality control testing for the entire plant and different waste streams are generated based on the production area products and materials being tested. One area (Photo 27) held a single plastic 30-gallon container of waste acid and toluene (D001, F003). One area (Photo 28) held a metal 55-gallon container of Waste Styrene (D001) and a third area (Photo 29) held a metal 30-gallon container of waste Methylene Chloride (F003). The containers were all closed, in good condition, labeled as hazardous waste, and had the appropriate hazard markings.

Photo 27: SAA Hazardous Waste Containers for the Facility Laboratory.

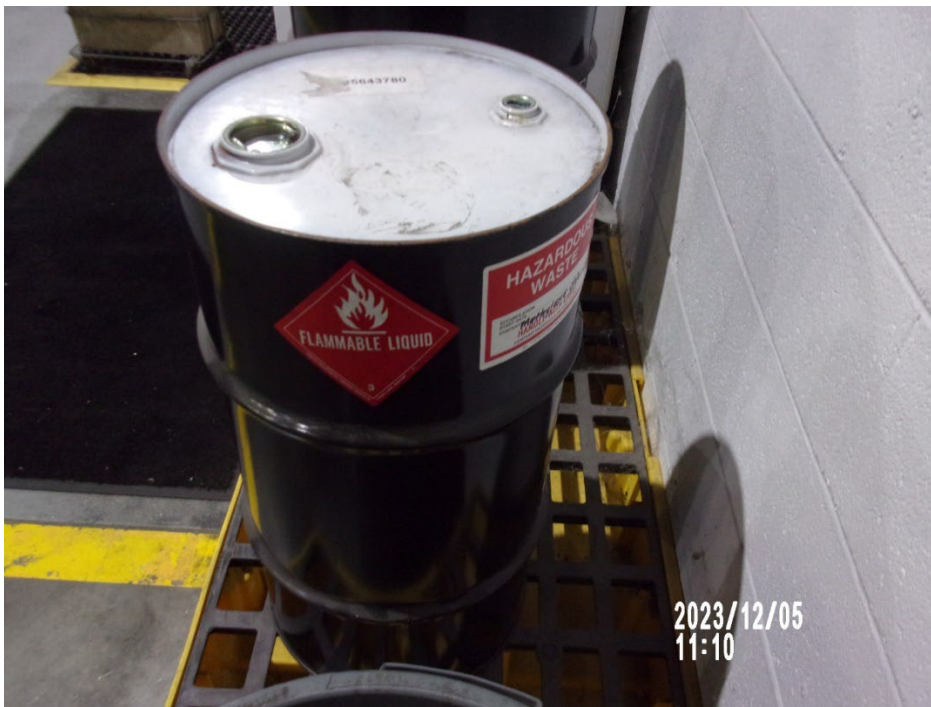
Photo 28: SAA Hazardous Waste Containers for the Facility Laboratory Containing Waste Styrene (55-Gallon Container) and Waste Methylene Chloride (30-Gallon Container).

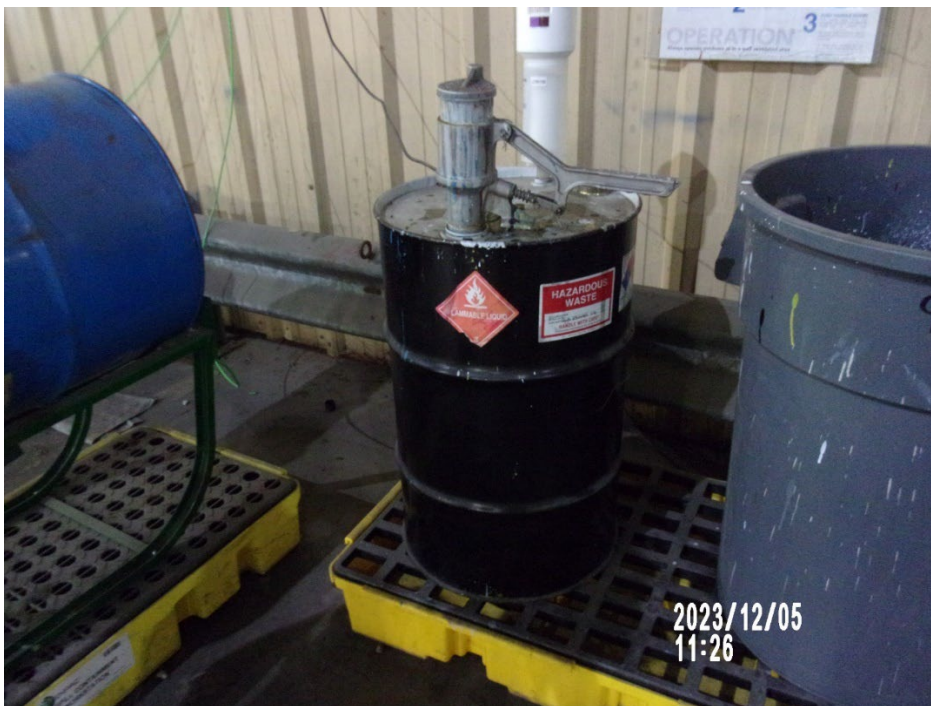
The Satellite Accumulation Area (Photo 30) had a can puncturing device that was affixed to a metal 30-gallon SAA hazardous waste container for liquids from the aerosol cans (Waste Codes D001, F003, F005). Punctured metal cans are being collected for metal recycling (Photo 31). Two plastic 210-gallon used oil tanks were present. No spills or leaks were observed. The tanks were labeled as "Used Oil" (Photo 32). There was also a SAA for paint waste (Photo 33), from painting at the facility, containing a single metal 30-gallon container (D001). The containers were all closed, in good condition, labeled as hazardous waste, and had the appropriate hazard markings.

Photo 30: Aerosol Can Puncturing Device Affixed to Metal 30-Gallon SAA Container.

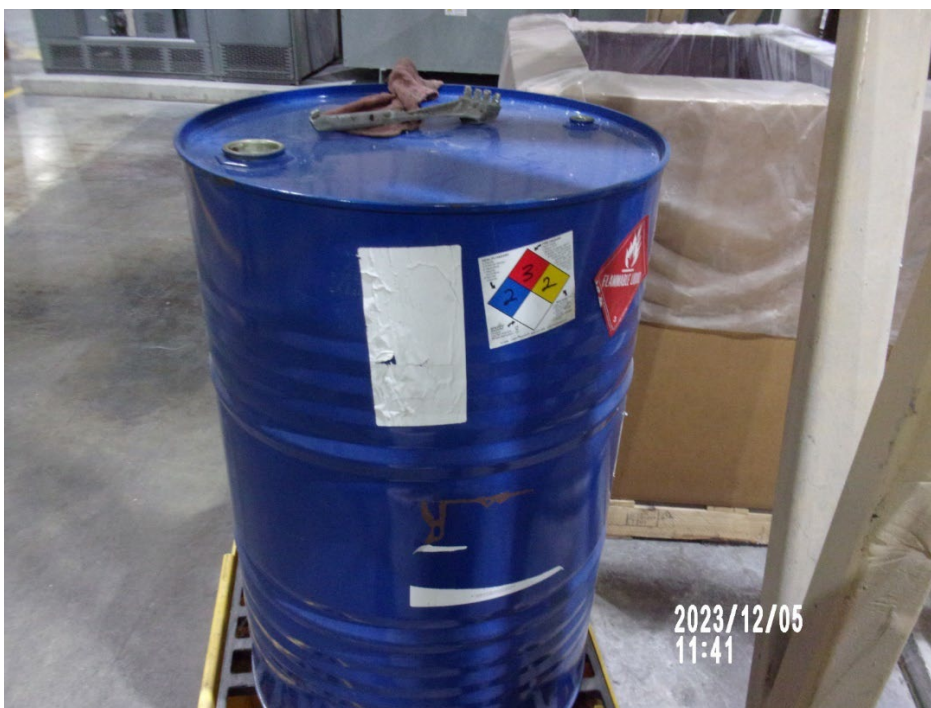
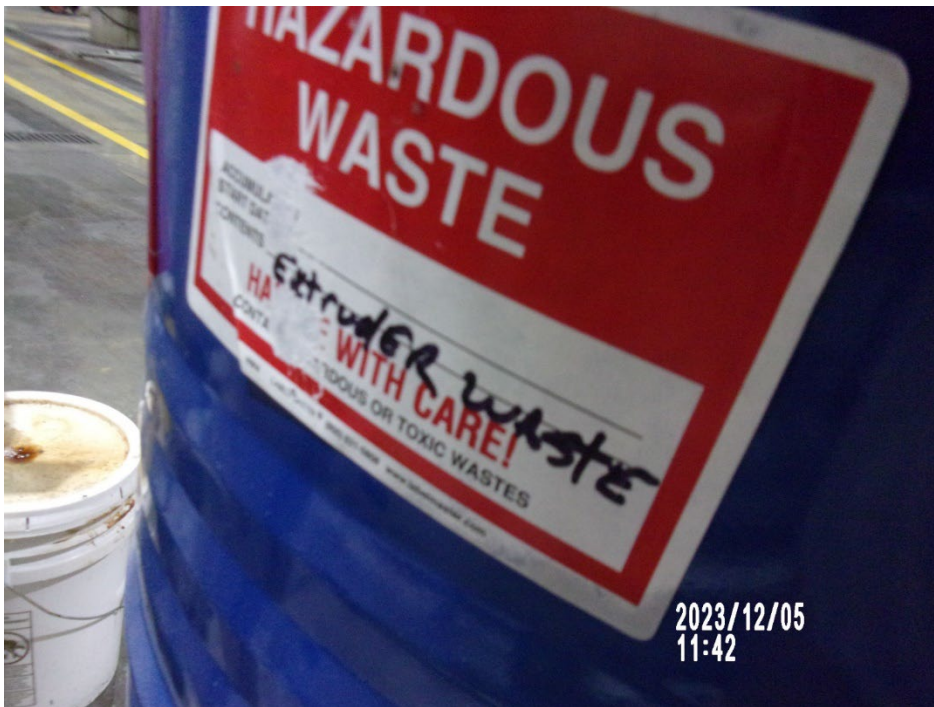
This area had a single SAA containing one metal 55-gallon container for extruder waste (Waste Styrene Monomer, D001). The container was closed, in good condition, labeled as hazardous waste, and had the appropriate hazard marking (Photos 34 and 35).

Photo 34: Metal 55-Gallon Hazardous Waste SAA Container in the Suspension Plant Containing Extruder Waste.

Photo 35: Label on Metal 55-Gallon Container Containing Extruder Waste.

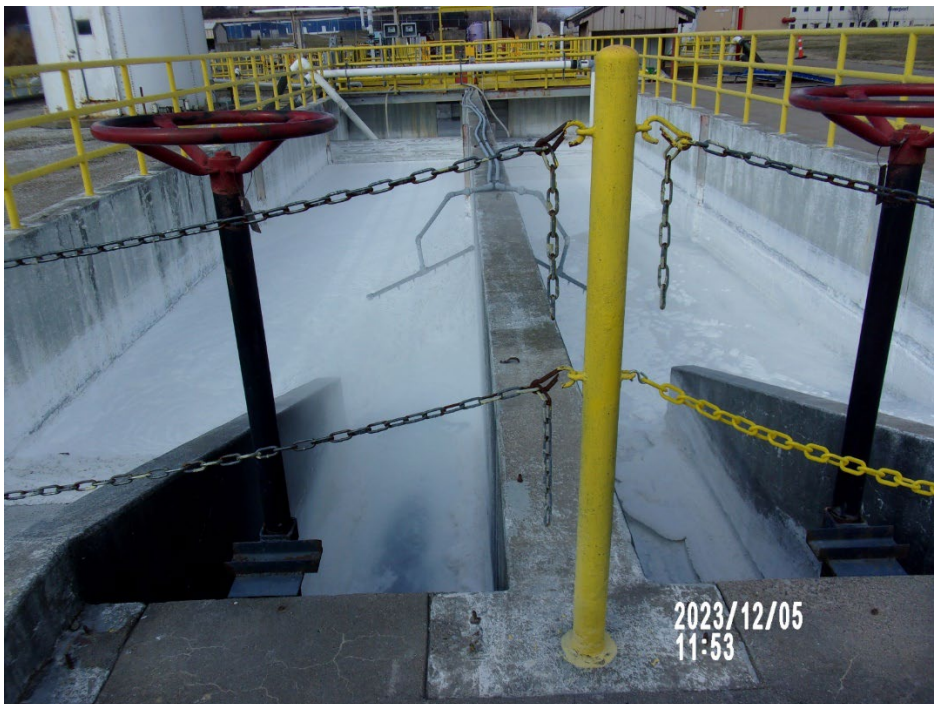
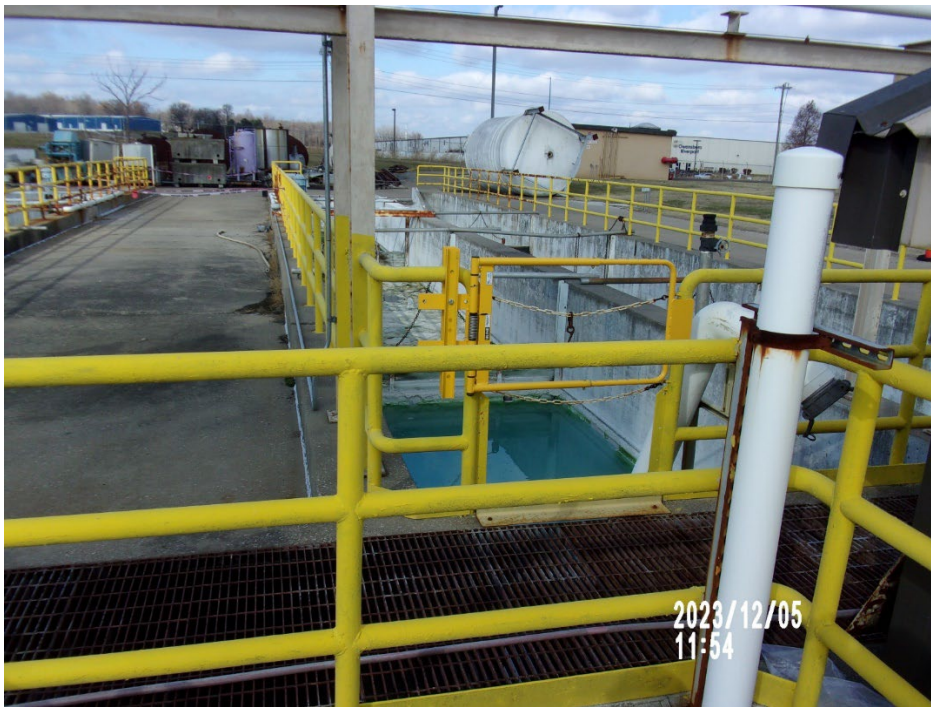
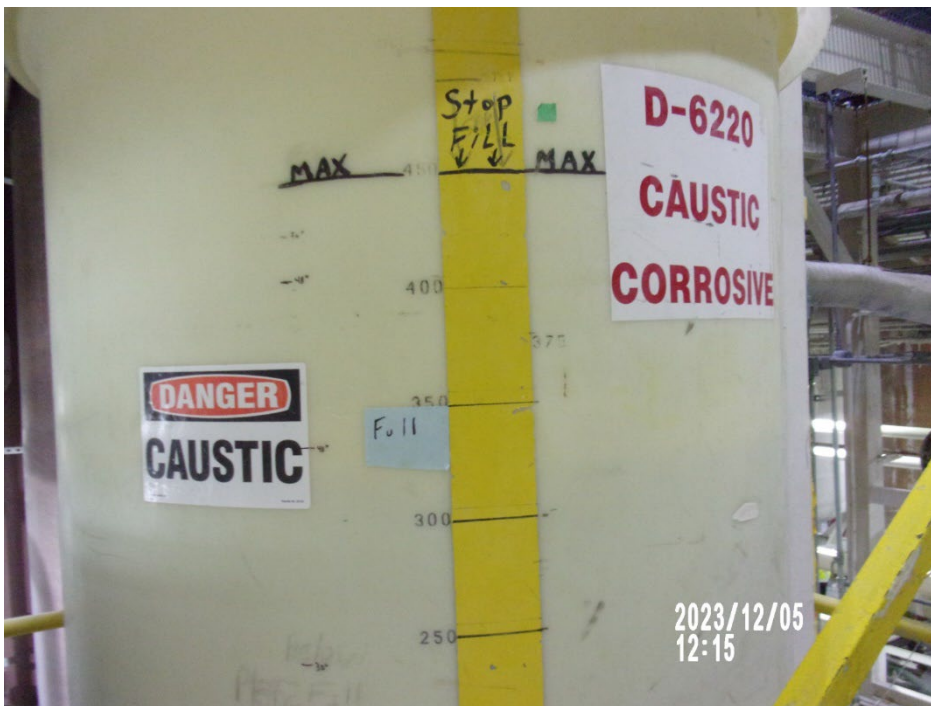
Effluent water from the suspension process and the impregnation process is hazardous for corrosivity (D002) but is managed in an on-site wastewater plant where the wastewater is neutralized (Photos 36 – 38). The facility has a Title V permit and has associated air pollution control equipment (Photo 39). The wastewater from the on-site wastewater plant is discharged to a Publicly Owned Treatment Works (POTW).

Photo 36: Wastewater Treatment tanks.

Photo 37: Wastewater Treatment Tanks.

Photo 38: Caustic Storage tank for pH Neutralization.
