## **RCRA Inspection Report**

SSAB Alabama Inc. (SSAB)  
12400 Highway 43, N  
Axis, Alabama 36505  
Mobile County

Thursday, November 21, 2024, 9:53 AM CST

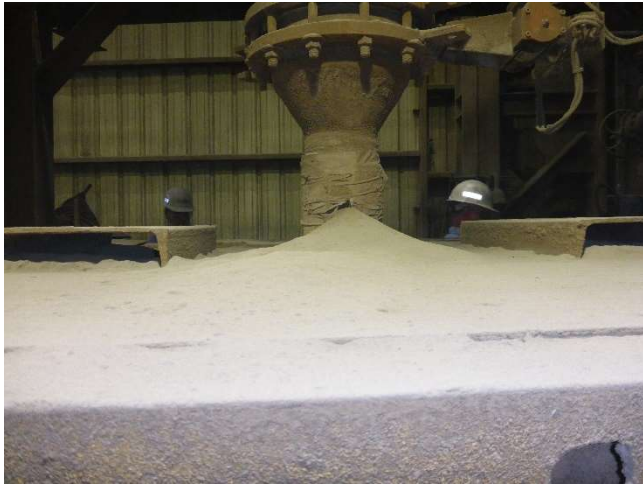
The inspection tour of the facility began in the Vacuum Tank Degasser (VTD) Storage Area. This area is located in the center of the property and is generally identified as the central accumulation area (CAA) #6, also referred to as the VTD Storage area to accumulate dust associated with the VTD operations. CAA #6 consisted of two areas adjacent to one another. One portion of the CAA included three hazardous waste tanks, and the other portion included one hazardous waste container. SSAB has determined that this dust is with a characteristic hazardous waste due to the presence of lead (D008) and, per the most recent Contingency Plan, also cadmium (D006). Three of the tanks were located together in one area and the container, a smaller collection hopper, was located across the room. The two CAA areas were clearly marked with signage and were chained off to protect from foot traffic. Two tanks and one container were observed to be open. One tank was observed with the lid propped open, one tank with a hole in the intake pipe releasing dust (Photos 1-2), and the hopper was constructed as an open-air purge system and was observed to have piles of dust along the top of the container and on the floor (Photos 3-4). The inspectors recommended that the open-air purge system be enclosed and sealed. Neither the three tanks nor the hopper had way to determine how full each was.

**Photo 1:** VTD Tanks

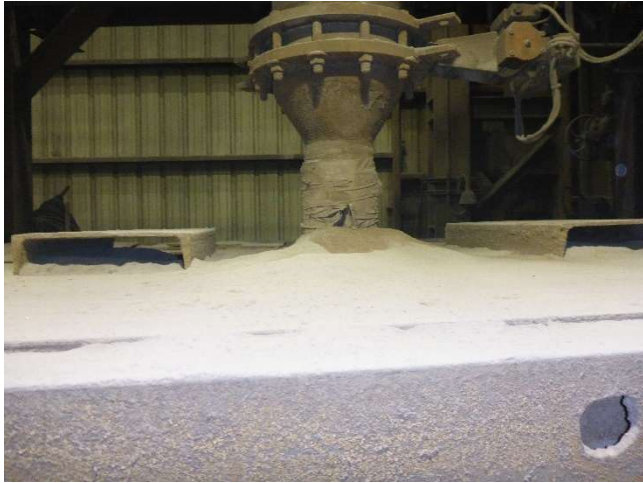
The inspectors observed that each of the tanks and container were labeled with an accumulation start date and with the words "Hazardous Waste". However, the inspectors observed that neither the three tanks nor the one hopper was marked with an indication that its contents exhibit the D008/D006 hazardous waste characteristic of toxicity, and no EPA waste codes were visible. Before leaving the area, the facility marked each hazardous waste label with the word "toxic" and with the "D008" EPA waste code. Facility personnel also made repairs to the leaking intake pipe for one tank during the inspection and immediately closed the lid on the other open tank.

**Photo 2:** VTD Tanks

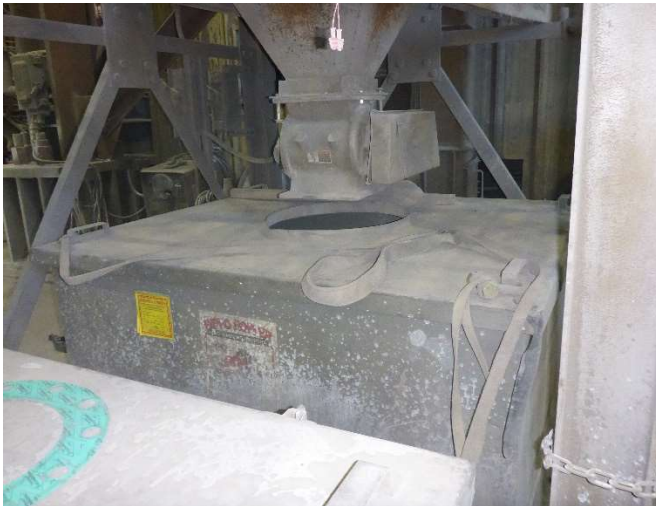
**Photo 3:** VTD Container

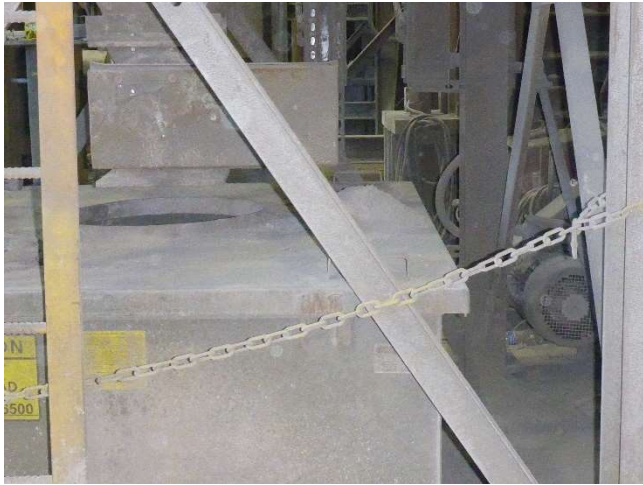
**Photo 4:** VTD Container

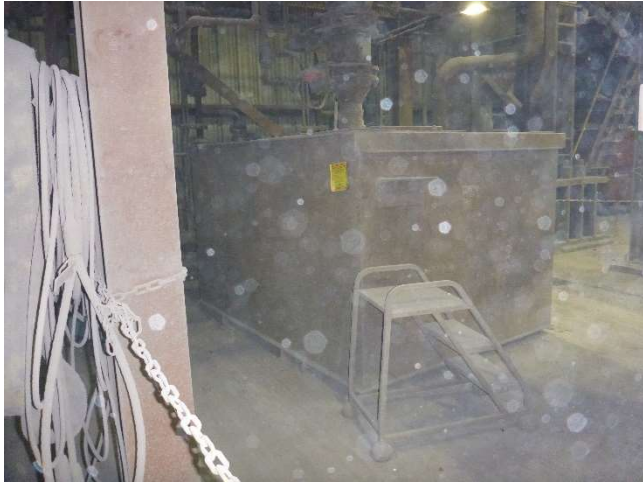
All surfaces in this area were observed to be covered in a layer of dust and visible dust particles were observed in the air (Photo 5). The tanks are in close proximity to a bay door that opens to the environment and this door was observed to be open. Facility personnel explained that the dust that was observed in this area is vacuumed out during down hours at a frequency of once a week, and that the material accumulated using the vacuum exhibits the hazardous waste characteristic of toxicity due to elevated levels of cadmium (D006) and lead (D008). SSAB has characterized the dust that is routinely removed from this area as K061 hazardous waste EAF dust. Please clarify the EPA waste codes for this waste. SSAB is required to make an accurate waste determination for this waste stream.

**Photo 5:** VTD - Visible dust

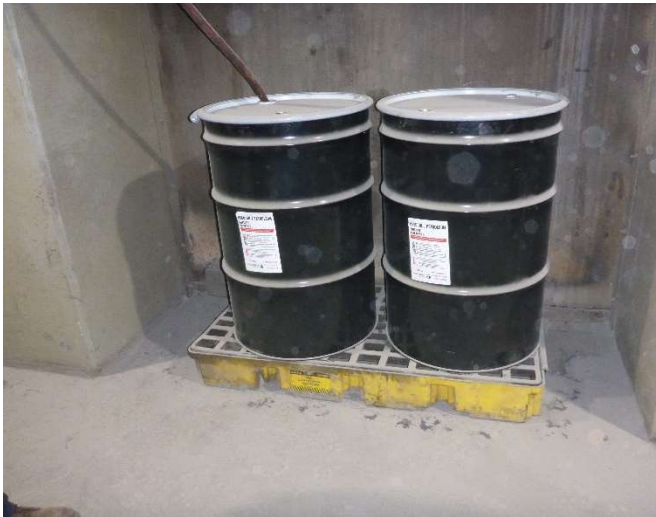
The inspectors identified two used oil 55-gallon containers. Both of these containers were on top of spill pallets, label with the words “used oil”, and in good condition (Photo 6). One container was currently being filled by an attached hose. No concerns were noted by the inspectors in this area.

**Photo 6:** Caster Building – Used Oil Storage

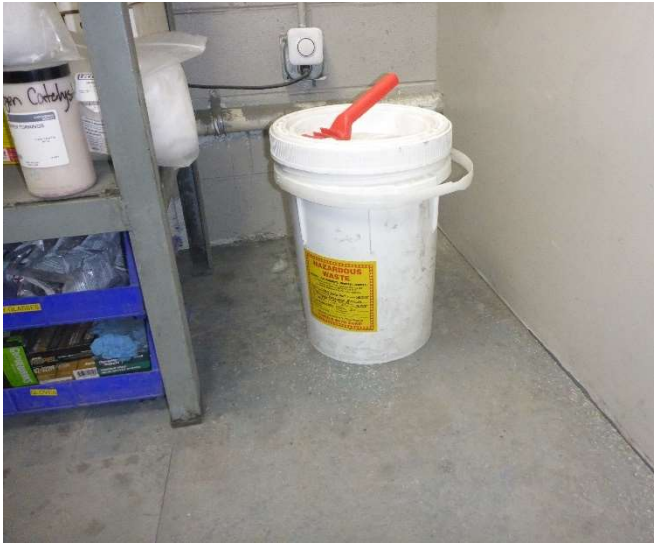
The facility manages a SAA in the QA/QC Lab area for managing hazardous waste magnesium perchlorate generated by the lab as reagent waste. This waste was observed to be in one 5-gallon bucket with the lid secured. The bucket was in good condition and marked with the words “Hazardous Waste” and the D001 EPA waste code for a flammability characteristic (Photo 7). The container was also marked with a DOT oxidizer hazard label.

**Photo 7:** QA/QC Lab Waste

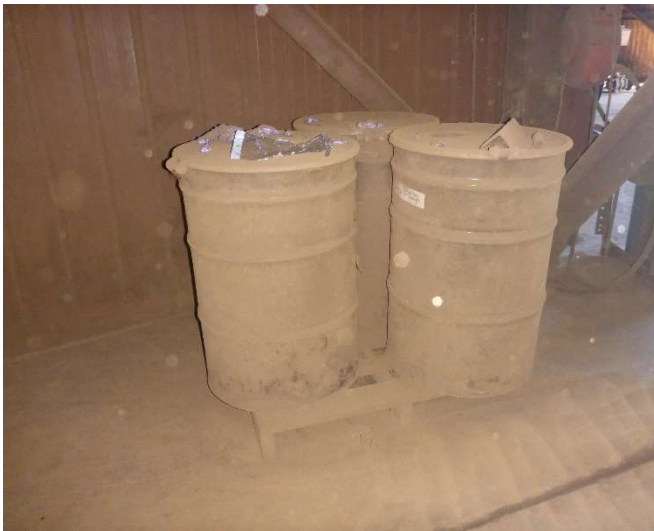
In the EAF Baghouse area, the inspectors observed five containers, which were unlabeled. These were observed to be in good condition but looked to have been sitting for a long period of time (Photo 8). Facility personnel stated that the containers held metal, which will be recycled on-site in the EAF.

**Photo 8:** EAF Baghouse – Containers 3 of 5 unlabeled

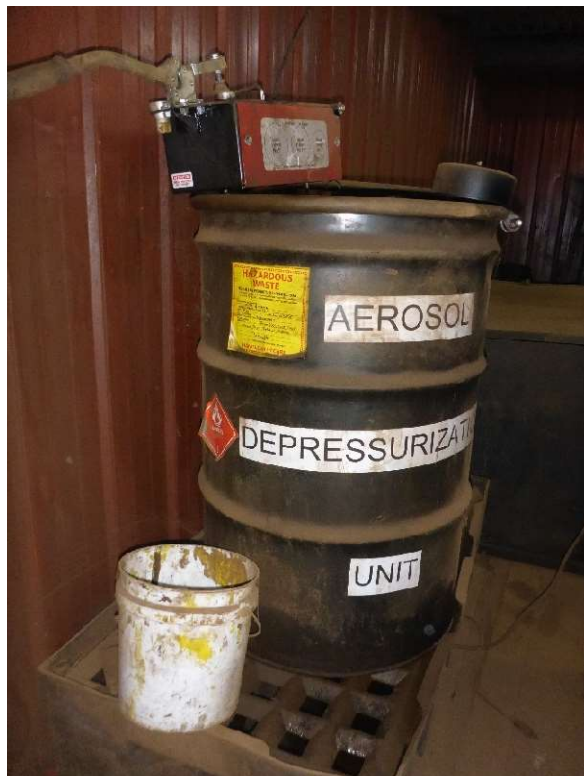
SAAB identified one designated SAA for managing aerosol can paint waste liquid; and the inspectors observed one 55-gallon container in this SAA. This container was marked "Aerosol Depressurization Unit", it had a label with the words "Hazardous Waste" with the EPA waste codes D001, D035, F003, and a DOT flammable hazard sticker (Photo 9). Pursuant to ADEM Admin. Code r. 335-14-2-.03(5)(b) [40 C.F.R. § 261.24(b)], D035 hazardous waste is a solid waste exhibiting the characteristic of toxicity for MEK, but the container was not marked with an indication that its contents exhibit the hazardous waste characteristic of toxicity. The inspectors also observed that the container had spilled liquid on the top but was closed and in good condition. This container also had a sufficient secondary containment spill pallet. One 55-gallon container contained punctured used cans and facility personnel noted that they would be sent out with the municipal plant trash or recycled. Regulations require the punctured cans to be recycled. Pursuant to ADEM Admin. Code r. 335-14-11-.02(4)(e)4. [40 C.F.R. § 273.13(e)(4)].

**Photo 9:** EAF Baghouse – Aerosol SAA

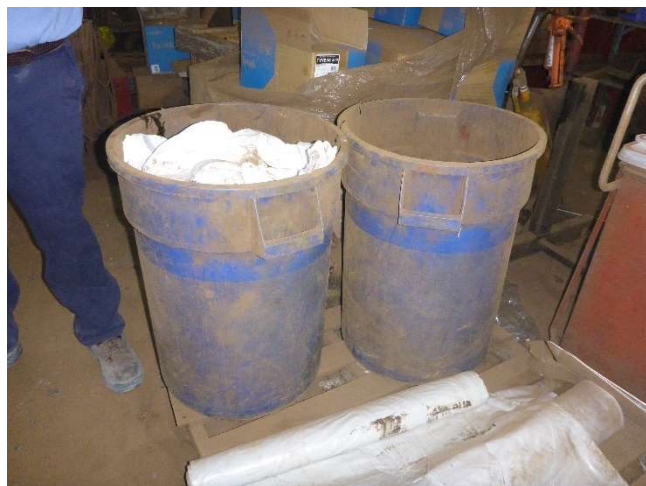
The inspectors observed two open top trash cans containing used PPE and debris in a second SAA at the EAF Baghouse area. Facility personnel stated that the PPE and debris were contaminated with K061 dust and will be transferred to the compactor unit before being shipped off-site as hazardous waste. The trash cans were not labeled with the words "Hazardous Waste" or with an identification of the hazards of their contents; they were not equipped with a lid to close the container (Photo 10). Although the total capacity of these trash cans exceeds 55-gallon limit set forth by the SAA Permit Exemption, it appeared that the volume of waste managed in the containers at the time of the inspection was less than 55 gallons.

**Photo 10:** EAF Baghouse – Open top trash cans with contaminated PPE and debris

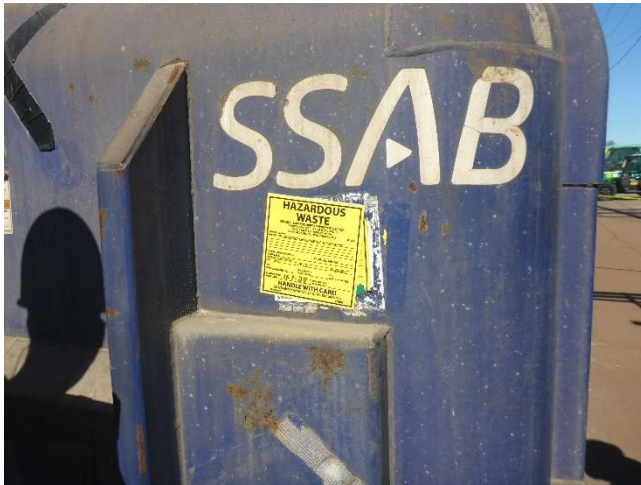
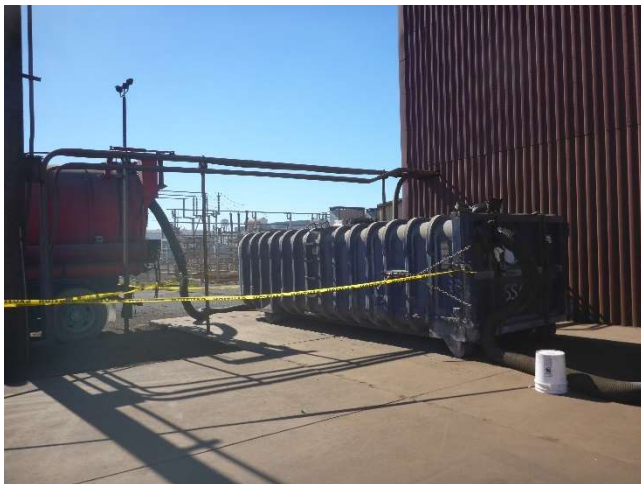
On the east exterior of the baghouse, the inspectors observed a contractor truck with a large vacuum hose intended to vacuum up the K061 dust and prepare it for hauling off-site. This vacuum hose was attached to a vacuum box designated as a CAA container. The container was labeled with the words "Hazardous Waste", with the EPA waste code K061, with an

accumulation start date of November 1, 2024, and with the phrase “contains hazardous or toxic waste” (Photos 11-12).

**Photo 11:** East of EAF Baghouse – Vac box

**Photo 12:** East of EAF Baghouse – Vac box, vacuum hose, and contractor truck

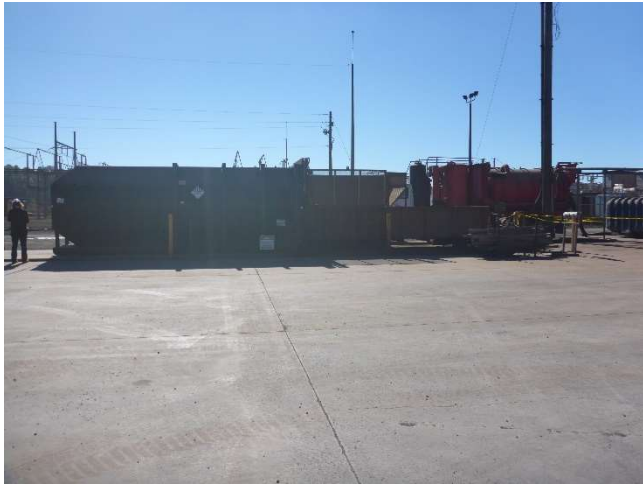
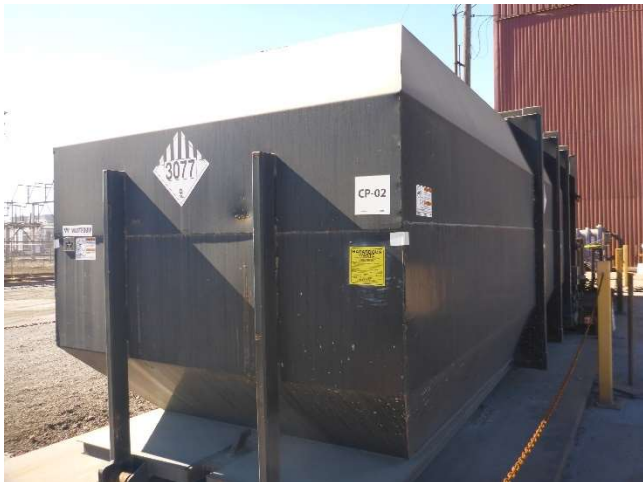
The compactor box, located outside of the EAF Baghouse is identified as CAA #3. The compactor box is utilized for the accumulation and compaction of hazardous waste debris and PPE contaminated with K061 dust. The compactor was observed by the inspectors to be in good condition, labeled with the words “Hazardous Waste”, identified with the EPA waste code K061, marked with an accumulation start date of September 30, 2024, and labeled with the phrase “contains hazardous or toxic waste” (Photos 13-14). This area was observed to be marked with a chain and sign with the words “Danger”.

**Photo 13:** East of EAF Baghouse – Compactor

**Photo 14:** East of EAF Baghouse – Compactor

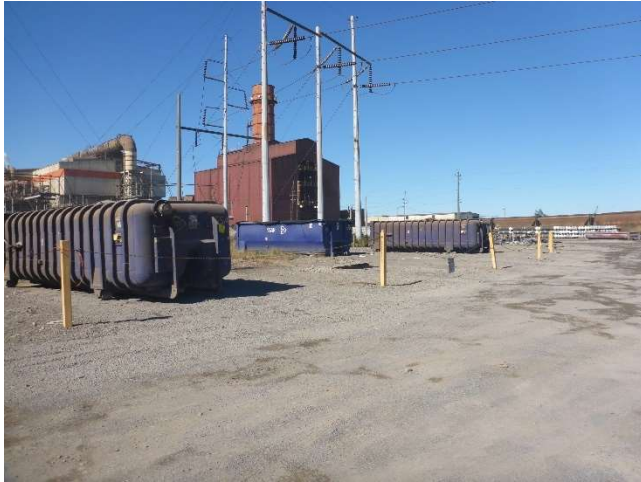
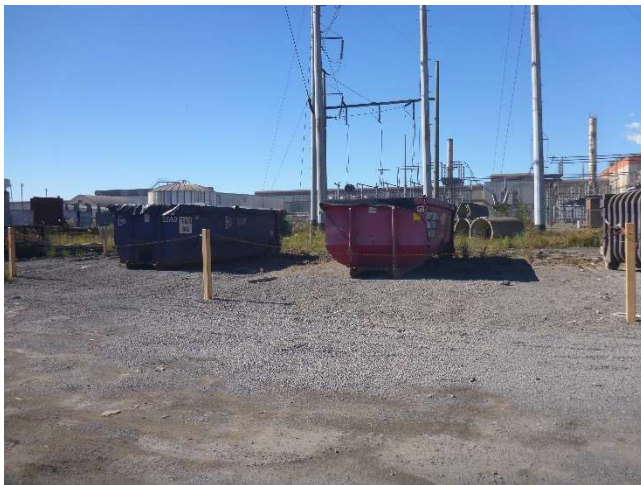
An outdoor CAA storage pad located east of the baghouse is identified as CAA #2. This CAA is designated for the storage of 25 cubic yard vacuum storage boxes (vac boxes) and 30-yard roll-off dumpsters with EAF baghouse dust and contaminated debris. The inspectors observed a total of five containers, including two vac boxes and three 30-yard roll-offs. Each container was observed to be in good condition, labeled with the words “Hazardous Waste”, marked with the EPA waste code K061, marked with an accumulation start date of October 14, 2024, and labeled with the phrase “contains hazardous or toxic waste” (Photos 15-16). The 30-yard roll off containers were tarped securely at the top. This area was observed to be marked with a chain and sign with the words “Danger”.

**Photo 15:** East of EAF Baghouse – Storage Pad

**Photo 16:** East of EAF Baghouse – Storage Pad

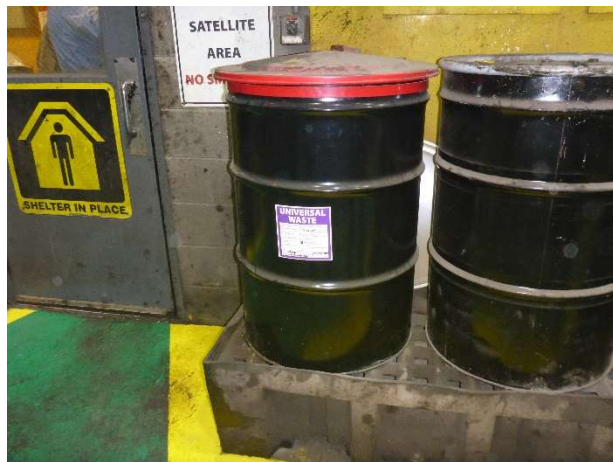
The Rolling Mill and Roll Shop production area is located mid property, south of the Reheat Furnace. The facility manages ‘non-empty’ aerosol cans in the Roll Shop as universal waste. The inspectors observed that the aerosol cans were stored in a 55-gallon container with a purple universal waste sticker. The label was dated October 17, 2024, and marked with an ‘X’ to indicate that contained non-empty aerosol cans. The container was on top of a secondary containment spill pallet and had a metal lid that was closed and secured (Photo 17).

**Photo 17:** Roll Shop – Universal Waste

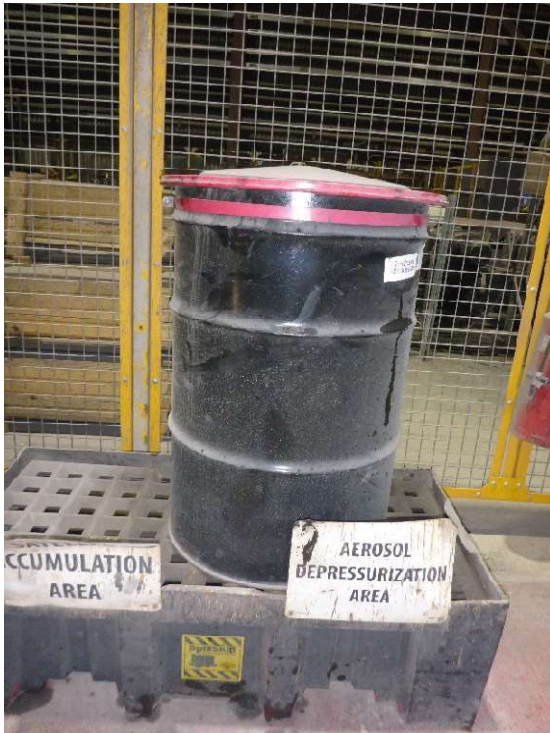
The inspectors also observed two 55-gallon containers with non-empty aerosol cans in the Finishing area. The first container had no universal waste label and was not dated. This container was on top of a secondary containment spill pallet and had a metal lid that was closed and secured (Photo 18). Facility personnel immediately added a universal waste label to the container as it was noticed.

**Photo 18:** Finishing Dept. – Universal Waste

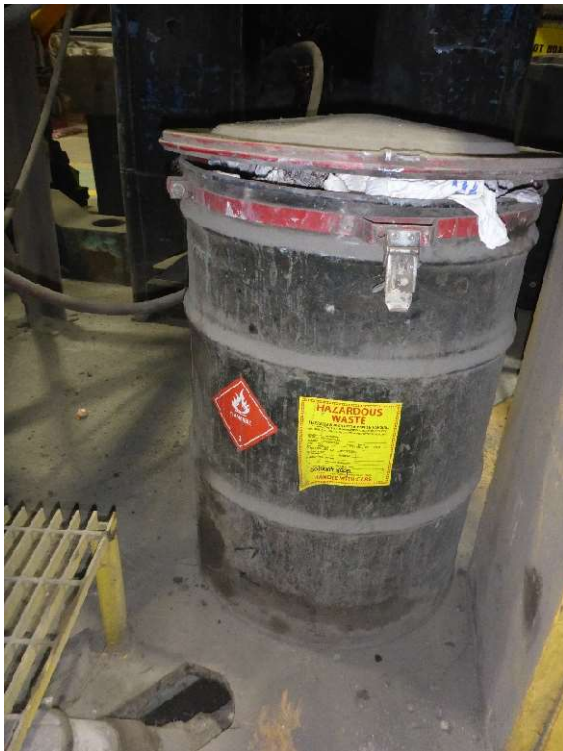
SSAB also manages an SAA for solid paint waste that is generated in the Finishing area. The inspectors observed a 55-gallon container labeled with the words “Hazardous Waste”, “Solvent rags”, EPA waste codes D001, D035, and F003, and a DOT flammable hazard sticker in this SAA (Photo 19). Pursuant to ADEM Admin. Code r. 335-14-2-.03(5)(b) [40 C.F.R. § 261.24(b)], D035 hazardous waste is a solid waste exhibiting the characteristic of toxicity for MEK. However, the container was not marked with an indication that its contents exhibit the hazardous waste characteristic of toxicity. This container was also observed to be open and full.

**Photo 19:** Finishing Dept. – Solvent rag container

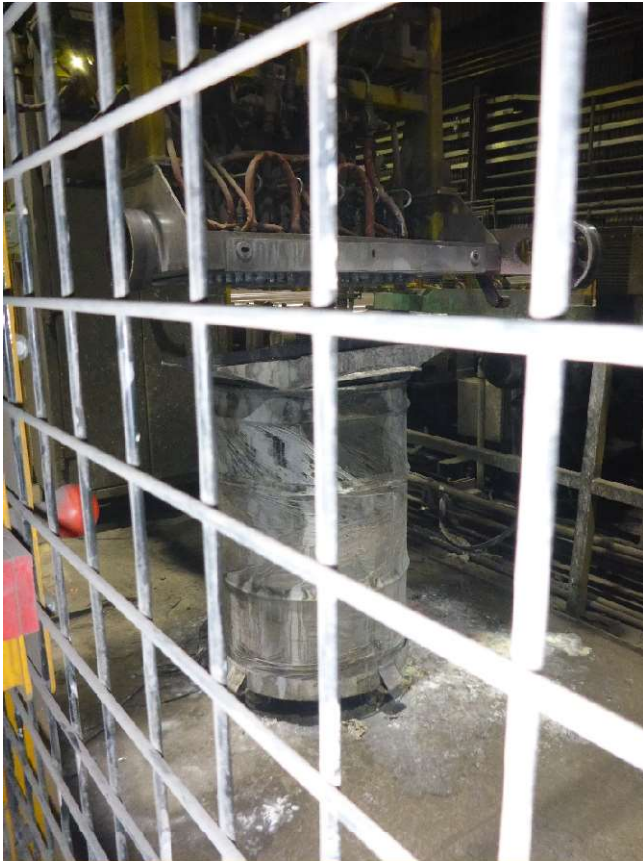
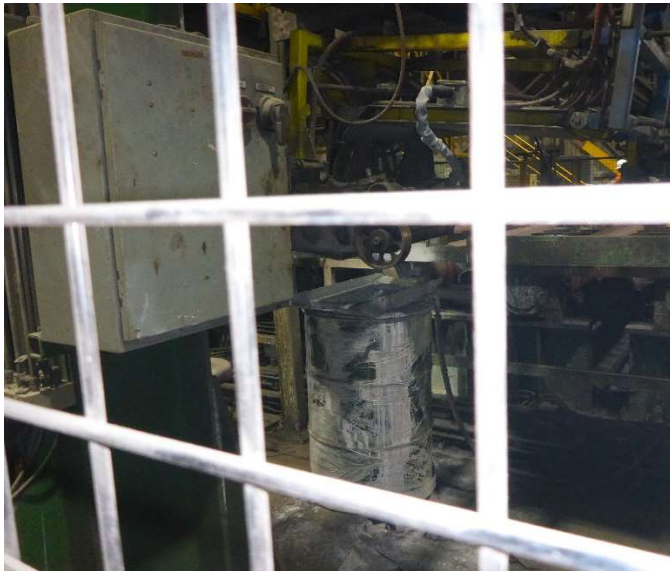
The spent solvent mixture is pumped via piping into a 55-gallon container labeled with a DOT flammable sticker and additional stickers with the words “solvent waste holding drum” and “recyclable solvent”. The spent solvent is transferred via a hose into a 16-gallon solvent reclamation unit. The unit has what looks to be a built-in secondary containment sump, but it was not discussed during the inspection. Once processed, the clean solvent is discharged into a clean solvent storage tank before it is reused onsite. The reclamation unit generates hazardous waste still bottoms that are accumulated in a SAA next to the unit. The inspectors observed one 55-gallon container of hazardous waste still bottoms in this SAA. The still bottoms container was observed to have a label with the words “Hazardous Waste” and was closed securely. The container was not marked with an indication that its contents exhibit the hazardous waste characteristic of toxicity or ignitability (Photo 22). Facility personnel added the words “flammable” and “toxic” to the label and applied a DOT flammable sticker.

**Photo 20:** Finishing Dept.- Solvent recovery collection container

**Photo 21:** Finishing Dept.- Solvent recovery collection container

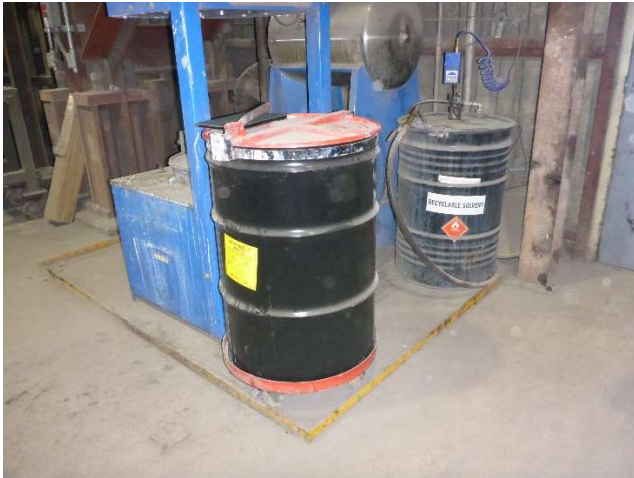
**Photo 22:** Finishing Dept. – Still bottoms container and solvent recovery unit

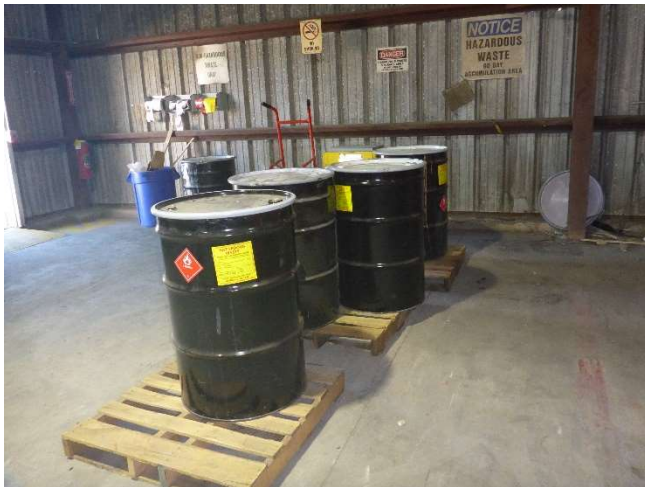
The Oil Storage Building is located on the southwestern side of the property and is generally identified as CAA #1. This building is utilized for storage before shipment of a variety of waste with the majority in 55-gallon containers. Signs with the words “no smoking”, “notice hazardous waste 90-day accumulation area”, and “danger” were observed by the inspectors. Security for this building included a keypad, cameras, and alarm. At the entry point for the building, the inspectors observed four 55-gallon containers of hazardous waste. Each container was in good condition, marked with the words “Hazardous Waste,” labeled with a DOT flammable sticker, and marked with an accumulation start date (Photo 23). One container of D001, D035, F005 hazardous waste paint related material was not marked with an indication that its contents exhibit the hazardous waste characteristic of toxicity.

**Photo 23:** Oil Storage Building – Hazardous waste containers

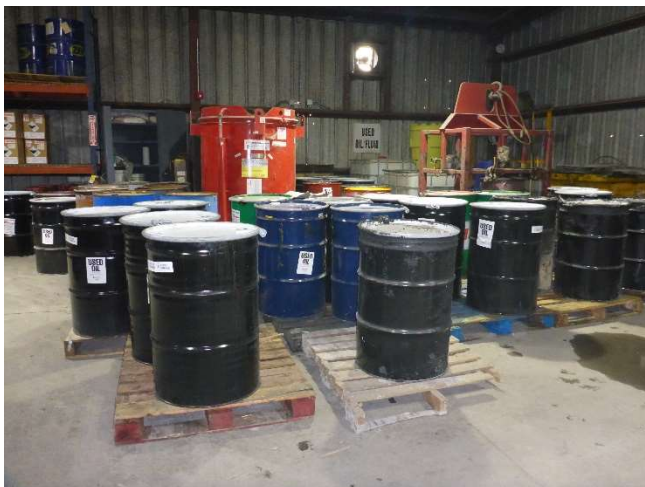
The inspectors noted thirty-seven 55-gallon and eight 5-gallon containers with used oil as the majority of the containers in the building, with a few nonregulated corrosives, DOT hazardous materials, and one universal waste container (Photo 24). The one universal waste container was marked ‘non-empty’ aerosol cans. The inspectors observed that the aerosol cans were stored in a 55-gallon container with a purple universal waste sticker. The label was dated October 31, 2024, and had an ‘X’ marked on a box on the label indicating that it was non-empty aerosol cans. The container was on top of a secondary containment spill pallet and had a metal lid that was closed and secured.

**Photo 24:** Oil Storage Building – Used oil

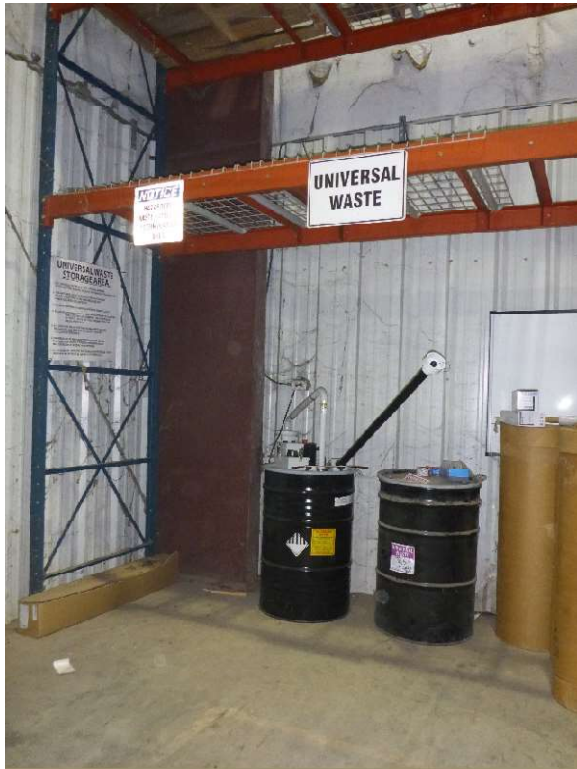
This warehouse is located adjacent to the Oil Storage Building and the Administrative Building. In addition to storage of parts and packing materials, SSAB also uses this area to crush used lamps and accumulate the crushed material as hazardous waste. The inspectors observed one 55-gallon container in the lamp-crusher area. The container lid was secure, and all components of the lamp-crusher unit appeared to be intact. This container had a label with the words “Hazardous Waste”, “toxic”, and an EPA waste code of D009 for mercury. The inspectors also observed another 55-gallon container, which was closed, labeled with a purple universal waste sticker that had the words “Used Ballasts,” and dated July 31, 2024 (Photo 25).

**Photo 25:** Logistics Warehouse – Universal and hazardous waste

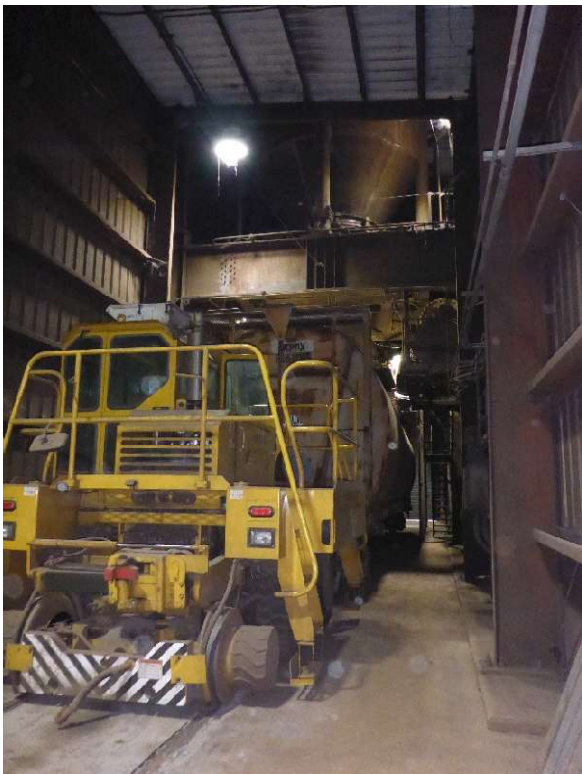
The EAF Baghouse is attached to a collection silo that stores the K061 baghouse dust and a K061 dust loadout building. The baghouse dust is transferred from the silo in the loadout building (Photo 26). Facility personnel explained the loadout procedures and stated that during loadout, the operation is staffed at all times and the building doors are closed from start to finish. The inspectors noticed a plastic 30-gallon container labeled with a hazardous waste sticker and was located under a SAA sign. This container was identified as a waste container for PPE contaminated with K061 dust. It was in good condition, labeled with the words "Hazardous Waste," marked with an indication that its contents are toxic, and closed (Photo 27). The building also has a vacuum system used for cleaning the area that attaches to vac boxes. The vacuumed dust is stored inside of vac boxes located outside of the loadout area. The inspectors observed two vac boxes in the chained off area identified as CAA #4 (Photo 28). Each vac box was in good condition, marked with an accumulation start date of November 1, 2024, labeled with the words "Hazardous Waste," labeled with the words "contains hazardous or toxic waste", and labeled with the EPA waste code K061 (Photo 28).

**Photo 26:** EAF Baghouse - Loadout Building

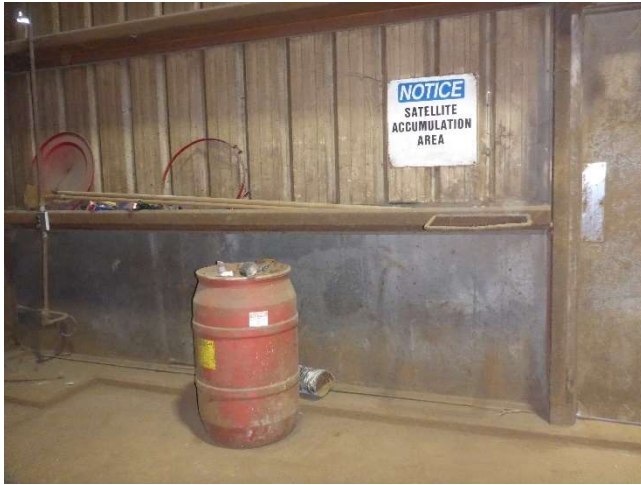
**Photo 27:** EAF Baghouse - Loadout Building - Contaminated PPE container

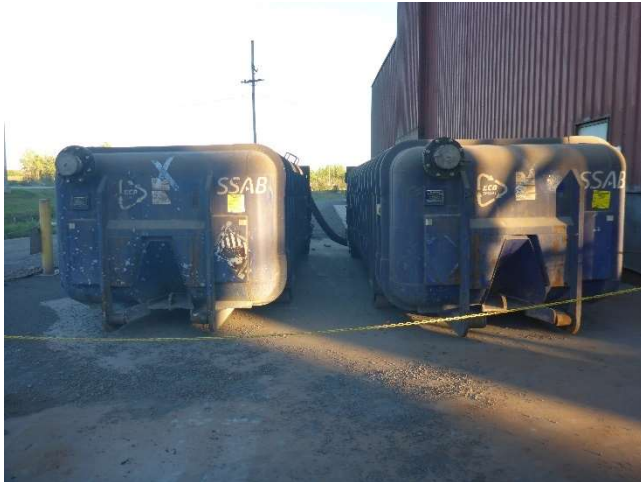
**Photo 28:** EAF Baghouse – CAA #4
