## **RCRA Inspection Report**

McEntire Joint National Guard Air Base  
1325 South Carolina Road  
Eastover, South Carolina 29044

EPA ID #: SC4572825160

April 13, 2021

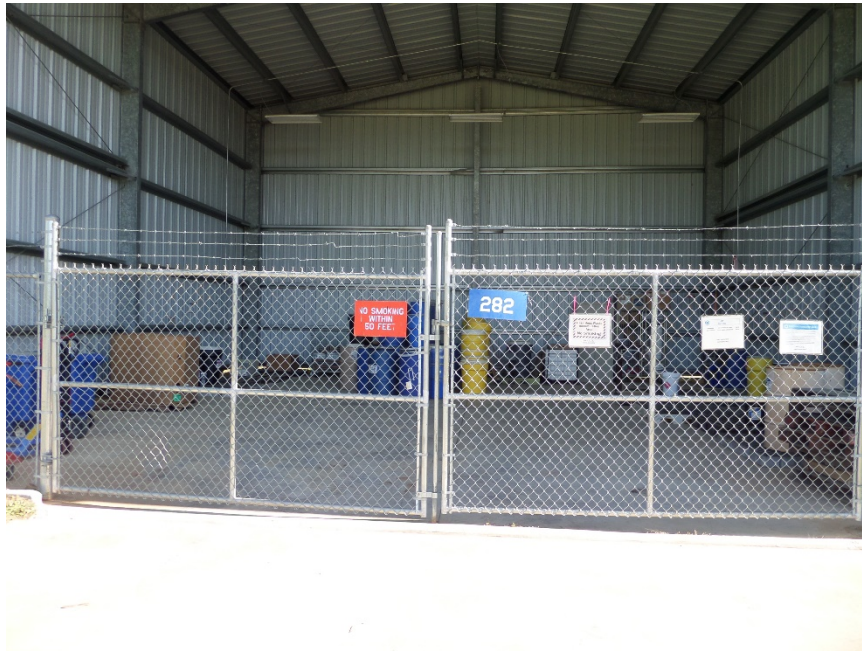
McEntire JNGB operates a CAA for temporary storage of its hazardous wastes, used oils and universal wastes prior to off-site shipment. The CAA is a three-sided metal building with a gated chain link fence, and concrete bermed floor (Photograph 1). The CAA was identified with a sign which read “Hazardous Waste Accumulation Area No Smoking” The CAA was equipped with a safety shower and eyewash unit, spill containment kit and a fire extinguisher.

Photograph 1: Front view of McEntire JNGB's hazardous waste central accumulation area.

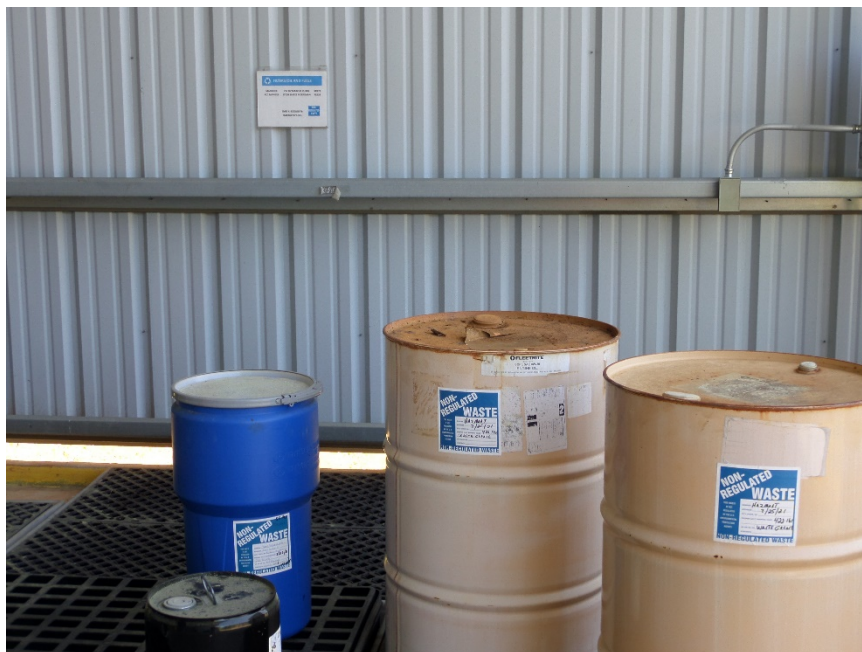
The facility stores waste segregated by waste classification and combustibility. All containers were stored along the two side walls of the building and on self-contained pallets. In the area assigned for non-RCRA regulated wastes, the inspectors observed two 55-gallon containers of waste grease, and two containers of Cee-Bee® cleaner (one 14-gallon container and one 5-gallon container). All containers were labeled, closed, and appeared to be in good condition (Photograph 2).

Photograph 2: Non-RCRA regulated grease waste containers in the facility's hazardous waste central accumulation area.

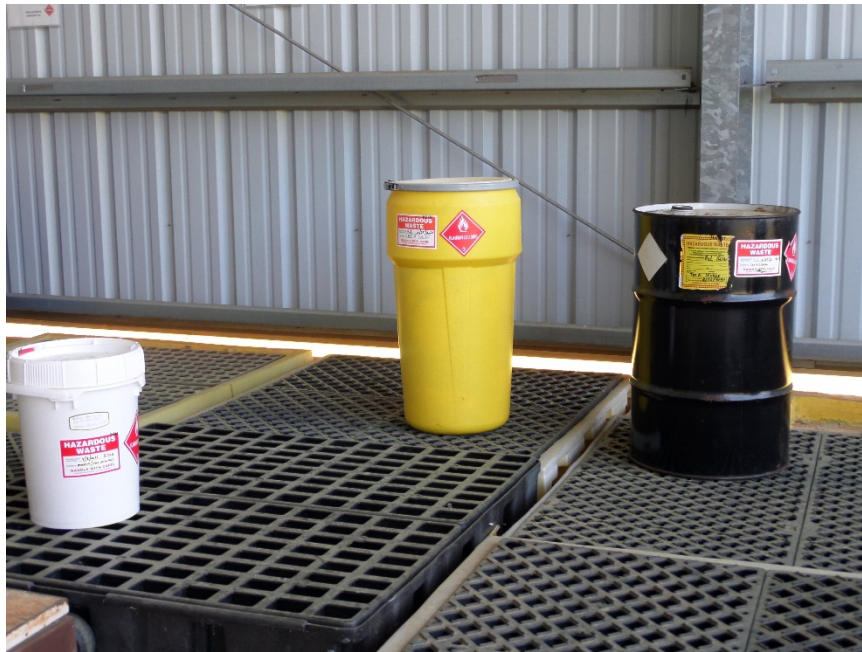
In the area assigned for RCRA regulated wastes, the inspectors observed one 14-gallon container of jet fuel contaminated absorbent pads, one 30-gallon container of jet fuel sludge and one 5-gallon container reported to contain a spent carbon canister from the paint cans puncturer unit. All hazardous waste containers were dated, closed, and appeared to be in good condition (Photograph 3).

Photograph 3: Hazardous waste containers in the facility's hazardous waste central accumulation area.

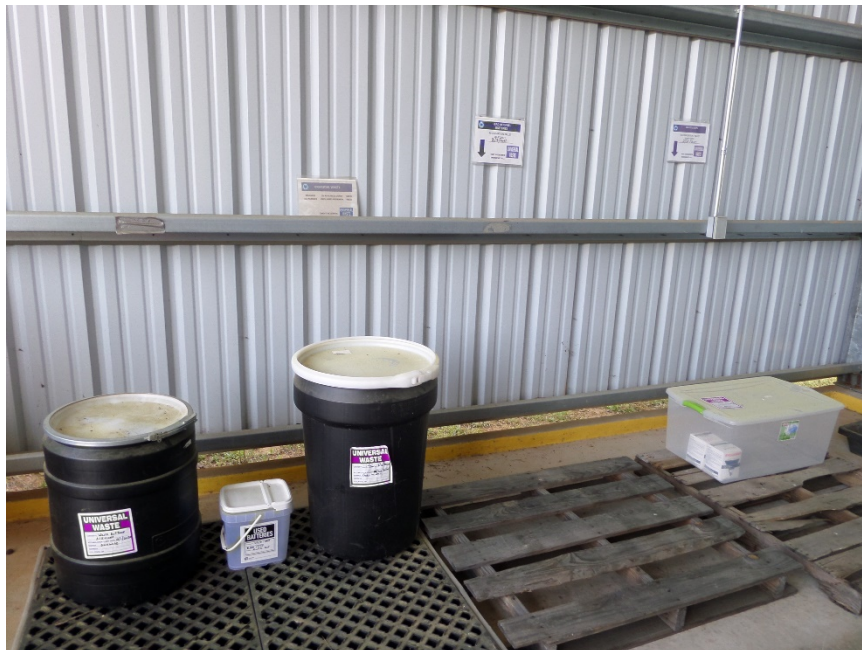
In the universal waste (UW) storage section, the inspectors observed one container of UW lamps, one container of lithium batteries, one container of UW alkaline batteries and one container of UW nickel-cadmium batteries. All containers were dated, closed, and appeared to be in good condition (Photograph 4).

Photograph 4: Universal waste containers in the facility's hazardous waste central accumulation area.

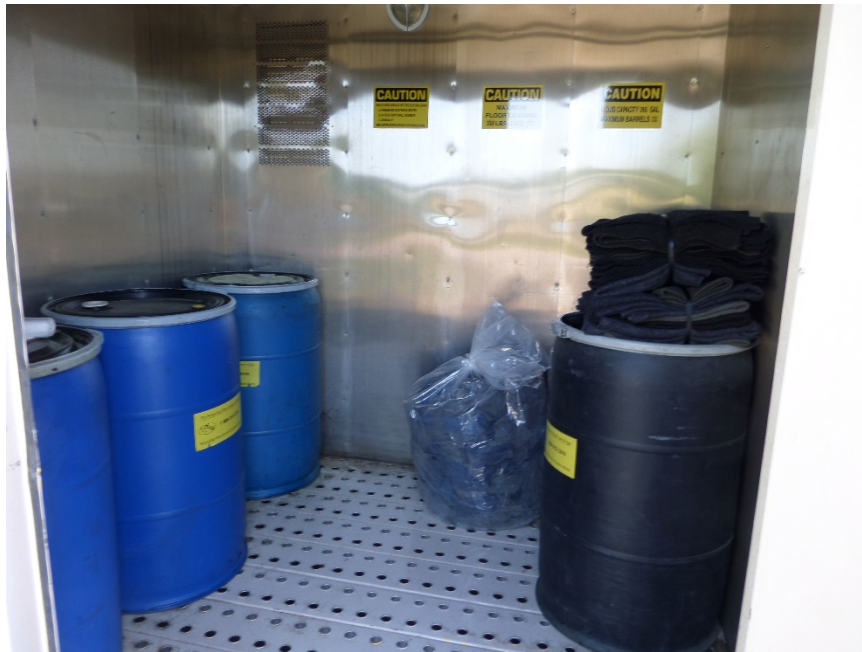
Adjacent to the CAA, the inspectors observed four self-contained metal shelters. In shelter D, the inspectors observed one 55-gallon container of non-RCRA regulated waste oil contaminated rags to be laundered (Photograph 5). No waste management activity was reported for shelter C. In shelter B, the facility operates an aerosol can puncturing device to empty its hazardous waste paint aerosol cans. The puncturing device was attached to the bung hole of a 30-gallon container.

Photograph 5: Shelter D - one 55-gallon container of non-RCRA regulated waste oil contaminated rags to be

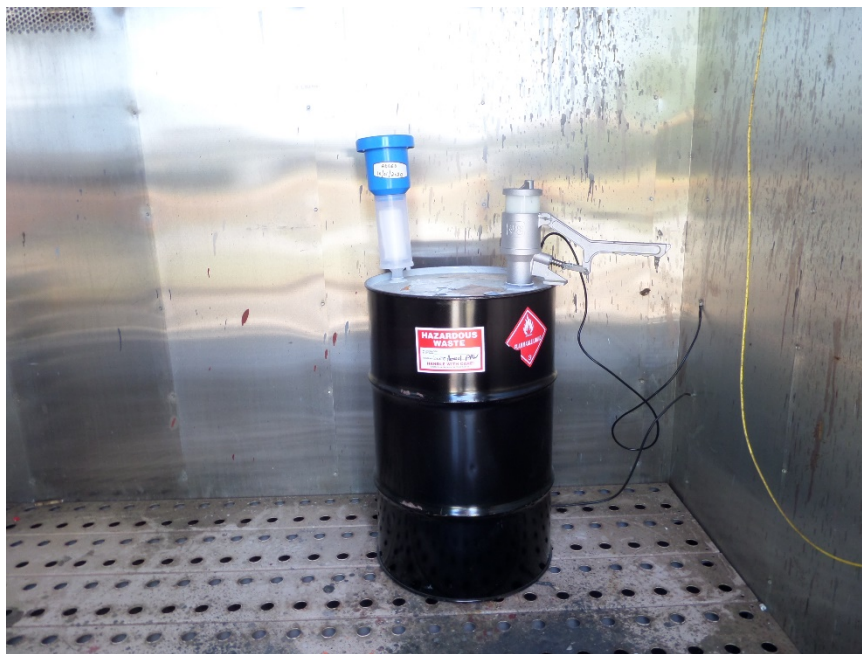
The container was properly labeled, closed, and appeared to be in good condition (Photograph 6). In shelter A, the facility operates an aerosol can puncturing device to empty its hazardous waste aerosol oil/lube cans. The puncturing device was attached to the bung hole of a 30-gallon container. The container was properly labeled, closed, and appeared to be in good condition (Photograph 7).

Photograph 6: Shelter B- Hazardous waste accumulation container with aerosol can puncturing device used to empty hazardous waste paint aerosol cans generated at the facility.

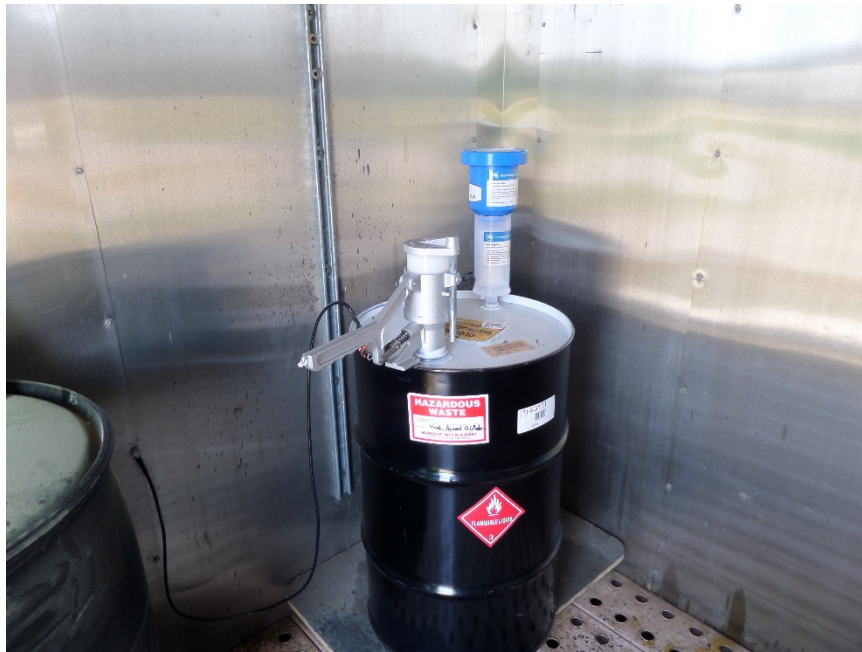
Photograph 7: Shelter A – Hazardous waste accumulation container with aerosol can puncturing device to empty hazardous waste aerosol oil/lube cans generated at the facility.

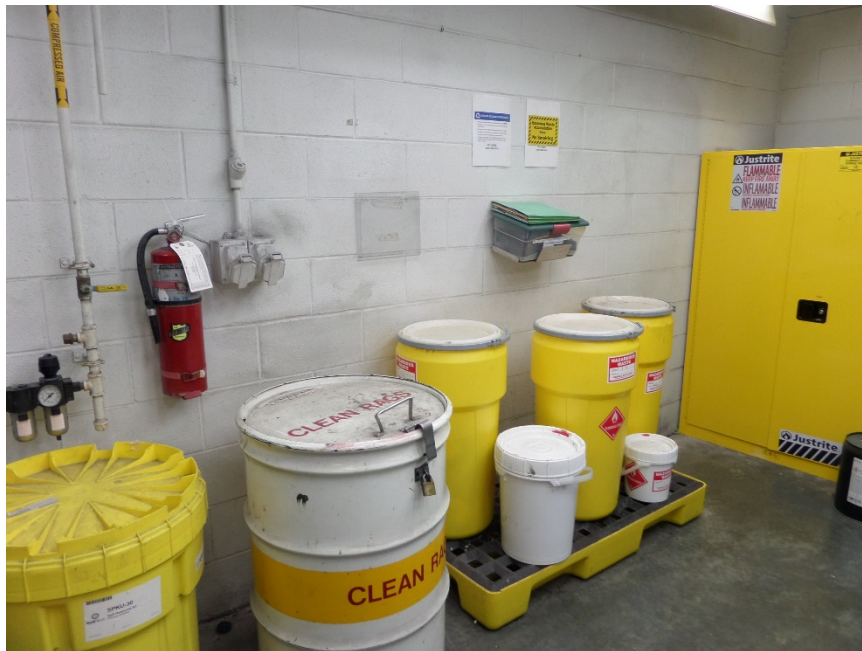
In satellite accumulation area (SAA) 019, the inspectors observed one 14-gallon container with hazardous waste resins, one 14-gallon container of flammable hazardous waste resins, one 14-gallon container of hazardous waste resin hardener contaminated materials, one 14-gallon container of hazardous waste paint waste, one 5-gallon container of hazardous waste spent cleaning solution and one 1-gallon container of spent alodine. All hazardous waste containers were properly labeled, closed, and appeared to be in good condition (Photograph 8).

Photograph 8: Hazardous waste containers observed in satellite accumulation area (SAA) 019. All containers were properly closed, labeled, and appeared to be in good condition.

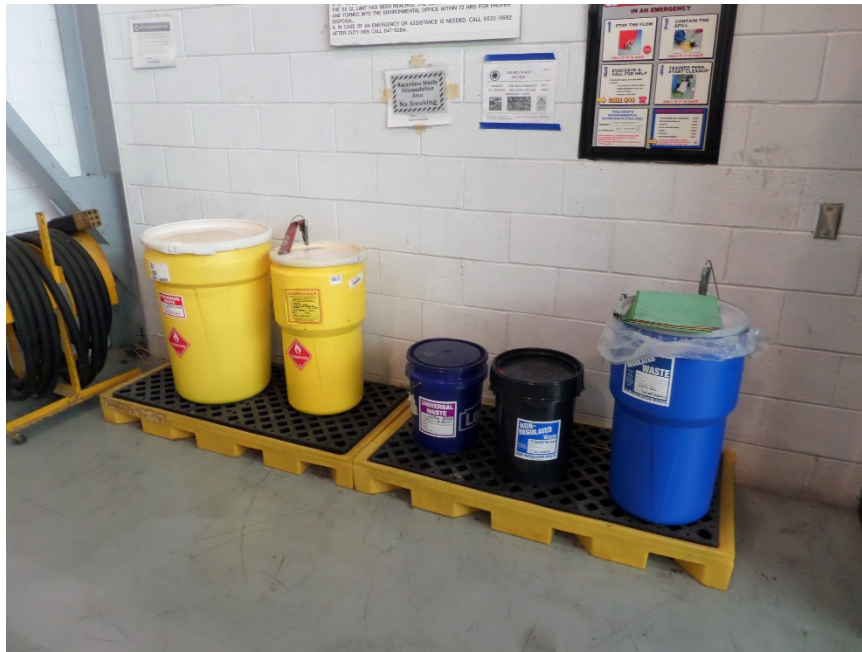
In the SAA for the aircrafts phase inspection area, the inspectors observed one 35-gallon container of hazardous waste resin hardener contaminated materials, one 14-gallon container of hazardous waste Jet A fuel contaminated absorbent pads, one 5-gallon container labeled of UW lithium batteries, one 5-gallon container of hydraulic oil filters and one 15-gallon container oil contaminated absorbent pads. All containers were properly labeled, closed, and appeared to be in good condition (Photograph 9).

Photograph 9: Containers observed in the SAA at the “Phase” Inspection Area. All containers were properly closed, labeled, and appeared to be in good condition.

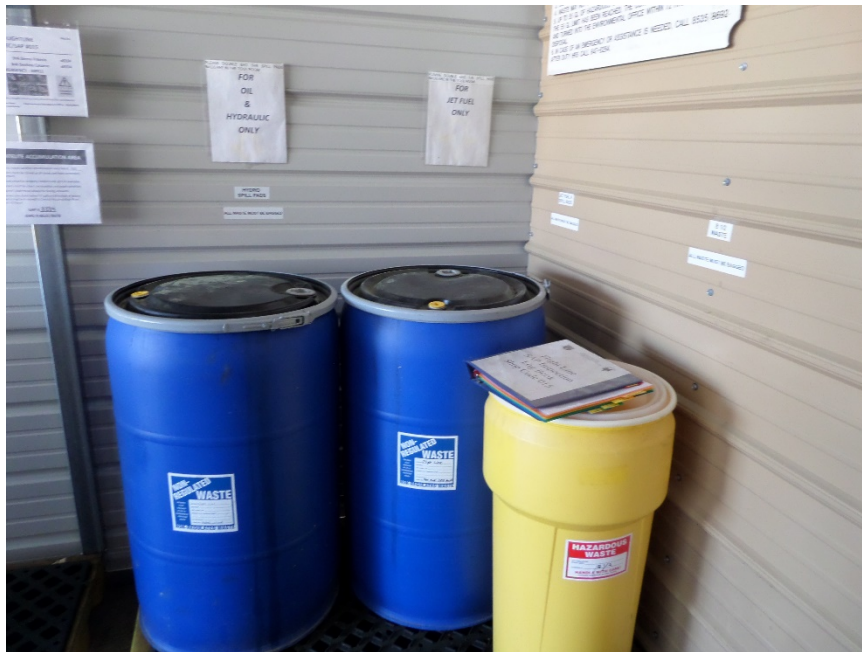
Outside the hangar, in an area referred to as the Flight Line, the facility operates an SAA for waste generated from maintenance activities of aircrafts fuel systems. In the SAA, the inspectors observed one 15-gallon container of hazardous waste off-spec resin kits (resin and hardener kits), one 55-gallon container of hydraulic oil contaminated absorbent pads and one 55-gallon container of jet fuel contaminated absorbent pads. All containers were properly labeled and appeared to be in good condition. The hazardous waste container was missing the ring that secures the container's lid (Photograph 10). (Note: On April 16, 2021, Lt. Col. Merriman emailed to the inspectors a photograph of the container with the lid properly secured.)

**Pursuant to 25 S.C. Code Ann. Regs. 61-79.262.15(a)(4) [40 C.F.R. § 262.15(a)(4)], which is a condition of the SAA Permit Exemption, a generator is required to keep containers of hazardous waste closed at all times during accumulation, except when adding, removing, or consolidating waste; or when temporary venting of a container is necessary for the proper operation of equipment, or to prevent dangerous situations, such as build-up of extreme pressure.**

Photograph 10: Containers in the SAA at the Flight Line Maintenance Area. activities of aircrafts fuel systems. The hazardous waste container (14-gallon yellow container) was missing the ring that secures the container’s lid.

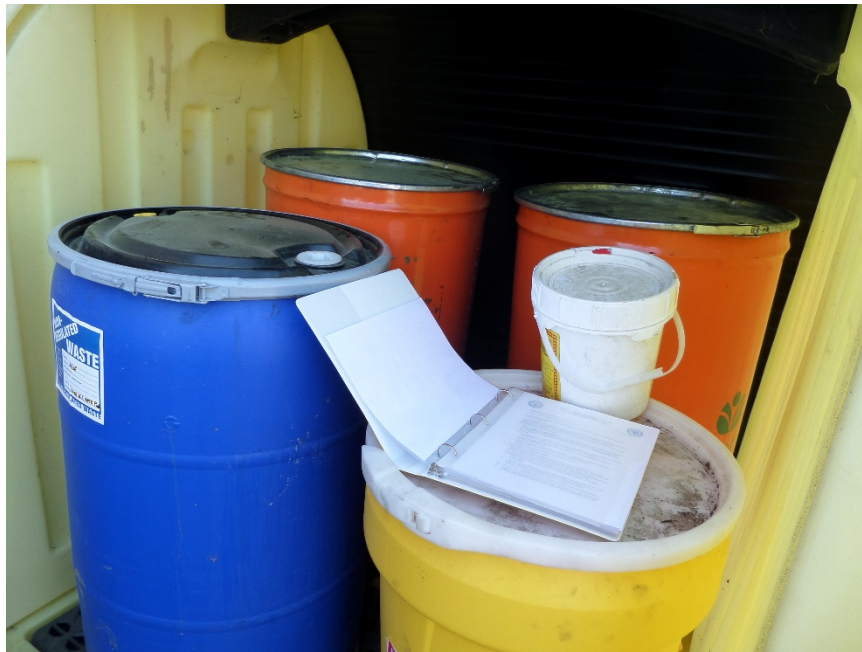
Outside the building, in a self-contained storage unit, the facility operates SAA 001. In the SAA, the inspectors observed one 1-gallon empty container labeled hazardous waste-lead, one 30-gallon container of hazardous waste jet fuel contaminated absorbent pads, one 55-gallon container of used oil contaminated absorbent pads, one 55-gallon container of used oil drained filters and one 55-gallon container of diesel filters. All containers were properly labeled, closed, and appeared to be in good condition (Photograph 11).

Photograph 11: Air Ground Equipment Maintenance Area - SAA 001  
One 1-gallon empty container labeled hazardous waste-lead, one 30-gallon hazardous waste container of jet fuel contaminated absorbent pads, one 55-gallon container of used oil contaminated absorbent pads, one 55-gallon container of used oil drained filters and one 55-gallon container of diesel filters.

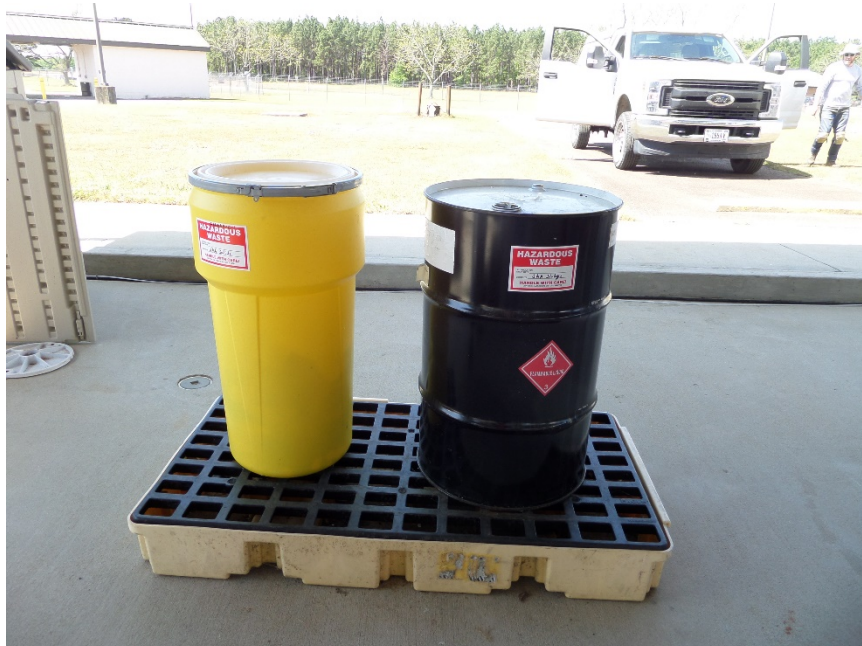
This is the loading/distribution station for the petroleum products used at the facility. In SAA 015, the inspectors observed one 30-gallon container of hazardous waste jet fuel filtration sludge and one 25-gallon hazardous waste jet fuel contaminated absorbent pads. All containers were properly labeled, closed, and appeared to be in good condition (Photograph 12)

Photograph 12: Hazardous waste containers in the SAA at the loading/distribution station for the petroleum products used at the facility.

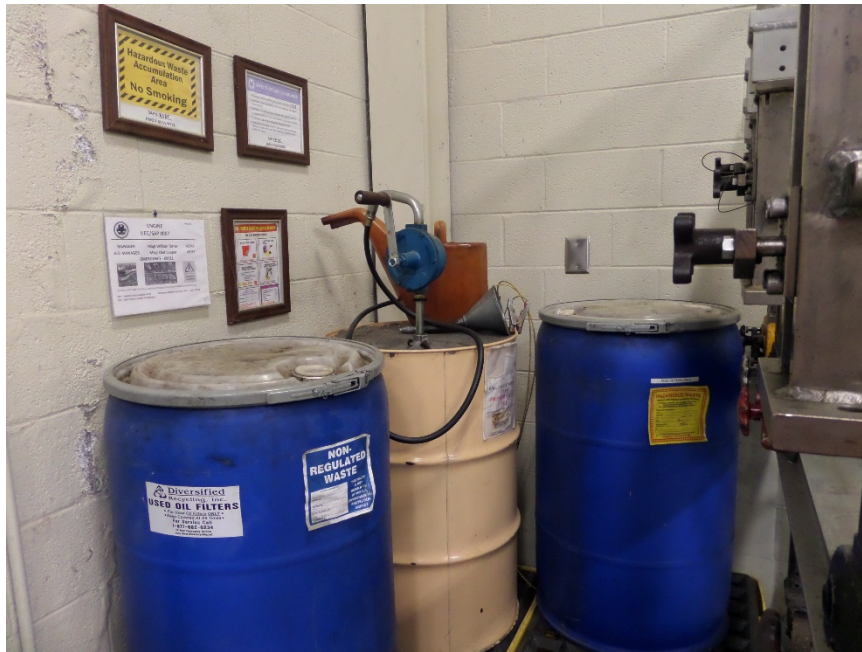
In this building, the facility conducts engine maintenance activities. In one area, the inspectors observed one 5-gallon container with alkaline waste batteries. In SAA 008, the inspectors observed one 55-gallon container of hazardous waste fuel filters and one 55-gallon container of used oil contaminated filters (Photograph 13). The containers were closed and appeared to be in good condition. The hazardous waste container was not marked with an indication of the hazards of its contents. (Note: Lt. Col. Merriman corrected the deficiency during the inspection.)

**Pursuant to 25 S.C. Code Ann. Regs. 61-79.262.15(a)(5) [40 C.F.R. § 262.15(a)(5)], which is a condition of the SAA Permit Exemption, a generator is required to mark or label its**

**containers (i) with the words “Hazardous Waste” and (ii) with an indication of the hazards of the contents.**

Photograph 13: Propulsion Building – Hazardous waste 55-gallon container and 55-gallon container of used oil contaminated filters in SAA 008 at the Propulsion Building. The hazardous waste container was not marked with an indication of the hazards of its contents.

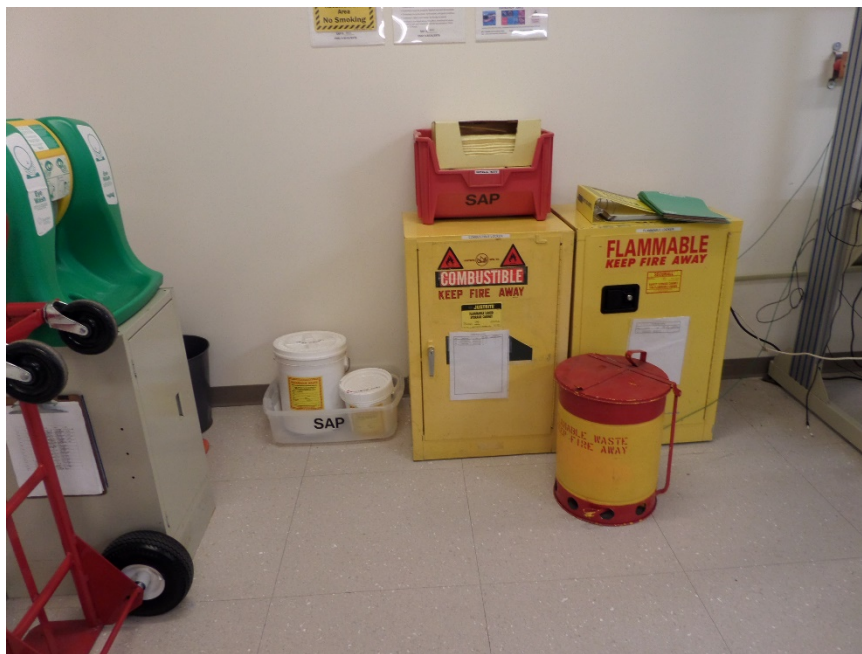
In this area, the facility maintains and calibrates aircrafts’ electronic equipment. In SAA 002, the inspectors observed one 5-gallon container of hazardous waste paint waste, one 1-gallon container of hazardous waste leaded solder flux and one 5-gallon container of solvent contaminated shop wipes. The containers were closed and appeared to be in good condition. Neither the hazardous waste paint waste container nor the hazardous waste leaded solder flux waste container was marked with an indication of the hazards of its contents (Photograph 14). (Note: On April 16, 2021, Lt. Col. Merriman emailed to the inspectors, photographs of the containers with the required markings.)

**Pursuant to 25 S.C. Code Ann. Regs. 61-79.262.15(a)(5) [40 C.F.R. § 262.15(a)(5)], which is a condition of the SAA Permit Exemption, a generator is required to mark or label its containers (i) with the words “Hazardous Waste” and (ii) with an indication of the hazards of the contents.**

Photograph 14: Avionics Intermediate Section - Hazardous waste in SAA 002. Neither the hazardous waste paint waste container nor the hazardous waste leaded solder flux waste container was marked with an indication of the hazards of its contents.

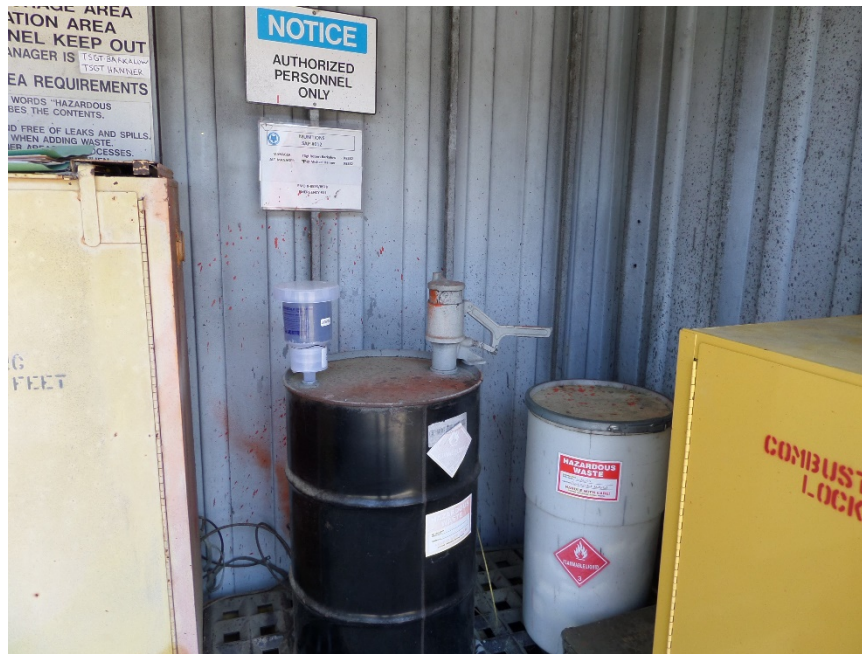
In this area, the facility generates hazardous wastes from touch-up painting activities. In SAA 012, the inspectors observed one 30-gallon hazardous waste container with an aerosol can puncturer attached to the container’s bung hole and one 14-gallon hazardous waste paint waste container. Both containers were properly labeled, closed, and appeared to be in good condition (Photograph 15).

Photograph 15: Munitions Storage Area – In SAA 012, the inspectors observed one 30-gallon hazardous waste container with an aerosol can puncturer attached to the container's bung and one 14-gallon hazardous waste paint waste container.
