### **Compliance Evaluation Inspection Report**

Challenge Richmond, LLC  
NPDES Permit: KY0074748  
Project No. CV-KY0074748-072721

Inspection Date: July 27, 2021

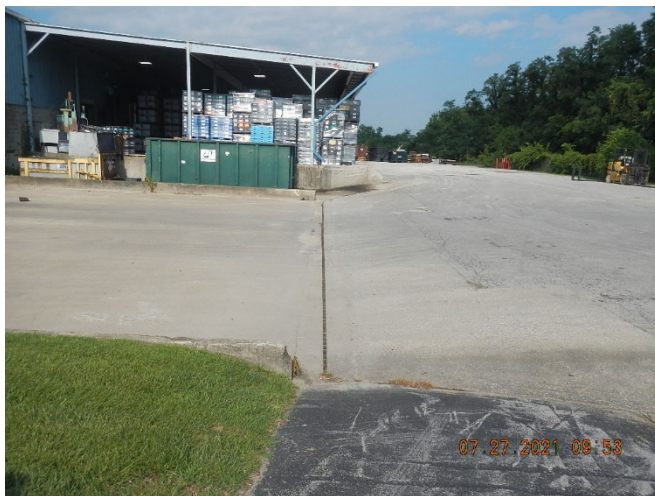
- Storm water drains were observed on the north-northeast and north-northwest side of the Facility. Storm drain socks were installed in the grated storm drains to catch sediment and other solids, (Photos 1, 2 and 3).

Photo 1: Loading dock drainage and truck loading garage.  
N-NE side of the building.

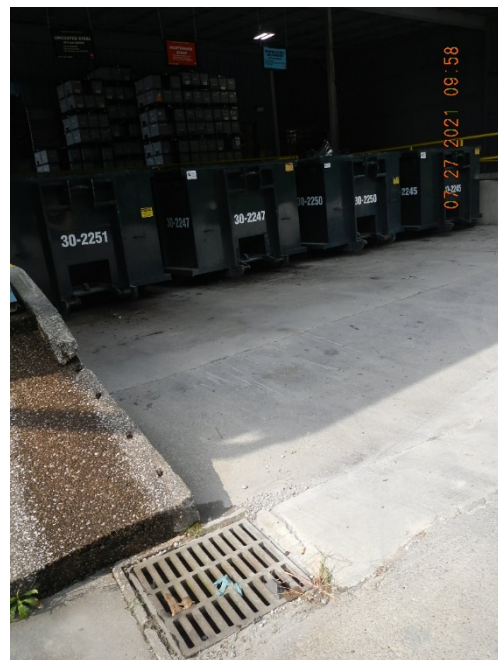
Photo 2: Loading area storm drainage.  
N-NW side of the building.

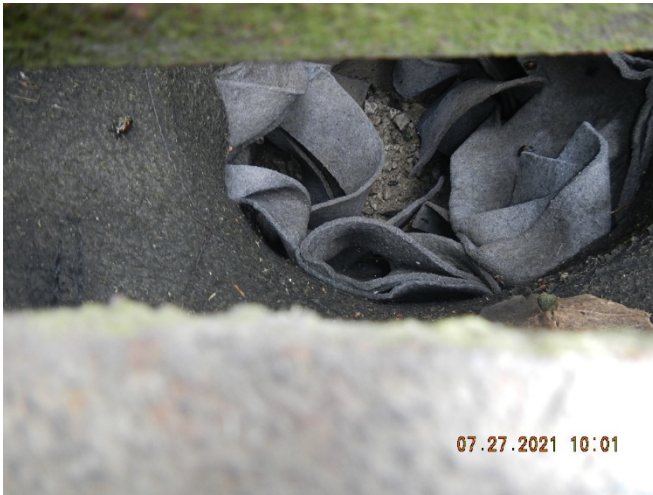
Photo 3: Loading area storm drain sock to catch gravel and other solids inside the culvert shown in Photo 2.

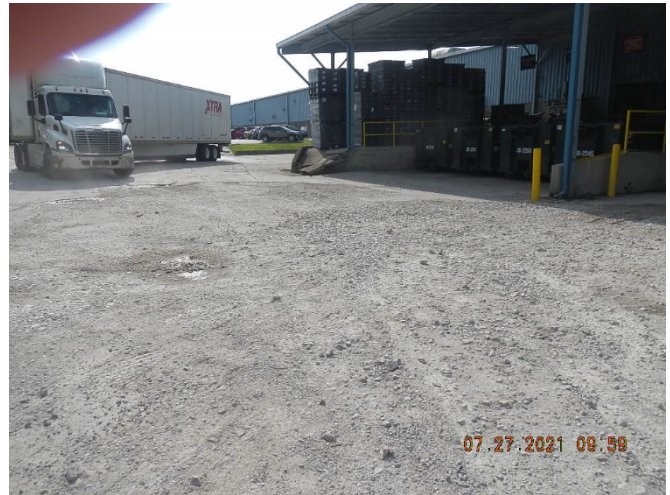
- The gravel lot located on the north-northwest side of the building deposits sediment into the storm drain socks. Sediment and gravel were observed in the drainage sock. Facility management stated that they plan to pave the parking lot in front of the scrap metal dock on the northwest side of the facility, (Photo 4).

TSS exceedances are likely a result of storm water runoff depositing gravel fines and dust from the gravel parking lot into the storm water drains. Paving the parking lot and the scrap metal dock to eliminate the gravel may address TSS exceedances. Facility management believes that storm water runoff from the galvanized roof is the source of zinc in the effluent. The Facility has in place a zinc control plan to address zinc exceedances; however, there is no current plan to replace the galvanized roof or provide a protective coating.

Photo 4: Gravel lot. N-NW side of the building.

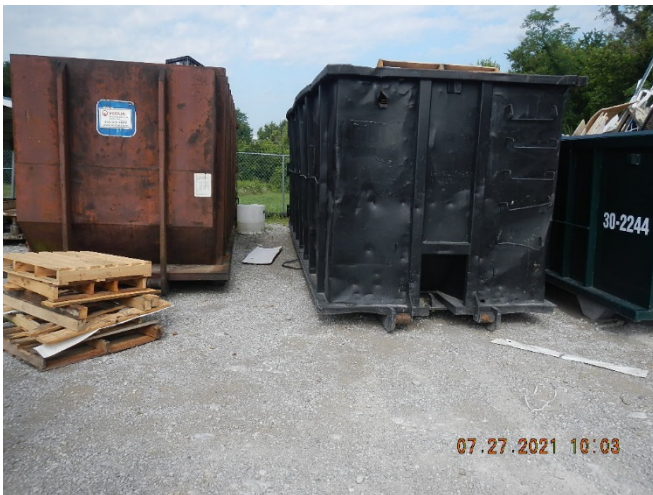
- Uncovered dumpsters on the northwest side of the Facility in the gravel parking lot. (Photo 5)
- Fence line in front of Outfall 001, northwest corner of the Facility, had drainage pipe laid next to the fence to control gravel and solids runoff from the parking lot (Photo 6).

Storm water contacting metal in the dumpsters can wash oxidized metal from the scrap and into the storm water runoff. Dumpsters containing scrap metal should be covered in accordance with the Facility's SWBMPP.

Photo 5: Dumpsters located in gravel lot. N-NE side of the building.

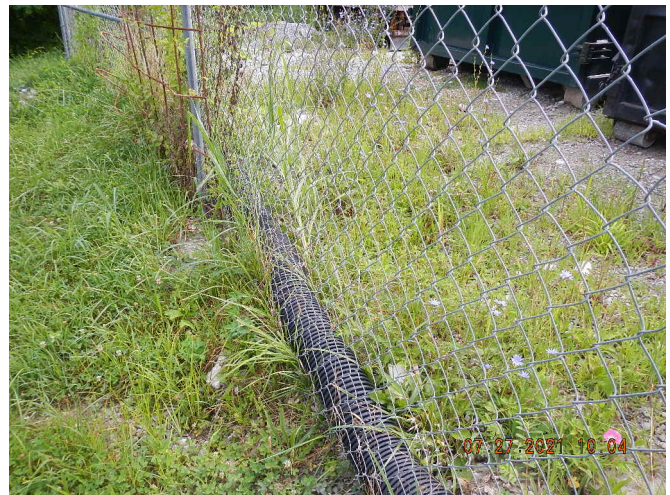
Photo 6: Fence located behind dumpsters shown in Photo 5.

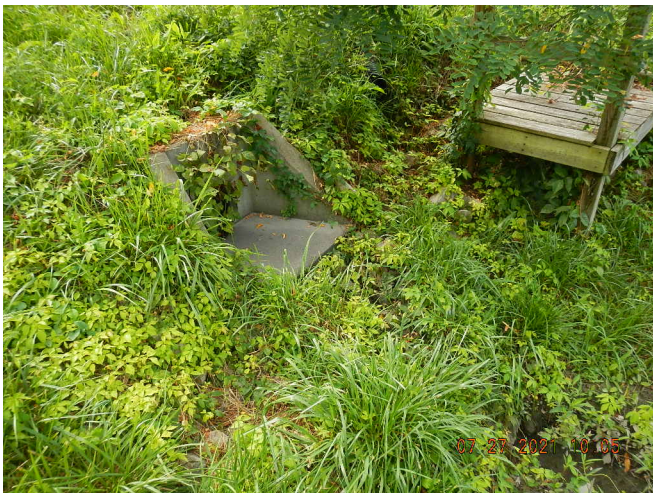
- No discharges were observed from Outfall 001 (Photo 7).
- Silt fence lining was installed in the construction zone on the east side of the Facility. Construction activity is to extend the existing parking lot (Photos 8 and 9).

Photo 7: Outfall 001 located approximately 25 feet from the fence shown in Photo 8.

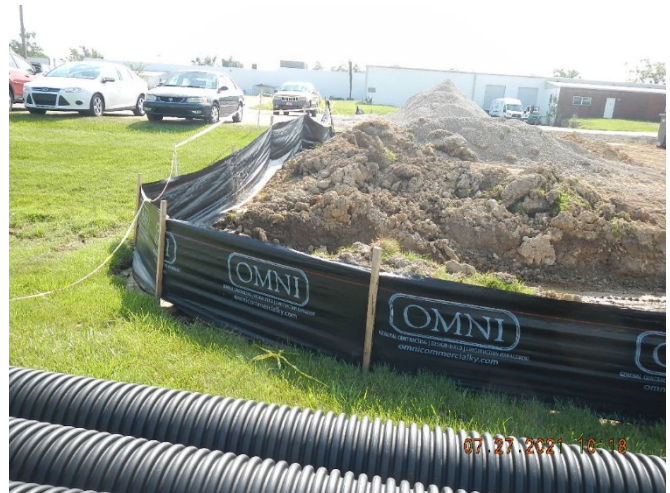
Photo 8: Construction zone silt fence. East side of the building.

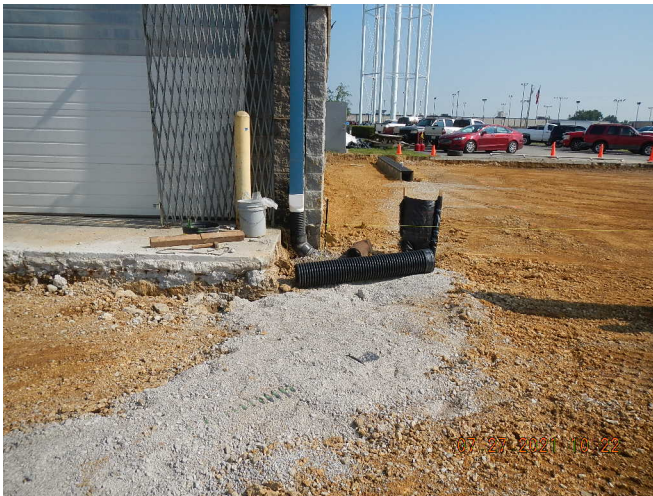
Photo 9: Construction zone SE corner of the building.

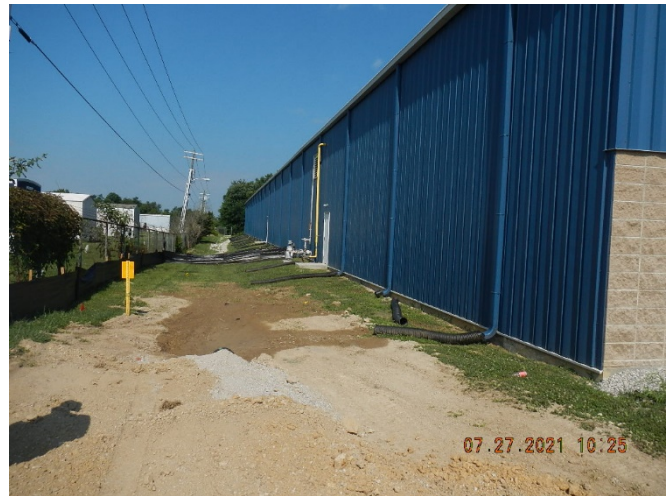
- The south side of the Facility's roof is drained to the west from a sloped area (Photo 10).

Photo 10: Construction zone SE corner of the building.

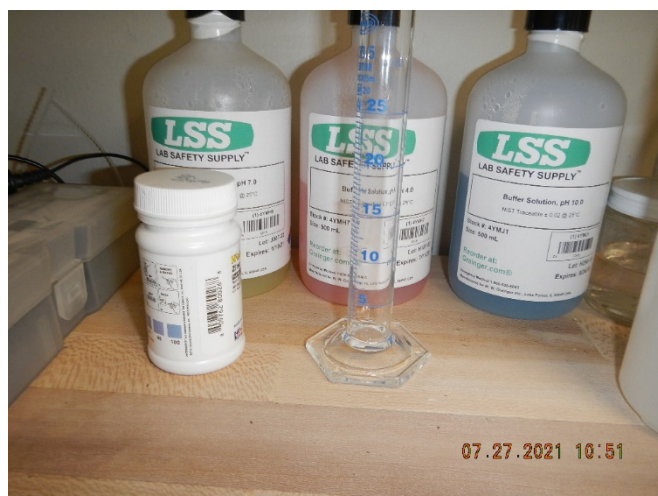
also reviewed the Facility's logbook used to record storm water flow and pH data, including pH probe calibration. Inspectors observed that the latest data recorded in the logbook, dated July 13, 2021, indicated that the pH probe was calibrated using 4.0 pH, 7.0 pH, and 10.0 pH buffer solutions (Photo 11). EPA inspectors also observed that pH buffer solutions located next to the pH probe expired in January 2021, July 2020, and August 2020 (Photo 12). The Facility also had on-site a buffer solution for 7.0 that was within its expiration date (Photo 13). The Facility's Environmental Manager mentioned that new buffer solutions are on order.

Photo 12: pH 4, 7, and 10 buffer solutions.

Using expired pH buffer solutions may provide inadequate pH probe calibration leading to non-representative sampling, as required by Section 2.9 of the NPDES Permit. Also, procedures should be put in place to ensure timely DMR submission to address late DMR violations and to ensure compliance with the NPDES Permit.

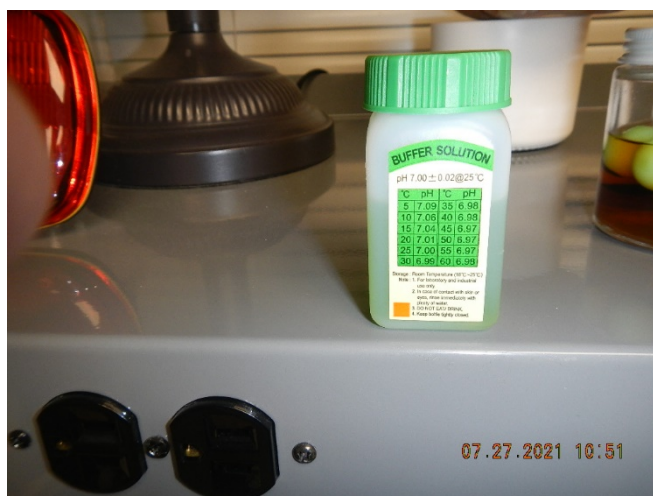
Photo 13: pH 7 buffer solution.
