# NPDES Compliance Inspection Report

## Midnite Mine Wellpinit, Washington

**Permit #: WA0025721 & WA0026841**

**Inspection Date: August 4, 2021**

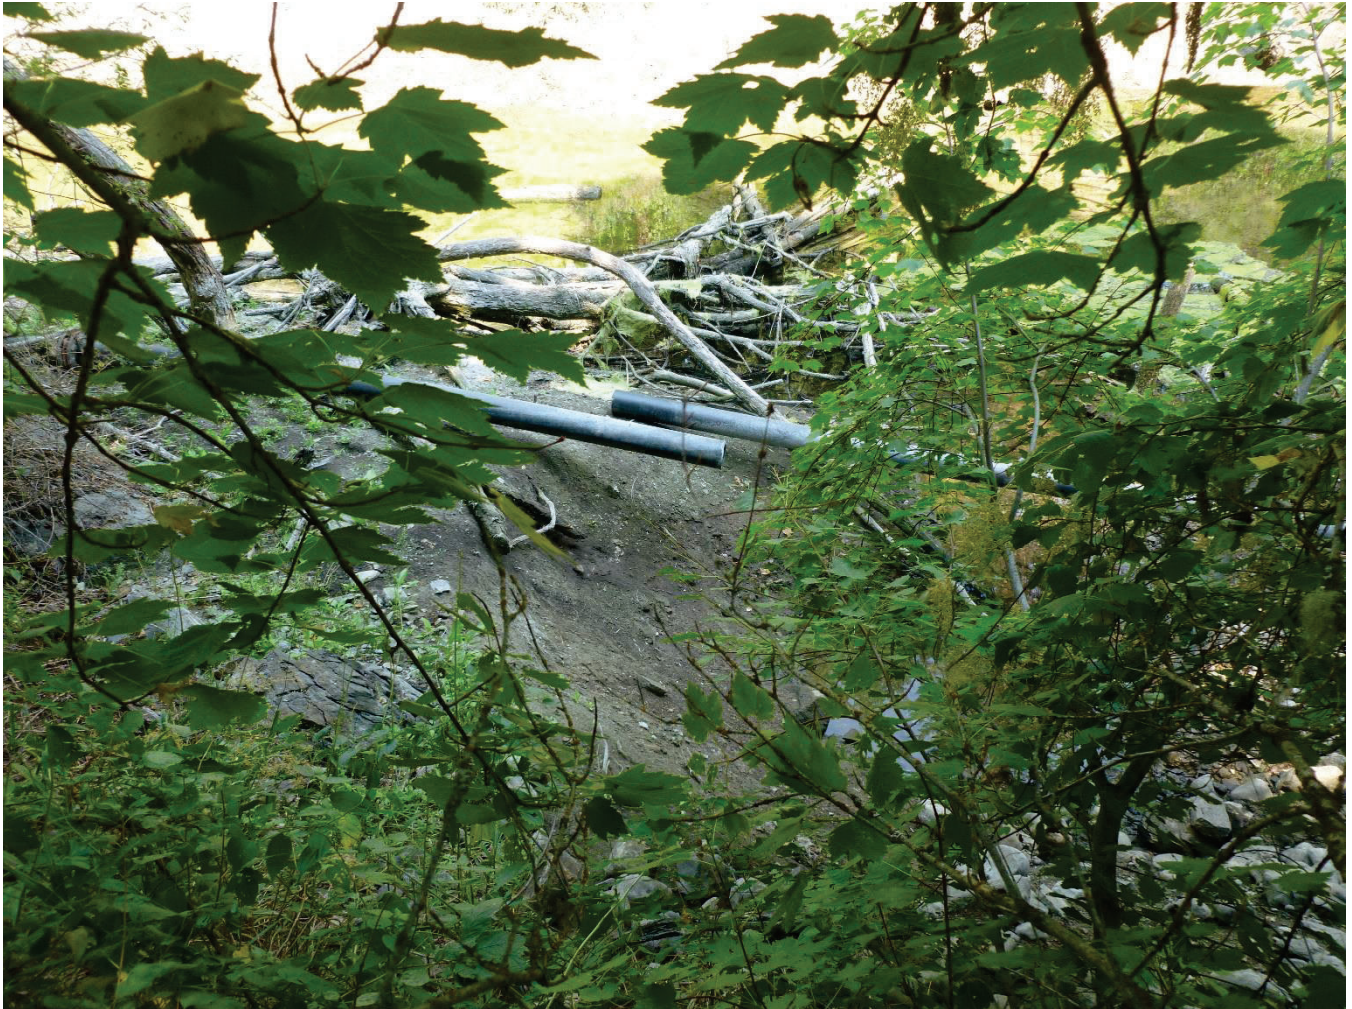
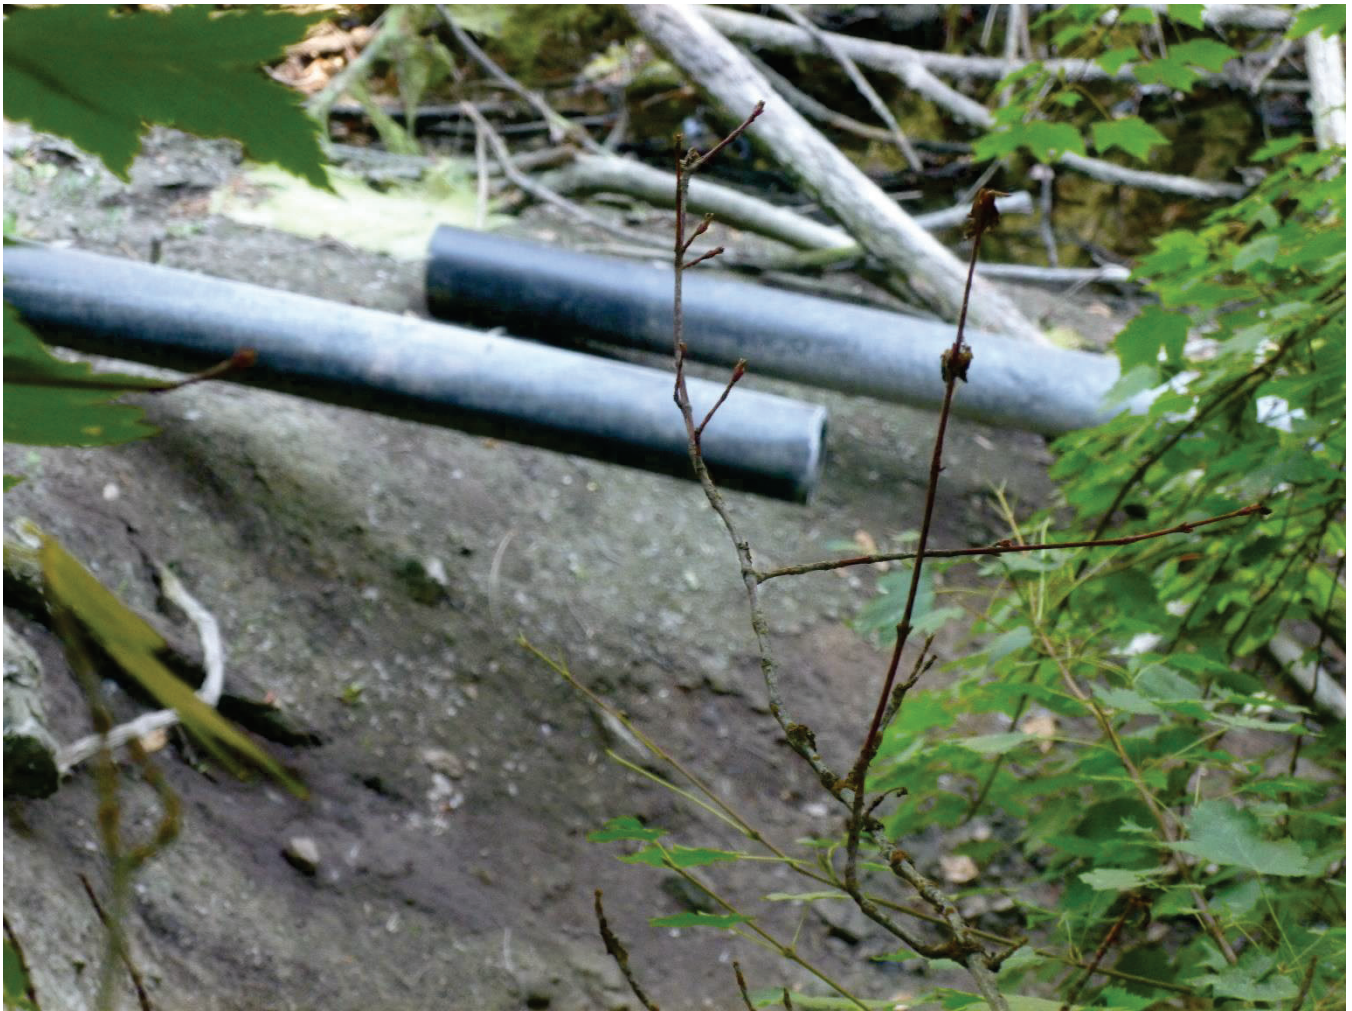
**Photo 1 / P1000997 – Discharge Point 004**

We entered the "hot zone" so that I could observe the WWTP's discharge point, designated Discharge Point 004 (**Photos 1 & 2**). There was no discharge at the time of the inspection. When the plant is discharging, the water exits the pipe on the left in the photos and flows to Blue Creek, which is a tributary of the Spokane River.

**Photo 2 / P1000998** – Discharge Point 004, close up

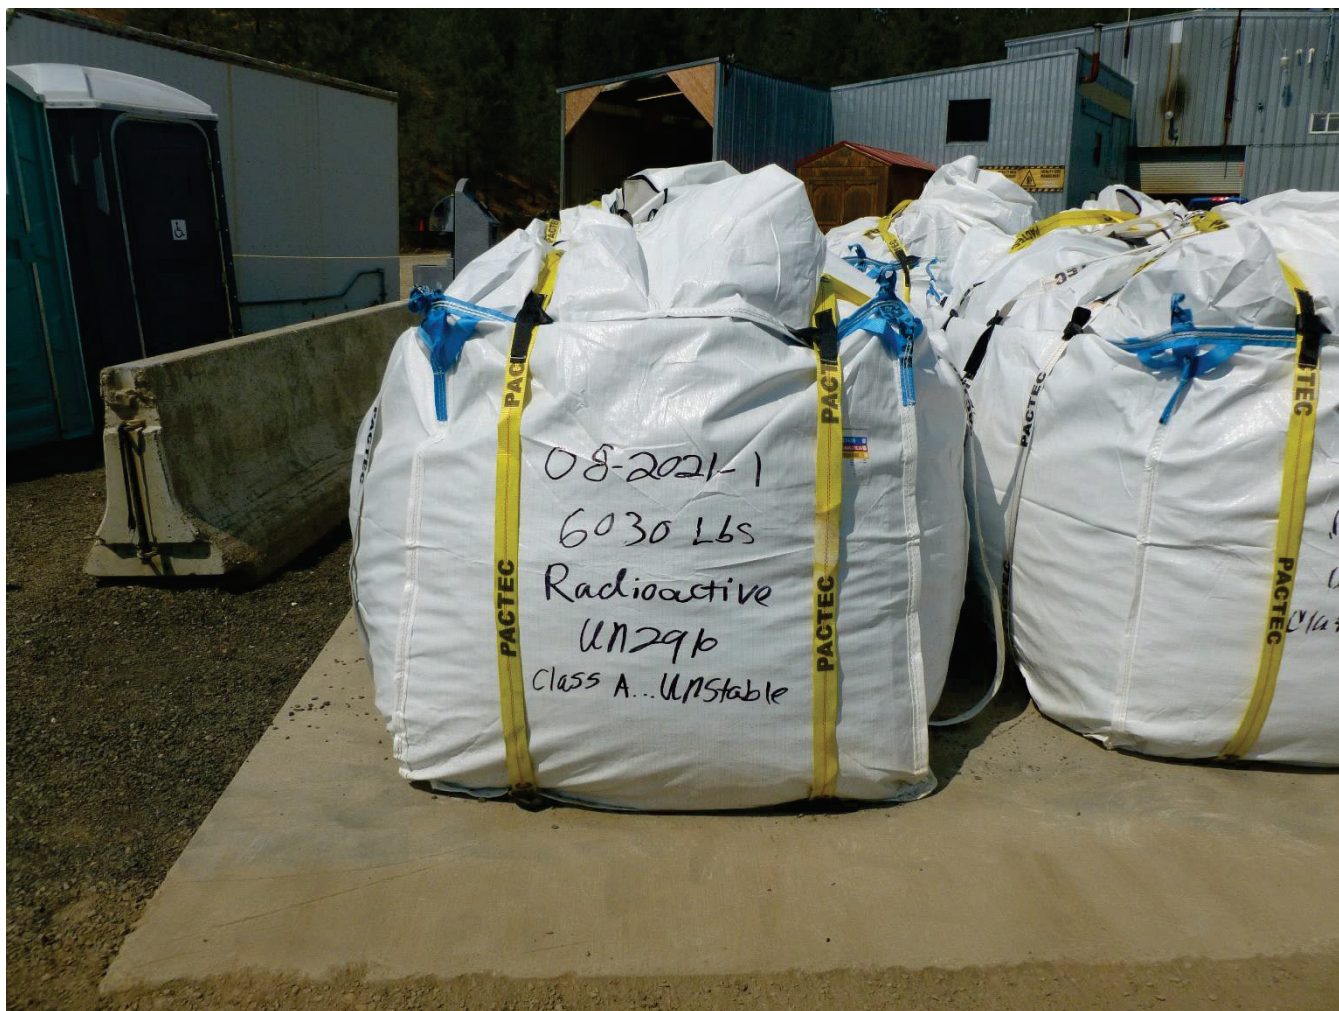
After exiting the "hot zone" and scanning ourselves for radiation exposure, Mr. Nelson and I drove to the WWTP. The first thing I noticed was several labeled totes (**Photo 3**) of material sitting near the WWTP parking lot. I asked Mr. Nelson about the totes. Mr. Nelson said that the totes contained radioactive sludge, also known as "alternative feed". The sludge was awaiting transport to another location so the uranium could be processed out.

**Photo 3 / P1000999** – Totes of Sludge, awaiting transport to processing facility

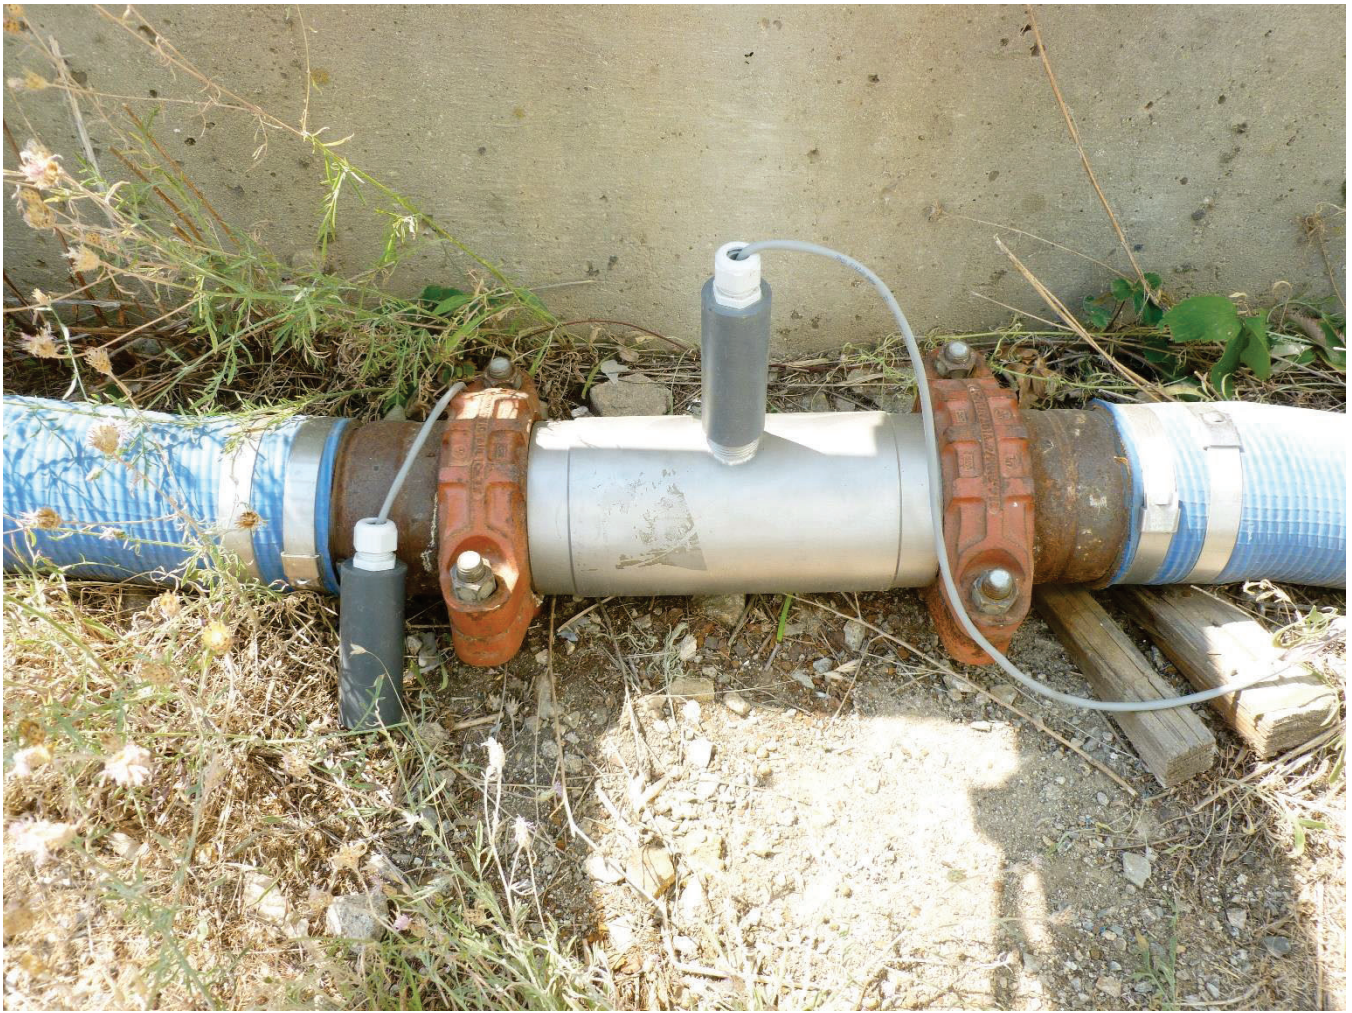
Contaminated water is brought into the WWTP building from Pit 3 through a 6-inch pipe where the water flows through a Blancett® flow meter (**Photo 4**). Per Mr. Nelson, the flow meter is taken off-line annually and sent to the manufacturer for calibration. The flow readings are obtained from a NuFlo® MC-III Flow Analyzer (**Photo 5**), which is attached to a wall in the treatment plant.

**Photo 4 / P1010013** – Blancett® Flow Meter

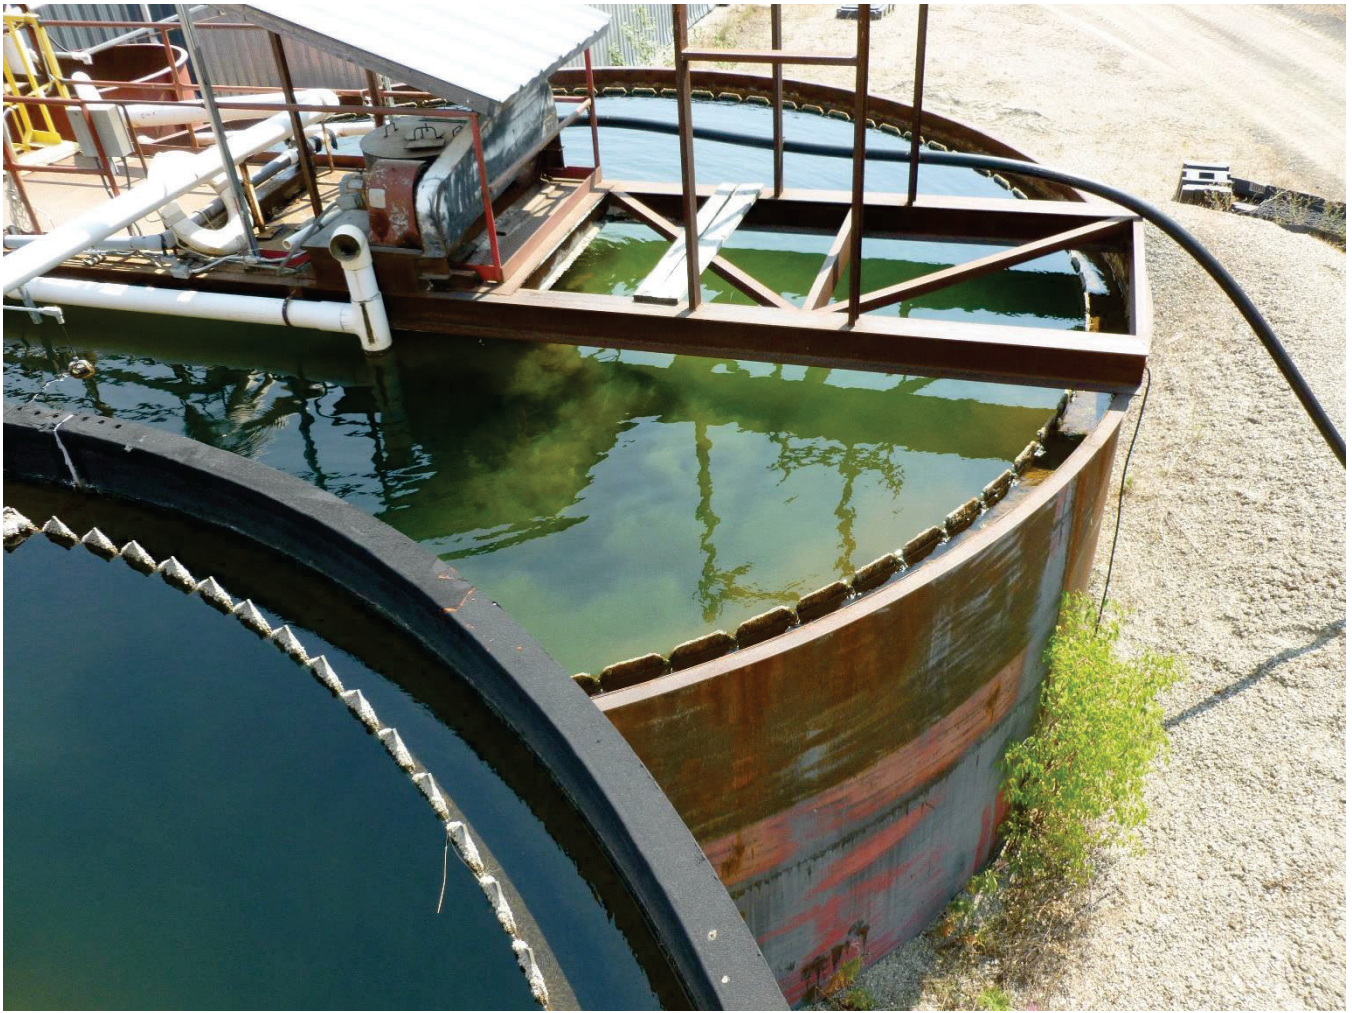
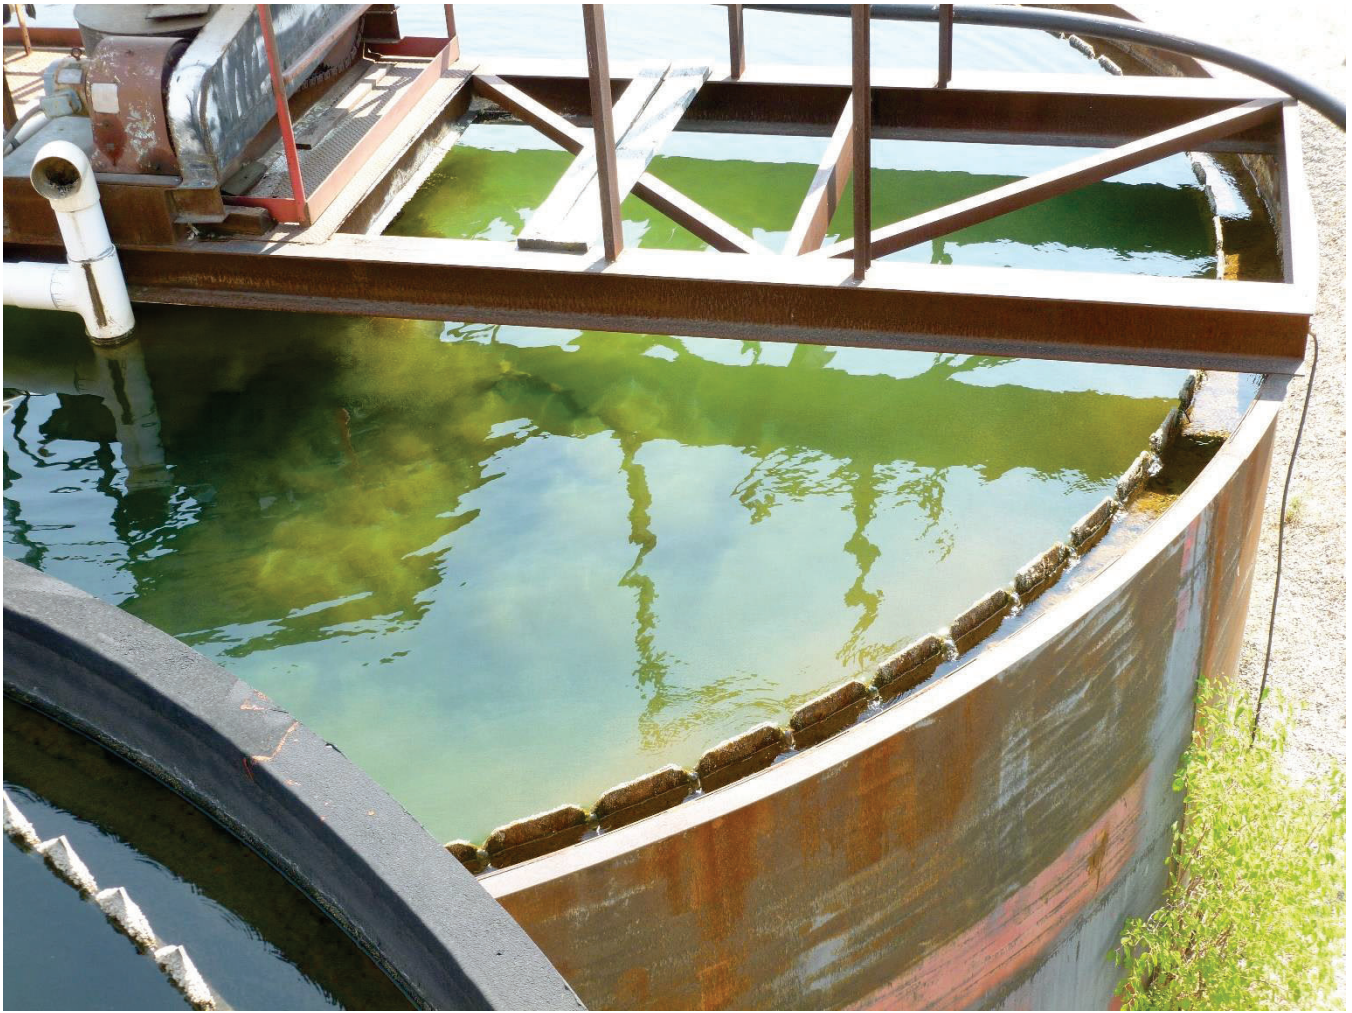
The water received from Pit 3 passes through a clarifier (**Photo 6 & 7**) which allows the sludge to settle out. The sludge is sent to a filter press (**Photo 8**) for de-watering. Once the de-watering in the filter press is complete, the sludge is prepared for transport to another location as the "alternate feed" shown in Photo 3.

**Photo 6 / P1010009** – Wastewater Plant Clarifier

**Photo 7 / P1010010** – Wastewater Plant Clarifier, close up

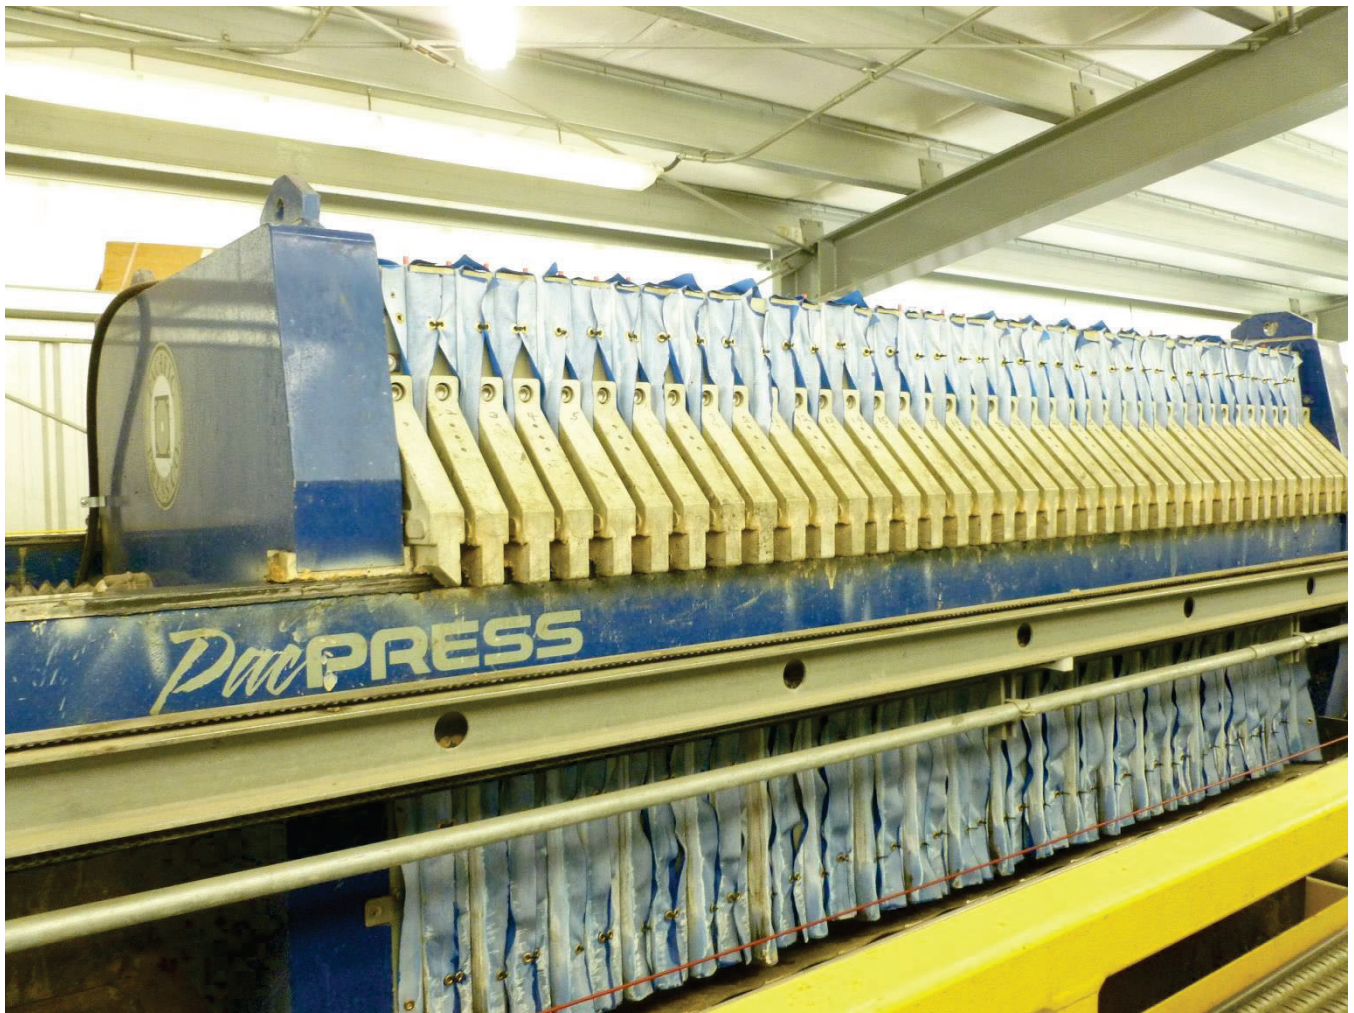
Photo 8 / P1010011 – Filter Press

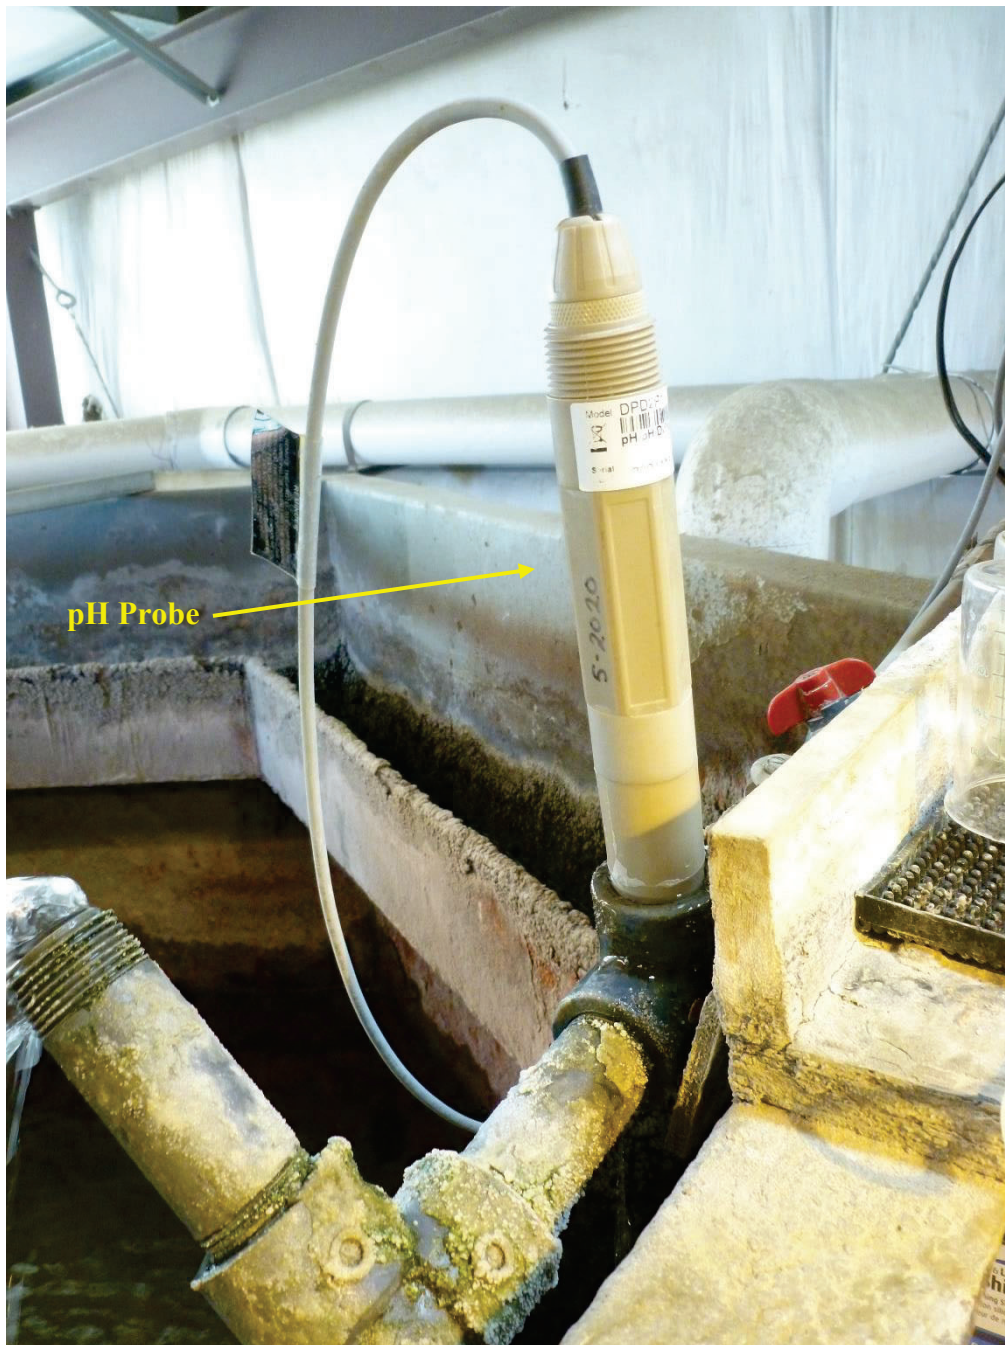
**Photo 10 / P1010003 – Effluent pH Monitoring Probe**

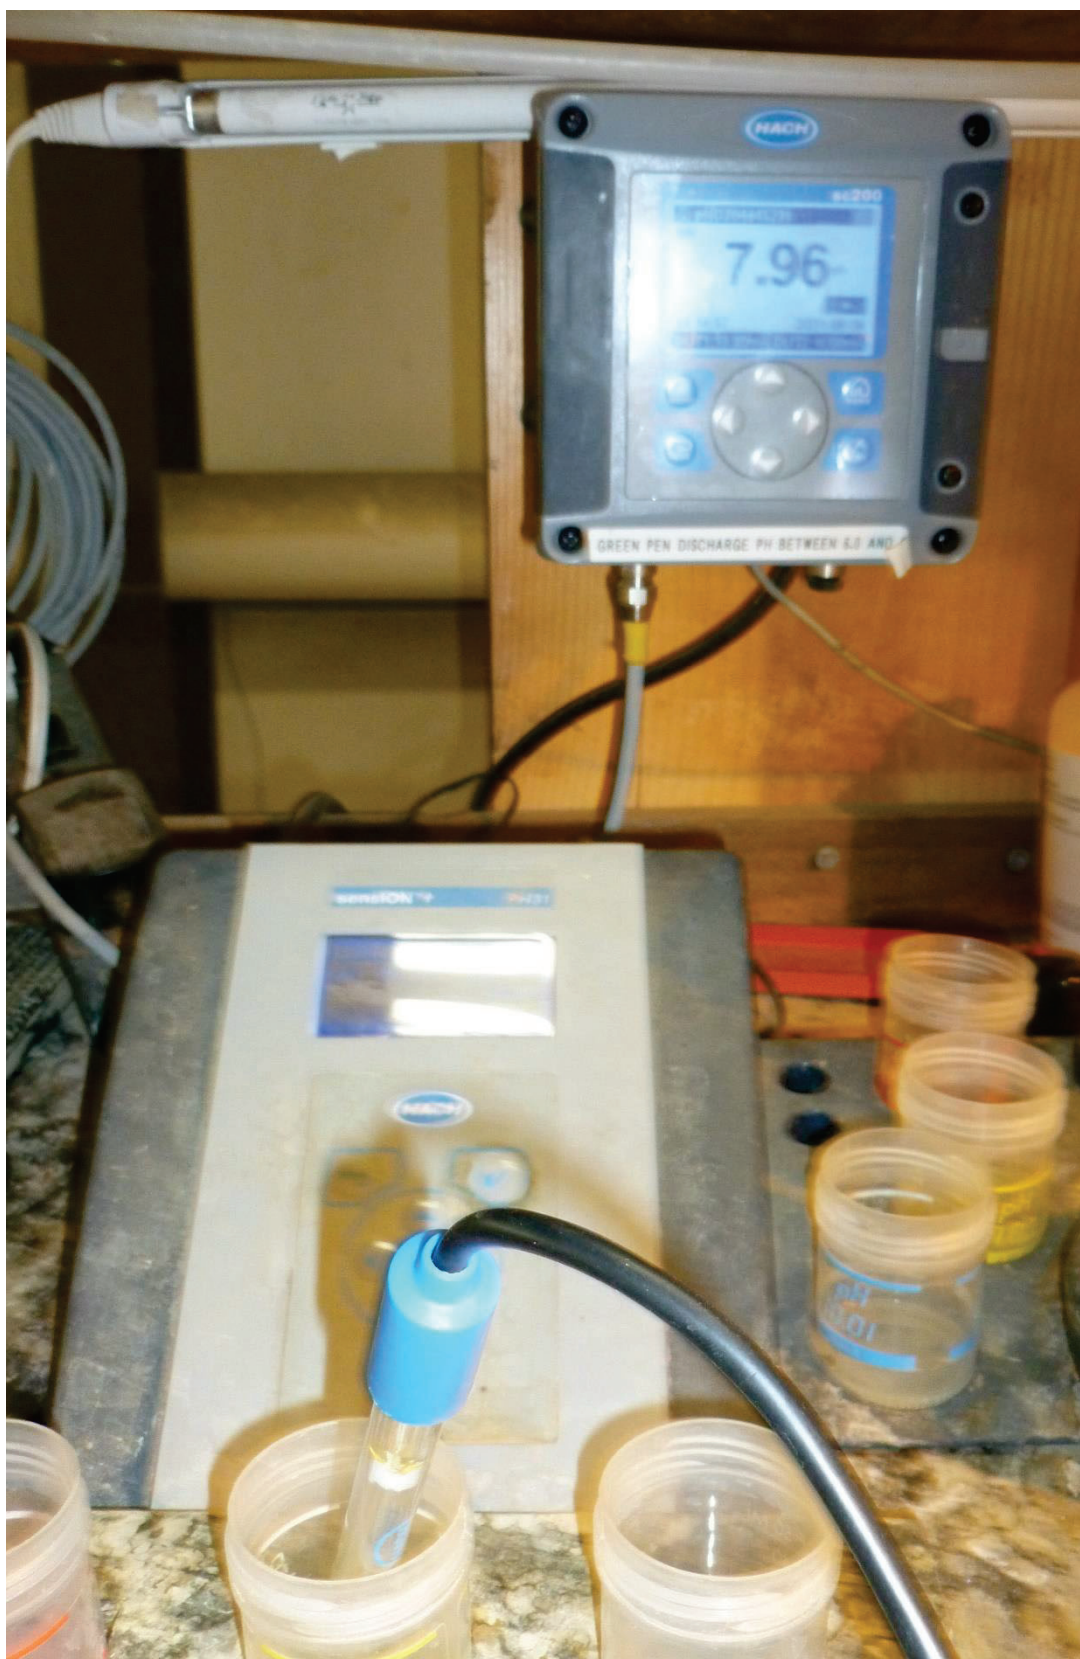
Photo 11 / P1010005 – pH Readout and Control Station
