**Region 6 - Enforcement & Compliance Assurance Division**  
**INSPECTION REPORT**

| Inspection Date: | 01/14/2026 | |
| Company Name: | <b>C12: Arkansas Oil, LLC</b> | |
| Facility Name: | <b>Midway Smackover Unit Tract #3 Tank Battery</b> | |

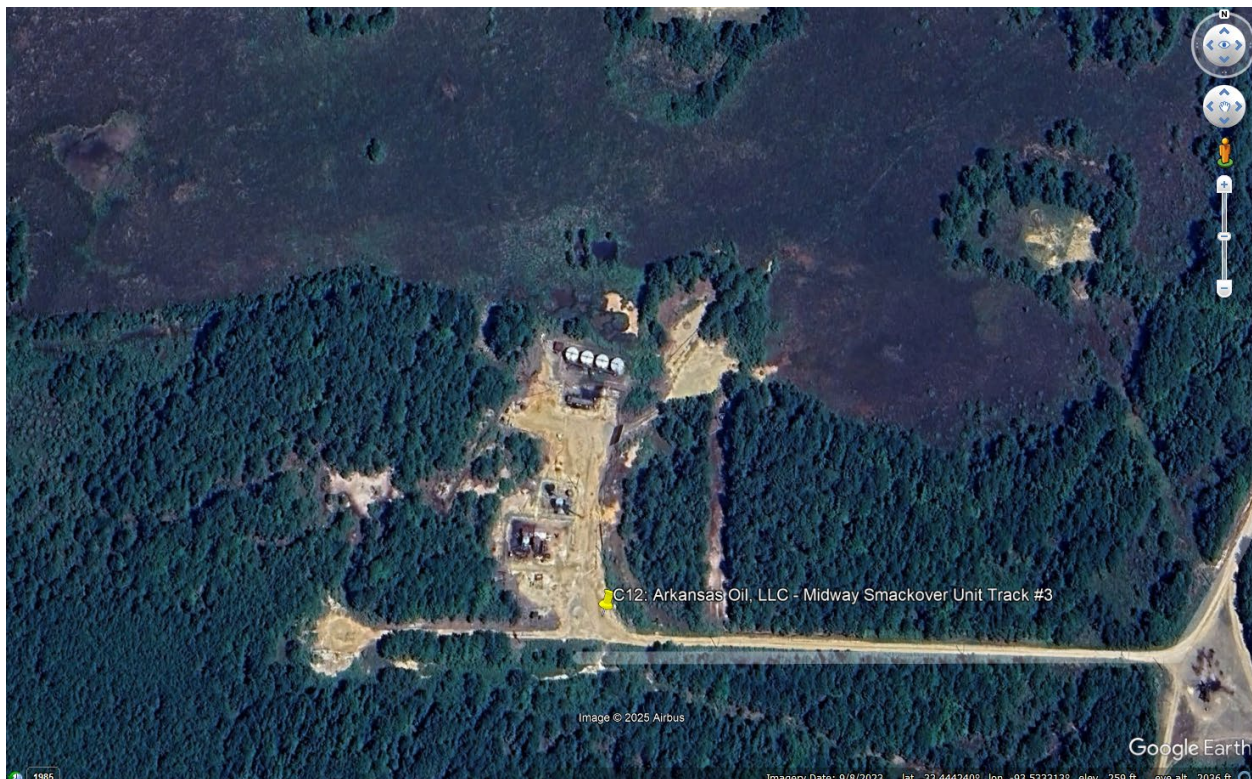
**Map 1.** Aerial imagery (Google Earth dated 09/08/2023) of the C12: Arkansas Oil, LLC / Midway Smackover Unit Tract #3 Tank Battery facility.

EPA conducted an inspection on the C12: Arkansas Oil, LLC / Midway Smackover Unit Tract #3 Tank Battery facility, which contains four (4) tank batteries for a total of ten (10) tanks that include storage, separation, and free water knock out (FWKO) for crude oil and saltwater processing and storage; and three (3) Class II saltwater disposal (SWD) injection wells. There are four (4) additional storage tanks for refined product.

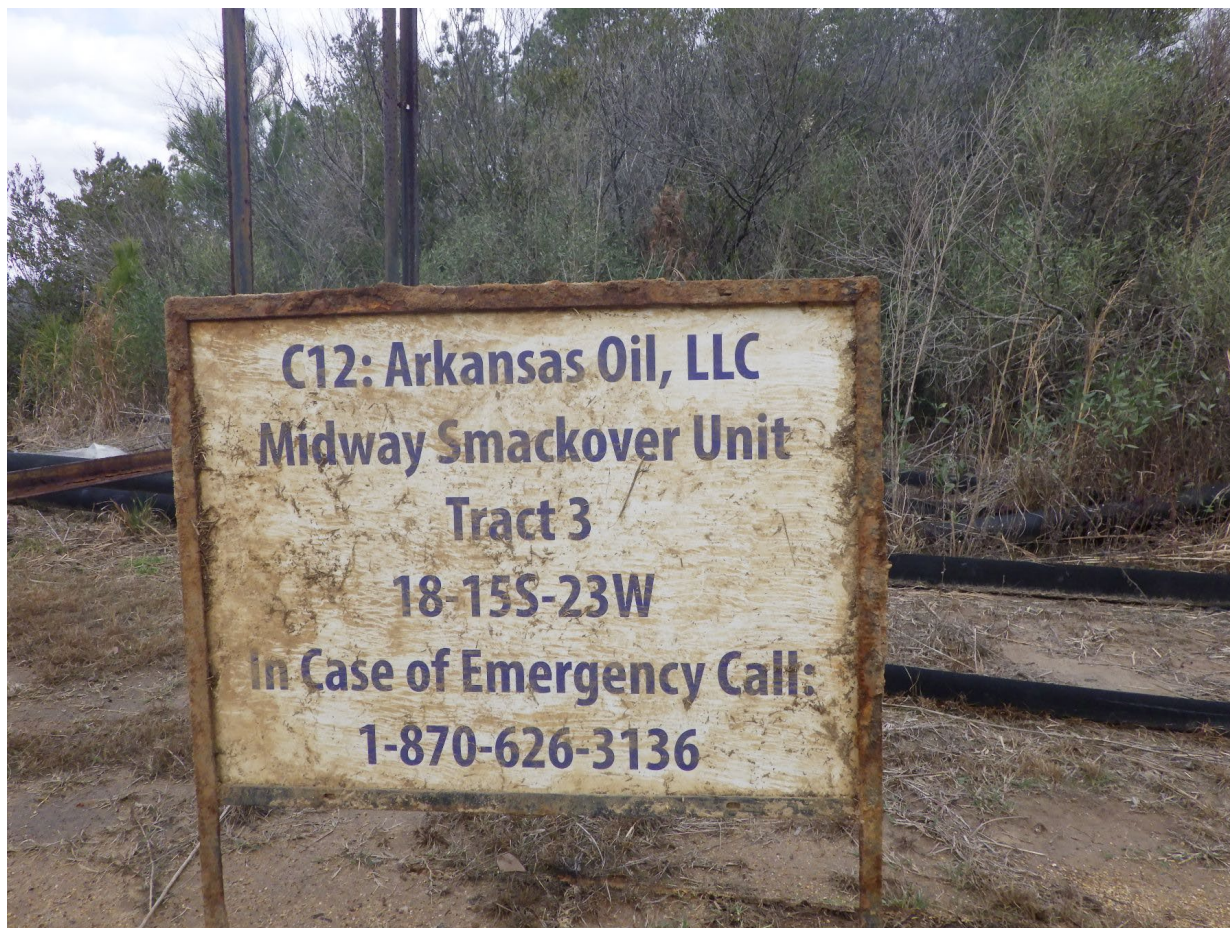
Photo No. 1

I observed the facility signage, tank batteries, pipes and valves, storage tanks, and separators/treaters; see Appendix 1 (Photographs Log), Photos No. 1 and No. 2. For additional GPS location and photo metadata, see Appendix 1.

| Description: | Looking SSW, this photo shows the signage for the Midway Smackover Unit Tract 3 Tank Battery ("facility"). | | |

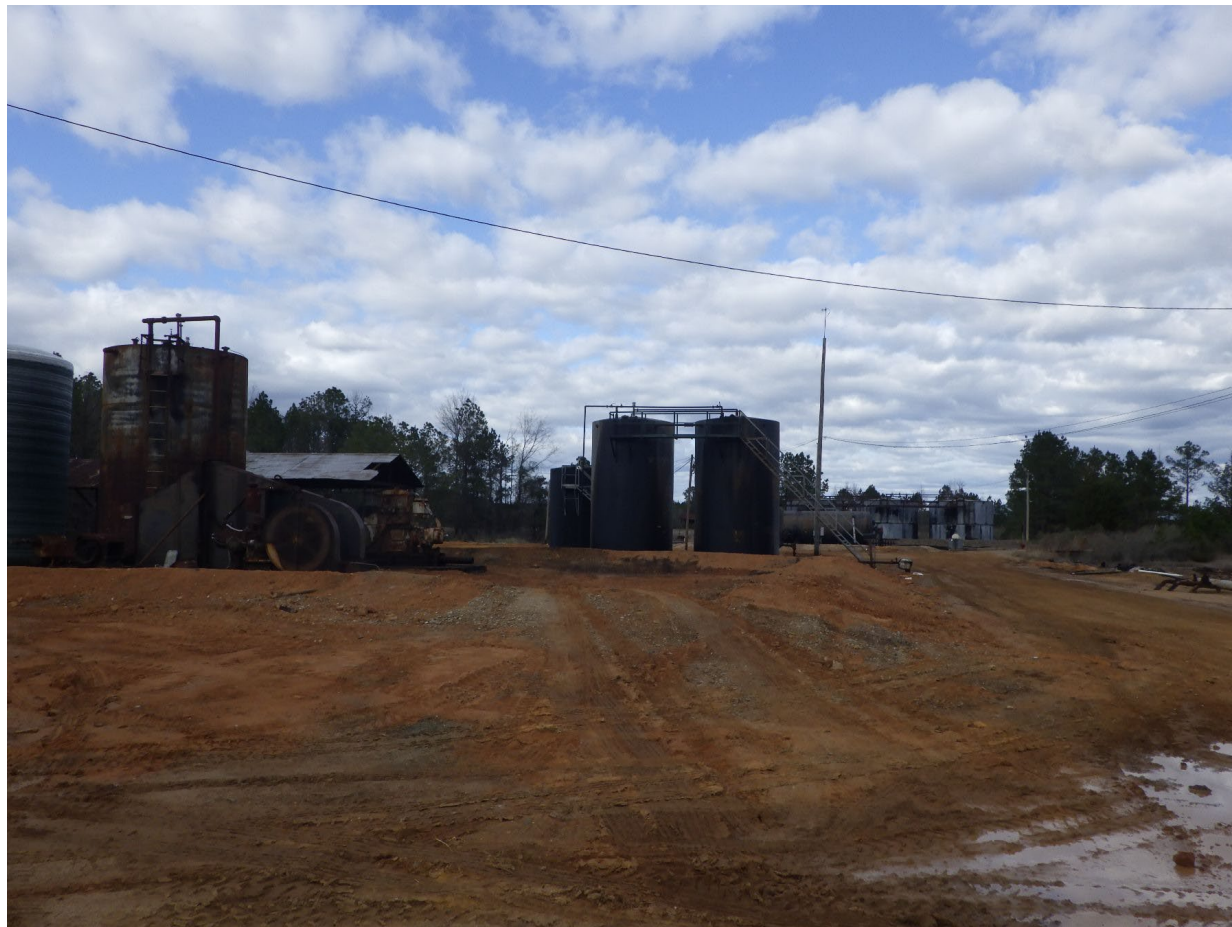
Photo No. 2

| Description: | Looking SW, this photo shows an overview of the facility. | | |

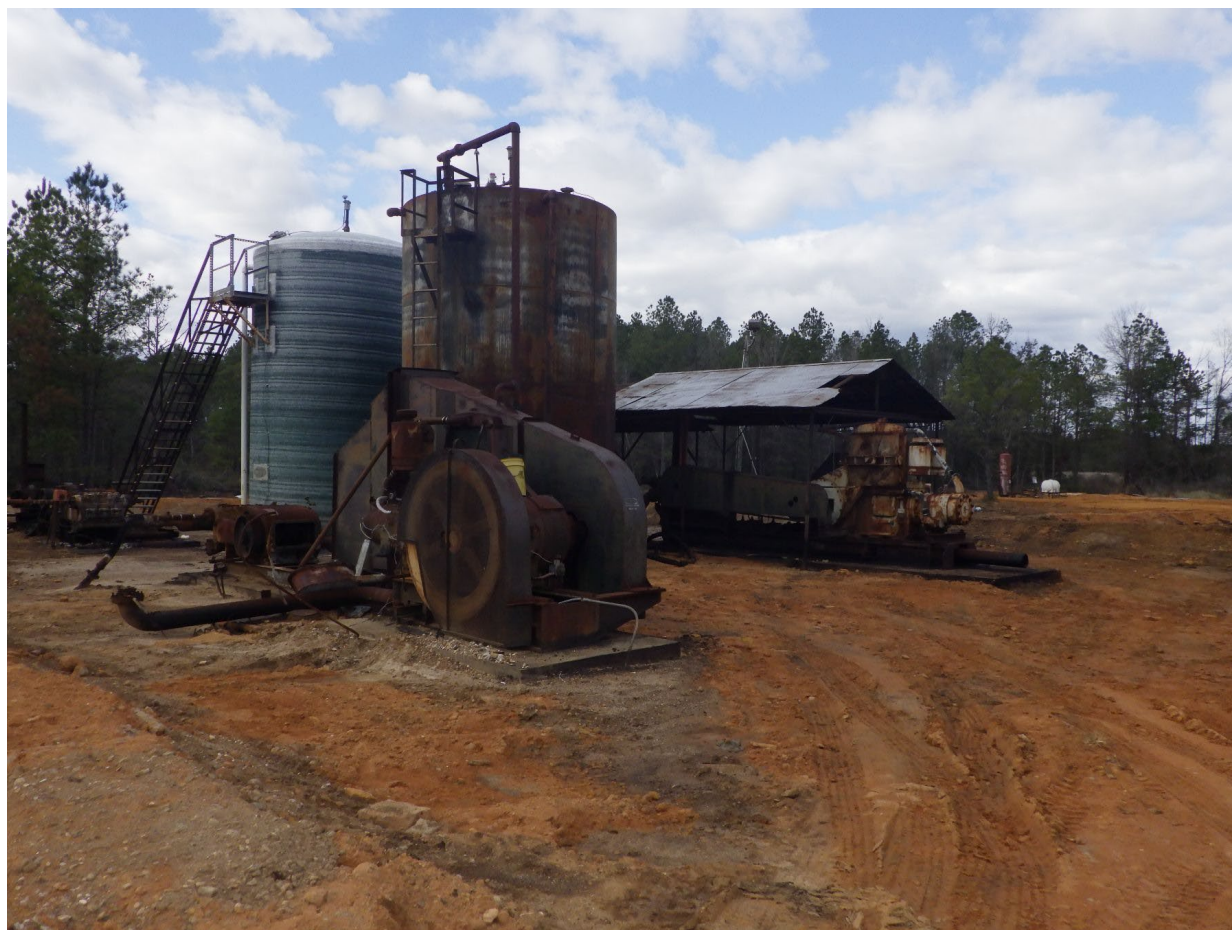
Photo No. 3

I observed the SWD injection well tank battery (Area 2) and drainpipe, see Photos No. 3 and No. 4.

| Description: | Looking SW, this photo shows an overview of the saltwater disposal (SWD) injection well tank battery. | | |

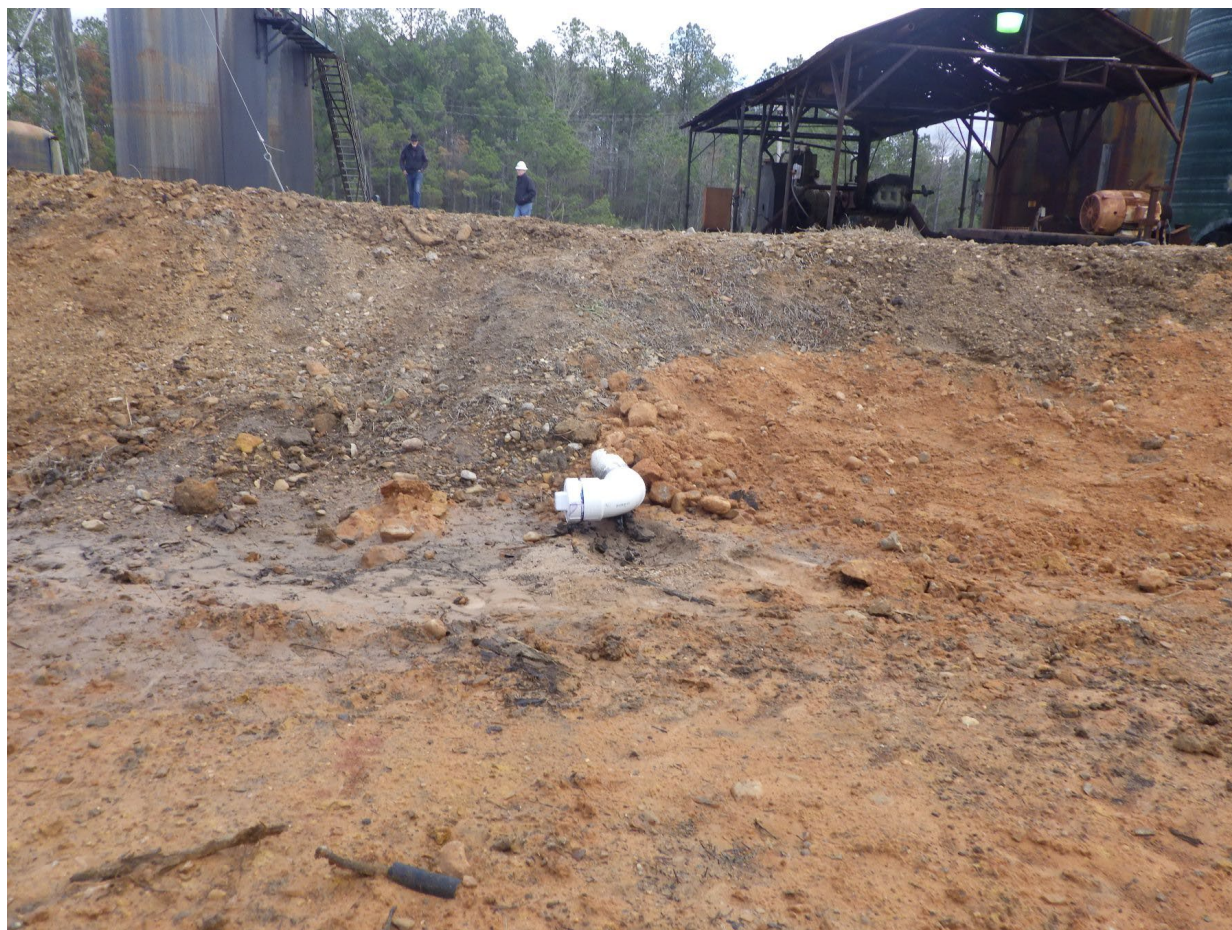
Photo No. 4

| Description: | Looking S, this photo shows the drainpipe for the SWD injection well tank battery. | | |

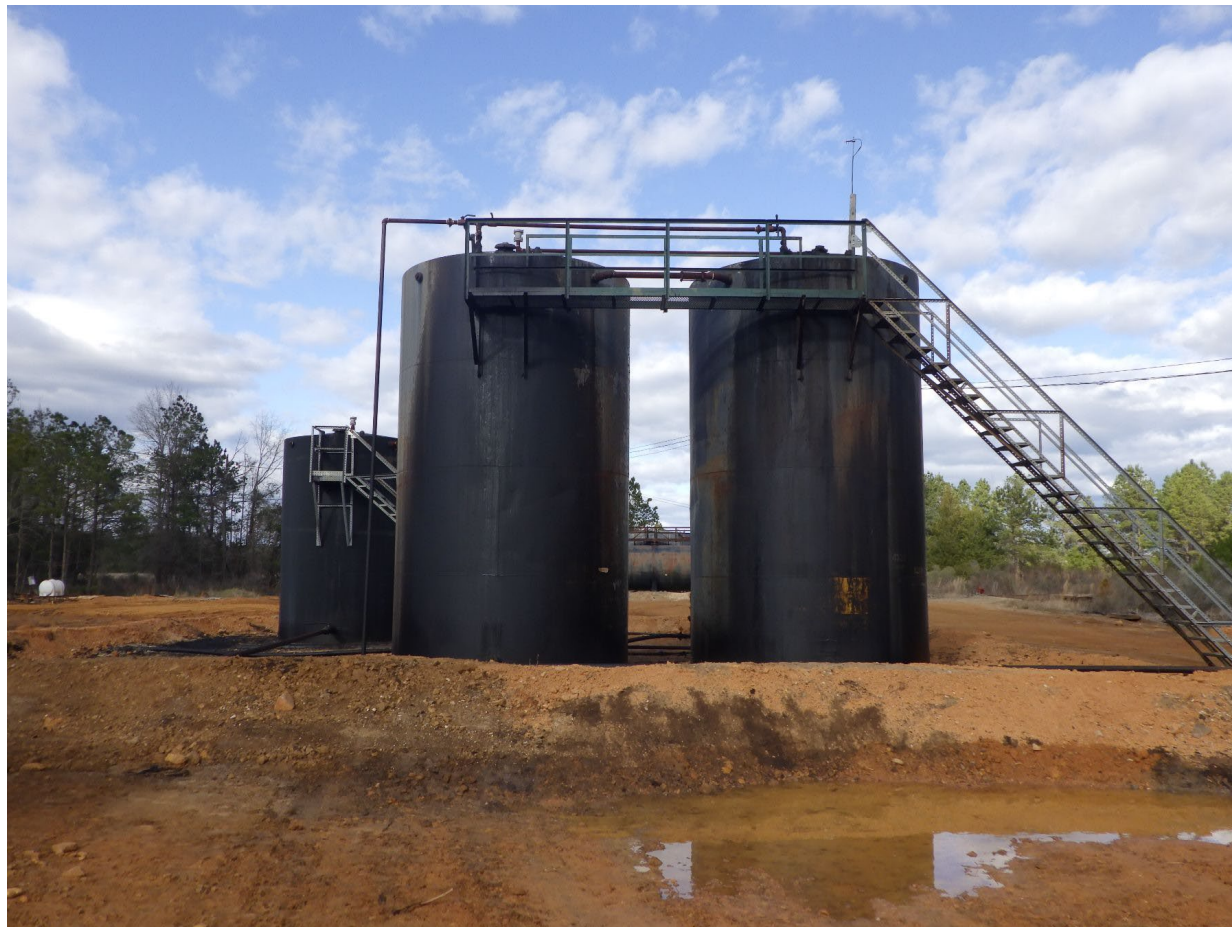
Photo No. 5

I observed the oil storage tank battery (Area 1) and drainpipe, see Photos No. 5 and No. 6.

| Description: | Looking SW, this photo shows an overview of the oil storage tank battery (Area 1). | | |

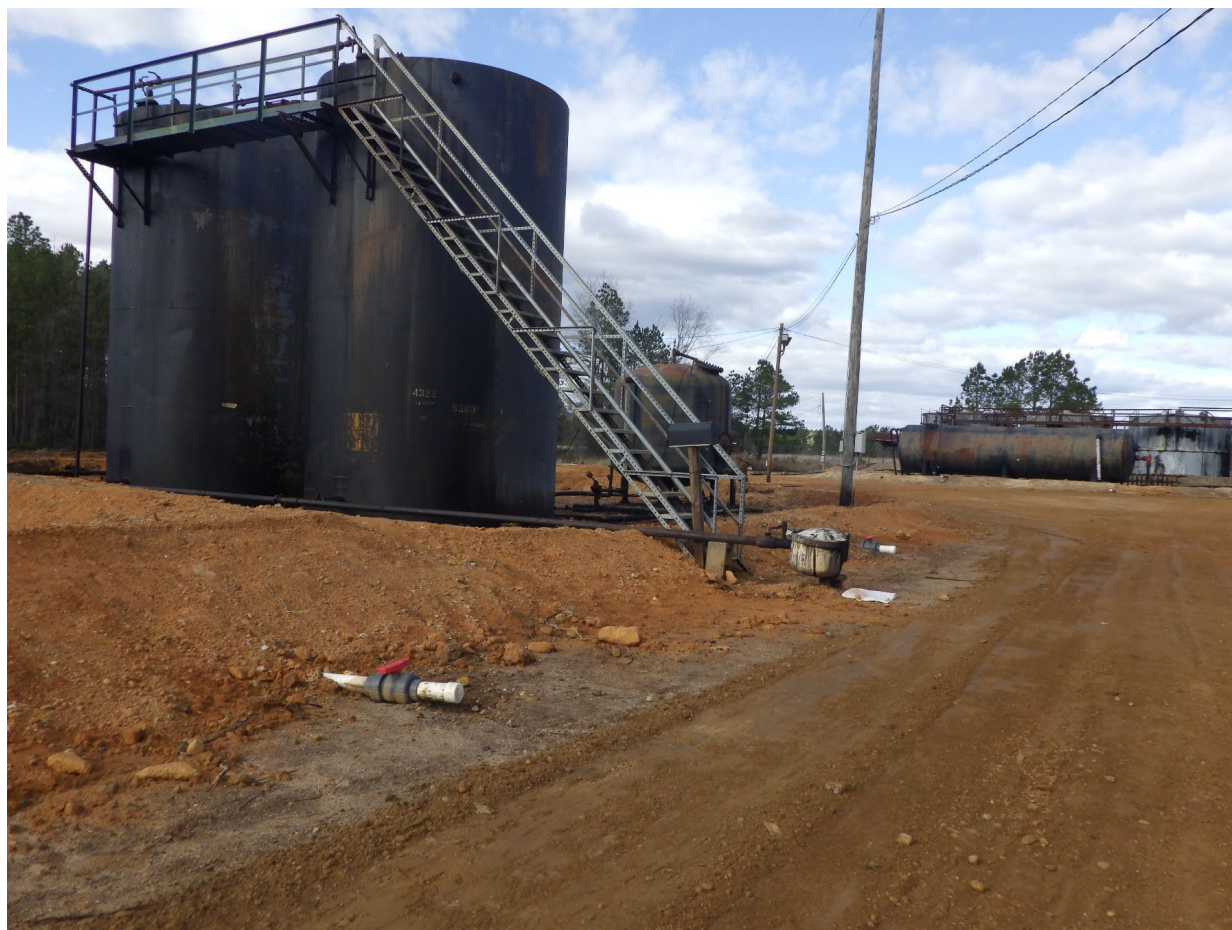
Photo No. 6

| Description: | Looking SW, this photo shows the drainpipes for the oil storage tank battery. | | |

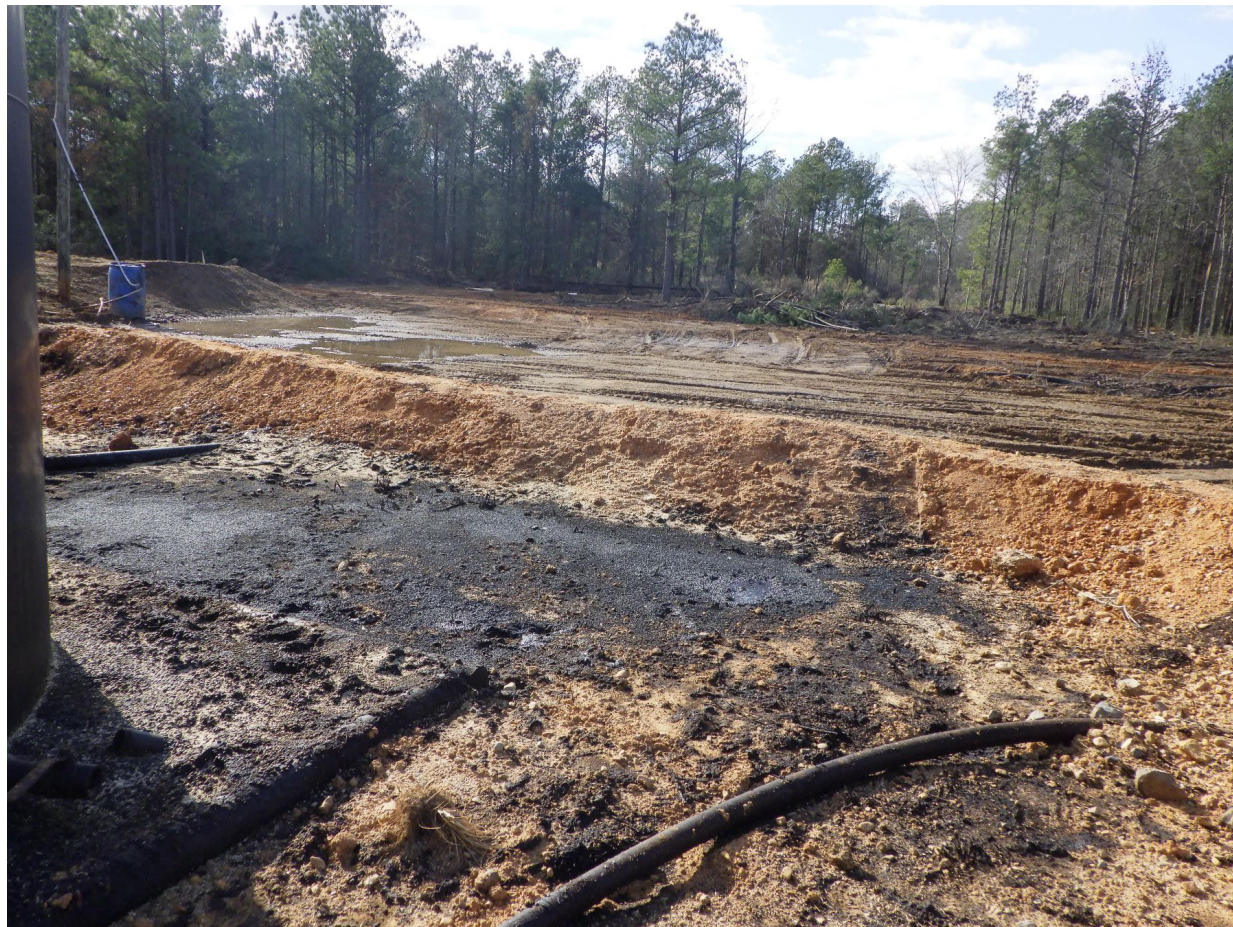
Photo No. 7

I observed loose oil inside the oil storage tank battery, see Photo No. 7.

- Loose oil inside the oil storage tank battery (Area 1), 40 CFR §112.9(b)(1) (Photo No. 7),
- Load line for FWKO tank battery (Area 3) without secondary containment, 40 CFR §112.7(c) (Photo No. 8),
- Loose oil from piping at the FWKO tank battery, 40 CFR §112.9(b)(1) (Photo No. 9),
- A tote (near the FWKO tank battery) used to store crude oil located outside secondary containment, 40 CFR §112.7(c) (Photos No. 8 and No. 15), and
- Loose oil inside oil storage tank battery (bolted tanks), 40 CFR §112.9(b)(1) (Photos No. 12 and No. 14)

| Description: | Looking SW, this photo shows loose oil inside the oil storage tank battery. | | |

Inspector will conduct follow-up phone calls with the company representative(s) over the coming weeks and months to ensure areas of concern are properly addressed. SEE Inspector Tom McKay will address SPCC rule concerns.

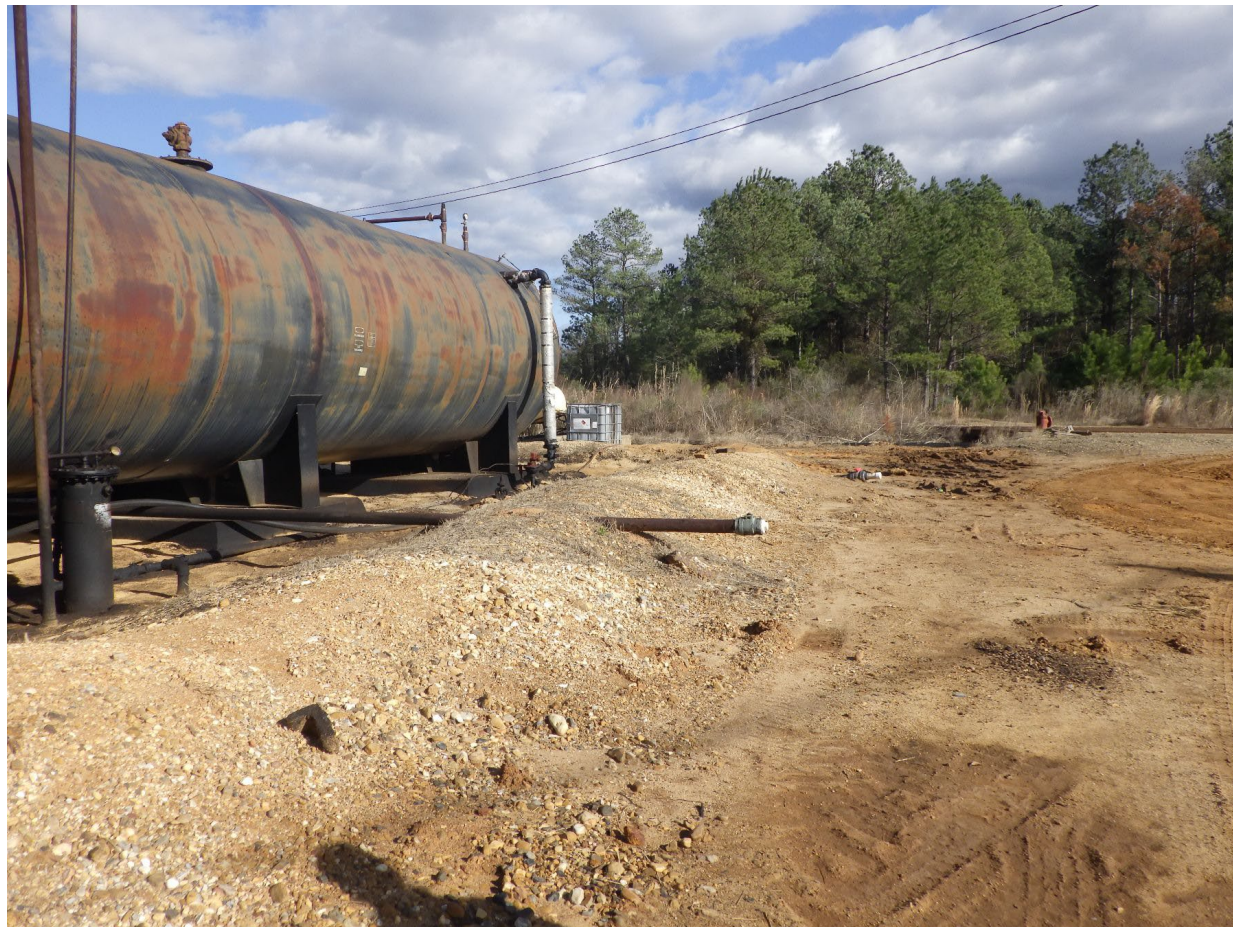
Photo No. 8

I observed the Free-water Knockout (FWKO) tank battery (Area 3) and a load line without secondary containment, see Photo No. 8.

I observed a tote with crude oil outside secondary containment near the FWKO tank battery, see Photos No. 8 and No. 15.

| Description: | Looking S, this photo shows the loading line for the FWKO tank battery without secondary containment. | | |

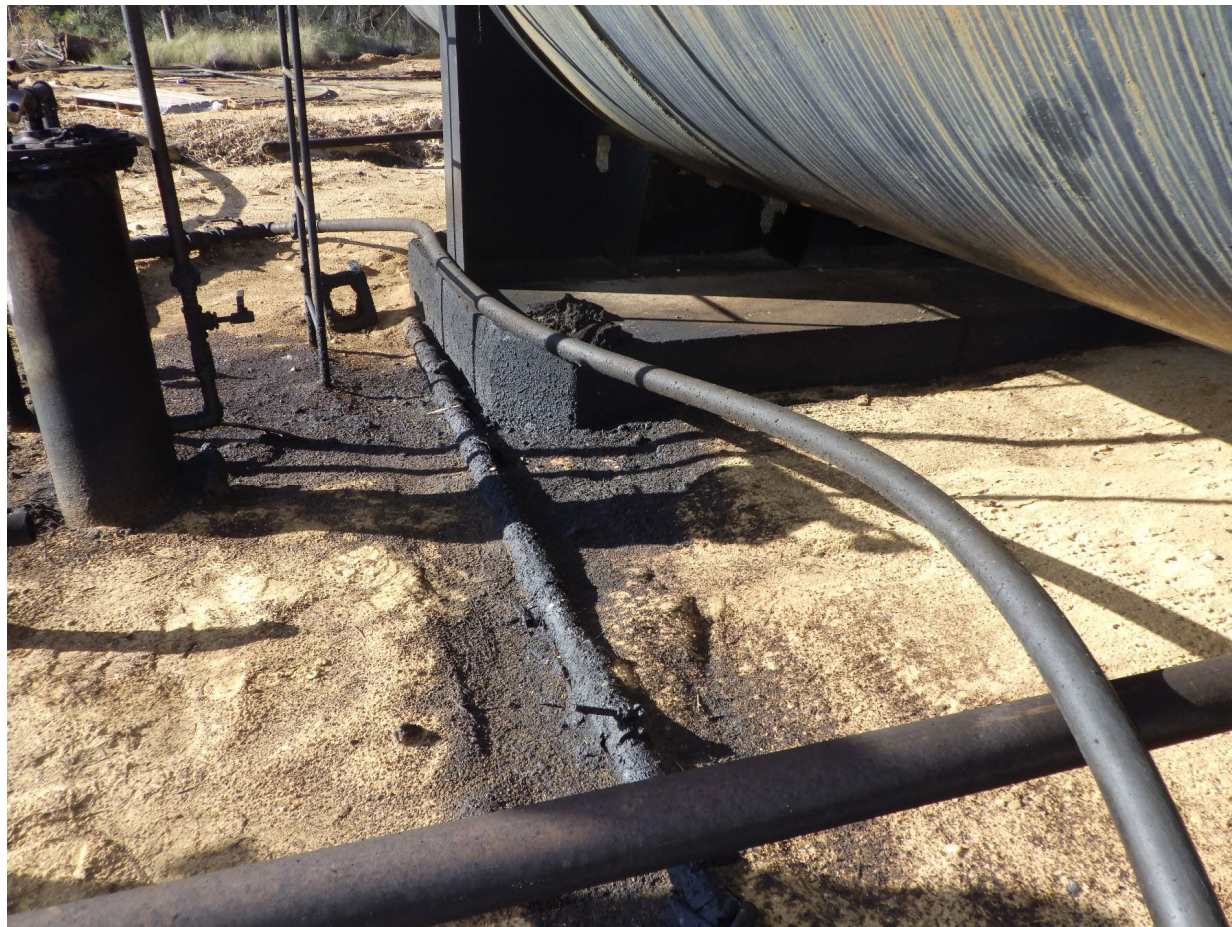
Photo No. 9

I observed loose oil from a section of piping at the FWKO tank battery, see Photo No. 9.

| Description: | Looking WSW, this photo shows an active leak from a pipe inside the FWKO tank battery. | | |

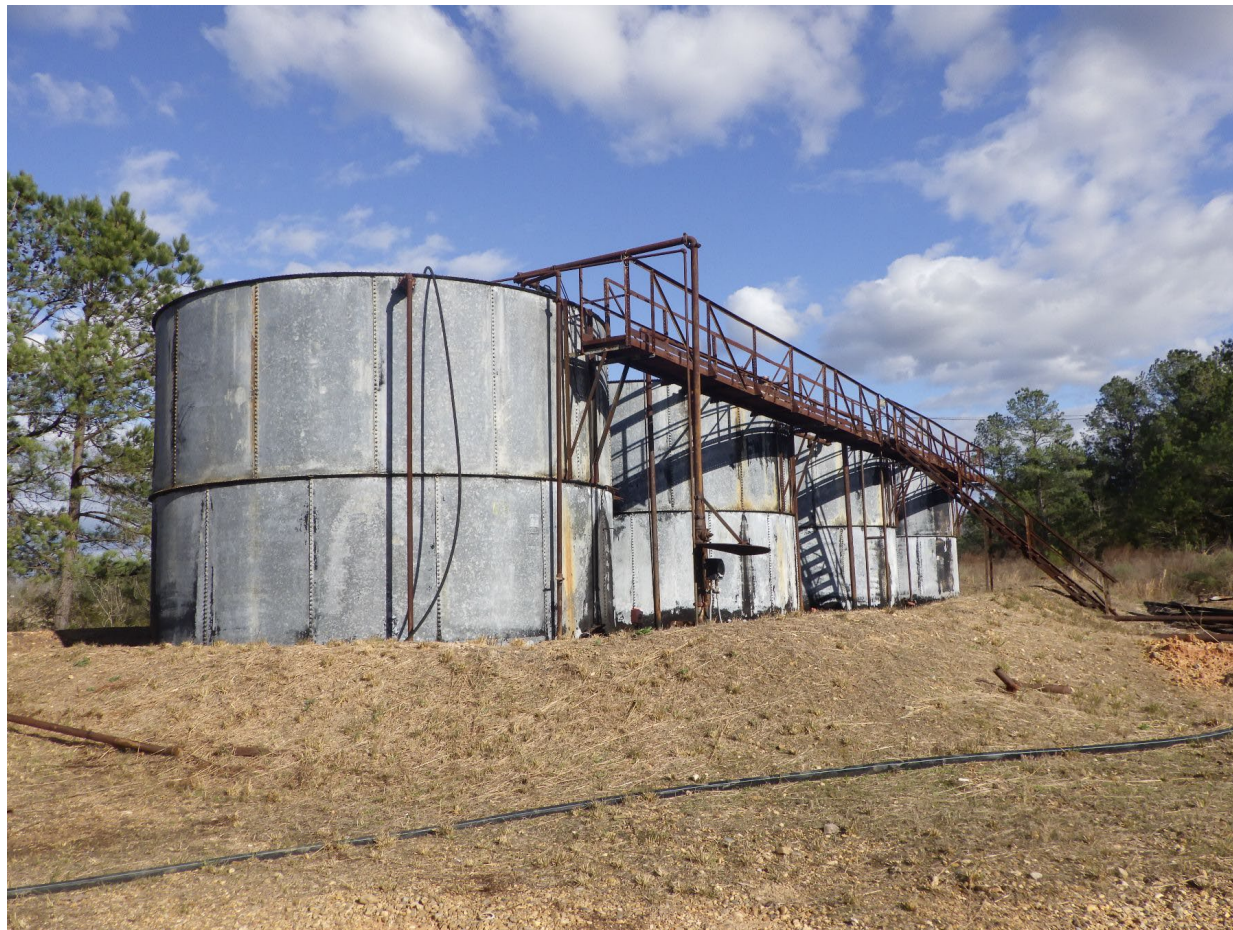
Photo No. 10

I observed an additional oil storage tank battery with four (4) bolted tanks, see Photo No. 10.

| Description: | Looking S, this photo shows a tank battery with older, bolted tanks. | | |

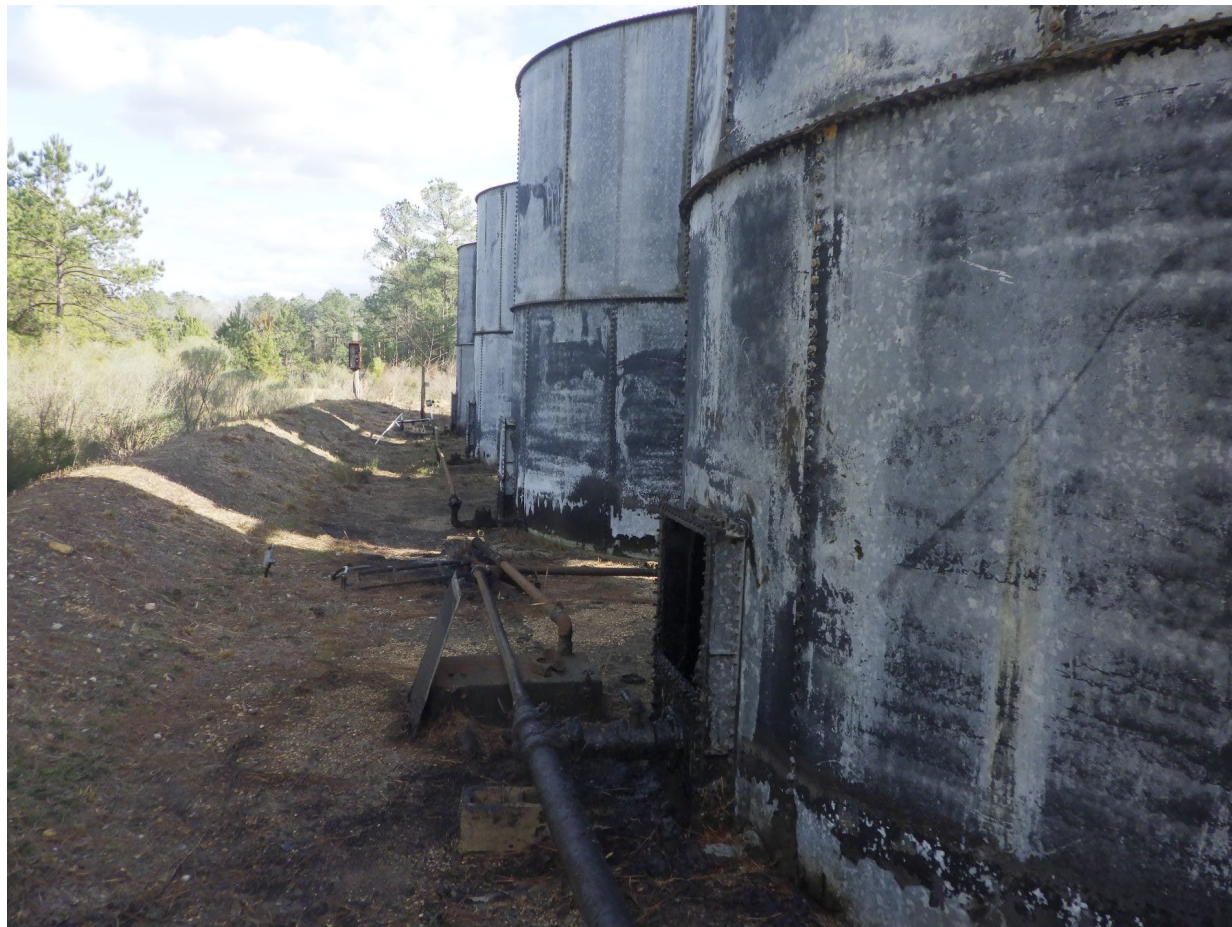
Photo No. 11

I observed one (1) bolted tank undergoing permanent closure (i.e., cleaned, plated/manway removed, and tagged, etc.), see Photos No. 11 through No. 14.

| Description: | Looking S, this photo shows the interior of the bolted tank battery with a pipe partially disconnected. | | |

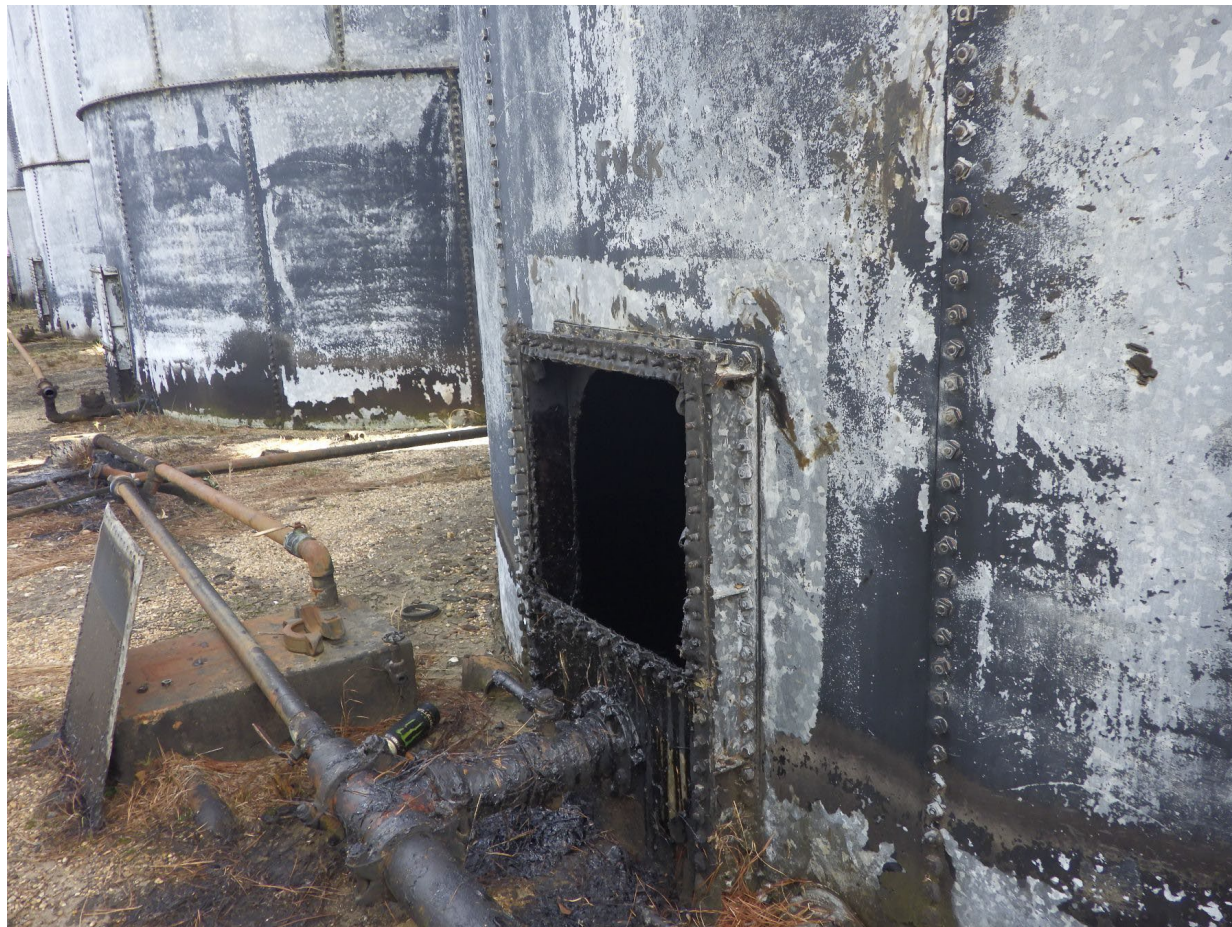
Photo No. 12

| Description: | Looking S, this photo shows a tank that C12: Arkansas Oil, LLC plated (i.e., removed the manway) in preparation for permanent closure. | | |

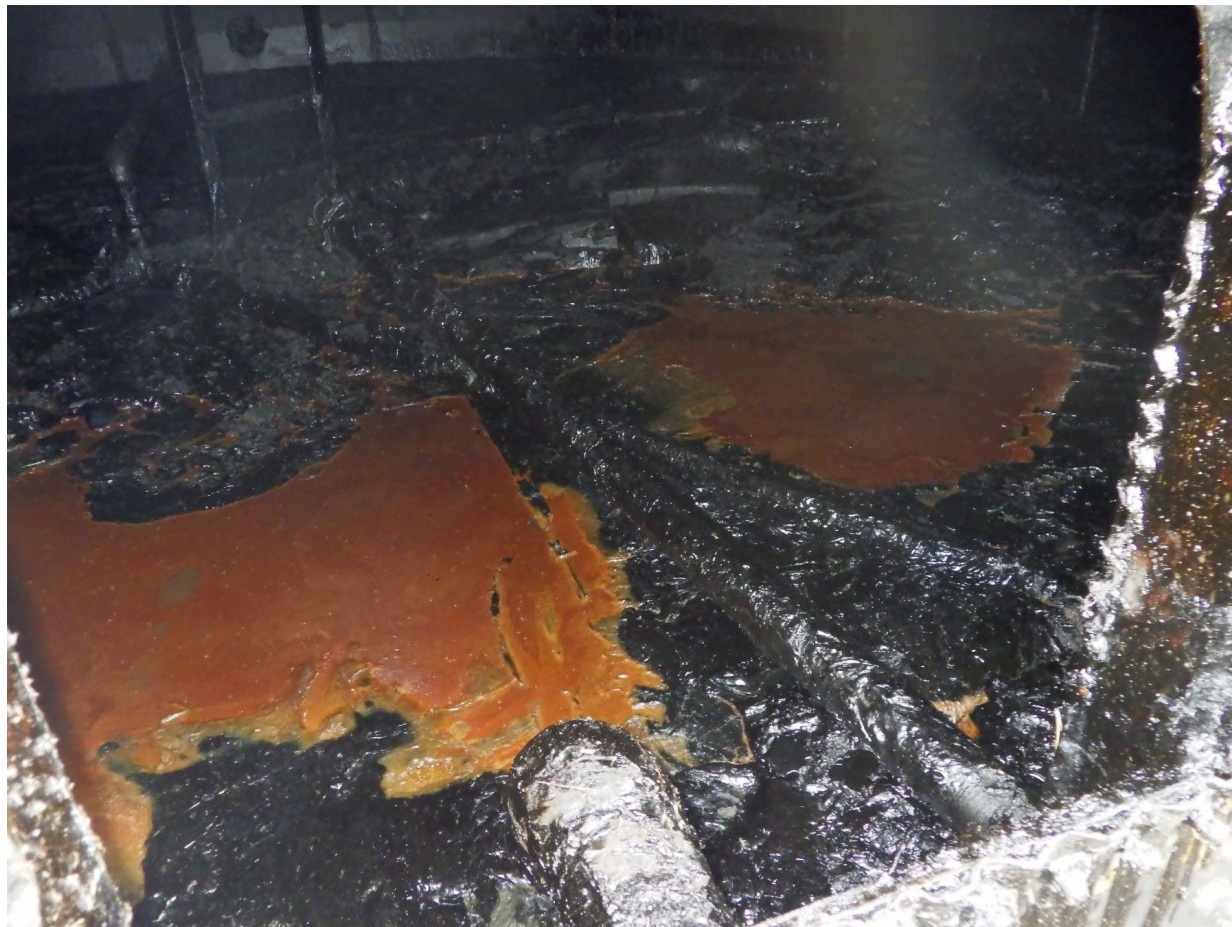
Photo No. 13

| Description: | Looking SSW, this photo shows sedimentation inside the plated tank that still needs to be removed prior to permanent closure. | | |

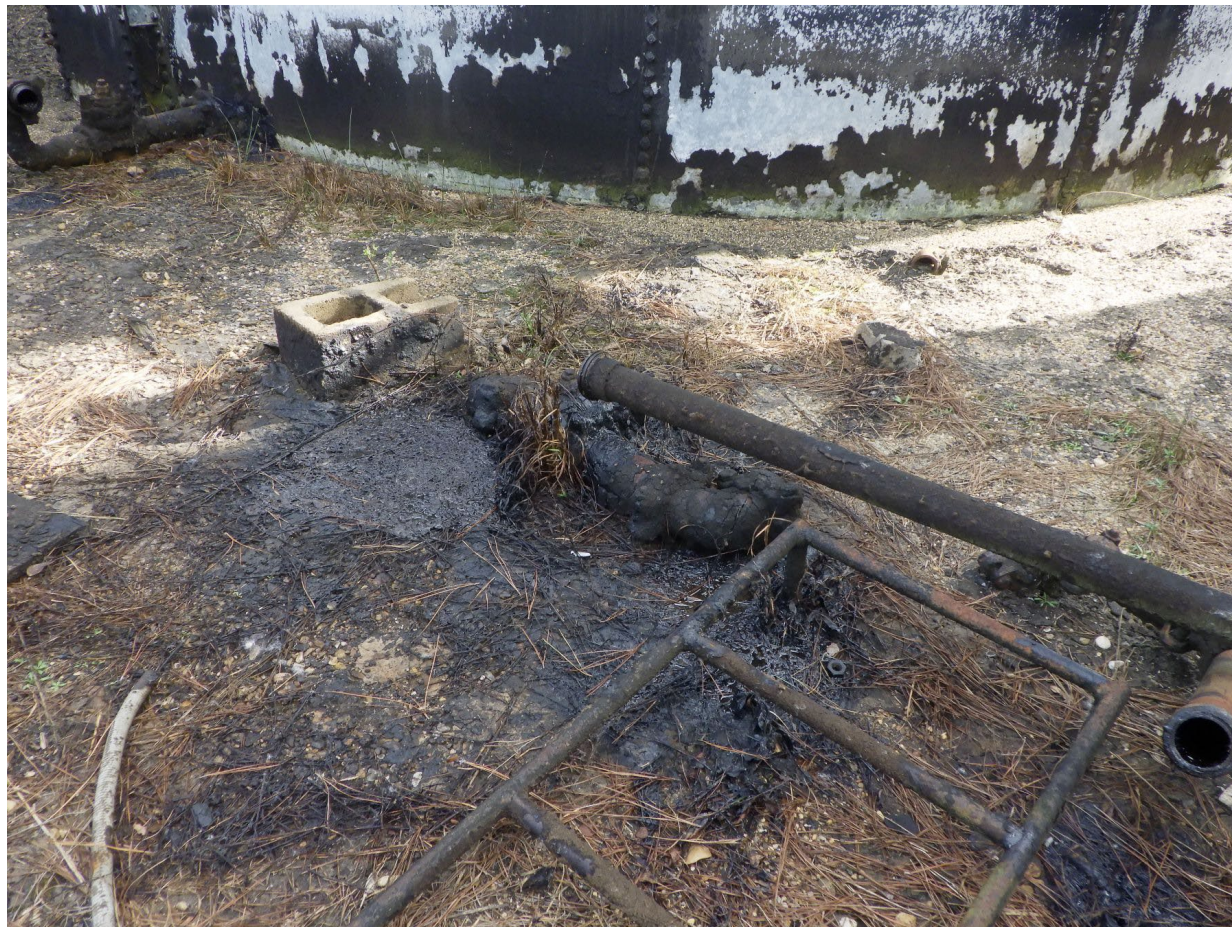
Photo No. 14

| Description: | Looking S, this photo shows an additional view of the removed section of pipe from Photo No. 11. | | |

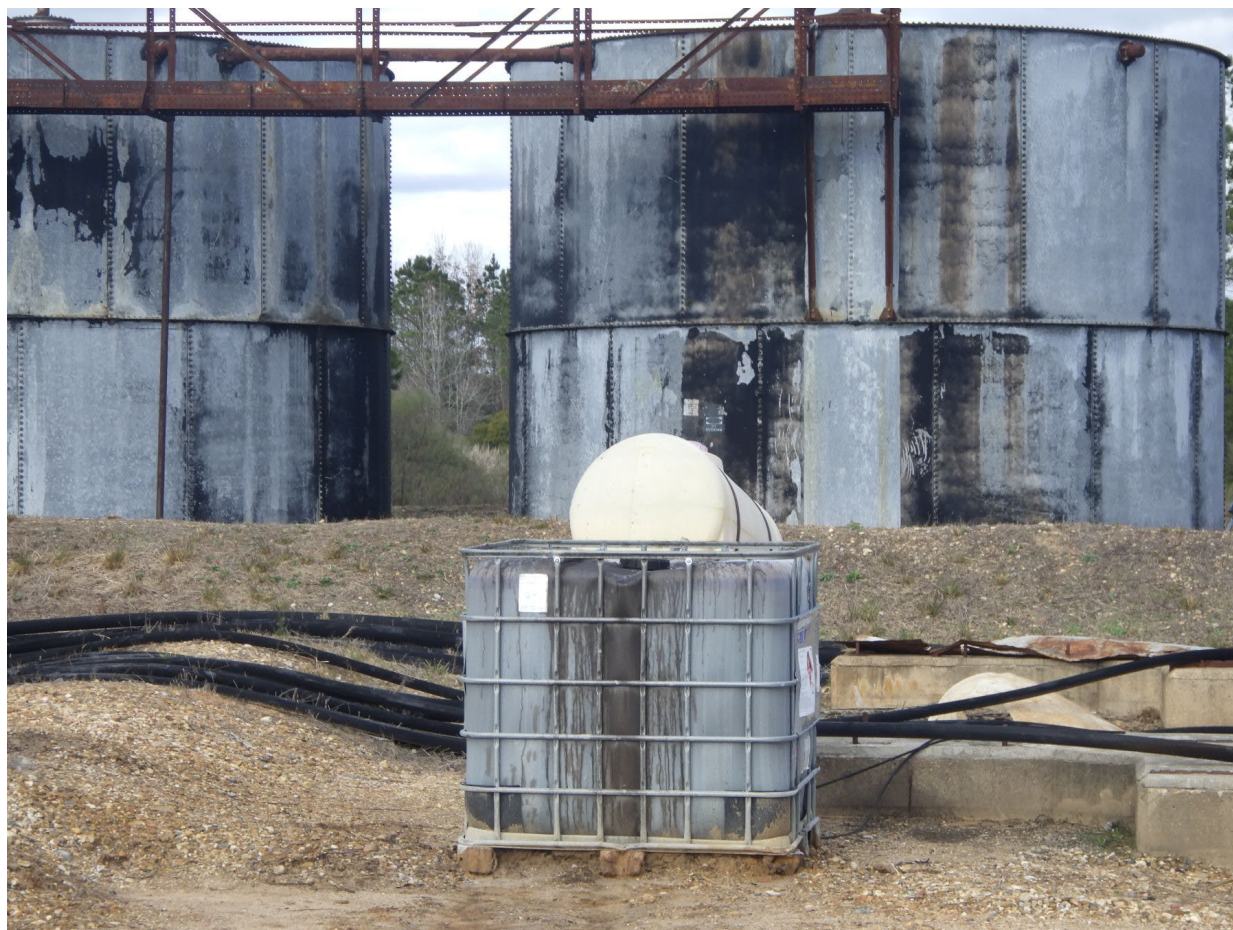
Photo No. 15

| Description: | Looking SW, this photo shows a closeup of the tote containing oil that was outside secondary containment from Photo No. 8. | | |
