## **RCRA Inspection Report**

USAF Shaw Air Force Base  
428 Chapin Street  
Shaw AFB, Sumter County, South Carolina 29152

January 31, 2023

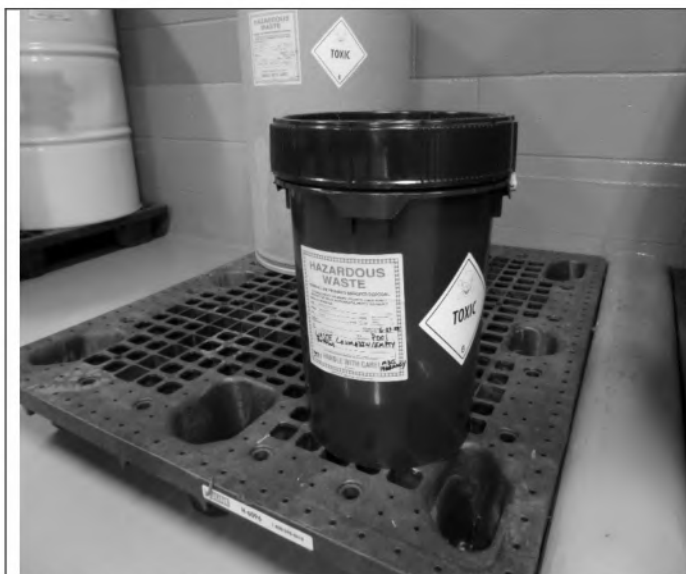
Inspectors observed the one 5-gallon container of coumadin in Bay 2, was marked with the date June 22, 2022, and a container granted an extension by SCDHEC to accumulate in the CAA for more than 90-days. The remaining hazardous waste containers granted an extension by SCDHEC were shipped to an off-site destination facility.

20 CES/CAA – (b)(6) Observed one 5-gallon container of waste coumadin in Bay 2. The container of waste coumadin was labeled with the words, “hazardous waste”, but not “hazardous waste pharmaceutical” Photograph 1 taken at 11:26 a.m.

**Pursuant to S.C. Code Ann. Regs. 61-79.266.502(e) [40 C.F.R. § 266.502(e)], labeling containers used to accumulate non-creditable hazardous waste pharmaceuticals at healthcare facilities. A healthcare facility must label or clearly mark each container of non-creditable hazardous waste pharmaceuticals with the phrase “Hazardous Waste Pharmaceuticals.”**

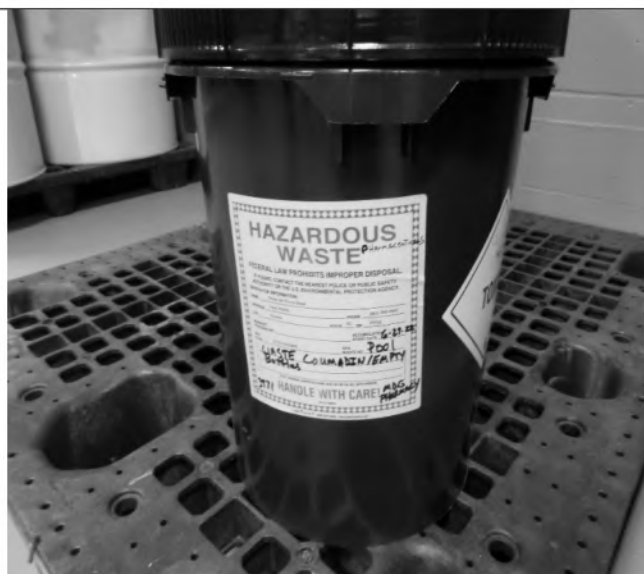
20 CES/CAA – (b)(6) Observed the facility mark the one 5-gallon container of waste coumadin in Bay 2 with the word “pharmaceutical” Photograph 2 taken at 11:29 a.m.

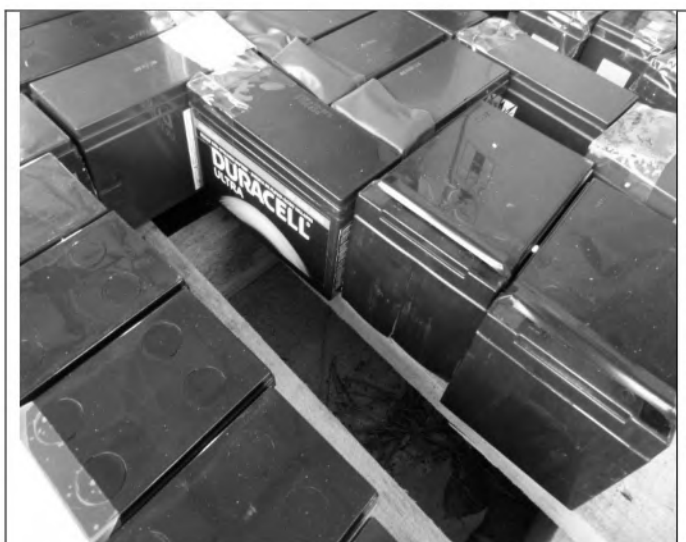
The inspectors observed approximately 70 lead acid batteries on pallets. Three batteries were not in good condition, either bulging or cracking (Photographs 3 and 4). The three batteries were overpacked in a plastic 5-gallon container and marked with the words “universal waste.

20 CES/CAA – (b)(6) Outdoor Storage Area. Observed three batteries were not in good condition, either bulging or cracking. Photograph 3 taken at 12:03 p.m.

**Pursuant to S.C. Code Ann. Regs. 61-79.273.33(a)(1) [40 C.F.R. § 273.33(a)(1)], a large quantity handler of universal waste must contain any universal waste battery that shows evidence of leakage, spillage, or damage that could cause leakage under reasonably foreseeable conditions in a container. The container must be closed, structurally sound, compatible with the contents of the battery, and must lack evidence of leakage, spillage, or damage that could cause leakage under reasonably foreseeable conditions.**

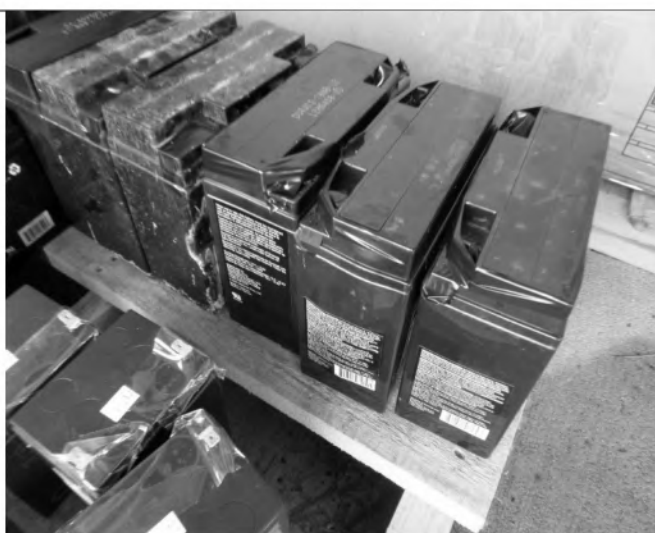
20 CES/CAA – (b)(6) Outdoor Storage Area. Observed three batteries were not in good condition, either bulging or cracking. Photograph 4 taken at 12:03 p.m.

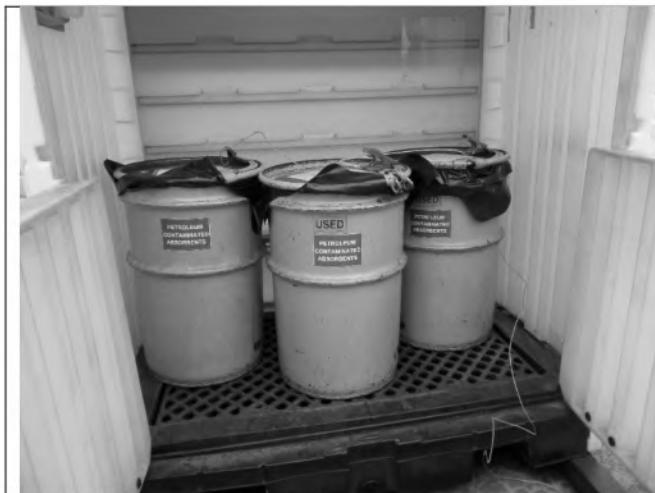
The inspectors were escorted outdoors to two locked storage lockers. The inspectors observed three 30-gallon containers in the first locker accumulating petroleum contaminated absorbent. The containers were closed, in good condition and labeled with the words “used petroleum contaminated absorbent” (Photograph 5). In the second locker the inspectors observed two 55-

77<sup>th</sup> FGS//MXADF (Tiger Maintenance Support) -  
(b)(6) Outdoor Storage Locker. Observed  
containers accumulating used oil related material.  
Photograph 5 taken at 1:36 p.m.

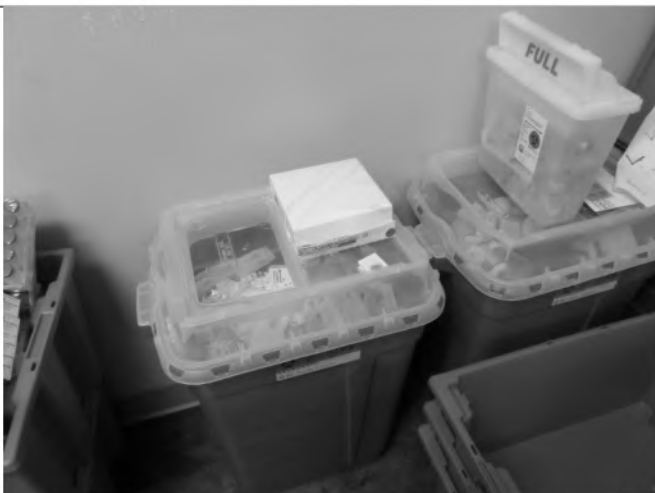
The inspectors observed two 20 to 30-gallon red containers accumulating pharmaceuticals to be shipped as credible pharmaceuticals for possible credit (Photograph 6). The creditable pharmaceuticals are shipped quarterly. Inspectors requested to review the records showing the pharmaceuticals are shipped for credit (b)(6) and (b)(6). (b)(6) indicated they would contact logistic to retrieve the records for the inspectors to review. Logistic (b)(6) indicated that the pharmacy should have a copy of the records and that shipping records for the credible pharmaceuticals were locked in a cabinet and were not available at the time of the inspection. The person responsible for securing the cabinet was not at the facility at the time of this inspection.

20 MDSS/SGSAP (Hospital Pharmacy) - (b)(6)  
Credible Pharmaceutical Storage Area. Observed two 20 to  
30-gallon red containers accumulating pharmaceuticals to be  
shipped for possible credit. Photograph 6 taken at 2:14 p.m.

**Pursuant to S.C. Code Ann. Regs. 61-79.266.503(e) [40 C.F.R. § 266.503(e)], A healthcare facility that initiates a shipment of potentially creditable hazardous waste pharmaceuticals to a reverse distributor must keep the following records (paper or electronic) for each shipment of potentially creditable hazardous waste pharmaceuticals for three years from the date of shipment:**

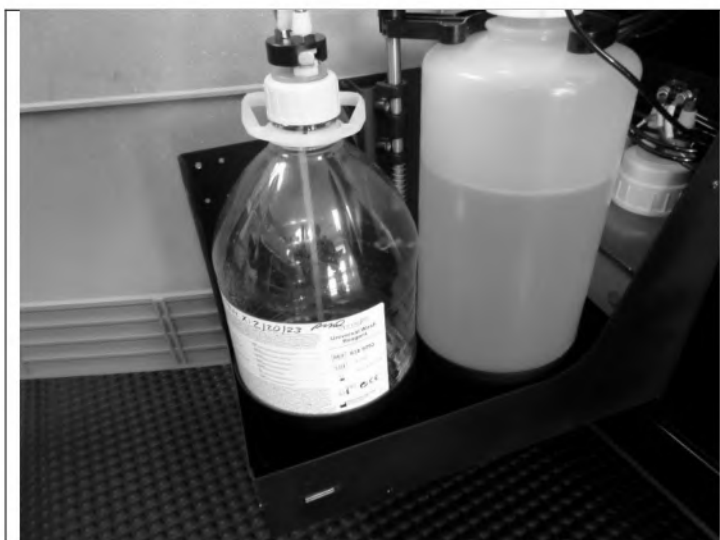
It appears the lines and internal parts of the Vitros instrument are cleaned on a regular maintenance schedule. The inspectors observed a one-gallon bottle of “Universal Wash Reagent” and an unmarked 2.5-gallon container of waste liquid stored inside the Vitros (Photograph 7). When full the container of waste liquid is removed from the Vitros and the content discharge to

the laboratory sink. It appears waste generated from the gram staining operation is discharged to the laboratory sink.

Hospital - Chemistry Laboratory. Observed container of wash  
reagent in "Vitros 5600" instrument. The inspectors observed the  
larger container on the right is accumulating possible waste  
liquid from cleaning the instrument. Photograph 7 taken at 2:49  
p.m.

**Pursuant to S.C. Code Ann. Regs. 61-79.262.11 [40 C.F.R. § 262.11], a person who generates a solid waste, as defined in 25 S.C. Code Ann. Regs. 61-79.261.2 [40 C.F.R. § 261.2], must use the steps articulated in S.C. Code Ann. Regs. 61-79.262.11 [40 C.F.R. § 262.11] to make an accurate determination as to whether that waste is a hazardous waste in order to ensure wastes are properly managed according to applicable RCRA regulations.**
