## **RCRA Compliance Evaluation Inspection Report**

EnergySolutions  
PO Box 2530  
Oak Ridge, Tennessee 37830  
County: Roane

June 9, 2022, 8:30 a.m.

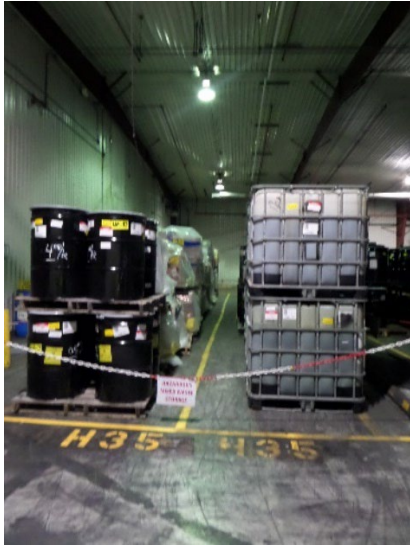
Photo-1 Inside H-Rows

At the time of the inspection, all containers in the "H-35" mixed-waste central accumulation area, were observed to be closed, labeled "Hazardous Waste," marked with hazard indication,

with adequate aisle-space, stacked on pallets (Photo-1). The oldest accumulation start-date on the container was observed to be March 21, 2022. Spill control and emergency response equipment are stationed nearby as mentioned previously. There were no hazardous waste deficiencies observed in this area.

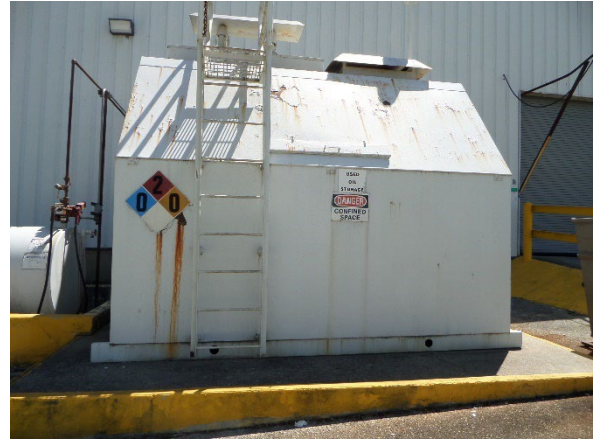
Photo-4 4000-gallon Used Oil Tank

The 4000-gallon double-walled above-ground tank for rad-contaminated used-oil-storage was inspected outside the CVRF (Photo-4). Used oil from this tank is piped directly into incinerator line A as supplemental fuel. At the time of the inspection, this tank was labeled “used oil”, and had no evidence of leakage or spillage.

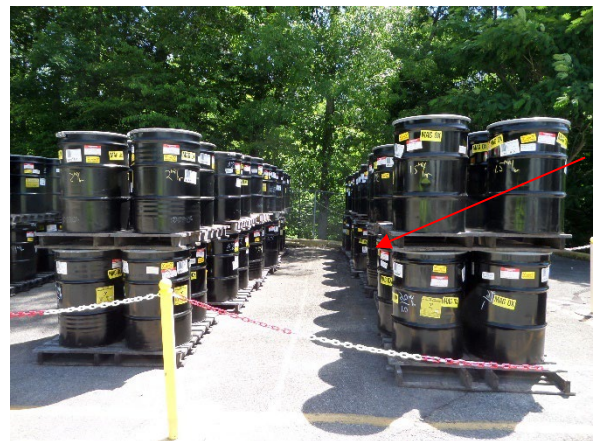
Photo-5 Outside H-rows Mixed Hazardous Waste Storage

Outside the northeastern corner of the CVRF complex, an outside mixed waste central accumulation area contains drums and sealed boxes of mixed hazardous waste called the “outside H-rows.”

At the time of the inspection, the outside H-Rows comprised of six rows with adequate aisle space. Each row contained approximately 40 containers double stacked on pallets. All the containers were observed to be closed, labeled with hazard indication and marked with an accumulation start date (Photo-5). All visible accumulation start-dates indicated storage for less than 90 days; however, it was not possible to determine the oldest container without undue exposure to radioactive materials within the containers. Facility records indicate that on the day of the inspection, the oldest container in storage was dated April 17, 2022. Emergency response equipment and communication equipment is available in a nearby operating area under a shed roof annexed to the CVRF complex.

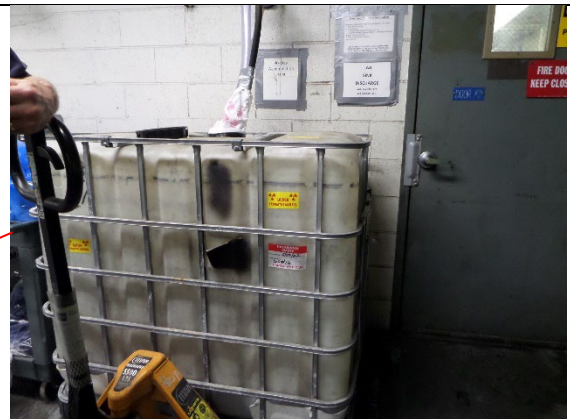
Photo-6 90-day CAA IBC Tote near Metal Melt TCLP Lab

The 90-day central accumulation area for the lab is a 275-gallon Intermediate Bulk Container (IBC) tote stationed outside the lab (WS#12). At the time of the inspection, this container was empty. It was closed and marked with the words “hazardous waste” but without any hazard indication marking (Photo-6). The inspectors recommended the Lab personnel to put a hazard indication prior to receiving any hazardous waste.

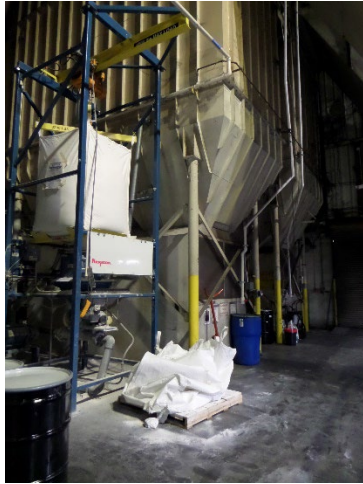
Photo-7 Metal Melt Baghouse Facility, Magox spill

The inspectors observed an unknown spill near one of the baghouse structures (Photo-7). Ms. Erin Sims-Taylor confirmed the spill as a Magox spill which appeared to be similar to the spill observed earlier in the CVRF Incinerator area. **Although it was a nonhazardous spill, the inspectors brought the housekeeping matter as an area of concern and recommended Energy Solution personnel to take appropriate steps for ensuring that the facility is designed, operated, and maintained to minimize the sudden or nonsudden release of materials including hazardous waste which could threaten human health and the environment. The Energy Solution personnel assured that the spill matter would be followed up with the appropriate process manager, the spill area would be cleaned up and the spilled material returned to the process.**

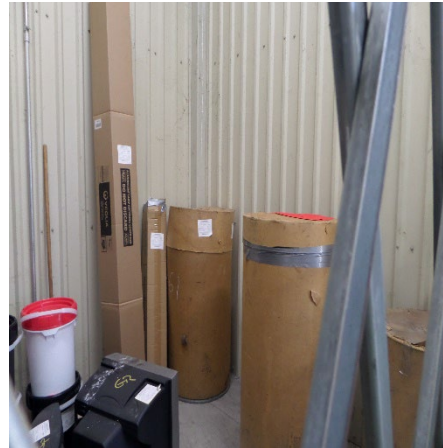
Photo-10 Universal Waste Storage Area

Universal wastes collected from the universal waste accumulation stations around the facility are stored inside a storage-room annexed to the Metal Melt facility. At the time of the inspection, the room was unlocked but the universal waste area was pad-locked behind a caged area. Universal waste containers behind the caged area were visibly closed and intact. However, it was not possible to check the labels and storage dates without getting access to the caged area. The caged universal waste storage area was inspected on June 13, 2022.

Containers included six 5-gallon buckets of universal waste batteries, one box of 8-foot waste lamps, three boxes of 4-foot waste lamps, three boxes of compact waste lamps, along with 13 containers of and uncontained larger articles of e-waste (Photo-10). All universal waste containers were observed to be closed, labeled “universal waste,” and marked with an accumulation start-date. The oldest date was observed to be March 30, 2022.

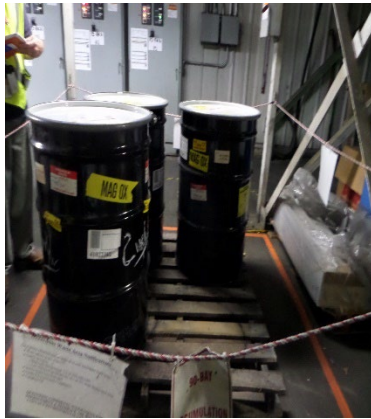
Photo-8 Metal Melt Baghouse 90-day CAA

At the time of the inspection, three containers were observed in the 90-day central accumulation area, closed, labeled “hazardous waste,” marked to indicate the nature of the hazard (Photo-8). The oldest accumulation start date was observed to be May 19, 2022, (WS#2127).

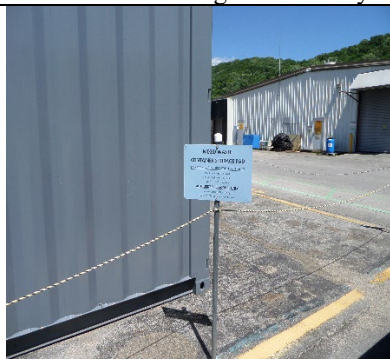
Photo-9 P4 Pad (Mixed Waste Storage)

A permitted outdoor storage area is located toward the western portion of the lot; it measures 60 feet by 30 feet on an asphalt surface, separated by rope-barriers with signage to indicate radioactive hazardous waste. Its boundary is clearly indicated by caution-rope with hanging signs, and stripes painted on the asphalt, as required in Permit TNHW-171. This facility is permit-limited to storing containers of dry mixed waste, and dry rad-only waste.

On the day of the inspection, the permitted outdoor P4 Pad was observed as having caution-ropes and signage in place. The asphalt under the storage area was observed as free from cracks or damage. One 1080 cubic foot intermodal container of dry material was stored in this area; it was closed, in good condition, marked as required with the words “hazardous waste,” hazard indications, an accumulation start-date of February 14, 2022, and with radioactive waste warning labels (Photo-9).
