## Region 6 - Enforcement & Compliance Assurance Division

### INSPECTION REPORT

| Company Name: | <b>Nevada Oil, LLC</b> | |
| Facility Name: | <b>Sandy Bend Tank Battery</b> | |

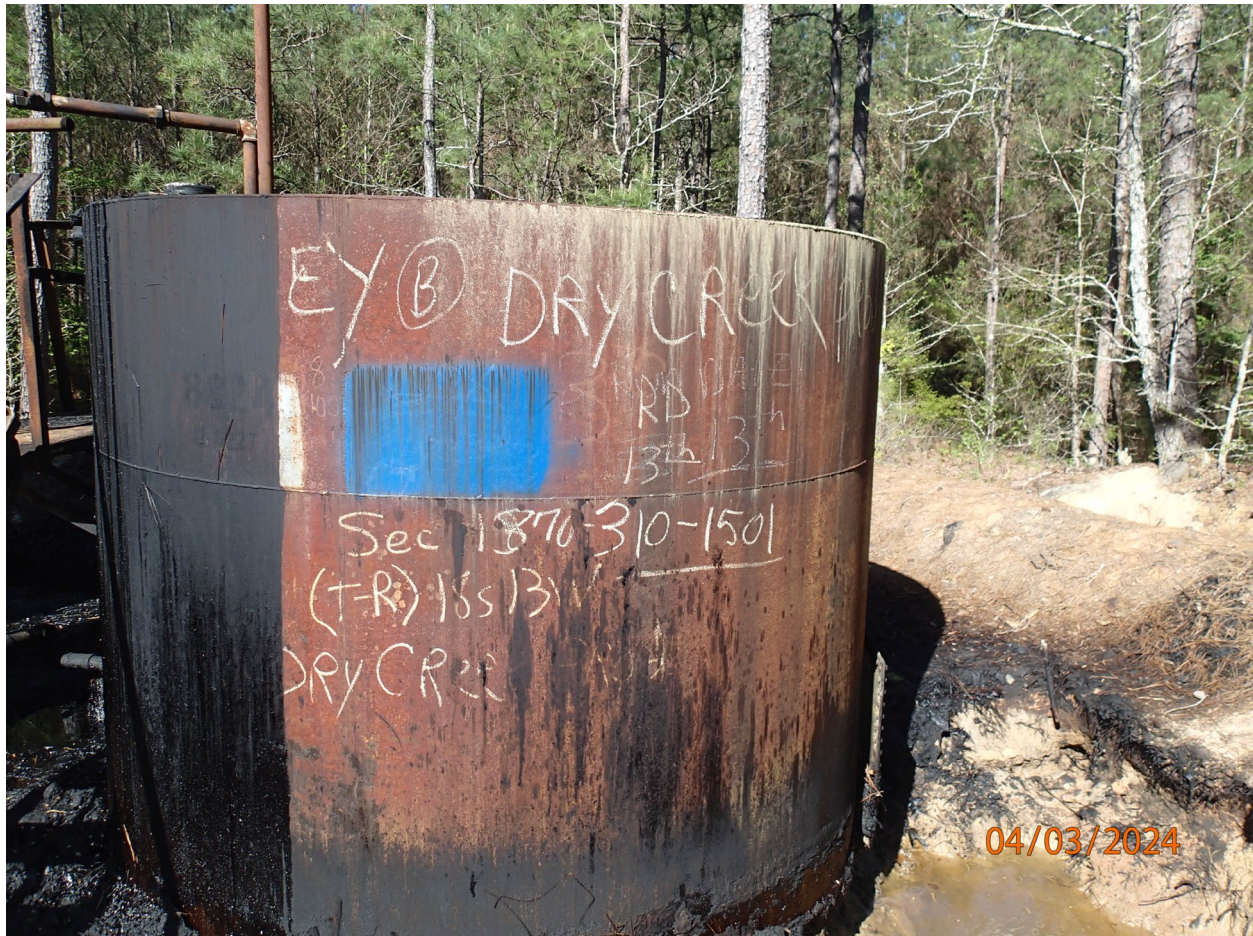
Photo No. 1

**Description:** Looking SE, this photo showed the signage at the facility.

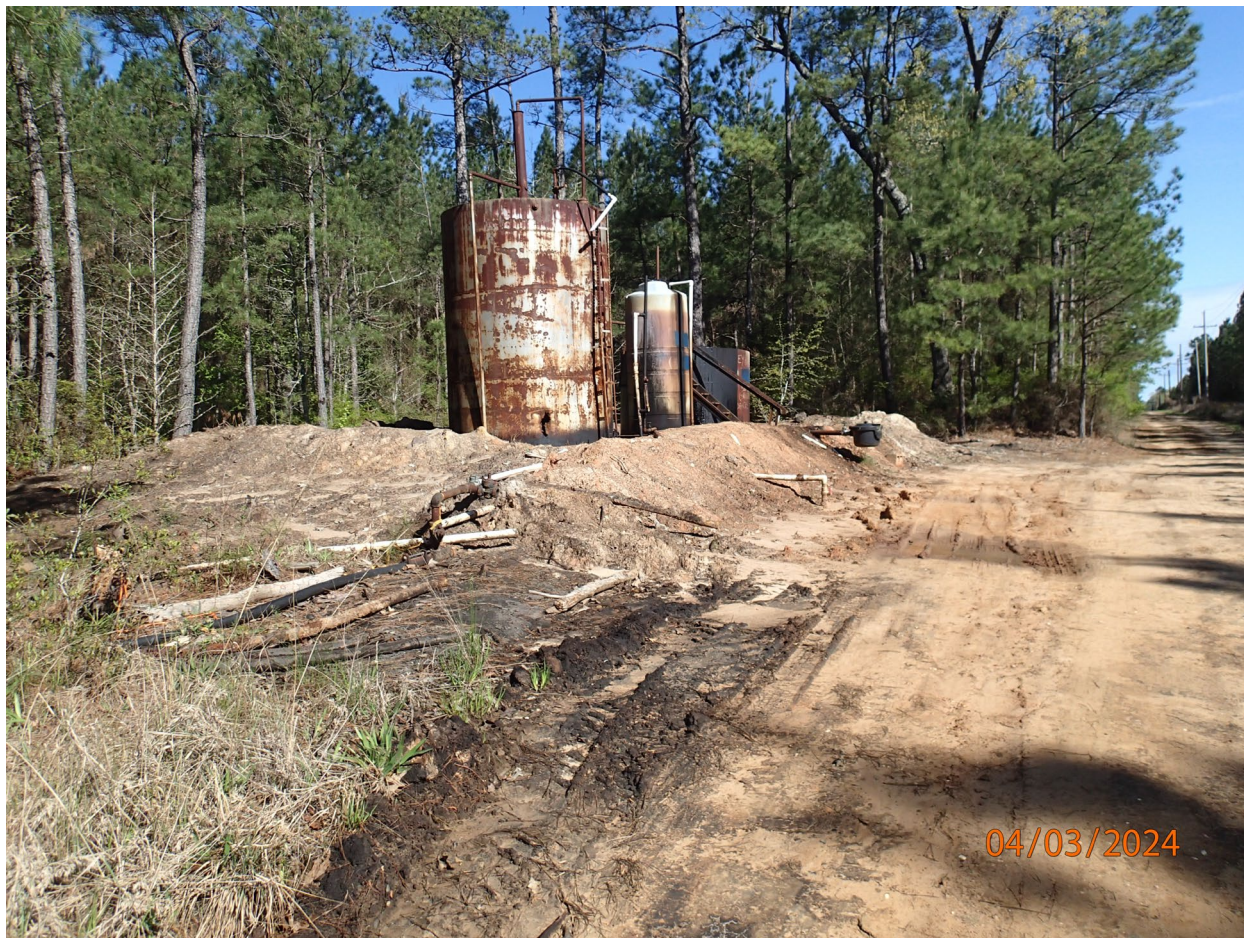
Photo No. 2

I observed the facility sign, secondary containment, oil-water separators, pipes and valves, and storage tanks located at the facility; see Appendix 1 (Photograph Log), Photo No. 1 and No. 2. For additional GPS location and photo metadata, see Appendix 1.

**Description:** Looking NE, this photo showed an overview of the facility with loose oil on the ground outside secondary containment.

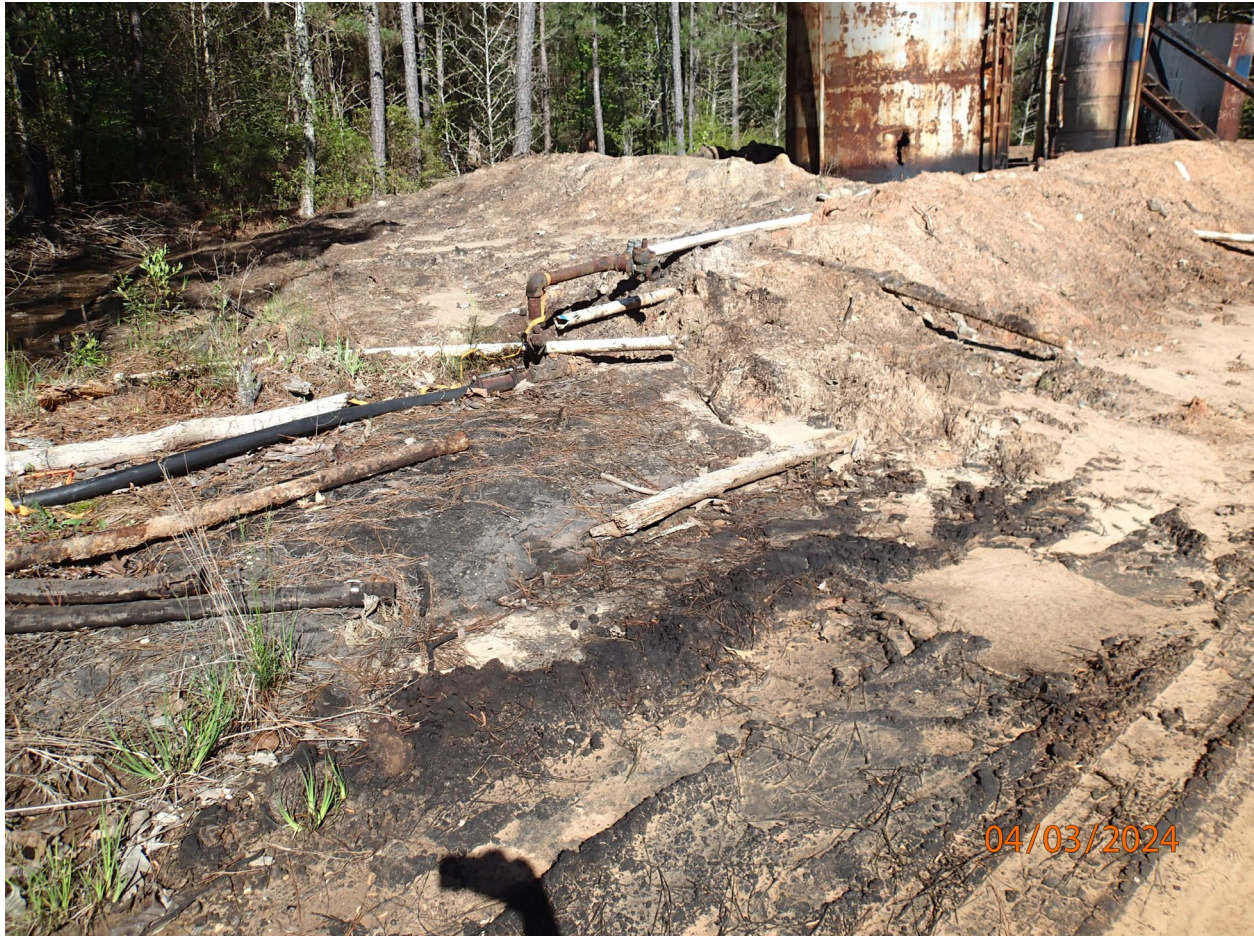
Photo No. 3

I observed loose oil on the ground outside secondary containment; see Photo No. 3.

**Description:** Looking NE, this photo showed a closeup of the loose oil observed in Photo No. 2.

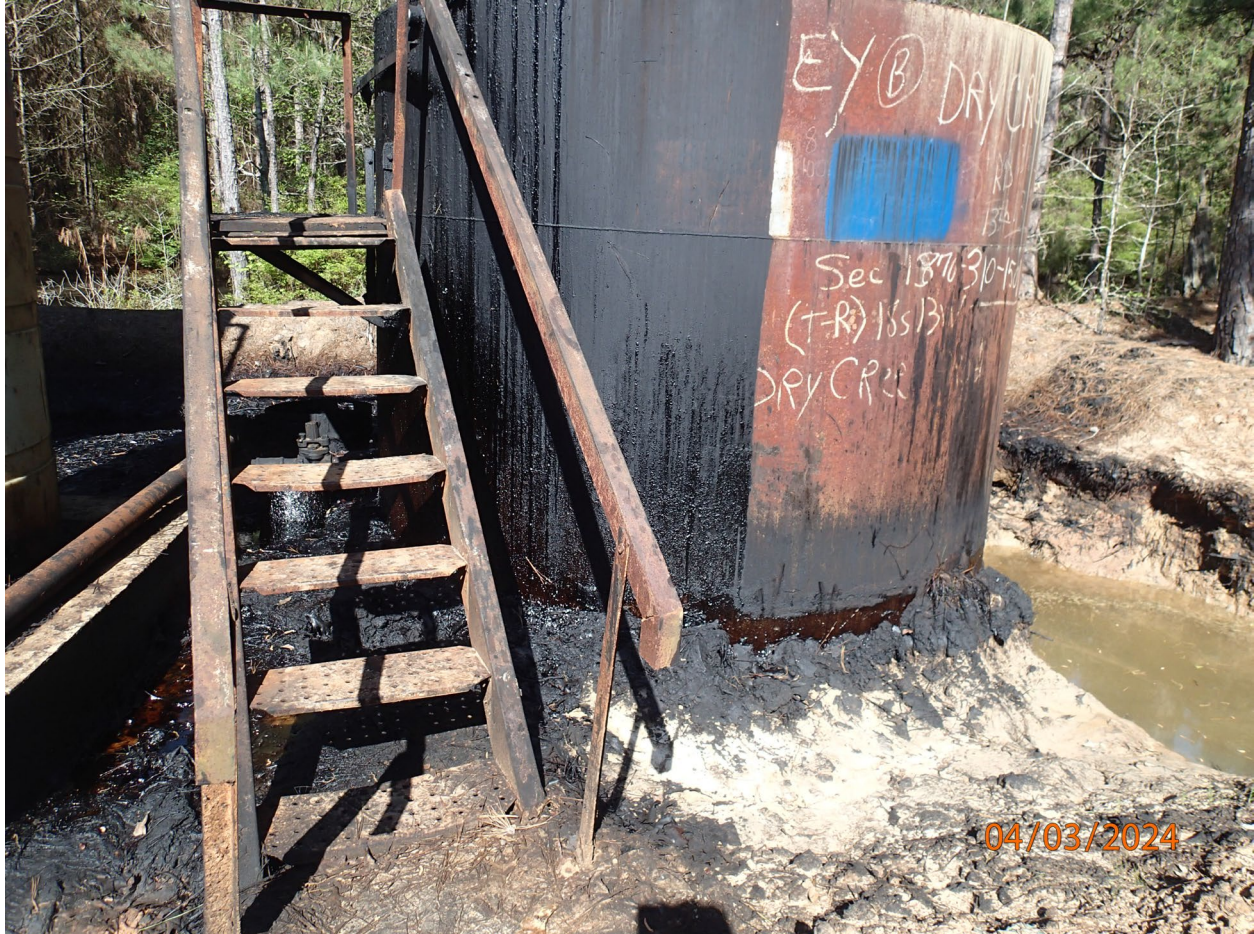
Photo No. 4

I observed loose oil inside secondary containment, see Photo No. 4, No. 6 through No. 8.

**Description:** Looking E-SE, this photo showed loose oil inside secondary containment at the front of the facility.

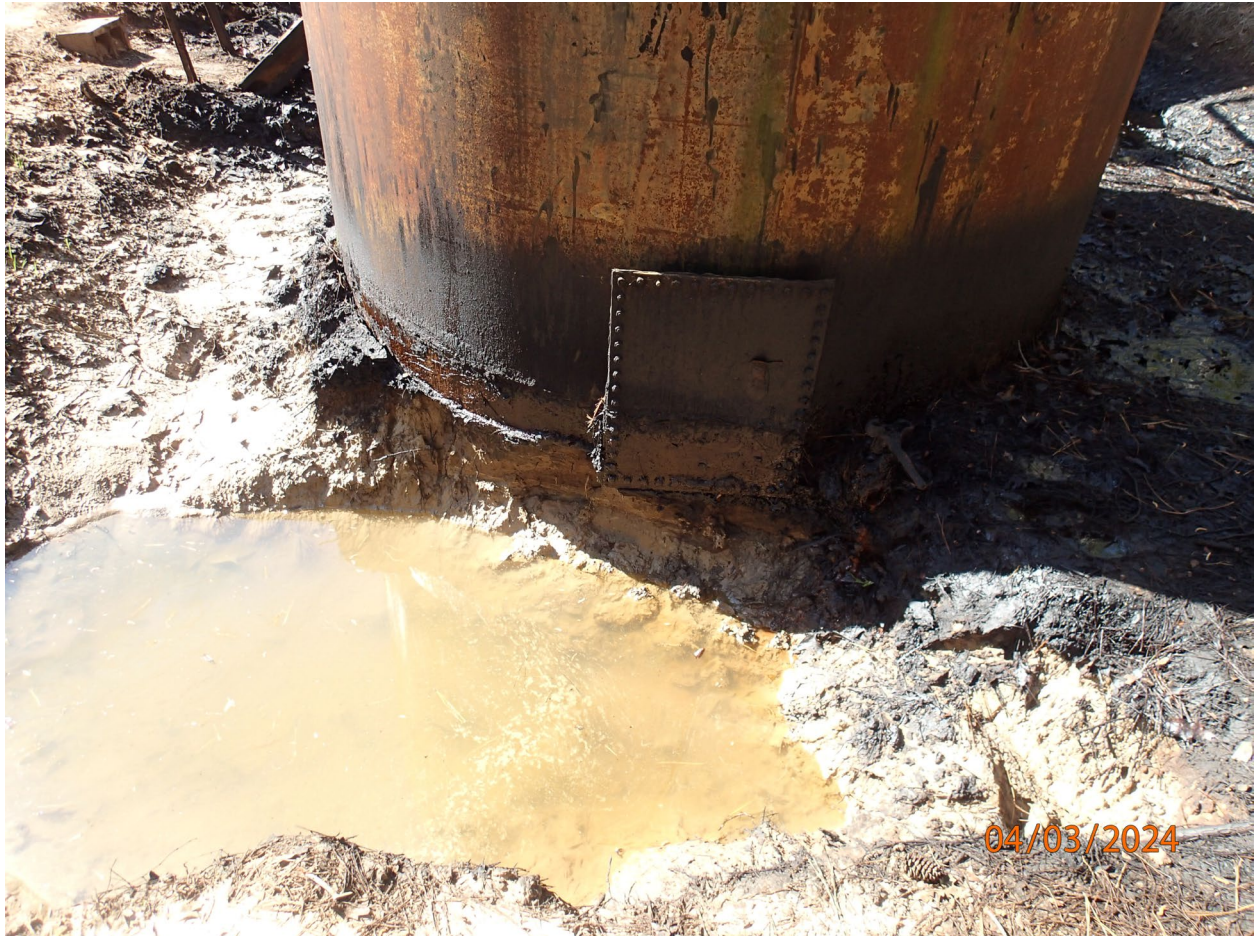
Photo No. 5

I observed a gap at the bottom on one of the storage tanks inside secondary containment, see Photo No. 5.

**Description:** Looking S-SW, this photo showed an eroded foundation around one of the tank bottoms and water stored inside secondary containment.

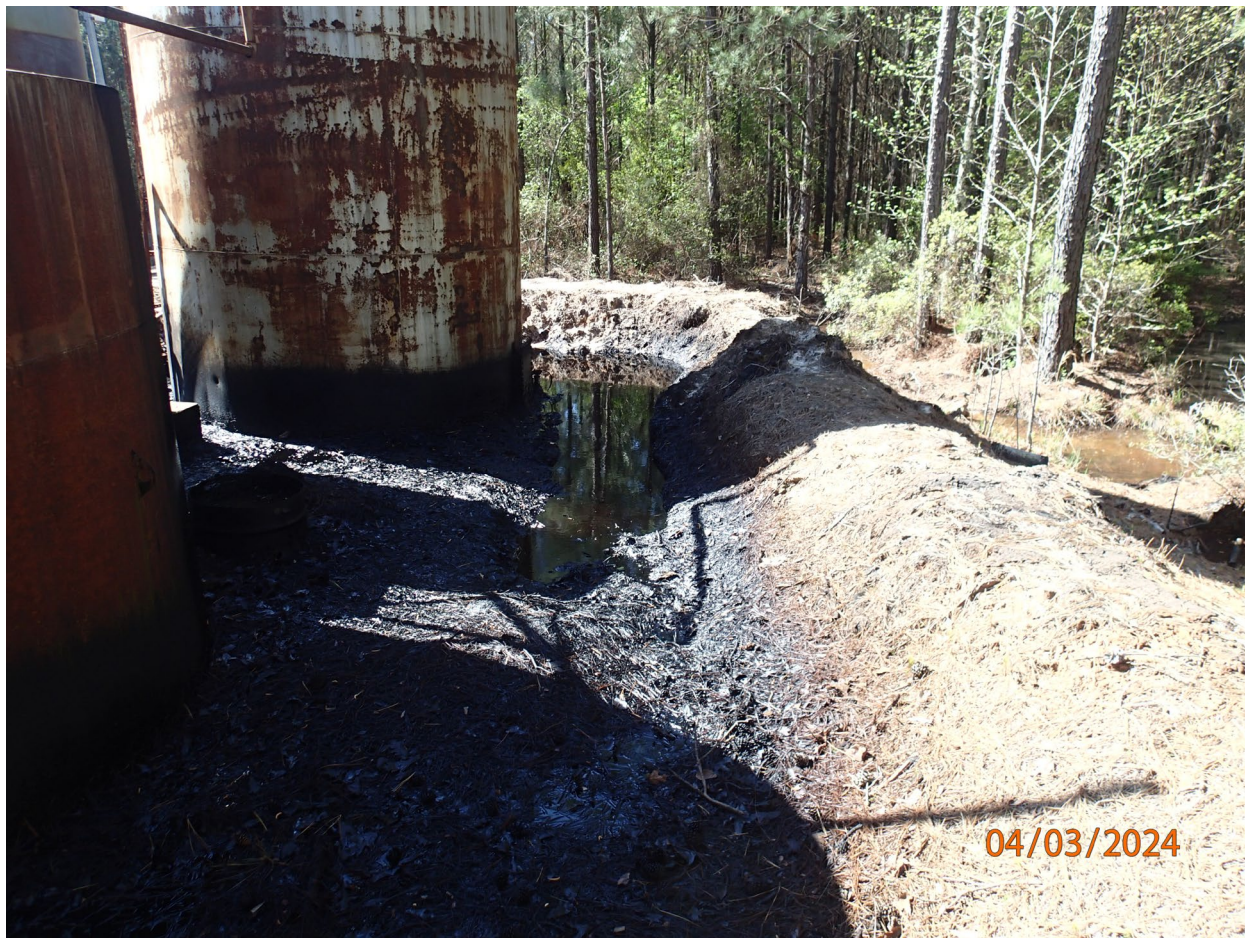
Photo No. 6

**Description:** Looking S, this photo showed loose oil and oil-saturated leaf litter inside secondary containment.

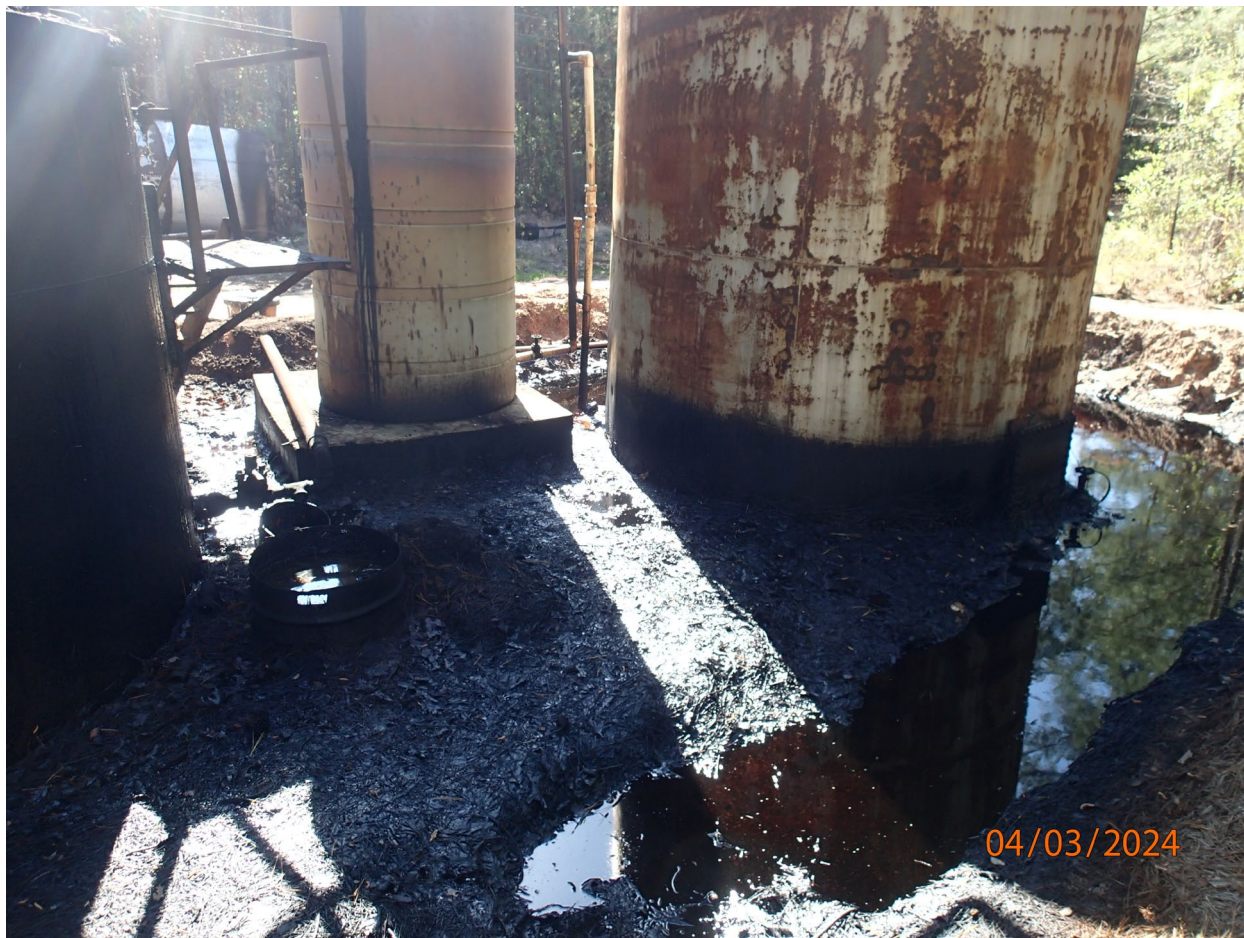
Photo No. 7

**Description:** Looking SW, this photo showed an additional view of the loose oil and oil-saturated leaf litter inside secondary containment from Photo No. 6.

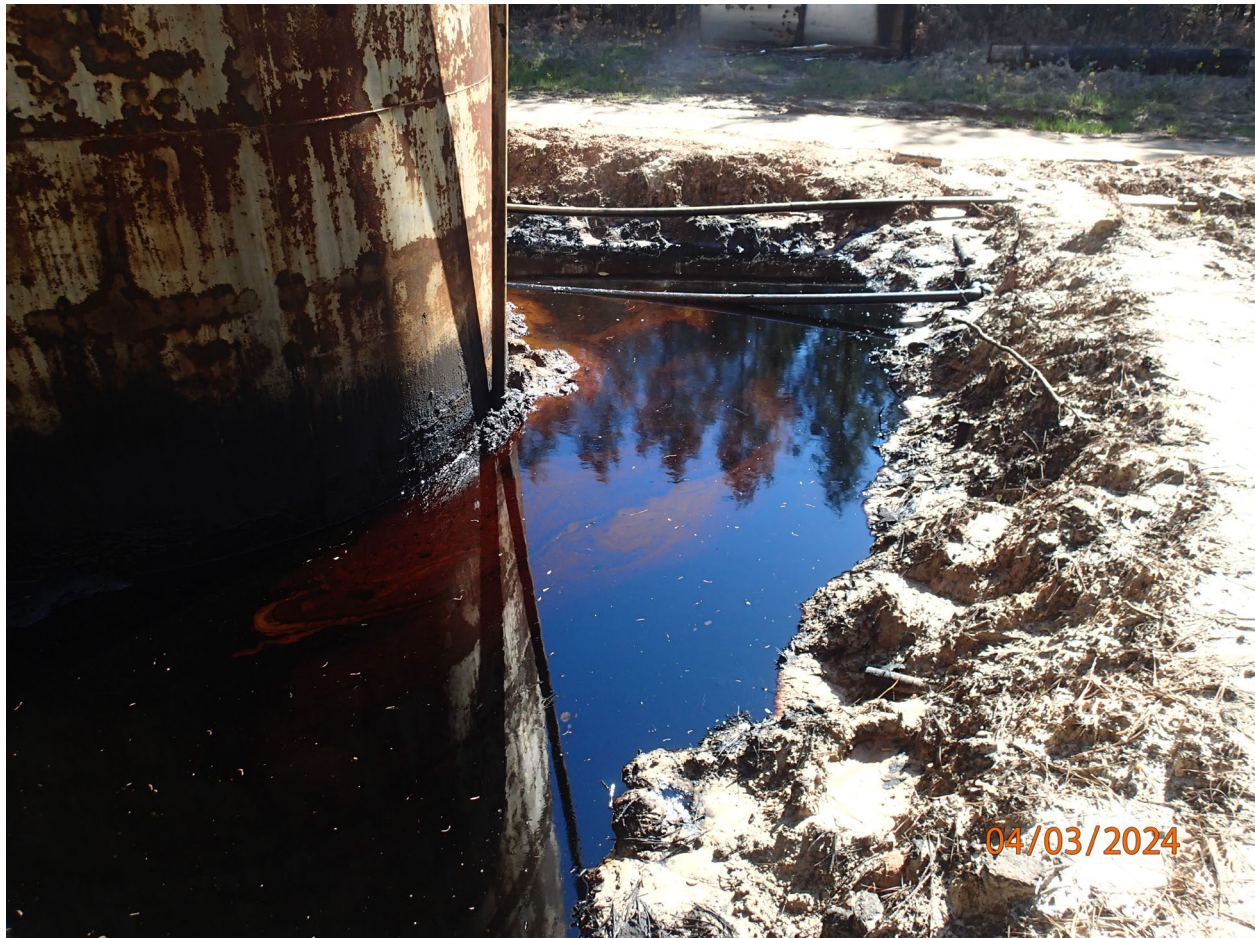
Photo No. 8

**Description:** Looking W-SW, this photo showed loose oil inside secondary containment.

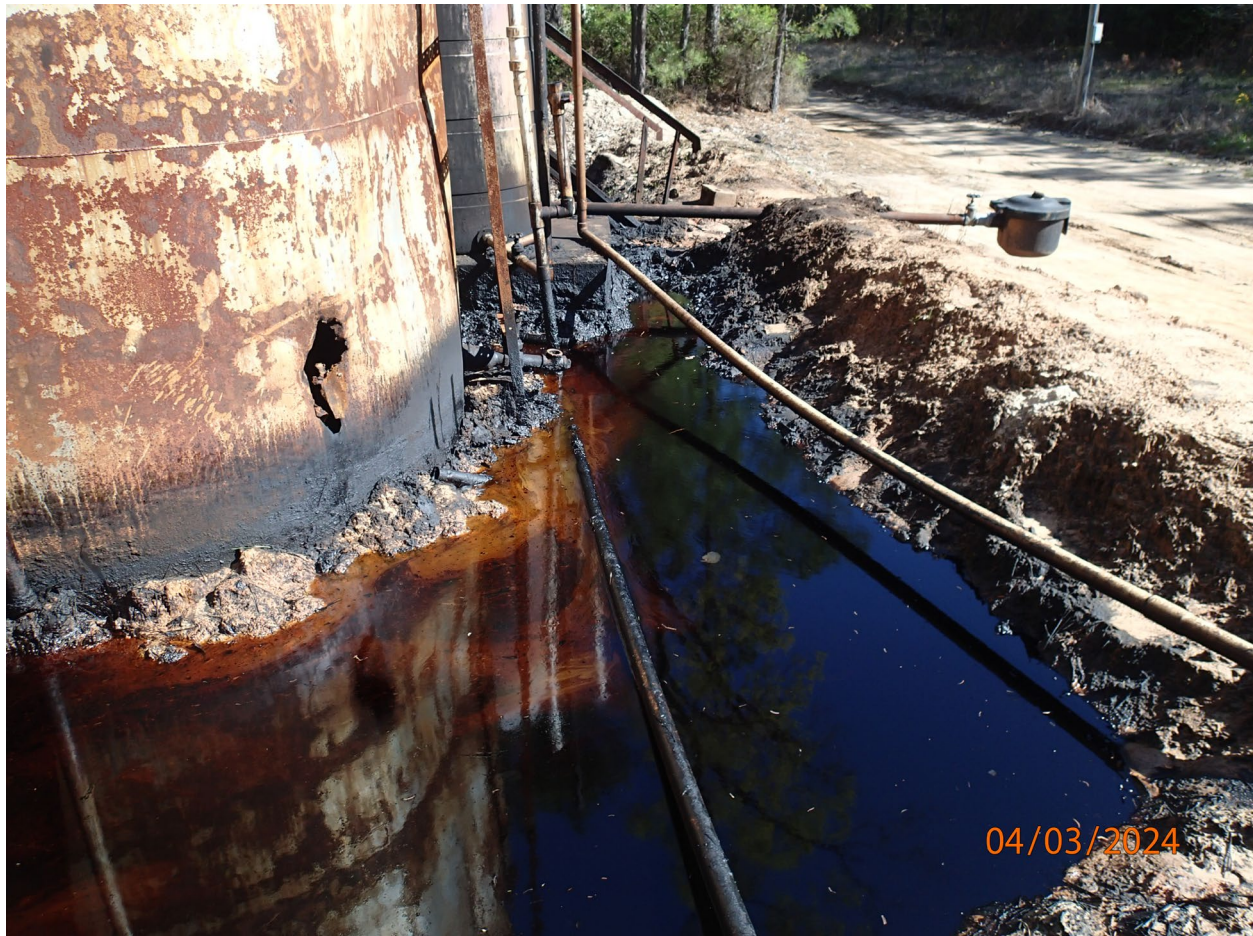
I observed one of the storage tanks inside secondary containment with a hole in the sidewall, see Photo No. 9 and No. 10.

**Description:** Looking NW, this photo showed a hole in one of the storage tanks and loose oil inside secondary containment.

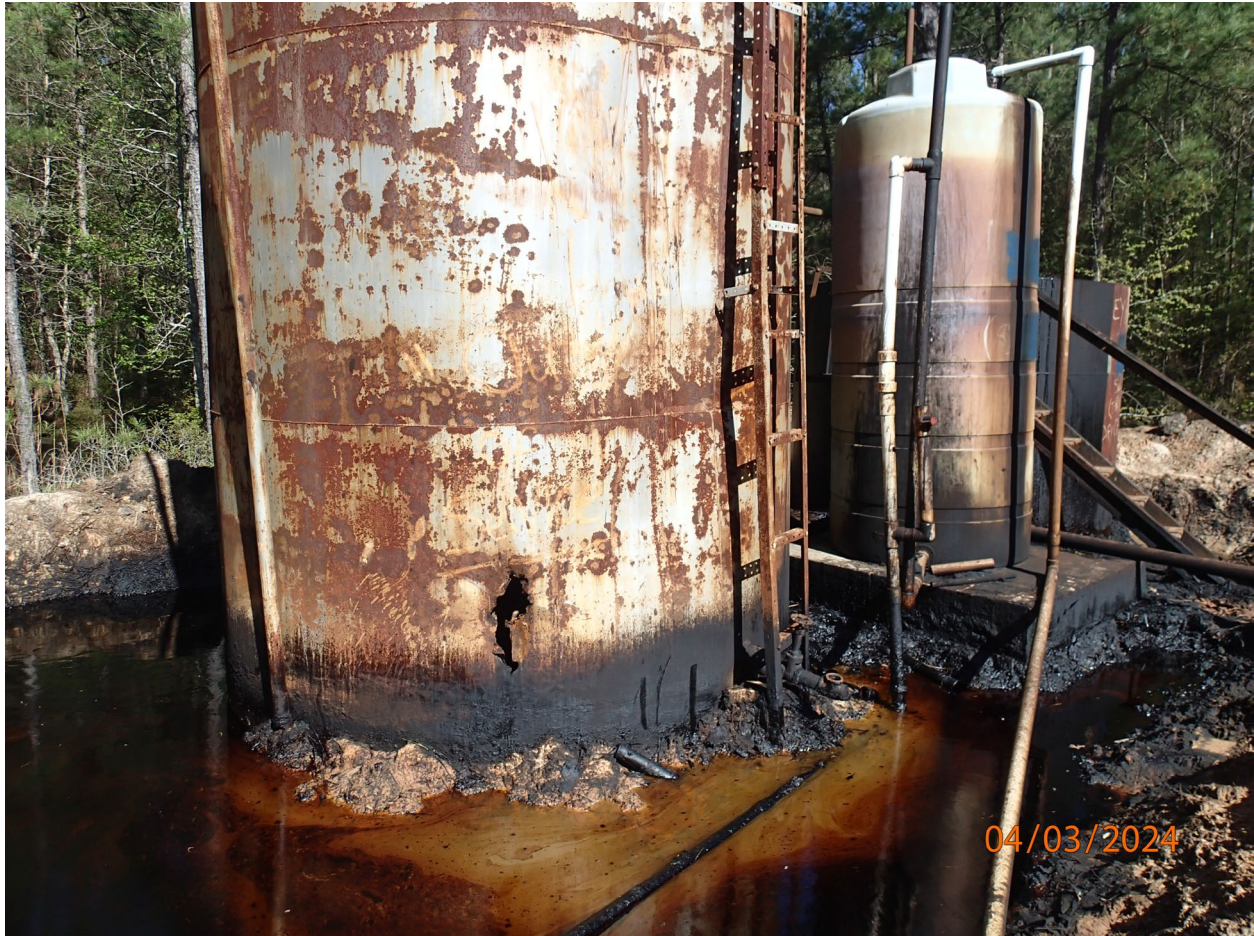
Photo No. 10

**Description:** Looking N-NE, this photo showed an additional view of the inside of secondary containment from Photo No. 9.

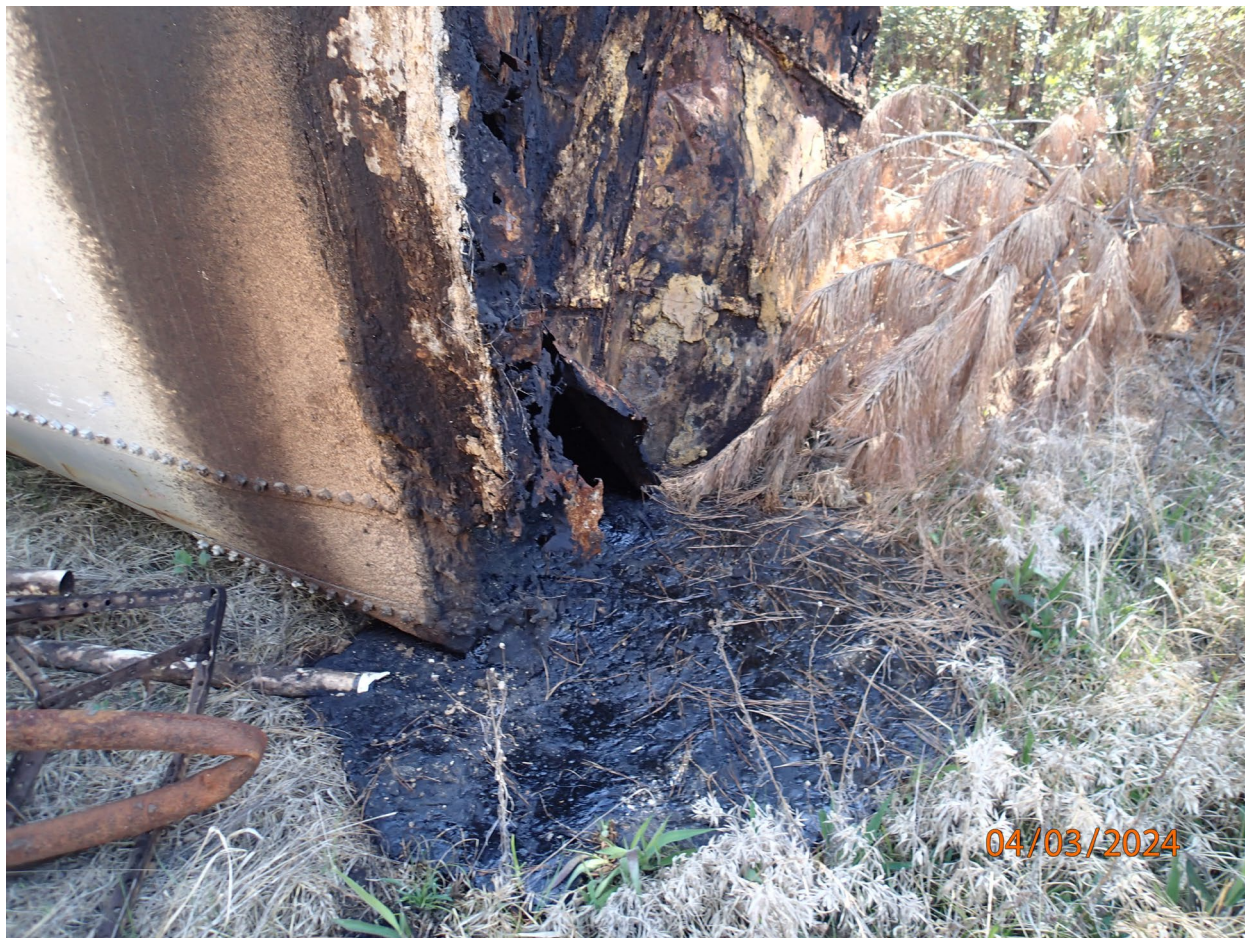
I observed a storage tank and an oil-water separator outside secondary containment with loose oil around the equipment, see Photo No. 11 and No. 12.

**Description:** Looking W, this photo showed a storage tank outside secondary containment with loose oil on the ground.

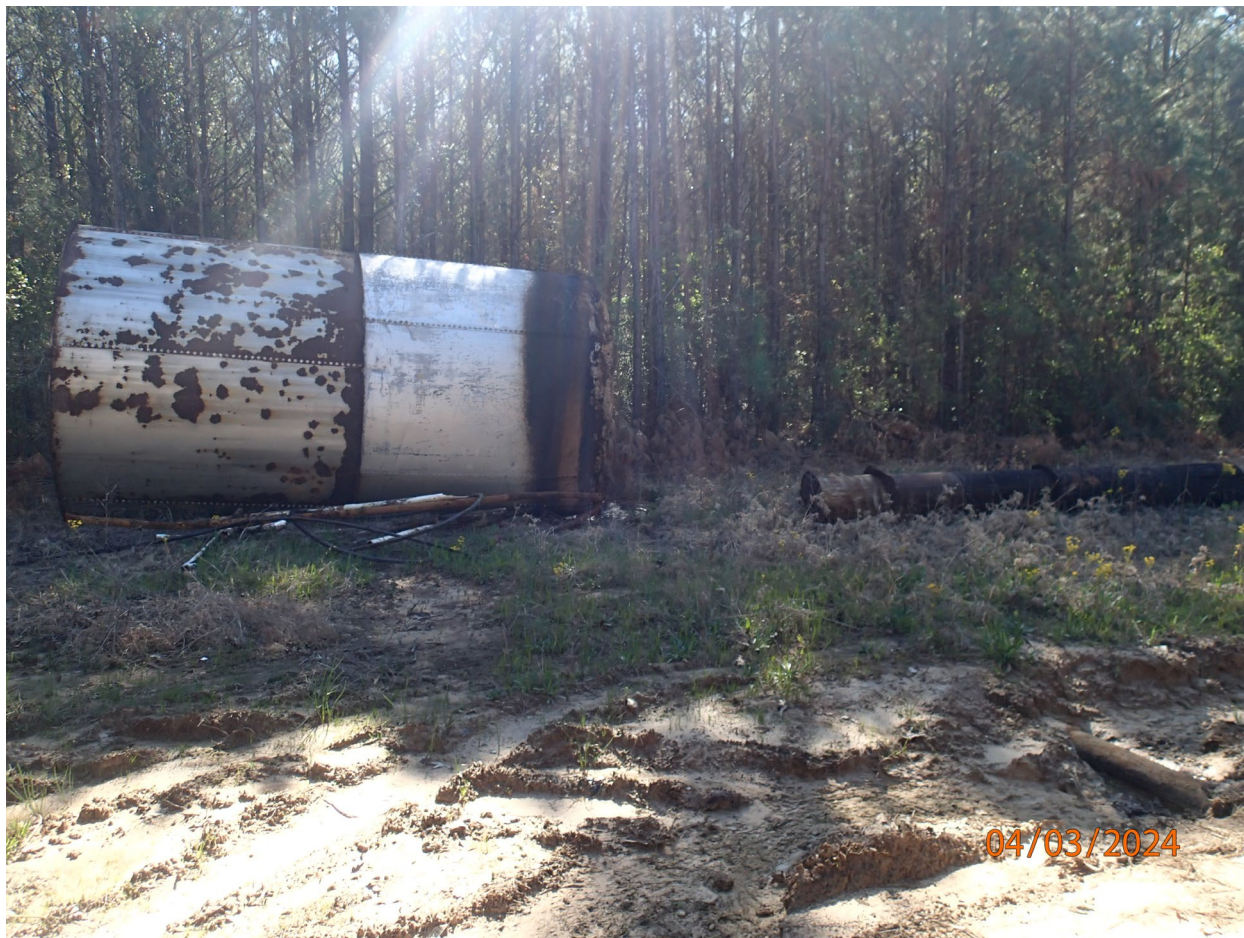
Photo No. 12

**Description:** Looking SE, this photo showed an overview of the storage tank from Photo No. 11.
