## REGION 10 Enforcement Division

### INSPECTION REPORT

| <b>Facility or Site Name:</b> | ELDEC CORP MARTHA LAKE | | |
| <b>Type of Operation:</b> | Aerospace Electronic Manufacturing | | |

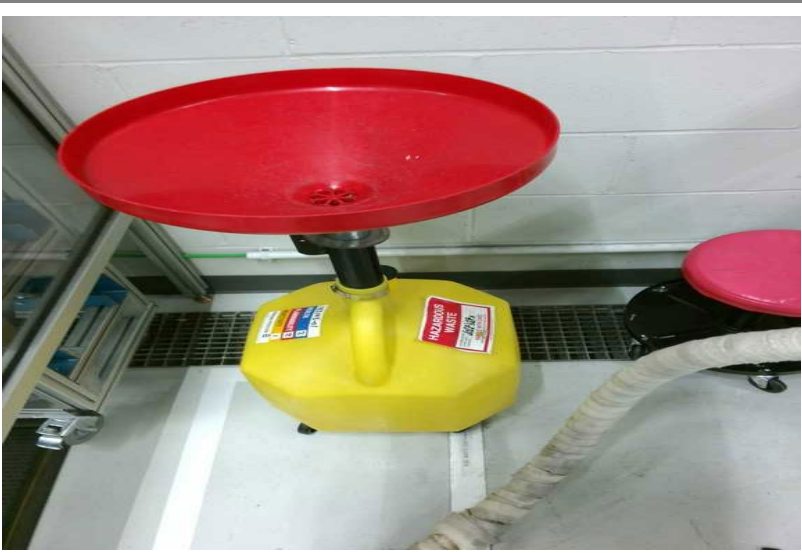
| <p>Observation_Image-<br/>202108311115091591221993.jpg</p> | |

| I observed six, approximately 5-gallon satellite receiver containers, labeled "Hazardous Waste," with funnels open to atmosphere. Each flow leakage container receives any overflow or leakage of jet A fuel from the testing hose when disconnected. The satellite receiver containers are emptied daily into a 55-gallon container. | |

| <b>Building:</b> Bldg 4 | <b>Area:</b> Fuel flow transmitter testing | <b>Sub-area:</b> |
|---|---|---|
| Six flow leakage satellite containers do not have closure devices (open containers). | <b>Citations:</b> | <b>Sections:</b> |

| <p>View of flow leakage container satellite jet A gets emptied daily into 55gallon drum. Does not have closure (open container).</p> | |

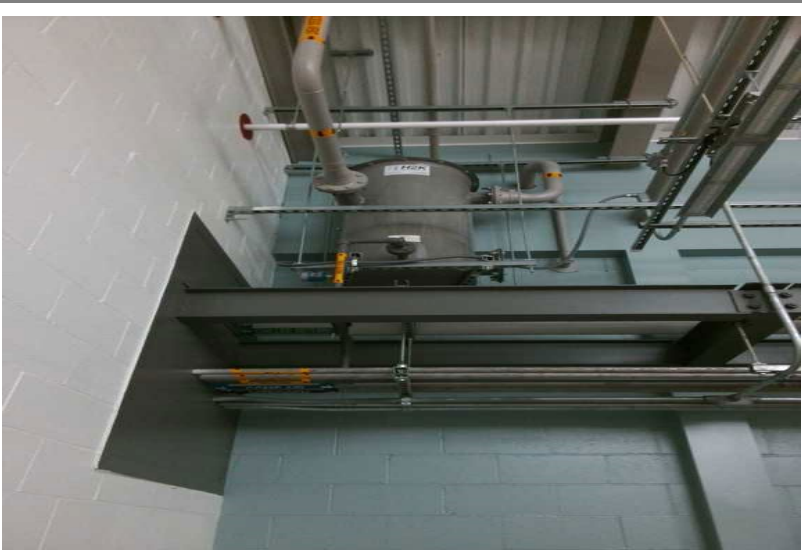
| <p>Observation_Image-<br/>2021083111221622161412476.jpg</p> | |

| Fuel condensation tank. Visual monitored for leaks weekly. Sensor to detect amount. If managed as hazardous waste, this tank requires leak detection and repair processes per Subpart CC requirements. On November 2, 2021 I sent an email to Brian Anderson asking if the fuel condensation tank contains hazardous waste. He replied the same day stating that the tank contains used Jet A fuel, which flows back to the tank farm area and is product, not hazardous waste. | |

| <p>Fuel condensation tank. Visual monitored for leaks weekly. Sensor to detect amount.</p> | |
