## **RCRA Inspection Report**

Kason Industries Inc  
57 Amlajack Blvd  
Newnan, Georgia 30265

EPA ID#: GAD097395693  
NAICS #: 332510 – Hardware Manufacturing

December 17, 2024

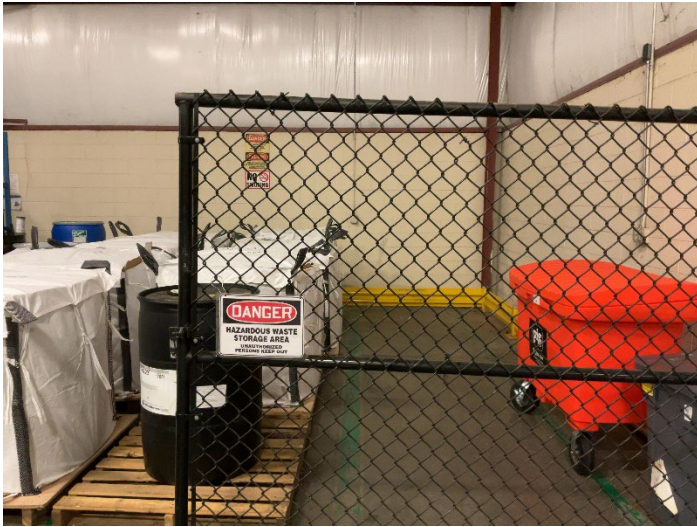
**Photograph 1**  
CAA fencing in Section 5 – Warehouse

Section 5 – Warehouse is used as the primary location for storage of manufacturing materials and finished products. Housed at the back of this warehouse is the primary central accumulation area (CAA). Inspectors observed that the area is fenced off along its open sides by a chain link fence standing approximately 6 feet in height with a rolling access gate. The area was posted with warning signs saying "Danger – Hazardous Storage Area" as well as "No Smoking" (Photograph - 1).

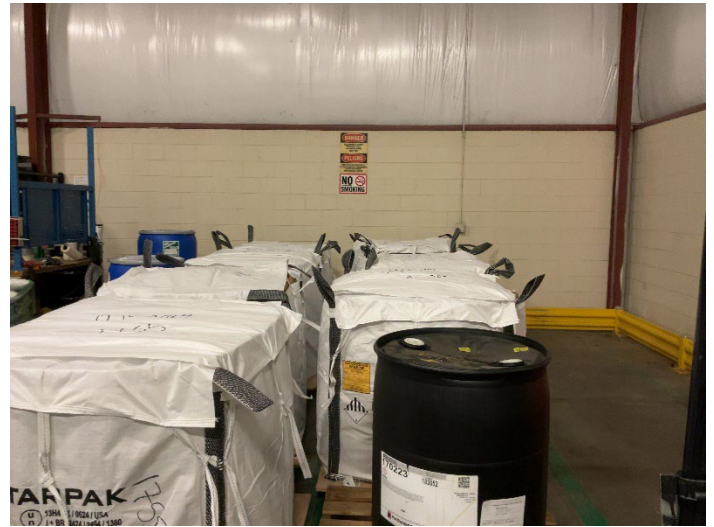
**Photograph 2**  
Super sacks of F006 waste in CAA in Section 5-  
Warehouse

Inside the storage area inspectors observed a total of seven (7) "super sacks" labeled as "Hazardous Waste", Hazardous Waste Solid, with waste codes F006 (electroplate filter cake waste) and D007 (Chromium) with an accumulation date of less than 90-days. All sacks were stored on pallets and appeared in good condition with no observable leaks of material. Sacks were stored in a manner that allowed for access to all sides. The facility had placed DOT Class 9 labels on the sacks. There were no other words or indicators of the hazard associated with the hazardous waste. Sean Leroux and Kevin Rowland were notified of the fact that the Class 9 DOT label does not effectively describe the characteristic hazard associated with the hazardous waste and were informed that the super sacks needed to have the word or labeling indicating "TOXIC". This was completed prior to inspector departure from the facility (Photographs 2, 3, 4, 6 – 9, and 26 – 28).

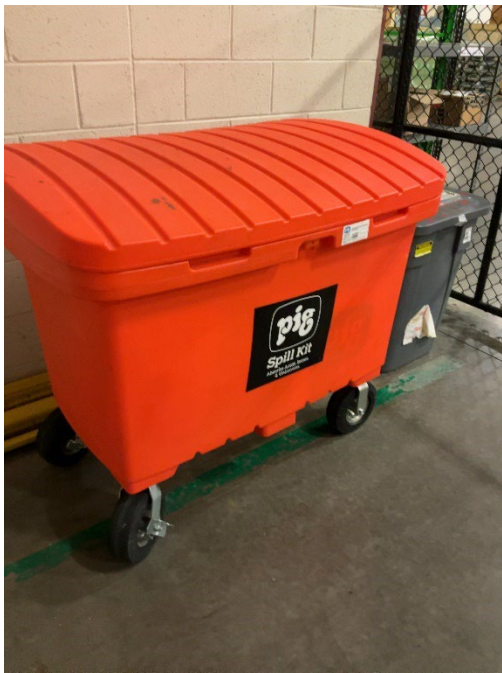
**Photograph 5**  
Section 5 warehouse CAA Spill kit

Inspectors observed that there was adequate fire protection for the area provided by appropriate portable fire extinguishers and sprinklers, a “No Smoking” sign, an eye wash station, and a large, closed utility box which contained spill response equipment. Inspectors asked how notification or communication was made in the event of emergency, and Sean Leroux told inspectors there was a Public Address / Intercom system just across the room that could address the entire facility to notify of an emergency. Inspectors were also told personnel would use personal cell phones for emergency communications.

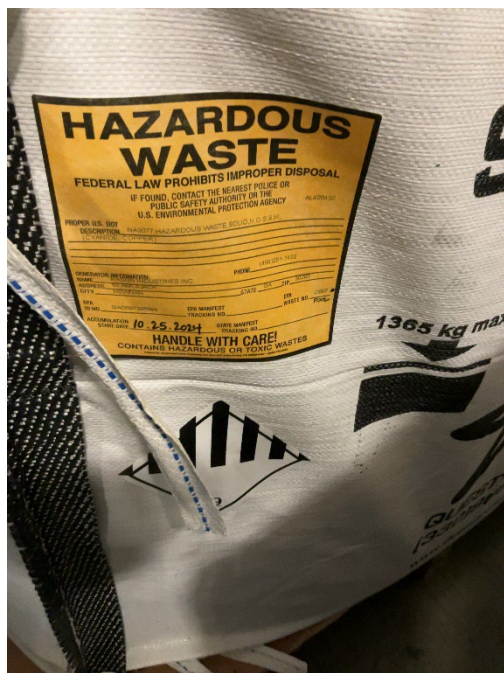
**Photograph 9**

Hazardous Waste labeling on super sac in Section 5- Warehouse CAA.

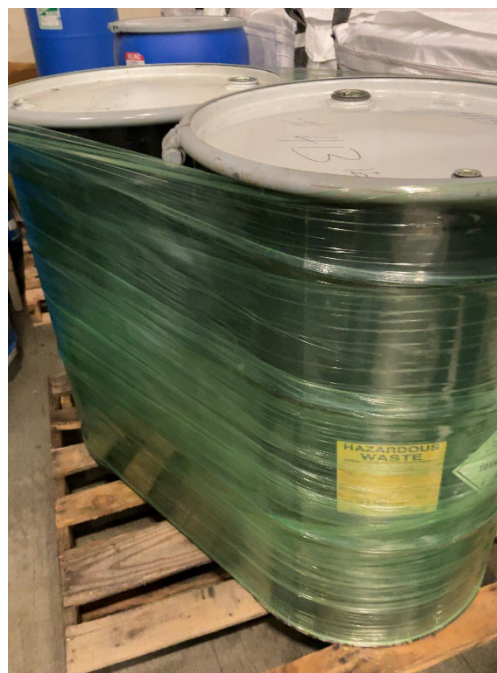
**Photograph 10**

Inspectors also observed two (2) 55-gallon steel drums located on a pallet and shrink wrapped. The containers were labeled “Hazardous Waste” and had the waste code F008 (electroplate residues containing cyanide) These containers had an accumulation date of less than 90-days. The containers were also marked with a “TOXIC” DOT placard, indicating a hazard for F008 waste. The containers were not marked with an indication of “Reactive” hazard, which is a hazard associated with F008 per regulations.

Hazardous Waste in drums in Section 5- Warehouse CAA.

**Pursuant to Ga. Comp. R. and Regs. 391-3-11-.08(1) [40 C.F.R. § 262.17(a)(5)(i)(B)], which is a condition of the LQG Permit Exemption, a generator is required to mark or label all containers of hazardous waste with an indication of the hazards associated with the contents.**

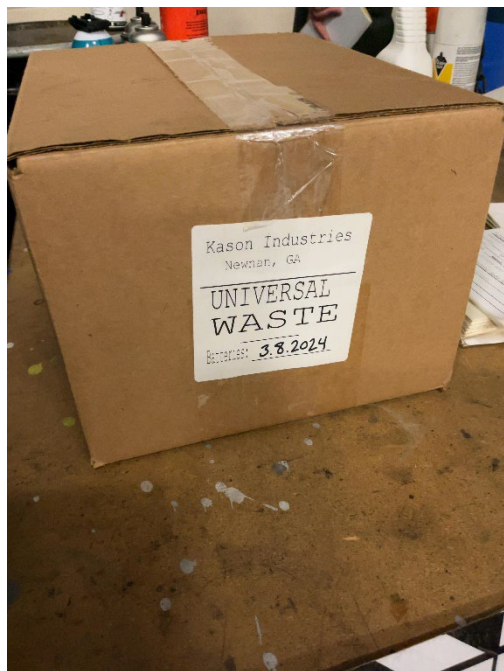
**Photograph 11**

Also observed in this area was a single box of waste batteries labeled as “Universal Waste Batteries” with an accumulation date of March 8, 2024. The box was in good condition and was closed and taped shut (Photograph 11).

Universal Waste Batteries in Section 5- Warehouse CAA.

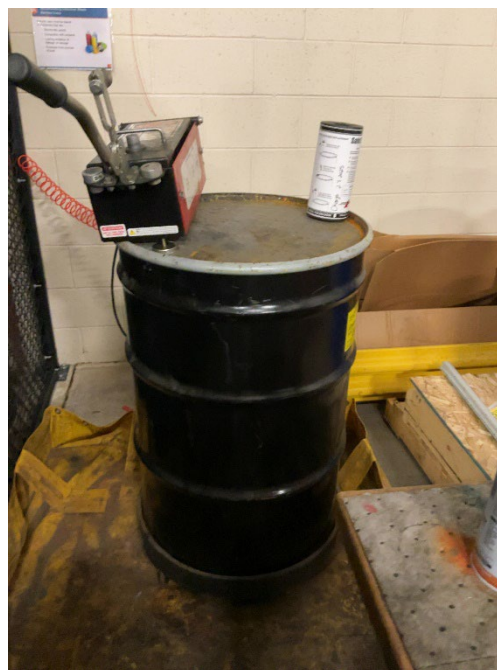
**Photograph 12**

Inspectors also observed a 55-gallon steel drum satellite accumulation area (SAA) with an aerosol can puncturing device on top. The device and drum were closed and in good condition. The drum was labeled “Hazardous Waste”, D001, and had an indication of the hazard “Flammable” placard. There was no observed empty can collection container or area.

Aerosol can puncturing container in Section 5- Warehouse CAA.

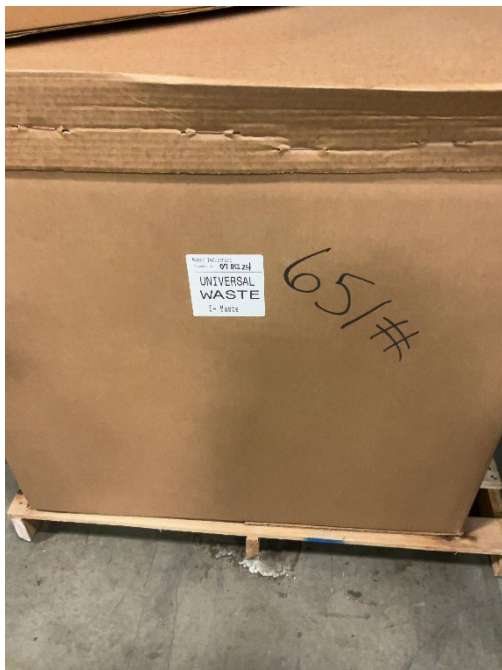
**Photograph 15**  
Universal E-waste in Section 5 Warehouse outside CAA.

Just outside the fenced CAA, inspectors observed an area for holding non-hazardous waste. In this area were a large cardboard box on a pallet labeled “Universal Waste E-Waste” and contained old computers, the box was in good condition and closed, with an accumulation date of July 7, 2024. This waste is not regulated as a universal waste. Also observed was a 4-foot box labeled “Universal Waste Bulbs” and not “Universal Waste – Lamps”, which was in good condition and sealed with an accumulation date of November 1, 2024 (Photographs 15 – 17).

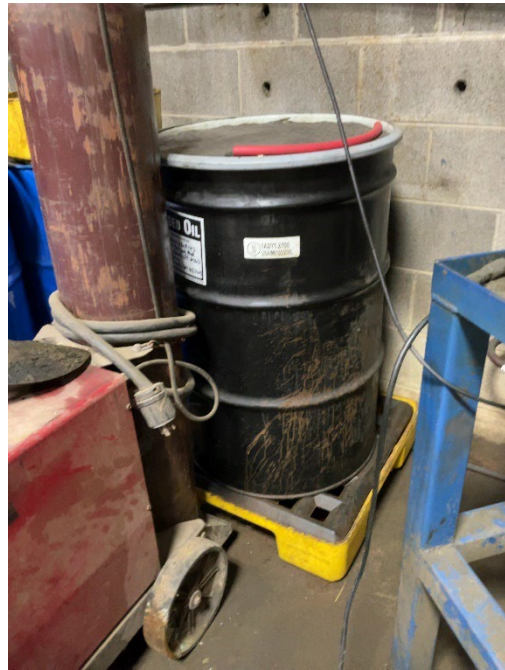
**Photograph 18**

Inspectors were taken to the boiler room which maintains the hot water for process baths and facility process use. In this area, inspectors observed a 55-gallon steel drum labeled as “Used Oil”. The container was closed and in good condition, with no observable signs of leakage (Photograph 18).

Used Oil drum Section 1 Boiler Room

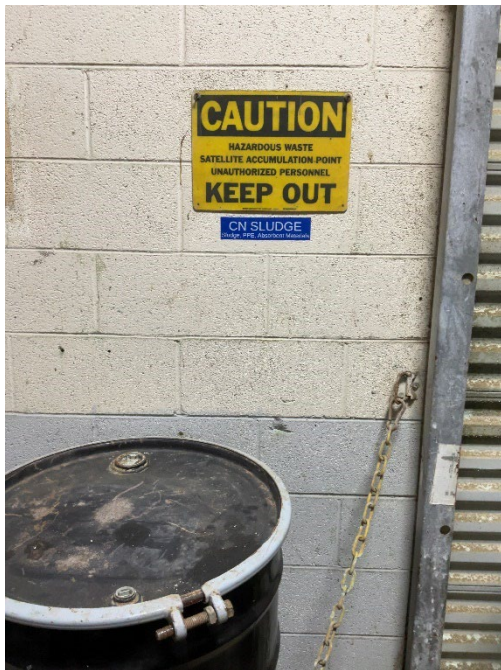
**Photograph 19**

observed three separate SAAs in this area two of the SAAs were marked with the following signs “CN Sludge” and “CN Filter Bags”. The third was placed next to a portion of the plating line. All SAAs contained 55-gallon metal drums which were closed and in good condition. All were labeled with the words “Hazardous Waste”. The “CN Sludge” SAA container had waste codes F008 (Copper Plating bath sludge containing cyanide) and D003 (Reactive Waste), and the DOT designation Waste Cyanide Solution UN1935. The drum was placarded with a hazard indicator for “Toxic”, there was no indicator for “Reactive” (Photographs 19 – 21). The “CN Filter Bags” SAA container had waste code F008 (Copper Plating bath sludge containing cyanide), and the DOT designation Waste Toxic Solids UN2811. The container had a hazard indication of “Toxic”. There was no indication of “Reactive” hazard (Photographs 22 – 24). The third SAA was labeled “Hazardous Waste”, with the waste code F008 (Copper Plating bath sludge containing cyanide), Carbonate Sludge, and the DOT designation Waste Toxic Liquids UN3287. The container had a placarded hazard indication of “Toxic”. There was no indication of “Reactive” hazard (Photograph 25).

CN Sludge sign for Cyanide Sludge SAA at Section 1 Plating Line.

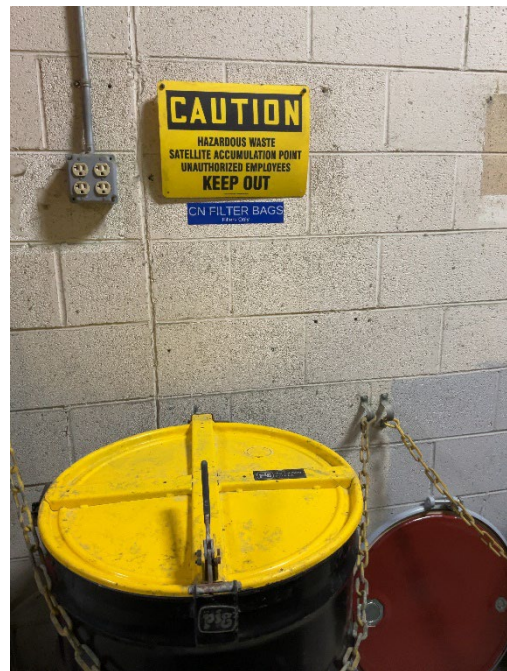
**Photograph 22**

CN Filter sign for Cyanide Filter SAA at Section 1 Plating Line.

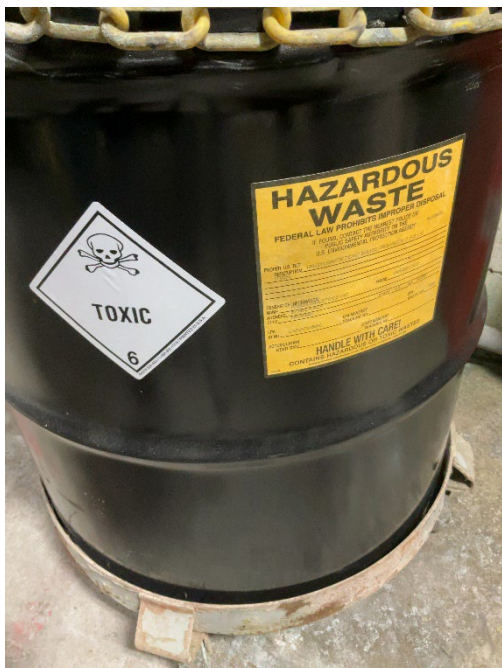
**Photograph 23**

Labels on Cyanide Filter SAA at Section 1 Plating Line

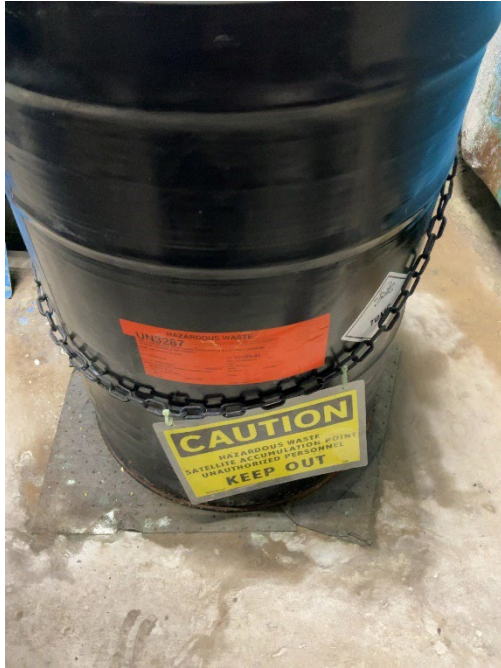
**Photograph 25**

Carbonate Sludge SAA at Section 1  
Plating Line.

**Pursuant to Ga. Comp. R. and Regs. 391-3-11-.08(1) [40 C.F.R. § 262.15(a)(5)(ii)], which is a condition of the SAA Permit Exemption, a generator is required to mark or label all containers of hazardous waste with an indication of the hazards associated with the contents.**

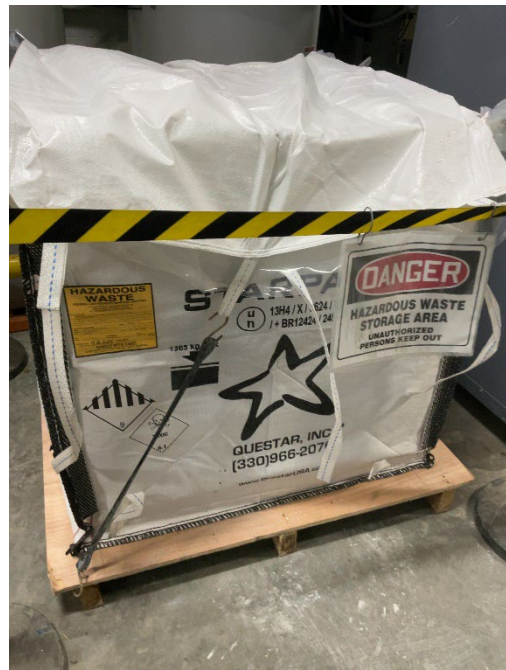
**Photograph 26**

Filter cake CAA located in Section 1  
Wastewater Treatment Area.

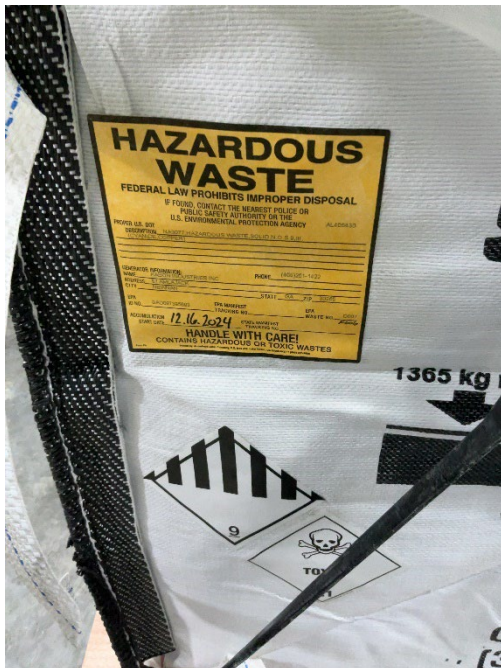
**Photograph 27**

Hazardous Waste label on Filter Cake CAA  
In Section 1 Wastewater Treatment Area.

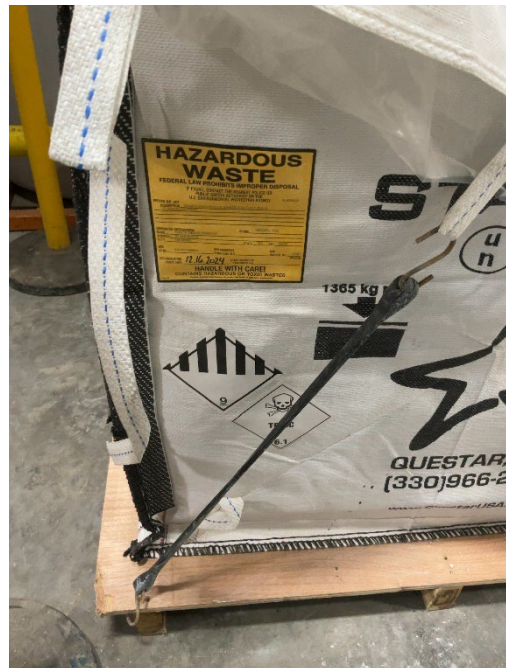
**Photograph 28**

Labels on Filter Cake CAA in Section 1  
Wastewater Treatment Area.
