Compliance Evaluation Inspection Report
Robert A. Roe Federal Building
200 Federal Plaza, Paterson, NJ 07505
December 10th, 2024

Compliance Evaluation Inspection

The facility has one 1,000-gallon diesel UST, which was installed in March 1990. The UST is constructed of fiberglass reinforced plastic (FRP), is double walled (DW) and utilizes interstitial monitoring for release detection according to its New Jersey Department of Environmental Protection (NJDEP) registration. Its piping was also registered as DW FRP with interstitial monitoring for release detection in addition to being European "Safe" Suction, with correspondence with third-party contractor being provided as proof of the European suction system.

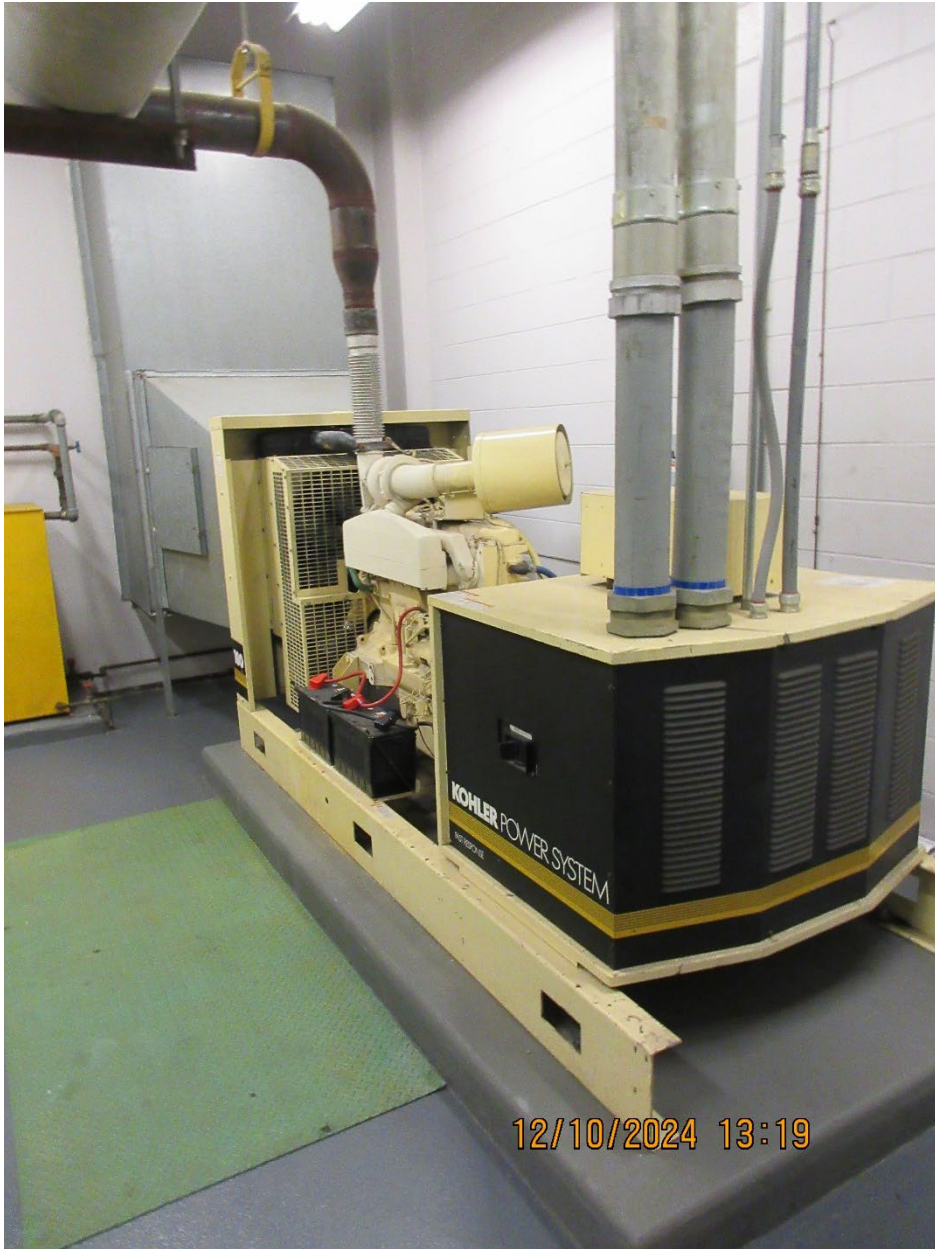
Photo 1 – Emergency Generator Room

The inspection started with a review of the records where Inspector Kevin Dyer met with Doel Rivera, the Building Manager for the facility. Mr. Rivera explained that the facility was in the process of installing an audio-visual alarm for the day tank after an inspection from the NJDEP highlighted the concern. After reviewing the records, John Elsea directed inspector Kevin Dyer downstairs to the emergency generator room (Photo #1). On the wall immediately adjacent to the doorway to the room was a placard displaying the contact info for Mr. Elsea, the Class C operator for the facility as well as the local fire department (Photo #2). Inside the room, on the wall opposite the emergency generator, was the UST monitoring system for the facility, a Veeder-Root TLS-300C (Photo #3). The UST monitoring system displayed no error messages outside of a low paper message. Mr. Elsea explained that a water pipe burst around June or July 2024 that caused the loss of some release detection print-out records that were stored in the room. As a result, no release detection records exist for 2023 or prior, but 2024 records from before the incident were able to be re-printed. The diesel day tank was located along the wall between the UST monitoring system and the emergency generator (Photo #4).

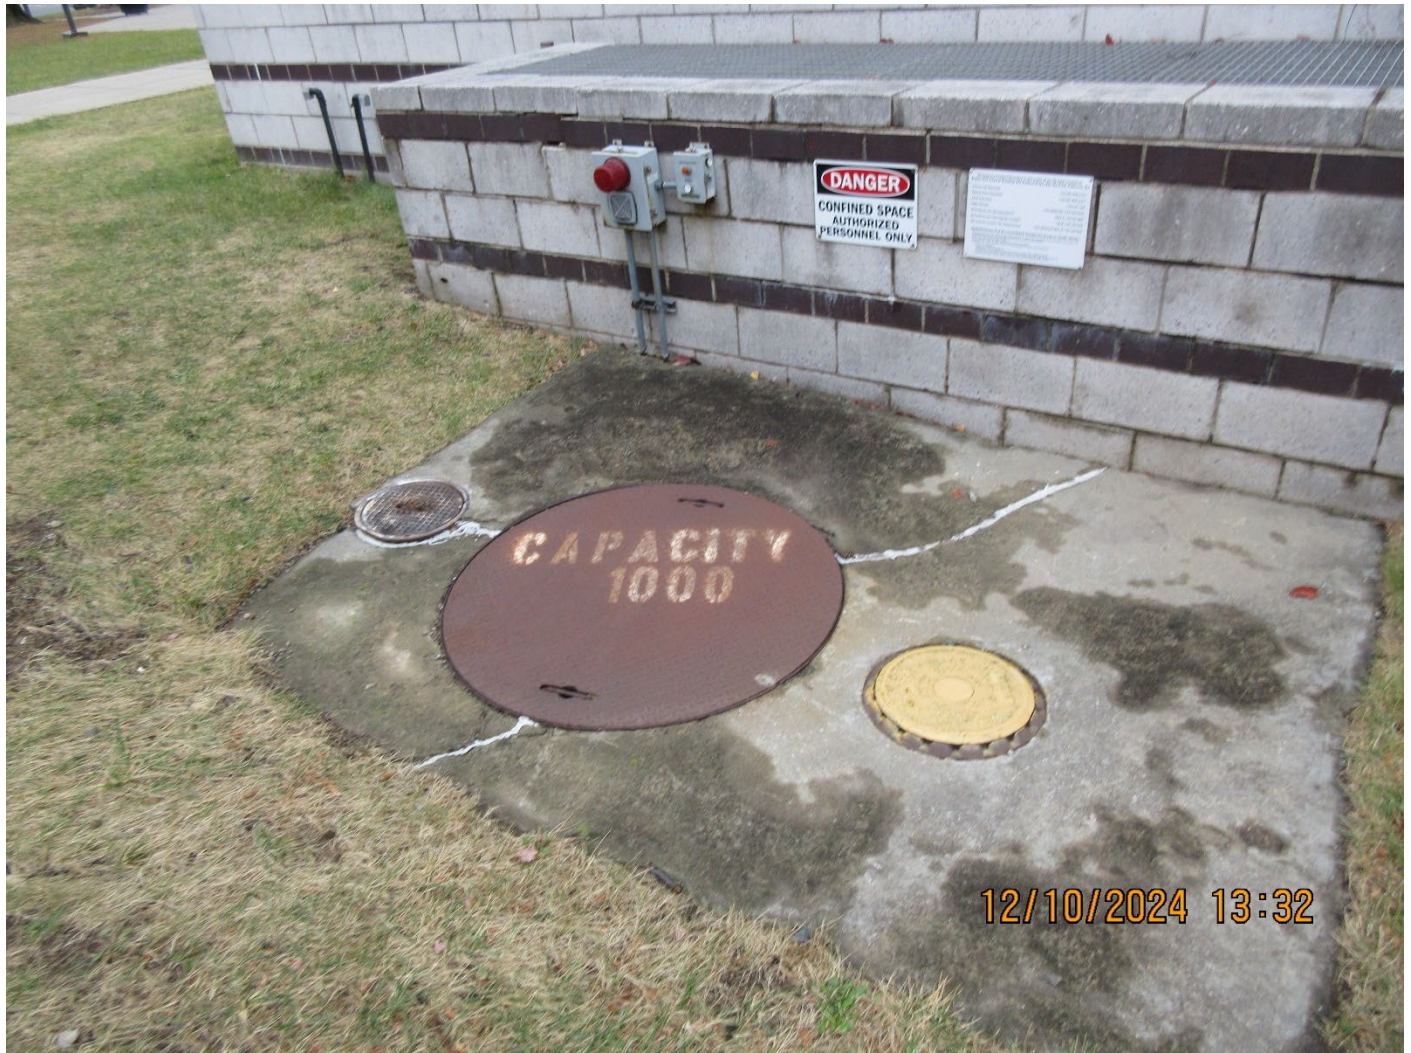
Photo 5 – Exterior photograph of the sumps and access ports along Ward Street.

Mr. Elsea then led Inspector Dyer outside the facility to inspect the sumps and fill port. These were located about 30 feet to the west of the access driveway for the facility's underground parking garage along Ward Street. The area (Photo #5) consisted of a turbine sump, an access port for the UST's interstitial monitor, a fill port with a spill bucket, and a high-level alarm (HLA). There was also a second fill port located 6 or so feet closer to the street, which Mr. Elsea explained was from a previous UST system and was disused (Photo #6). The concrete around the sumps was highly deteriorated and cracked, which possibly left the sump vulnerable to flooding. The cracks were filled with a foam sealant, but the fix looked temporary. Mr. Elsea removed the sump lid and revealed the interior of the turbine sump, which was adequately free from debris and liquid (Photos #7 and #8). A liquid sensor was present within the sump but was located higher than recommended to get an early enough read on any leaks within the containment sump (Photo #9). Cross-referencing materials on non-metallic pipe identification, it appears the blue piping seen in the turbine sump (Photos #7 and #8) is APT Polytech XP FRP piping. This is a type of FRP piping, which contradicted what Mr. Elsea had said about the piping being flex pipe.

Two feet to the left of the turbine sump was an access port to the sensor within the tank interstice (Photo #5). The access port (Photo #10) had no debris or liquid inside, though cracking along the concrete basin looks to make the port susceptible to flooding. The high-level alarm, located just behind the turbine sump, was tested to be clearly visible and audible to those delivering fuel (Photo #11). The fuel port was located a couple feet to the right of the turbine sump (Photo #5). The interior of the fuel port contained a spill bucket that was free from debris but had an inch or two of liquid inside (Photo #12). From opening the fuel port cap and looking inside, it was also clear that a flapper valve was present (Photo #13).

Finally, to better prevent environmental issues down the line, the facility may want to consider, as a best management practice, repair of the concrete basin the sump lids are coupled to, which were cracked at the time of the inspection, to better prevent flooding within the sumps (Photo #5).
