**Region 6 - Enforcement & Compliance Assurance Division**  
**INSPECTION REPORT**

| Facility Name: | <b>Bosque Farms Wastewater Treatment Plant</b> | |
| Identification/Permit Number: | NM0030279 | |

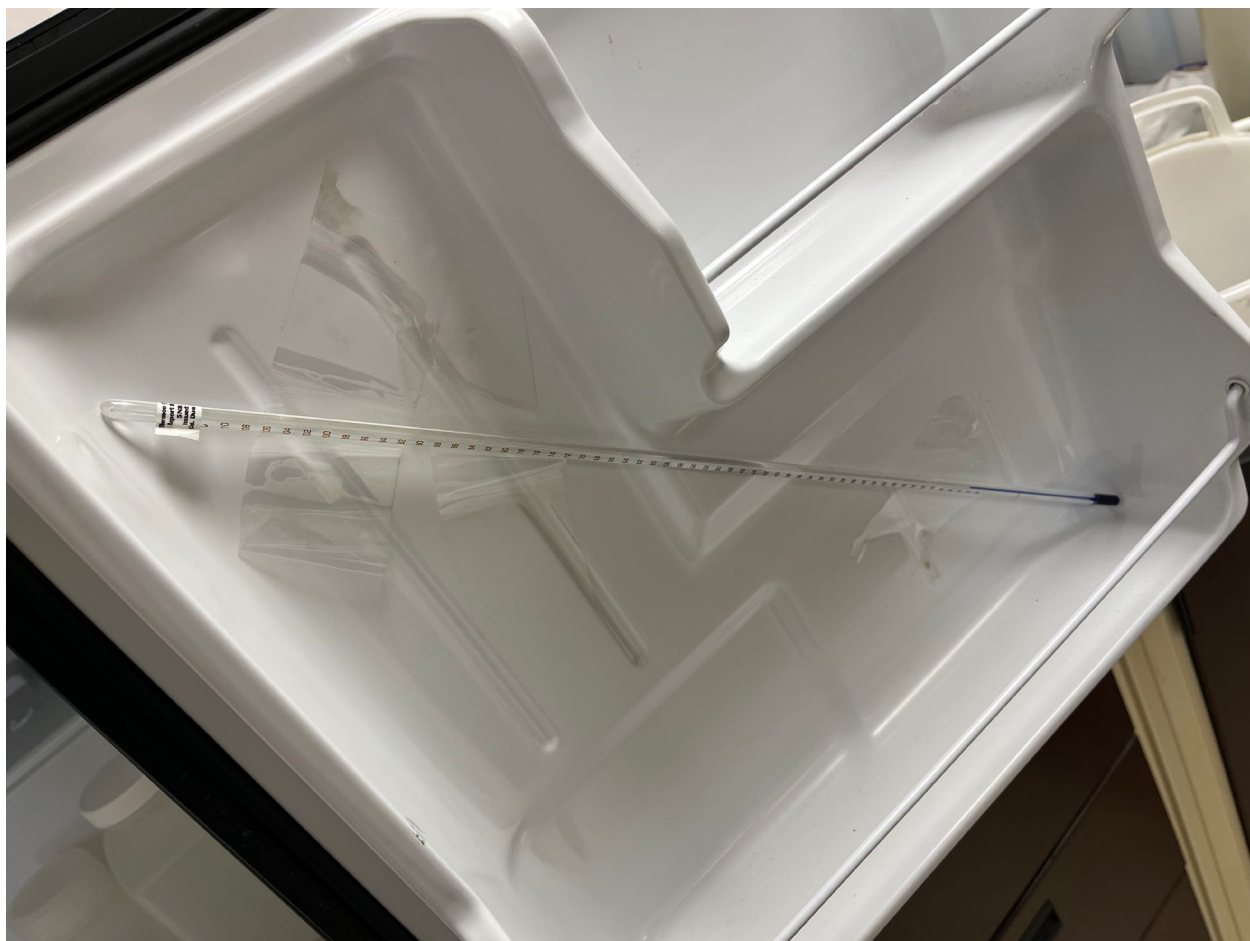
Photo No. 2

View of an additional thermometer laying inside the sample refrigerator door. March 11, 2025, 10:55 AM (IMG\_256). Photographed by D Esparza.

Another view of the thermometer laying inside the sample refrigerator door. Could not determine calibration dates. March 11, 2025, 10:55 AM (IMG\_256). Photographed by D Esparza.

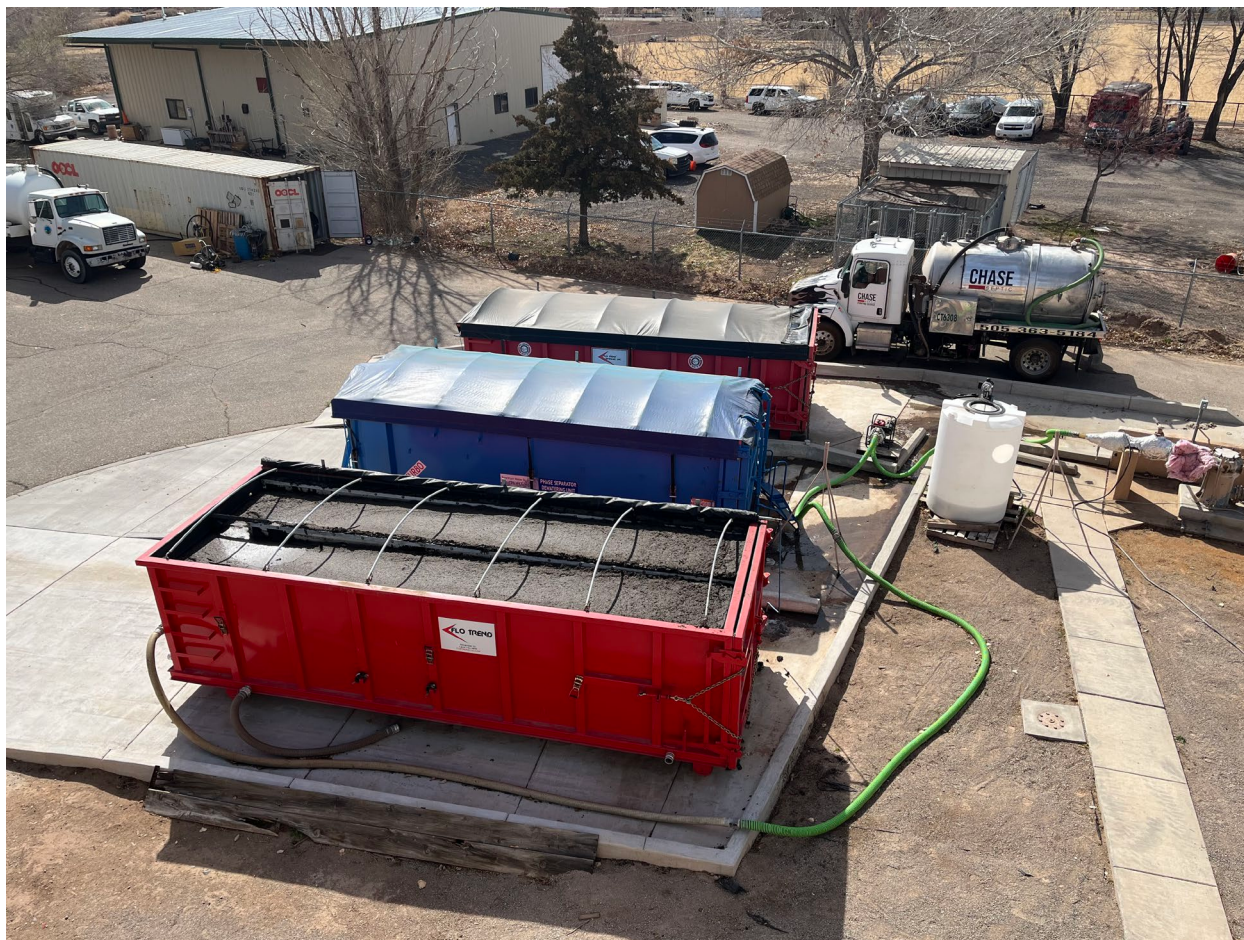
Photo No. 4

View of the three (3) on-site sludge boxes the WWTP utilizes after thickening and/or dewatering. The boxes are vacuum truck pumped (as pictured) and transported either to the 240-acre Bosque Farms owned unlined fenced disposal facility for surface disposal via injection or to the permitted landfill in Rio Rancho, New Mexico for final disposition. March 11, 2025, 11:03 AM (IMG\_260). Photographed by D Esparza.

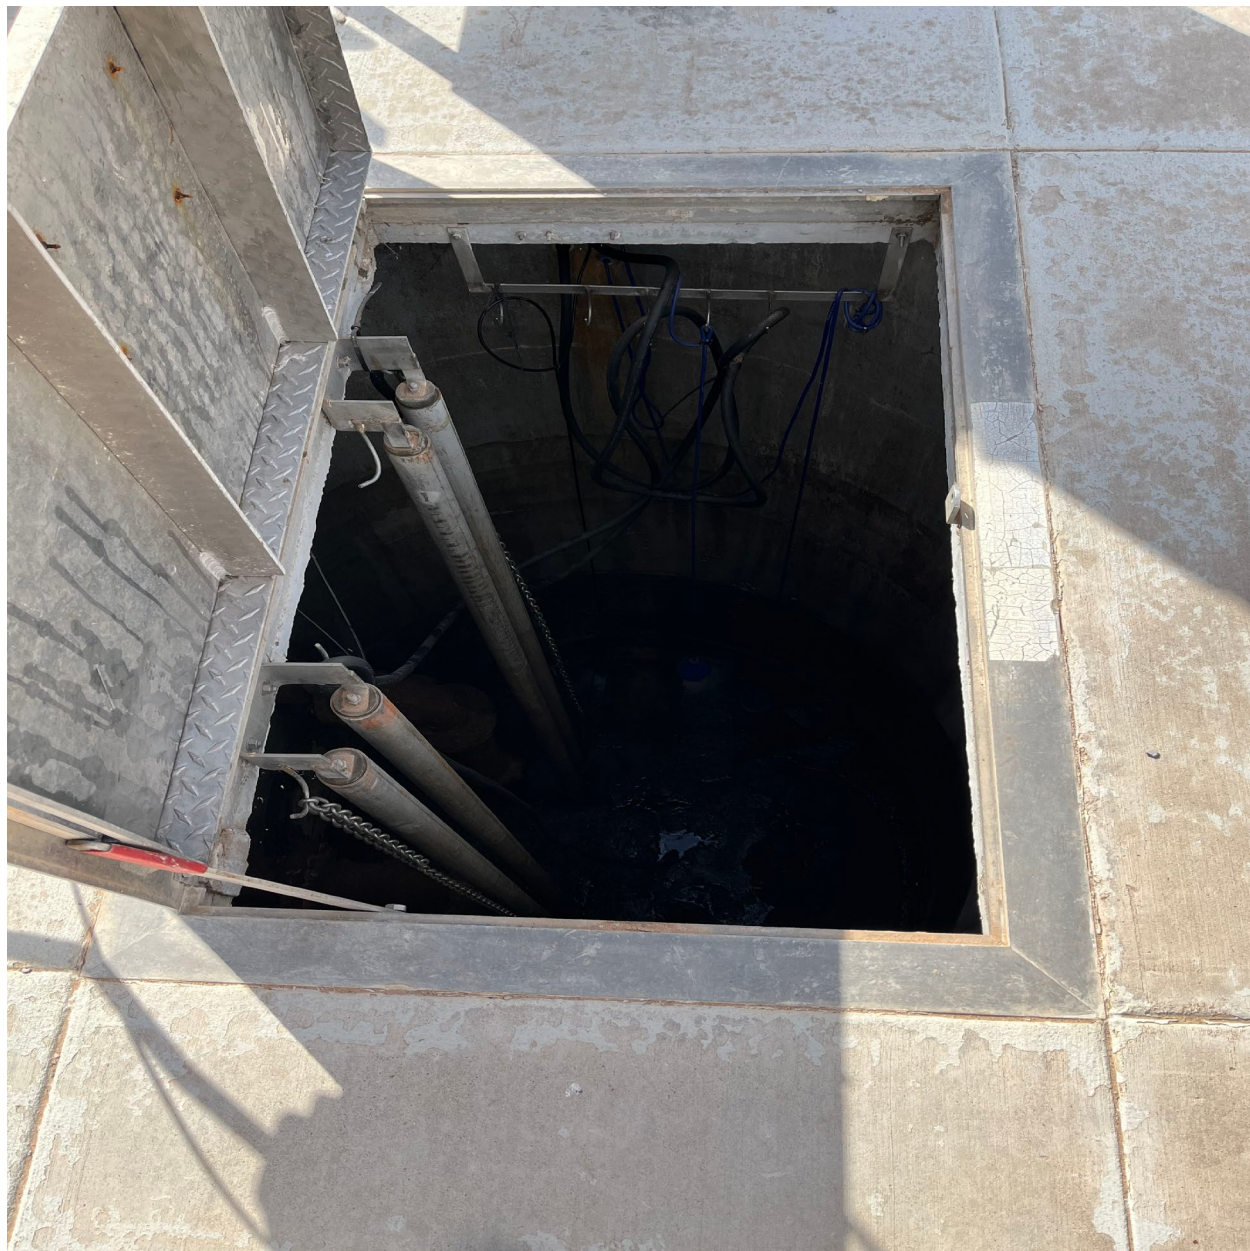
Photo No. 5

View of the locked hatchway to the on-site lift station. Note: currently there is not a safety gate in place beneath the hatchway opening, though it was stated that one is waiting to be installed. March 11, 2025, 11:16 AM (IMG\_265). Photographed by D Esparza

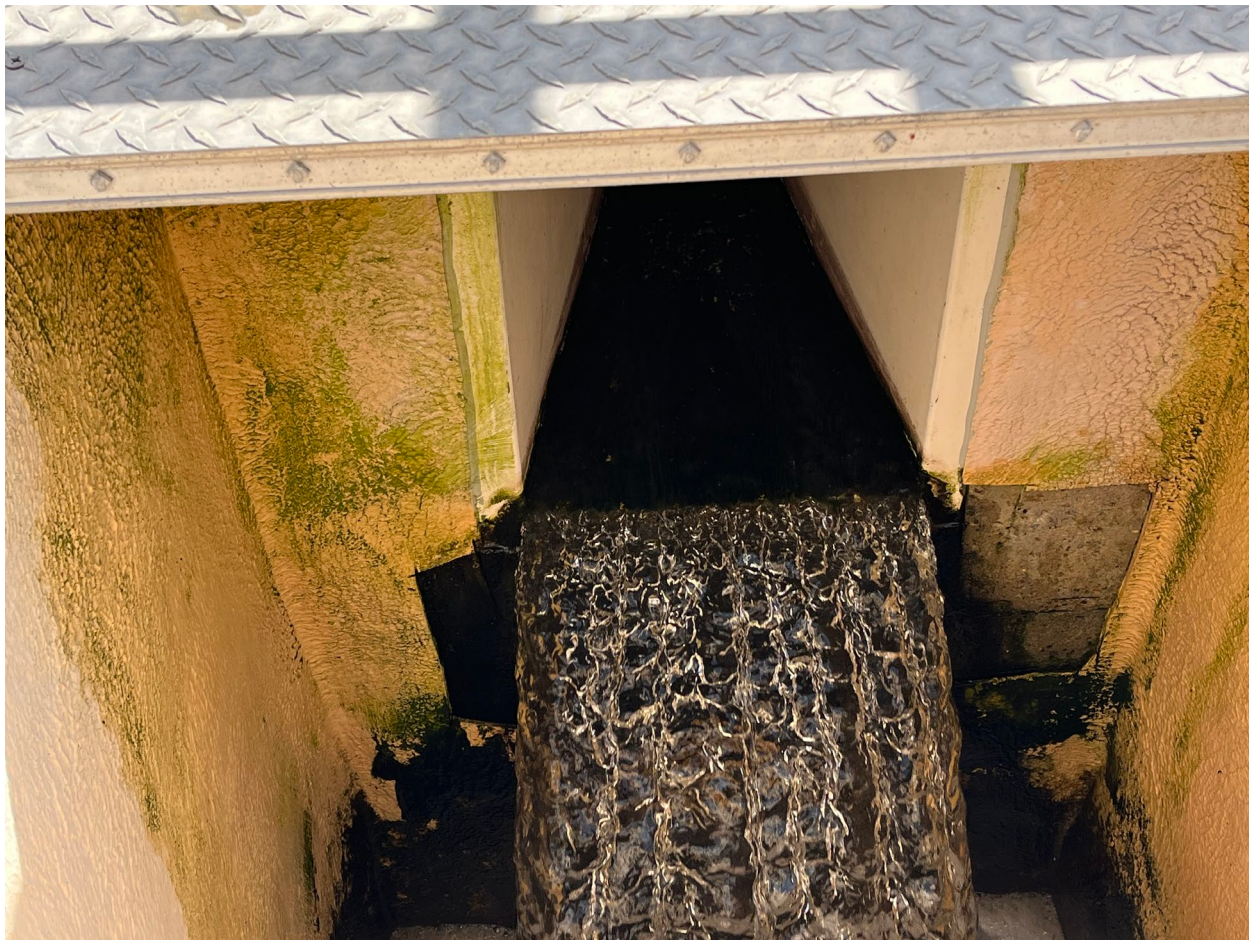
Photo No. 7

- Bosque Farms utilizes two (2) banks of ultra-violet (UV) lights with 6 bulbs each for disinfection and are manually cleaned as needed.
- After disinfection the effluent traverses through a Parshall flume thence to the outfall and discharge into the Rio Grande. The flume exhibited algae growth which could impair accurate permit sample collection and/or flow measurement.
- The WWTP has secure perimeter fencing; thus, limiting access. The overall WWTP's operations and maintenance (O&M), and general facility housekeeping appeared to be in good order
- The Village participated in the FY-22 EPA-Compliance Advisor Program (CAP) and was provided or assisted in the development of the following through the CAP Close-out Report (January 7, 2025):

View of the Parshall flume exhibiting algae growth inside and along the discharge point which could impair accurate permit sample collection and/or flow measurement. March 11, 2025, 11:23 AM (IMG\_270). Photographed by D Esparza

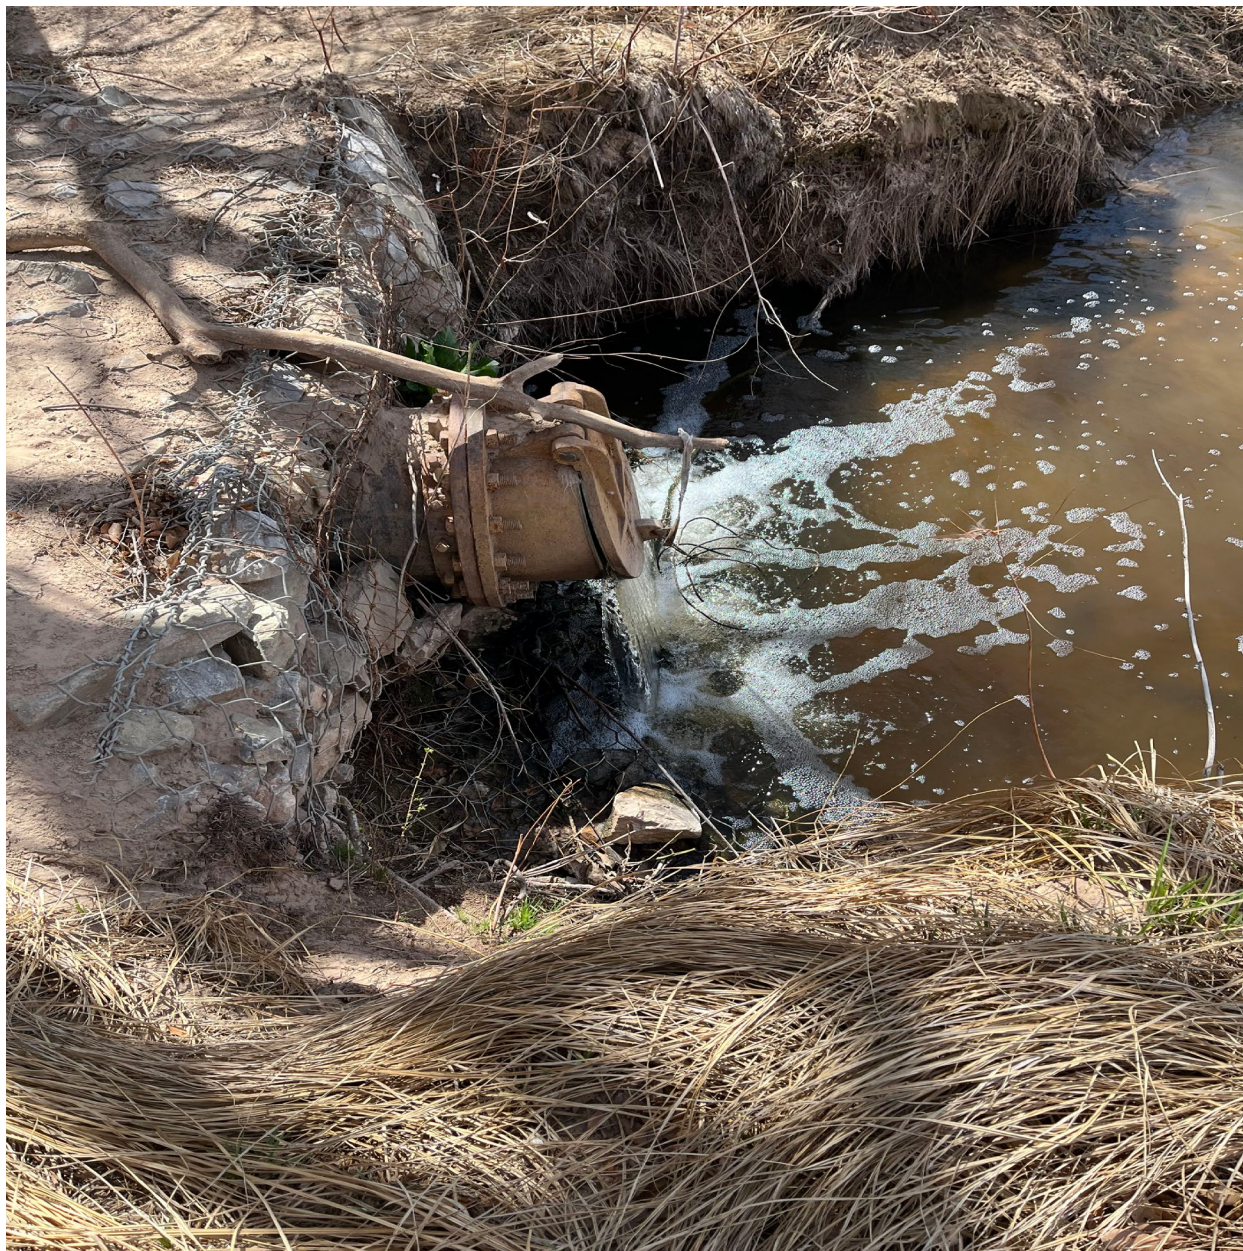
Photo No. 8

View of the WWTP effluent discharge into the Rio Grande. March 11, 2025, 12:06 PM (IMG\_272).  
Photographed by D Esparza
