UNITED STATES ENVIRONMENTAL PROTECTION AGENCY

**Subj:** September 27, 2023, Inspection Report  
Clean Water Act - National Pollutant Discharge Elimination System ("NPDES")  
Attleboro WPCF

- A. *Facility Name:* Attleboro Water Pollution Control Facility (WPCF)
- B. *Facility Location:* 27 Pond Street North  
Attleboro, MA 02703
- C. *Facility Contacts:* Thomas Hayes, Supt.  
Bill Johnson, Asst Supt
- D. *NPDES ID No(s):* WPCF: MA0100595  
MSGP: MANOEJ03G
- E. *CWA 311:* SPCC: R1-MA-00175

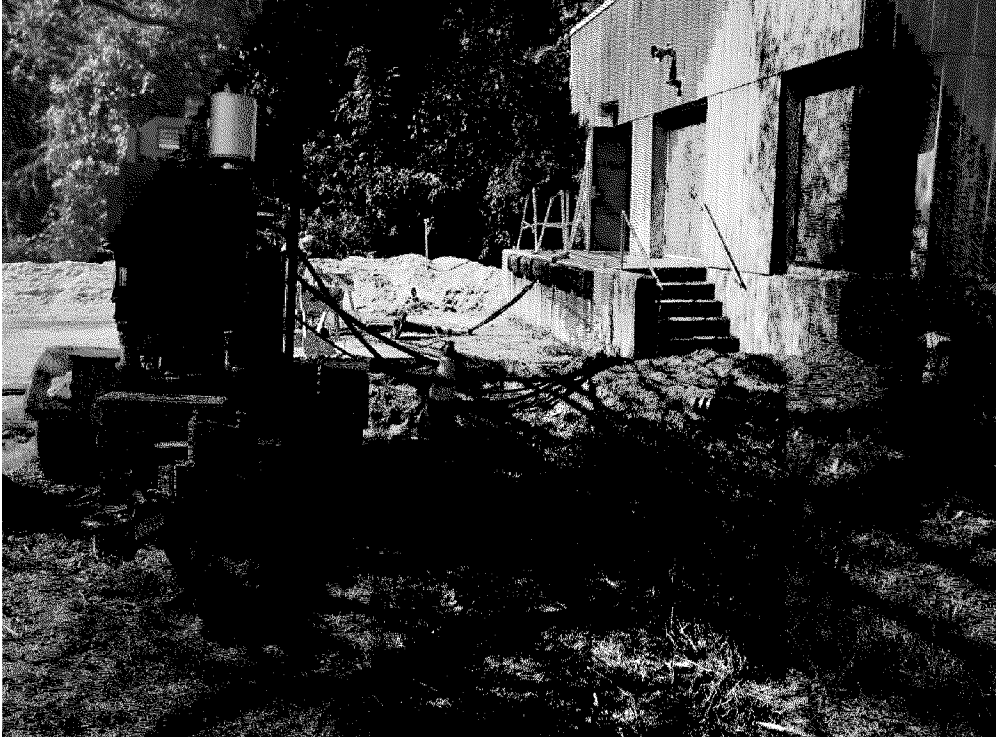
Photo 1 – Portable Pump at Screening Building

The facility tour began at the screening building. Before going in, I noted a diesel-fueled portable pump set up outside the building [photo 1]. I noted that there was no secondary containment in the event of spill, as required by CWA 311 regulations. Adjacent to the pump, I observed a ditch that I was told has an outlet to the Ten Mile River, in the event of a discharge. No water or oil was observed in the ditch at the time of the inspection. In response to my question, I was told the pump was refueled using portable fuel containers brought to this location. I recommended that the facility remove the pump or install secondary containment. Following the inspection, Mr. Johnson provided documentation that the portable pump had been removed, and subsequently, that containment booms had been purchased that will be deployed around the pump, as a standard operating procedure.

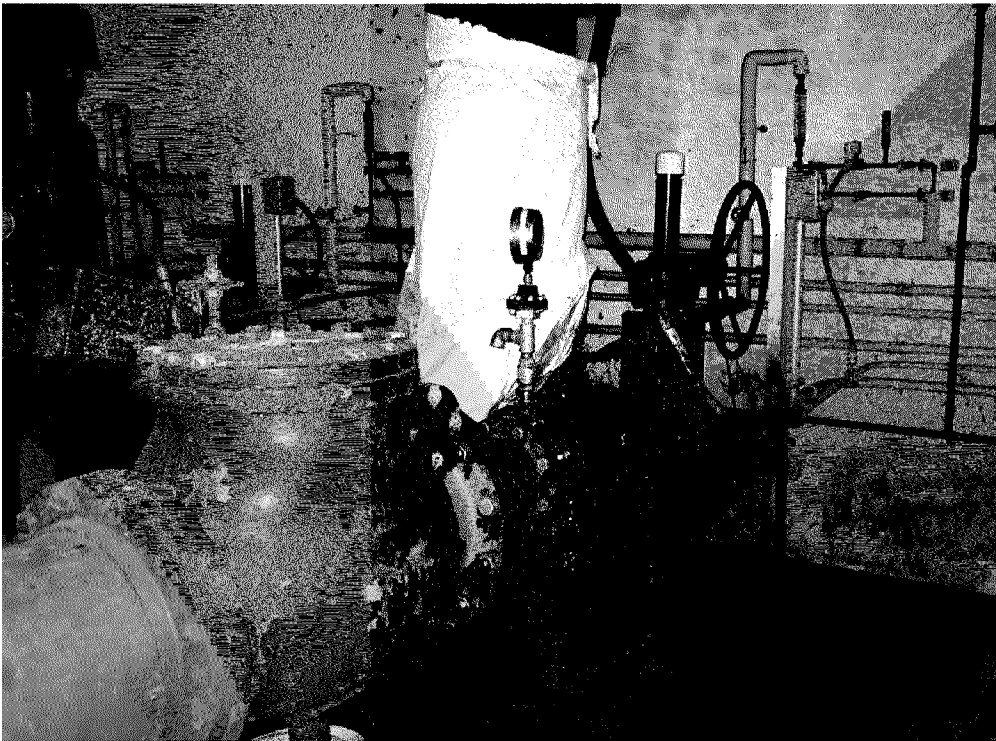
Photo 2 – Screen Building Pump

In the screening building, I observed minor leaking from seals on pumps 1 and 3 and was told that pump 2 was offline for repairs [photo 2]. At the septage handling building, I was initially told that the tank was full. However, SCADA system indicated that the septage tank was empty. It was later verified that the tank was, in fact, empty and the SCADA reading was correct. I was also told that a scum pump SCADA system reading was incorrectly reporting the tank was full when it was empty.

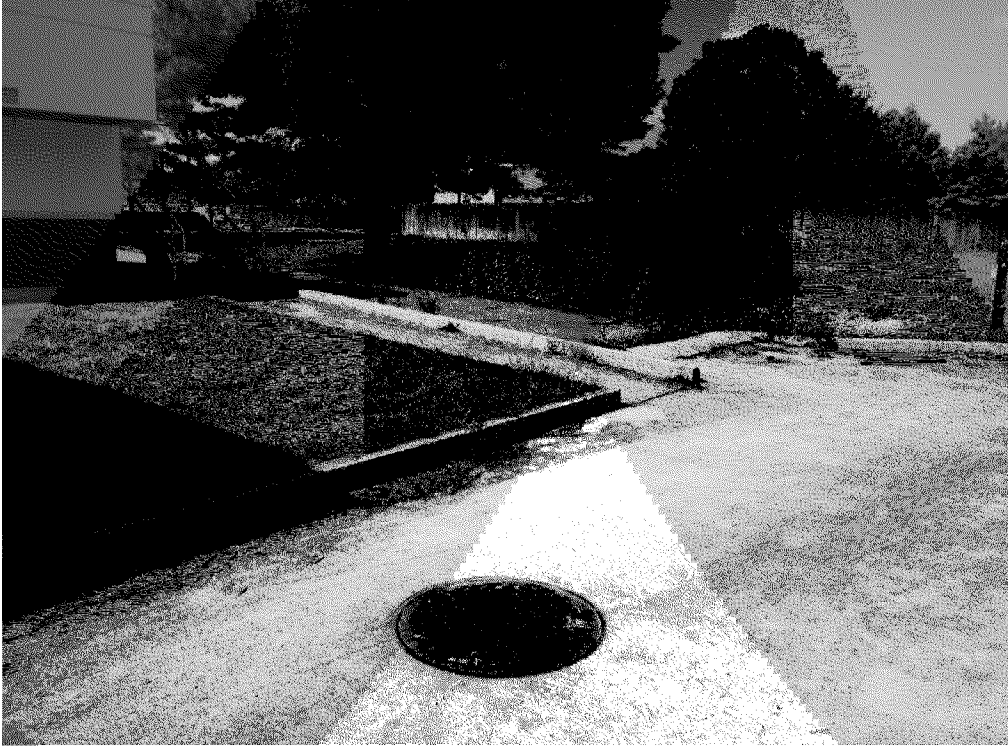
Photo 3 – Part of Emergency Generator, Catch Basin, and Shut-off Valve (far right of photo)

In the grit chamber, we were told that automatic bar screen cleaning was broken and was being cleaned by hand. We were told that the emergency generator could power the entire plant and that it is tested weekly and under load once per month. It has a 3,500 gallon double-wall diesel tank. Adjacent to the emergency is a pull-off area for refueling. There is a stormwater catch-basin in the pull-off. A shut-off valve for the catch basin visible at the far right of the photo, below [photo 3].

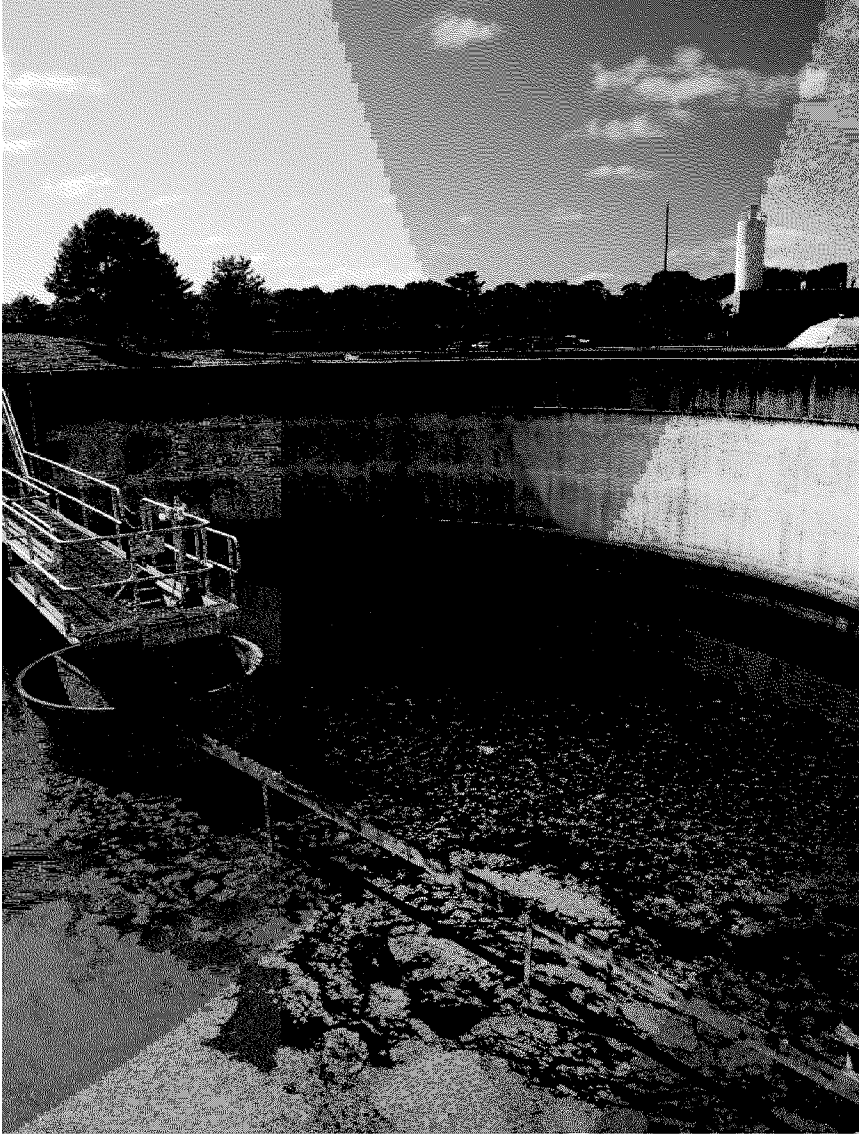
Photo 4 – One of Three Final Clarifiers

The facility has 3 final clarifiers. I was told that the facility maintains a blanket of approximately 1 foot of sludge and that a thin layer of scum observed on the surface of the tanks was excess Micro C [photo 4].
