## **RCRA Inspection Report**

RTX Corporation, Pratt and Whitney  
Division  
8801 Macon Road  
Columbus, Georgia 31908  
Muscogee County

EPA ID#: GAD980711816  
NAICS #: 336412 – Aircraft Engine and Engine  
Parts Manufacturing

January 14, 2025; 8:20 a.m. – 5:30 p.m., January 15, 2025; 8:00 a.m. – 11:30 a.m.

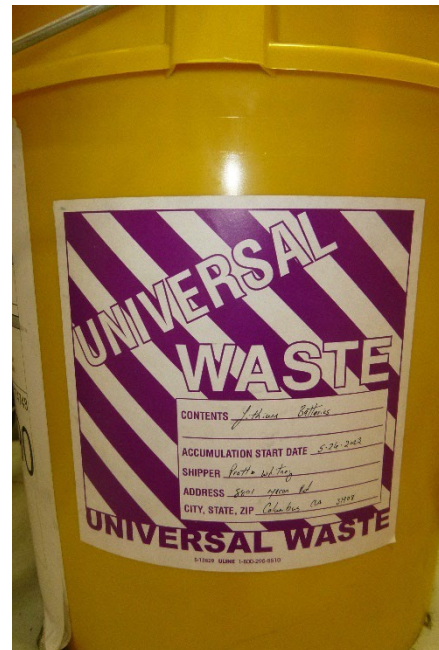
Photograph 11. POG 2507 Universal Waste Batteries

The following POGs in this area had observations noted. In POG 2507 at column G-28, P&W was storing three (3) 5-gallon plastic containers of universal waste batteries. One container was solely accumulating alkaline batteries. These containers were closed and in good condition. All three containers were labeled with two different universal waste labels. P&W personnel stated that one was the old label and the other was new label. The new labels were each marked with accumulation start dates of April 2, 2024. P&W should review containers and ensure accurate labeling (Photographs 11-15).

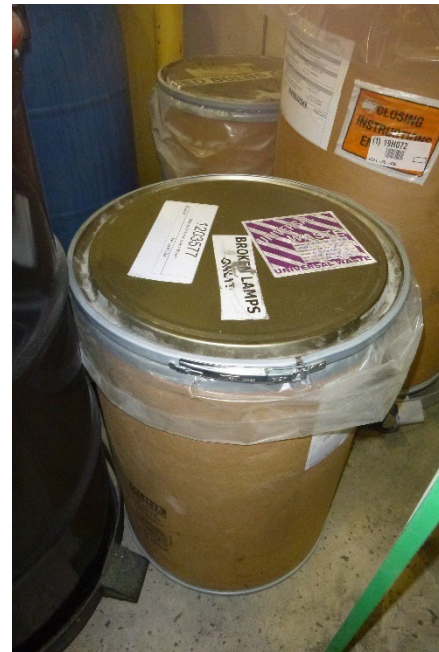
**Photograph 30. POG 2126B Broken Lamps labeled Universal Waste**

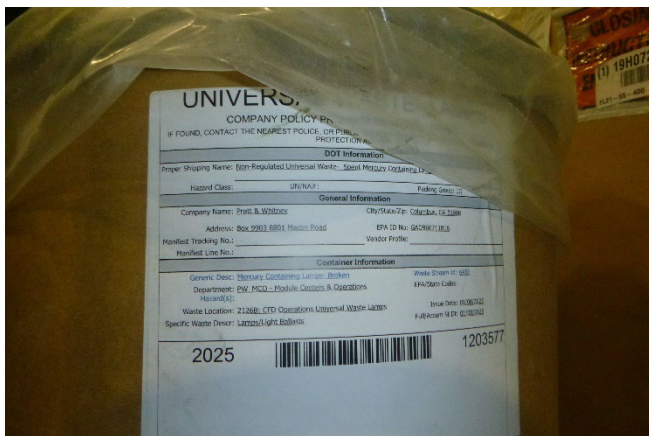
In POG 2126B at column C-14, inspectors observed two containers; the first was a 30-gallon fiberboard container containing broken and/or crushed waste fluorescent lamps, the second was a 55-gallon fiberboard container containing intact fluorescent lamps. Both containers were labeled as “Universal Waste Lamps”, in good condition, and dated with accumulation start dates of less than one year. The 55-gallon container was considered open because the lid was not clamped down or fully seated on the rim of the container. The 30-gallon container was also labeled as broken lamps. Photographs 28-31 and 34).

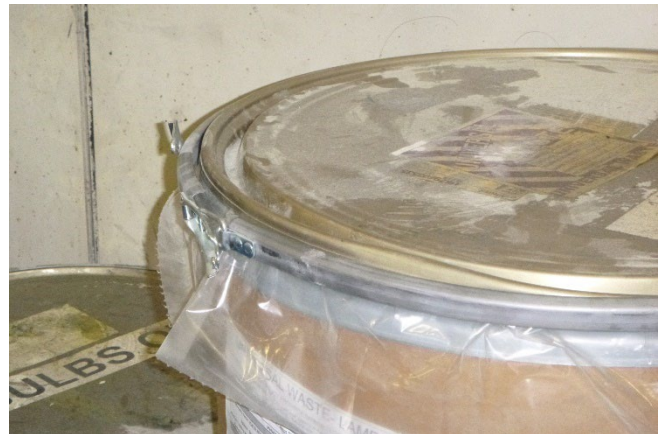
**Photograph 34. POG 2126B Open Universal Waste Lamp Container**

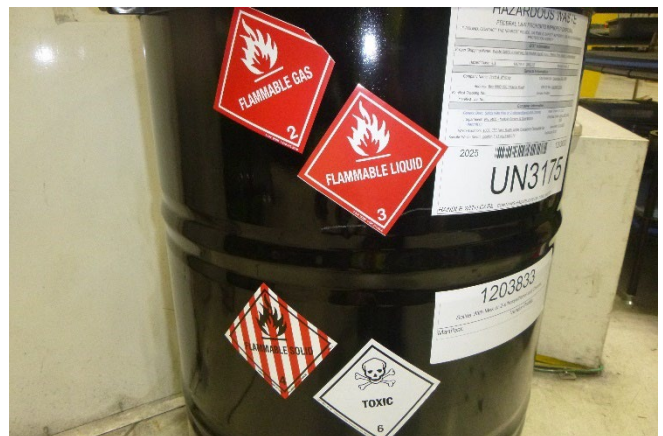
**Photograph 35. POG 1009 HW Container**

In POG 1009 at column E-13, inspectors observed a 55-gallon steel container which was storing “Solids with MEK or 2-Ethoxyethanol, Waste Profile 5721F”; this container was in good condition and closed. This container was labeled with the words “Hazardous Waste”, with waste codes D001, D007, D035, and F005 and with hazard indicator labels for Toxic, Flammable Gas, Flammable Liquid, and Flammable Solid. P&W representative, David Houser, stated that this was a solid waste (Photographs 35-37). It appears that there were incorrect hazard indicators on this container. P&W removed the indicators of flammable liquid and flammable gas during the inspection.

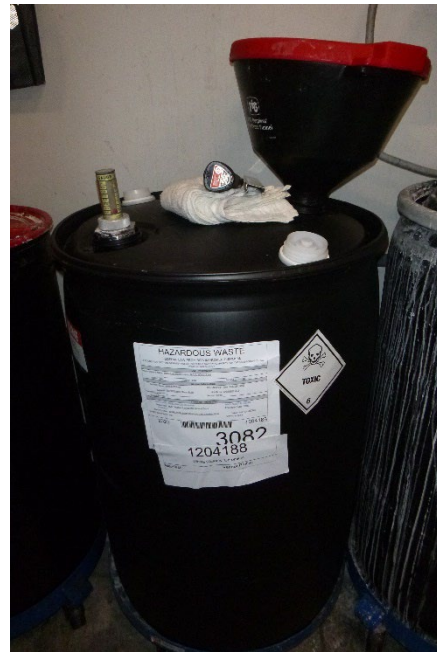
Photograph 41. POG 1032B and 1033

The inspectors noted observations at the POGs in Table 4. In PECM, POG 1032B, inspectors observed a 55-gallon poly container with a latched funnel installed on the lid. Upon entering the room, inspector Alan Newman noted that the lid to the funnel was open; P&W's David Houser closed the lid. The container was labeled as "Hazardous Waste", Wastewater with Chromium, Waste Profile 5213M, and waste code D007 (Photographs 41 - 43). The container was in good condition.

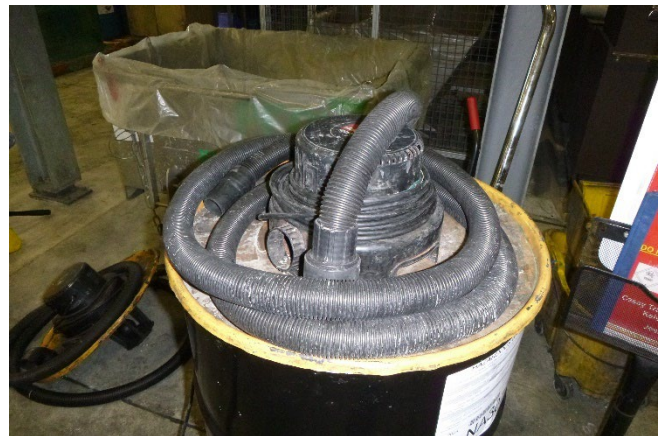
**Photograph 46. POG 2554 Vacuum Top Container**

In PECM Filter, POG 1033 (labeled as POG 2554 on facility plan) inspectors observed a 55-gallon steel container with a vacuum top lid. The container was labeled as "Hazardous Waste", Hazardous Waste Solids, D007, and had a "Toxic" indication of the hazard label. This container was used in the electrolyte balancing and filter area to suck up hazardous waste from the various maintenance processes. The vacuum on top of the container was open due to the hole in the vacuum (Photographs 46-48).

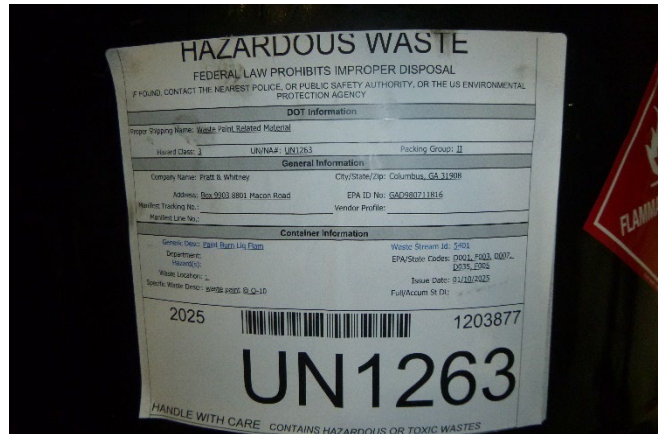
**Photograph 53. POG 1019 HW Container Indicators**

In POG 1019 at column Q-10, inspectors observed a 55-gallon steel container labeled “Hazardous Waste”, Paint Burn Liq Flam, D001, F003, D007, D035, and F005, and was labeled with a hazard indicator of Flammable Liquid. The container was in good shape and was closed. There was no “Toxic” hazard indicator observed on the container (Photographs 52-54).

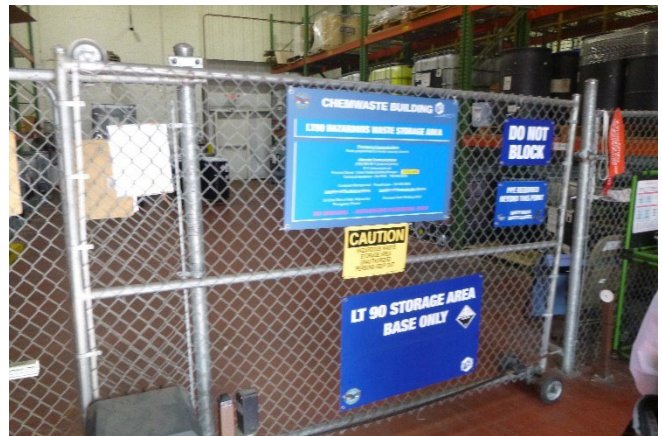
**Photograph 56. Chem Waste CAA Base Side Signage**

The Chem Waste building is the primary CAA for storage of the wastes removed from the SAAs throughout the facility, as well as additional universal waste. The area is divided into two sections for bases and acids. There is a solid concrete wall dividing the areas to prevent any interaction between the materials in the event of release. The areas were marked with appropriate signage and had all necessary fire protection, decontamination, and spill control equipment (Photographs 56, 82, and 83).

The base side of the CAA contained several 55-gallon containers and 300-gallon poly containers, placed under and on four industrial racks along both sides and on pallets along the back wall (Photographs 56 – 59).

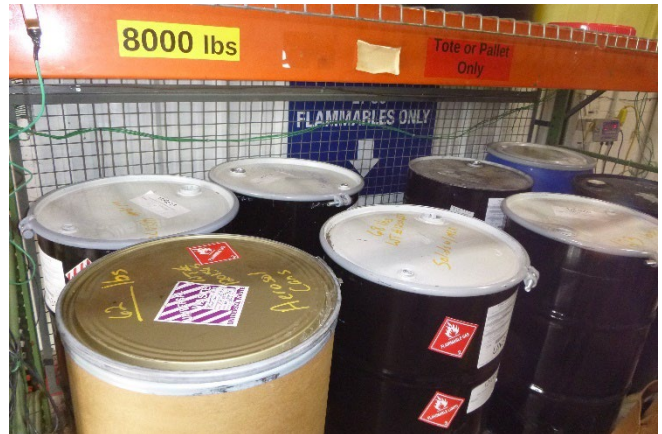
**Photograph 62. CAA Base Side container storage**

Inspectors observed (2) 55-gallon fiberboard containers which were labeled “Universal Waste – Aerosol Cans”; these containers were closed, in good condition, and marked with accumulation start dates of less than one year (Photograph 62).

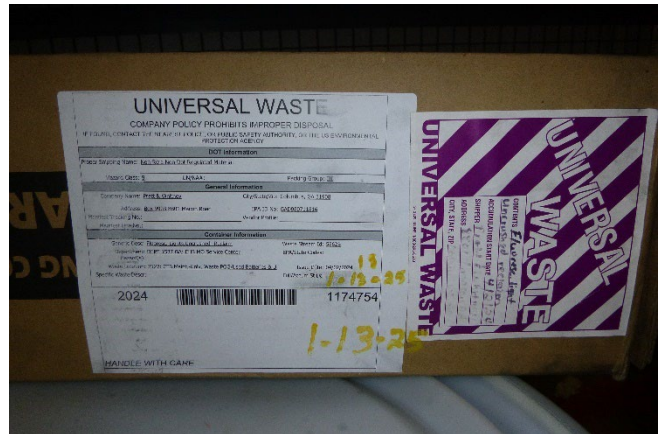
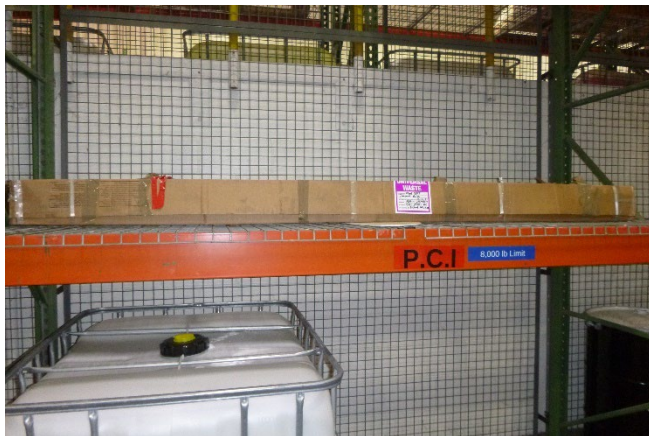
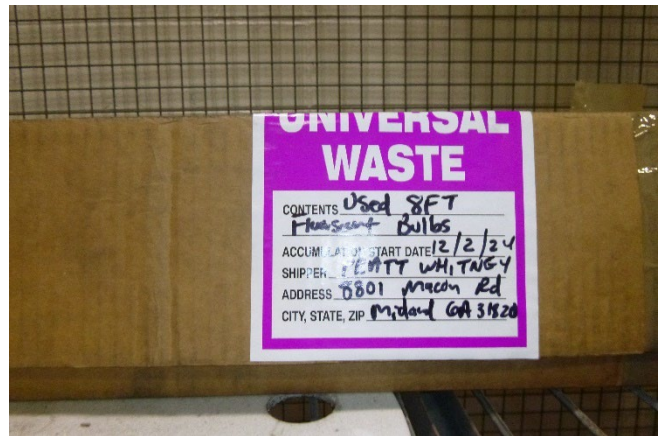
Inspectors observed one (1) 8' box labeled "Universal Waste – Bulbs" and one (1) 4' box labeled "Universal Waste – Fluorescent Lights, Uncrushed". The boxes were in good condition and closed, with accumulation start dates less than 1 year (Photographs 77 – 80). Additionally, there was one (1) 30-gallon fiberboard container labeled "Universal Waste – Electronic Scrap". There are no requirements at this time to manage electronic waste as Universal Waste.

Photograph 77. CAA Acid Side Universal Waste Lamps
