## **RCRA Inspection Report**

Daicel Safety Systems America, LLC  
720 Old Liberty Church Road  
Beaver Dam, Kentucky 42320  
Ohio County  
EPA ID No.: KYR000034207

March 21, 2022; 1:40 pm - 5:00 pm C.S.T. and March 22, 2022; 8:00 am - 5:00 pm C.S.T.

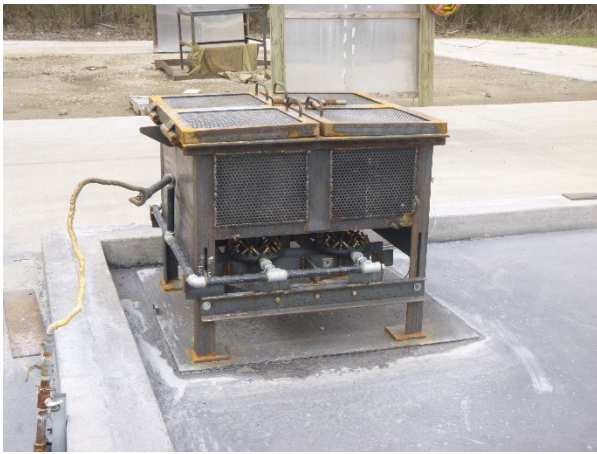
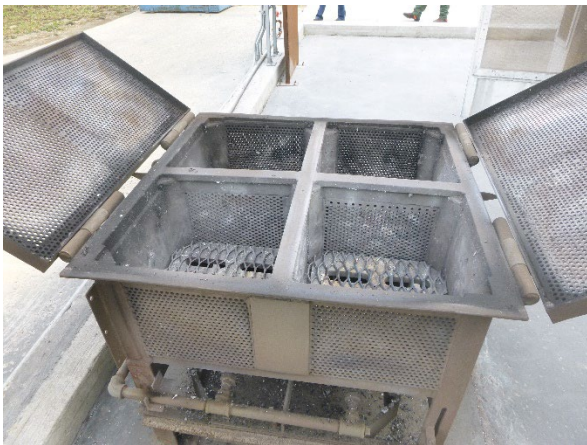
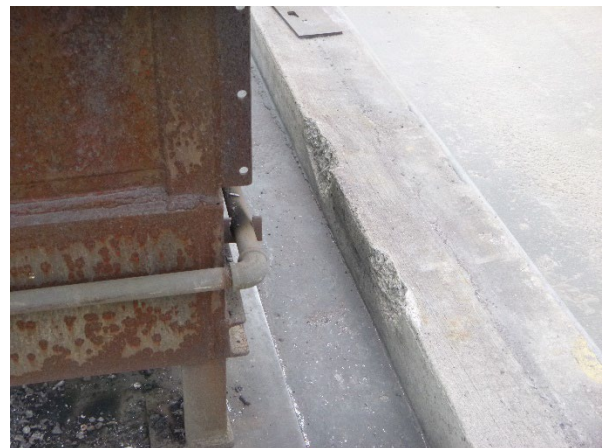
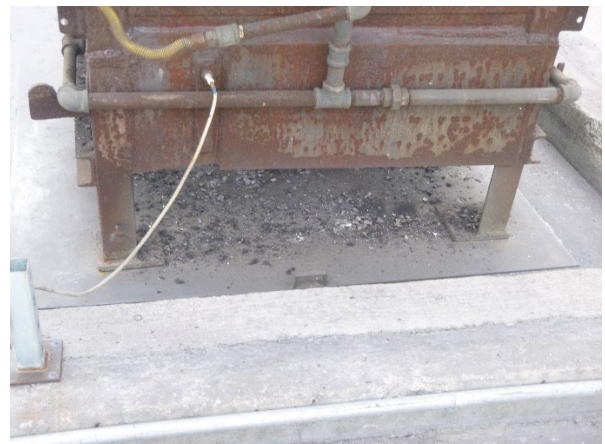
Daicel operates the cage unit for treatment of generate and two propane inflator treatment units (Photos 1-6). These units were not in use on the day of the inspection due to anticipated rain. In order to initiate treatment, two buttons for two operators are required to be engaged at the same time. There was a small amount of ash noted underneath one of the inflators burn units. This ash is sent off site for metals recovery. There was no waste noted in the permitted pellet treatment unit on the day of the inspection.

Photo 1: Inflator Burn Unit

Photo 2: Inflator Burn Unit

Photo 5: Inflator Burn Unit

Photo 6: Inflator Burn Unit

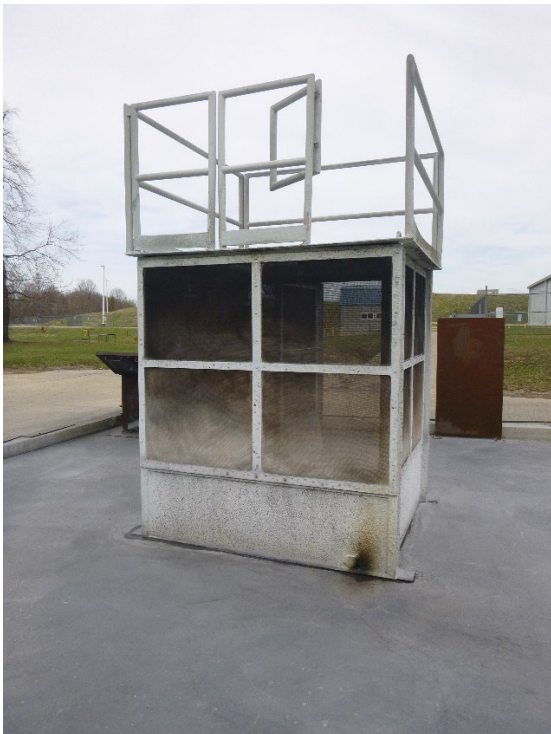
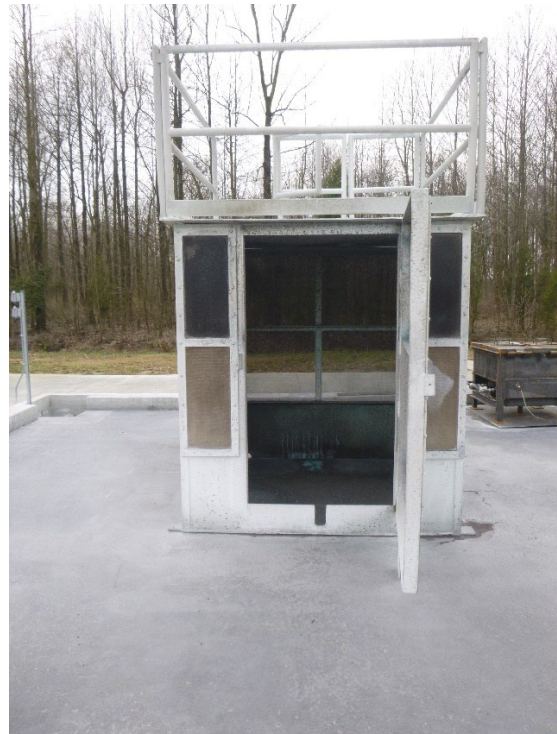
Photo 3: RCRA Permitted Pellet Treatment Unit

Photo 4: RCRA Permitted Pellet Treatment Unit

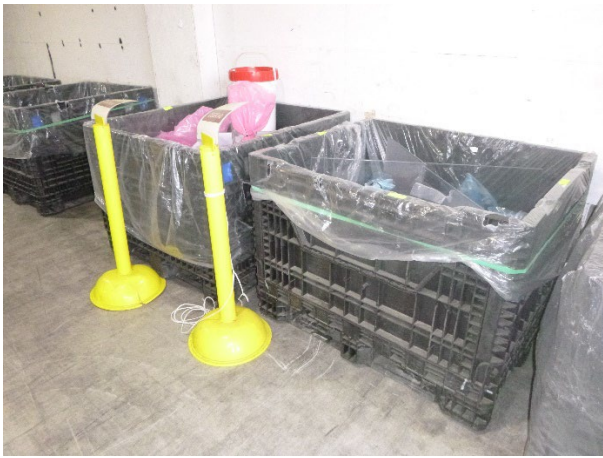
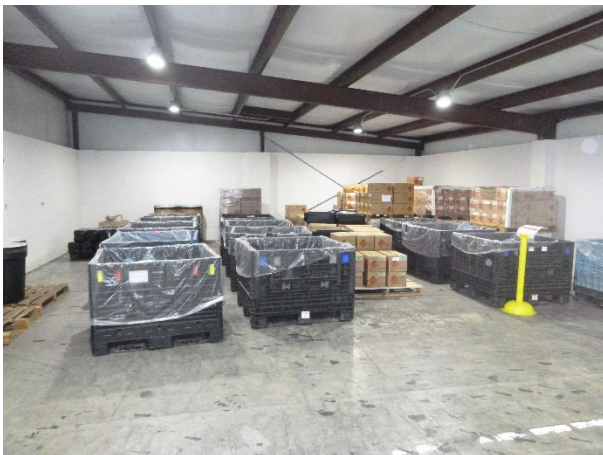
Daicel utilizes Magazine 3 to store segregated waste NQ and waste GB staged for treatment (Photos 7-9). NQ waste is stored in plastic bags in open top, plastic-lined, gaylord boxes. GB waste is stored similarly to NQ waste and in boxes from Daicel's Arizona facility which are shipped to Kentucky for treatment. The plastic bags were labeled with the name of the waste type, the accumulation start date, and EPA waste codes but not with an indication of the hazard (Photo 8).

Photo 7: Magazine 3.

Photo 9: Magazine 3.

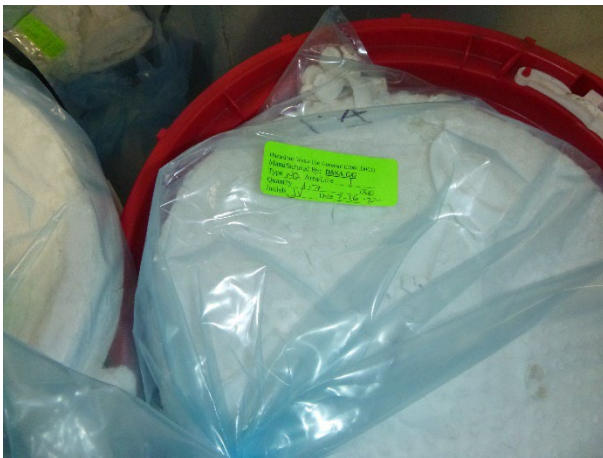
Photo 8: Magazine 3.

**Pursuant to 401 KAR 39:080 Section 1 [40 C.F.R. § 262.17(a)(5)(i)], which is a condition of the LQG Permit Exemption, a generator must mark or label its containers with an indication of the hazards of the contents.**

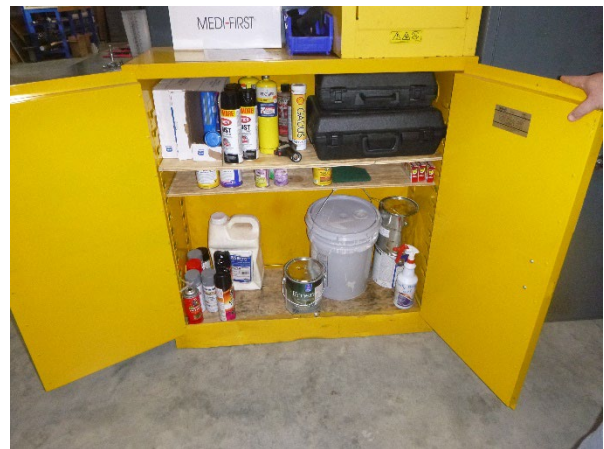
Photo 11: Compressor Room.

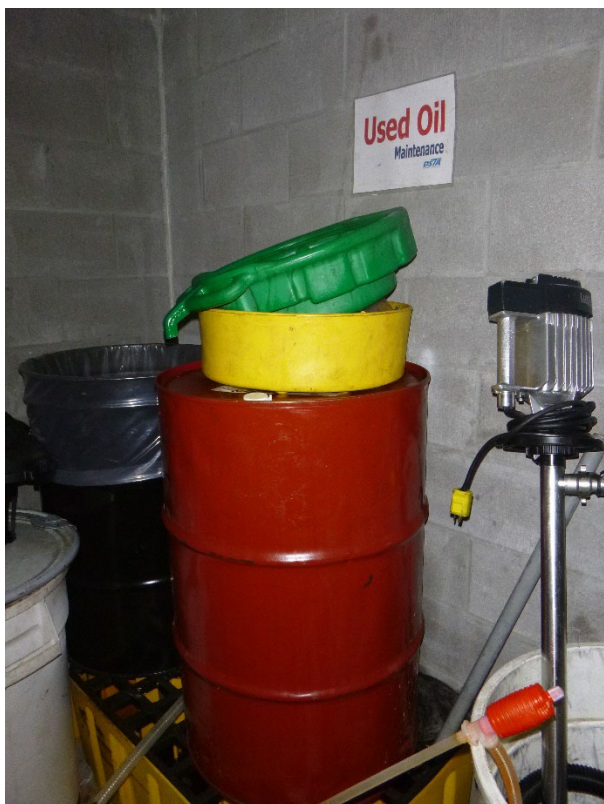
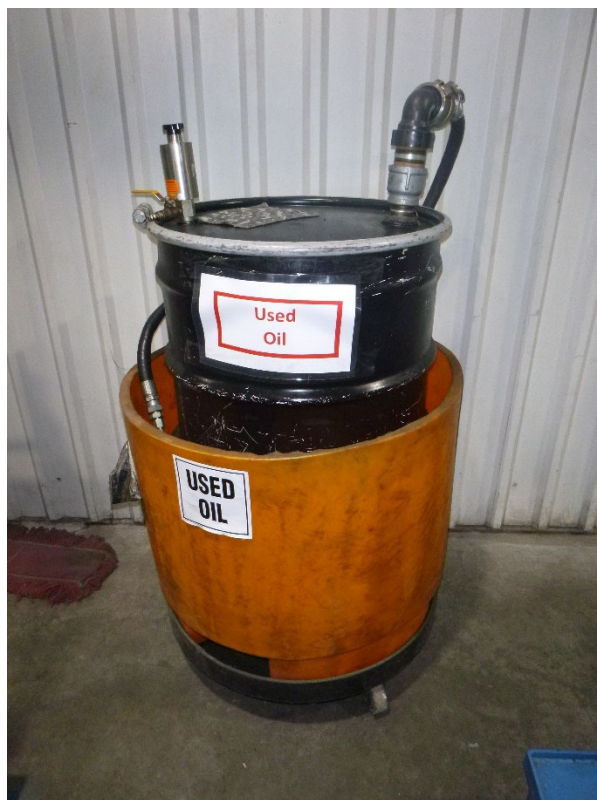
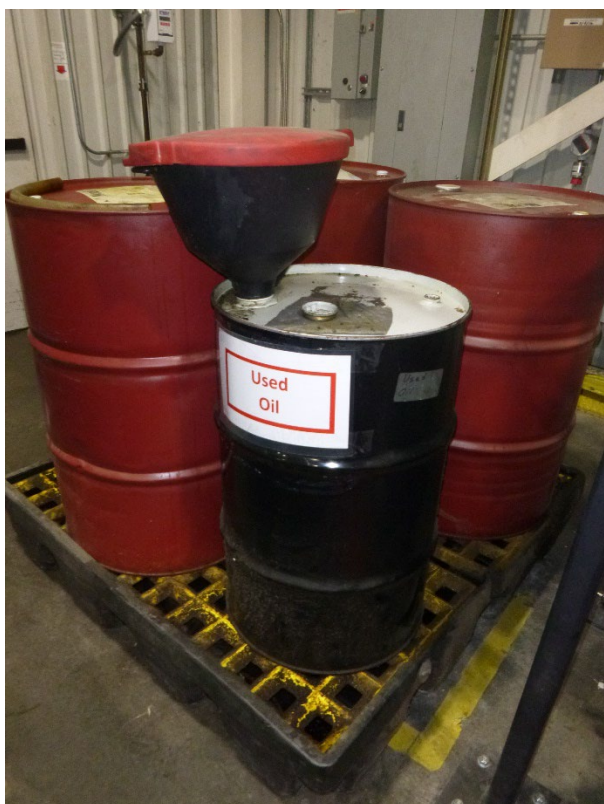
Daicel was storing used oil in a red metal 30-gallon container on a secondary containment pallet (Photo 13). This container was in good condition labeled used oil. There was one Crystal-Clean parts washer used in this area for cleaning using a citrus non-hazardous solution. This solution is swapped out every three months. Daicel also utilizes an ultrasonic cleaner in this area. A 55-gallon red metal container of used oil was stored without being labeled; wall behind the container was labeled with the words “Used Oil” (Photo 12). There was one container of used oil in a portable secondary containment cart (Photo 14-15). The secondary containment cart was partially full of used oil. Daicel is required to remediate used oil that spills into secondary containment areas.

Photo 12: Container of Used oil.

Photo 14: Used Oil containers.

Photo 13: Used Oil container.

**Pursuant to 401 KAR 39:080 Section 4(1) [40 C.F.R. § 279.22(c)(1)], containers and aboveground tanks used to store used oil at generator facilities must be labeled or marked clearly with the words “Used Oil.”**

**Pursuant to 401 KAR 39:080 Section 4(1) [40 C.F.R. § 279.22(d)], upon detection of a release of used oil to the environment, the facility must clean up and manage properly the released used oil and other materials.**

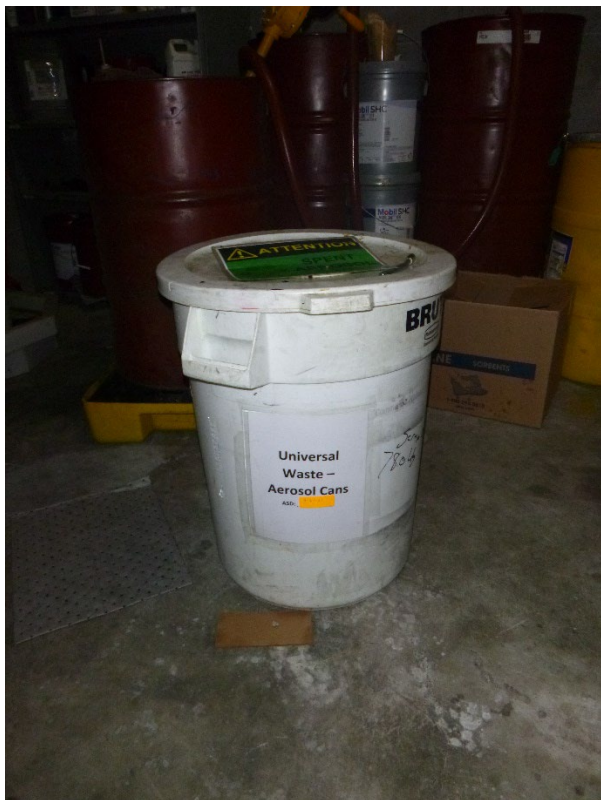
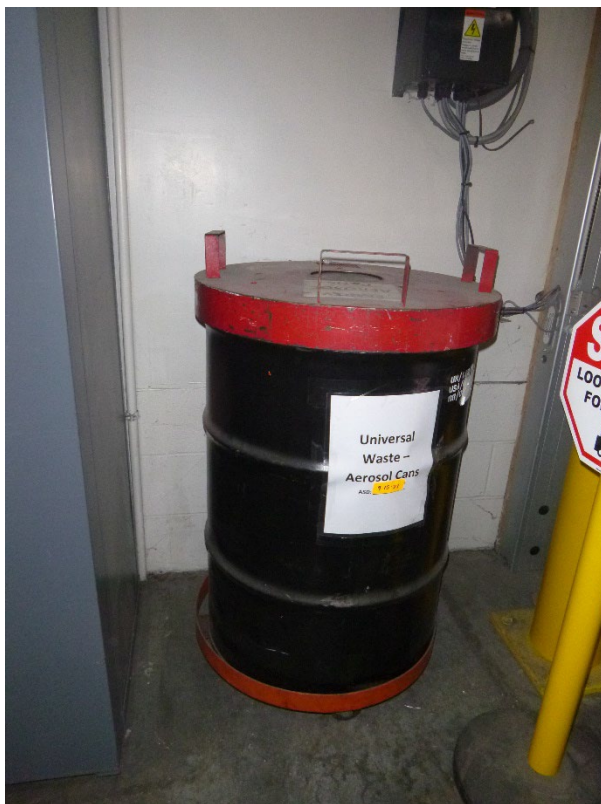
There were one white 30-gallon plastic container and one black 55-gallon container accumulating intact universal waste aerosol cans dated September 21, 2021 and September 15, 2021, respectively (Photos 16-17). These containers were in good condition and closed. Daicel was storing live scrap in three 55-gallon red metal containers. One for driver live scrap, one for partial driver’s scrap, and one for LE scrap long. The lids of these containers were spring loaded and vented. These wastes were not determined to be hazardous (Photos 18-19). The inspection team recommends that these containers be more completely labeled as to their contents.

Photo 16: Universal Waste Aerosol Can accumulation container.

Photo 17: Universal Waste Aerosol Can accumulation container.

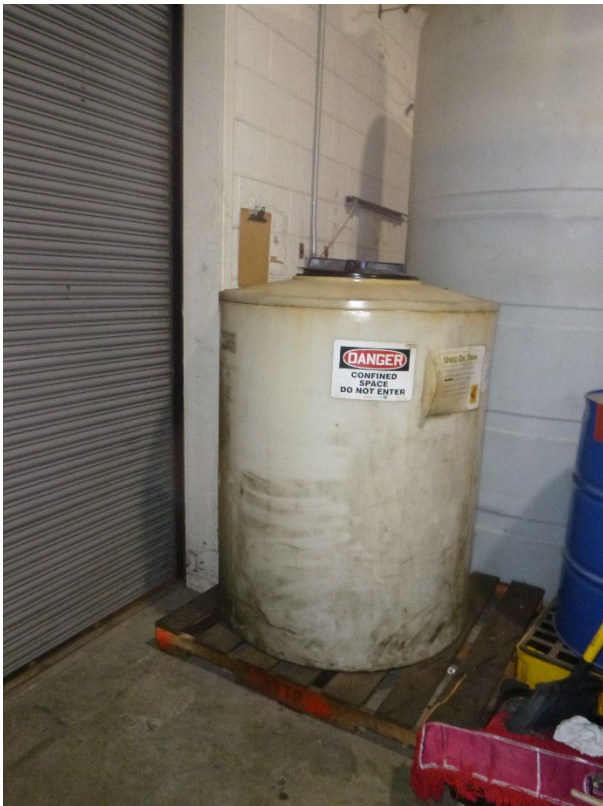
Daicel was storing used oil in a double-walled 200-gallon tank in the compressor room. This tank appeared to be in good condition and labeled (Photo 20). The inspection team noted a blue 55-gallon container with orange tape to restrain use (Photo 21). Daicel representatives stated that this container held isopropyl alcohol at a concentration too strong for use at this portion facility. This product was purchased and was unable to be returned during the Covid -19 pandemic. Facility personnel later stated that there were other areas of the facility that would be able to use this product as-is and had the container reassigned to another department. The inspection team noted one 55-gallon fiber container that was labeled as a hazardous waste that was accumulating broken universal waste lamps (Photos 22 and 24). This container was in good condition and labeled. A second fiber container accumulating intact universal waste lamps was next to the

Photo 20: Used Oil Tank.

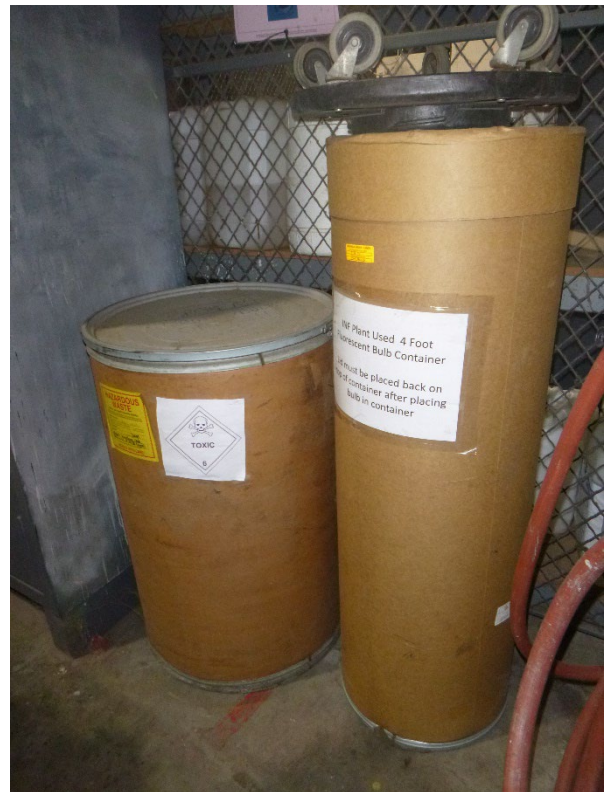
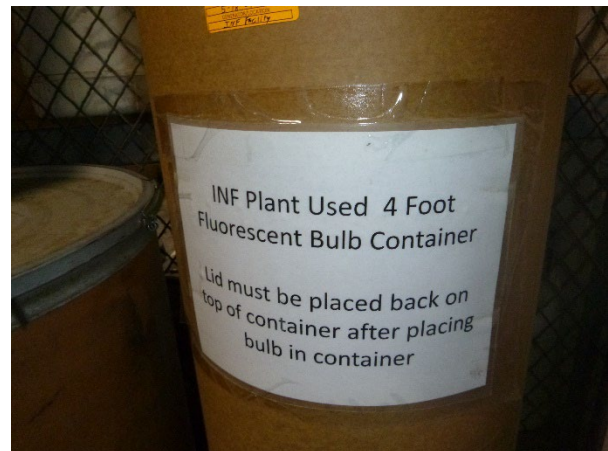
container of broken lamps (Photo 22-23). This container was closed, labeled, and dated May 28, 2021.

Photo 22: Hazardous Waste and Universal Waste lamp containers.

Photo 23: Universal Waste lamp container.

Photo 24: Hazardous Waste container for broken lamps.

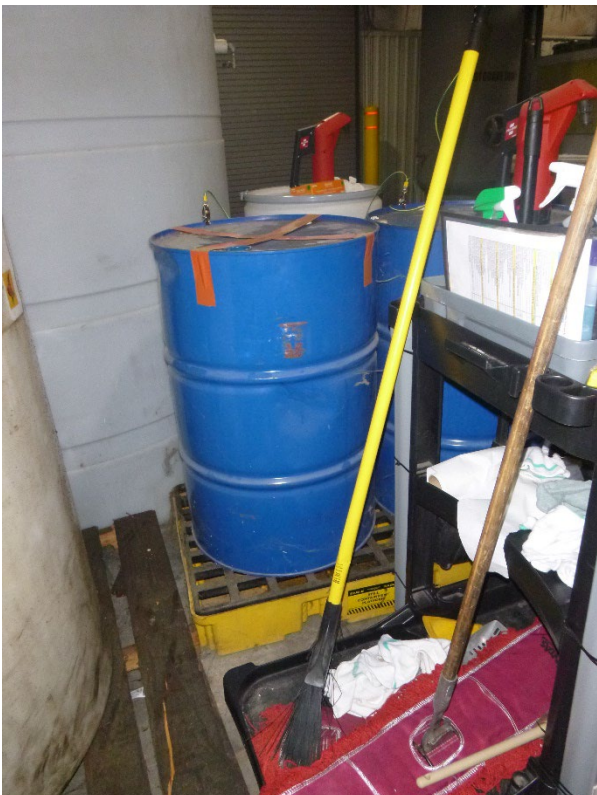
Photo 21: Isopropyl Alcohol Container.

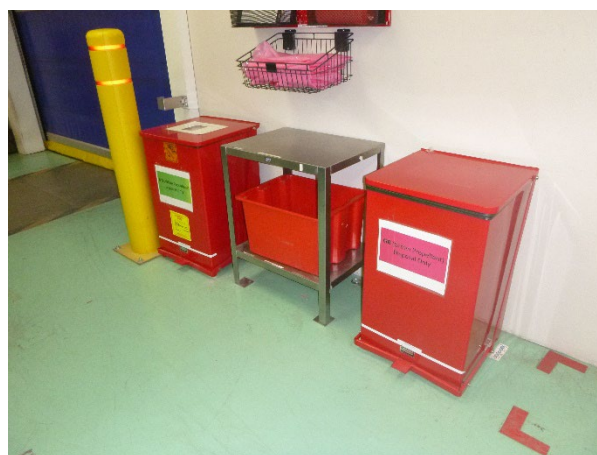
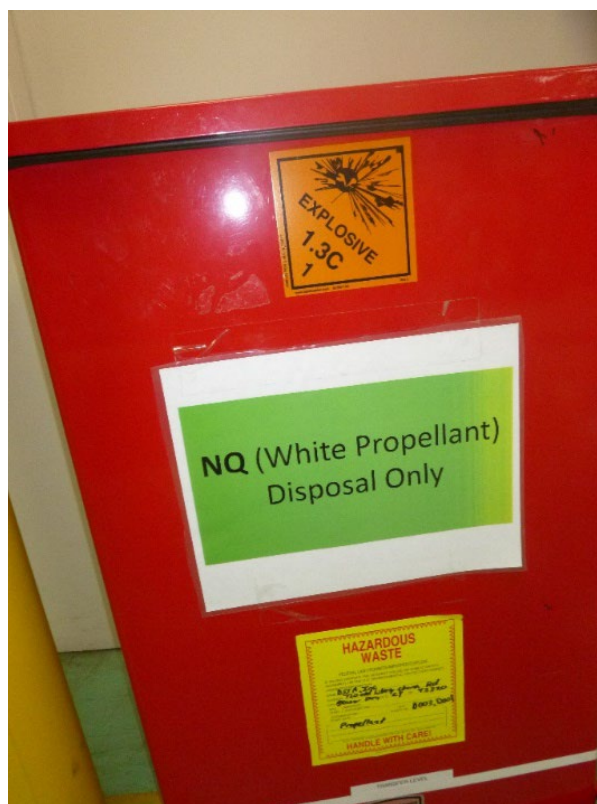
In the D3 Assembly Area, Daicel accumulates NQ (White Propellant) (D003, D001) in a red 30-gallon foot operated metal container (Photos 27-28). This container was labeled, in good condition, and closed. Daicel also accumulates GB (Green Propellant) and initiator/enhancer scrap in this area (Photos 27, 29, 30). Daicel accumulates “used WD-40” (D001) in a black 55-gallon container near D7 assembly area (Photo 31-32). This container was closed, labeled, and in good condition.

Photo 27: Assembly SAA.

Photo 28: Assembly SAA.

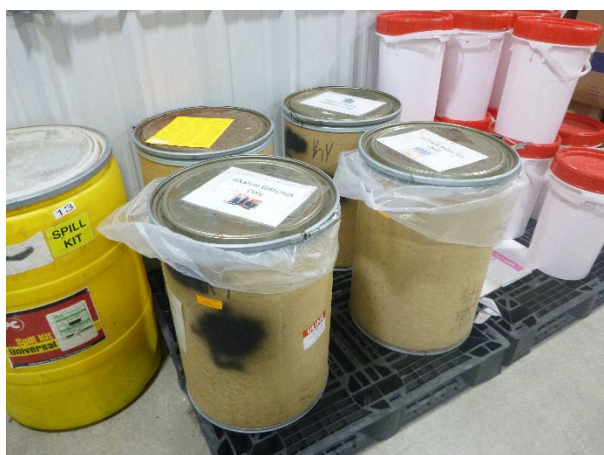
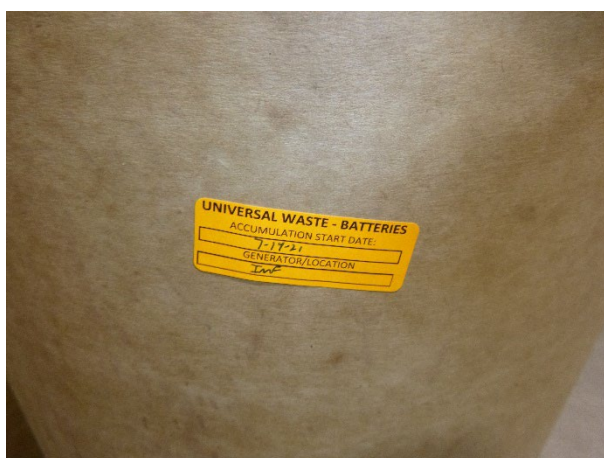
Daicel collects used batteries and manages them as universal waste. On the day of the inspection the inspection team noted four 30-gallon fiber containers: one storing alkaline batteries, one storing lithium batteries, and two storing rechargeable batteries (Photo 25-26). Each container was labeled, and the three universal waste containers were each labeled with an accumulation start date of July 14, 2021. Daicel generates oily waters (non-hazardous) in their production activities from their wet saws. There were five 55-gallon containers on site on the day of the inspection.

Photo 25: Universal waste batteries.

Photo 26: Universal waste batteries.

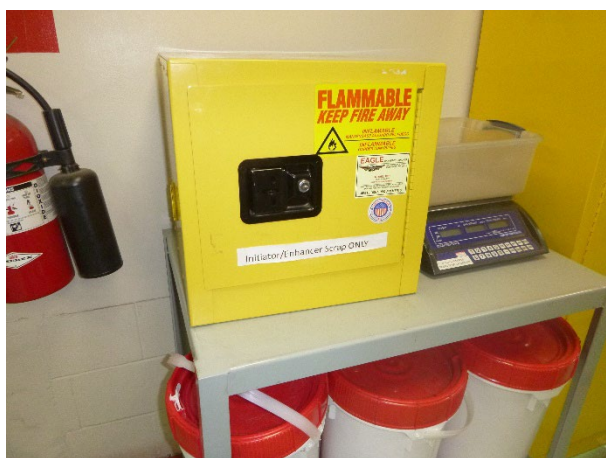
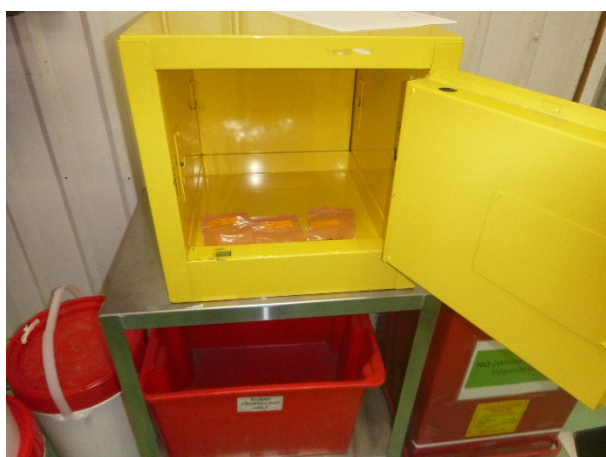
Photo 29: Initiator/enhancer scrap.

Photo 30: Initiator/enhancer containers in Flammable cabinet.

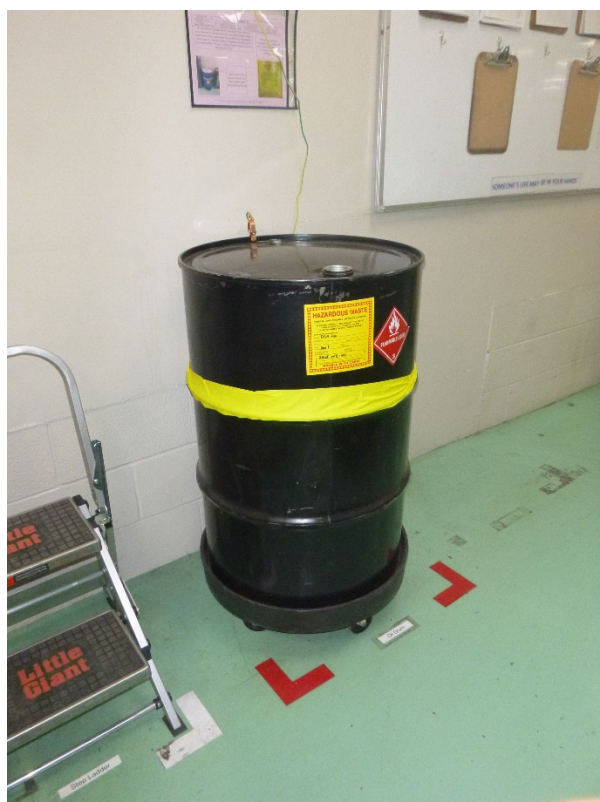
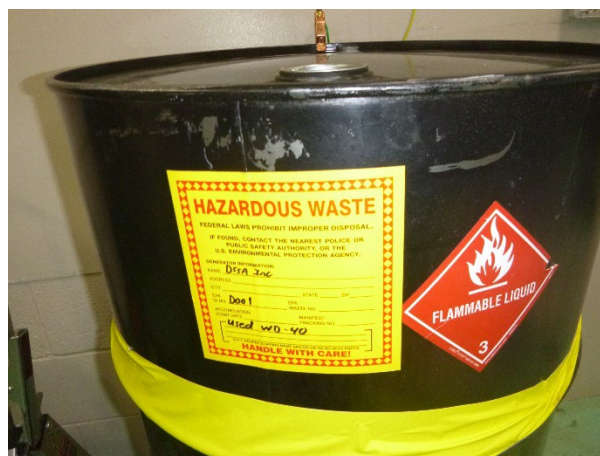
Photo 31: SAA for WD-40.

Photo 32: SAA for WD-40.

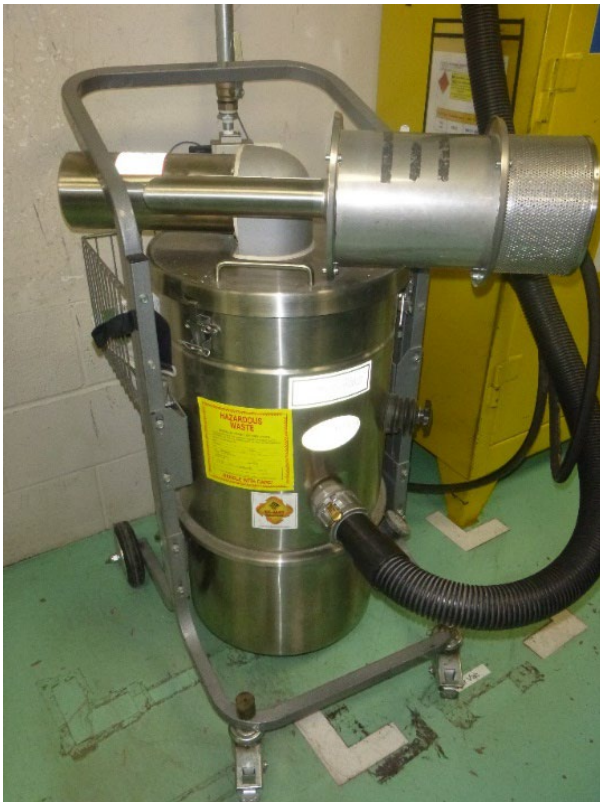
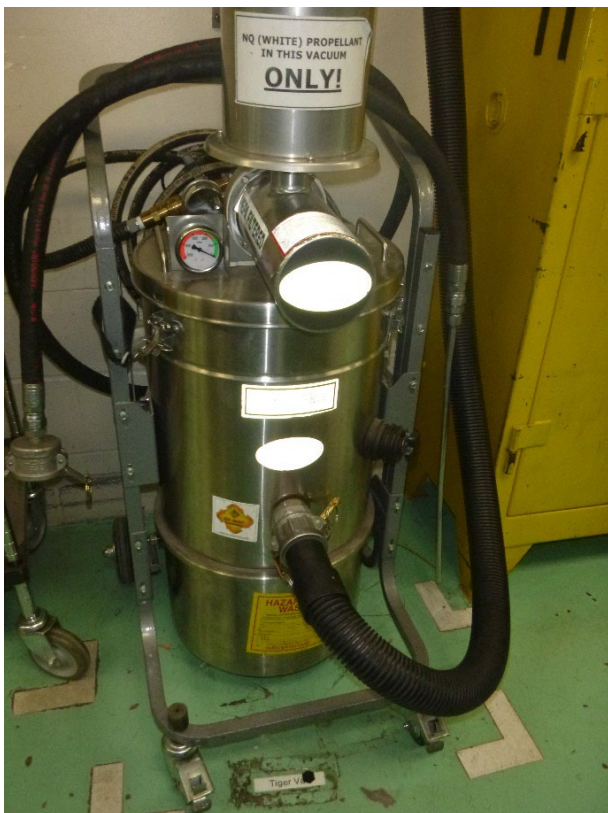
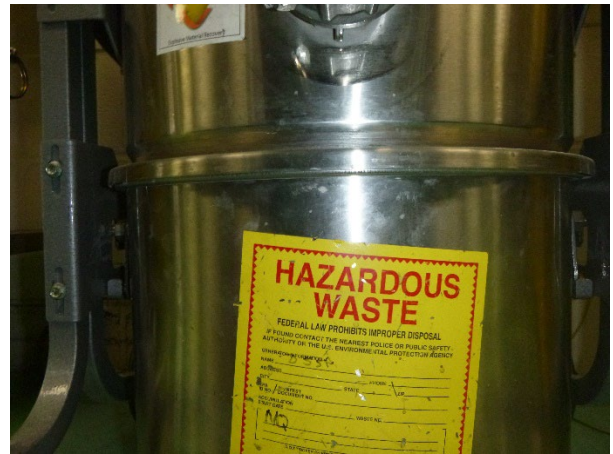
Throughout the assembly area, Daicel operates multiple portable vacuum system units to clean production units (Photos 33-35). These vacuums are affixed with storage compartments that are being managed satellite accumulation containers. Although these compartments are labeled as hazardous waste they are not labeled with the indication of the hazard. At several locations in the Assembly area, Daicel was accumulating Live Scrap at production area end caps (Photo 36).

Photo 33: Portable vacuum system.

Photo 35: Portable vacuum system.

Photo 34: Portable vacuum system.

**Pursuant to 401 KAR 39:080 Section 1 [40 C.F.R. § 262.15(a)(5)], which is a condition of the SAA Permit Exemption, a generator is required to mark or label its containers (i) with the words “Hazardous Waste” and (ii) with an indication of the hazards of the contents.**

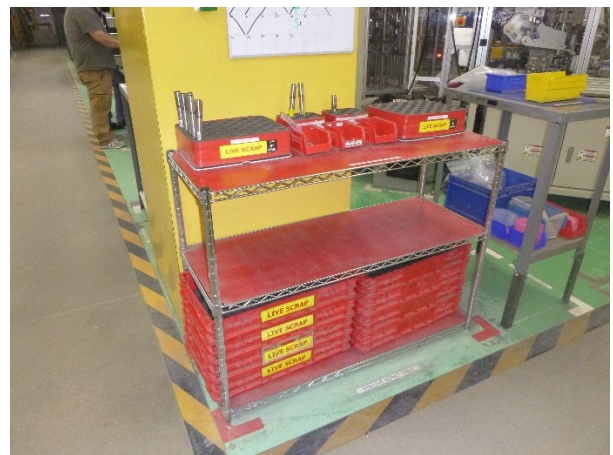
Photo 36: Live Scrap initial Accumulation.
