**UNITED STATES ENVIRONMENTAL PROTECTION AGENCY  
REGION 8  
RESOURCE CONSERVATION AND RECOVERY ACT**

**Facility Name:** Polar Bear Water Treatment      **Facility Location:** 41.755800, -107.585100

**Type and Purpose of Inspection:** Compliance Evaluation Inspection

**Facility Type:** Commercial Oilfield Waste Disposal Facility (COWDF)

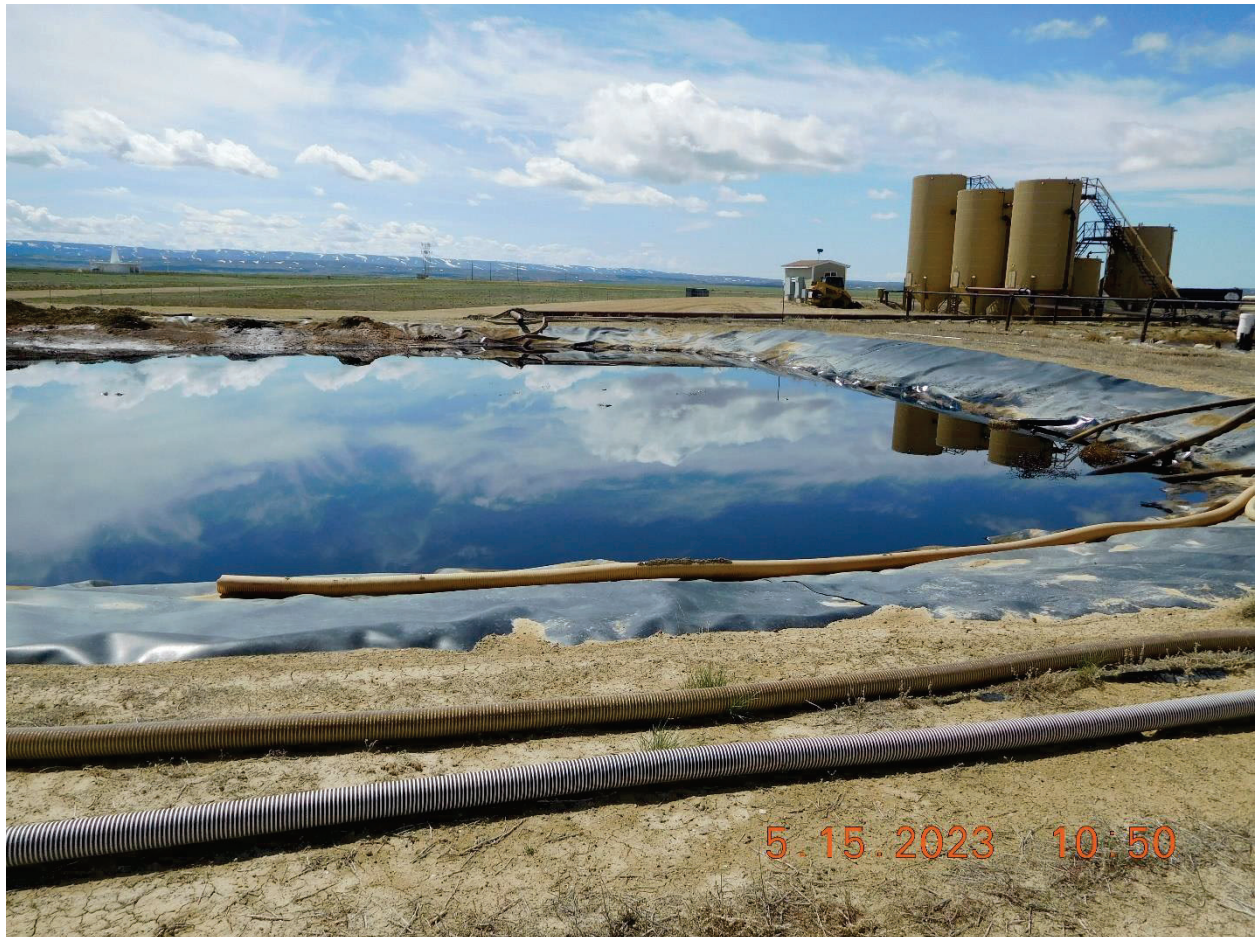
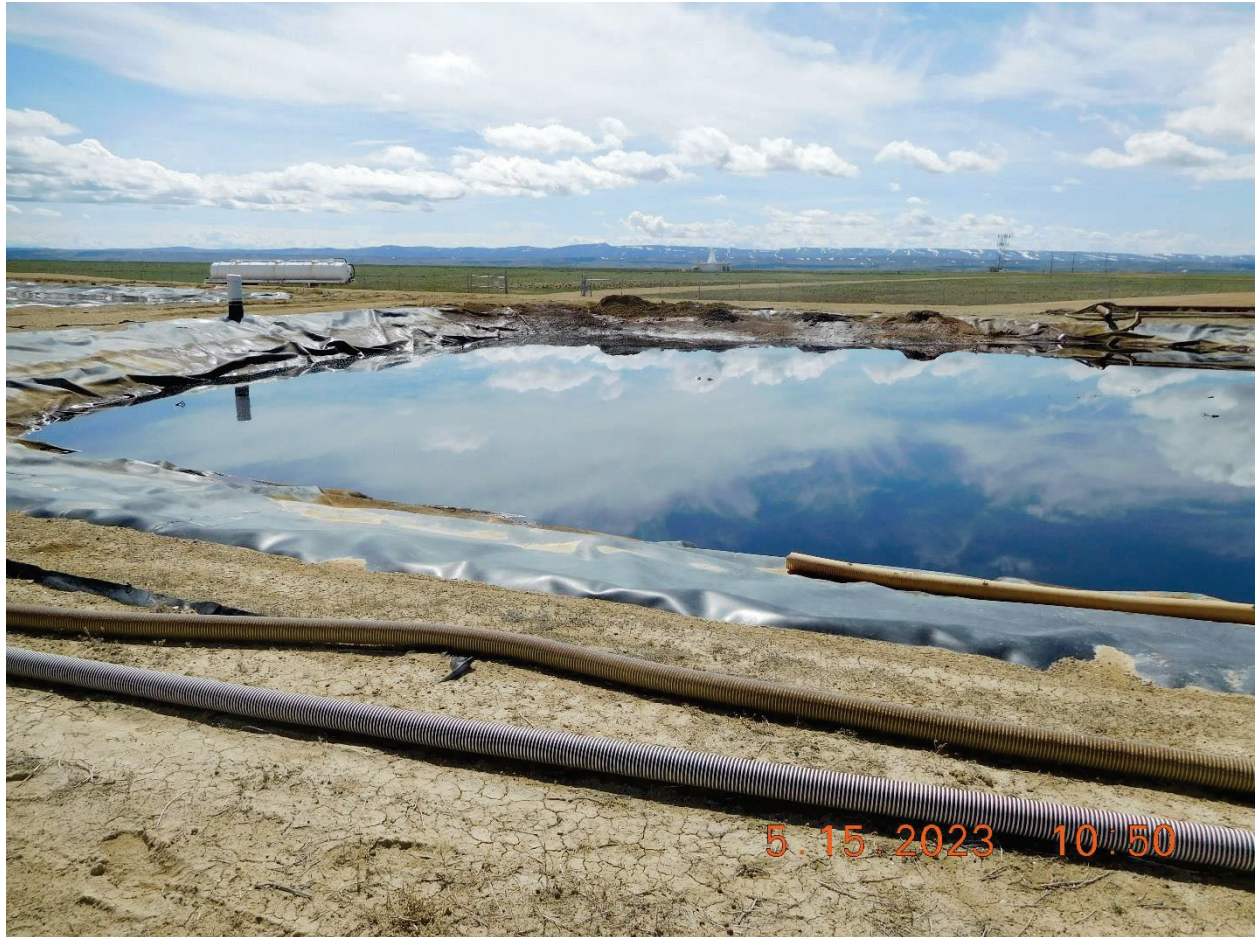
**Data Collected and Observations:** During the walk-through, I observed that slop/skim pit 1 (see Attachment 1 – Site Map) was netted, but that two additional slop/skim pits, which Mr. Heinzen identified as slop pits 2 and 3, also identified on the Site Map, were not netted. At slop pit 2, I observed that it was 100% covered in floating oil and was not netted. See Attachment 2 – Photo Log, photos 1986 and 1987. All additional photos described below are also included in Attachment 2.

Oily waste that is not physically restricted from access by birds and other wildlife is a concern because of the potential for injury or mortality. Specifically, the large amount of oil on evaporation pond 8 and slop pits 2 and 3 poses a potentially serious threat to birds and other wildlife.

Photo 1986: DSCN1986.jpg – photo of slop/skim pit 2, with oil on 100% of the surface.

Photo 1987: DSCN1987.jpg – photo of the same area shown in photo 1986, panned left.

A closing conference was conducted with Mr. Heinzen in which we relayed concerns about the oil on the un-netted slop/skim pits and Pond 8. I also stated that I would be writing an inspection report, which should be provided to the facility within 70 days.

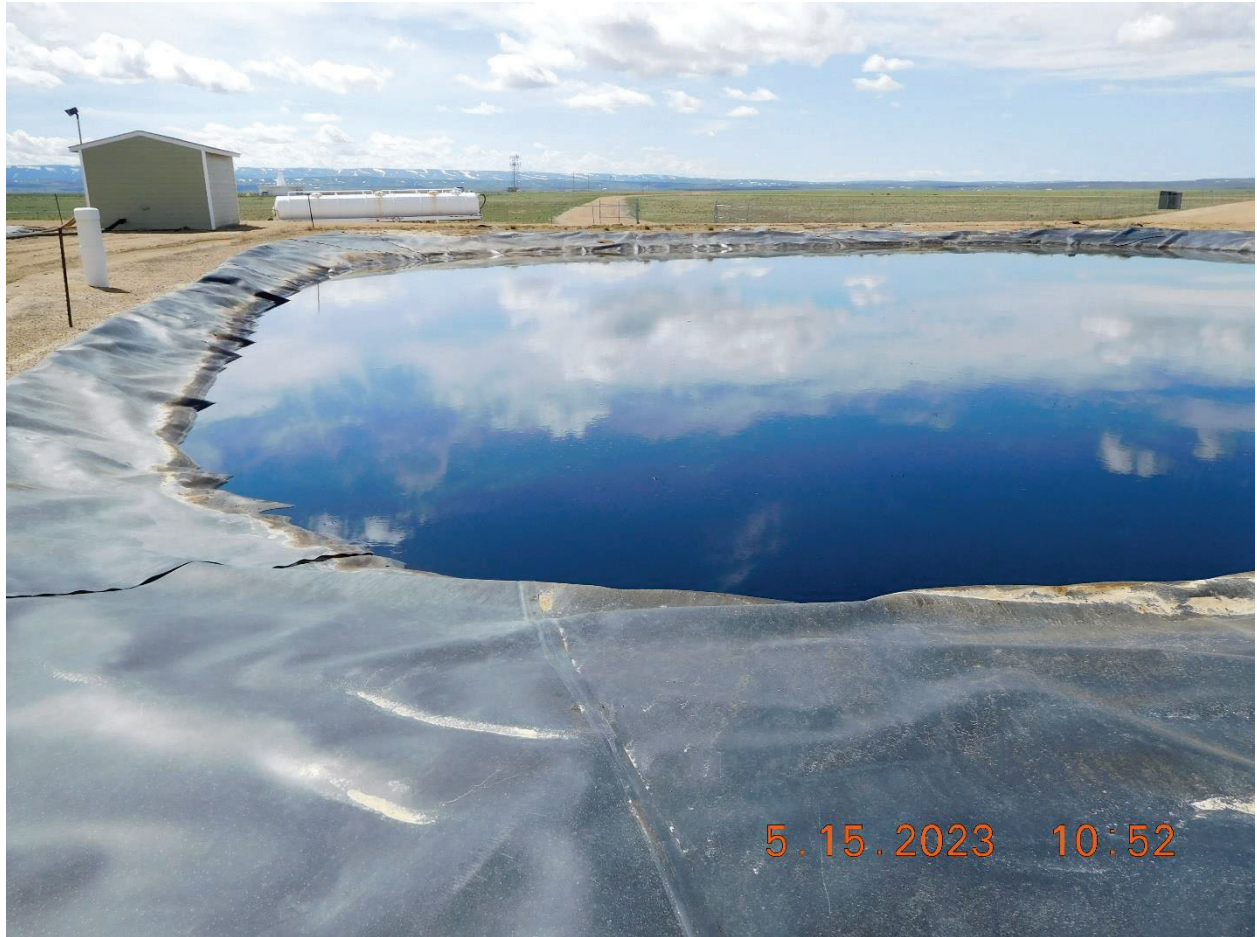
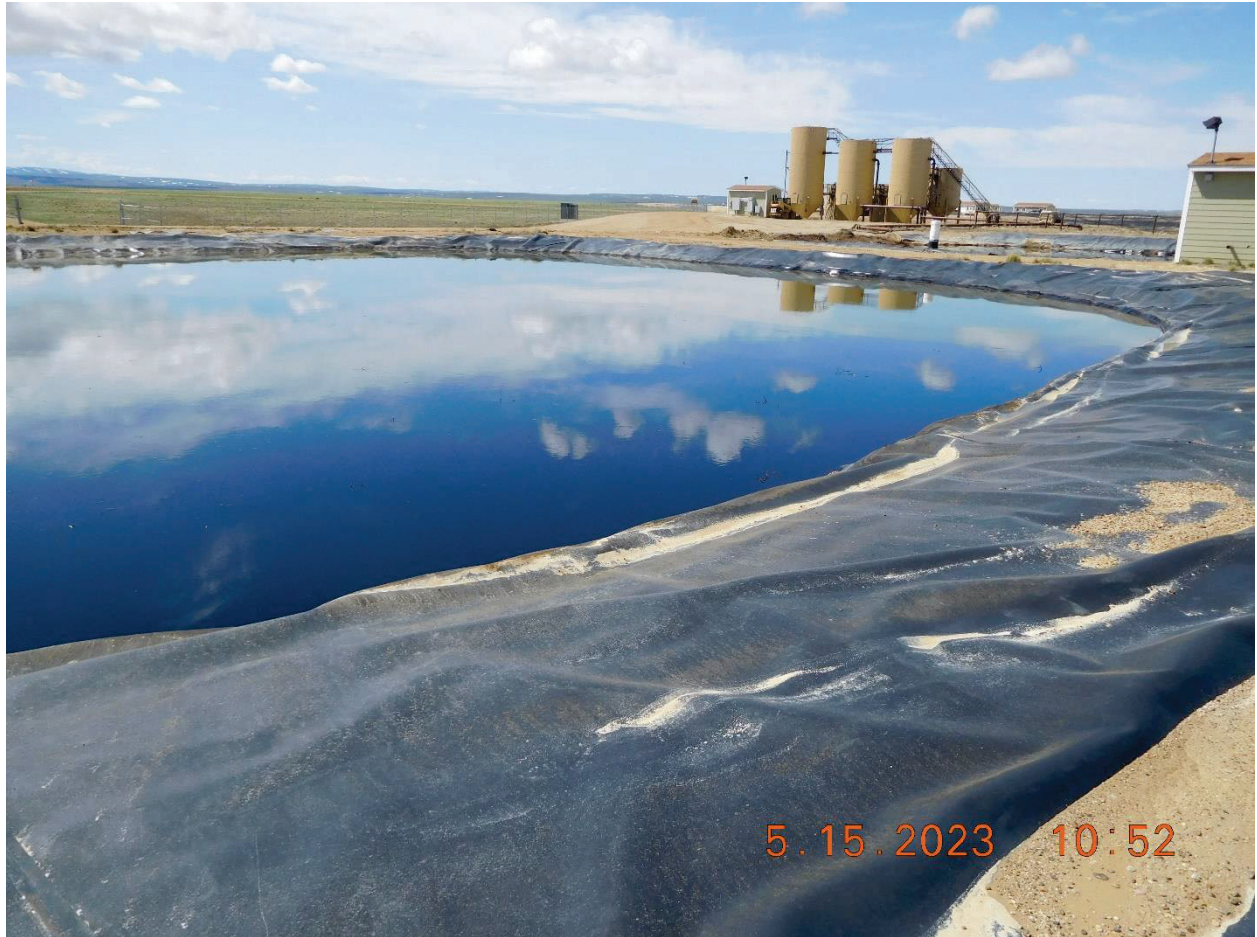
At slop pit 3, I observed that approximately 50% of the surface was covered in floating oil and that it was not netted.

Photo 1988: DSCN1988.jpg – photo of slop/skim pit 3, with oil on 50% of the surface.

Photo 1989: DSCN1989.jpg – photo of the same area shown in photo 1988, panned right.

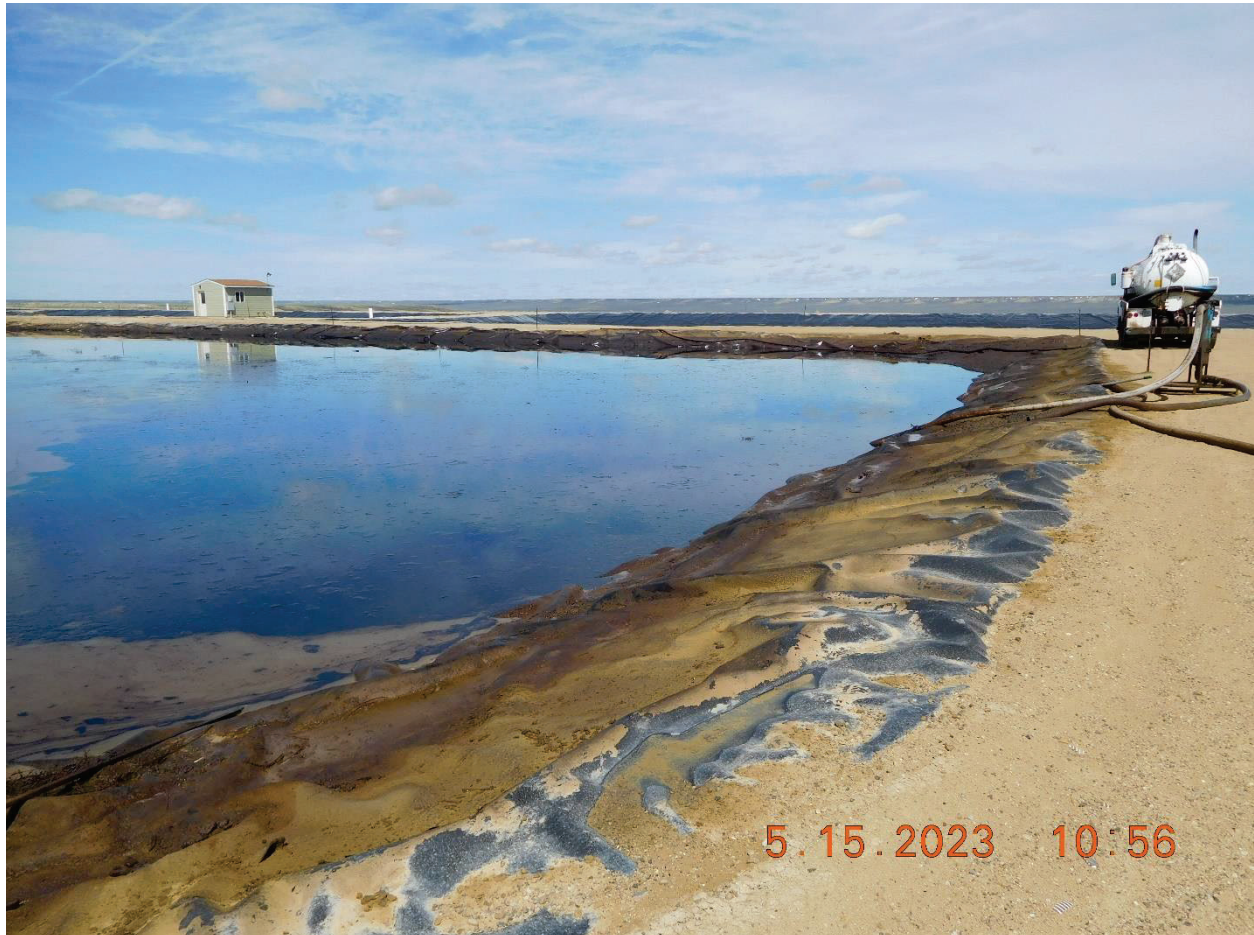
On evaporation pond 8, approximately 70% of the pond surface was covered with a layer of floating oil. See Attachment 2 – Photo Log, photos 1990-1995. I observed an object in the pond that could potentially have been a bird carcass but was unable to confirm.

Photo 1990: DSCN1990.jpg – photo of evaporation pond 8, with oil on approximately 70% of the surface. Photo taken from the southeast corner of the pond facing northwest.

Photo 1991: DSCN1991.jpg – photo of the same area shown in photo 1990, panned left.

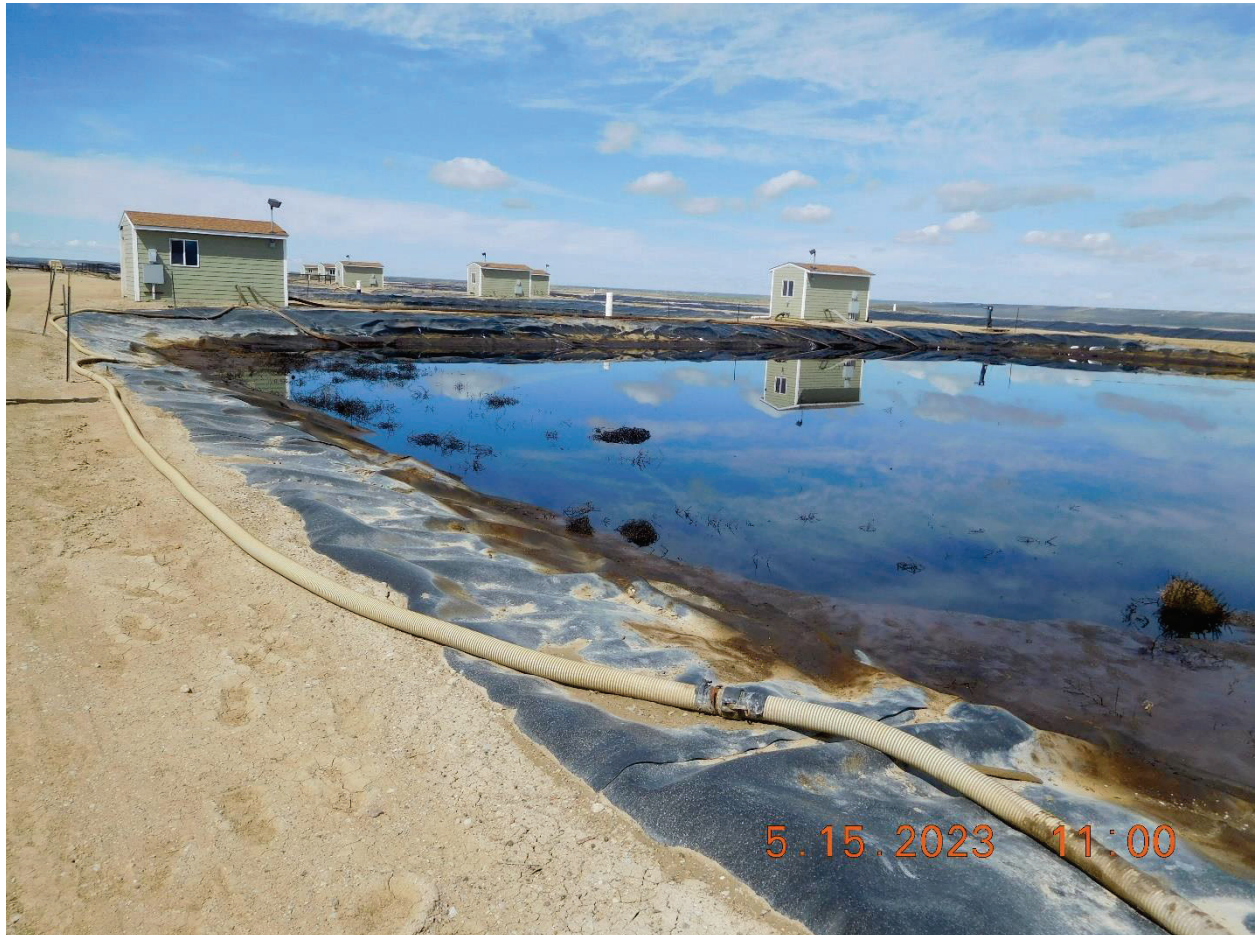
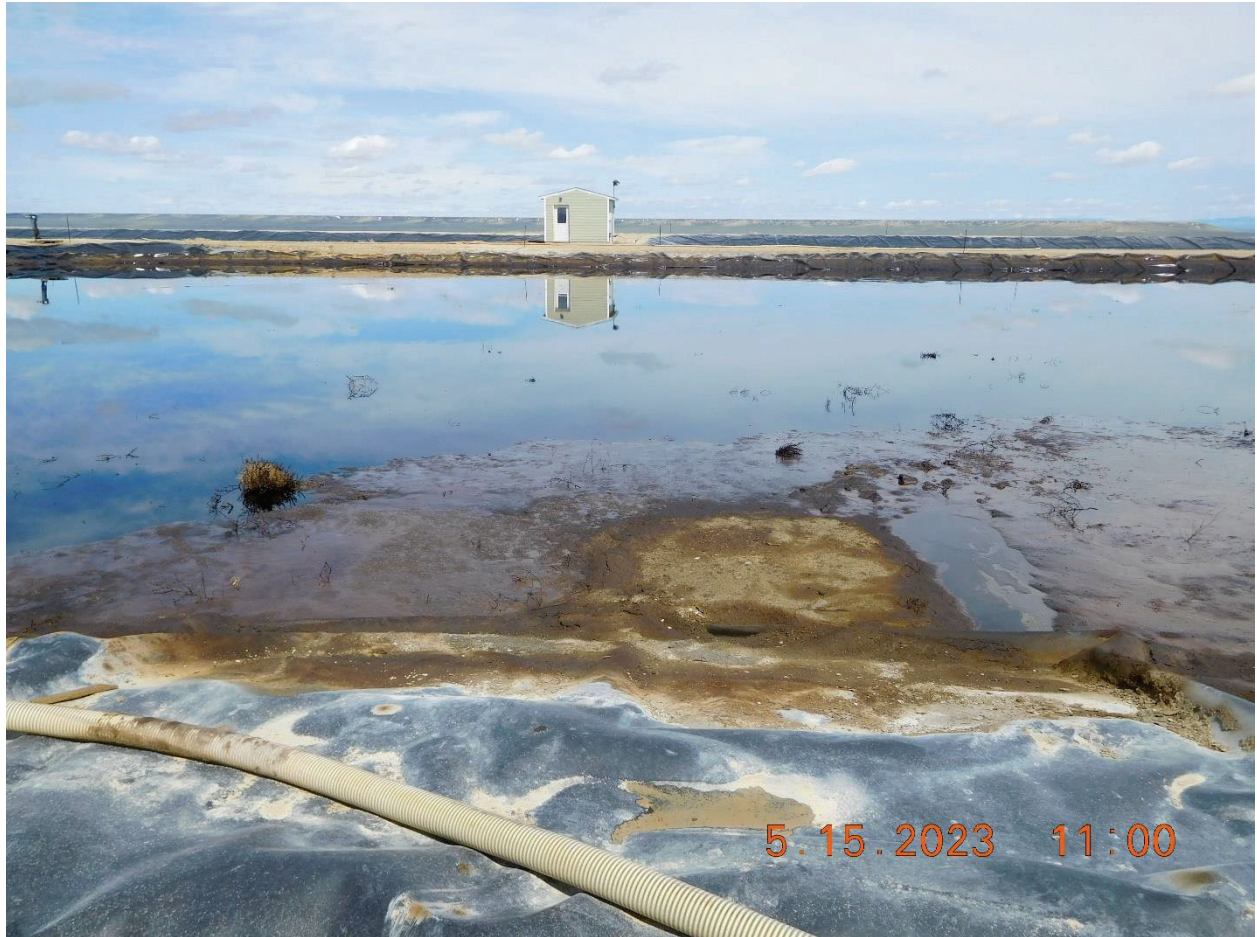
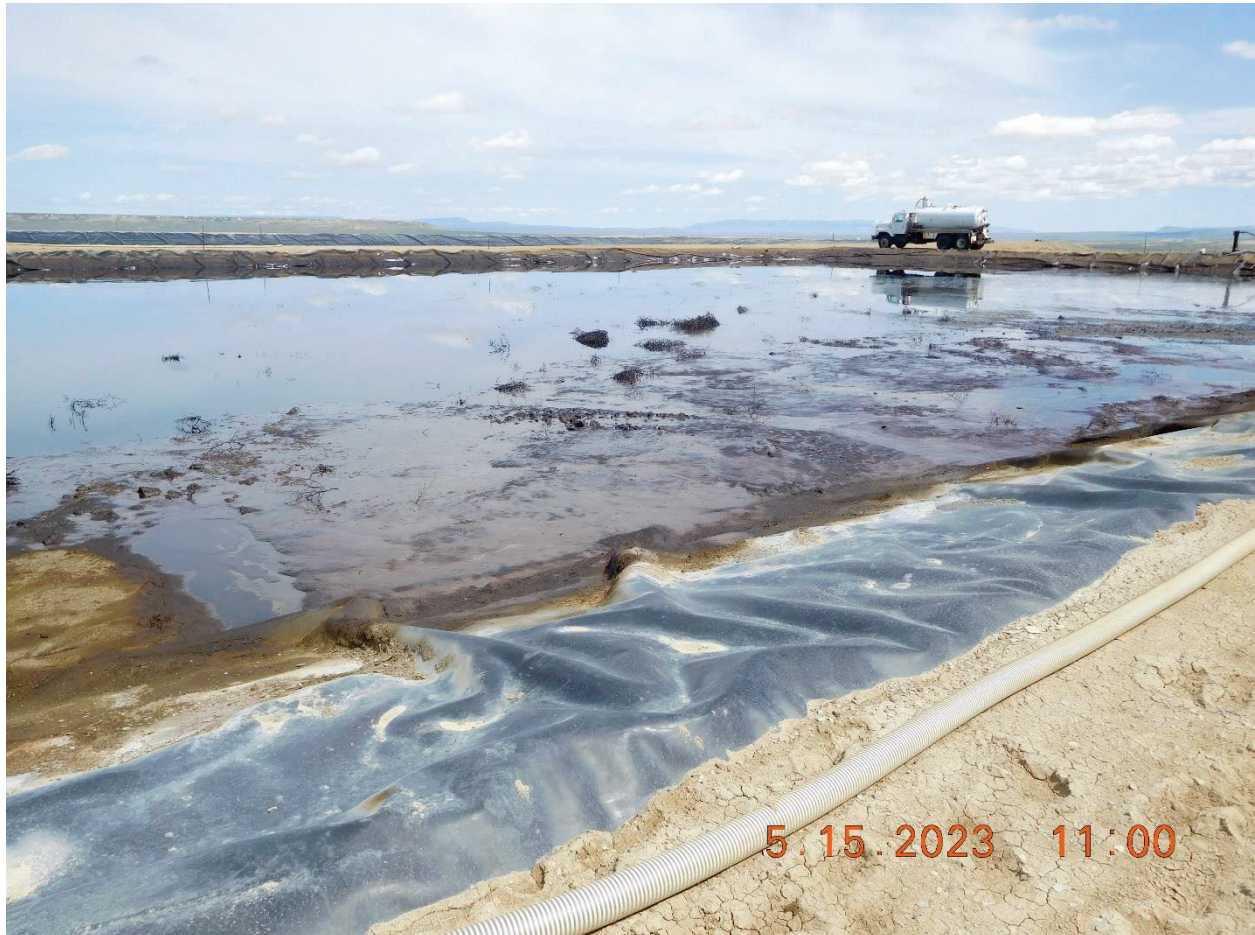
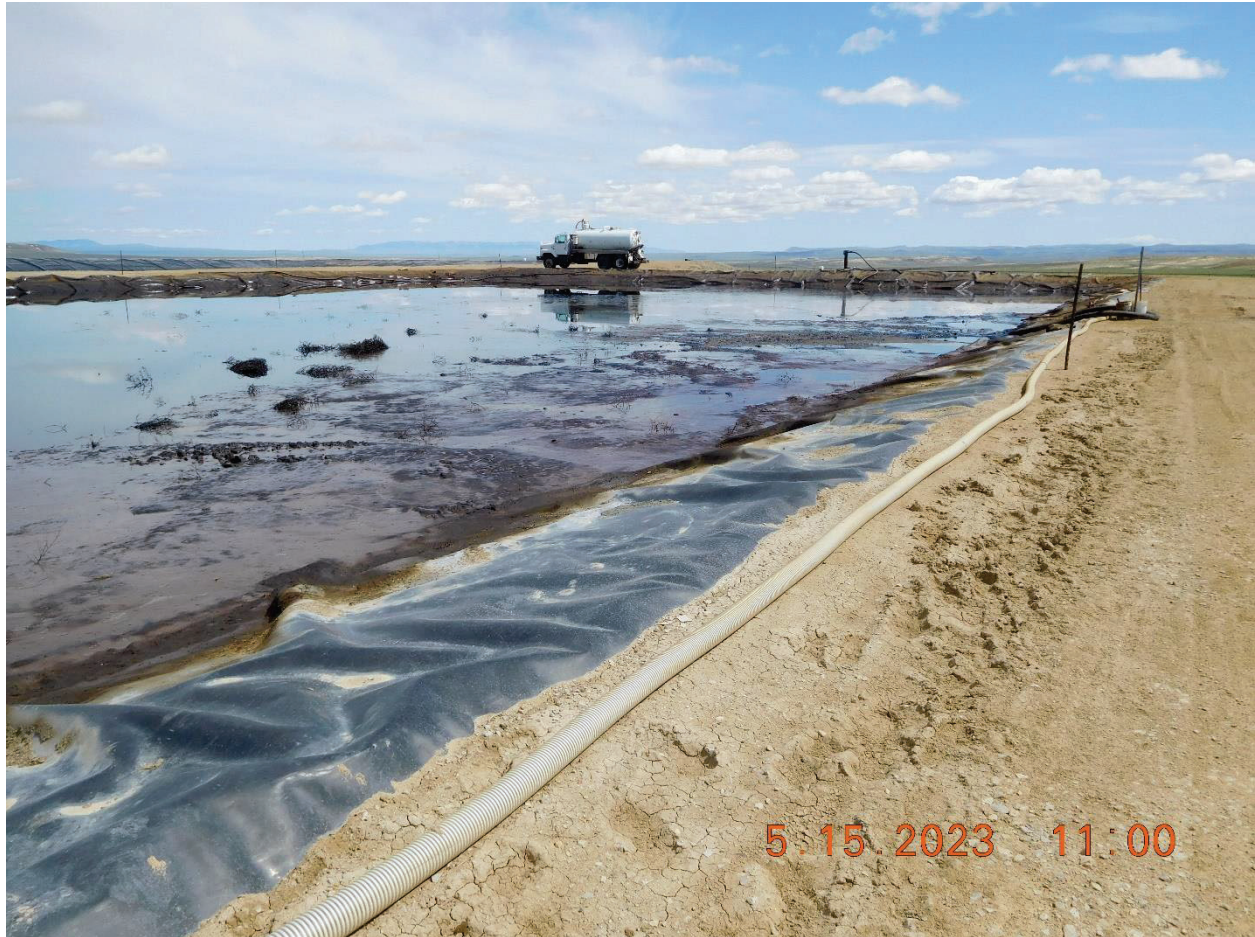
Photo 1992: DSCN1992.jpg – photo of evaporation pond 8 taken near the center of the pond on the south side facing west.

Photo 1993: DSCN1993.jpg – photo of the same area shown in photo 1992, panned right.

Photo 1994: DSCN1994.jpg – photo of the same area shown in photos 1992 and 1993, panned right.

Photo 1995 DSCN1995.jpg – photo of the same area shown in photos 1992-1994, panned right.
