**Inspection Report Addendum for Well: MT20330-00640**  
**Inspection Date: 10/23/2023**

| <b>U.S. Environmental Protection Agency</b><br><b>Region 8</b> | | <b>UIC PHOTOGRAPHIC LOG</b> | |
| <b>Facility Location:</b><br>MT20330-00640 (Blackfeet 4), Glacier County, UT | | <b>Photographer:</b><br>Gary Wang | <b>Camera:</b><br>Ricoh WG-5 |

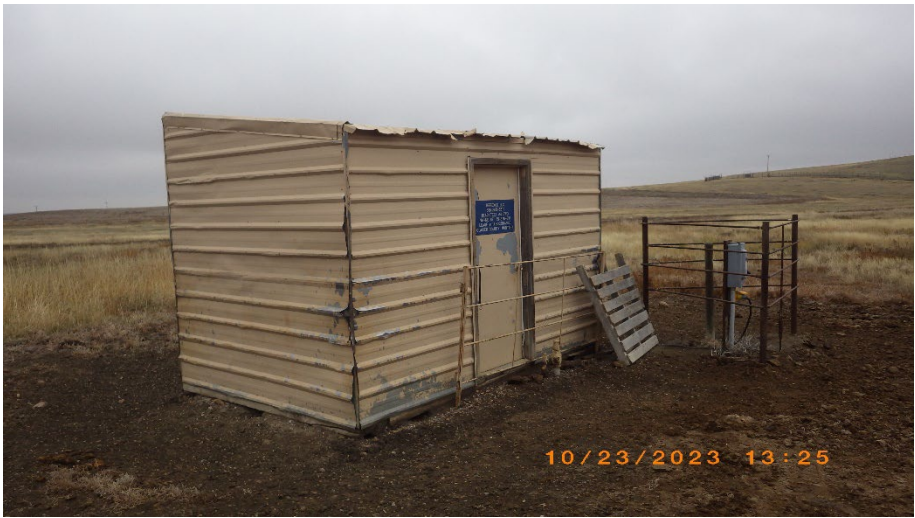
| <b>Photo No.</b><br>1 of 12 | <b>Time:</b><br>1:25 pm | | |

| <b>Photo Description:</b><br>Blackfeet 4 injection well shed | | | |

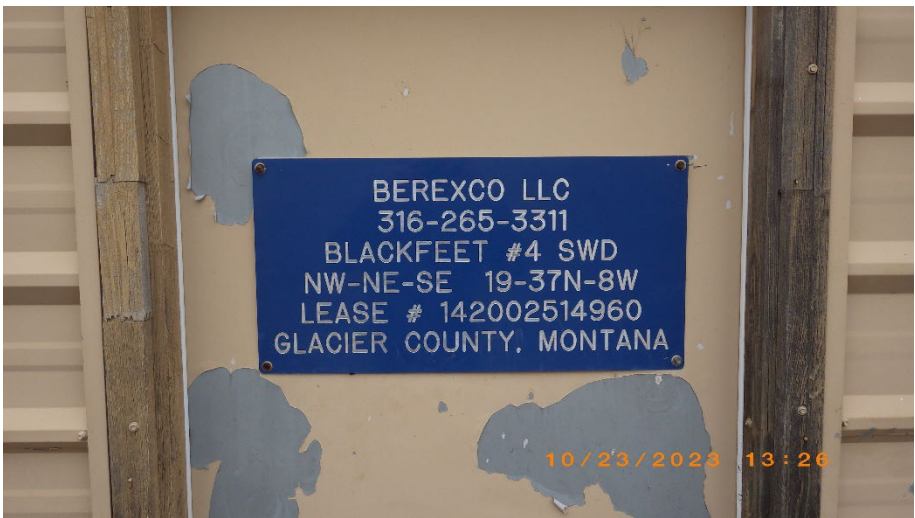
| <b>Photo No.</b><br>2 of 12 | <b>Time:</b><br>1:26 pm | | |

| <b>Photo Description:</b><br>Well sign information at injection well | | | |

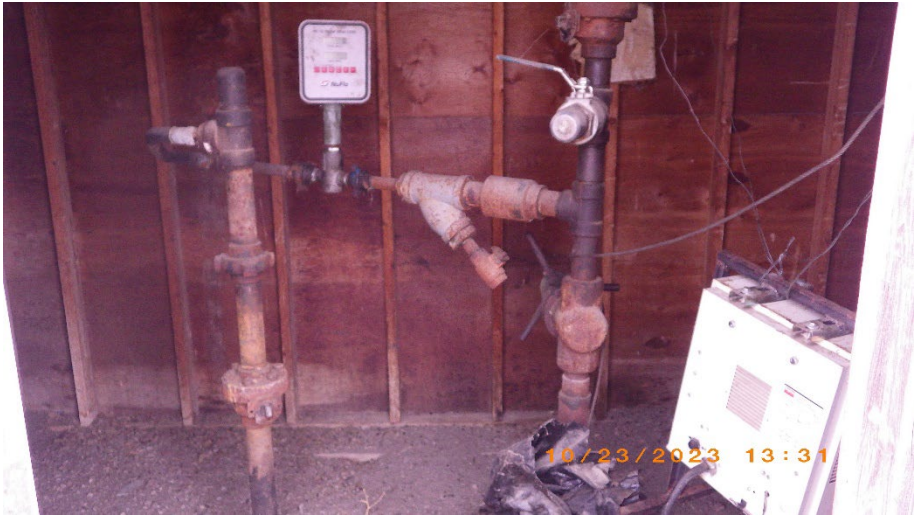
| <b>Photo Description:</b><br><p>Wellhead showing flow line coming in from left. The operator's pressure gauge on the well's tubing is out of frame. The stem valve is shown to be in the open position verifying communication with the tubing pressure gauge.</p> <p>Well has been shut in since July 2021.</p> | | | |

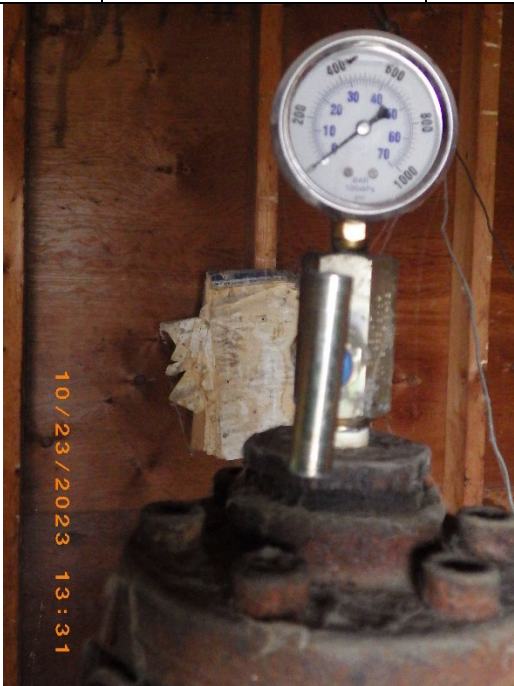
| <b>Photo Description:</b><br><p>Operator's analog pressure gauge on the wellhead tubing read 0 psi, on a 1000 psi range gauge.</p> <p>MAIP for the well is 1000 psi.</p> | | | |

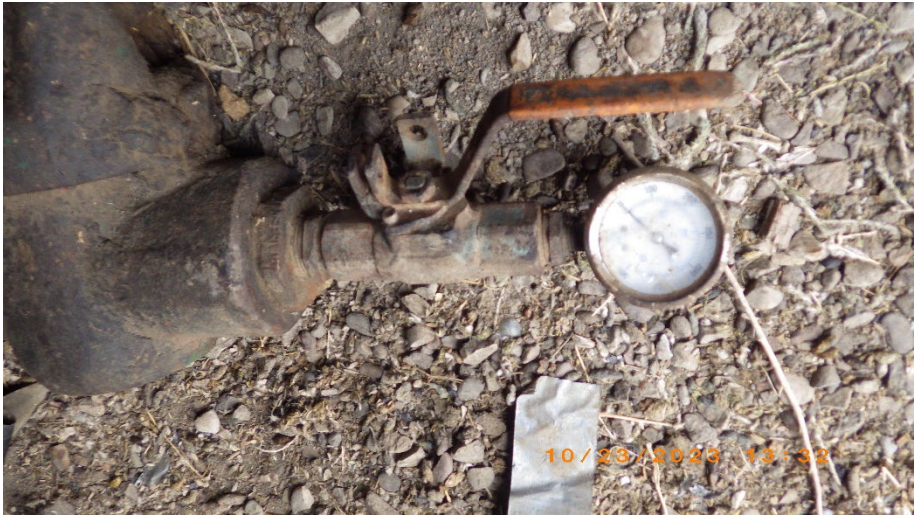
| <b>Photo Description:</b><br><p>Operator's analog pressure gauge on the tubing-casing annulus read 0 psi on a 600-psi range gauge.</p> <p>Valve is in the open position, showing communicating between annulus and pressure gauge</p> | | | |

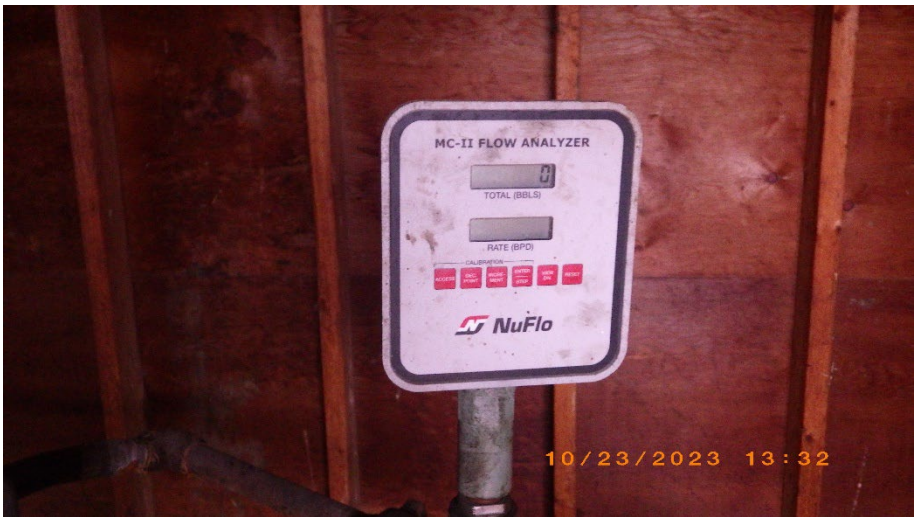
| <b>Photo Description:</b><br><p>Well totalizer flow meter read no rate (blank display) and volume of 0 bbl.</p> <p>Operator indicated that the battery for the flow analyzer was recently replaced, and thus reset the total flow to 0 bbl.</p> | | | |

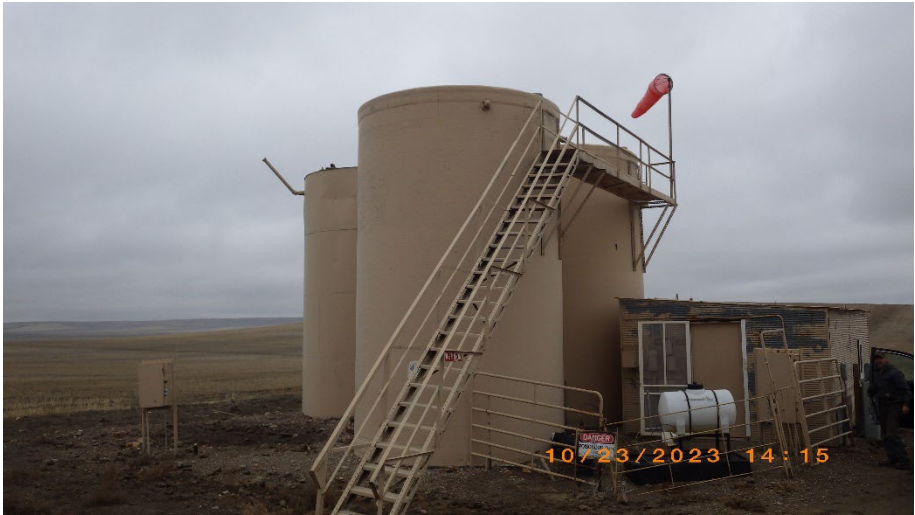
| <b>Photo No.</b><br>7 of 12 | <b>Time:</b><br>2:15 pm | | |

| <b>Photo Description:</b><br>Pump facility that feeds injection fluids to the Blackfeet 4 well. | | | |

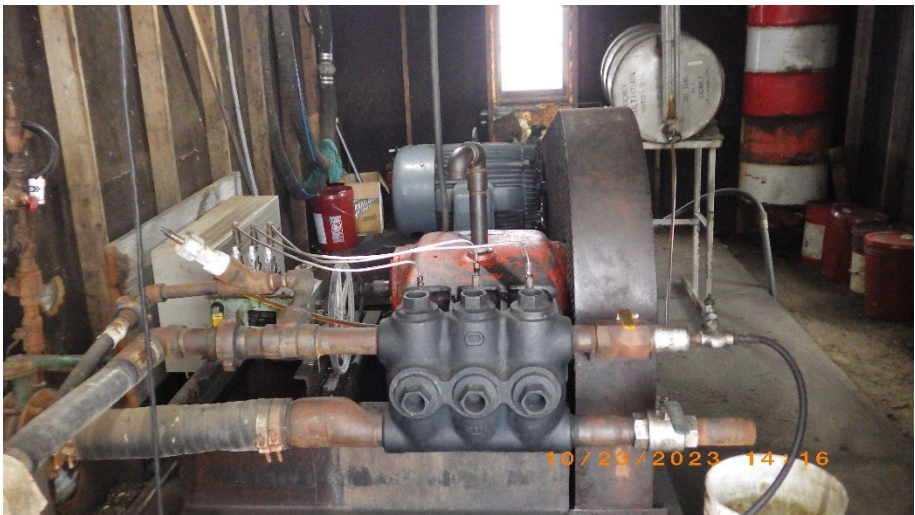
| <b>Photo No.</b><br>8 of 12 | <b>Time:</b><br>2:17pm | | |

| <b>Photo Description:</b><br>Pump in pumphouse was not running during inspection. | | | |

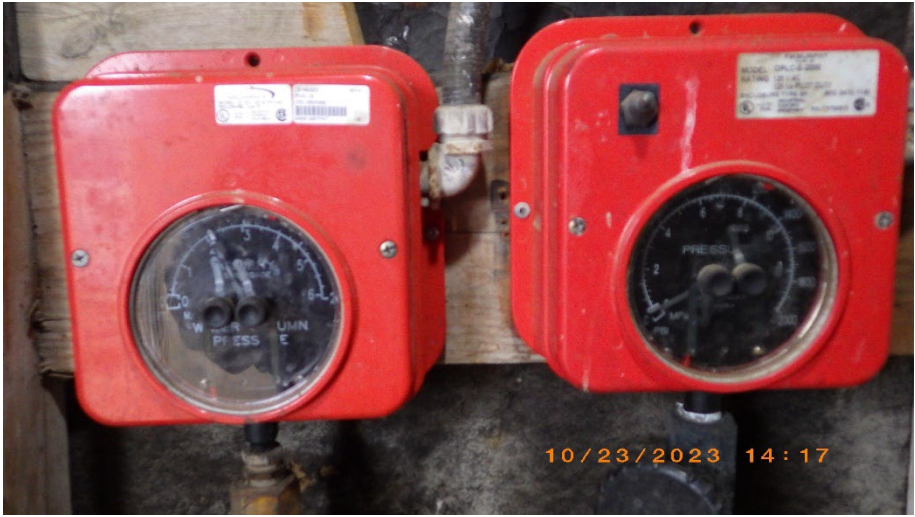
| <b>Photo Description:</b><br>Murphy switches observed at the pump house for the pump. The left murphy switch sets water column pressure. The right murphy switch sets pump pressure. | | | |

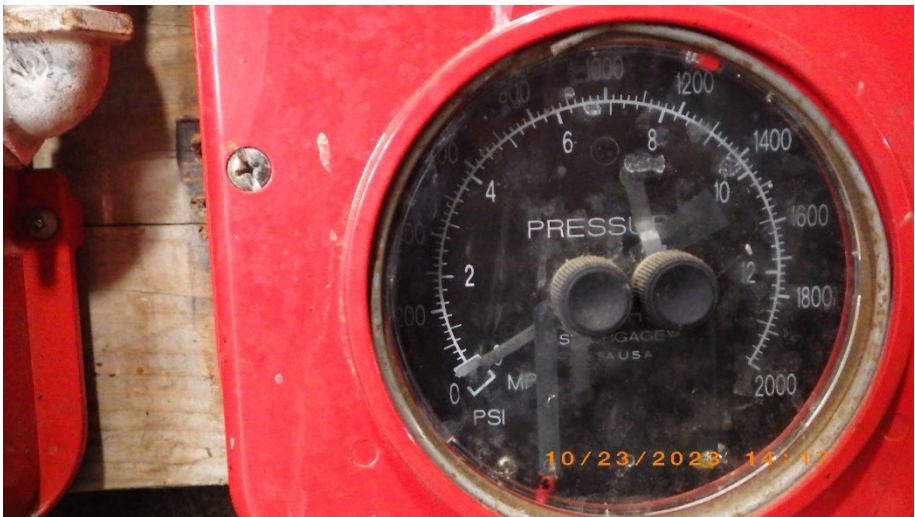
| <b>Photo No.</b><br>10 of 12 | <b>Time:</b><br>2:17 pm | | |

| <b>Photo Description:</b><br>The right murphy in pumphouse, switch sets pump pressure is observed to have shutoff pin set at approximately 1000 psi. | | | |

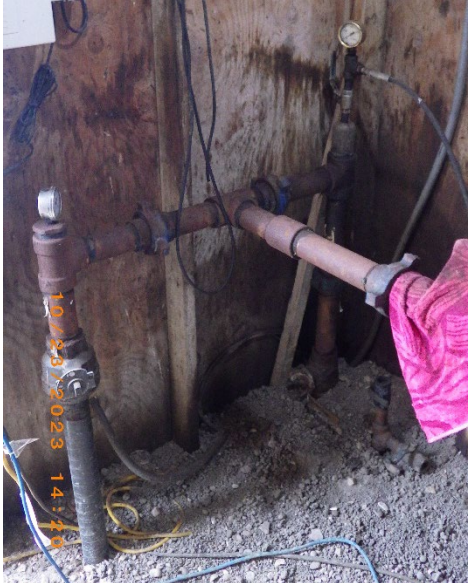
| <b>Photo Description:</b><br><p>The flow line from pump, coming in from the right side of the frame, feeds both of Berexco's Blackfeet 4 (MT20330-00640) well and Tribal A 30-6 (MT21109-08235) well. The flowline that splits right at the T-junction flows towards the Blackfeet 4 well.</p> <p>The handle valve at bottom of the right flowline, by the ground, shows that the flowline to Blackfeet 4 is in the shut position.</p> | | | |

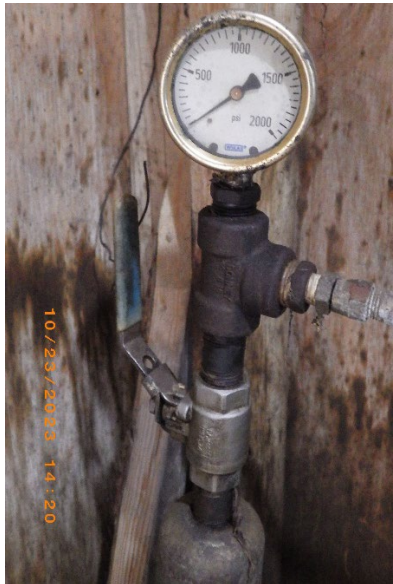
| <b>Photo No.</b><br>12 of 12 | <b>Time:</b><br>2:20 pm | | |

| <b>Photo Description:</b><br><p>The analog pressure gauge for the flowline towards Blackfeet 4 read 0 psi on a 2000 psi range gauge.</p> | | | |
