**Region 6 Enforcement and Compliance Assurance Division  
INSPECTION REPORT**

| Regulatory Program(s) | Clean Air Act (CAA) § 112(r) and 40 Code of Federal Regulations (C.F.R.)<br>Part 68 Chemical Accident Risk Management Plan (RMP) | |
| Company Name: | <b>WATCO/South Kansas &amp; Oklahoma Railroad, LLC (SKOL)</b> | |
| Facility Name: | Tulsa SKOL Location | |

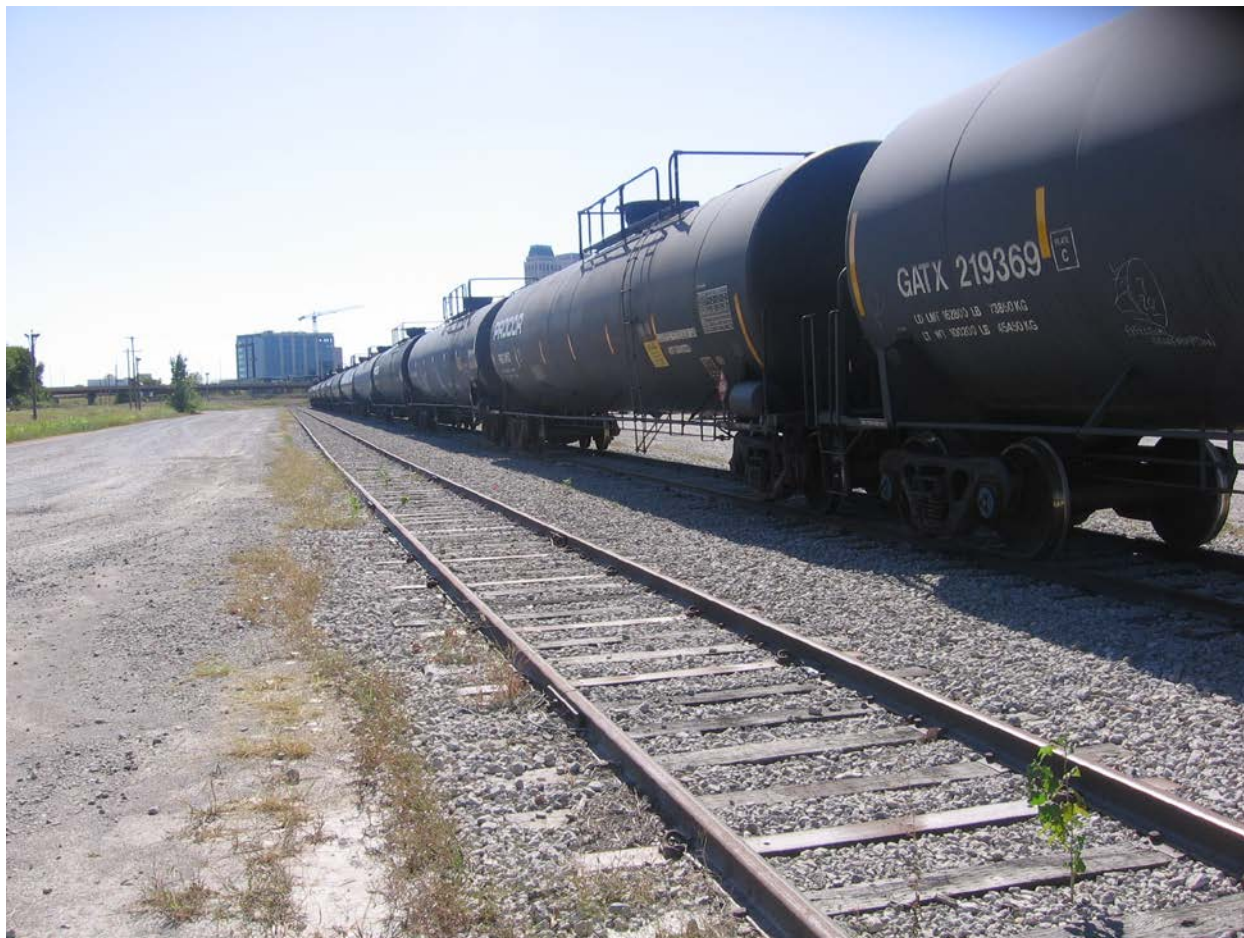
Photo No. 1

I conducted a walk-through of the facility, accompanied by facility representatives to observe the facility process, equipment, and railcar operations. I observed 13 railcars (Photo No. 1) on one railroad track that were connected to each other with rail car couplings (Photo No. 2). I observed the handling and unloading of butane from three non-moving/static railcars, which were not connected to a locomotive, onto to three non-moving/static tanker trucks (Photo No. 3).

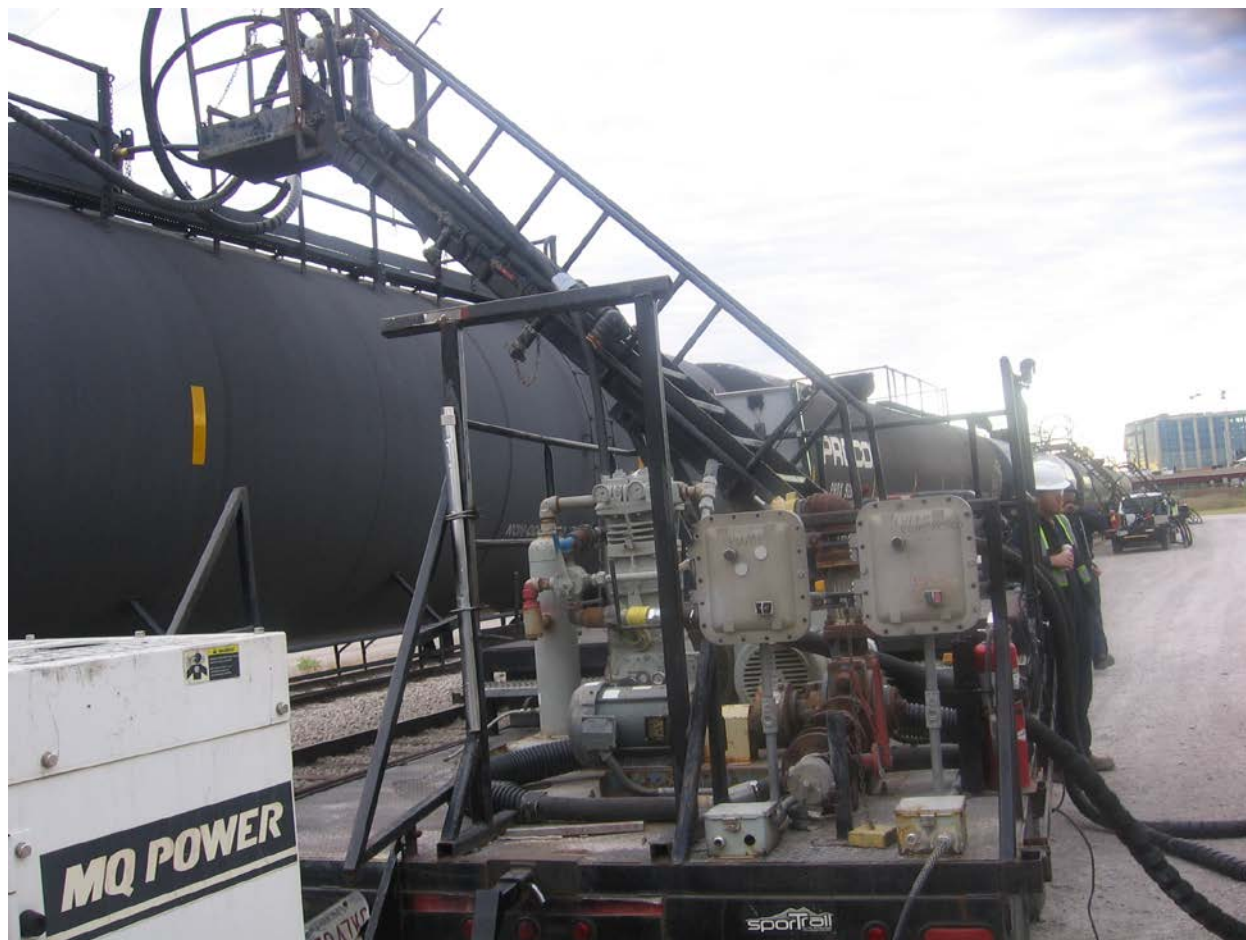
Photo No. 4

During unloading, a mobile generator was used to operate a compressor with a hose connected to the railcar. Facility representatives explained this procedure was to compress vapor in the railcar to assist in pushing the butane out of the railcar into the tanker truck (Photo Nos. 4 and 5). Hoses were connected from the railcar to the tanker truck (Photo No. 6). I observed one small thermal anomaly from a potential hydrocarbon vapor trail at a tank hatch valve connector on railcar TILX 306572 with the Forward Looking Infrared (FLIR™) Series GF320 camera (Photo No. 7). The onsite contractors tightened the connector with a wrench. I considered this action by the onsite contractors an on-the-spot correction. I observed onsite operators using soapy water solution in spray bottles to check for leaks in accordance with the facility's written standard operating procedures, a copy of which facility representatives provided.
