### Clean Air Act Inspection Report

**Inspection Type:** Partial Compliance Evaluation

**Facility Name:** R&A Auto Body

**Facility Location:** 914 Main Road; Tiverton, RI 02878

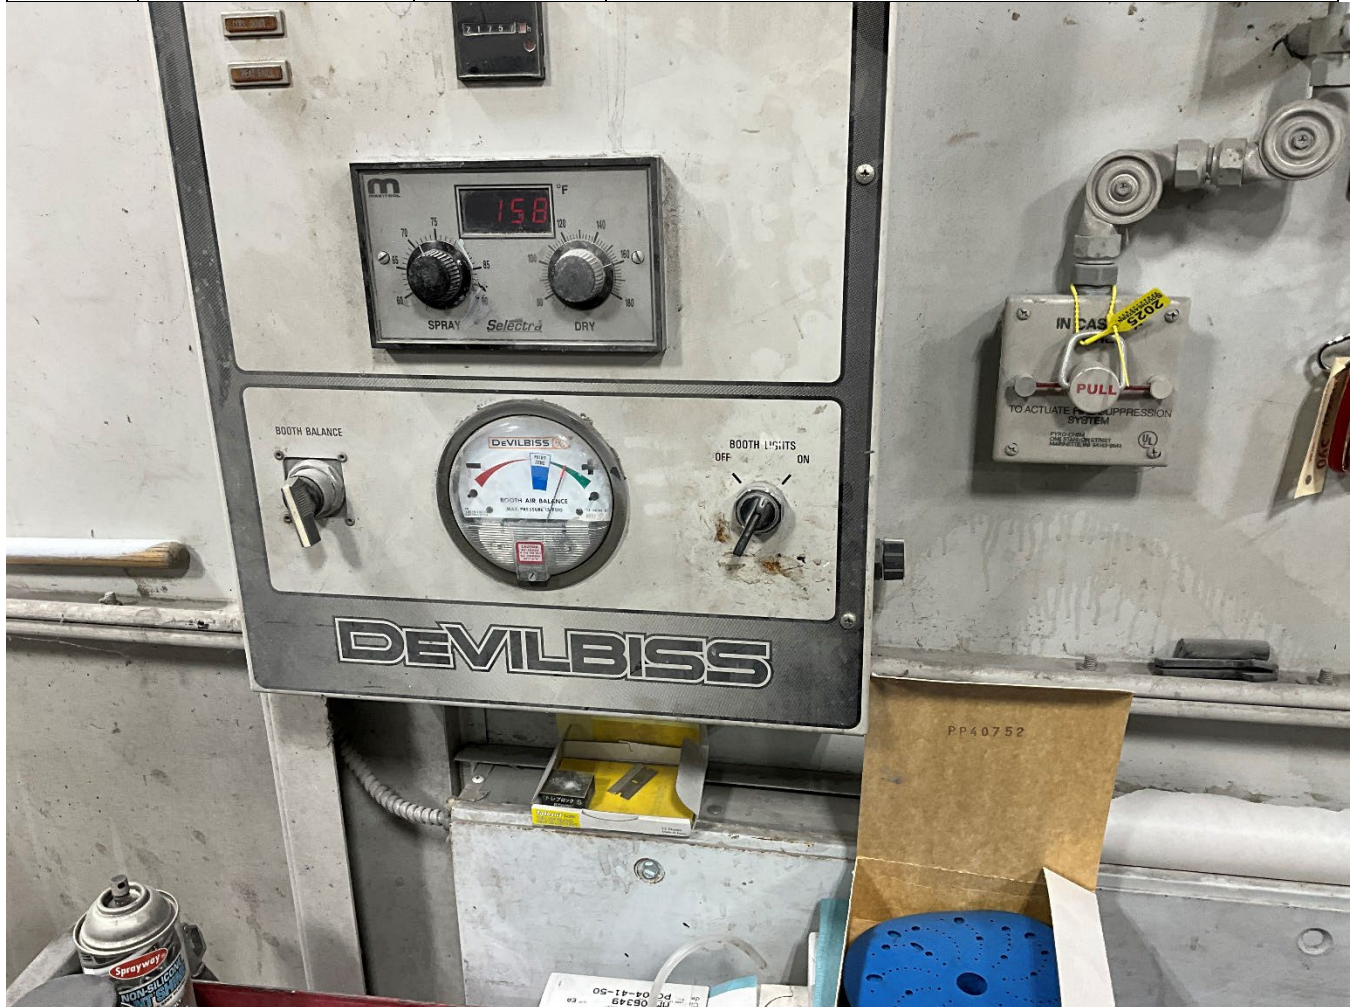
The group viewed the pressure meter on the outside of the booth (Appendix – Photo 1). The meter indicated a pressure on the positive side of the “paint zone.” Mr. Oman said that this was because the filters in the pit need to be changed. Mr. Oman said that the booth was currently being used for “baking.”

| Report Photo Number | File Name | Time Taken | Description |
|---|---|---|---|
| 1 | IMG_0103.JPG | 10:26 AM | Paint booth pressure gauge |

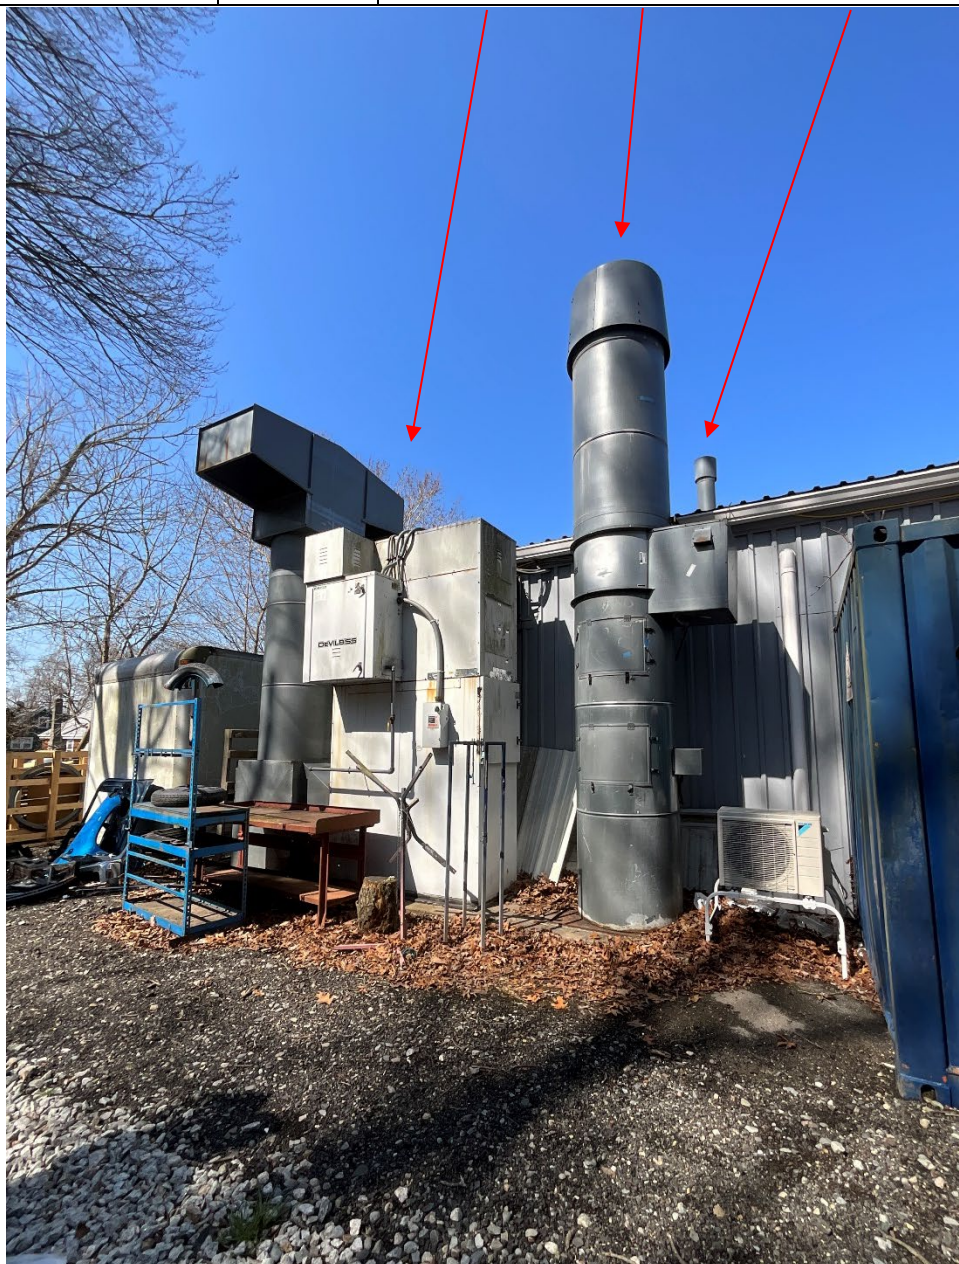
Mr. Oman said that some materials in the Air Makeup Unit are degraded and so the Unit is being replaced with similar equipment.

Mr. Oman said that the existing stack is six feet above the roof line but is being extended by an additional three feet. Mr. Oman said that the stack is being moved two to three feet so that it will be at least 25 feet from the property line.

The group visited the outdoor air handling equipment (Appendix – Photo 2). Mr. Oman described how the Air Makeup Unit pulled in air through an elevated intake, heated the air, warmed the air, and sent it into the building. Mr. Oman described how an approximately 18-inch diameter stack exhaust air that has gone through the filters in the pit below the paint booth.

In addition to the main stack, two other stacks were observed on the roof. Mr. Oman said that the stack near the main stack is connected to an outlet duct near the floor of the paint booth that does not flow through the filters. Mr. Oman said that he had never used this outlet duct and did not know what purpose it may have once served. Mr. Oman said that a damper located in the duct prevented discharges to the stack. Mr. Oman said that the second other stack provided exhaust from the paint room.

| Report Photo Number | File Name | Time Taken | Description |
|---|---|---|---|
| 2 | IMG_0108.JPG | 10:49 AM | Air Makeup Unit, main stack, and bypass stack |
