## **RCRA Inspection Report**

Diversified Structural Composites  
1512 Interstate Drive  
Erlanger, Kentucky 41018  
EPA ID Number: KYD000051573

September 16, 2021 8:05 a.m.-12:00 pm

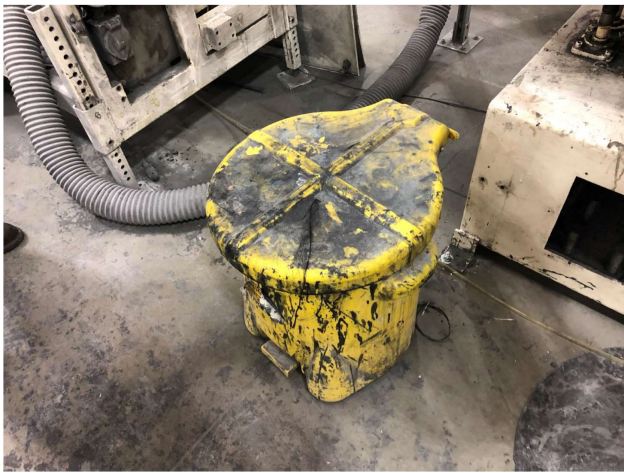
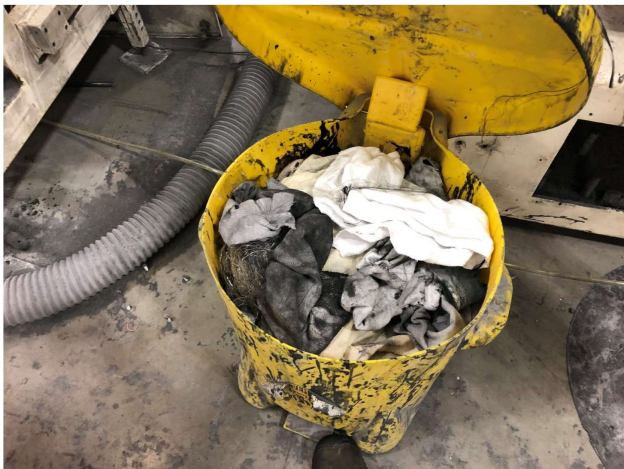
DSC operates twenty (20) production lines; four are new lines. On the day of the inspection, the inspection team noted 20-gallon flip-top yellow containers and open top 40-gallon lined black containers on the production lines (Photos 1-3). The facility representative stated that the yellow containers were for oily waste rags and the black container was accumulating trash including packaging material. There were no issues noted in the production areas.

Photo 1: Oily Rag accumulation container.

Photo 2: Oily Rag accumulation container.

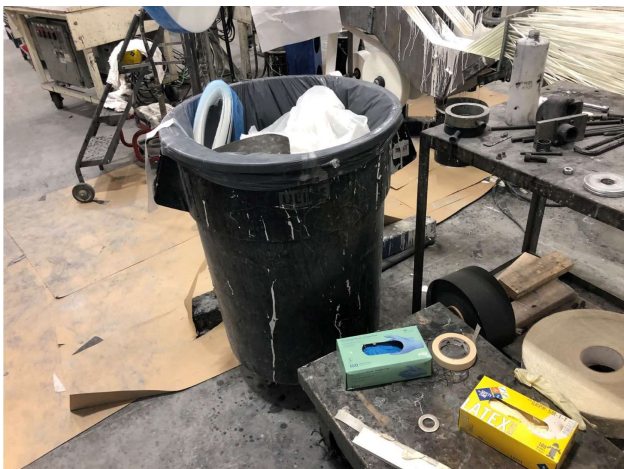
Photo 3: Trash container on manufacturing line.

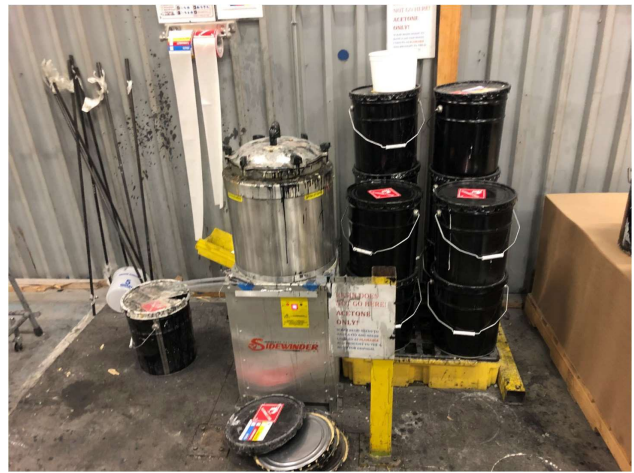
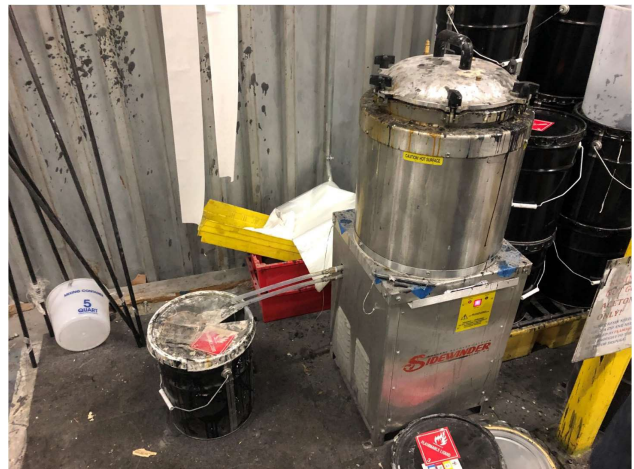
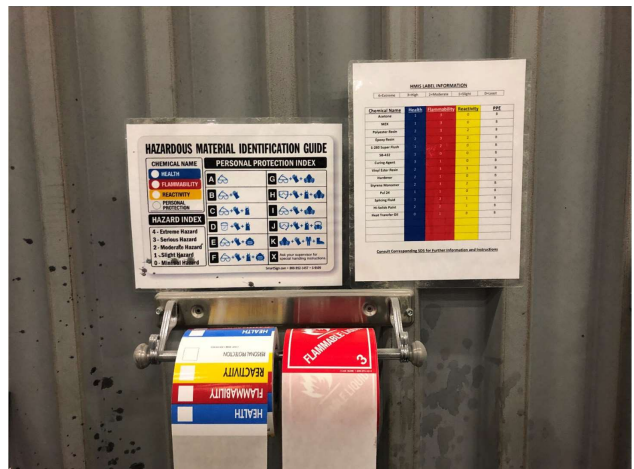
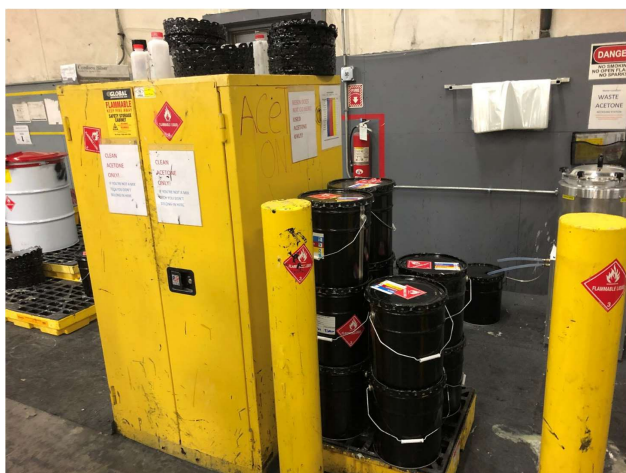
DSC was operating two Sidewinder Model M-2 solvent recovery system units (Photos 4-9). These units recover acetone generated on the production lines and accumulated in 5-gallon black metal buckets. This waste stream is being managed as a hazardous secondary material destined for reclamation onsite. DSC notified that they manage hazardous secondary material on their annual notification to KDEP. A facility representative stated that the recovered acetone is reused in the process instead of purchasing new acetone. At the time of the inspection, there were ten 5-gallon black containers waiting to be distilled at unit 1 (Photo 4). This area showed some signs of un-remediated spills of waste (Photos 5-6); the inspection team considered this to be an area of concern. Spills of hazardous secondary material should be managed as spills of hazardous waste. There were ten 5-gallon black metal buckets awaiting processing at unit 2 (Photos 8-9 and 28).

Photo 4: Solvent Recovery System 1 and staged 5-gallon containers of Acetone.

Photo 5: Solvent Recovery System 1.

Photo 6: Solvent Recovery System 1.

Photo 7: Solvent Recovery System 1.

Photo 9: Solvent Recovery System 1.

**Pursuant to 401 KAR 39:080 Section 1(1) [40 C.F.R. § 262.17(a)(6)], which incorporates 401 KAR 39:080 Section 1(1) [40 C.F.R. § 262.251], and is a condition of the LQG Permit Exemption, a generator is required to maintain and operate its facility to minimize the possibility of a fire, explosion, or any unplanned sudden or non-sudden release of hazardous waste or hazardous waste constituents to air, soil, or surface water which could threaten human health or the environment.**

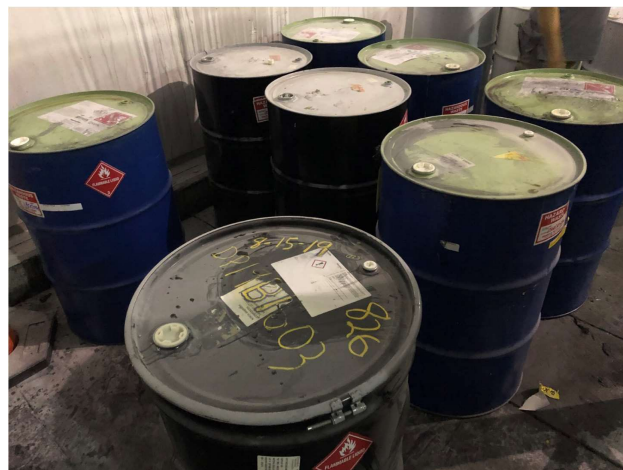
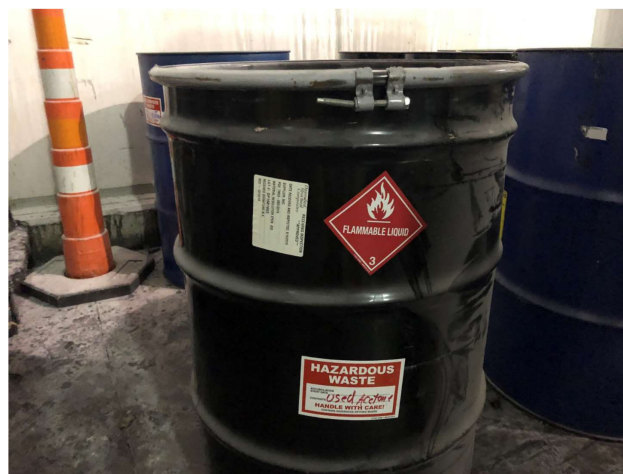
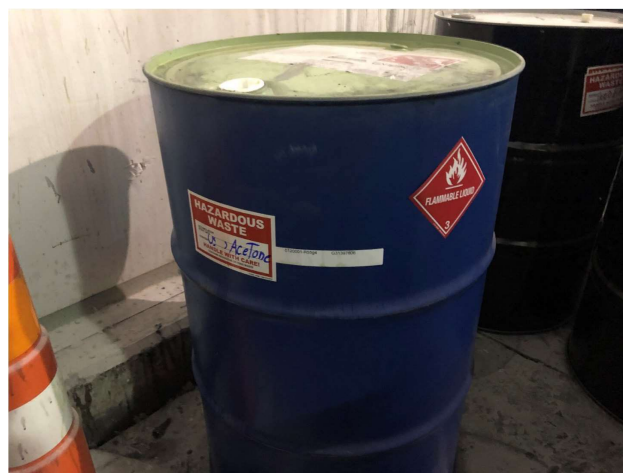
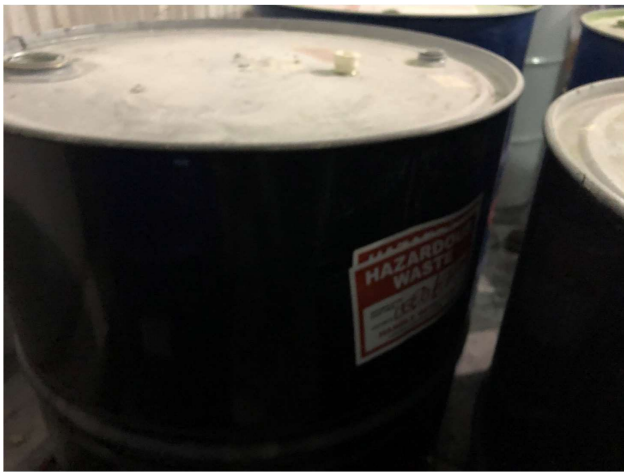
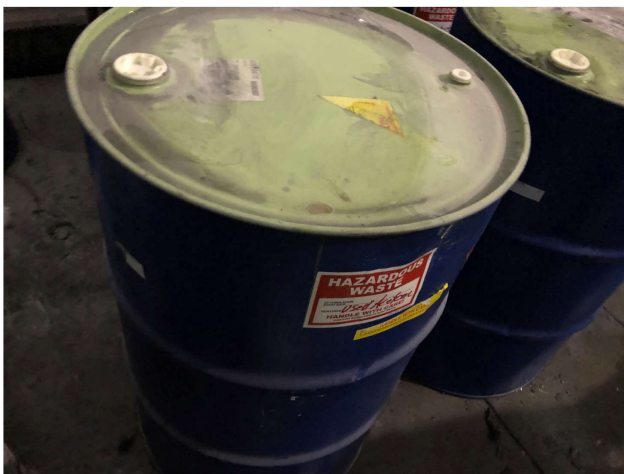
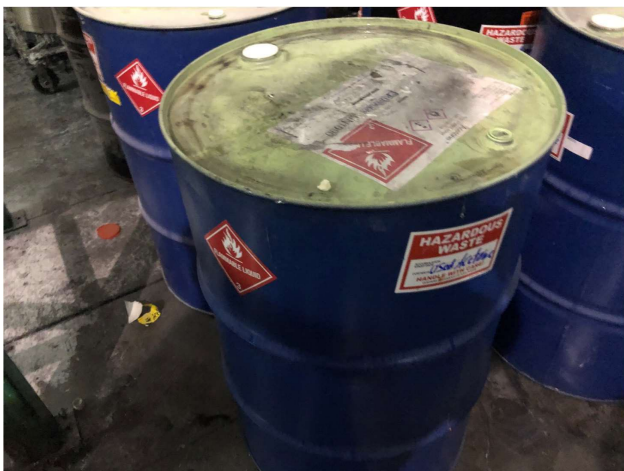
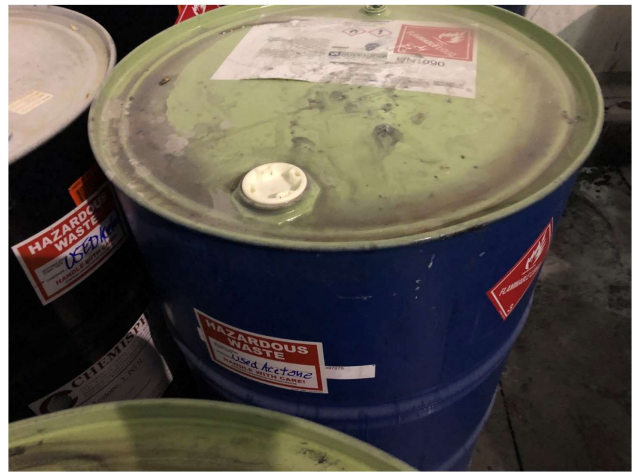
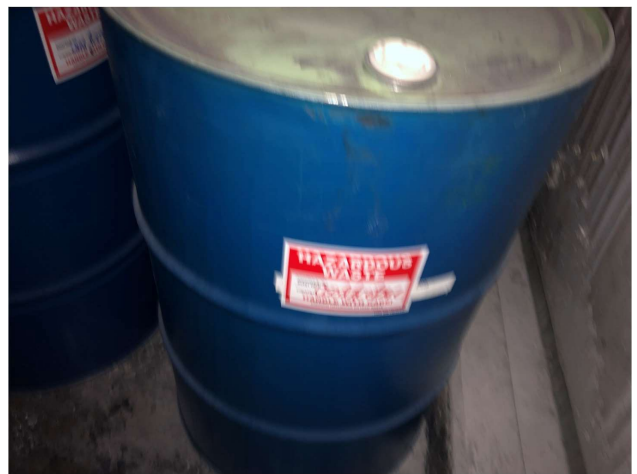
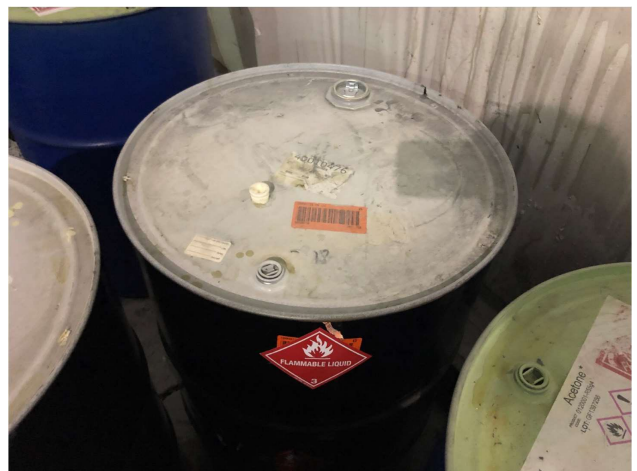
DSC formulates batch chemicals in the mix room as requested by customers. DSC was operating a CAA which was storing eight 55-gallon metal containers (Photos 10-24). These containers did not have adequate aisle space between the containers. These containers were not labeled with accumulation start dates. This is a repeat deficiency. A safety shower and fire extinguisher were located near the CAA (Photos 19-20). The spill kit for the mix room was located on the production floor just outside the mix room door (Photo 21). Facility personnel use cell phones as the main communication device in this area. The inspection team recommends that a spill kit be located inside the mix room to have adequate emergency equipment on hand. The Emergency Contact List, Spill/Release Reporting Requirements, and the Emergency Evacuation Plan were posted near the CAA (Photos 22-24).

Photo 10: Mix Room CAA.

**Pursuant to 401 KAR 39:080 Section 1(1) [40 C.F.R. § 262.17(a)(6)], which incorporates 401 KAR 39:080 Section 1(1) [40 C.F.R. § 262.255], and is a condition of the LQG Permit Exemption, a generator is required to maintain aisle space to allow the unobstructed movement of personnel, fire protection equipment, spill control equipment, and decontamination equipment to any area of facility operation in an emergency, unless aisle space is not needed for any of these purposes.**

**Pursuant to 401 KAR 39:080 Section 1(1) [40 C.F.R. § 262.17(a)(5)(i)(C)] Labeling and marking of containers and tanks, which is a condition of the LQG Permit Exemption, an LQG must mark or label its containers with the following: (C) the date upon which each period of accumulation begins clearly visible for inspection on each container.**

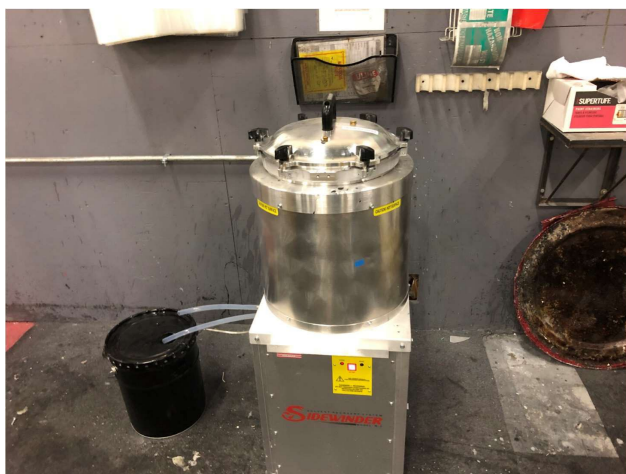
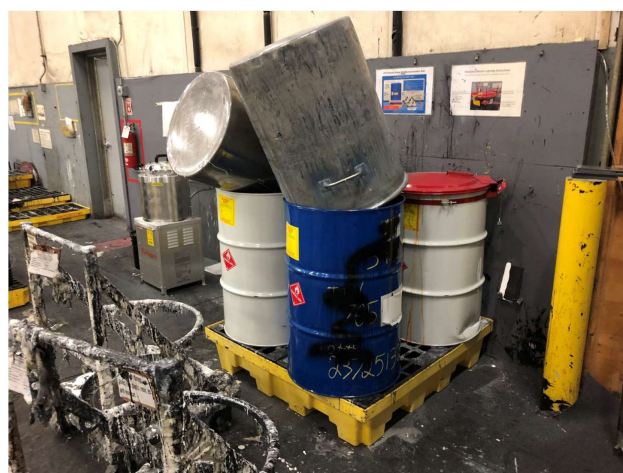
Photo 8: Solvent Recovery System 2.

Photo 28: Solvent Recovery System 2 and Pots draining into containers.

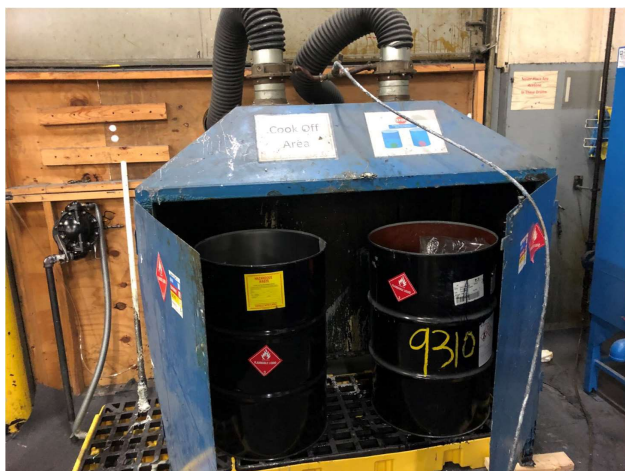
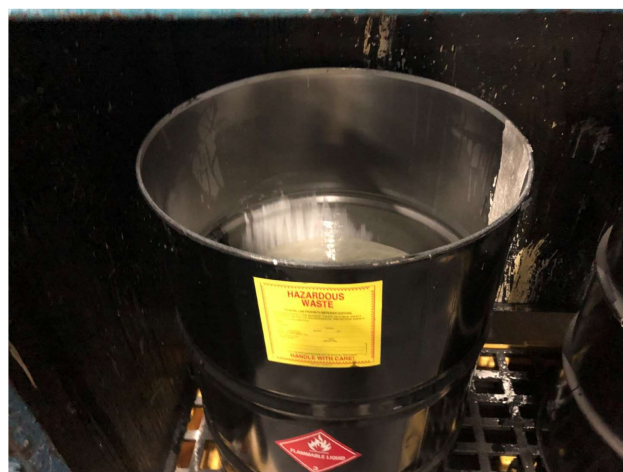
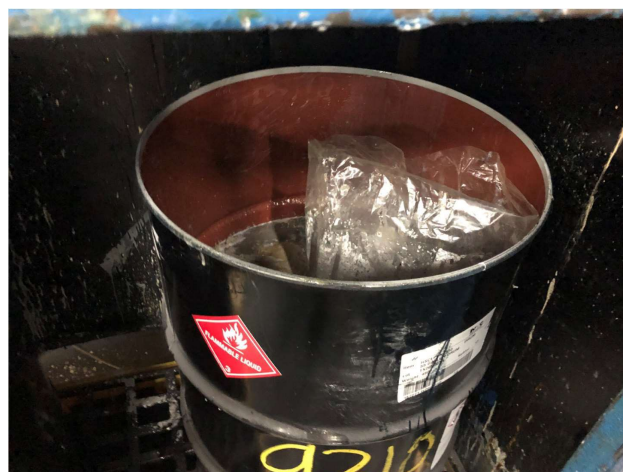
DSC operates one blue box cook off area to allow waste resins to cure. The emissions from this curing process are directed outside the building (Photo 25-27). There is no heat or catalyst added to these containers to assist in the curing process which takes between a few days and a couple of weeks. Adjacent to this area the inspection team noted four containers on a yellow spill pallet (Photo 28-30). Two white metal containers with red flip top lids were labeled, closed, and in good condition. The other two containers were open, labeled, and in good condition. There were production pots upended on top of these two open containers to drain out the wastes from the pots. It was unclear how long these pots take to drain into the open containers. Facility representatives stated that these pots would be in high use throughout the facility and would not be here long. However, there were no workers in this area monitoring the transfer of the wastes for the duration of the inspection. This material must be managed as a hazardous waste until it has completed the curing process and has completely solidified. These containers were not labeled with accumulation start dates. There was a third white container with a red lid with resin curing inside. This container was not labeled with an accumulation start date (Photo 32). Postings for container labeling and SOPs were also observed (Photos 31 and 33-36).

Photo 25: Cook Off Area.

Photo 26: Cook Off Area container.

Photo 27: Cook Off Area container.

**Pursuant to 401 KAR 39:080 Section 1(1) [40 C.F.R. § 262.17(a)(5)(i)(C)] Labeling and marking of containers and tanks, which is a condition of the LQG Permit Exemption, an LQG must mark or label its containers with the following: (C) the date upon which each period of accumulation begins clearly visible for inspection on each container.**

**Pursuant to 401 KAR 39:080 Section 1(1) [40 C.F.R. § 262.17(a)(1)(iv)], which is a condition of the LQG Permit Exemption, (A) a container holding hazardous waste must always be closed during accumulation, except when it is necessary to add or remove waste; and (B) A container holding hazardous waste must not be opened, handled, or stored in a manner that may rupture the container or cause it to leak.**

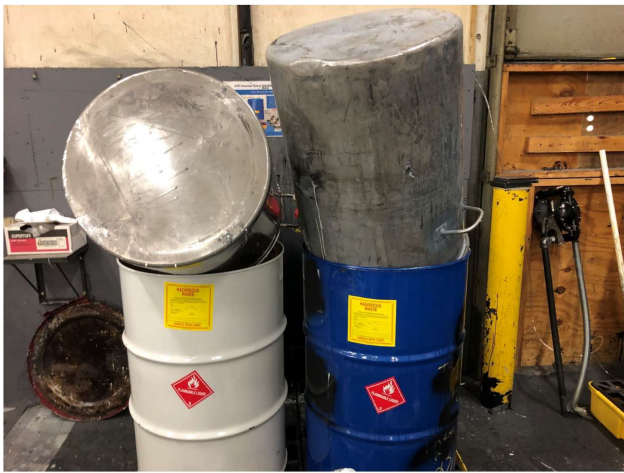
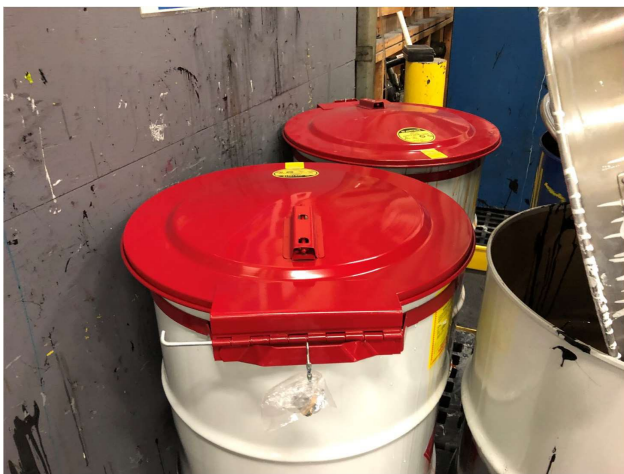
Photo 29: Pots draining into containers.

Photo 30: Waste Gel containers.

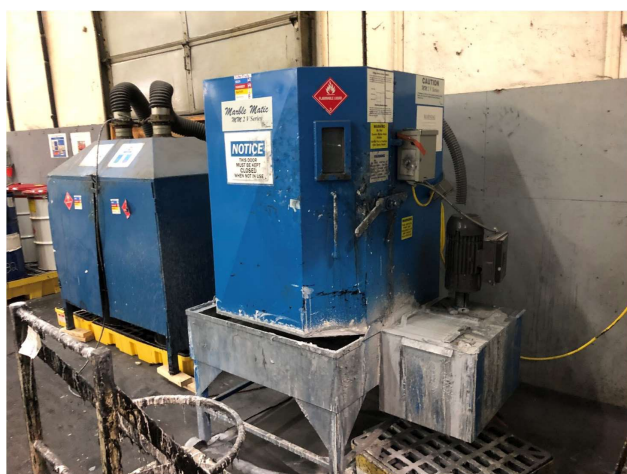
The Mable Matic pot washer machine was used to clean to clean gel resin out of pots utilizing reservoir of solvent using S280 super flush. The inspection team requested the MSDS and waste profile for the spent S280 super flush during the inspection. This information has not been submitted. DSC has previously determined that this was a non-hazardous waste. On occasion this material has been reassessed at the receiving TSD as a hazardous waste.

Photo 36: Pot washer machine with solvent reservoir.

**Pursuant to 401 KAR 39:080 Section 1 [40 C.F.R. § 262.11], a person who generates a solids waste as defined in 40 C.F.R. § 261.2, must determine if that waste is a hazardous waste.**

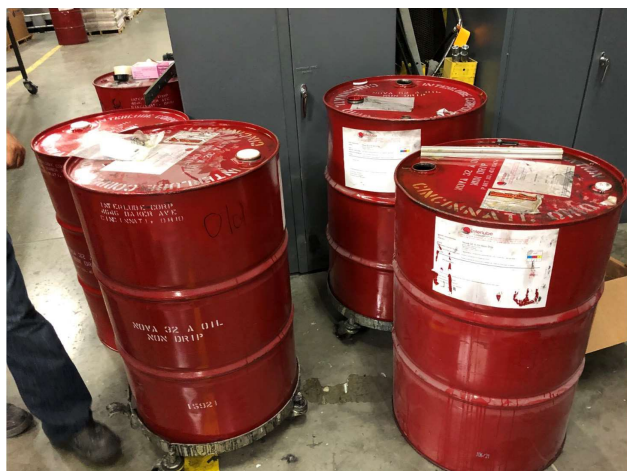
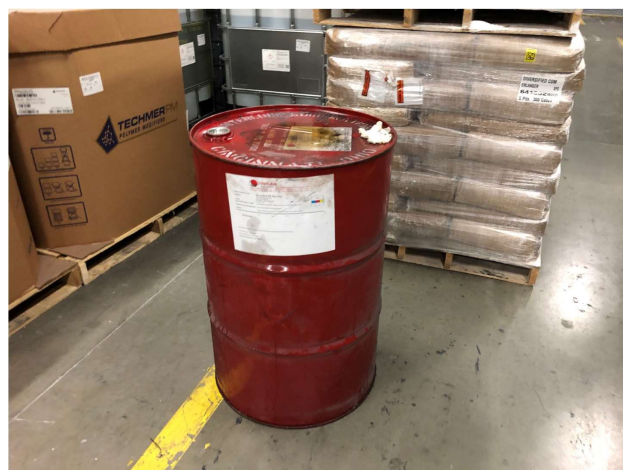
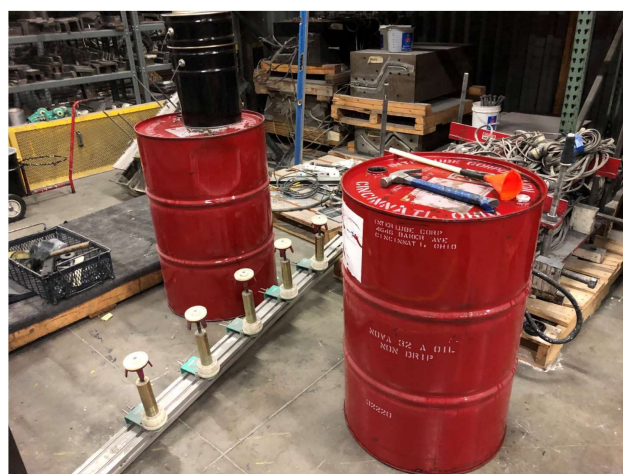
There were three 55-gallon containers of new oil and three of used oil (Photos 37-39). The used oil containers were not labeled with the words “Used Oil.

Photo 38: New and Used Oil.

Photo 39: New and Used Oil.

Photo 37: New and Used Oil.

**Pursuant to 401 KAR 39:080, Section 4(1) [40 C.F.R. § 279.22(c)(1)], containers and aboveground tanks used to store used oil at generator facilities must be labeled or marked clearly with the words “Used Oil.”**

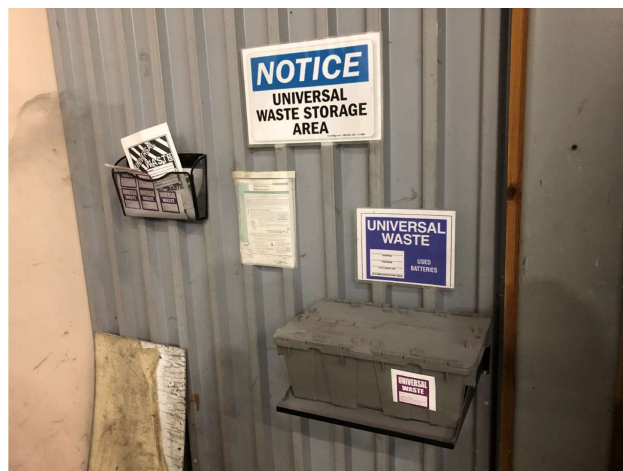
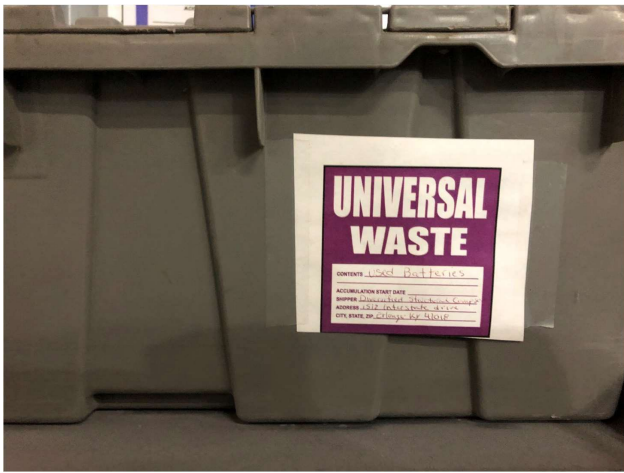
DSC was using a box to store used batteries. The box was labeled but not dated, and DSC did not track how long these batteries had been in storage another way (Photos 40-41).

Photo 40: Universal Waste Batteries.

Photo 41: Universal Waste Batteries.

**Pursuant to 401 KAR 39:080 Section 3(1) [40 C.F.R. § 273.15(a) and (c)], a SQHUW may accumulate universal waste no longer than one year and must to be able to demonstrate the length of time that the universal waste has accumulated from the date that it became a waste or was received.**
