## **RCRA Inspection Report**

Techtrix, Inc.  
525 Plainview Street  
Gadsden, Alabama 35901-2027  
Etowah County

January 18, 2024; 1:00 pm – 3:00 pm. C.D.T.

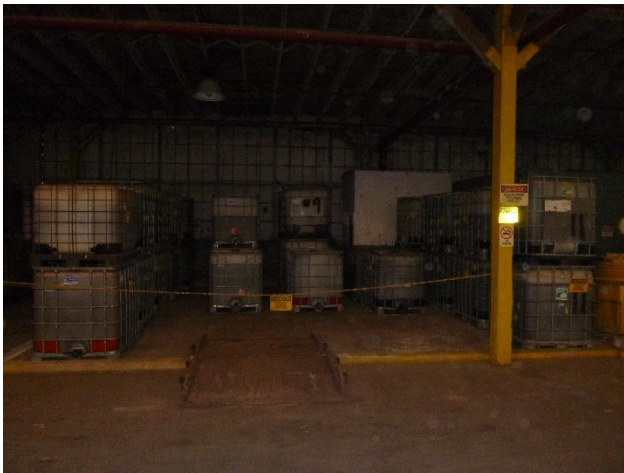
Photograph 1: CAA 1.

| Central Accumulation Area | Number of Containers of Hazardous Waste | Waste Stream | Oldest Accumulation Start Date |
|---|---|---|---|
| CAA 1 | 31 - 250-gallon totes | WS #3 | 3/20/2020 |

Each CAA was being managed with sufficient aisle space, the containers were in good condition, labeled, and closed. There were three 250-gallon totes in the Former non-hazardous waste CAA that were tucked behind some antiquated equipment at the rear of this area and discovered once the forward totes were removed for treatment. The facility was not operating the CAAs

storing hazardous waste with adequate secondary containment. This is a repeat violation from previous inspections. The facility was storing waste for more than 90 days. This is repeat violation and the subject of the 2021 RCRA 7003 CAFO. Techtrix continues to treat and to discharge treated wastewaters at the site on schedule with the approved compliance milestones submittal.

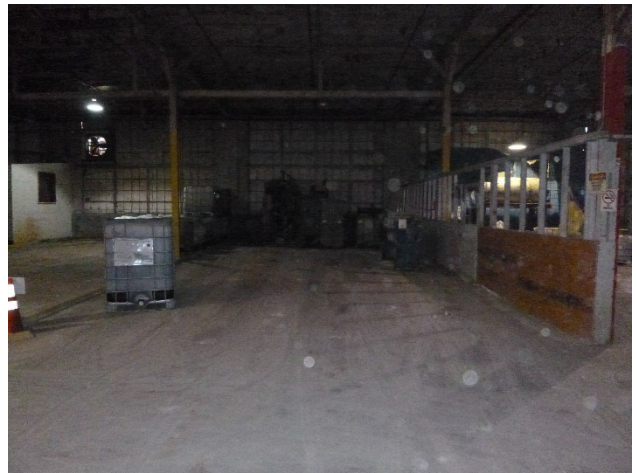
Photograph 4: Former Non-Hazardous Waste CAA.

| Central Accumulation Area | Number of Containers of Hazardous Waste | Waste Stream | Oldest Accumulation Start Date |
|---|---|---|---|
| Former Non-Hazardous Waste CAA | 3 – 250-gallon totes &<br>3 - 250-gallon totes newly discovered behind equipment (Unknowns) | Treated Filter Press Supernate and unknowns | 3/20/2020 |

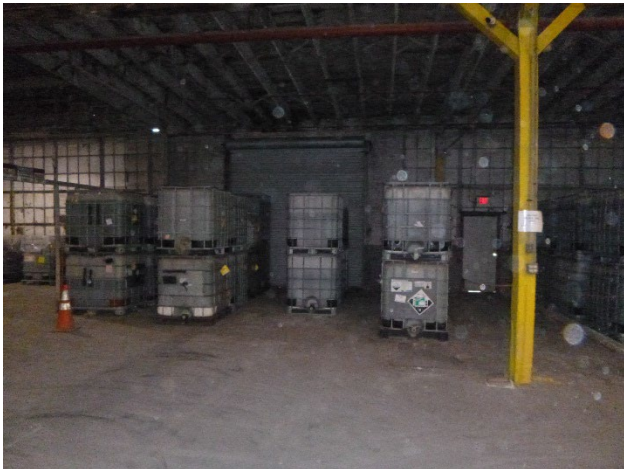
Photograph 2: Bay Door CAA.

| Central Accumulation Area | Number of Containers of Hazardous Waste | Waste Stream | Oldest Accumulation Start Date |
|---|---|---|---|
| Bay Door CAA | 29 - 250-gallon totes | WS #1 | 3/20/2020 |

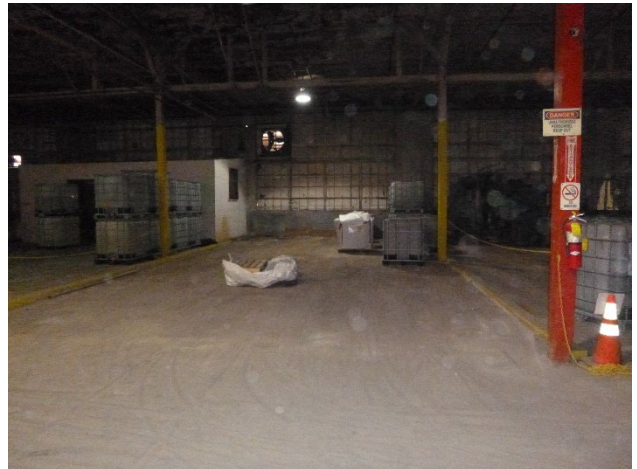
Photograph 5: CAA 2.

| Central Accumulation Area | Number of Containers of Hazardous Waste | Waste Stream | Oldest Accumulation Start Date |
|---|---|---|---|
| CAA 2 | 4 – Supersacks of F006<br>10 – 250-gallon totes | WS #7 | 9/25/2023 |

There were three containers of unknown materials in CAA 2.

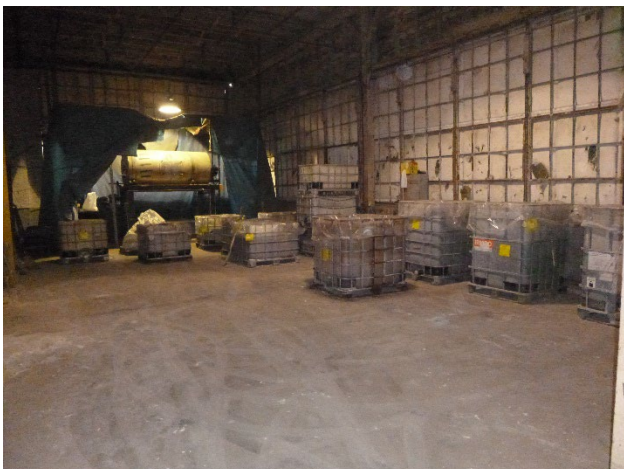
Photograph 3: CAA for Solids.

| Central Accumulation Area | Number of Containers of Hazardous Waste | Waste Stream | Oldest Accumulation Start Date |
|---|---|---|---|
| Solid Hazardous Waste CAA | 9 - 250-gallon totes<br>2 - 55-gallon containers<br>1 - Supersack | WS #7 | 3/20/2020 |

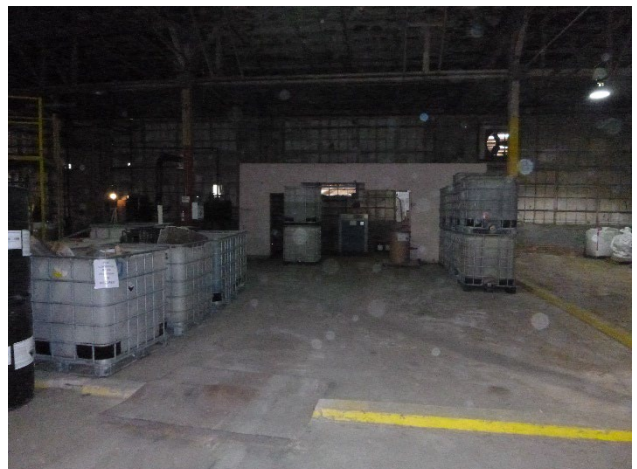
Photograph 6: Compressor Room CAA.

| Central Accumulation Area | Number of Containers of Hazardous Waste | Waste Stream | Oldest Accumulation Start Date |
|---|---|---|---|
| Compressor Room CAA | 4 – 250-gallon totes<br>18 - 55-gallon containers of Solids | Empty Containers | N/A |

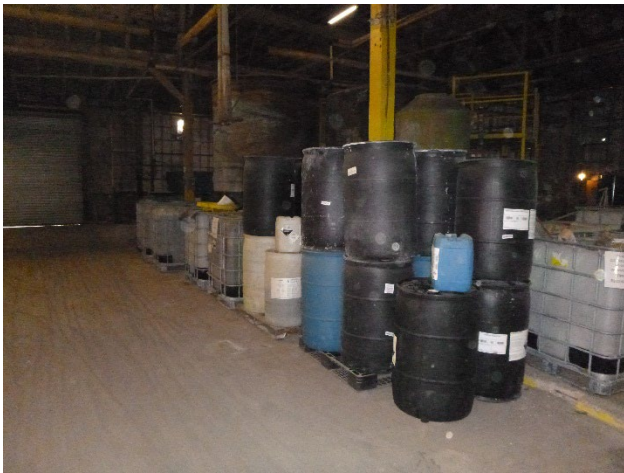
Photograph 7: Filter Press Storage Area.

| Central Accumulation Area | Number of Containers of Hazardous Waste | Waste Stream | Oldest Accumulation Start Date |
|---|---|---|---|
| Filter Press | 8 – 250-gallon totes | Process Supernate | N/A |

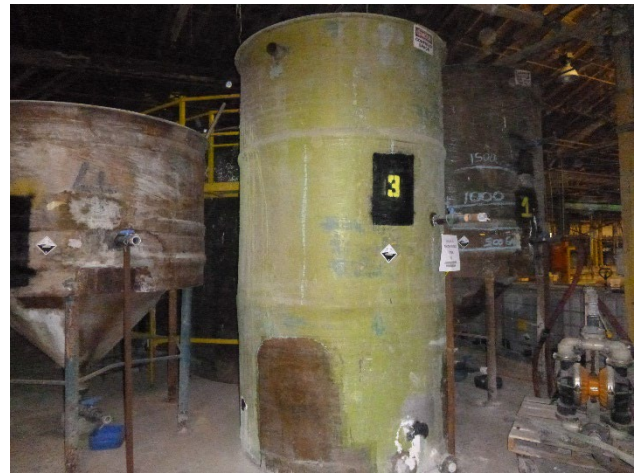
Photograph 10: Tank 11.

There are just two tanks remaining onsite that are storing historic waste out of the original eleven: Tanks 7 and 11. As the staff have extra time, the tanks are being cleaned out. The removed waste is stored in the solids CAA area.

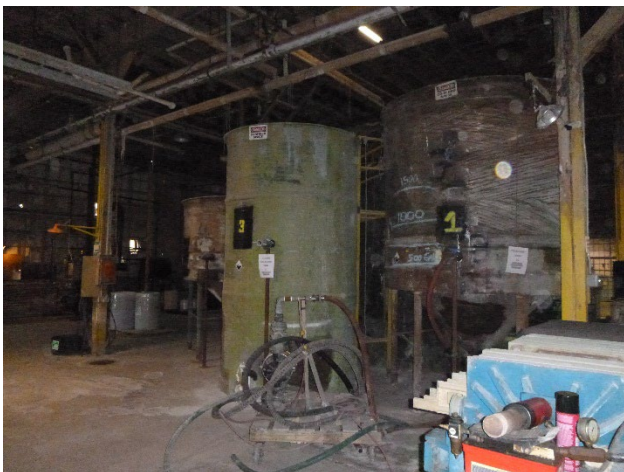
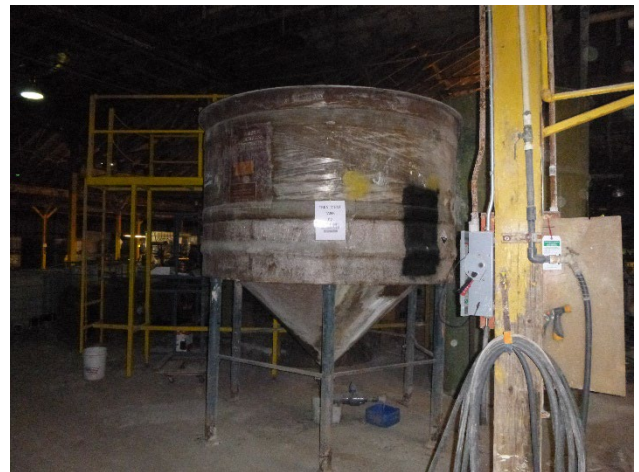
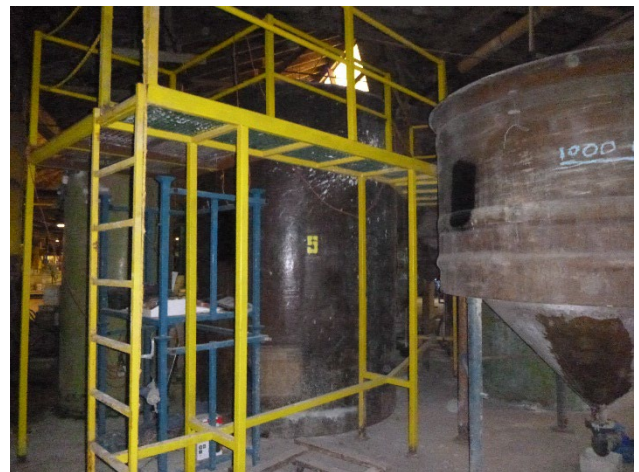
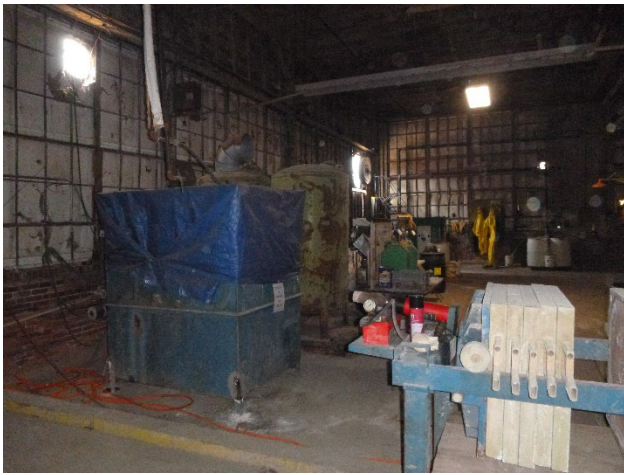
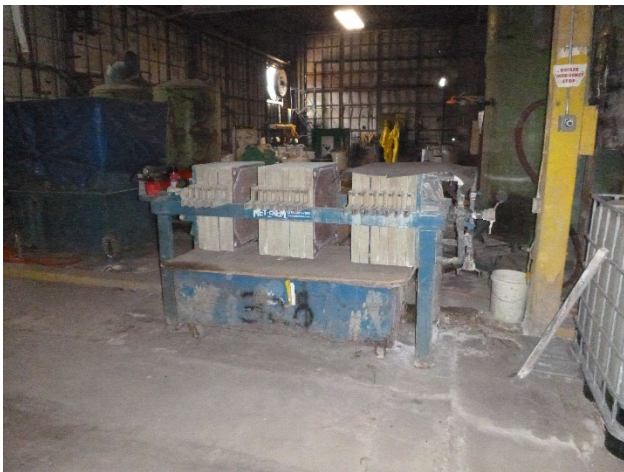
Photograph 11: Wastewater Treatment Tanks.

Photograph 9: Wastewater Treatment Tanks.

Photograph 12: Wastewater Treatment Tanks.

Photograph 13: Wastewater Treatment Tanks.

Photograph 14: Wastewater Treatment Tanks.
