### INSPECTION REPORT

| Regulatory Program(s) | NPDES Stormwater/CWA 402 | |
| Company Name: | The Ridgemont Company | |
| Facility Name: | Village at Gateway – Public – Commercial | |

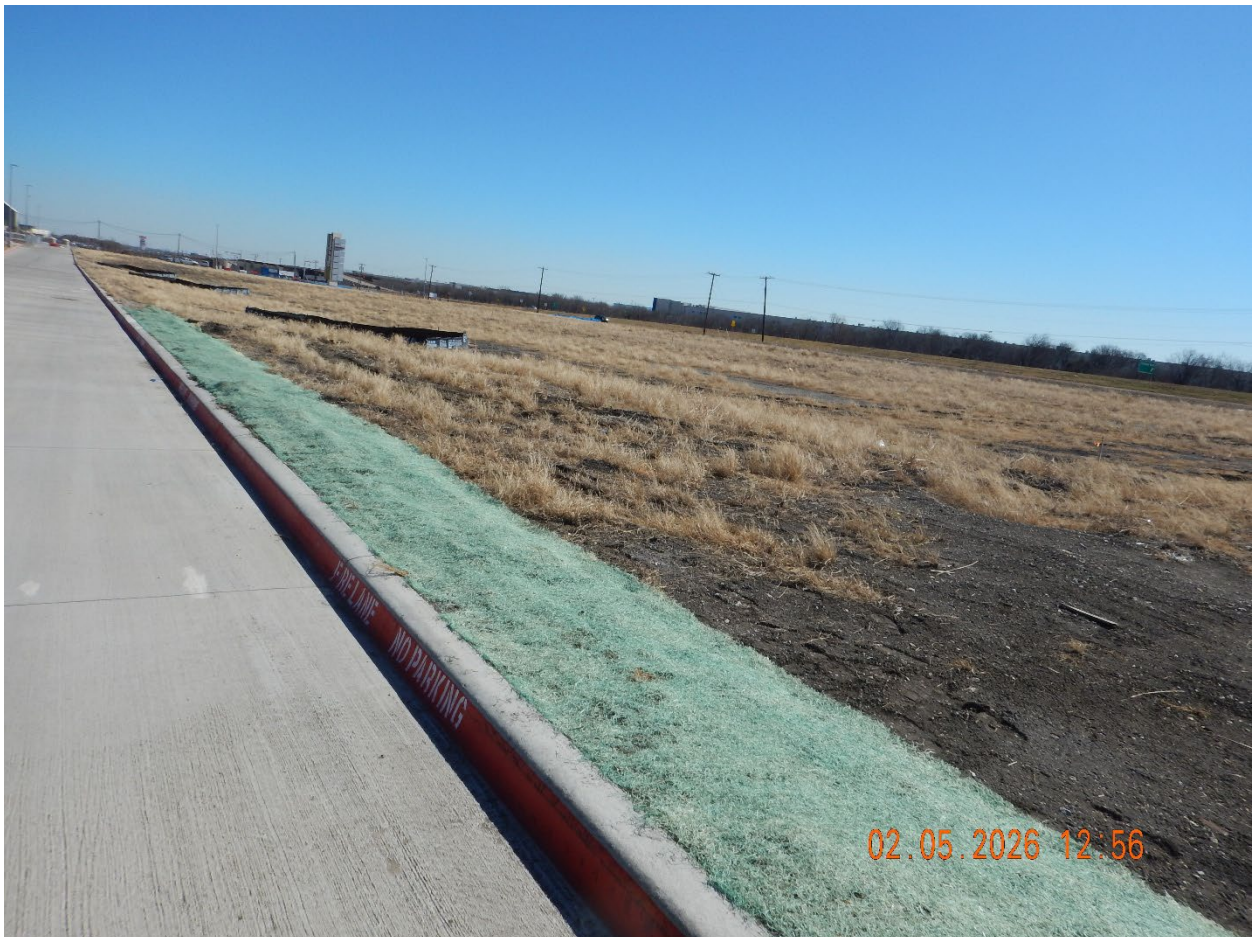
Photo no. 1

- I observed that the site was mostly stabilized with minimal exposed sediment. In areas where exposed sediment was present, BMPs (erosion control blanket and silt fence) were installed (**Appendix 1, Photos 1-2**).

Description: Greenspace near Lot 7 with erosion control blanket installed. Also note the vegetative cover and silt fence around the inlets in the background.

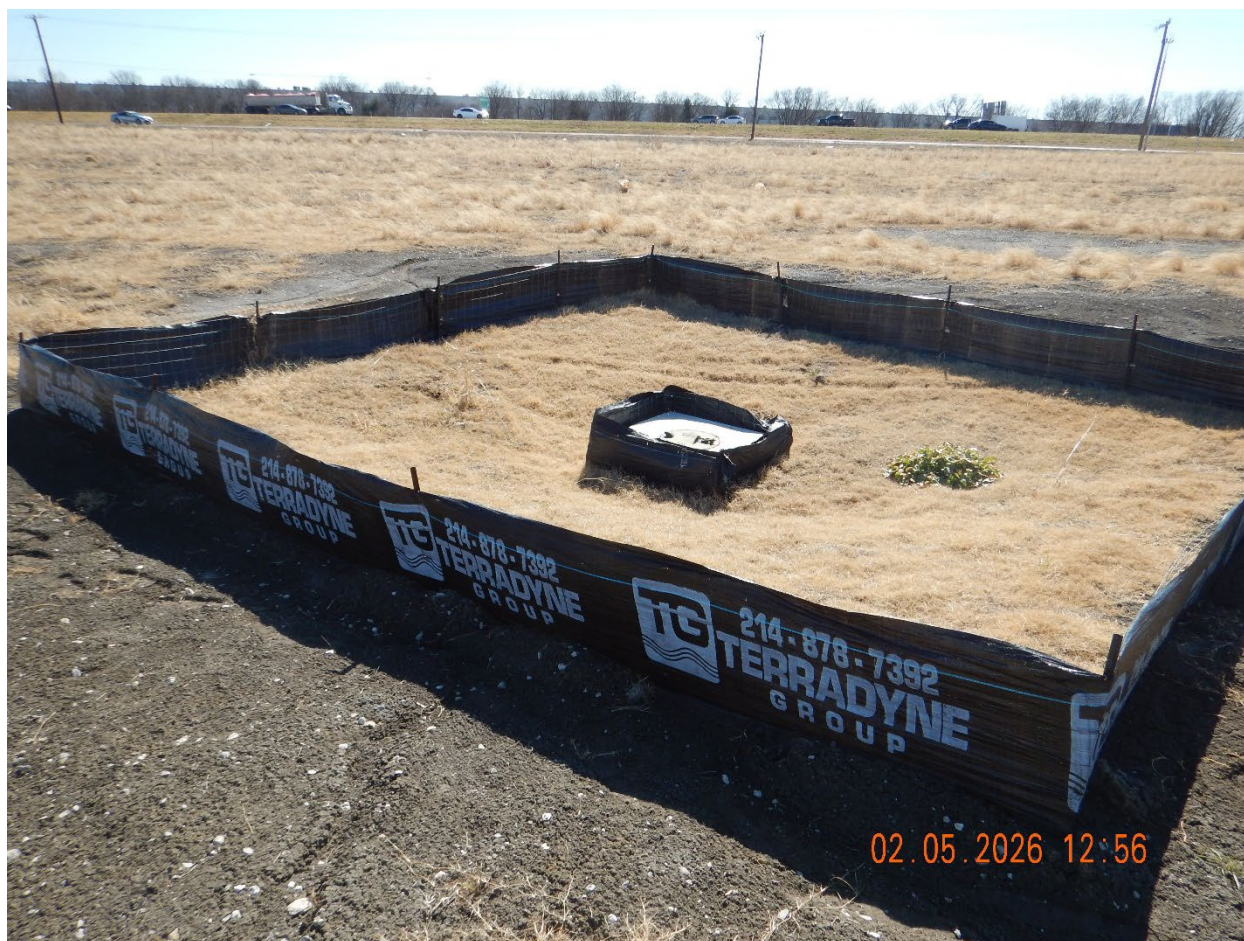
Photo no. 2

Description: Closer view of the silt fence around the inlets from Photo 1.

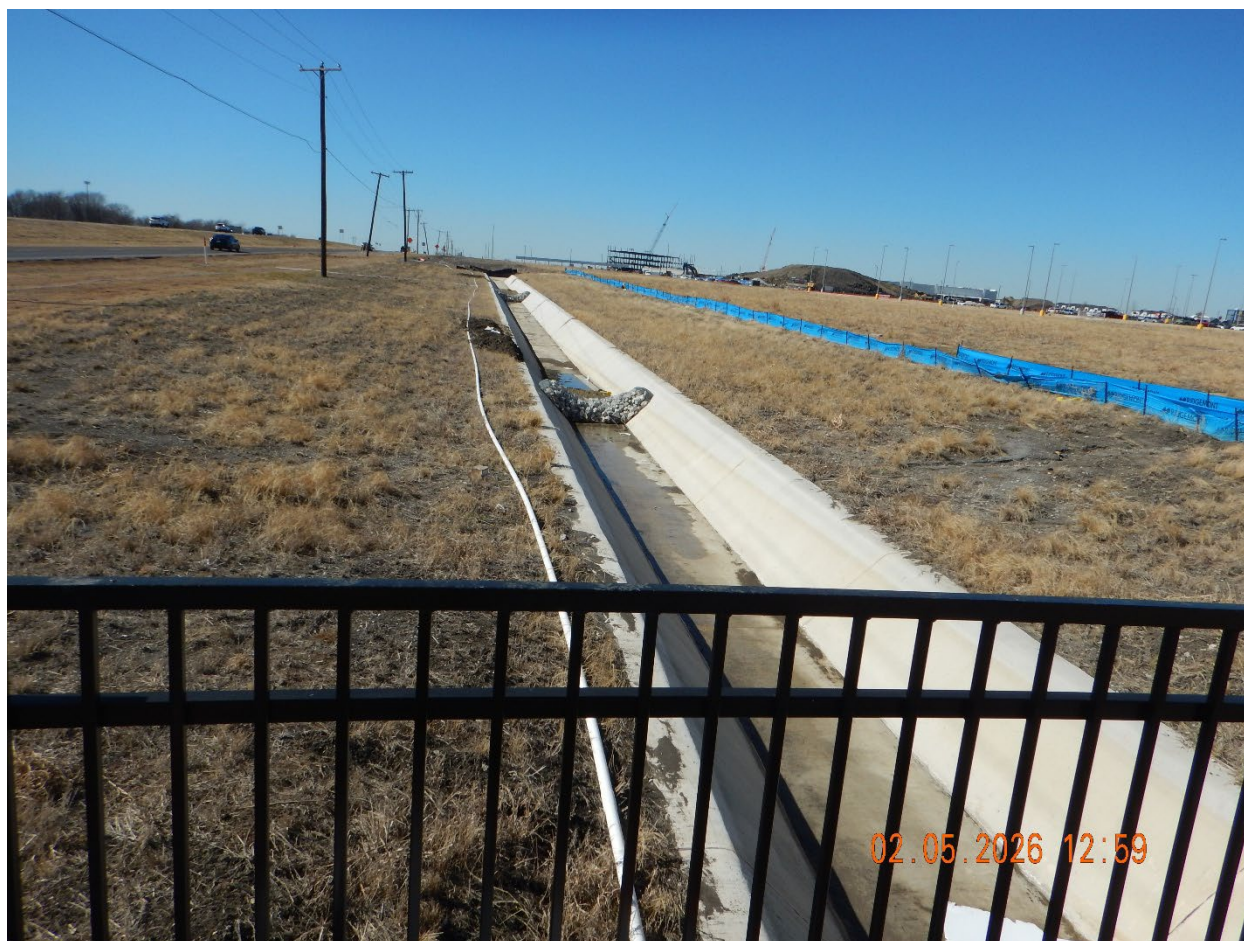
Photo no. 3

- Rock check dams were observed in the drainage channels (**Appendix 1, Photo 3**).
- The detention pond (previously a sediment retention basin) at the southeast corner of the site had stabilized slopes, silt fence, and a rock check dam installed (**Appendix 1, Photo 4**). The site representatives advised that the drop inlets and box culvers on-site connect to the pond.

Description: Rock check dams in the drainage channels parallel to US Highway 80.

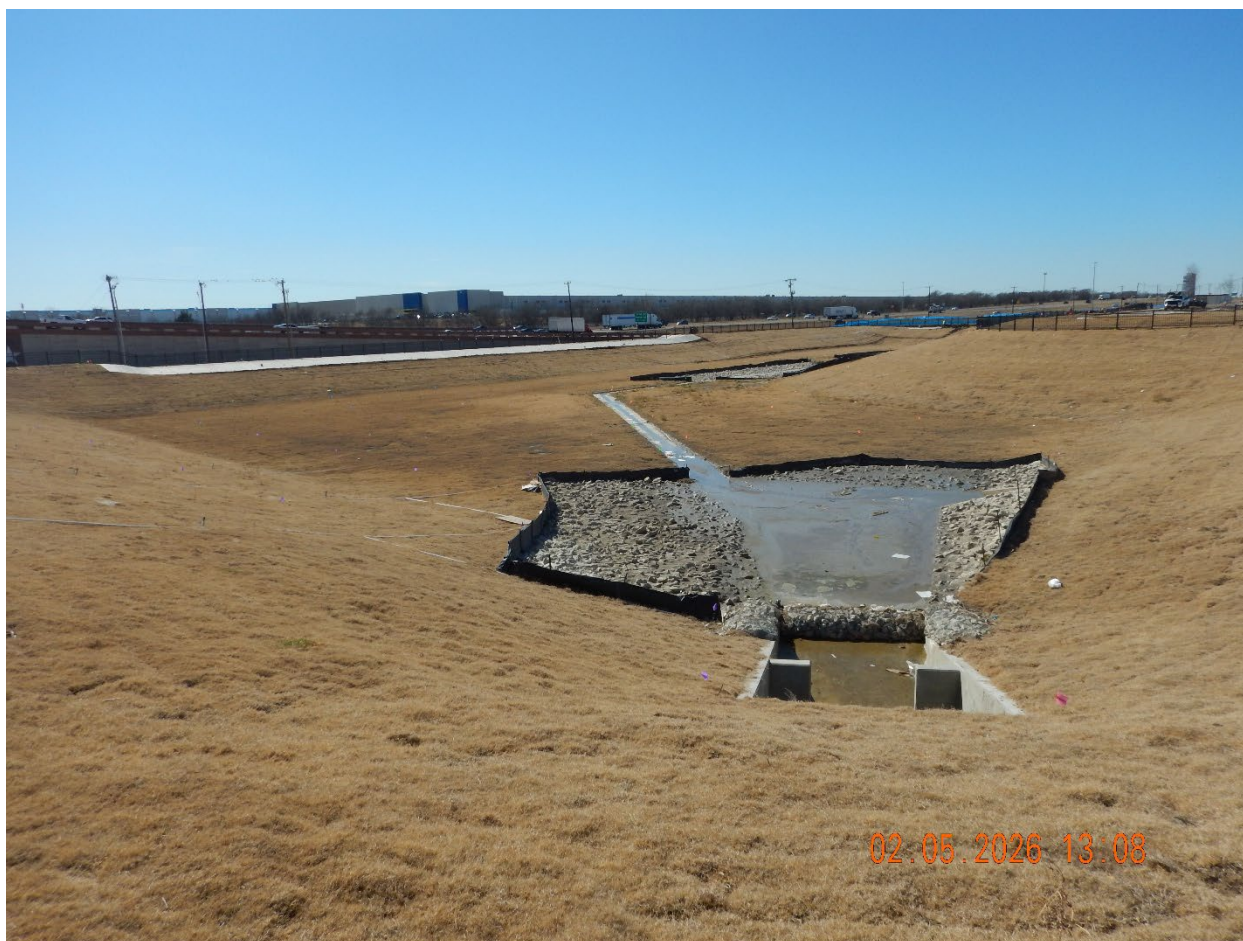
Photo no. 4

Description: The detention pond at the southeast corner of the site with stabilized slopes, silt fence, and a rock check dam installed.
