## EPA REGION 10 Enforcement Division

### INSPECTION REPORT

| Type of Inspection | Compliance Evaluation Inspection (CEI) | |
| Facility or Site Name | North Slope Borough Sa 10 a.k.a. Vehicle Maintenance Shop (VMS) | |

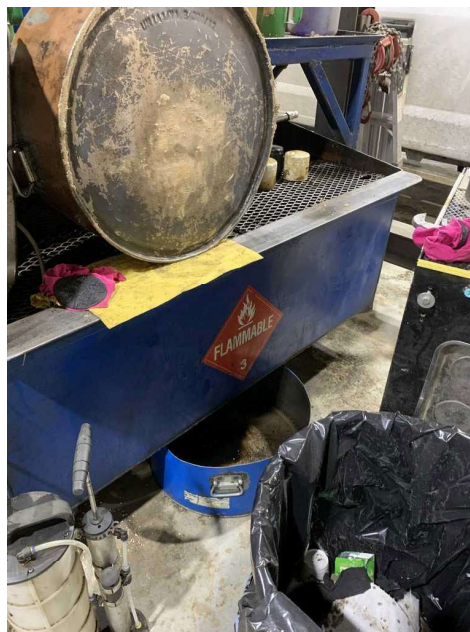
| [Title] | | | IMG_1608.jpg |

| <p>While in the Vehicle Maintenance shop, we saw a used oil storage tank with a storage capacity between 125 and 150 gallons. At the time of the inspection, the tank was not labeled with the words "Used Oil." I told Mr. Smith the used oil regulations required all used oil storage units to be labeled with the words "Used Oil."</p> <p>Mr. Smith labeled the storage tank with the words "Used Oil" during the inspection.</p> | | | |

| <b>Building:</b> Vehicle Maintenance Shop | <b>Area:</b> | <b>Sub-area:</b> |
|---|---|---|
| Used oil storage tank was not labeled with the words "Used Oil." | <b>Regulations:</b> | <b>Sections:</b> |

| Another view of the used oil storage tank, showing that it is not labeled with the words "Used Oil." | | | |

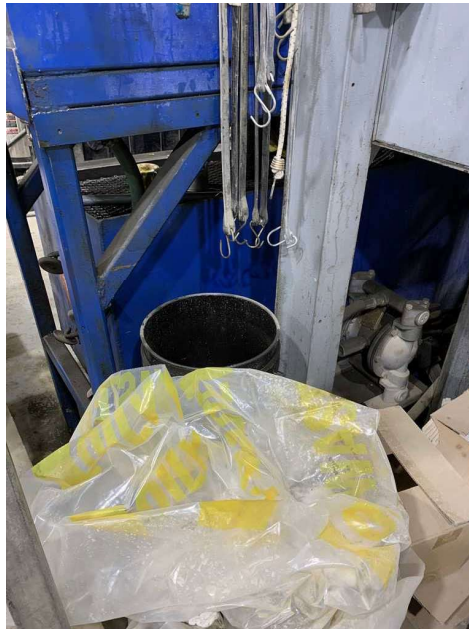
| [Title] | | | IMG_1610.jpg |

| Another view of the used oil storage tank, showing that it is not labeled with the words "Used Oil." | | | |

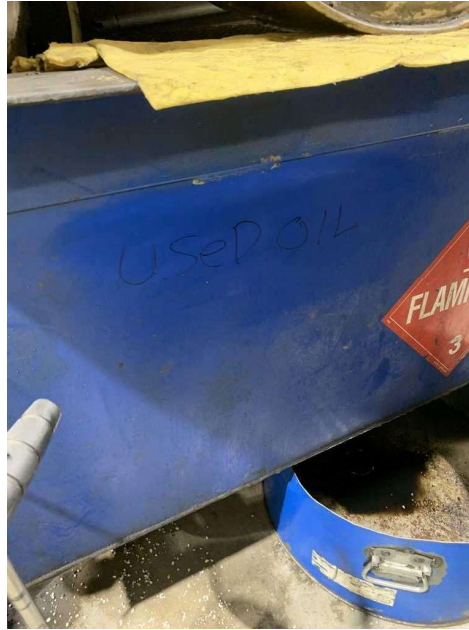
| [Title] | | | IMG_1611.jpg |

| View of the used oil storage tank after being labeled with the words "Used Oil" during the inspection. | | | |

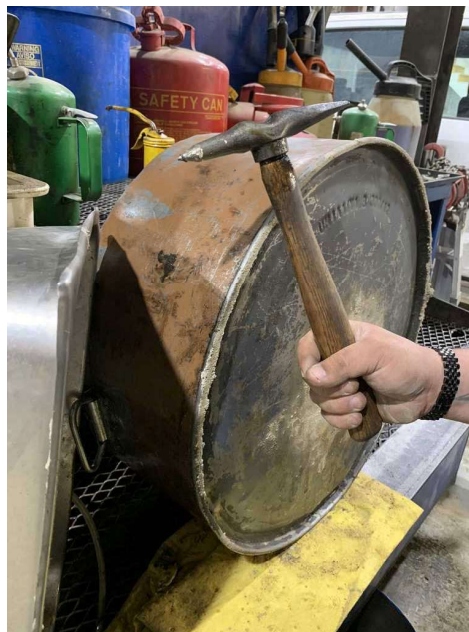
| [Title] | | | IMG_1612.jpg |

While still in the VMS, I asked Mr. Smith to show me where they accumulate waste aerosol cans and how they are managed. Mr. Smith explained that as they generate waste aerosol cans, they are punctured over the used oil storage tank using a hammer punch. He then said the punctured cans go into an oily waste bag. Mr. Smith told us the bags of oily waste are taken to the Oxbow Landfill for disposal.

| <b>Building:</b> Vehicle Maintenance Shop | <b>Area:</b> | <b>Sub-area:</b> |
|---|---|---|
| Waste aerosol cans they are punctured over the used oil storage tank using a hammer punch. The punctured cans go into an oily waste bag and are taken to the Oxbow Landfill for disposal. | <b>Regulations:</b> | <b>Sections:</b> |

| View of the hammer punch that is being used at the facility to puncture waste aerosol cans over the used oil tank. | | | |

I explained the regulations, requiring VSQGs to manage their waste properly. I told Mr. Smith that his facility's current method of puncturing the waste aerosol cans was not meeting that requirement. I suggested to Mr. Smith, that his facility might want to manage their waste aerosol cans as a universal waste and avoid the puncturing process.
