CHALLENGE LEAD RESISTANCE CORROSION

The lead lined acid boiling tank in the bead catalyst plant at the Socony Vacuum Oil Co. plant at Paulsboro, N.J., is now giving good service after alterations which involved doubling the number of straps (now 24 in. apart), increasing the thickness of the lead from 1/4 in. to 3/8 in. and changing from chemical to tellurium lead. This flat bottomed tank has eliminated sagging encountered in hemispherical and "V" bottom installations. The time of service has not been sufficiently long to judge fully its merits but to date performance has been highly satisfactory.

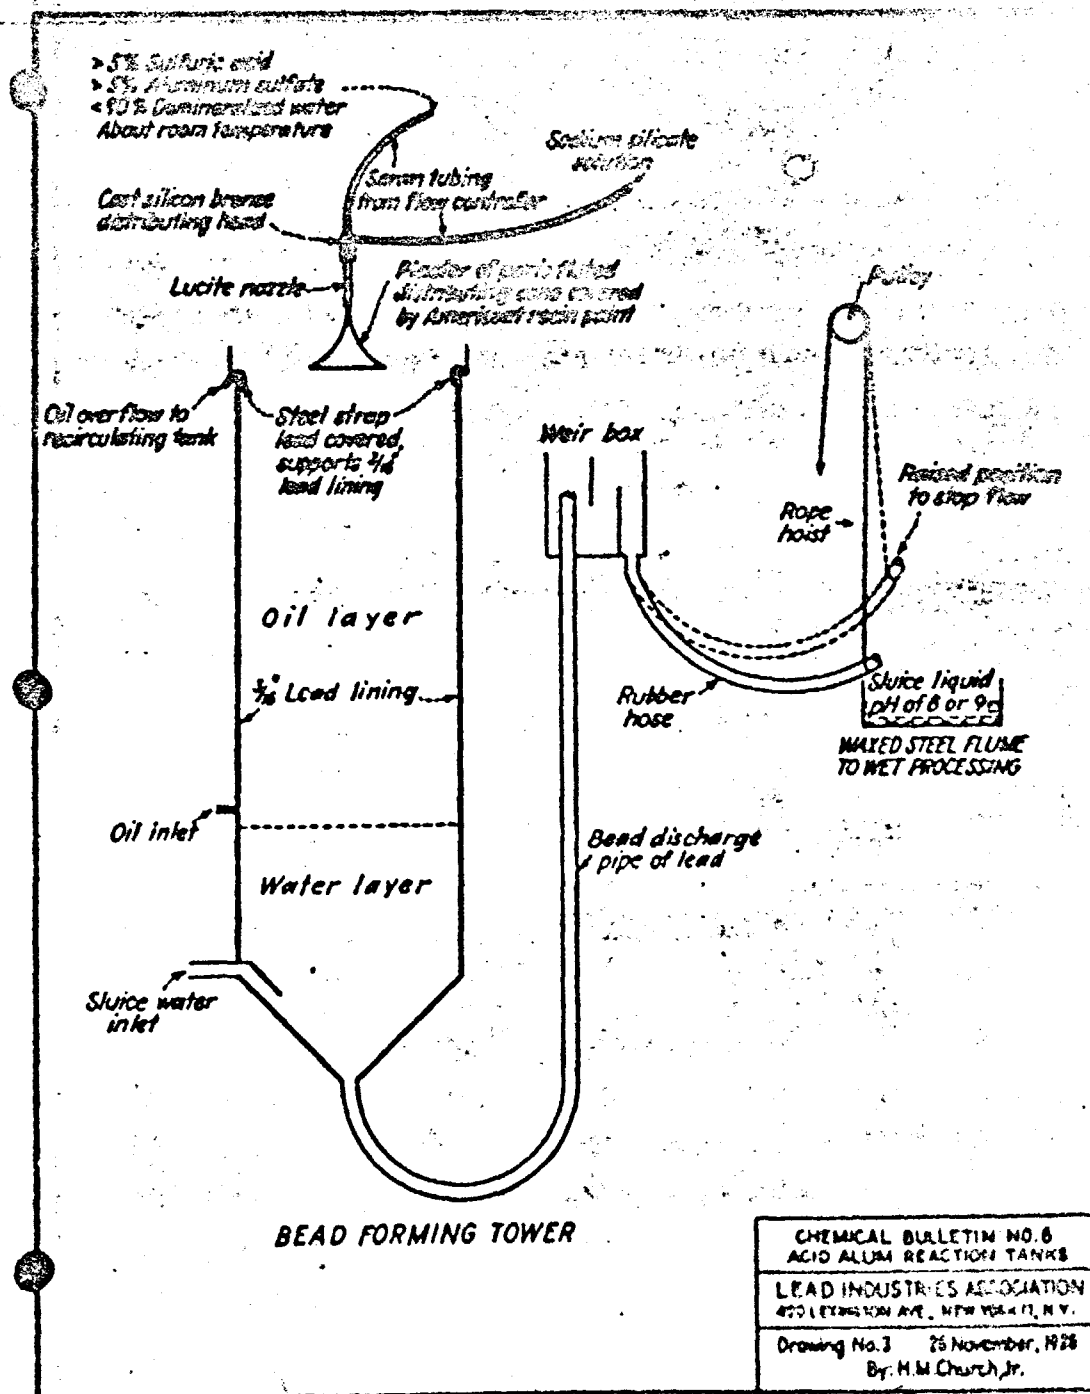
The 120-inch lead lining of the bead forming tower is supported by a perforated lead plate. In Drawing No. 3 the entire tower is shown with the lead lining. All lead lining of the cell structure around which corrosion is taking place is shown in the drawing. A sluice water inlet and an oil inlet allow the liquid properties to be maintained as shown.

In addition, 3/16 in. lead lining is hung from a single horizontal steel strap near the top of the bead forming tower. This lead lining has served with no signs of failure since November, 1944, at room temperature and in the presence of dilute acid alum solution as shown in Drawing No. 3.

1. The bead forming tower, lined with 3/16-in. chemical lead is unaffected by corrosion from the dilute acid and aluminum sulfate solutions.
