## Clean Water Act Section 404: Site Visit/Case Development

| Site Name | John L Conner, Jr., Site 1, Pecan Orchard | | | | |

| Inspection Purpose | Initial site visit | | |

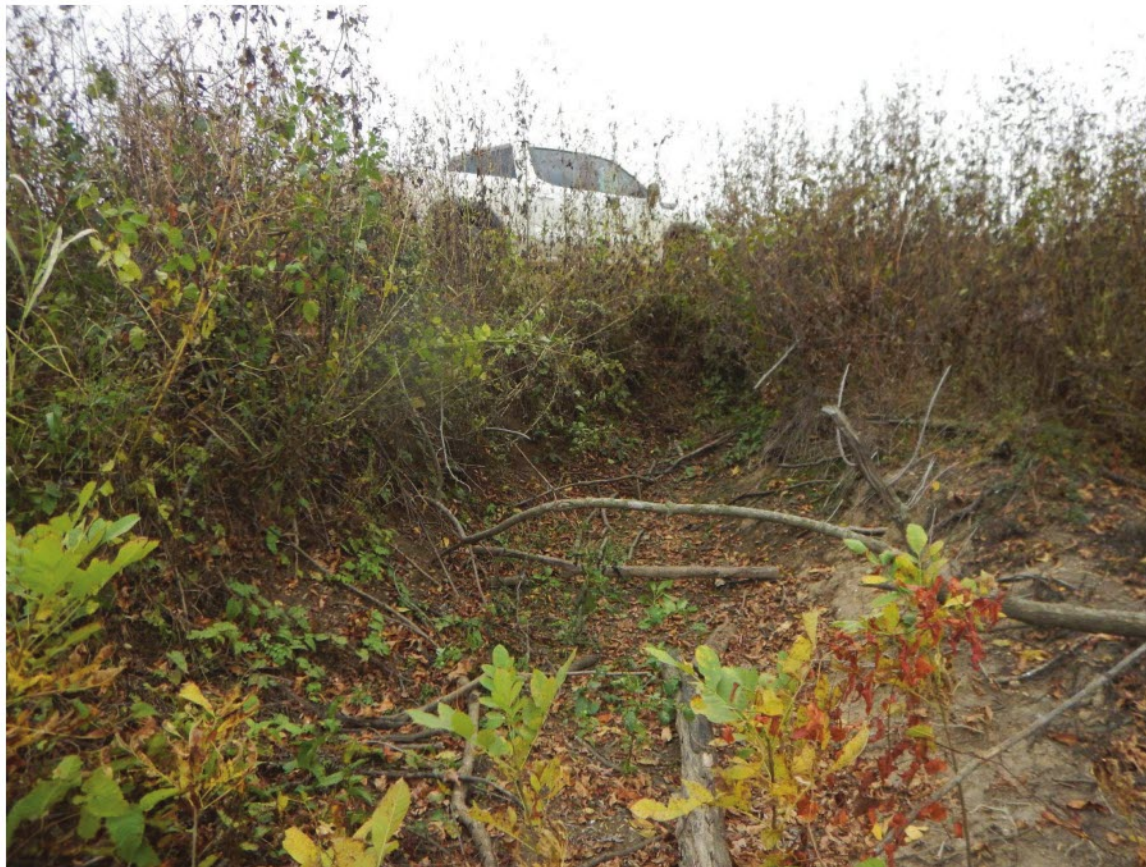
Photo No. 1

| Photo File Name | Date and Time of Photo | Photographer | Description |
|---|---|---|---|
| DSCN6159 | 11/09/2023, 9:33 AM | Chelsey Sherwood | Culvert connection to wetland appears to be buried under road. Picture taken facing west. |

| A 404 permit was not obtained for filling and discharging in Mill Creek, an unnamed stream, and adjacent/abutting wetlands. There are potential concerns of the road severing the wetland and impeding flow as the old culvert could not be seen and appears to be buried. | | | |

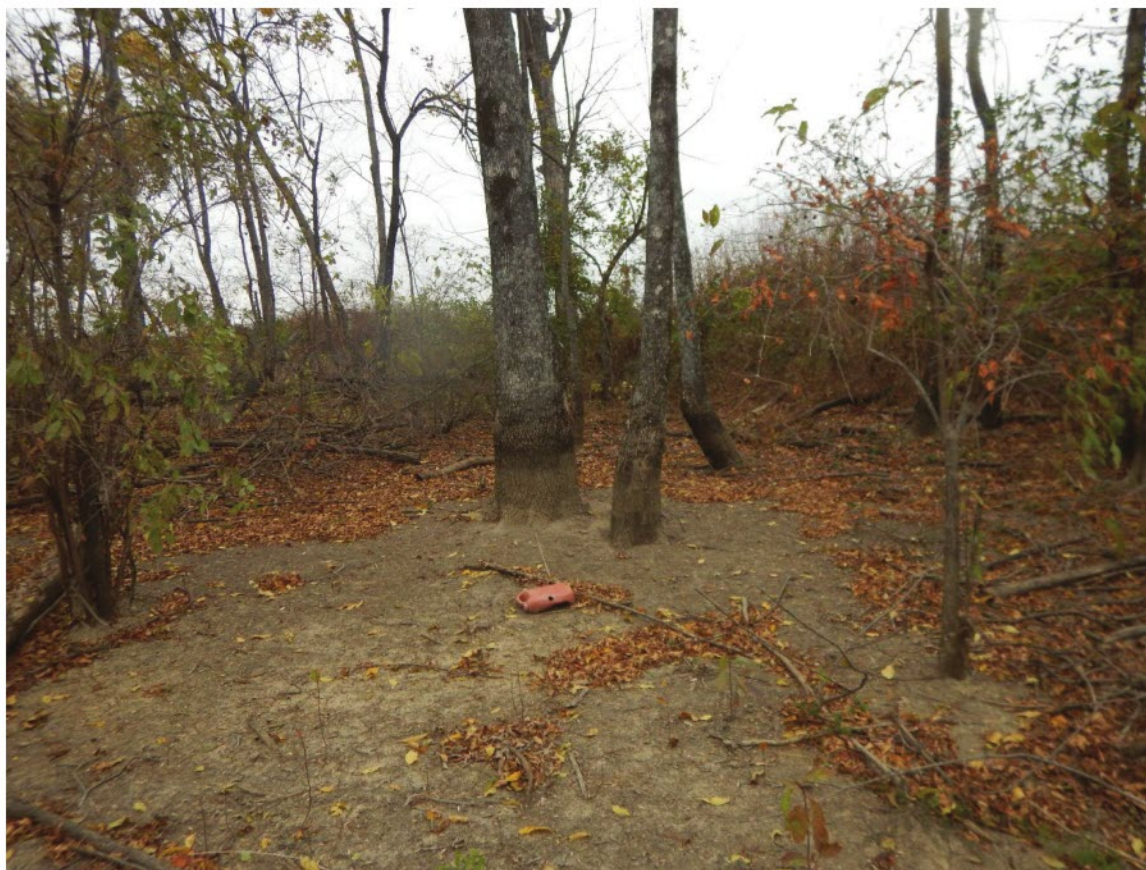
Photo No. 2

| Photo File Name | Date and Time of Photo | Photographer | Description |
|---|---|---|---|
| DSCN6160 | 11/09/2023, 9:34 AM | Chelsey Sherwood | Wetland area on north side of road. Note waterlines on trees. Picture taken facing north. |
