## **RCRA Inspection Report**

Clean Harbors Florida LLC  
7001 Kilo Ave.  
Bartow, Florida 33830

March 13, 2024

The purpose of this inspection was to conduct an unannounced compliance evaluation inspection to determine Clean Harbors Florida LLC’s compliance with the conditions of its RCRA Hazardous Waste Facility Operating Permit No. 64247-HO-018, the applicable requirements of RCRA and the corresponding Florida regulations. This was an EPA lead inspection.

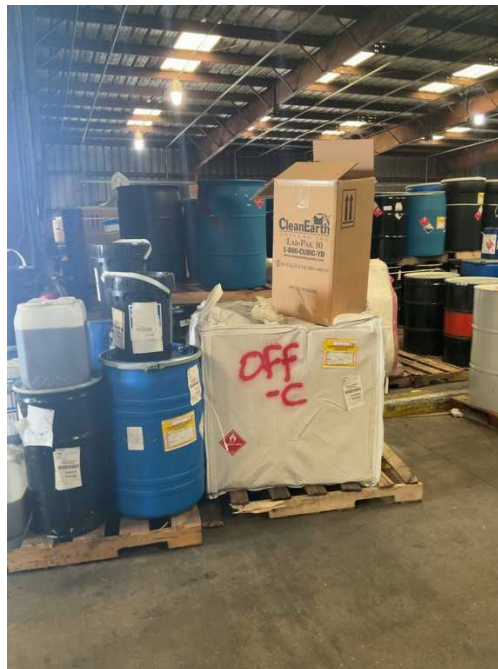
| Photo 4 | IMG-2024031310174617462694436.jpg |

Several containers in the North Container Storage Building were observed to be dented and improperly stacked to where some containers of waste were tilted or leaning from pallets (Photos 4, 10, 11, 14, and 18). Insufficient aisle space was observed in some areas (Photos 7, 8, 9, 13, and 20). Four containers of hazardous waste with the following Clean Harbors barcode numbers had accumulation start dates beyond one year: A0056Z6Y dated 09/02/22, A006T3IO dated 12/14/22, A0055584 dated 08/30/22, and A00ERIZQ dated 08/05/22 (Photos 12, 16, 17, and 19).

| North Container Storage Building - SWMU 13 | 27.9562282, -81.77927889 |

**Pursuant to Permit Condition I. 27, the Permittee shall maintain compliance with the requirements of 40 C.F.R. § 268, which incorporates 40 C.F.R. § 268.50(c), which states an**

Pursuant to Permit Condition II.B.1.d., containers in storage shall be on pallets or otherwise elevated so that any liquids on the floor will not come into direct contact with the containers. The maximum container volume that may be placed on one pallet shall not exceed 255 gallons in drums or 330 gallons in one bulk container. Containers may be stacked up to two pallets high. Aisle space between pallet rows or between pallet rows and adjacent walls shall not be less than 30 inches.

Pursuant to Permit Condition II.B.1.e., containers and roll-off boxes shall be kept closed except when adding or removing waste and shall be handles in a manner that will not allow the containers to rupture or leak. If a container holding hazardous waste is not in good condition, or begins to leak, the waste shall be transferred to another container in good condition pursuant to 40 § C.F.R 264.171 and 40 § C.F.R 261.173.

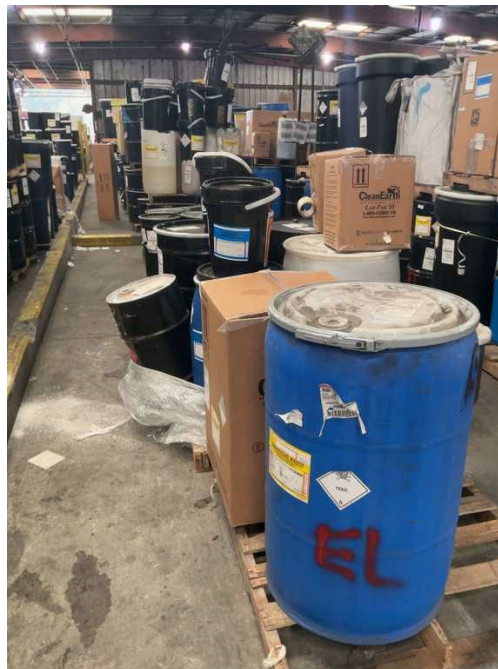
| Photo 10 | IMG-2024031310341334132763389.jpg |

| North Container Storage Building - SWMU 13 | 27.95617568, -81.7795006 |

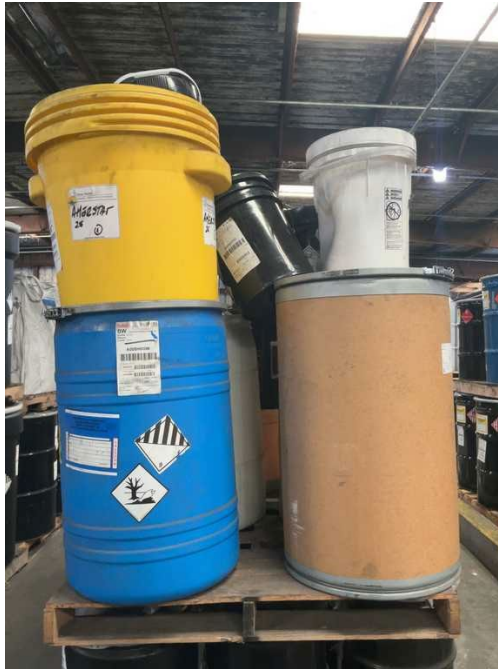
| Photo 11 | IMG-2024031310353335332388159.jpg |

| North Container Storage Building - SWMU 13 | 27.95628012, -81.77942365 |

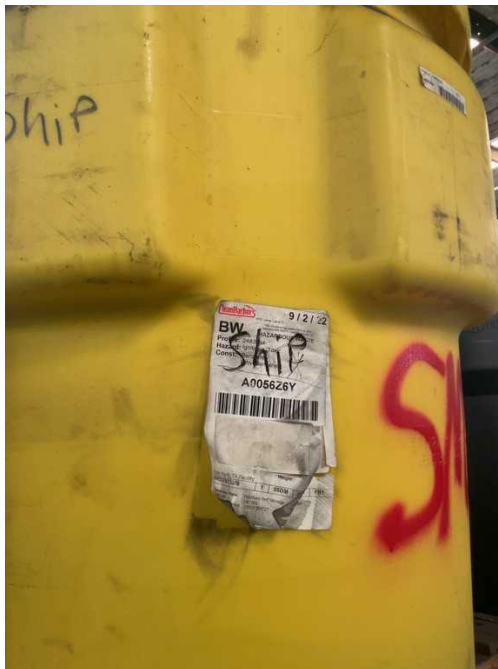
| Photo 12 | IMG-2024031310383438342424826.jpg |

| North Container Storage Building - SWMU 13 | 27.95637391, -81.7794094 |

owner/operator of a treatment, storage or disposal facility may store such wastes beyond one year; however, the owner/operator bears the burden of proving that such storage was solely for the purpose of accumulation of such quantities of hazardous waste as are necessary to facilitate proper recovery, treatment, or disposal.

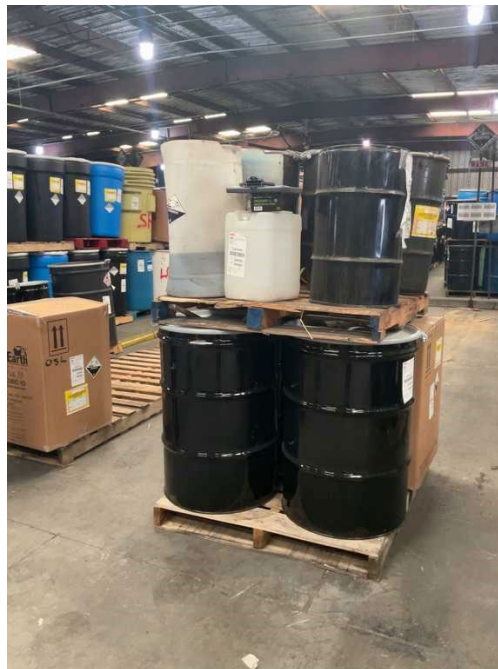
| Photo 14 | IMG-2024031310455945592489862.jpg |

| North Container Storage Building - SWMU 13 | 27.95620355, -81.77961861 |

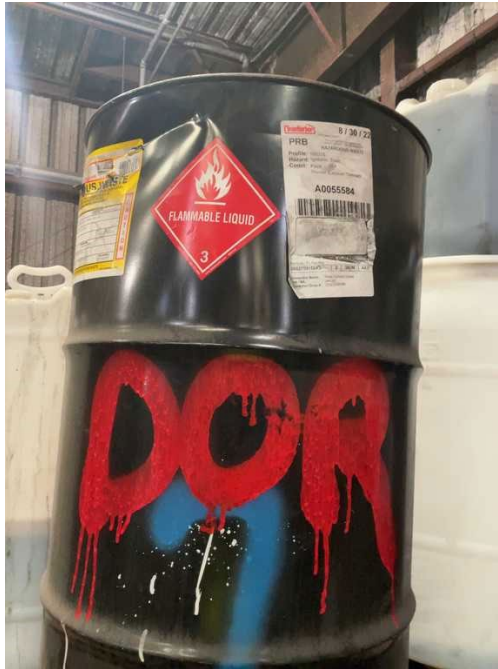
| Photo 17 | IMG-2024031310572657262496337.jpg |

| North Container Storage Building - SWMU 13 | 27.95609471, -81.77959246 |

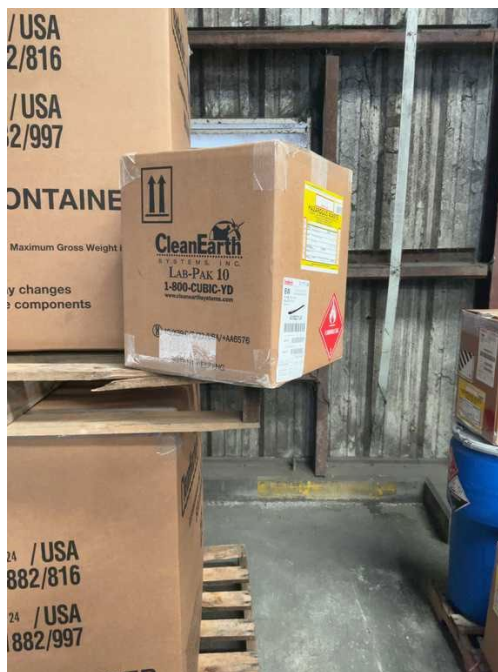
| Photo 18 | IMG-202403131100330332872318.jpg |

| North Container Storage Building - SWMU 13 | 27.95606714, -81.77935835 |

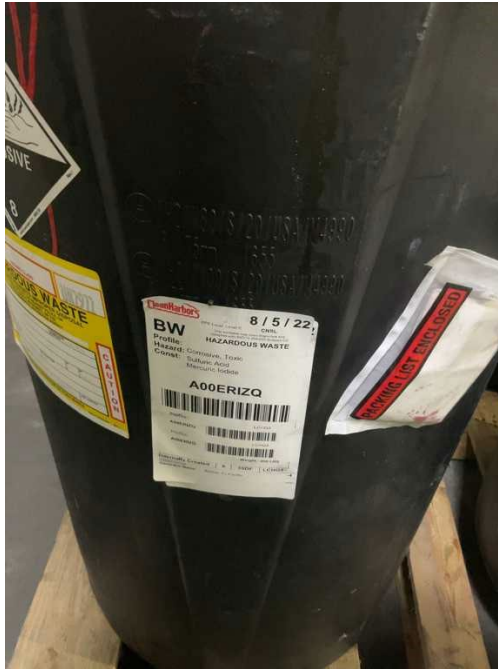
| Photo 19 | IMG-202403131102382382532121.jpg |

| North Container Storage Building - SWMU 13 | 27.95605335, -81.77962448 |

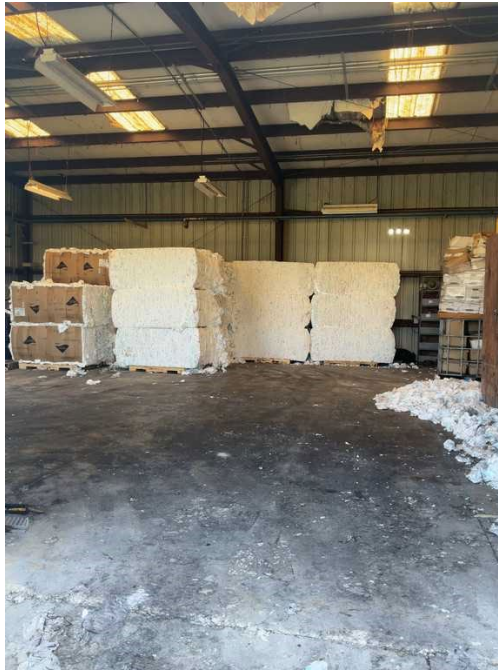
| Photo 21 | IMG-202403131117031733803104.jpg |

The boiler has been removed from this building which is now used for storage of off-specification baby diapers (Photo 21). This material is used in the solid waste solidification proves. No hazardous waste was observed in this area.

| Boiler Building | 27.95574452, -81.77982749 |

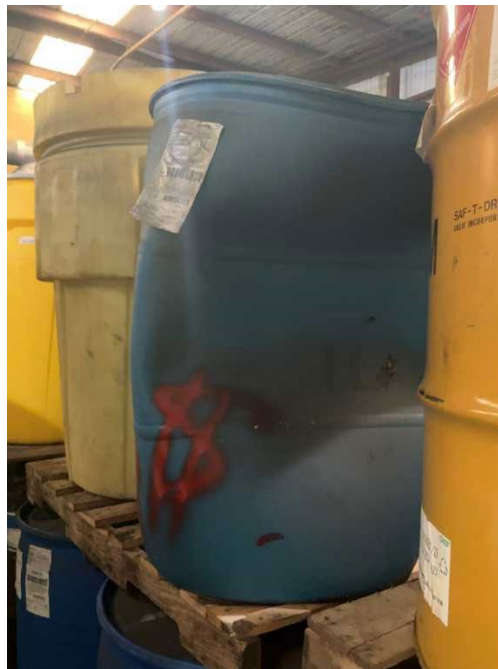
| Photo 30 | IMG-2024031311482948291972846.jpg |

Several containers in the South Container Storage Building were observed to be dented and improperly stacked to where some containers were tilted or leaning from pallets (Photos 30 and 33). Insufficient aisle space was observed in some areas.

| South Container Storage Building - SWMU 2 | 27.9550124, -81.77948869 |

**Pursuant to Permit Condition II.B.1.d., containers in storage shall be on pallets or otherwise elevated so that any liquids on the floor will not come into direct contact with the containers. The maximum container volume that may be placed on one pallet shall not exceed 255 gallons in drums or 330 gallons in one bulk container. Containers may be stacked up to two pallets high. Aisle space between pallet rows or between pallet rows and adjacent walls shall not be less than 30 inches.**

**Pursuant to Permit Condition II.B.1.e., containers and roll-off boxes shall be kept closed except when adding or removing waste and shall be handled in a manner that will not allow the containers to rupture or leak. If a container holding hazardous waste is not in good condition, or begins to leak, the waste shall be transferred to another container in good condition pursuant to 40 § C.F.R 264.171 and 40 § C.F.R 261.173.**

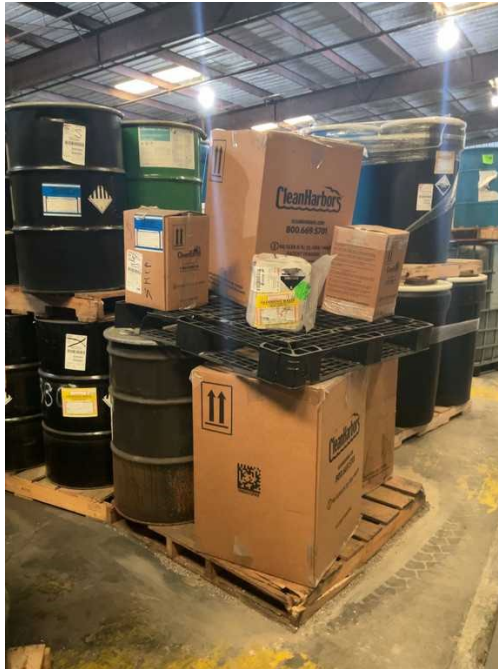
| Photo 33 | IMG-202403131151015112349811.jpg |

| South Container Storage Building - SWMU 2 | 27.95503482, -81.77956053 |

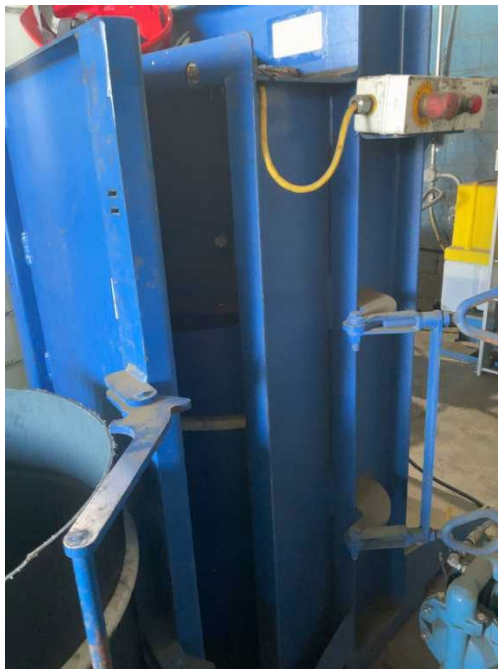
| Photo 34 | IMG-202403131203443442335863.jpg |

This area also contains a small container crusher (Photo 34) for waste hand sanitizer bottles. The waste hand sanitizer is consolidated into one container to be sent for recycling. Empty 55-gallon drums are stored near this area and are sent for recycling to Mauser Packaging Solutions in Tampa, FL. Larger containers are sent to TR Drum, LLC in Plant City, FL for recycling.

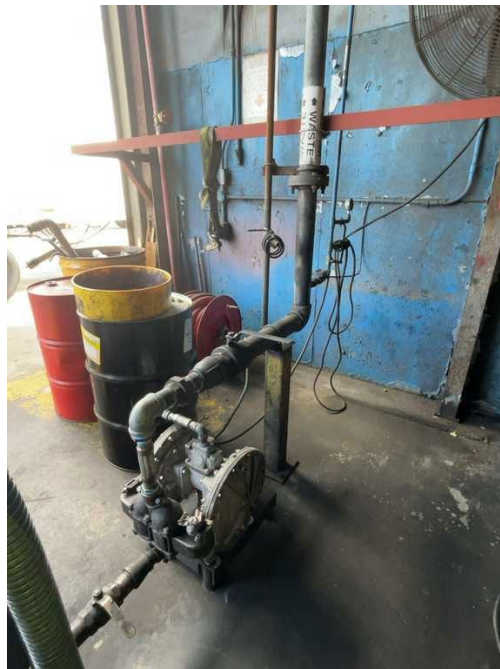
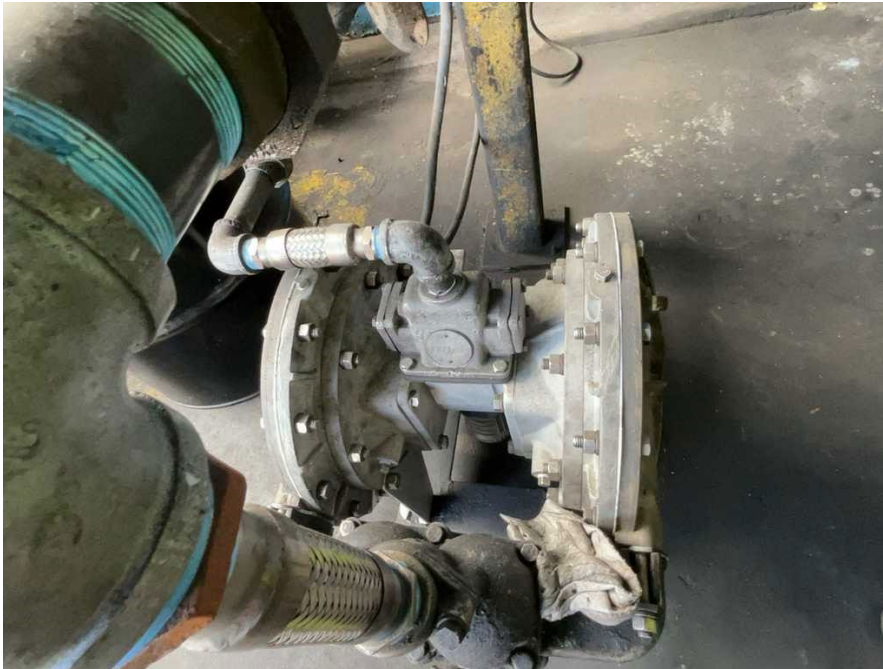
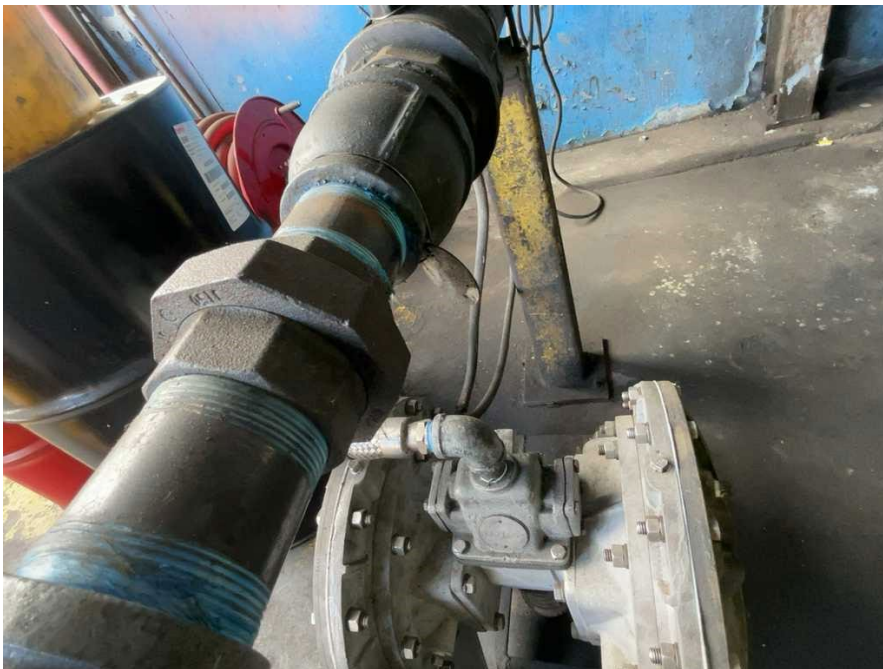
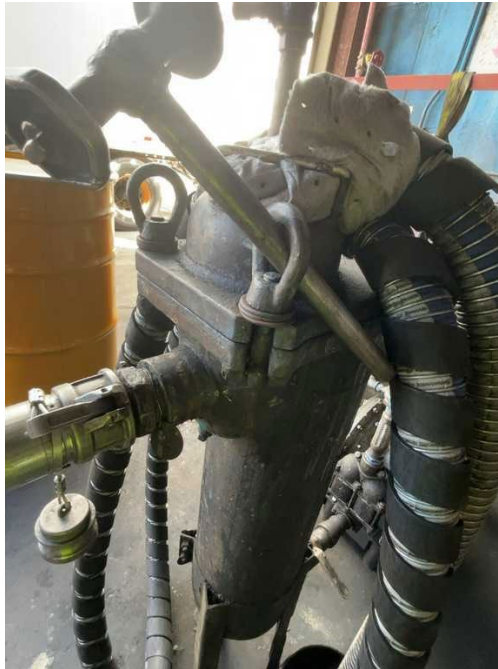
This area is used to pump waste fuel and lean water (aqueous solution contaminated with solvent or listed waste) from containers to one of five hazardous waste tanks in the South Tank Farm. The tank ancillary equipment in the fill station is tagged pursuant to subpart BB of the organic air emissions (Photos 35-39).

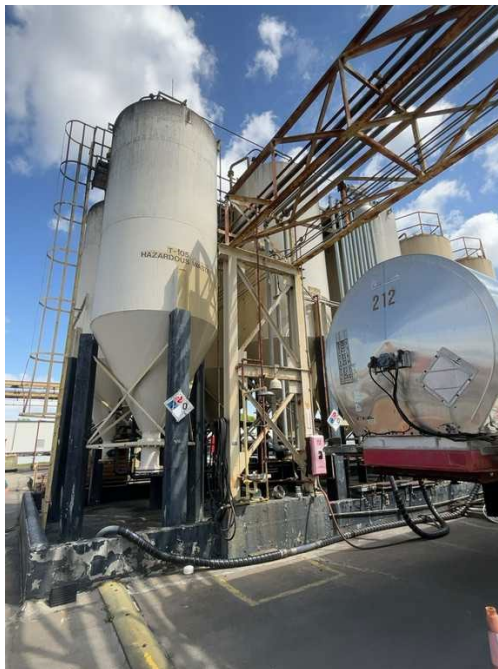
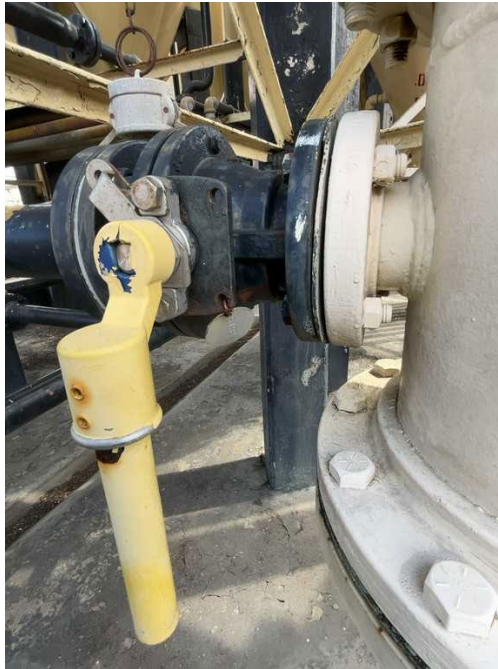
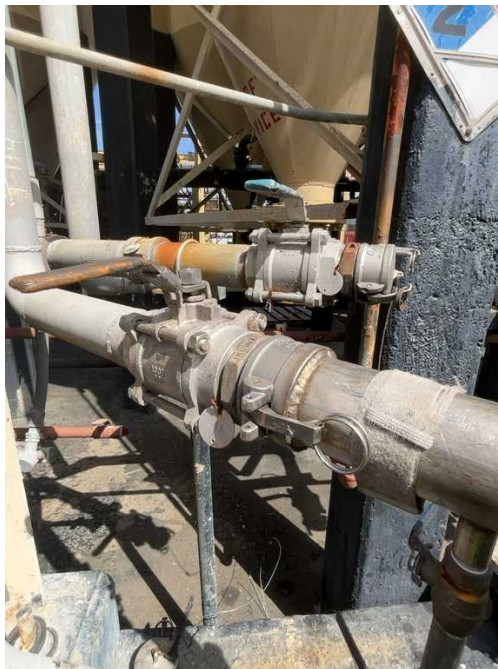
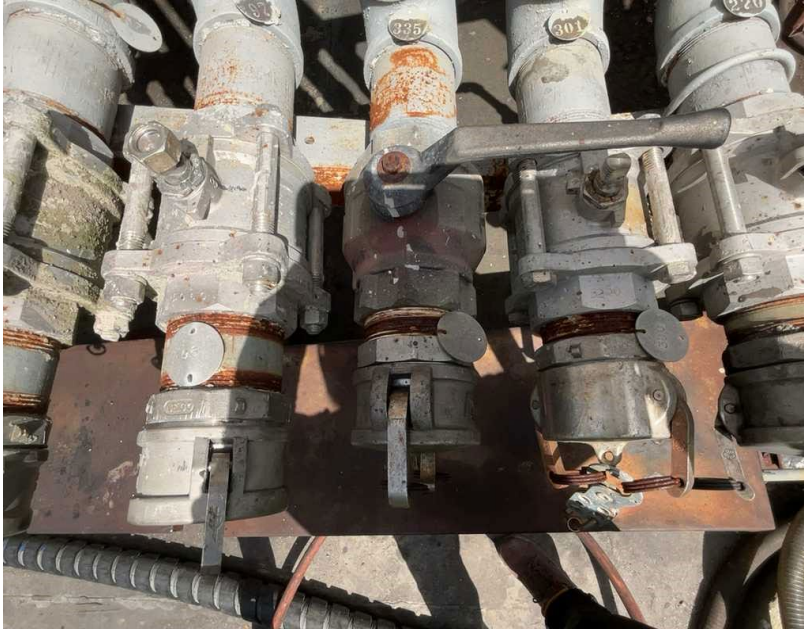
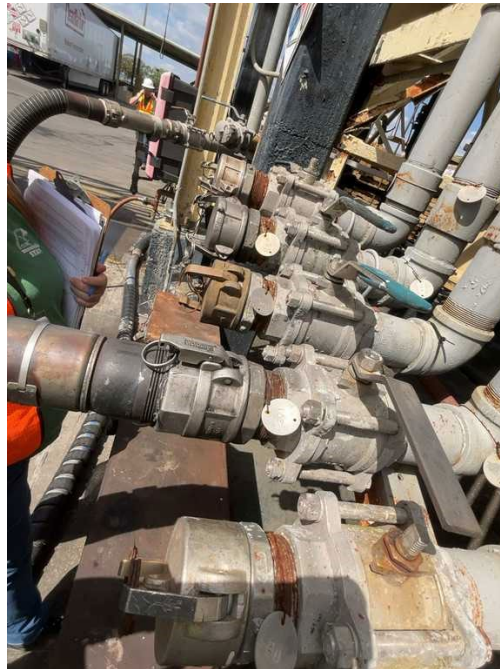
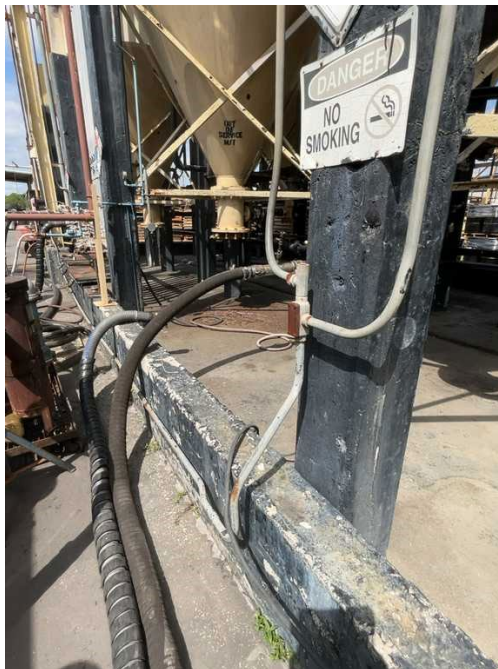
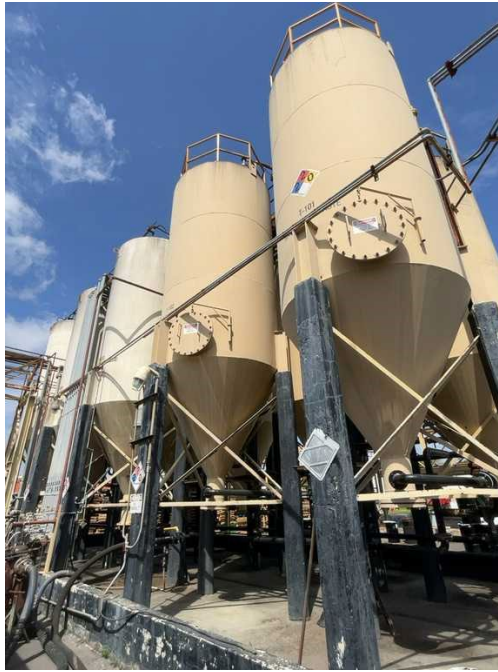
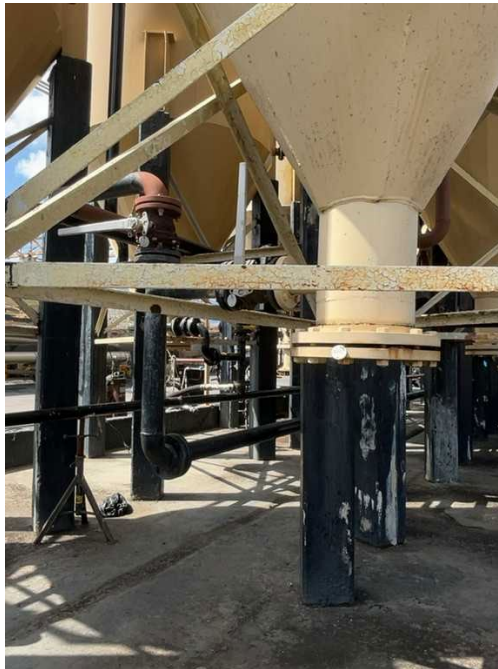
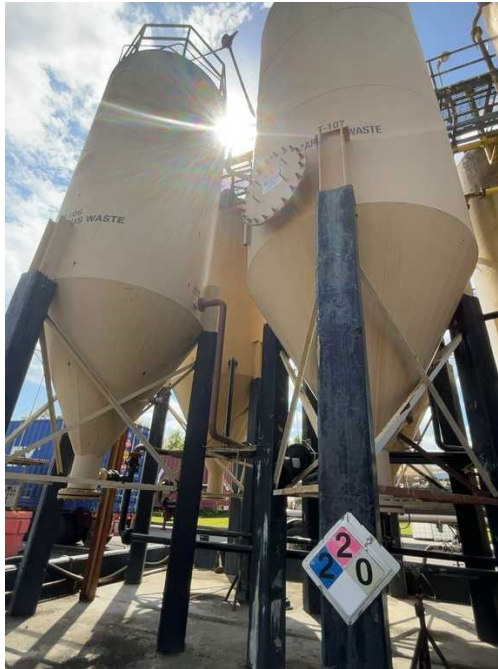
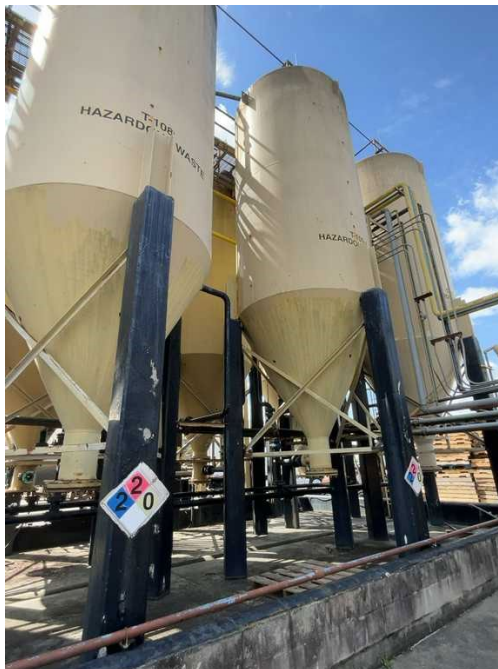
The South Tank Farm consists of Tanks T-101 through T-110. All ten aboveground storage tanks have a storage capacity of 6,000 gallons, have cone-shaped bottoms, and are situated in concrete secondary containment. Hazardous wastes in these tanks are pumped into bulk tankers and transported to a permitted disposal facility or sent to the CSX Transflo international transfer facility and loaded onto rail cars to be sent to a permitted disposal facility.

All tanks contained a hazardous waste label and an NFPA diamond to indicate the hazard of the contents. The tanks appeared in good condition and all tank pumps, valves, and flanges appeared to be marked. Nuts and bolts did not appear to be missing on the tanks and end caps were secure on piping (Photos 40-50).

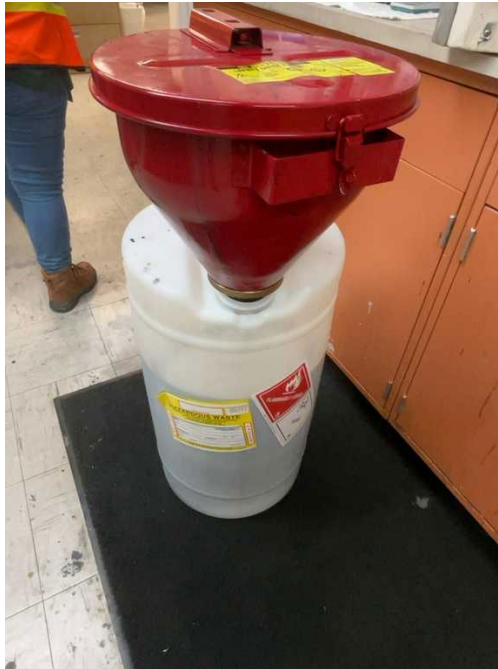
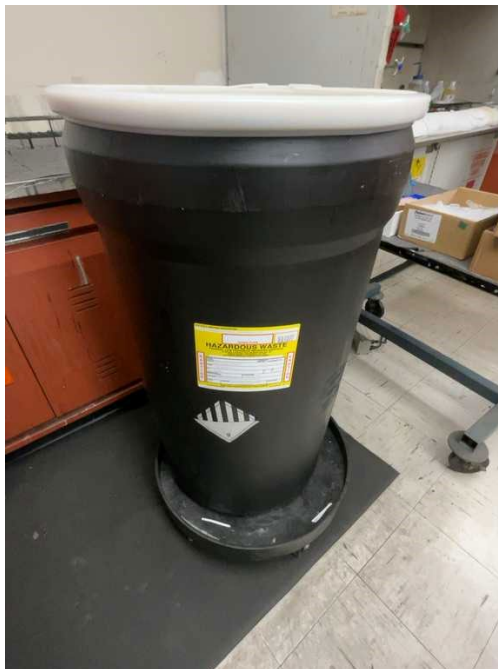
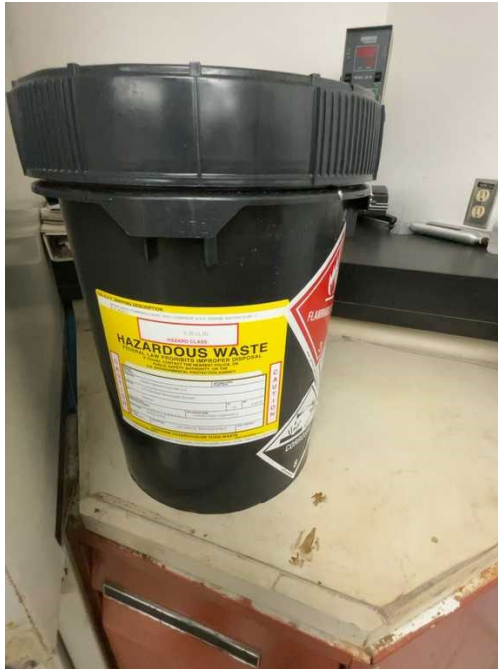
The laboratory is used to conduct onsite waste analysis. Laboratory samples are barcoded for tracking purposes. Samples are disposed of into one of three satellite accumulation areas (SAA) after wastes have been analyzed. The inspectors observed the following wastes (Photos 51-53):

- One 20-gallon container of waste flammable liquids. The container was closed, labeled “Hazardous Waste—Flammable Liquids”, and marked with an indication of the hazard of the contents;
- Two 55-gallon containers of flammable solids/ solid debris contaminated with solvents. The container was closed, labeled “Hazardous Waste—Flammable Solids/ Solid Debris Contaminated with Solvents, and marked with an indication of the hazard of the contents; and
- One 5-gallon container of lab waste broken vials. The container was closed, labeled “Hazardous Waste—Lab Waste Broken Vials”, and marked with an indication of the hazard of the contents.
