INSPECTION REPORT

Inspection Date(s):	04/05/2022 - 04/08/2022	Announced: Yes			
Time:	Entry: 02:30 PM (CT)	Exit: 09:04 AM (CT)			
Media:	Water				
Statute(s)/Program(s):	Clean Water Act, NPDES				
Type of inspection:	SSO - Sanitary Sewer Overflow Recon Inspection				
Access:	Granted				
Permittee Name:					
City of Cahokia Heights					
Facility or Site Name:					
City of Cahokia Heights					
Facility/Site Physical Address:					
103 Main Street					
(City, state, zip code)					
Cahokia Heights, IL					
County/Parish:					
St. Clair					
Mailing address: (If different)					
(City, state, zip code)					
Facility/Site Identifier:					
ILN000019					
Permit Number:					
Unpermitted Facility					
SIC or NAICS:					
Persons Participating in Inspection:					
Title	Name	Phone	Email	Present at Opening Conf.	Present at Closing Conf.
Lead Inspector	Dean Maraldo	3123532098	maraldo.dean@epa.gov	Yes	Yes
Inspector	Ted Flatebo	(312) 886-9402	flatebo.ted@epa.gov	Yes	No

SSO recon inspection for the City of Cahokia Heights.

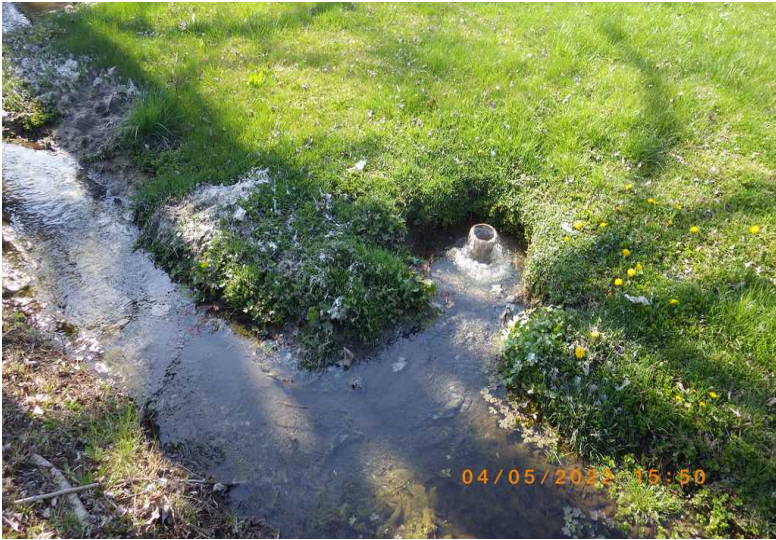
Flowing SSO from sewer cleanout on N82nd Street

RIMG0065.JPG	
04/05/2022 03:50 PM (CT)	
Dean Maraldo	
N82nd Street SSO	
No CBI	
No PII	
SSO observed flowing from sewer cleanout. Noted toilet paper residue in the ditch and along banks. Photo taken at 3:50 pm on April 5, 2022.

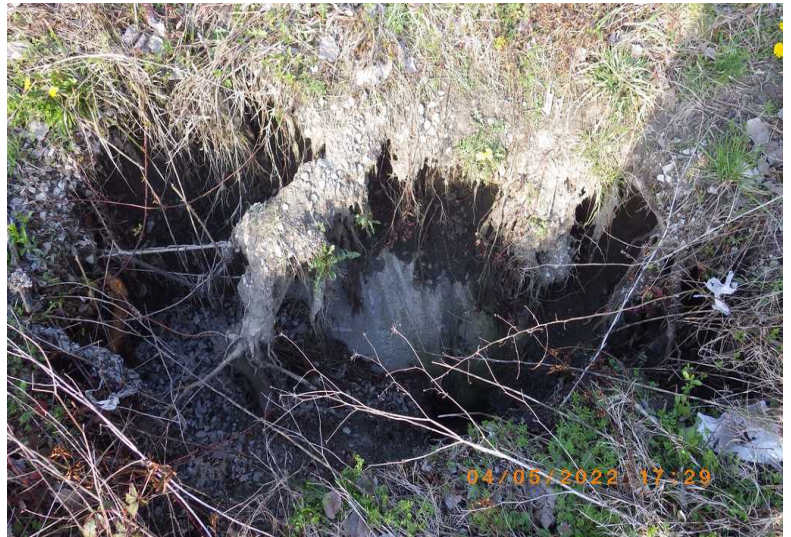
Collapsed ground revealing apparent storm sewer main
RIMG0066.JPG
04/05/2022 05:29 PM (CT)
Dean Maraldo
Former Village of Cahokia Lift Station 5 (rear)
No CBI
No PII
Photo taken at 5:29 pm on April 5, 2022.

DM4-CC-NT
I asked Dennis Traiteur about the exposed pipe adjacent to the former Village of Cahokia Lift Station 5 (rear). He was not aware of the exposed pipe and said he would look into it right away and get back to me with an update.

“Per the conversation you had with Dennis this morning in regards to the hole near the (Jerome & Mousette) lift station; this is a storm sewer drain that needs to be repaired. Storm drains are the Street Departments jurisdiction and they are aware of the needed repair.”

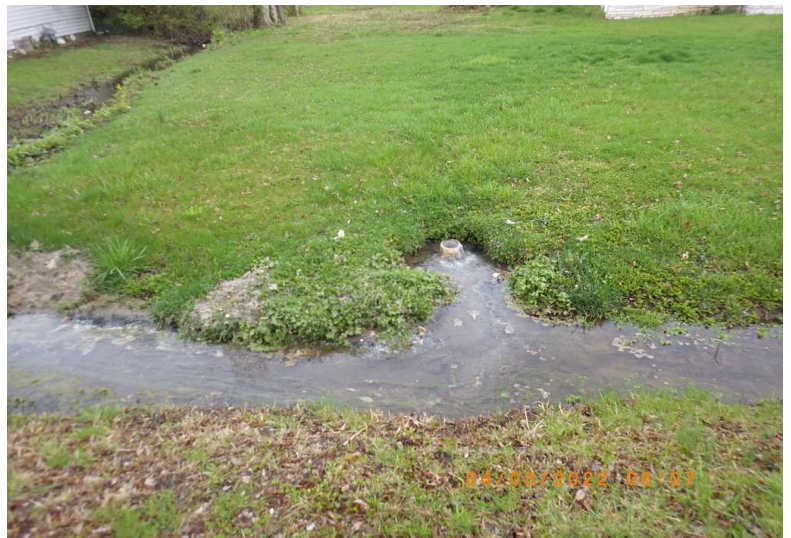
Photo(s) 1. PLST0001.JPG

Location: N82nd Street SSO	
DM4-OB-003	
On April 5, 2022, I observed the location of the chronic SSO point in front of a residential property on the north side of N82nd Street. The SSO was flowing (see Photo 1) and toilet paper debris was observed around the flowing cleanout.	Citations: Section 301(a) of the CWA, 33 U.S.C. § 1311
DM4-OB-007	
We returned to Cahokia Heights on April 8 to observe the N82nd Street SSO location. The SSO was flowing (see Photo 3) and toilet paper debris was observed around the flowing cleanout.	Citations: Section 301(a) of the CWA, 33 U.S.C. § 1311

Flowing SSO from sewer cleanout on N82nd Street
PLST0001.JPG
04/08/2022 08:07 AM (CT)
Dean Maraldo
N82nd Street SSO
No CBI
No PII
SSO observed flowing from sewer cleanout. Noted toilet paper residue in the ditch and along banks. Photo taken at 8:07 am on April 8, 2022.
