EPA REGION 6 Enforcement Division

INSPECTION REPORT

| <b>Type of Inspection</b> | Focused Compliance Inspection (FCI) | | | |
| <b>Facility or Site Name</b> | PMI Environmental Services | | | |

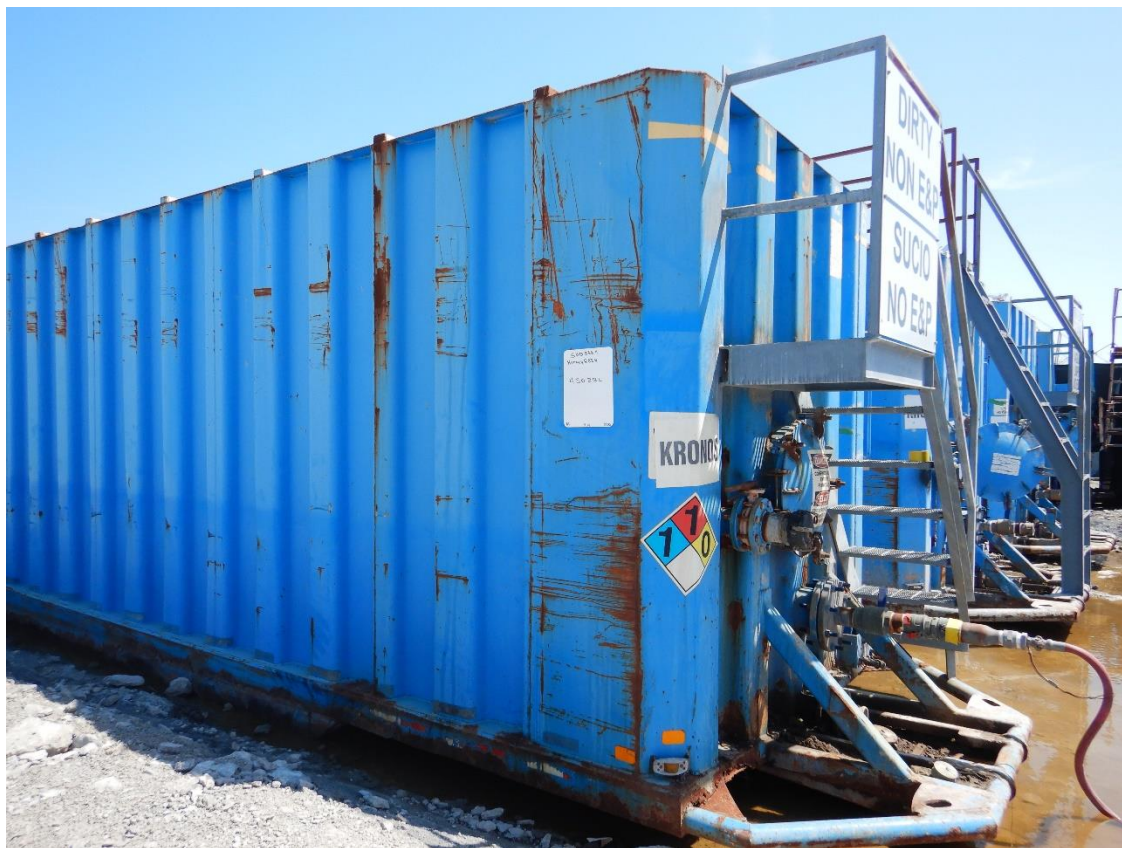
Photo No. 1

- The inspection team observed the cleaning system for vessels, which included multiple frac tanks used to recycle washwater. There were two sets of frac tanks dedicated to washing vessels that managed E&P waste and another set of frac tanks dedicated to non-E&P washing. Facility personnel stated that the frac tanks for non-E&P washing were not fully operational (see Appendix 1 – Photos 1 through 3). No apparent AOCs were observed in these areas at the time of the inspection.

Description: View of frac tanks staged for future use in non-E&P vessel tank cleaning.

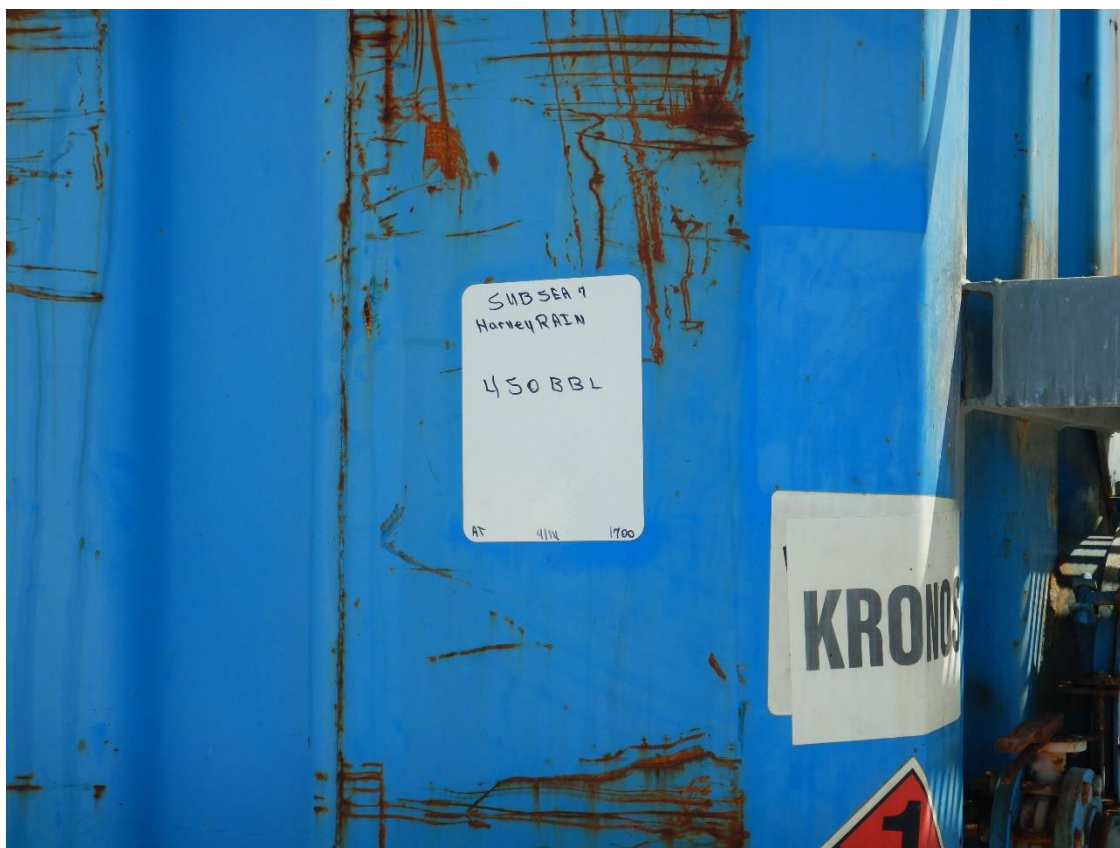
Photo No. 2

Description: View of a label on one of the frac tanks staged for future use in non-E&P vessel tank cleaning.

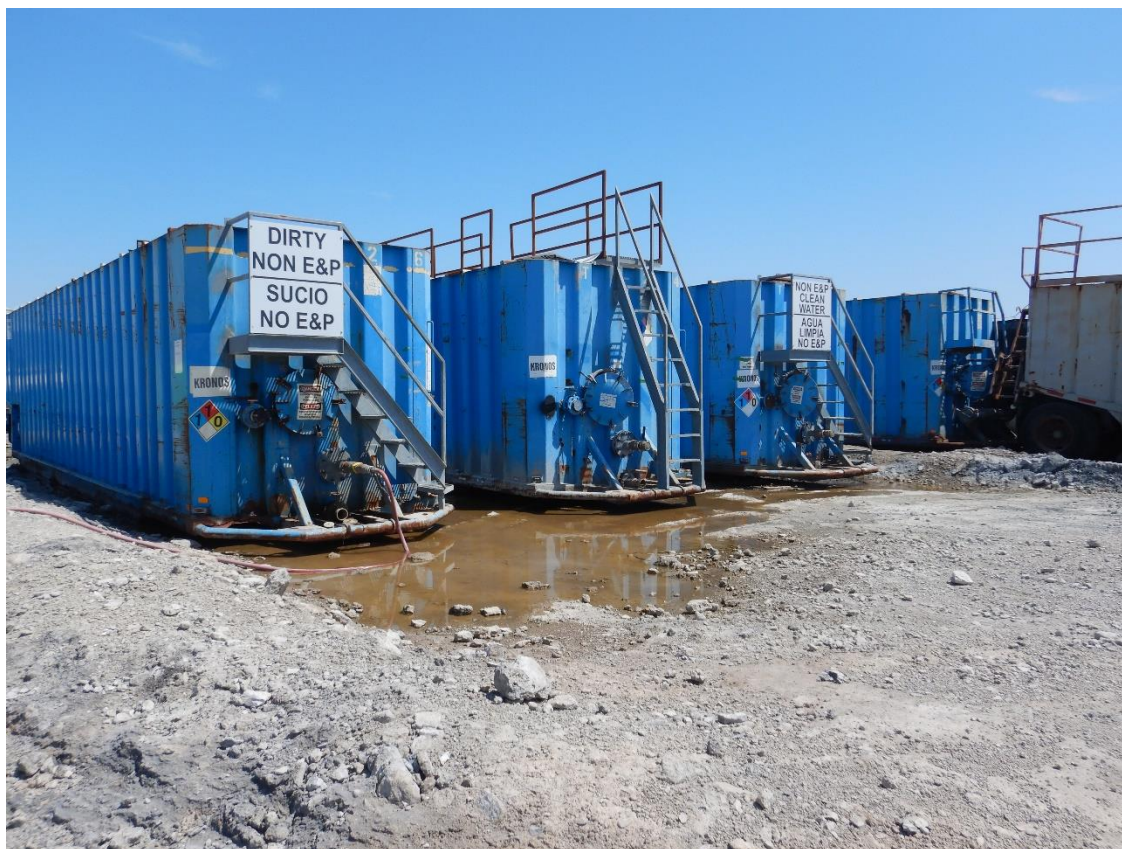
Photo No. 3

Description: View of frac tanks staged for future use in non-E&P vessel tank cleaning.

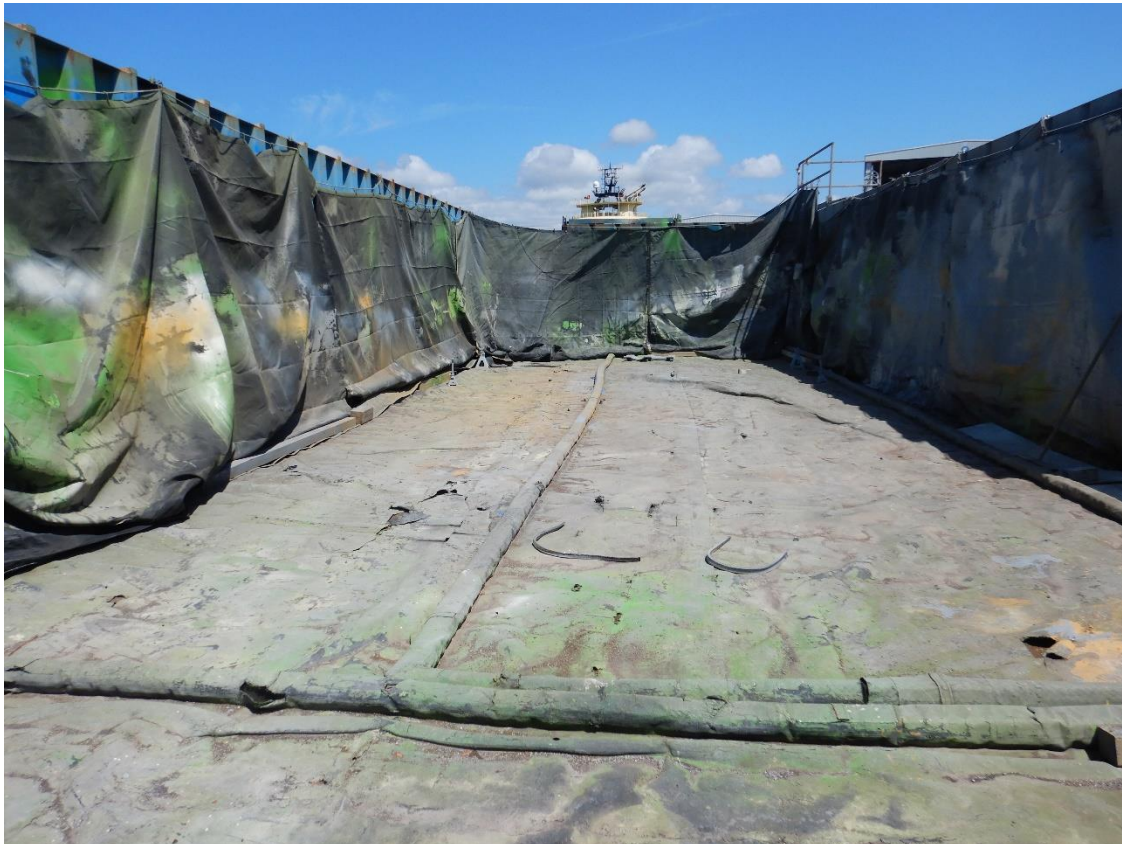
**Photo No. 4**

- The inspection team observed the painting and cleaning area for the frac tanks (see Appendix 1 – Photos 4 and 6). PMI conducts sponge blasting in the area to remove old paint from frac tanks and uses spray coating methods. Facility personnel stated that there is no paint waste from cleaning spray equipment since paint thinner is recycled back into the paint for reuse. In the area, the inspection team observed cuts and tears in the tarp directly open to the ground, which may allow paint chips or fugitive paint spray to be released to the environment (see Appendix 1 – Photo 5). It is uncertain whether paint chips or spray could be characterized as hazardous waste during any use of the area [**AOC #1:** *The painting and cleaning area for frac tanks was not operated to minimize the release of waste, potentially hazardous waste, to the environment. – 40 CFR 262.251*]. PMI did provide analytical data to show that blast media and paint chips sampled from the area was not hazardous based on metals content (see follow-up responses at the end of this section). It is uncertain whether the material sampled is representative of any future waste that will be generated in the area.

Description: View of the painting and cleaning area for frac tanks.

- Blast media and paint chips sampled from the frac tank painting and cleaning area were shown to be nonhazardous according to analytical data (Appendix 3).

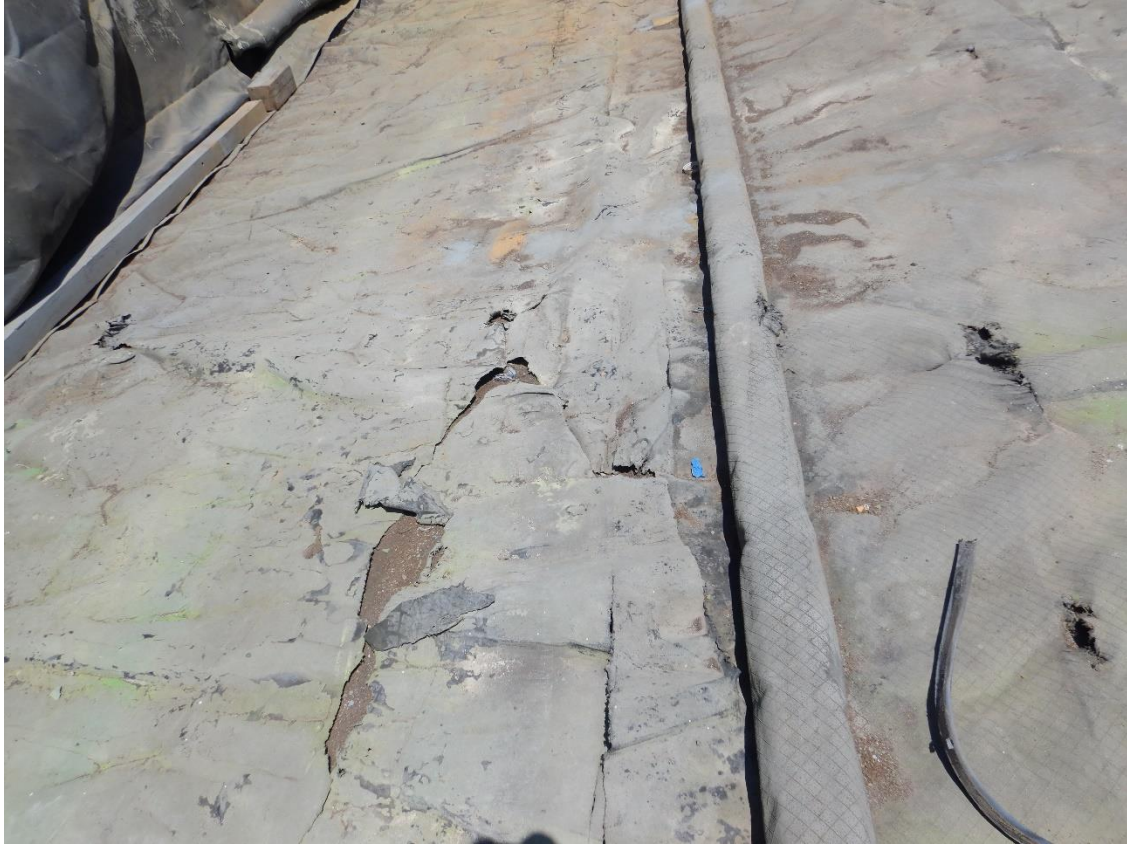
Photo No. 5

| <b>Tenant:</b> PMI Environmental Services | | |
|---|---|---|
| <b>AOC #1</b> – The painting and cleaning area for frac tanks was not operated to minimize the release of waste, potentially hazardous waste, to the environment. | <b>Citation:</b> 40 CFR 262.251 | Section: 2 |

Description: Rips observed in the liner system for the painting and cleaning area for frac tanks. The ground beneath the liner was exposed in several areas.

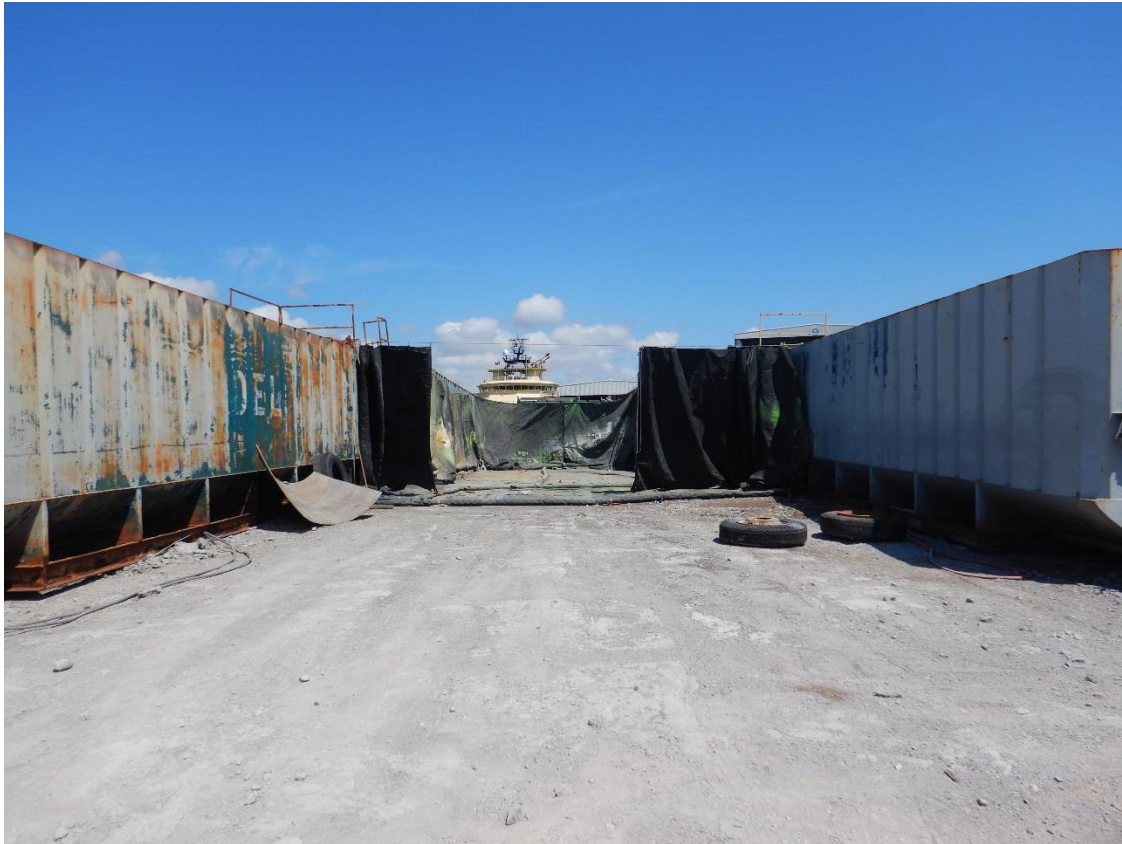
Photo No. 6

Description: Overview of the painting and cleaning area for frac tanks.

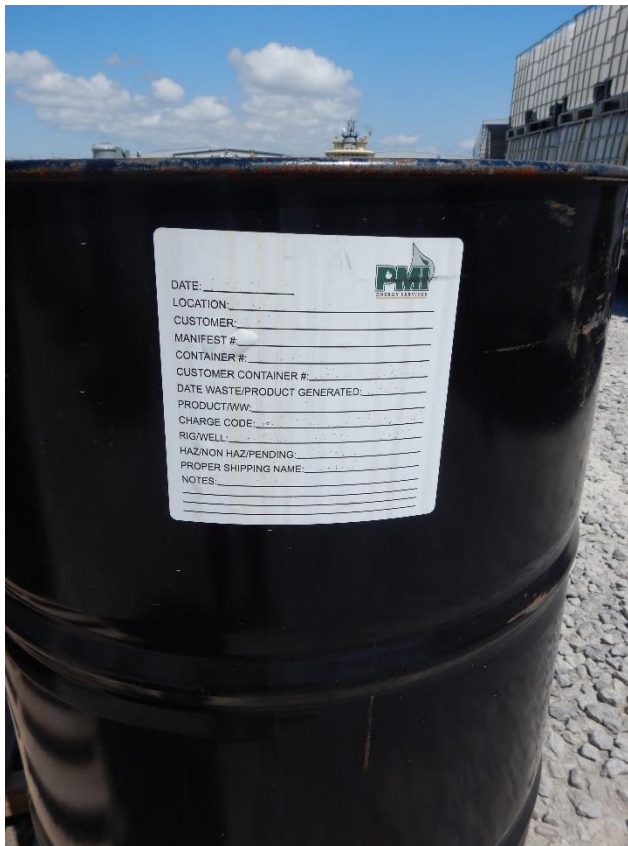
Photo No. 7

| <b>Tenant:</b> PMI Environmental Services | | |
|---|---|---|
| <b>AOC #2</b> – Containers holding waste pending analysis, or potentially hazardous waste, were either unlabeled or did not have clear labeling indicating the material as hazardous waste or hazardous waste pending analysis. | <b>Citation:</b> 40 CFR 262.17(a)(5)(i) | Section: 2 |

Description: View of a faded label on a drum of washwater pending waste analysis in a staging area.

- PMI provided a letter from LDEQ acknowledging their status as a hazardous waste transfer facility (Appendix 4).
- PMI provided photographs showing new signage for designated waste pending analysis areas as well as photographs of a label printer that was purchased (Appendix 5). PMI purchased the label printer to prevent label fading or illegible labels. PMI also stated in their email that containers pending analysis or mislabeled during the inspection were moved to the proper storage area and labeled.

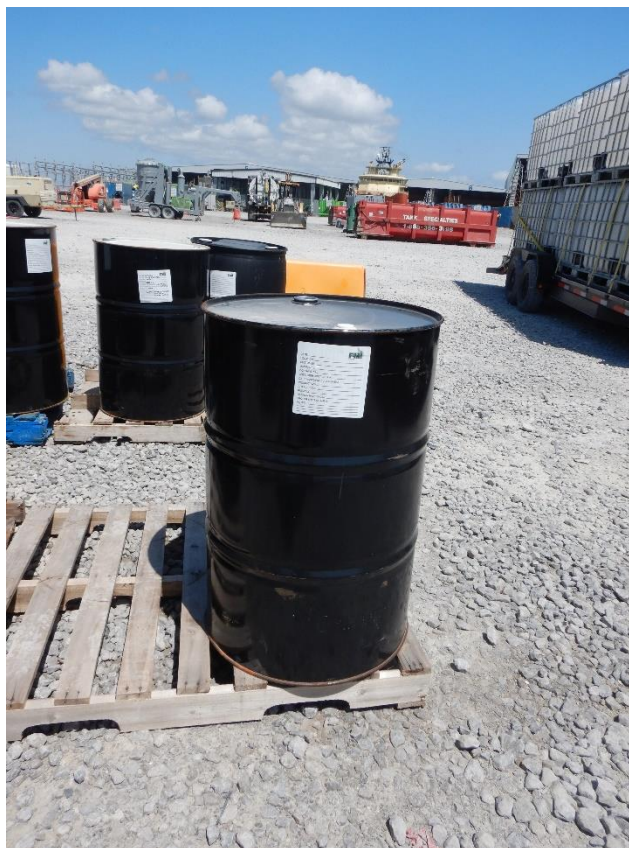
Photo No. 8

Description: View of a drum of washwater with a faded label pending waste analysis in the staging area (same drum as in Photo No. 7).

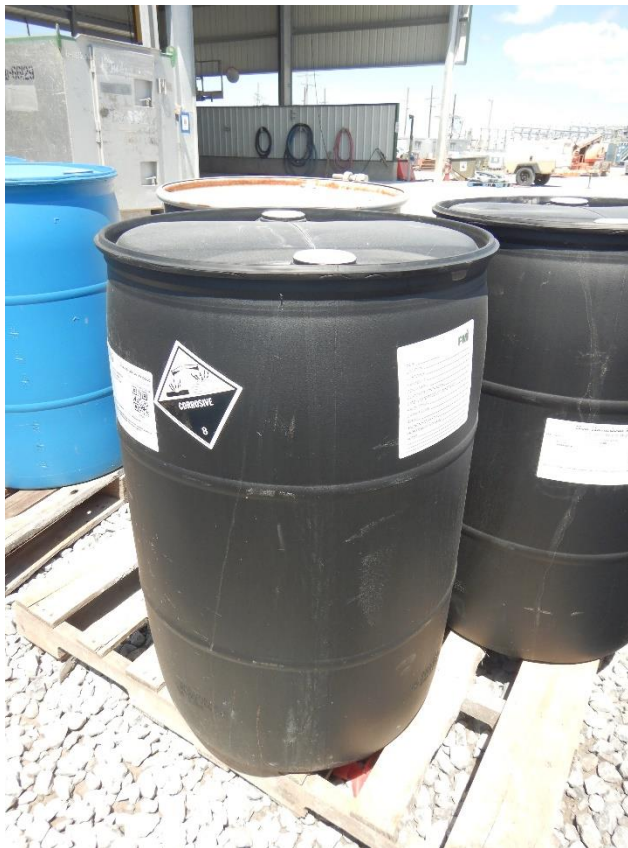
Photo No. 11

nonhazardous. Mr. Bush, stated that they always sample washwater to make a waste determination. During the inspection, the inspection team observed one 55-gallon drum with both a nonhazardous waste label from PMI and a hazardous waste label from BEOM (see Appendix 1 – Photos 9 through 11), one 55-gallon drum with a PMI label that was illegible (see Appendix 1 – Photos 7 and 8), several 55-gallon drums with only a PMI label and pending analysis – including one dated on 12/31/23 (see Appendix 1 – Photos 14 and 15), and 55-gallon drums without any label (see Appendix 1 – Photo 16) [**AOC #2: Containers holding waste pending analysis, or potentially hazardous waste, were either unlabeled or did not have clear labeling indicating the material as hazardous waste or hazardous waste pending analysis – 40 CFR 262.17(a)(5)(i)**]. Several of the containers were also labeled as hazardous waste (see Appendix 1 – Photos 12 and 13). Additionally, the containers of hazardous waste or hazardous waste pending analysis were staged alongside nonhazardous wastes on pallets on the ground outside of the central accumulation area (CAA) [**AOC #3: Hazardous waste and wastes pending analysis were not managed in the CAA, so it is uncertain if inspection requirements and emergency preparedness requirements were met for these wastes. – 40 CFR 262.17(a)(1)(v) and 40 CFR 262.252**].

Description: View of a 55-gallon drum with both a PMI nonhazardous waste label and a BEOM hazardous waste label (see Photo Nos. 9 and 10).

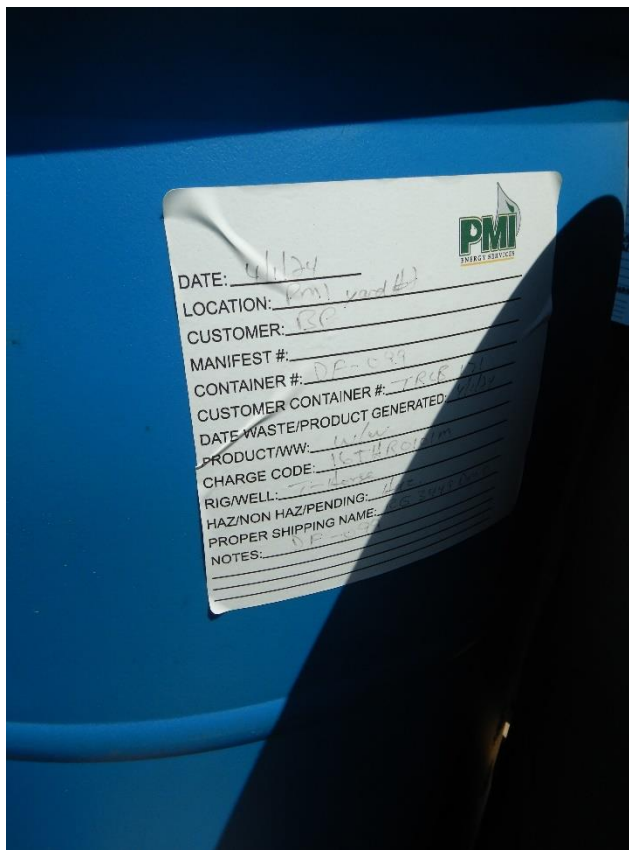
Photo No. 12

| <b>Tenant:</b> PMI Environmental Services | | |
|---|---|---|
| <b>AOC #3</b> – Hazardous waste and wastes pending analysis were not managed in the CAA, so it is uncertain if inspection requirements and emergency preparedness requirements were met for these wastes. | <b>Citation:</b> 40 CFR 262.17(a)(1)(v) and 40 CFR 262.252 | Section: 2 |

Description: View of a PMI label on a 55-gallon drum identifying it as hazardous waste washwater.

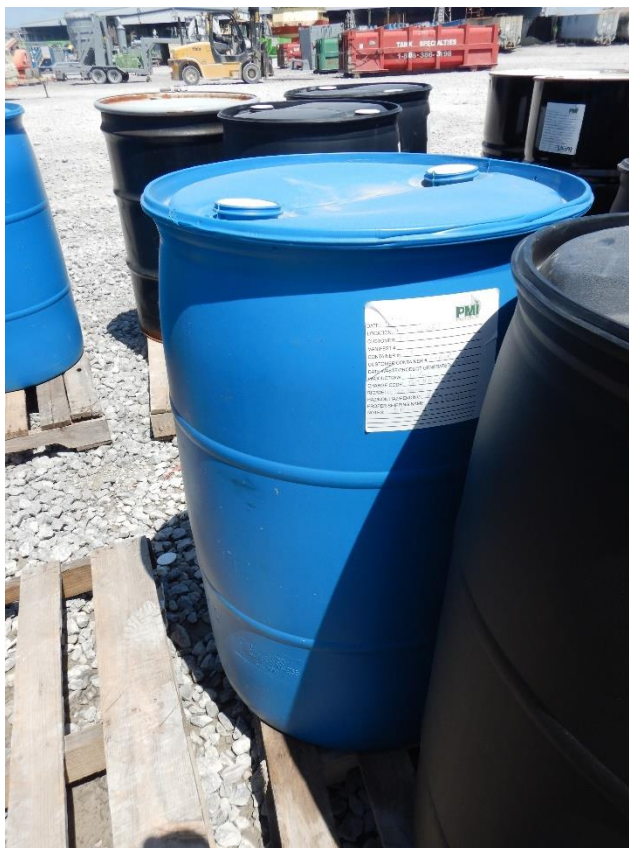
Photo No. 13

Description: View of a 55-gallon drum of washwater with a PMI label identifying it as hazardous waste.

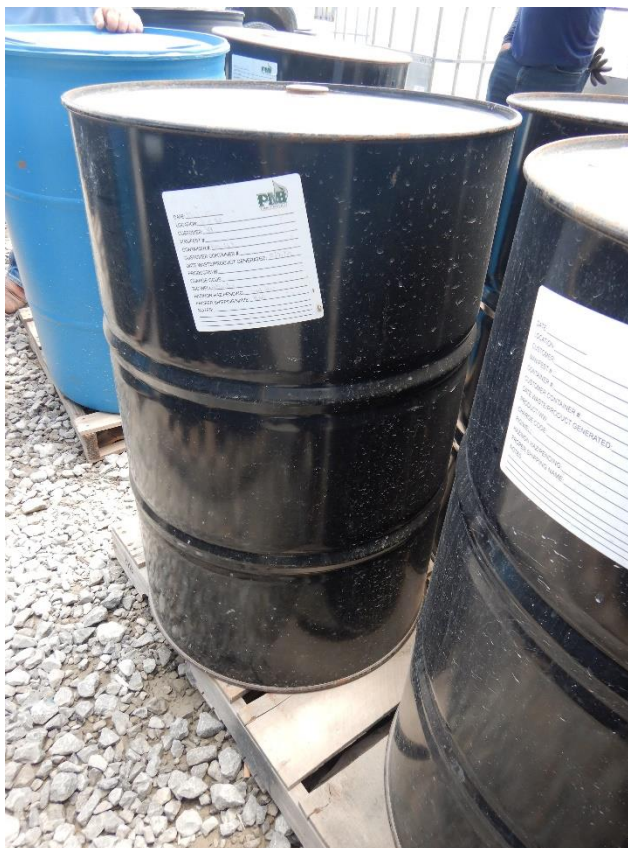
Photo No. 15

Description: View of a 55-gallon drum with a PMI nonhazardous waste label showing a generation date in December 2023. The PMI label is used as a temporary label until analysis confirms the waste determination.

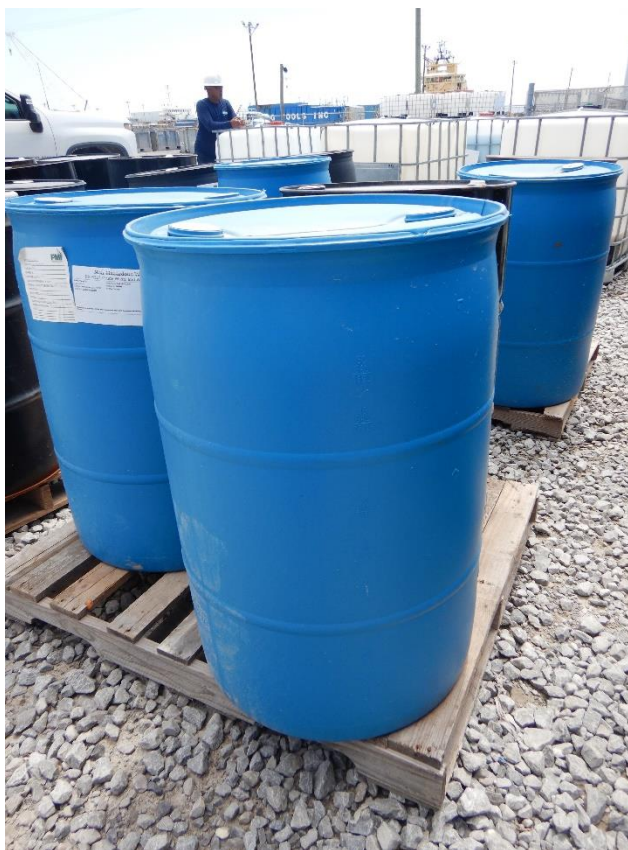
Photo No. 16

Description: View of an unlabeled 55-gallon drum in the staging area.

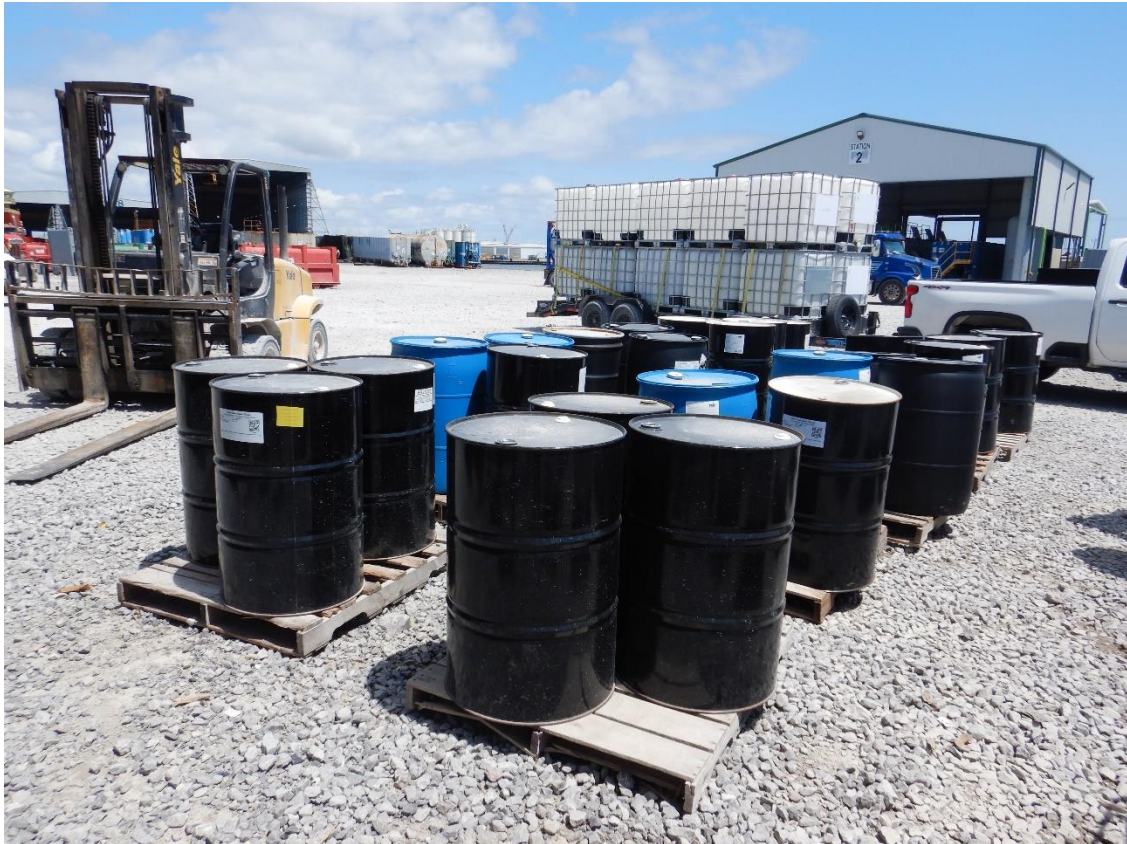
**Photo No. 17**

- The inspection team visited the staging area designated for containers of product and nonhazardous washwater (see Appendix 1 – Photos 17 and 18). PMI personnel label and place containers of washwater in the area as either nonhazardous waste or waste pending analysis. A contractor from BEOM, Mr. Bush at the time of the inspection, then samples the containers of washwater and uses the analytical results to make a waste determination for each container. After a determination is made, the BEOM contractor places another label on the container for whether it is hazardous or

Description: Overview of the staging area for products and nonhazardous wastewater.

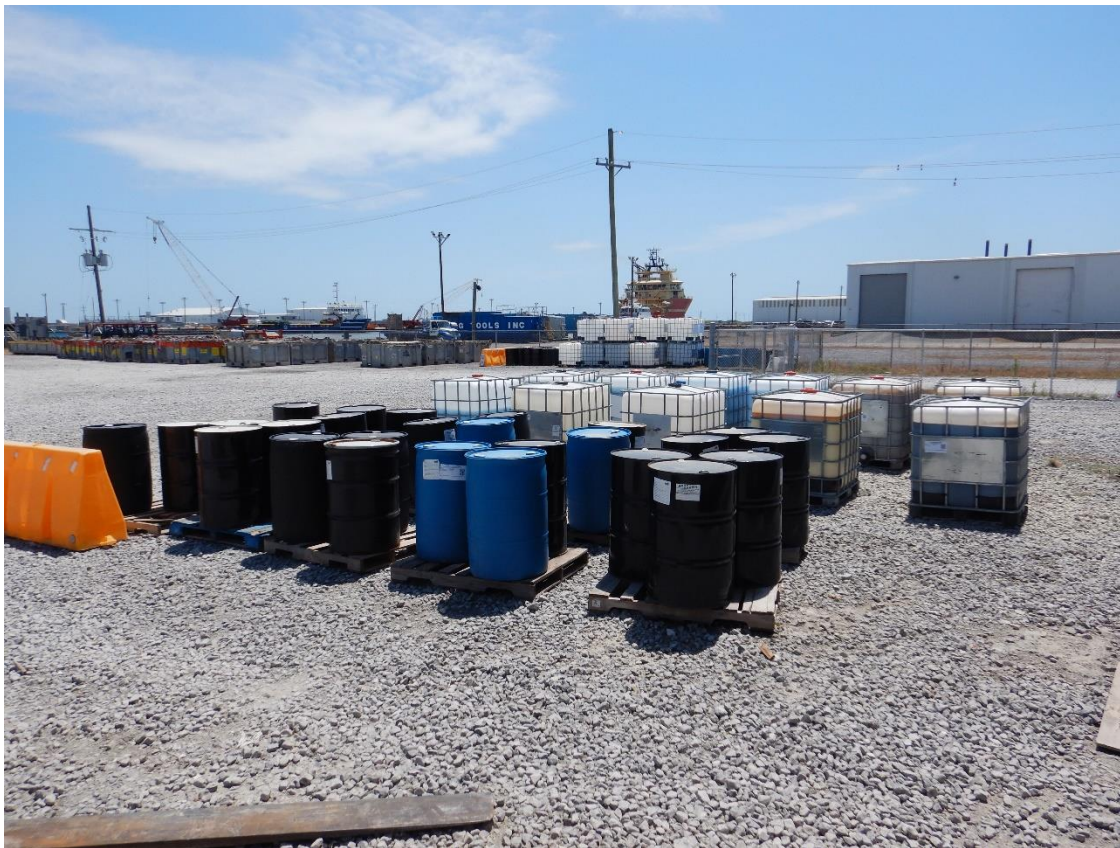
Photo No. 18

Description: Overview of the staging area for products and nonhazardous wastewater.

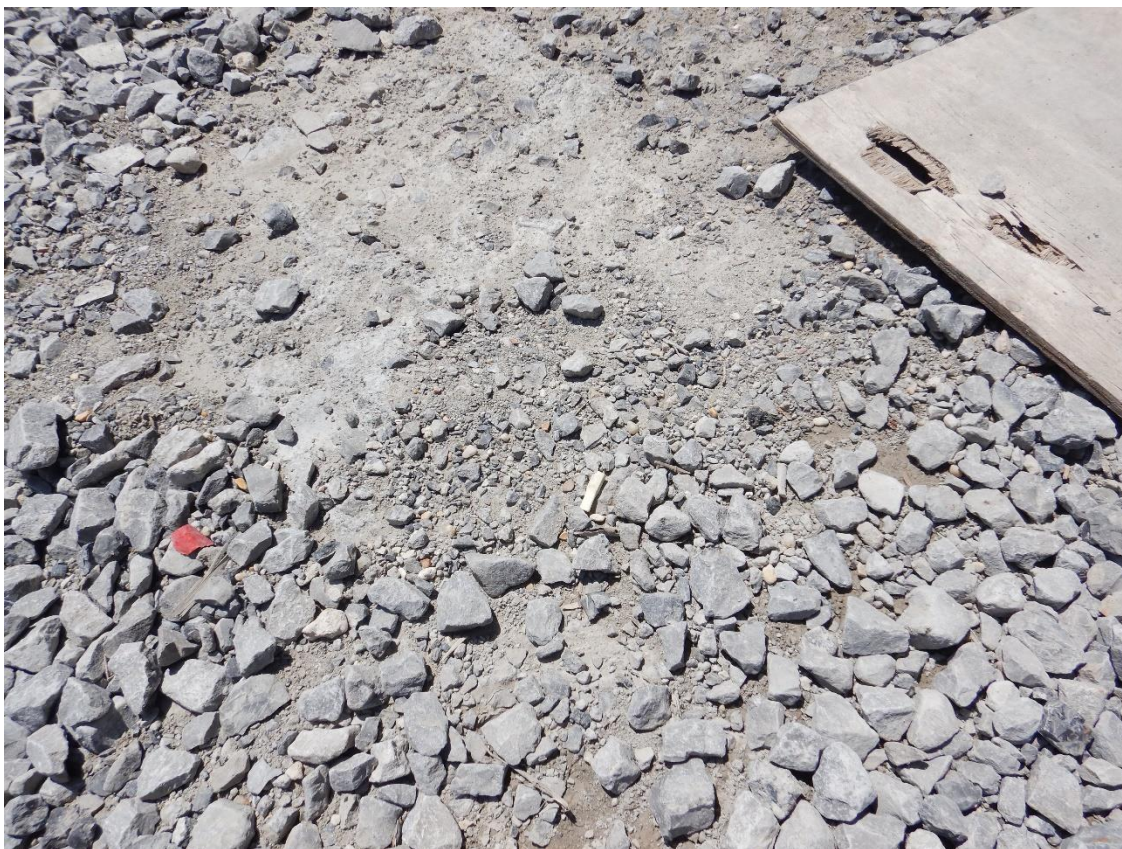
Photo No. 19

- The inspection team observed several cigarette butts on the ground near the CAA and 10-day transfer area where ignitable wastes are managed (see Appendix 1 – Photos 19 through 23) [**AOC #4: There were signs of personnel smoking cigarettes as potential sources of ignition near where ignitable hazardous waste is accumulated and handled – 40 CFR 262.17(a)(1)(vi)(B)**].
- The inspection team also observed the staging area for incoming RCRA-empty containers as well as a cargo shipping container where paints and thinner are stored, and no issues were noted at the time of the inspection.

| <b>Tenant:</b> PMI Environmental Services | | |
|---|---|---|
| <b>AOC #4:</b> There were signs of personnel smoking cigarettes as potential sources of ignition near where ignitable hazardous waste is accumulated and handled. | <b>Citation:</b> 40 CFR 262.17(a)(1)(vi)(B) | Section: 2 |

Description: View of a cigarette butt located on the ground near the hazardous waste accumulation area on site.

- PMI stated in their email response that they conducted a meeting with employees to address smoking in and around the hazardous waste storage area, and that there are plans to build designated smoking areas in a separate area of the facility.

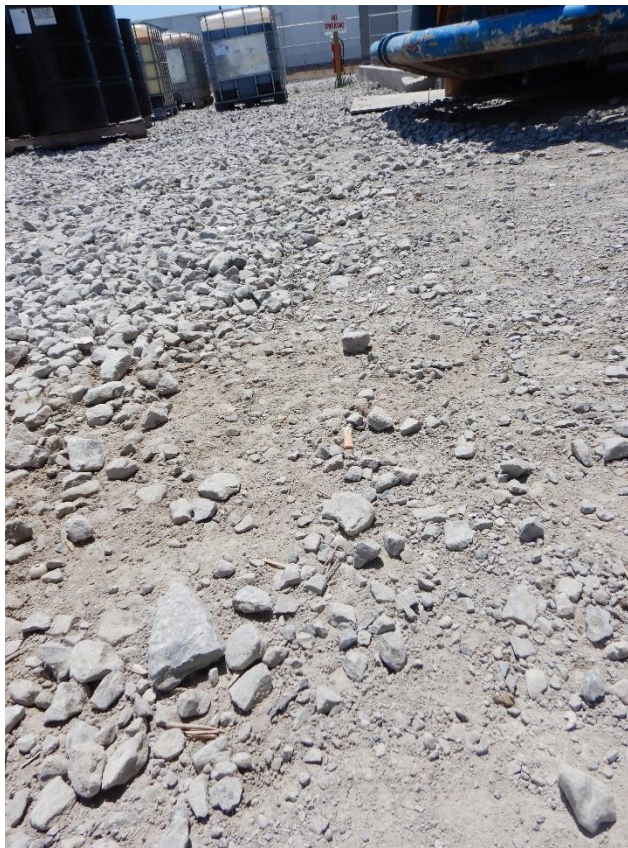
Photo No. 20

Description: View of a cigarette butt located on the ground near the hazardous waste accumulation area on site.

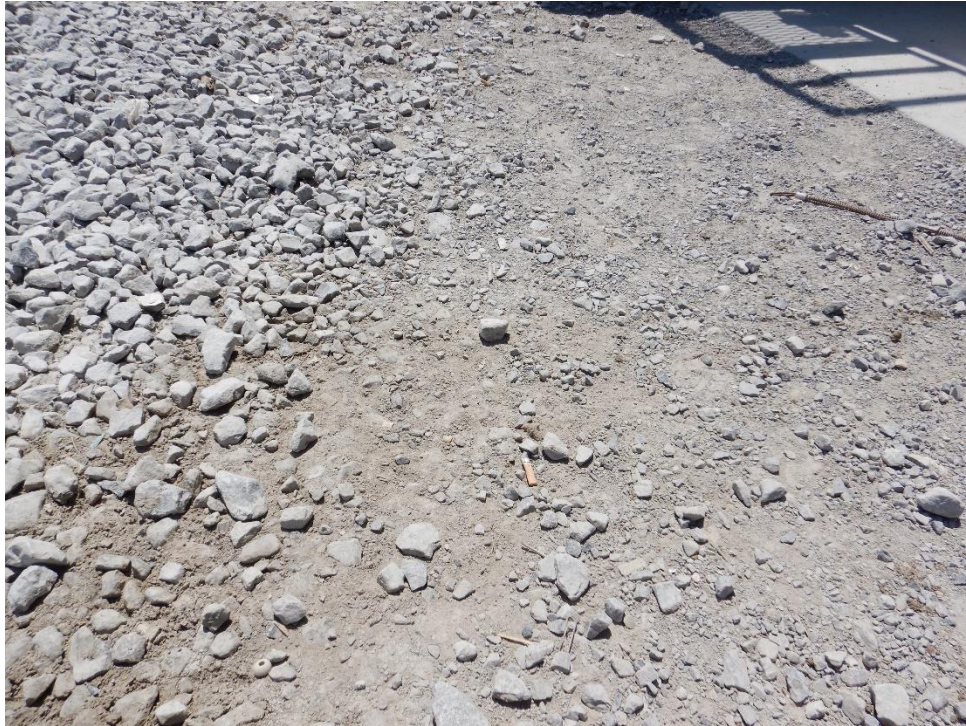
Photo No. 21

Description: View of a cigarette butt located on the ground near the hazardous waste accumulation area on site.

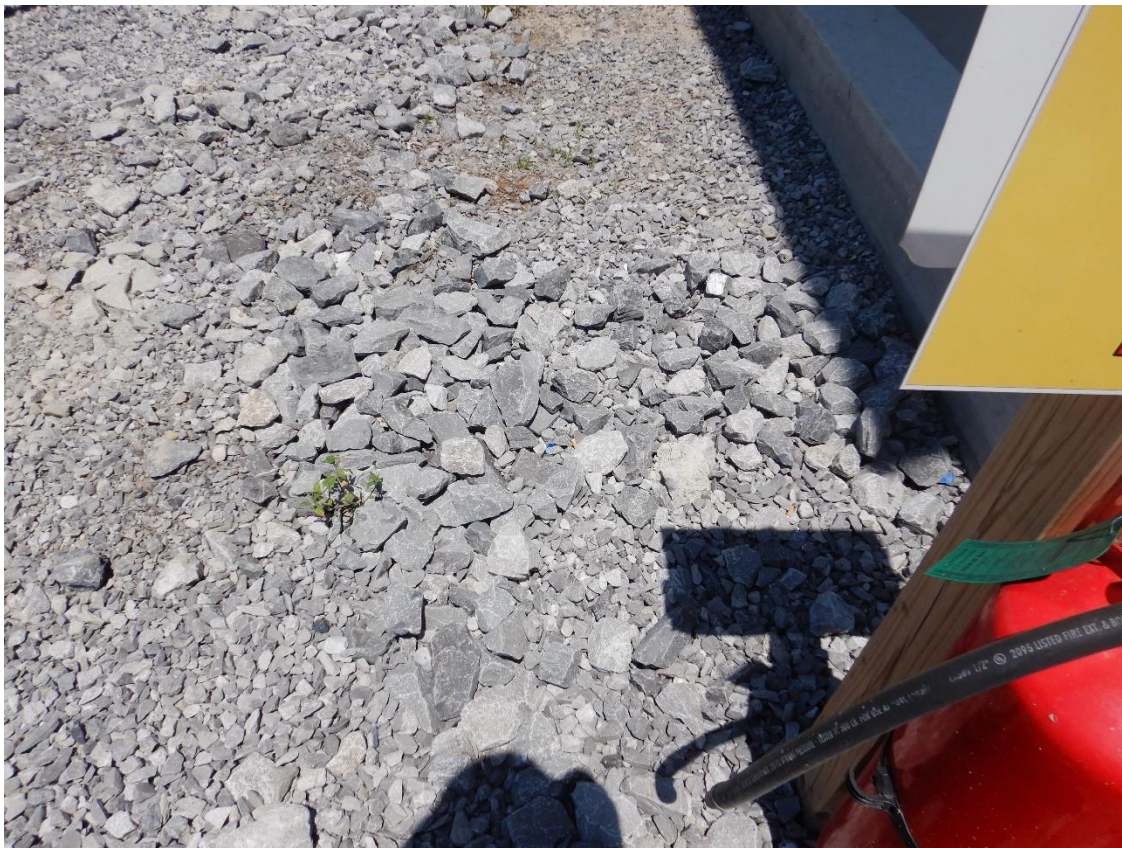
**Photo No. 22**

Description: View of a cigarette butt located on the ground near the hazardous waste accumulation area on site.

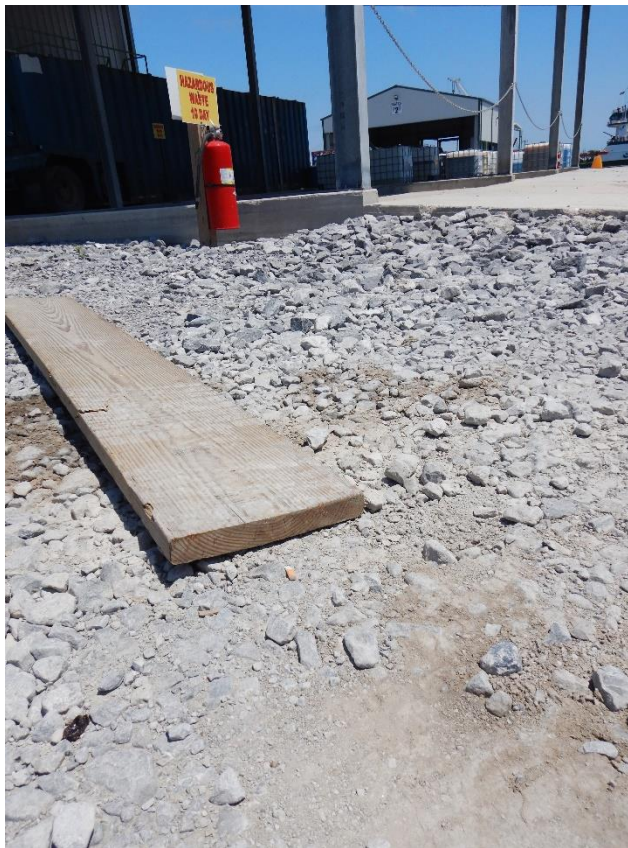
Photo No. 23

Description: View of a cigarette butt located on the ground near the hazardous waste accumulation area on site.
