## **RCRA Inspection Report**

Marine Corp Air Station New River  
AS3525 Perimeter Road  
Jacksonville, North Carolina 28545

## **7) Purpose of Inspection**

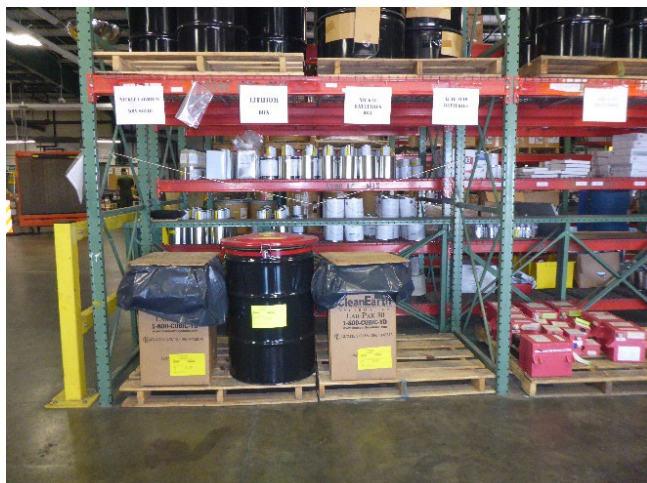
- Bay A1 (Photo 1) is identified for consolidating Nickle-Cadmium Dry-Solid Batteries, Lithium-Ion Batteries, Nickle Batteries Dry, and Lead Acid Batteries. The inspectors observed two wooden pallets in this bay. One pallet held a 30-gallon cardboard box, which was labeled for accumulating universal waste nickle cadmium batteries, and one 55-gallon container, which was labeled for accumulating universal waste lithium-ion batteries. The second pallet contained one 30-gallon cardboard box, which was labeled for accumulating universal waste nickel batteries.

**Photo 1:** Bay A1 for consolidating and storing nickel-cadmium dry-solid batteries, lithium-ion batteries, nickel batteries dry, and lead acid batteries in the CAA.

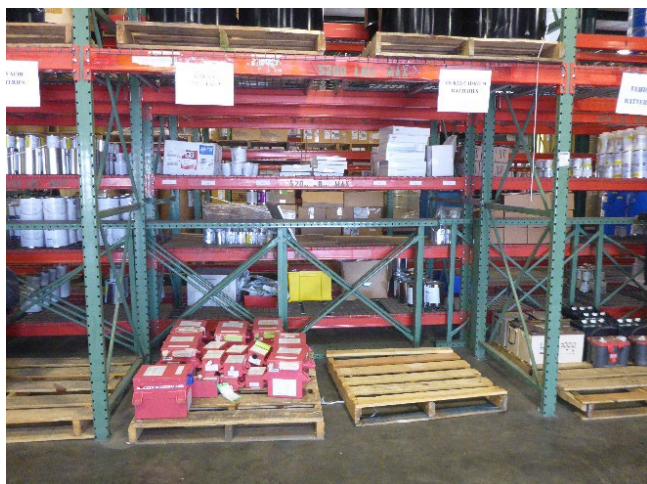
- Bay A2 (Photo 2) is identified for consolidating Aircraft Batteries and Nickel-Cadmium Batteries. The inspectors observed two wooden pallets in this bay. One pallet held a collection of used aircraft batteries. Facility representatives explained that used aircraft batteries are brought here for management and recycling when they can no longer be maintained for continued use on-site. The batteries were not labeled with the words “universal waste.”

**Photo 2:** Bay A2 for consolidating and storing used aircraft batteries and nickel-cadmium batteries in the CAA.

**Pursuant to 15A NCAC 13A .0119(b) [40 C.F.R. § 273.14(a)], a small quantity handler of universal waste (SQHUW) must identify the type of universal waste by labeling or marking each universal waste battery or container in which the batteries are contained clearly with one of the following phrases: “Universal Waste – Battery(ies), or “Waste Battery(ies),” or “Used Battery(ies).”**

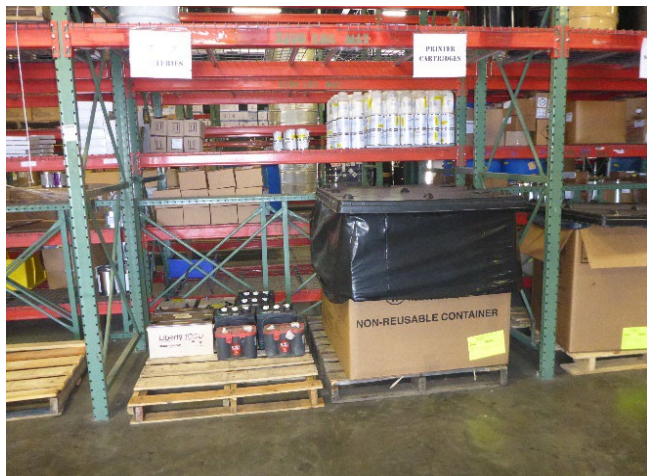
- Bay A3 (Photo 3) is identified for consolidating vehicle batteries and printer cartridges. The inspectors observed two wooden pallets in this bay. One pallet held approximately eight used lead-acid batteries. The batteries were not labeled with the words “universal waste.” The second pallet held a cubic yard box labeled for the accumulation of used printer cartridges.

**Photo 3:** Bay A3 for consolidating and storing vehicle batteries and printer cartridges in the CAA.

**Pursuant to 15A NCAC 13A .0119(b) [40 C.F.R. § 273.14(a)], a small quantity handler of universal waste (SQHUW) must identify the type of universal waste by labeling or marking each universal waste battery or container in which the batteries are contained clearly with one of the following phrases: “Universal Waste – Battery(ies), or “Waste Battery(ies),” or “Used Battery(ies).”**

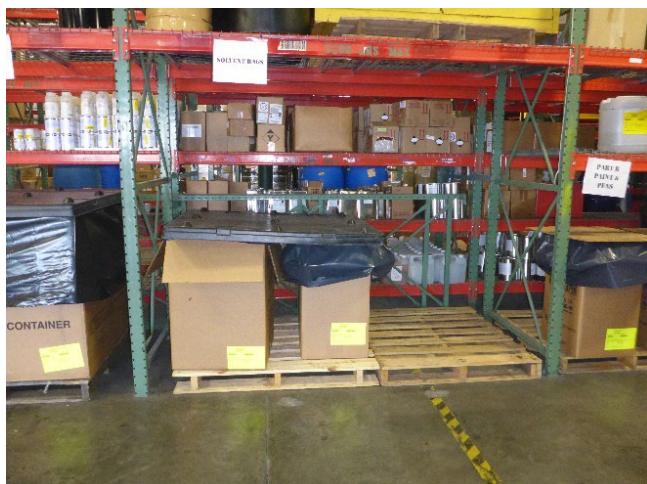
- Bay A4 (Photo 4) is identified for consolidating solvent rags. The inspectors observed two wooden pallets in this bay. One pallet held two cardboard boxes, and the other pallet was empty. The inspectors observed one 55-gallon cardboard box, which was labeled for accumulating hazardous waste used solvent rags, marked with an indication that the contents are toxic, and dated May 1, 2024, and one 30-gallon cardboard box, which was labeled for accumulating hazardous waste cadmium plating rags / debris, marked with an indication that the contents are toxic and corrosive, and dated May 8, 2024; and

**Photo 4:** Bay A4 for consolidating and storing solvent rags in the CAA.

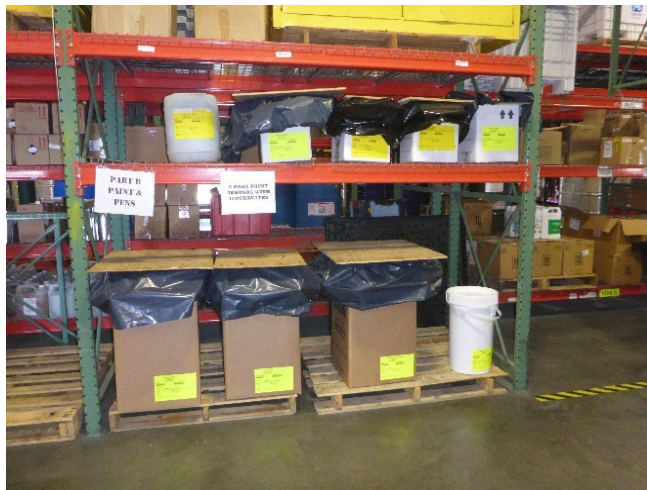
- Bay A5 (Photo 5) is identified for consolidating Part B Paint and Pens and Two-Part Aerosol with isocyanates. The inspectors observed two wooden pallets on the floor and five smaller containers on the first shelf in this bay. The first pallet held two 30-gallon cardboard boxes: one that was labeled for the accumulation of hazardous waste paint, marked with an indication that the contents are flammable and corrosive, and dated May 20, 2024; and one that was labeled for the accumulation of universal waste used aerosol cans and dated May 29, 2024. The second pallet held one 30-gallon cardboard box and one 10-gallon bucket. The box was labeled for the accumulation of non-RCRA regulated waste paint remover, and the bucket was labeled for the accumulation of hazardous waste Alodine, marked with an indication that its contents are toxic and corrosive, and dated May 1, 2024.

The inspectors observed one 5-gallon carboy container and four 5-gallon cardboard boxes on the first shelf in Bay A5. The carboy was labeled for accumulating nonhazardous waste austins A1 bleach. One box was labeled for accumulating hazardous waste zinc chloride and hydrochloric acid; it was marked with an indication that its contents are corrosive; and it was dated May 1, 2024. One box was labeled for accumulating non-RCRA nonregulated etching and desmutting, and dated December 18, 2023. One box was labeled for accumulating universal waste aerosols, and dated

December 28, 2023. The final box was labeled for accumulating hazardous waste nitric acid and chromium trioxide; it was marked with an indication that its contents are toxic and corrosive.

**Photo 5:** Bay A5 for consolidating and storing part B paint and pens and two-part aerosol with isocyanates in the CAA.

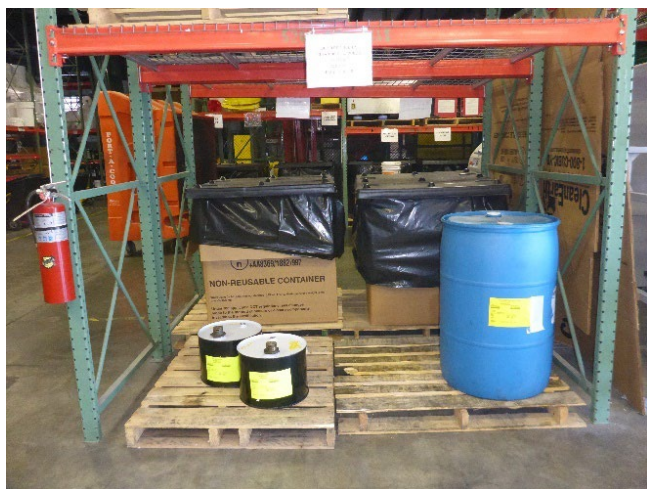
- Bay B1 (Photo 6) is identified for consolidating liquid detergents and cleaning compounds. The inspectors observed two wooden pallets in this bay. The first pallet held two 5-gallon containers: one labeled for accumulating hazardous waste paint related material, marked with an indication that its contents are flammable, and dated May 20, 2024; and the other labeled for accumulating hazardous waste isopropanol, marked with an indication that its contents are flammable, and dated May 23, 2024. The second pallet held one 55-gallon container, which was labeled for accumulating non-RCRA detergent;

**Photo 6:** Bay B1 for consolidating and storing liquid detergents and cleaning compounds in the CAA.

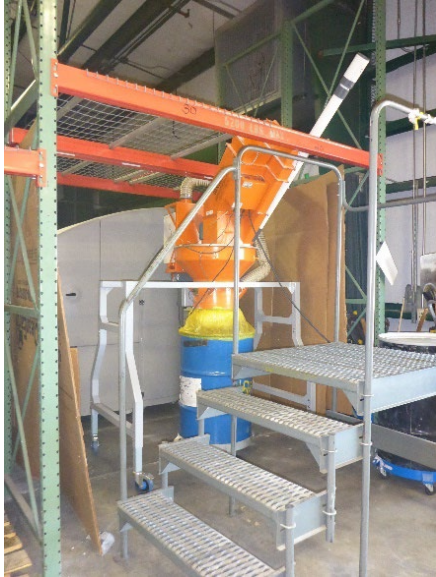
- Bay B2 (Photo 7) is dedicated to a unit for managing used fluorescent bulbs. The inspectors observed one 55-gallon container, which is equipped with a bulb crushing device, in this bay. Facility personnel stated that the crushed glass and the used filters generated by this unit have each been sampled and analyzed to determine if either is a hazardous waste. According to personnel, the facility has determined that the crushed glass is not a hazardous waste, but the used filters are. The 55-gallon container was not labeled, and personnel estimate that container is filled about once every three-to-four months;

**Photo 7:** Bay B2 for crushing used fluorescent lamps and accumulating and storing the crushed glass generated by this process in the CAA.

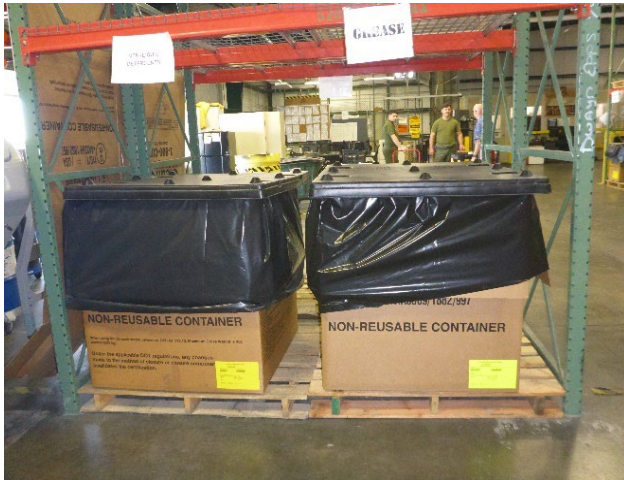
- Bay C1 (Photo 8) is identified for the accumulation of non-liquid detergents and grease. The inspectors observed two wooden pallets in this bay. Each pallet held one cubic yard box. One box was labeled non-RCRA detergent, and the other was labeled non-RCRA grease;

**Photo 8:** Bay C1 for consolidating and storing non-liquid detergents and grease in the CAA.

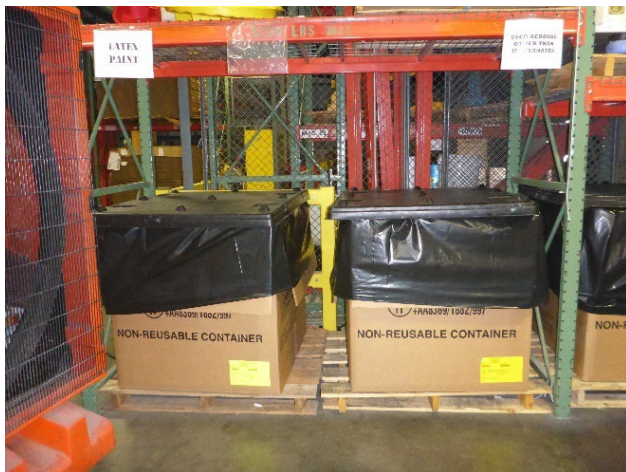
- Bay C2 was not used for accumulating or storing wastes at the time of the inspection;
- Bay D1 (Photo 9) is identified for the accumulation of latex paint and used aerosols other than isocyanates. The inspectors observed two wooden pallets in this bay. Each pallet held one cubic yard box. One box was labeled non-RCRA latex paint. The other box was labeled universal waste aerosols and dated March 25, 2024; and

**Photo 9:** Bay D1 for consolidating and storing latex paint and used aerosols other than isocyanates in the CAA.

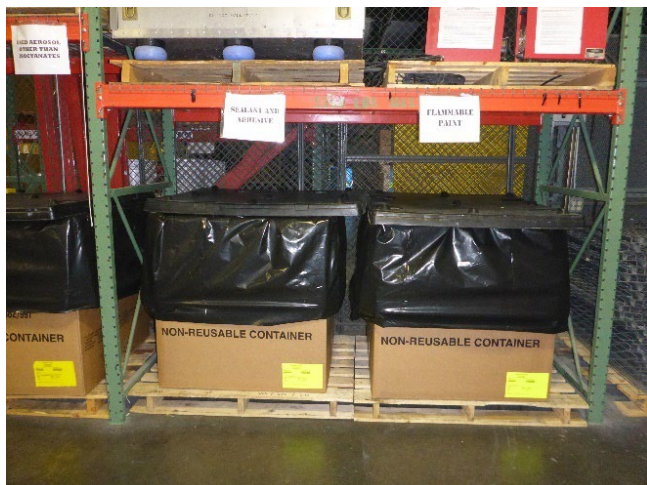
- Bay D2 (Photo 10) is identified for the accumulation of sealant and adhesive and of flammable paint. The inspectors observed two wooden pallets in this bay. Each pallet held one cubic yard box. One box was labeled hazardous waste sealant / adhesives, marked with an indication that its contents are corrosive, and dated June 5, 2024. The other box was labeled hazardous waste paint, marked with an indication that its contents are flammable, and dated June 7, 2024.

**Photo 10:** Bay D2 for consolidating and storing sealant and adhesive and flammable paint in the CAA.

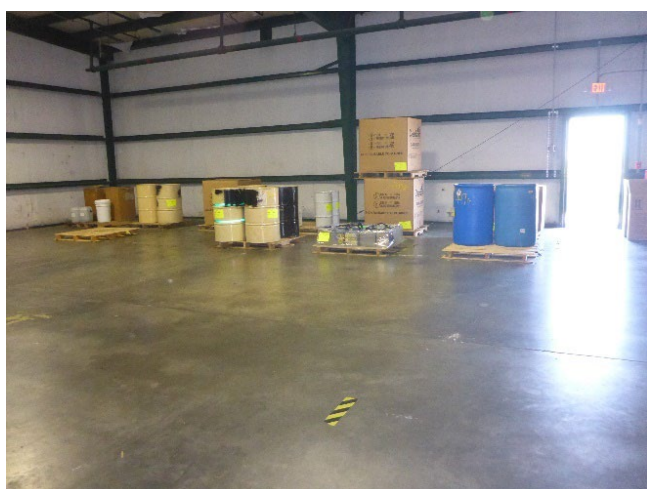
and the remaining two rows (Photo 12) are used to stage containers that are ready for shipment.

The inspectors observed a total of twelve wooden pallets in the two remaining rows, which are used to stage containers that are ready for shipment:

**Photo 12:** Two rows of containers ready for shipment in the CAA.

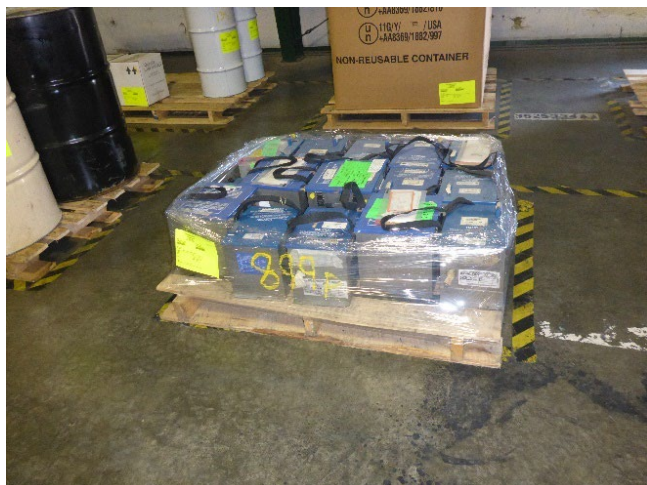
- Pallet 9 (Photo 13) held lead acid batteries, which were shrink-wrapped together on the pallet. The inspectors observed a label, which included the words “universal waste batteries” and the date June 5, 2024, on the shrink-wrapping.

**Photo 13:** Pallet of lead-acid batteries ready for shipment in the CAA. Batteries shrink-wrapped together. Shrink-wrapped was labeled universal waste batteries, but individual batteries were not labeled.

**Pursuant to 15A NCAC 13A .0119(b) [40 C.F.R. § 273.14(a)], a small quantity handler of universal waste (SQHUW) must identify the type of universal waste by labeling or marking each universal waste battery or container in which the batteries are contained clearly with one of the following phrases: “Universal Waste – Battery(ies), or “Waste Battery(ies),” or “Used Battery(ies).”**

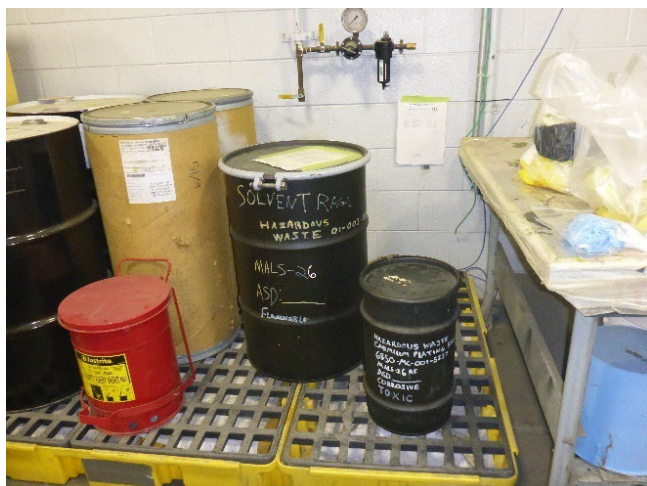
USMC New River operates a cadmium plating process in the MALS 26 / AS 518 area, and generates contaminated rags used in plating and general cleaning activities performed in this area. The installation manages one SAA in the MALS 26 / AS 518 area for managing hazardous waste, and the inspectors observed two containers on a secondary containment pallet in this SAA (Photo 14): one 35-gallon container for accumulating hazardous waste rags generated from solvent cleaning activities, and one 5-gallon container for accumulating hazardous waste rags generated in the cadmium plating process. The 35-gallon container was labeled hazardous waste solvent rags and marked with an indication that the contents are flammable. The 5-gallon

container was labeled hazardous waste cadmium plating rags, and marked with an indication that the contents are toxic and corrosive. The secondary containment pallet also held a flammable can for accumulating rags used to clean grease and lubricants.

**Photo 14:** One 35-gallon container for accumulating hazardous waste rags generated from solvent cleaning activities and one 5-gallon container for accumulating hazardous waste rags generated in the cadmium plating process in the MALS 26 Air Frames Metals Shop SAA.

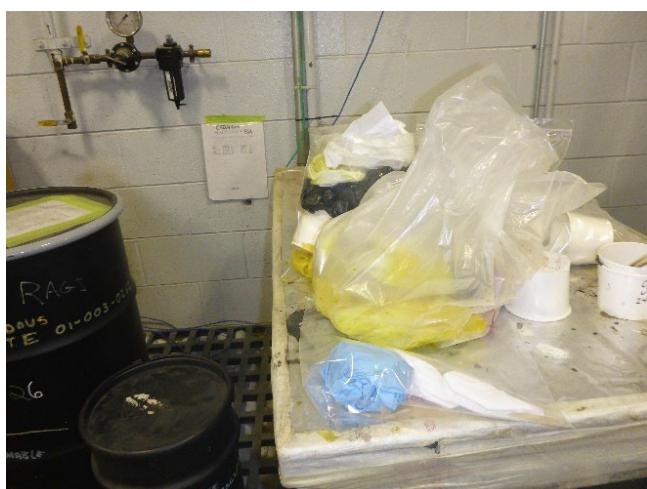
When returning through the Air Frames Metal Shop on the way to exiting the MALS 26 area, the inspectors observed two plastic bags left on a mobile cart at the SAA (Photo 15). Facility personnel on the inspection tour initially believed that the bags, which were not labeled with the words hazardous waste or marked with an indication of the hazards of the contents, contained hazardous waste Alodine. When asked, personnel working in the area explained that the bags contained cadmium plating waste and they immediately transferred the bags into the 5-gallon container of hazardous waste cadmium rags upon request from the MCAS New River personnel on the inspection tour.

**Photo 15:** Two plastic bags containing hazardous waste rags that was left on the cart at the MALS26 Air Frames Metals Shop SAA.

**Pursuant to 15A NCAC 13A .0107(a) [40 C.F.R. § 262.15(a)(5)], which is a condition of the SAA Permit Exemption, a generator is required to mark or label its containers with the words “Hazardous Waste” and with an indication of the hazards of the contents.**

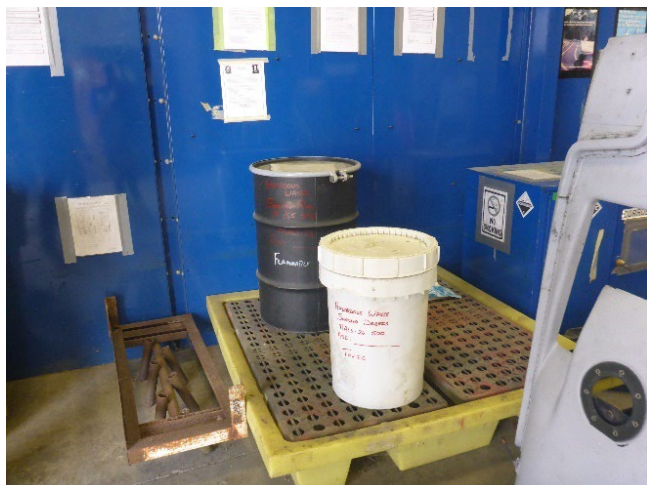
USMC New River manages one SAA in the Air Frames Composite Shop for managing hazardous waste solvent rags and sanding debris that is generated by paint removal activities. The inspectors observed two containers in this SAA (Photo 16): one 30-gallon container for hazardous waste solvent rags and one 20-gallon container for hazardous waste sanding debris. The 30-gallon container was labeled hazardous waste and marked with an indication that the contents are flammable. The 20-gallon container was labeled hazardous waste and marked with an indication that the contents are toxic. Personnel explained that sanding activities are performed inside a down-draft booth, and dust and debris generated by this process is swept up and placed into the 20-gallon container in the SAA.

**Photo 16:** One 30-gallon container for accumulating hazardous waste solvent rags and one 20-gallon container for accumulating hazardous waste sanding debris in the MALS 26 Air Frames Composite Shop SAA.

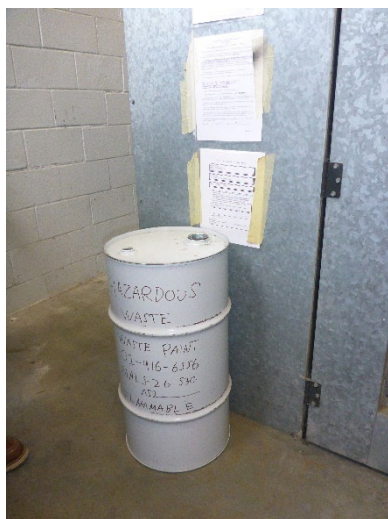
Painting activities are performed in a small paint booth within the Air Frames Composite Shop. Most painting is done using a two-part aerosol paint product. The installation manages one SAA at the paint booth for accumulating hazardous waste paint related material that is generated by these activities (Photo 17). The inspectors observed one 20-gallon container in this SAA. The container was labeled hazardous waste paint and marked with an indication that the contents are flammable. The inspectors also observed a layer of plastic taped to the floor inside the paint booth, and a filter system with sixteen filter cells. Personnel explained that a pressure gauge system is used to track the performance of the paint booth filters, and that the filters are replaced approximately once every three months. When they are replaced, the used paint booth filters, plastic liner, and tape is managed as hazardous waste.

**Photo 17:** One 20-gallon container for accumulating hazardous waste paint related material in the Air Frames Composite Shop Paint Booth SAA.

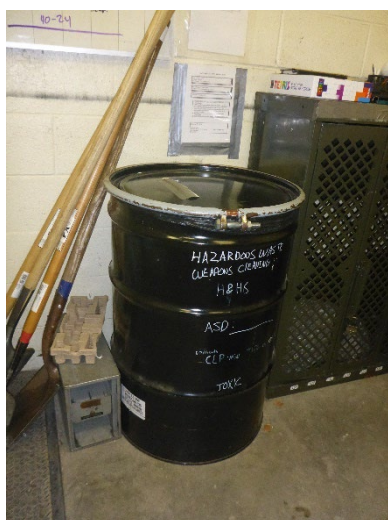
The armory for smaller caliber weapons is housed in the Headquarters and Headquarters Squadron Building AS 4145. The installation manages one SAA for managing hazardous waste weapons cleaning debris generated in each designated armory room within the building. The inspectors observed one 55-gallon container in the VMM 774 / MAG 49 armory (Photo 18), one 55-gallon container in the MWSS – 272 armory (Photo 19), and one 55-gallon container in the MAG 26 armory (Photo 20). Each container was labeled hazardous waste weapons cleaning debris and marked with an indication that the contents are toxic.

**Photo 18:** One 55-gallon container for accumulating hazardous waste weapons cleaning debris in the VMM 744 / MAG 49 armory SAA.

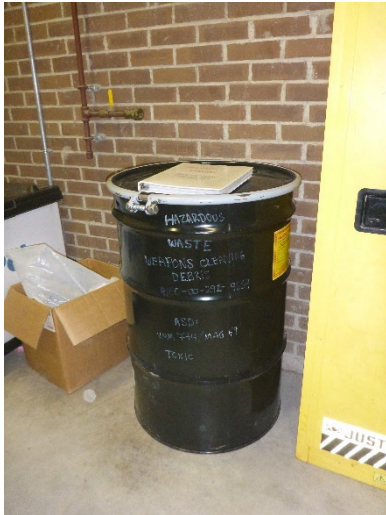
**Photo 19:** One 55-gallon container for accumulating hazardous waste weapons cleaning debris in the MWSS - 272 armory SAA.
