**Region 6 - Enforcement & Compliance Assurance Division**  
**INSPECTION REPORT**

| Company Name: | Toll Bros., Inc. | |
| Facility Name: | Wandering Creek at Brookhollow | |
| Identification/Permit Number: | TXR1519LV and TXR1527SB | |

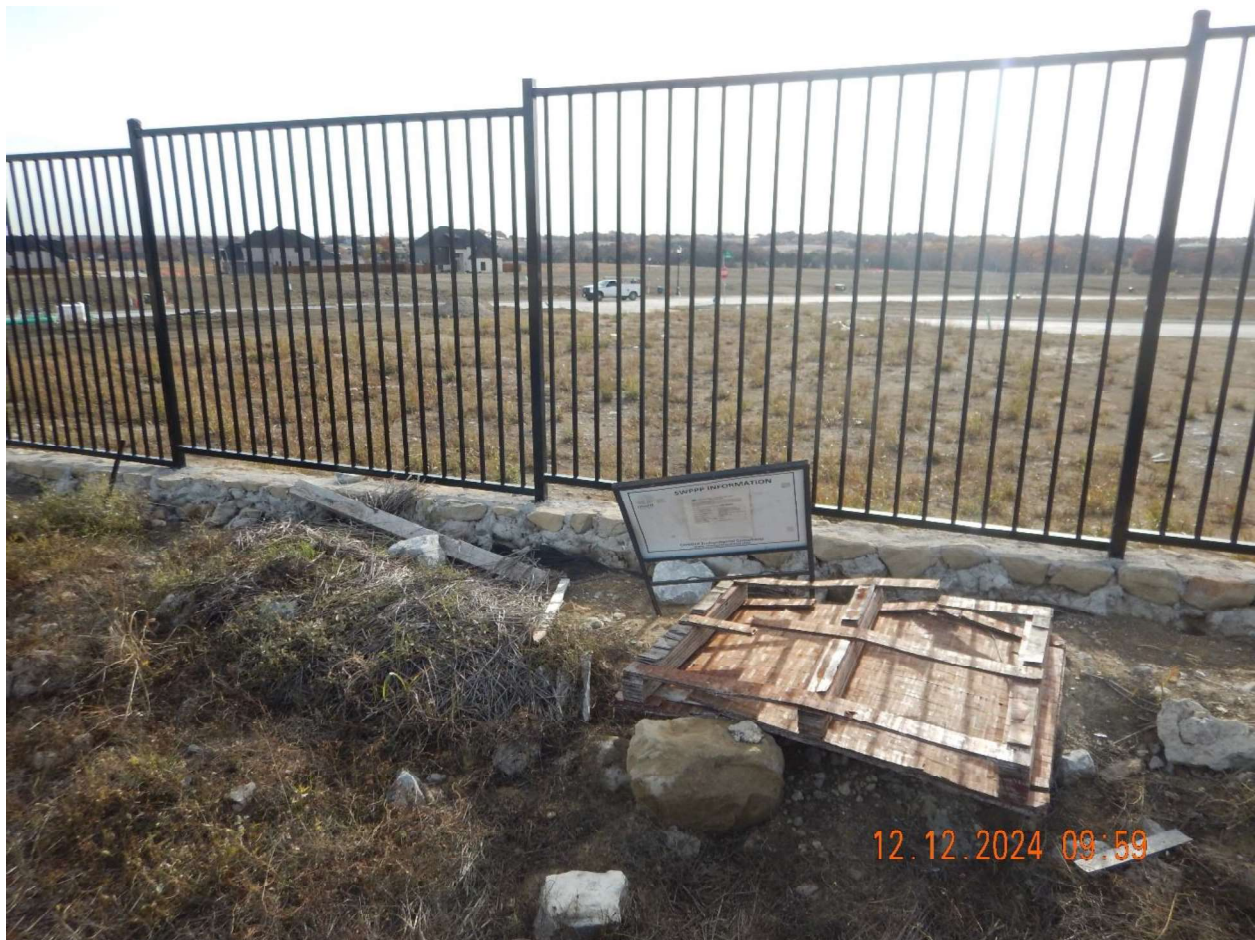
Photo no. 1

- Trash, including a discarded pallet and wood materials were observed near the CSN east of the intersection of East 1st Street and Williamsburg Place (**Appendix 1, Photo 1**).

Description: The large CSN (TPDES Permit #: TXR1519LV) covering land development activities posted east of the intersection of East 1<sup>st</sup> Street and Williamsburg Place. Also pictured is trash, including a discarded pallet and wood materials.

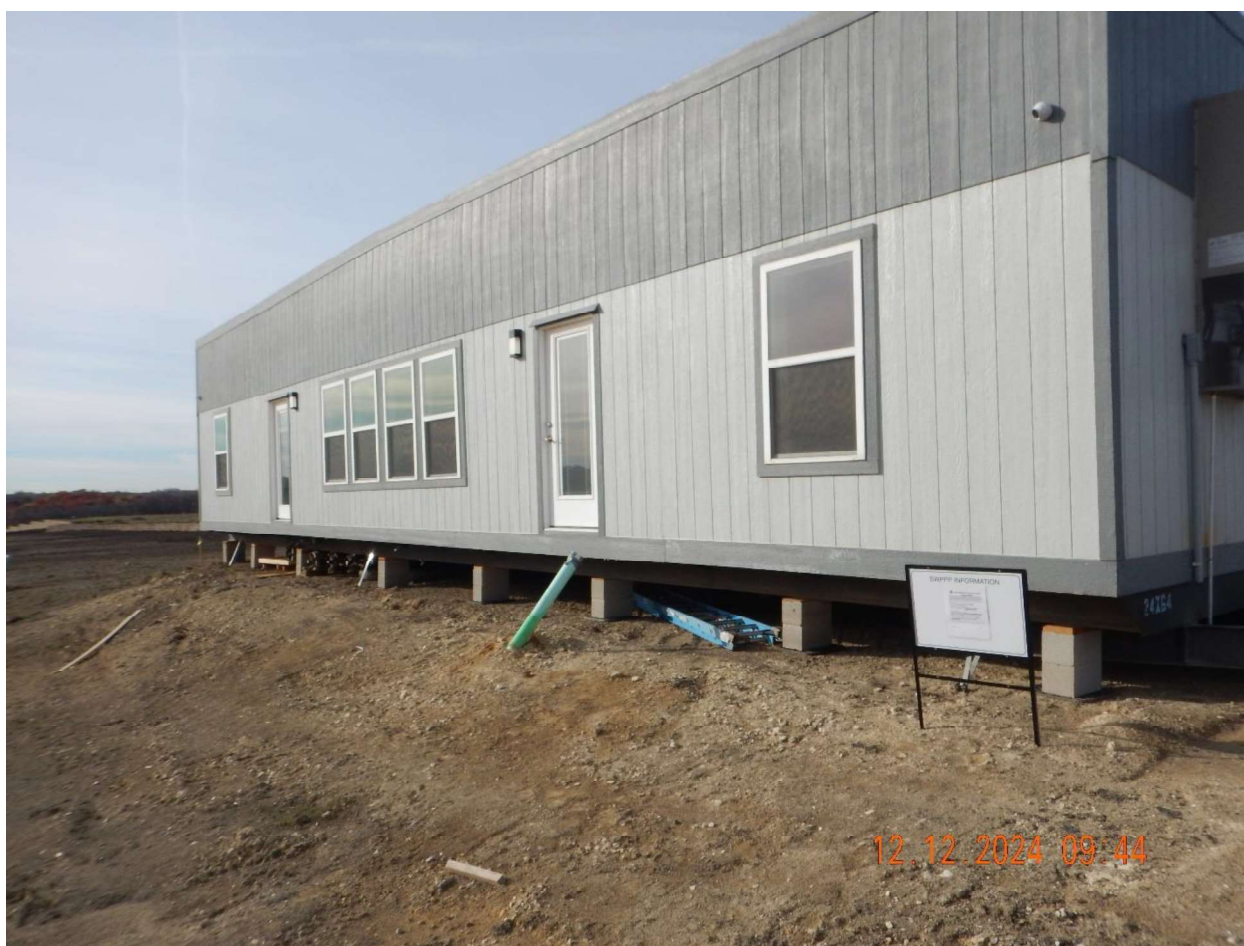
Photo no. 3

Description: The large CSN (TPDES Permit #: TXR1527SB) covering home building activities posted by the construction/sales trailer near the intersection of Williamsburg Place and Arden Road.

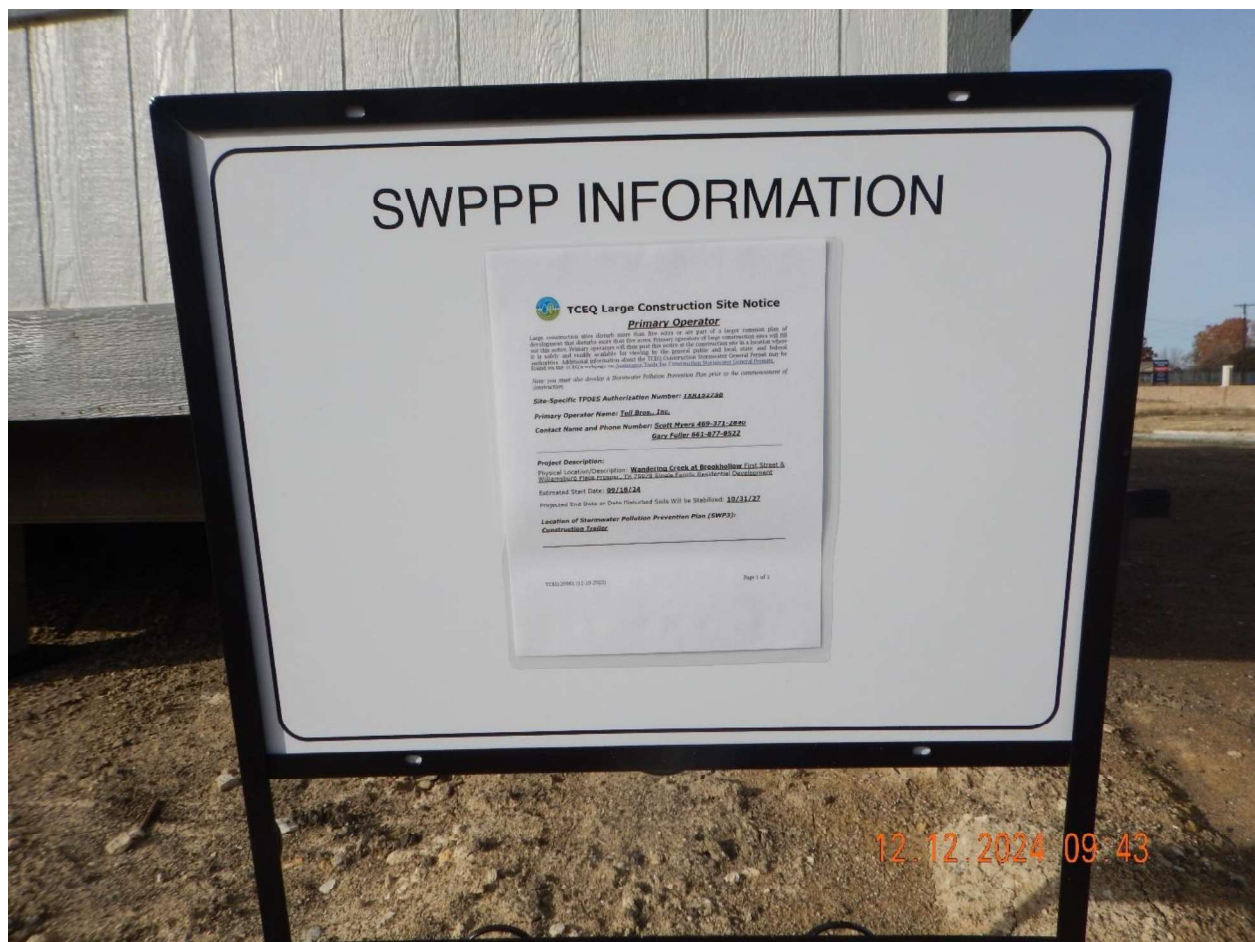
Photo no. 4

Description: Closer view, of the large CSN (TPDES Permit #: TXR1527SB) by the construction/sales trailer. Toll Bros., Inc., is listed as the primary operator with coverage effective September 9, 2024, and an estimated start date of September 18, 2024.

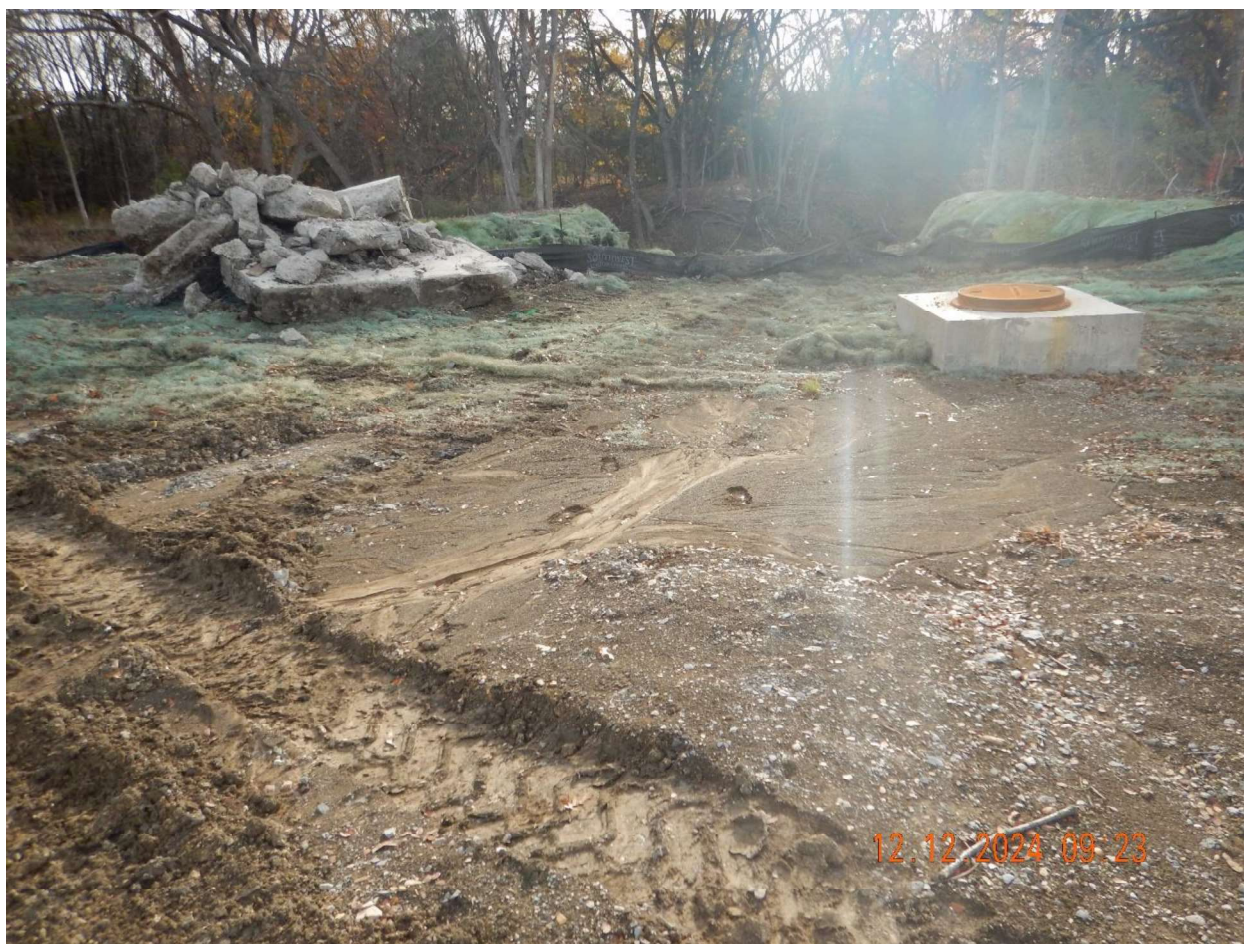
Photo no. 5

- Silt fencing, erosion control blanket(s), and a rock check dam were installed near the outfall at the southeast corner of the site (**Appendix 1, Photos 5-7**).

Description: View of the silt fence and erosion control blanket installed near the outfall that discharges into Rutherford Branch (southeast corner of the site). Also pictured is concrete debris on top of portions of the erosion control blanket.

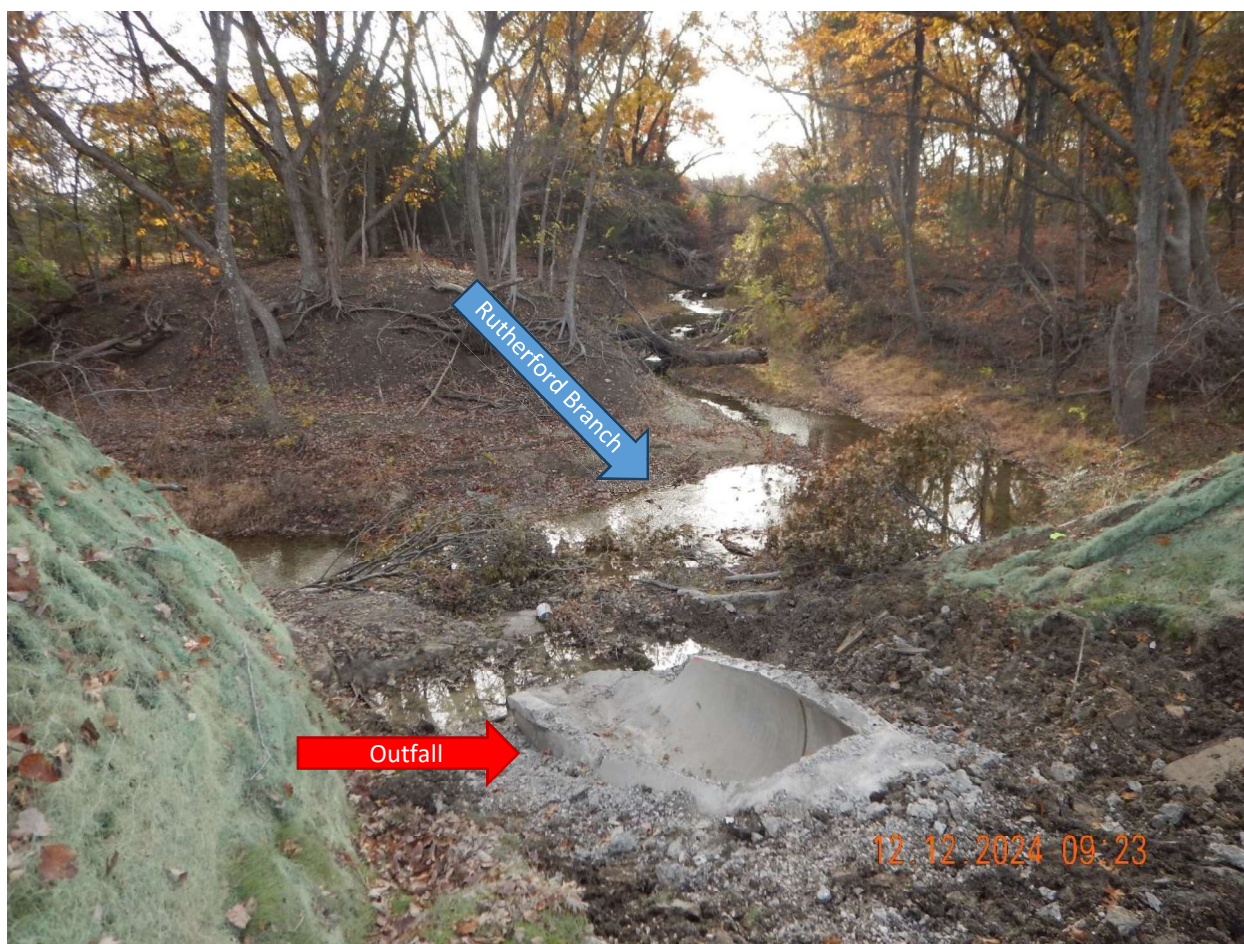
Photo no. 6

- The outfall at the southeast corner of the site had minimal to no sediment buildup with relatively clear water in Rutherford Branch (**Appendix 1, Photo 6**).

Description: Closer view, of the outfall that discharges into Rutherford Branch, at the southeast corner of the site. The soil along the sloped bank had erosion control blanket installed. The outfall had minimal to no sediment buildup and the water of Rutherford Branch appeared relatively clear at the time of inspection.

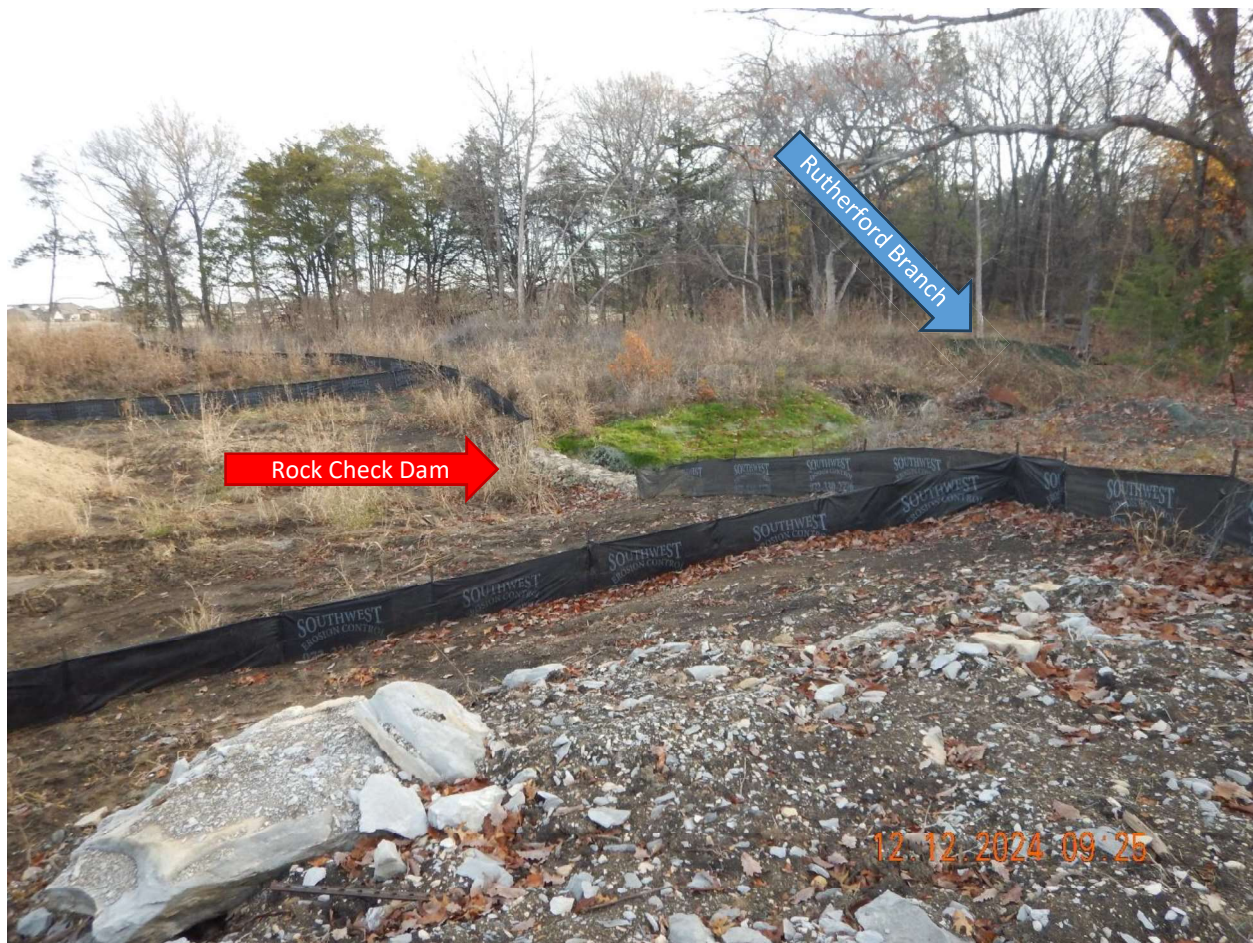
Photo no. 7

Description: Silt fencing and a rock check dam observed near the southeast corner of the site, just north of the outfall (not pictured).

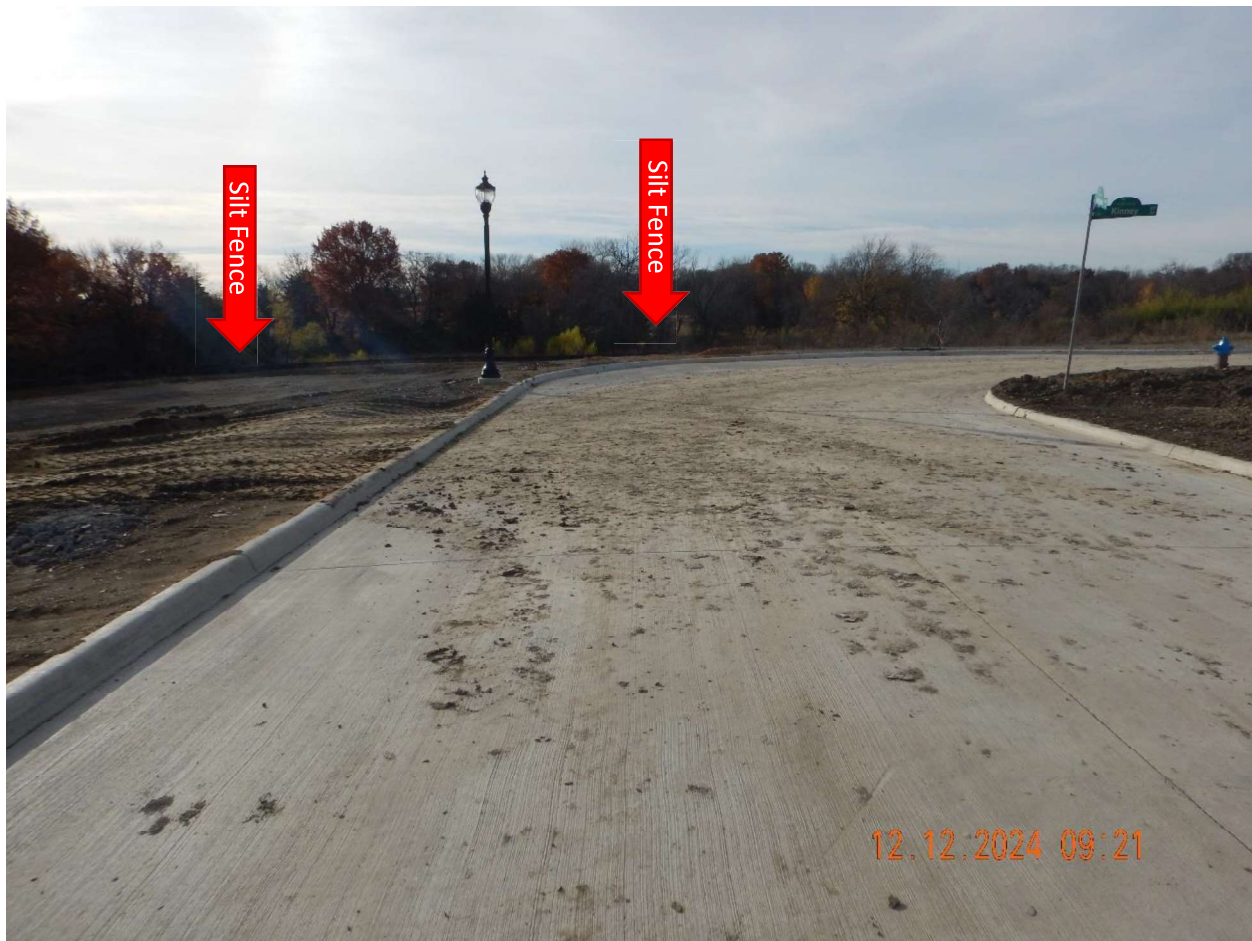
Photo no. 8

- The site was primarily paved streets and exposed sediment with minimal to no Best Management Practices (BMPs) present along the lots.
- Silt fencing was installed along the perimeter of the site (**Appendix 1, Photo 8**).

- Sediment and sediment track-out was observed on the paved areas throughout the site, which is located within the Town of Prosper's MS4 (**Appendix 1, Photos 8, 12, and 14**).

Description: View of silt fencing installed along the perimeter of the site. Also pictured is exposed sediment along the lots and sediment trackout on the street near the intersection of Watson Drive and Kinney Street.

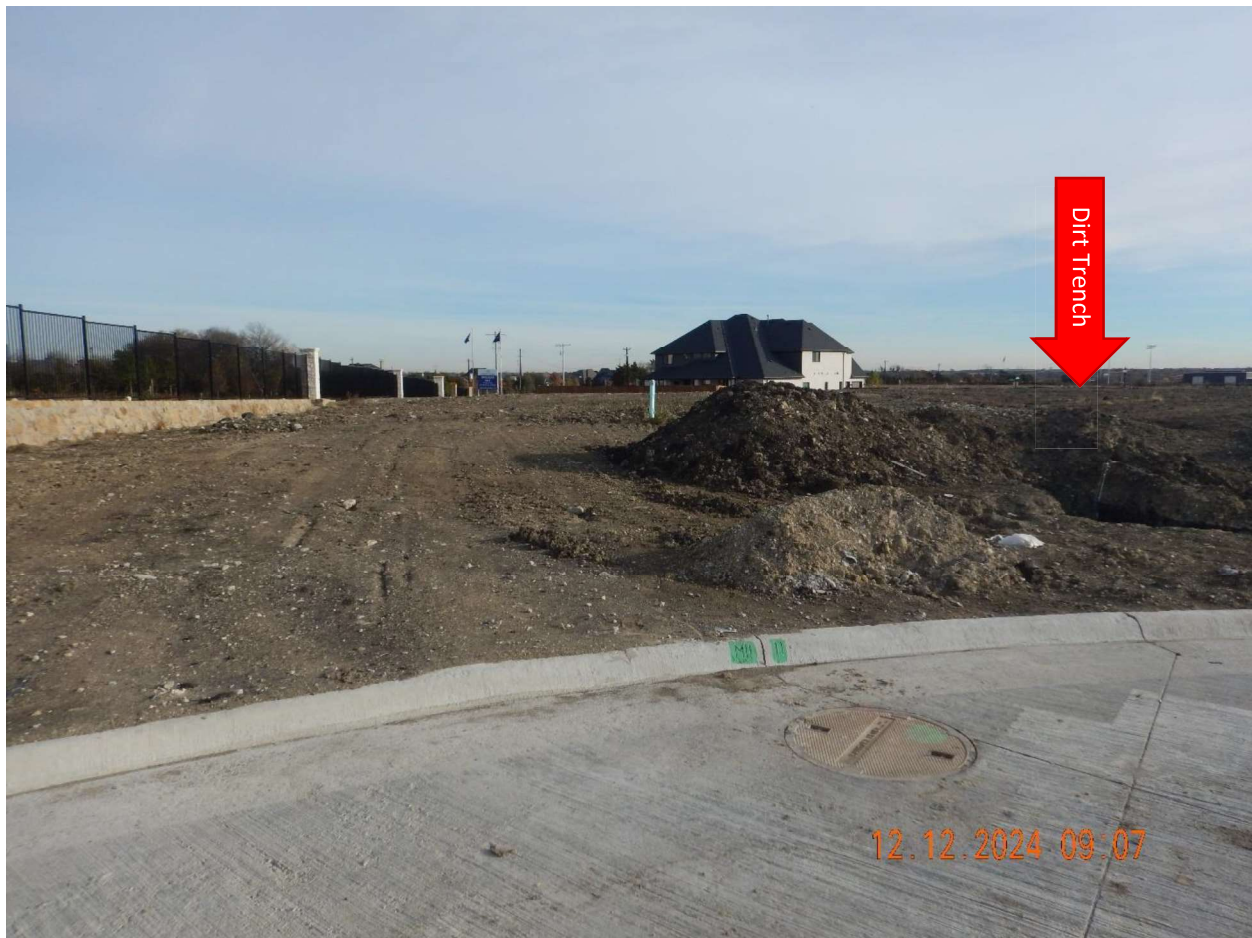
Photo no. 9

- Approximately 75-85% of the lots throughout the site did not have BMPs installed to contain sediment and dirt piles (**Appendix 1, Photos 8-14 and 17-18**). The interior lots (i.e. lots not along the site's perimeter boundary line) did not have any BMPs installed except for the two (2) lots covered under TPDES Permit #: TXR1527SB on Williamsburg Place.

Description: Exposed sediment and dirt piles along the lots on Harrison Lane. At the time of inspection, dirt trenches were observed along Harrison Lane, which were associated with utilities being installed (on this street).

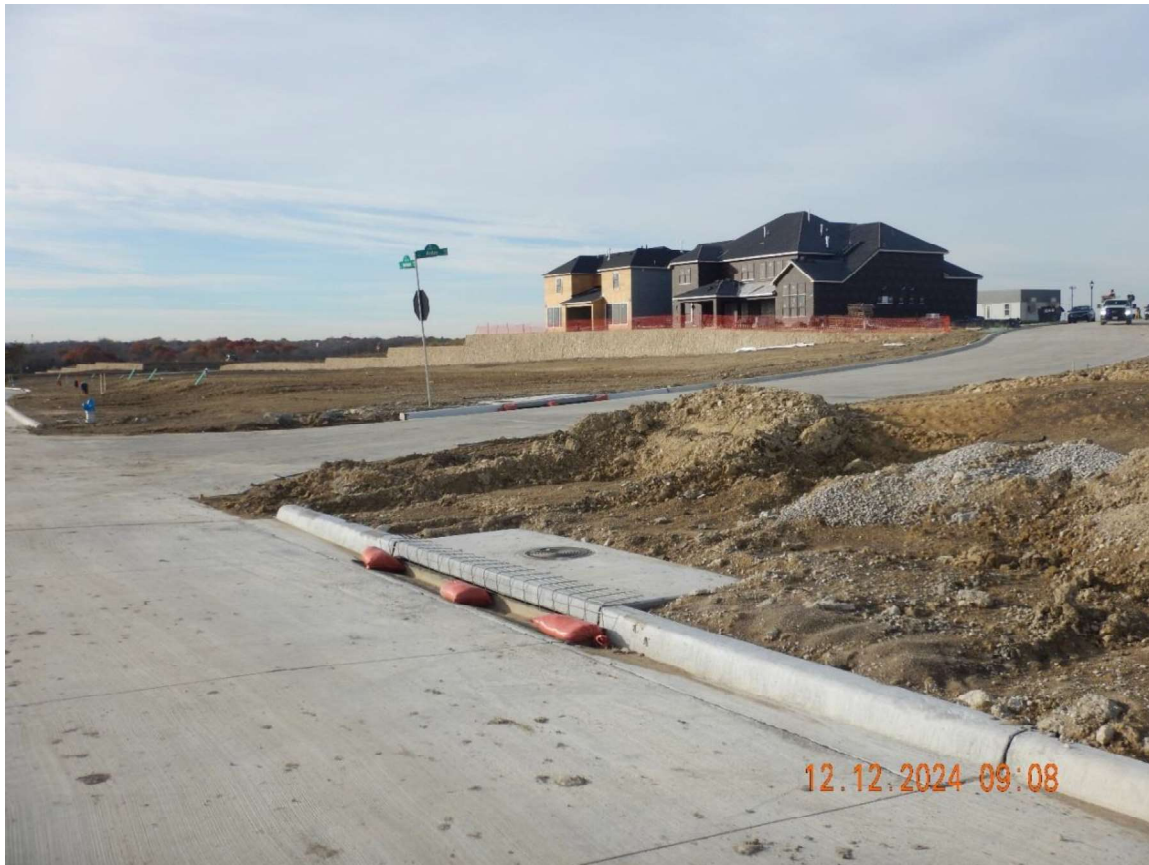
Photo no. 10

Description: Exposed sediment and dirt piles along the lots near the intersection of Harrison Lane and Arden Road. The pictured inlet protection had evidence of sediment buildup, likely due to the amount of exposed sediment on the lots throughout the site. Also pictured are the two (2) lots with active homebuilding (TPDES Permit # TXR1527SB) and the construction/sales trailer.

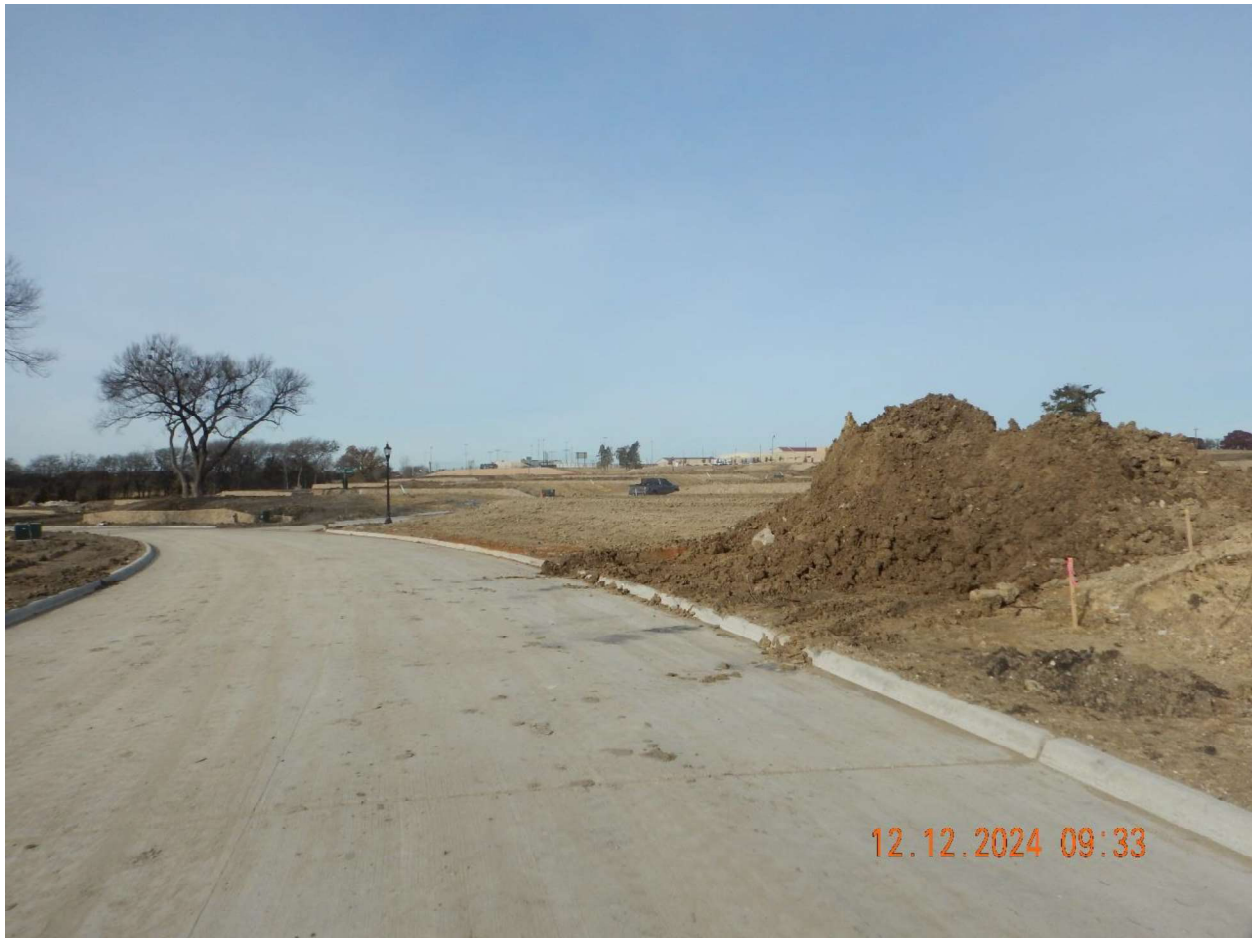
Photo no. 11

Description: Exposed sediment and large uncontained dirt piles on Kinney Street.

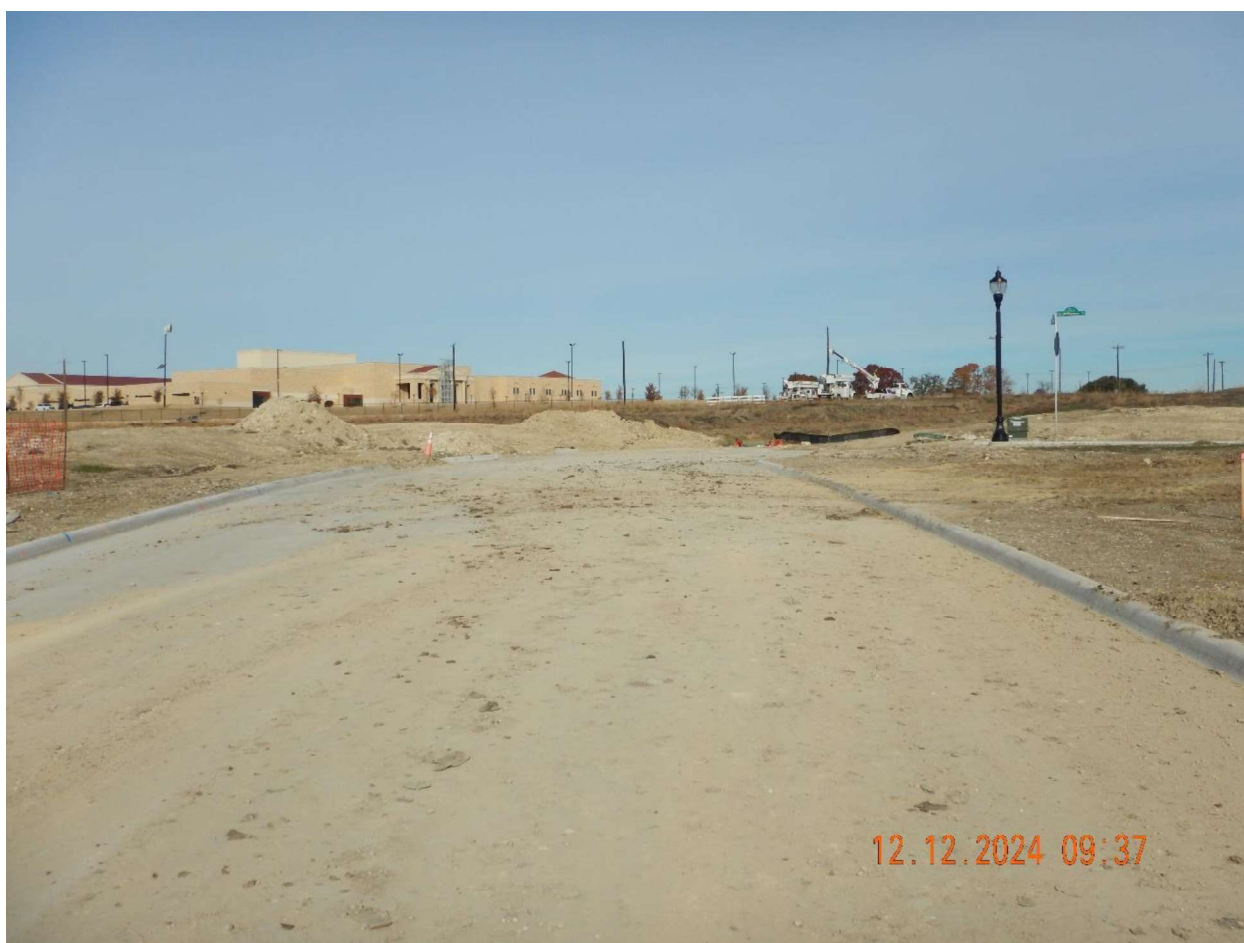
Photo no. 12

Description: Exposed sediment, uncontained dirt piles, and sediment/sediment track-out on the street near Jefferson Drive.

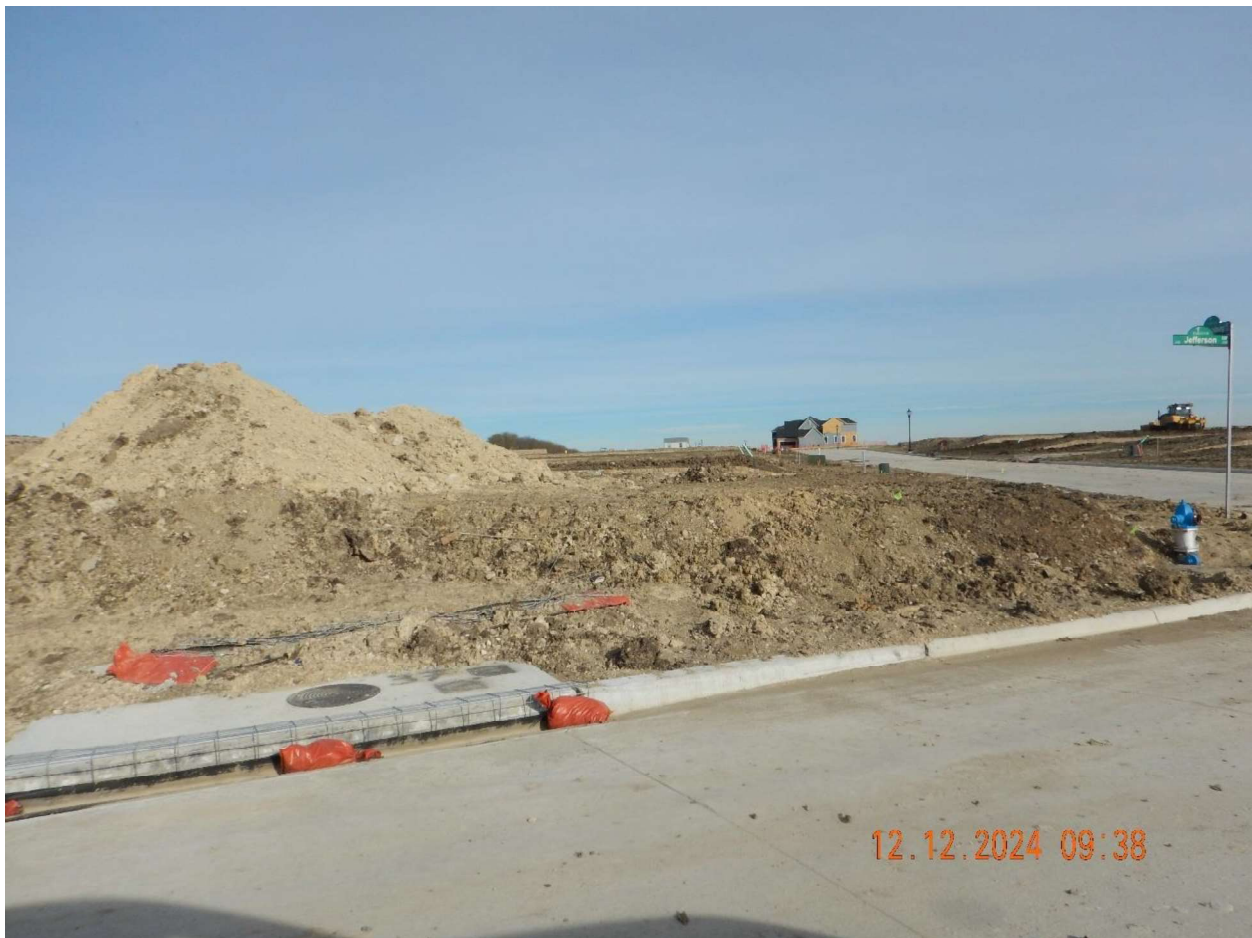
Photo no. 13

Description: Large uncontained dirt piles and exposed sediment on Jefferson Drive and Williamsburg Place. Inlet protection was observed at the curb inlet.

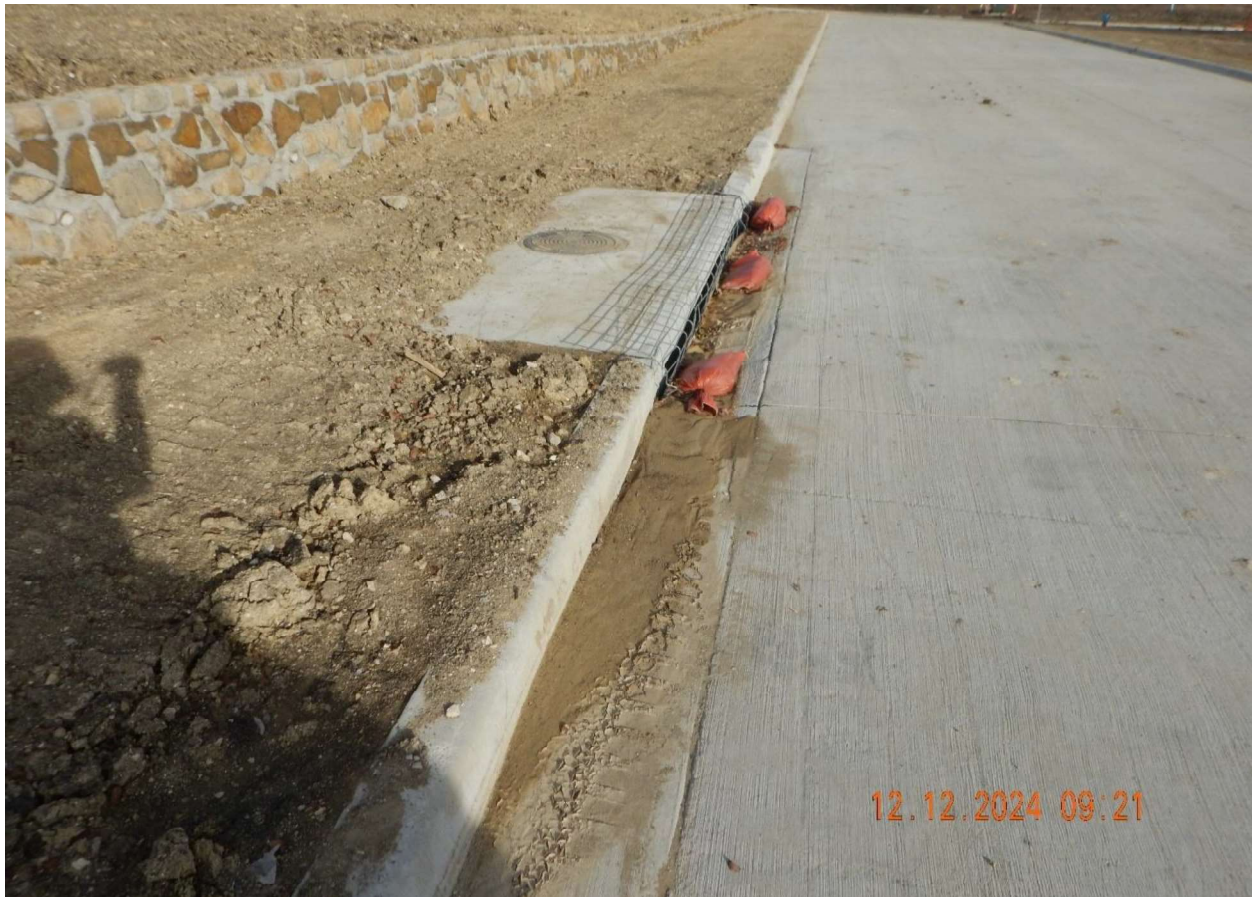
Photo no. 14

- Some of the inlet protection throughout the site were heavily silted with sediment (**Appendix 1, Photo 14**).
- Some sections of the silt fencing around the perimeter of the site needed maintenance (**Appendix 1, Photo 16**).

Description: Inlet protection heavily silted with sediment on Watson Drive, likely rendering the BMP ineffective due to water flow restriction(s). Exposed sediment was also noted along the lots.

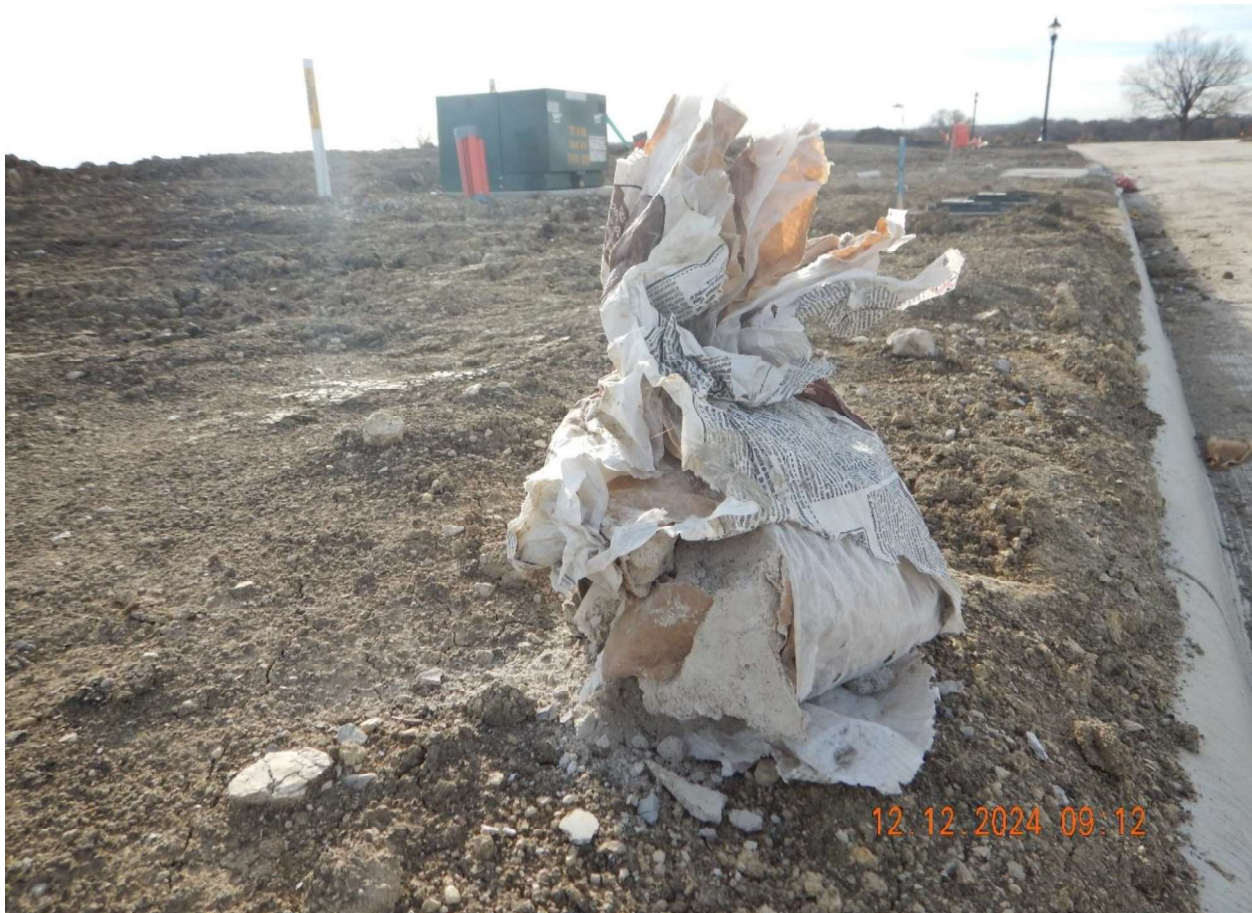
Photo no. 15

- Improper disposal or storage of a ripped mortar mix bag was observed near the curb on Harrison Lane (**Appendix 1, Photo 15**).
- Some blowable trash was observed along the lots (**Appendix 1, Photos 17-18**).

Description: A ripped mortar bag observed near the curb on Harrison Lane.

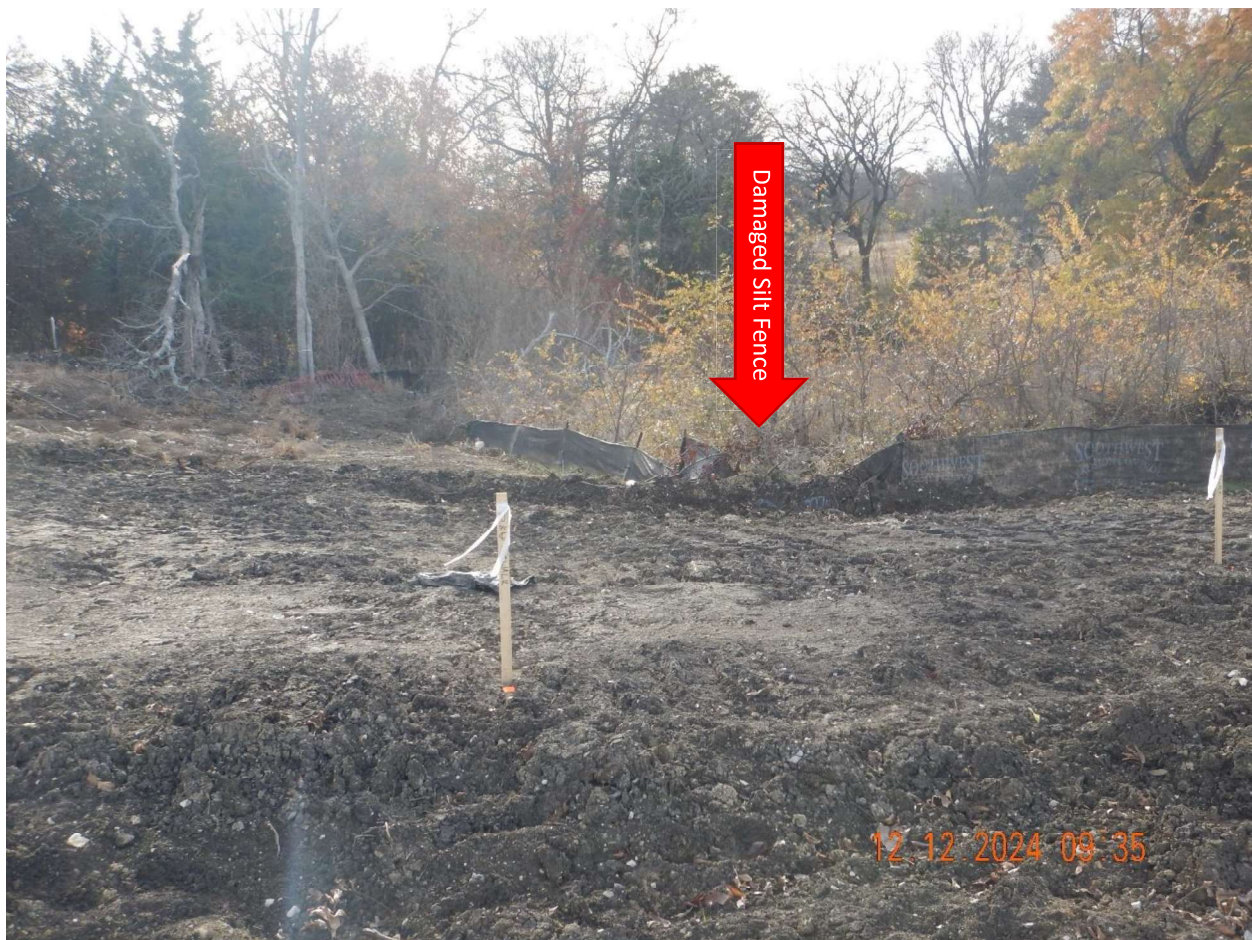
Photo no. 16

Description: A section of silt fencing in need of maintenance near the southwest corner of the site on Kinney Street.

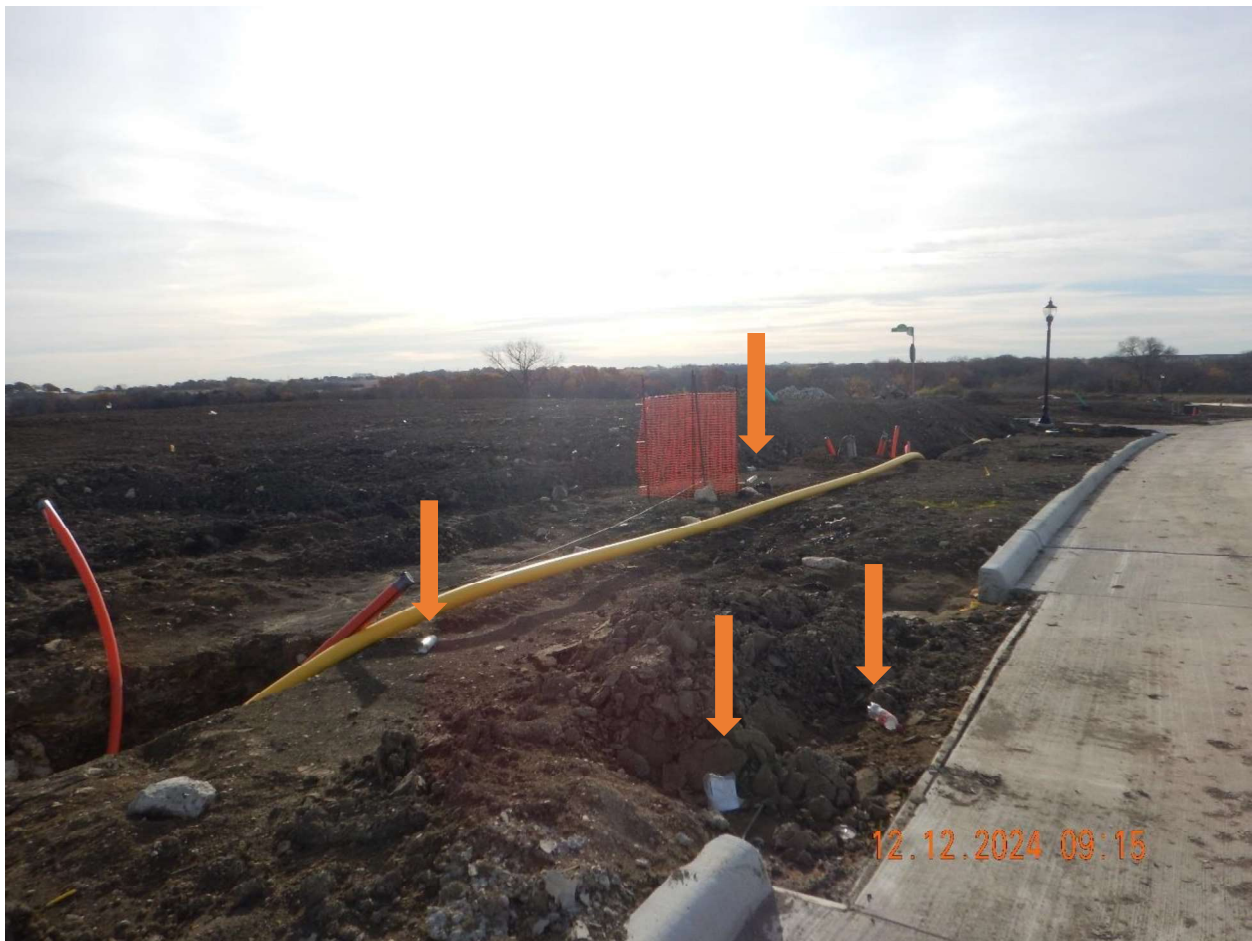
Photo no. 17

Description: Blowable trash including bottles, cans, and other plastic debris observed on the lots along Harrison Lane.

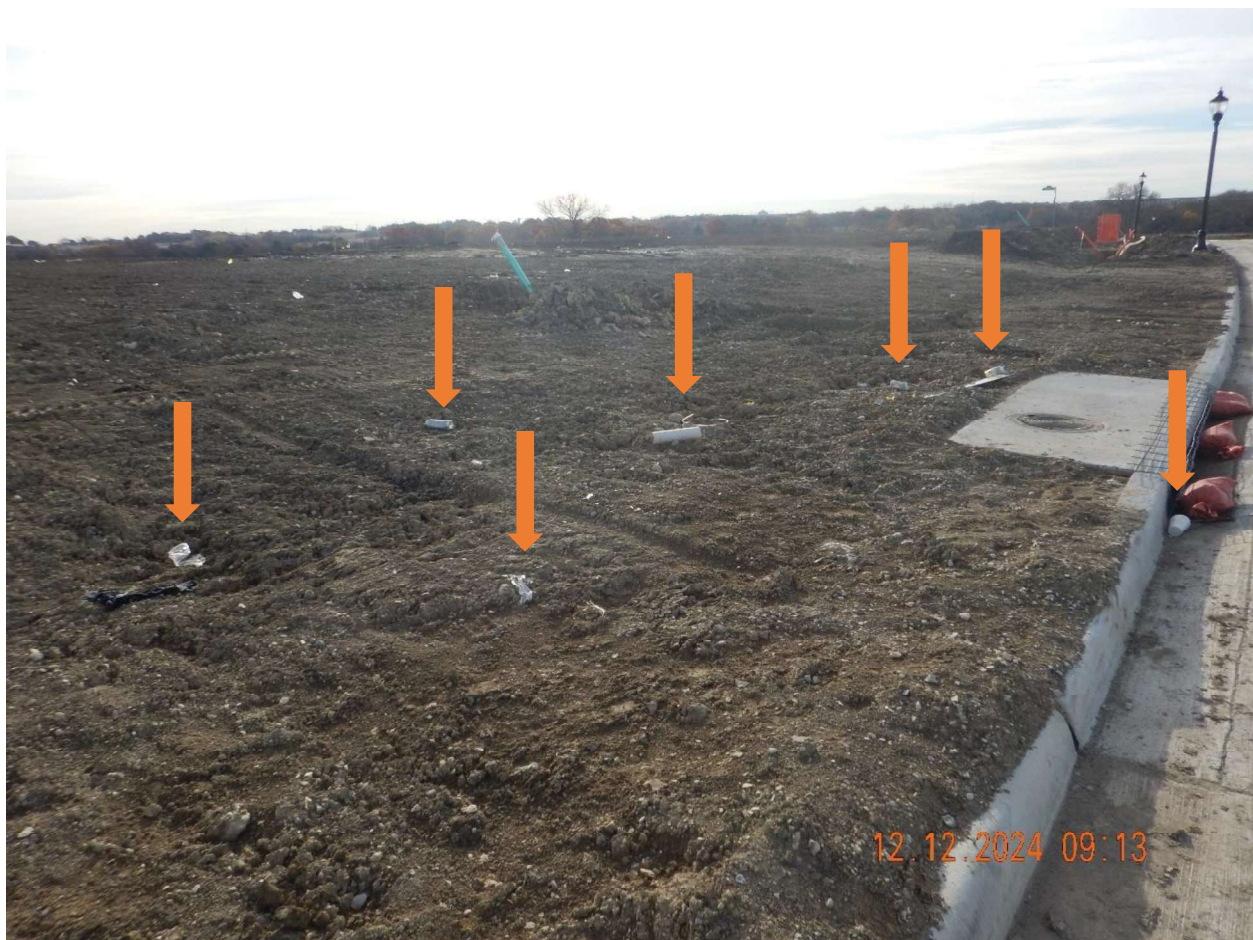
Photo no. 18

Description: Blowable trash observed on the lots and near the inlet on Harrison Lane.

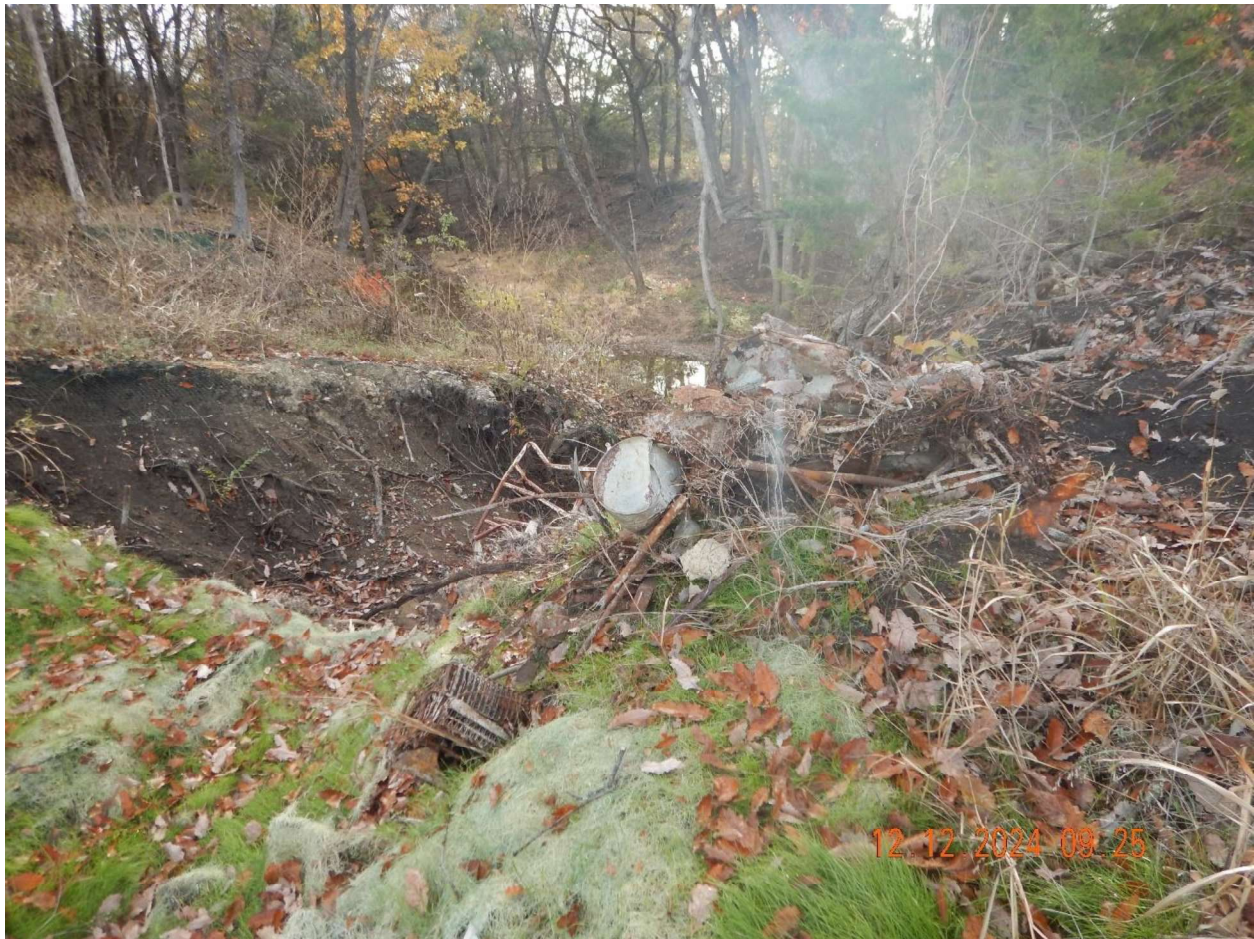
Photo no. 19

- Dumped trash was observed at the southeast corner of the site near the rock check dam (**Appendix 1, Photo 19**). The inspector was unable to definitively determine the source of the dumped trash.

Description: Dumped trash and materials observed near the rock check dam (also pictured in Photo no. 5). The inspector was unable to definitively determine the source of the dumped trash.
