INSPECTION REPORT

| <b>Statute(s)/Program(s)</b> | Clean Water Act, NPDES, WWTP | | |
| <b>Type of Inspection</b> | CEI - Compliance Evaluation Inspection | | |
| <b>Facility or Site Name</b> | Braithwaite WWTP | | |

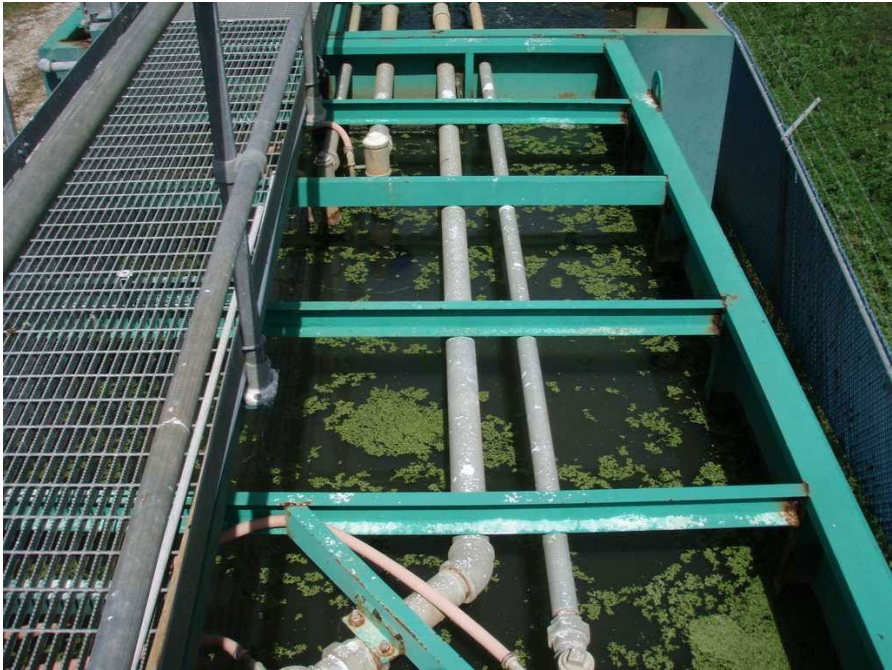
| Sludge Return Line | P3140050.JPG | |

| At the time of the inspection, the sludge return line (airlift system) was not operational. Facility Work Order #21714. | | |

| Airlift line was not operational at the time of the inspection. | | |

Discussed the sludge return in need of repair. The facility provided a work order for the repair and explained that when the repairs were completed, an email would be sent detailing repairs and sludge returns functions.

| Location: | Area: | Sub-area: |
|---|---|---|
| Requested e-mail with pictures of completed Work Order #21714. | | |

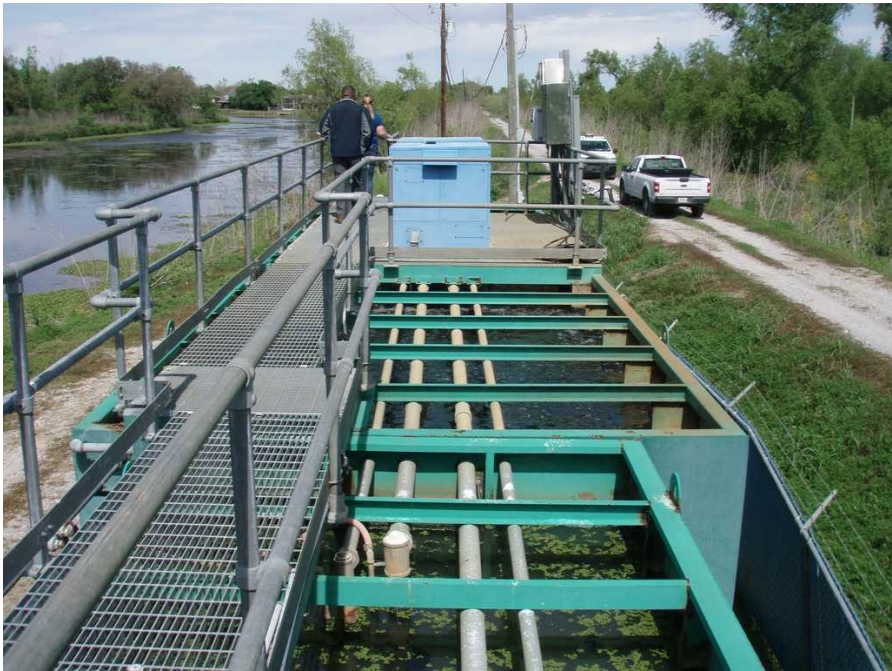
| Sludge Return Line | P3140051.JPG | |

| Airlift line was not operational at the time of the inspection. | | |

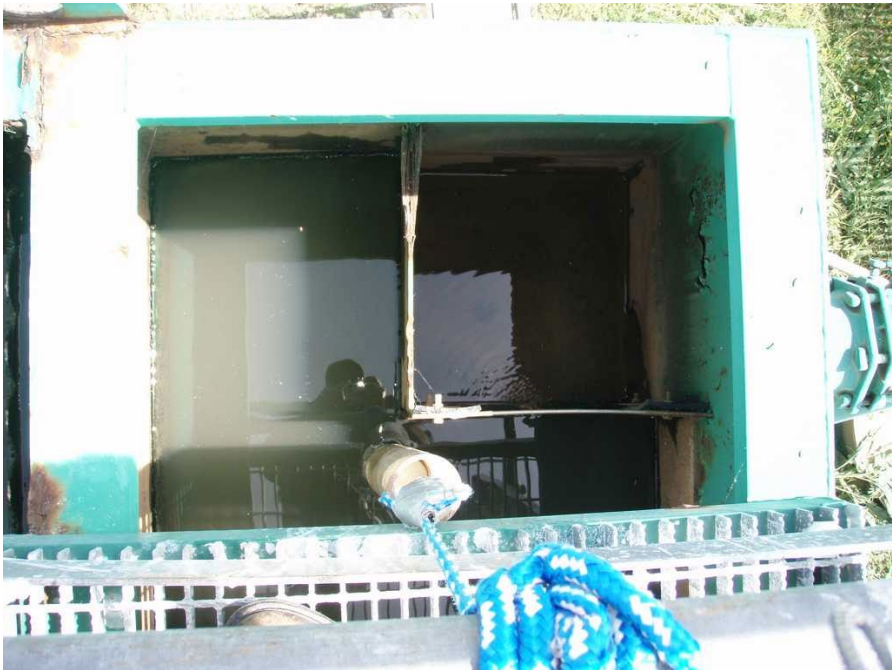
| Discharge | P3140052.JPG | |

| Facility discharge was clear. No solids were present and CL tablets were visible in the tablet tube. | | |

| Discharge was clear and tablets were visible in the tablet tube. | | |

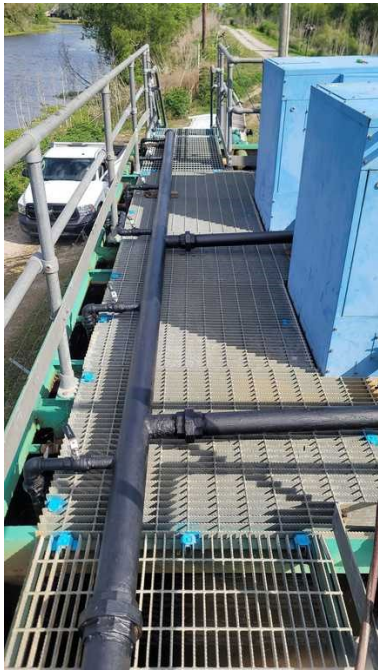
| Completed Work | processed-0baeca77-bce9-4c18-85b4-95590de82d67_Pgv04Mul.jpeg | |

| Received e-mail on April 19, 2023, from Robert Morgan - Sr. Area Manager with pictures of completed work required for sludge return to function correctly. | | |

| Completed repairs on treatment system. Received 4/19/2023 | | |

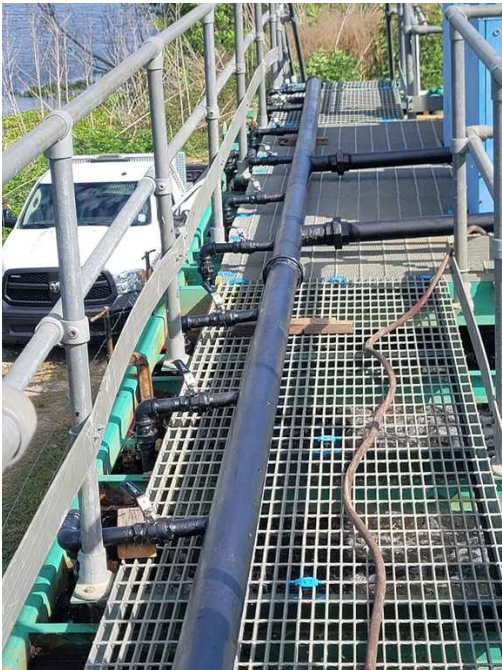
| Completed Work | processed-24cc9fb2-00bb-40a9-accf-47c082c8ade8_6iEWuEfA.jpeg | |

| Completed repairs on treatment system. Received 4/16/2023. | | |
