INSPECTION REPORT

| Type of Inspection | Compliance Evaluation Inspection (CEI) | |
| Facility or Site Name | Rock Lake State Hatchery | |
| Permit Number(s) (If Applicable) | NM0030155 | |

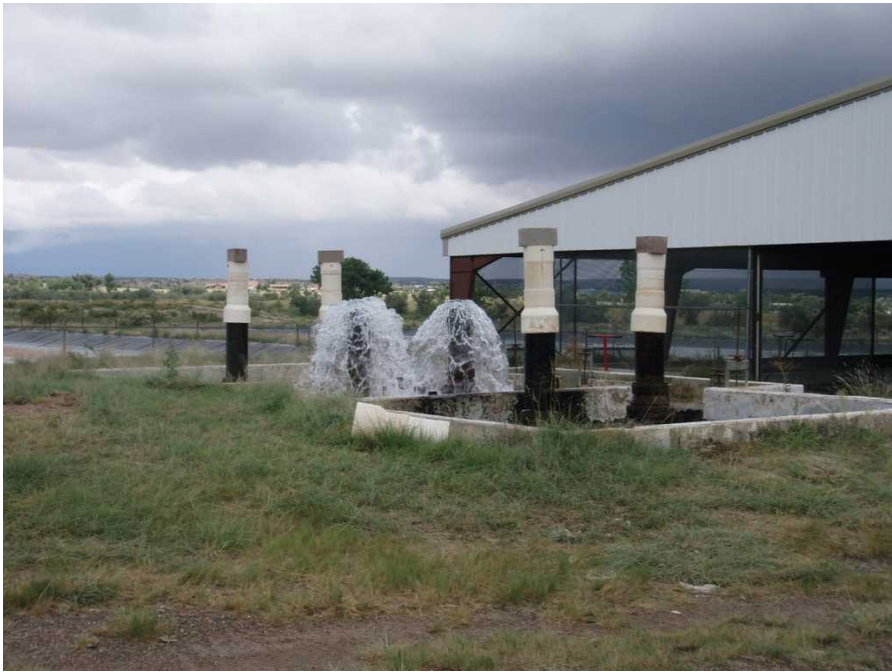
| In flow from Rock Lake | | | P1010030.JPG |

| Rock Lake delivers 3,000 to 3,500 gallons per minute of spring water to the hatchery. | | | |

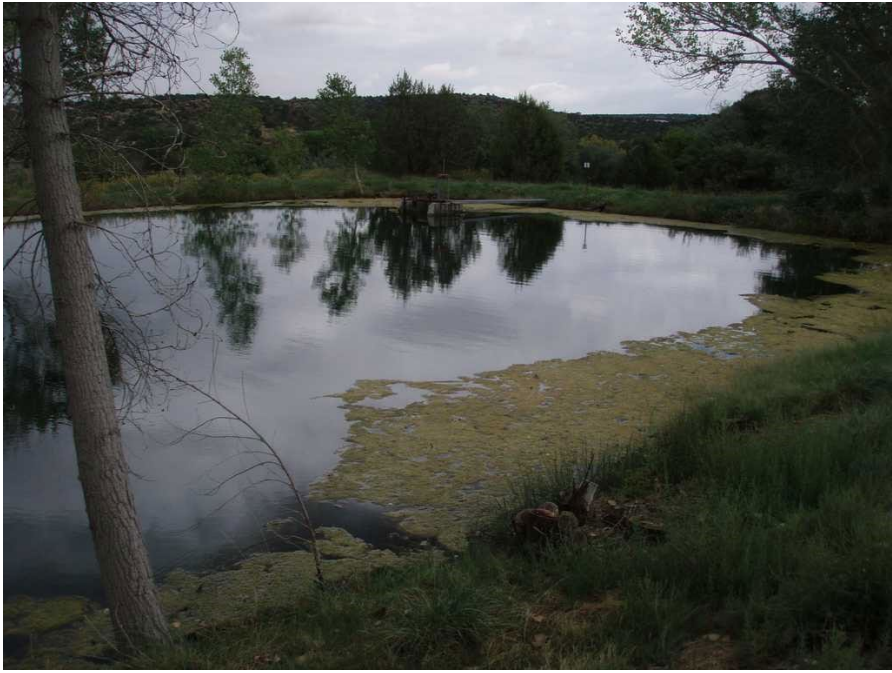
| Settling Ponds | | | P1010037.JPG |

| The combined flow of warmwater (Outfall 004) and cold-water (Outfall 003) combine before discharging into two settling basins that discharge to Outfall 001. | | | |

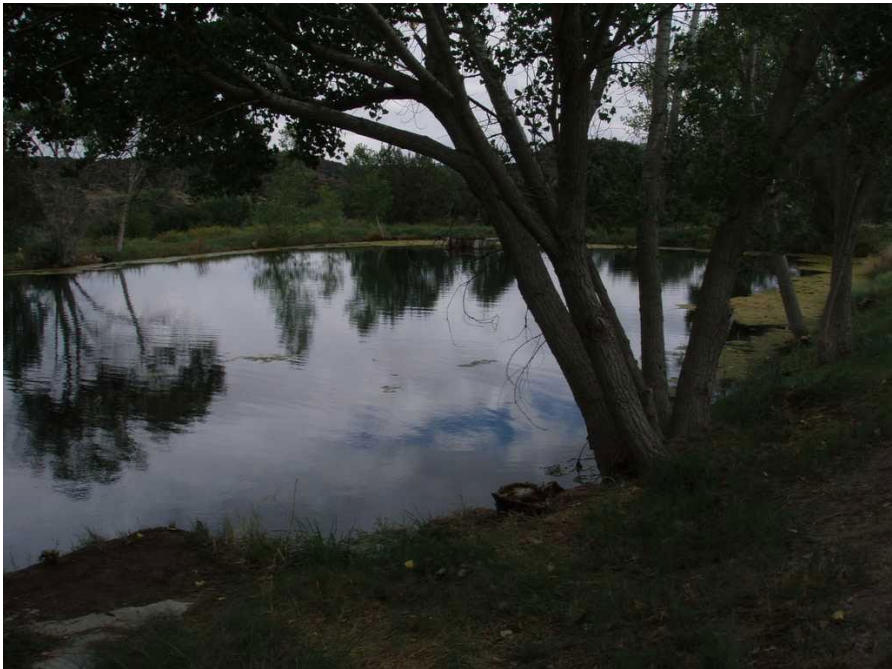
| Settling Ponds | | | P1010036.JPG |

| The combined flow of warmwater (Outfall 004) and cold-water (Outfall 003) combine before discharging into two settling basins that discharge to Outfall 001. | | | |

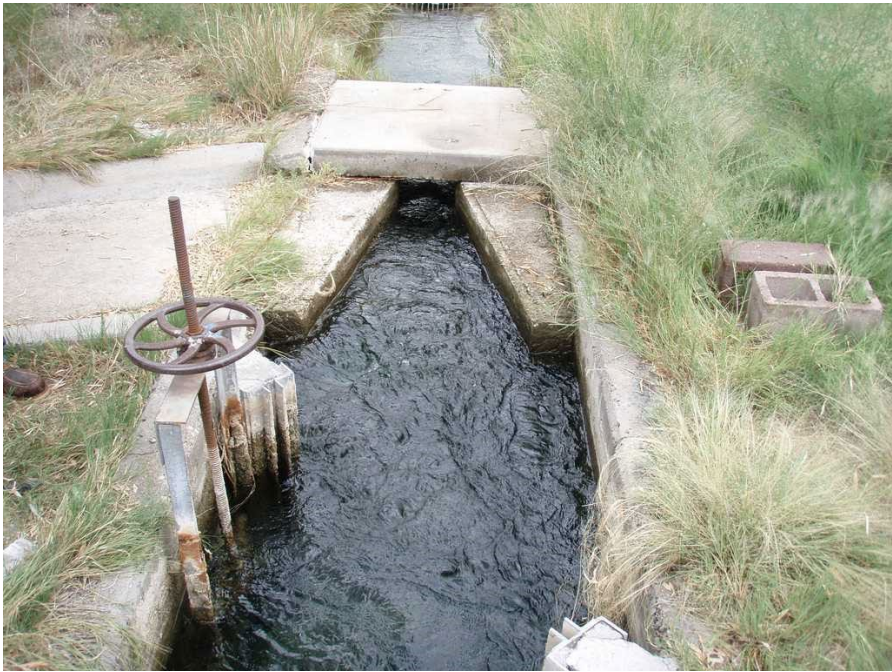
| Outfall 001 | | | P1010040.JPG |

| The combined flow of warmwater (Outfall 004) and cold-water (Outfall 003) combine before discharging into two settling basins that discharge to Outfall 001. | | | |

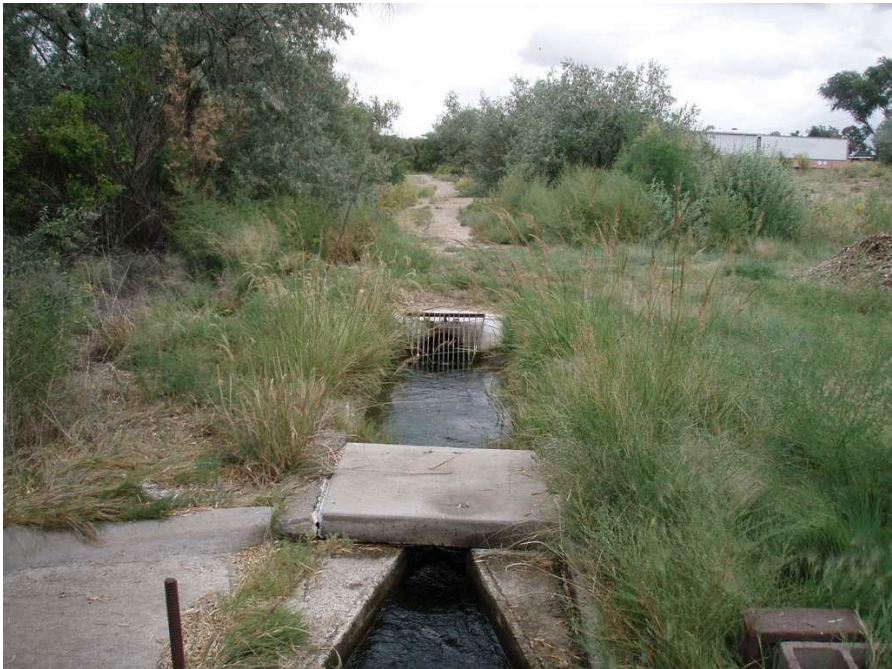
| Outfall 001 | | | P1010041.JPG |

| The combined flow of warmwater (Outfall 004) and cold-water (Outfall 003) combine before discharging into two settling basins that discharge to Outfall 001. | | | |

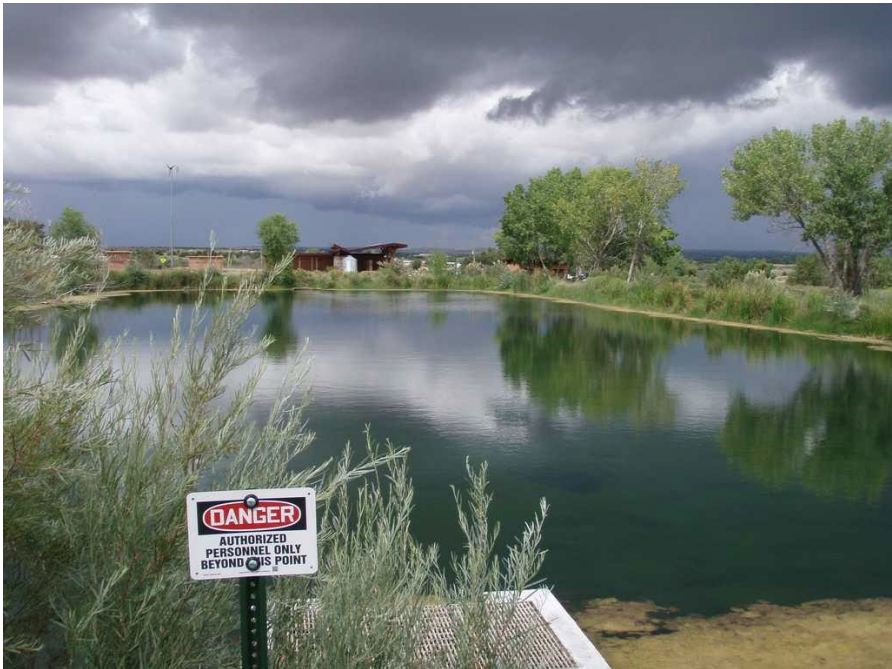
| Settling Ponds | | | P1010043.JPG |

| The combined flow of warmwater (Outfall 004) and cold-water (Outfall 003) combine before discharging into two settling basins that discharge to Outfall 001. | | | |

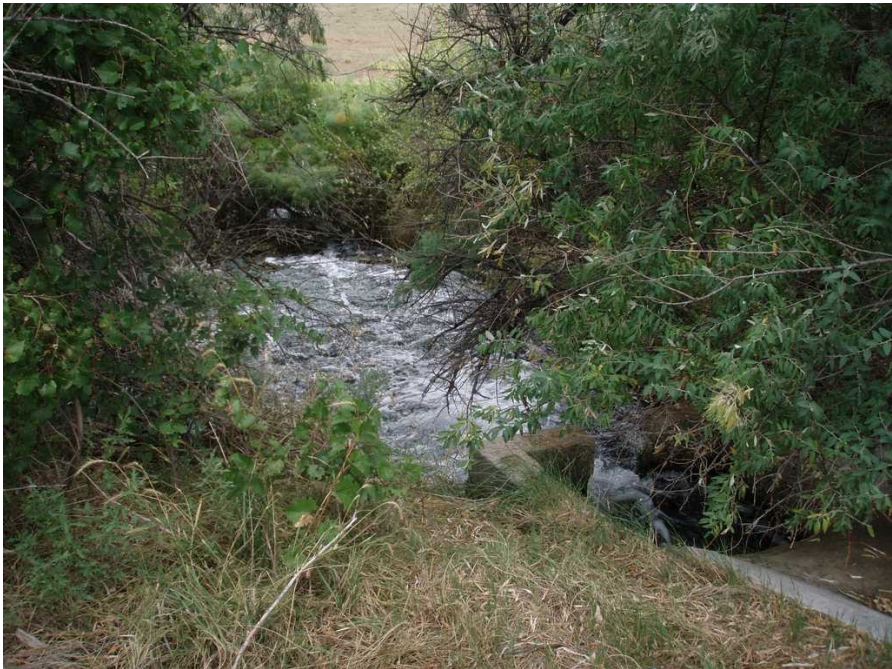
| Outfall 001 | | | P1010042.JPG |

| The combined flow of warmwater (Outfall 004) and cold-water (Outfall 003) combine before discharging into two settling basins that discharge to Outfall 001. | | | |

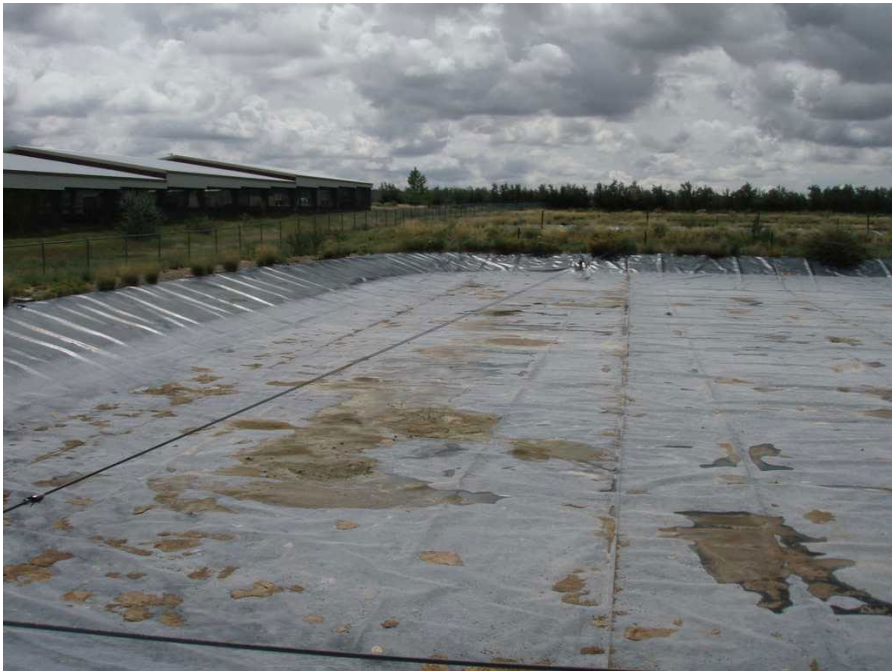
| Warmwater Pond | | | P1010045.JPG |

| Location/Area/Sub-area | Description |
|---|---|
| Outfall 004 | There are 18 one-acre ponds and two quarter-acre ponds that discharge to Outfall 004. All ponds were lined with an impermeable membrane. |

| Liner in warmwater pond | | | |

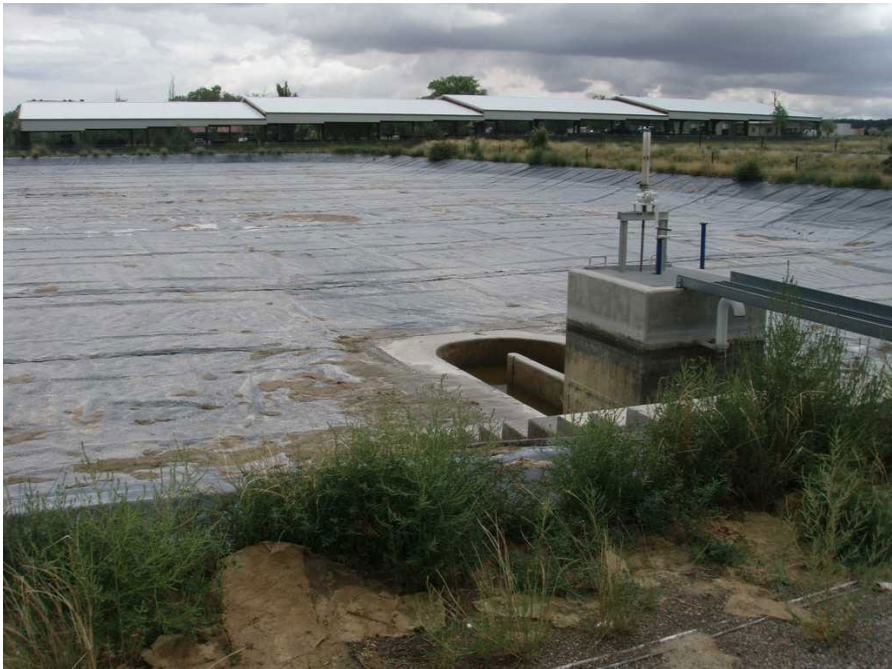
| Warmwater Pond | | | P1010046.JPG |

| Warmwater pond liner. | | | |
