## **RCRA Inspection Report**

Apex Tool Group LLC  
1150 Clipper RD.  
Sumter, South Carolina 29154  
EPA ID No: SCD067012070

June 29, 2021

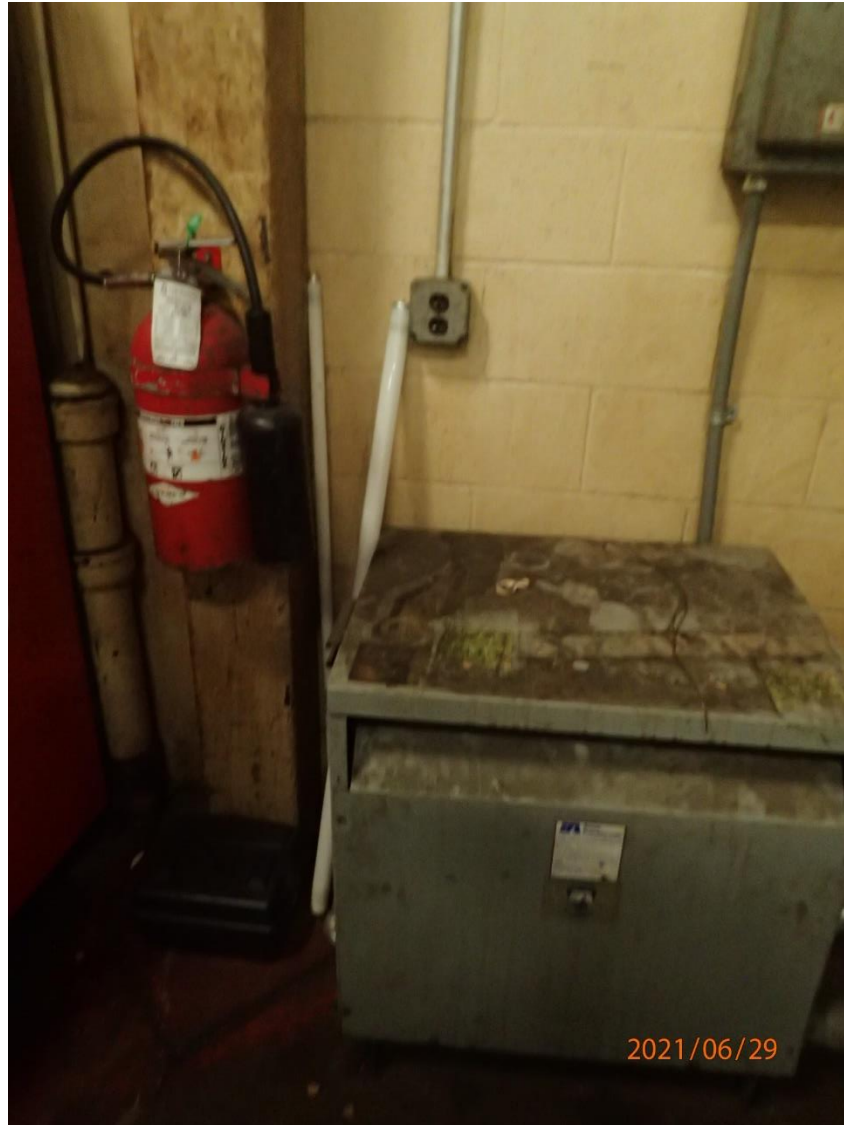
Near the Q/A Lab and offices, two spent fluorescent lamps were observed without being in a closed, labeled, and dated container (Photo #1)

**Photo 1:** Two spent fluorescent lamps were observed without being in a closed, labeled, and dated container.

**Pursuant to 25 S.C. Code Ann. Regs. R.61-79.273.13(d)(1) [40 CFR 273.13(d)(1)], a small quantity handler of universal waste must manage lamps in a way that prevents releases of any universal waste or component of a universal waste to the environment, as follows: A small quantity handler of universal waste must contain any lamp in containers or packages that are structurally sound, adequate to prevent breakage, and compatible with the contents of the lamps. Such containers and packages must remain closed and must lack evidence of leakage, spillage or damage that could cause leakage under reasonably foreseeable conditions**

**Pursuant to 25 S.C. Code Ann. Regs. R.61-79.273.14(e) [40 CFR 273.14(e)], states that each lamp or a container or package in which such lamps are contained must be labeled or marked clearly with one of the following phrases: “Universal Waste - Lamp(s),” or “Waste Lamp(s),” or “Used Lamp(s).”**

**Pursuant to 25 S.C. Code Ann. Regs. R.61-79.273.15(c) [40 CFR 273.15(c)], a small quantity handler of universal waste who accumulates universal waste must be able to demonstrate the length of time that the universal waste has been accumulated from the date it becomes a waste or is received.**

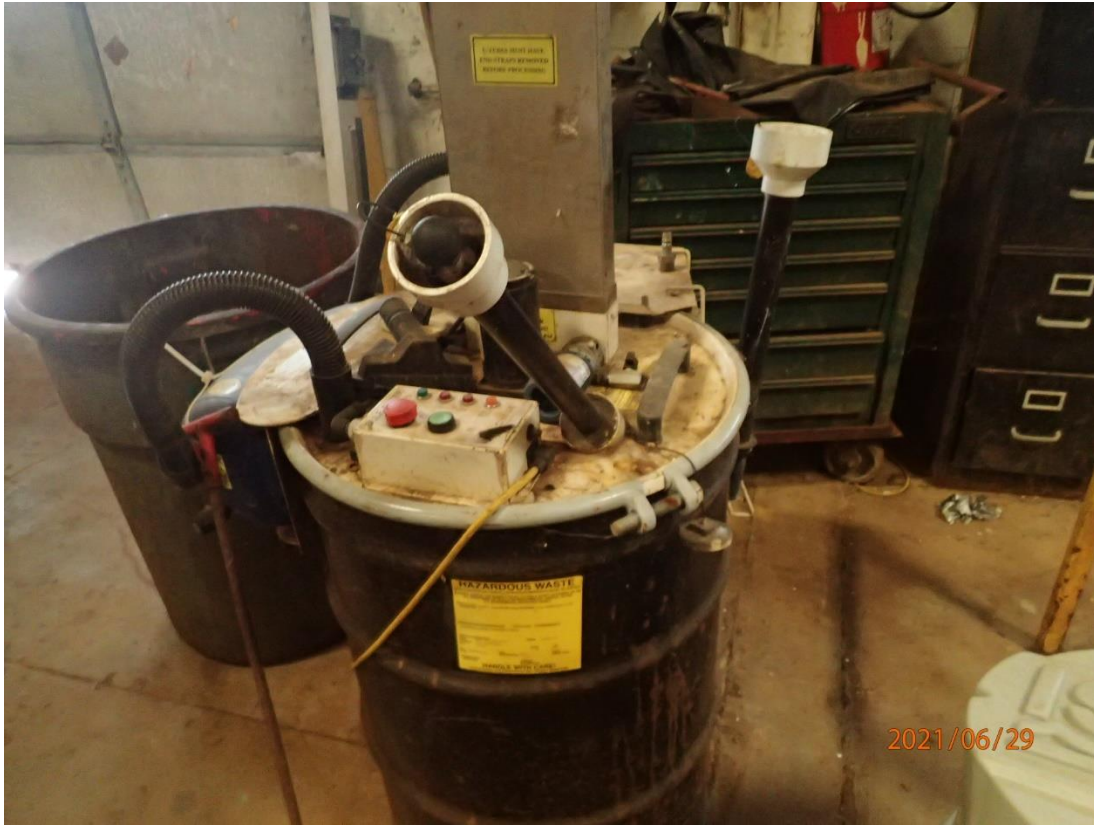
a bulb crusher on top. The drum was closed and labeled “Hazardous Waste – Crushed Lamps”, but it was not marked to indicate the hazard of its contents (Photo #2).

**Photo 2:** 55-gallon SAA drum with a bulb crusher on top, labeled “Hazardous Waste – Crushed Lamps”, closed, but did not indicate the hazard of the contents.

**Pursuant to 25 S.C. Code Ann. Regs. R.61-79.262.15 (a)(5)(ii) [40 CFR 262.15(a)(5)(ii)], a generator must mark or label its container with the following: An indication of the hazards of the contents (examples include, but are not limited to, the applicable hazardous waste characteristic(s) (i.e., ignitable, corrosive, reactive, toxic); hazard communication consistent with the Department of Transportation requirements at 49 CFR part 172 subpart E (labeling) or subpart F (placarding); a hazard statement or pictogram consistent with the Occupational Safety and Health Administration Hazard Communication Standard at 29 CFR 1910.1200; or a chemical hazard label consistent with the National Fire Protection Association code 704).**

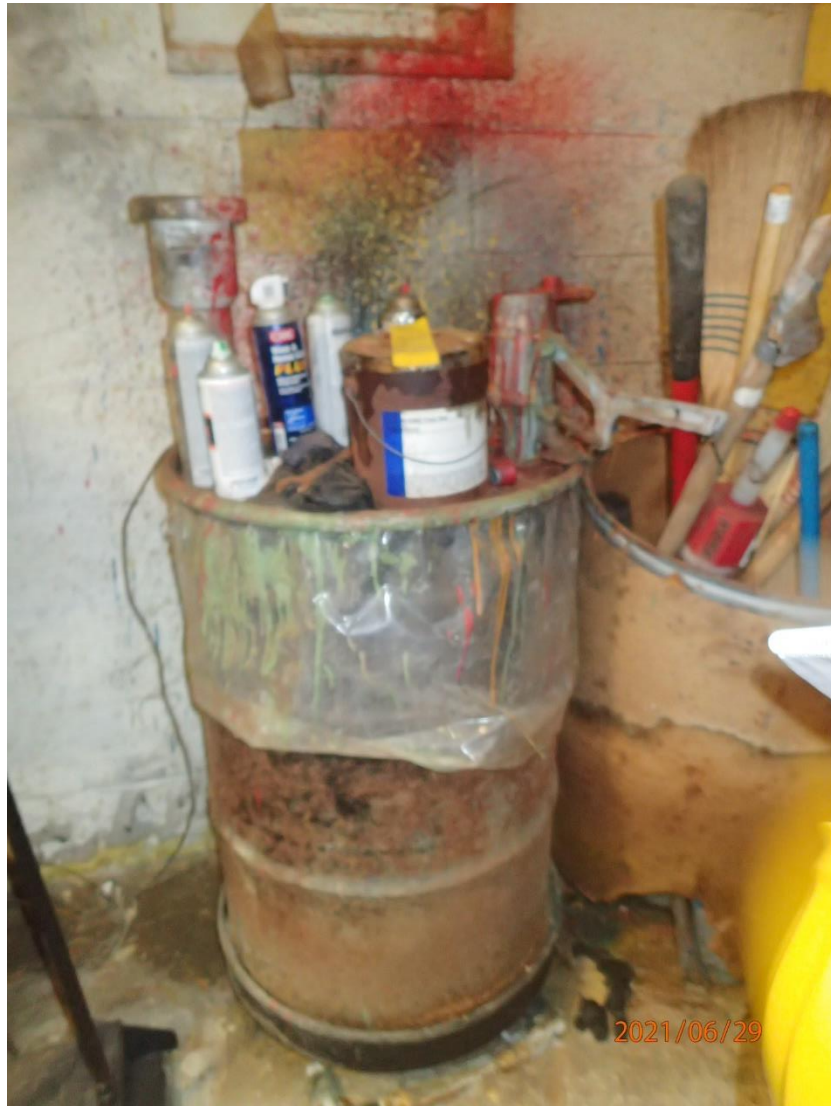
- One SAA for accumulating the contents of aerosol cans, which contained (1) 55-gallon drum equipped with an aerosol can puncturing device on top. The drum was open and had no label (Photo #3).

**Photo 3:** 55-gallon SAA drum equipped with an aerosol can puncturing device on top, open, and no label.

**Pursuant to 25 S.C. Code Ann. Regs. R.61-79.262.15(a)(4) [40 CFR 262.15(a)(4)], A container holding hazardous waste must be closed at all times during accumulation, except: (i) When adding, removing, or consolidating waste; or (ii) When temporary venting of a container is necessary (A) For the proper operation of equipment, or (B) To prevent dangerous situations, such as build-up of extreme pressure.**

**Pursuant to 25 S.C. Code Ann. Regs. R.61-79.262.15(a)(5)(i) [40 CFR 262.15(a)(5)(i)], a generator must mark or label its container with the following: The words “Hazardous Waste”.**

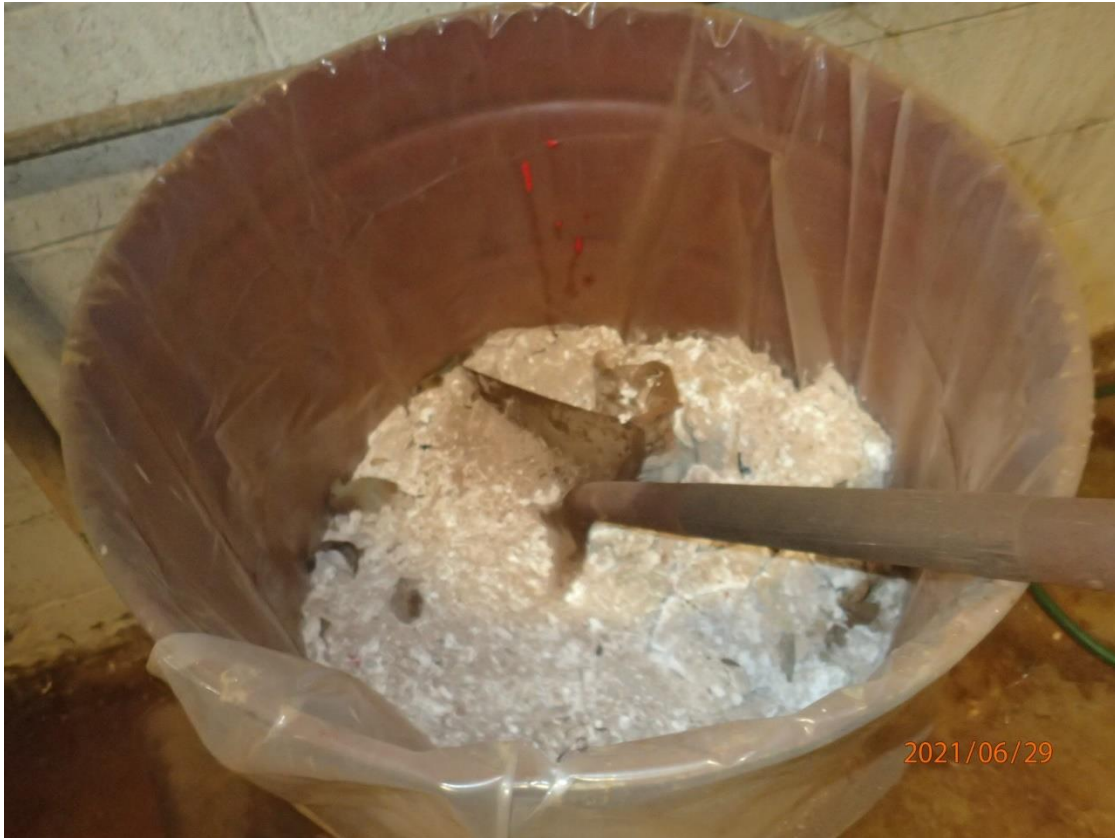
- One (1) 55-gallon drum with what appeared to be floor sweepings, was observed open and not labeled. Facility personnel were unsure if the material was hazardous or non-hazardous waste when asked. (Photo #4 and Photo #5). A waste profile / analysis was requested for the floor sweeping material at the end of the inspection and in a follow up email dated 07/02/2021.

**Photo 4:** 55-gallon drum with what appeared to be floor sweepings, was observed open and not labeled. Facility personnel were unsure if the material was hazardous or non-hazardous waste when asked.

**Pursuant to 25 S.C. Code Ann. Regs. 61-79.262.11 [40 CFR 262.11] A person who generates a solid waste, as defined in 40 CFR 261.2, must make an accurate determination as to whether that waste is a hazardous waste in order to ensure wastes are properly managed according to applicable RCRA regulations.**

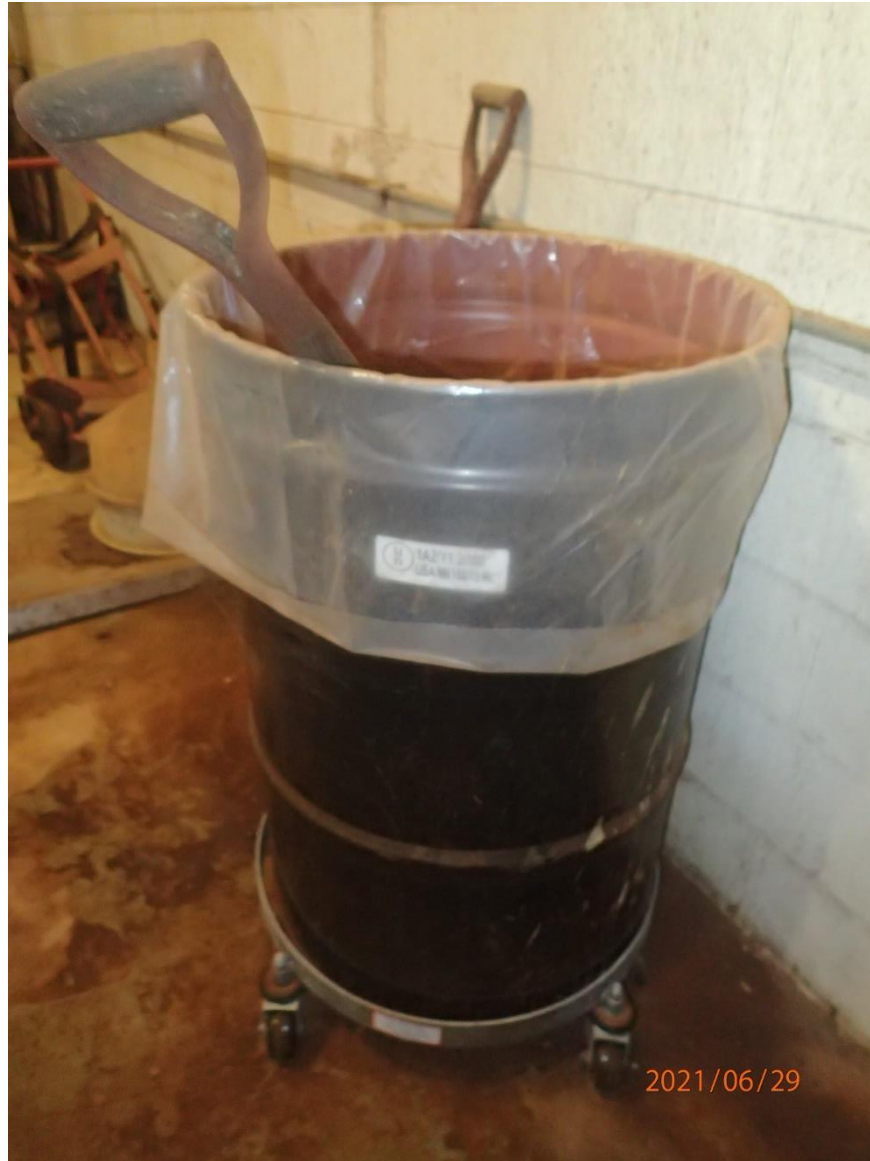
**Photo 5:** 55-gallon drum with what appeared to be floor sweepings, was observed open and not labeled. Facility personnel were unsure if the material was hazardous or non-hazardous waste when asked.

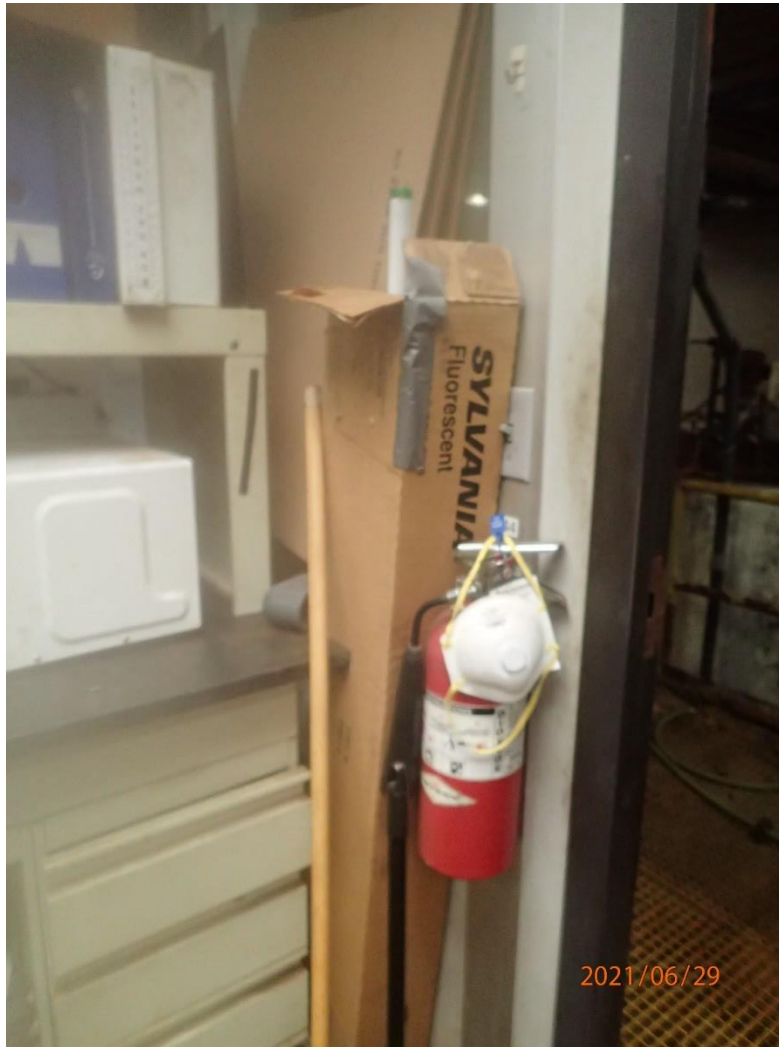
- One (1) box of fluorescent lamps, open, and not labeled. Facility personnel were not able to identify if the fluorescent lamps were used or new (Photo #6).

**Photo 6:** Box of fluorescent lamps, open, and not labeled. Facility personnel was not able to identify if the fluorescent lamps were used or new.

**Pursuant to 25 S.C. Code Ann. Regs. R.61-79.273.13(d)(1) [40 CFR 273.13(d)(1)], a small quantity handler of universal waste must manage lamps in a way that prevents releases of**

any universal waste or component of a universal waste to the environment, as follows: A small quantity handler of universal waste must contain any lamp in containers or packages that are structurally sound, adequate to prevent breakage, and compatible with the contents of the lamps. Such containers and packages must remain closed and must lack evidence of leakage, spillage or damage that could cause leakage under reasonably foreseeable conditions.

Pursuant to 25 S.C. Code Ann. Regs. R.61-79.273.14(e) [40 CFR 273.14(e)], each lamp or a container or package in which such lamps are contained must be labeled or marked clearly with one of the following phrases: "Universal Waste - Lamp(s)," or "Waste Lamp(s)," or "Used Lamp(s)."

Pursuant to 25 S.C. Code Ann. Regs. R.61-79.273.15(c) [40 CFR 273.15(c)], a small quantity handler of universal waste who accumulates universal waste must be able to demonstrate the length of time that the universal waste has been accumulated from the date it becomes a waste or is received.

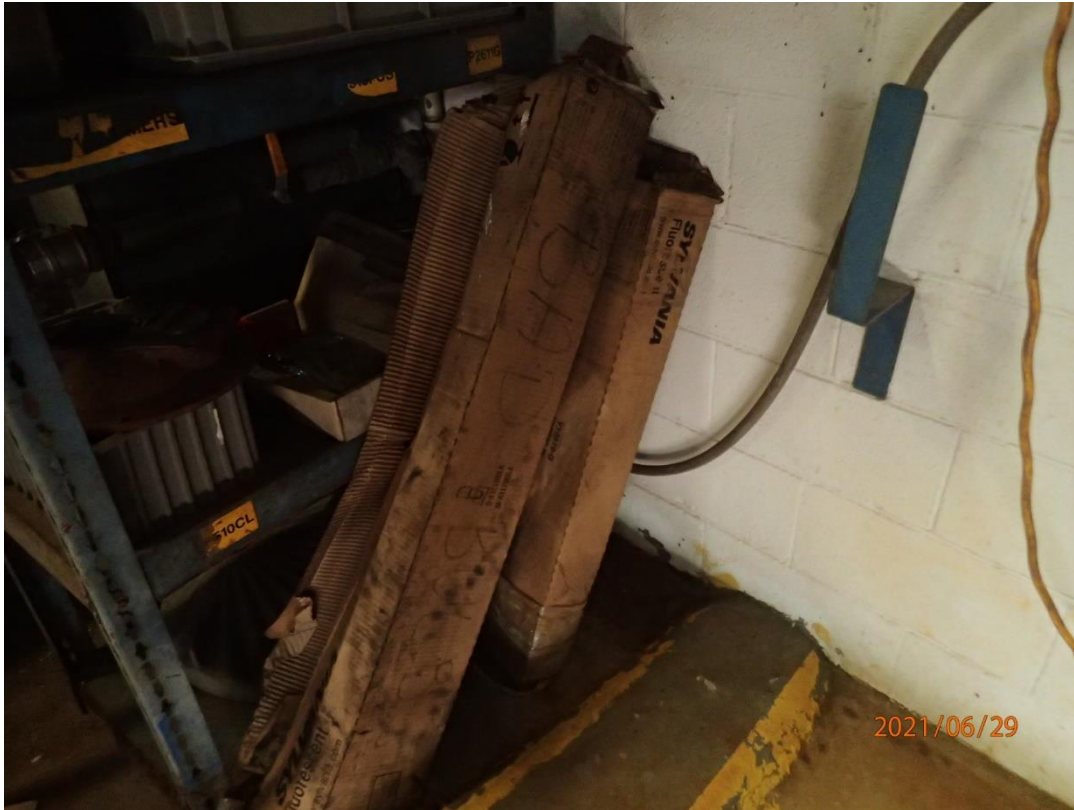
- Two (2) boxes of fluorescent lamps were also observed on the first floor of the WWTP (Photo #7). The boxes were open, labeled “Bad Bulbs”, and not marked with a start accumulation date.

**Photo 7:** Two (2) boxes of fluorescent lamps labeled “Bad Bulbs” were also observed on the first floor of the WWTP.

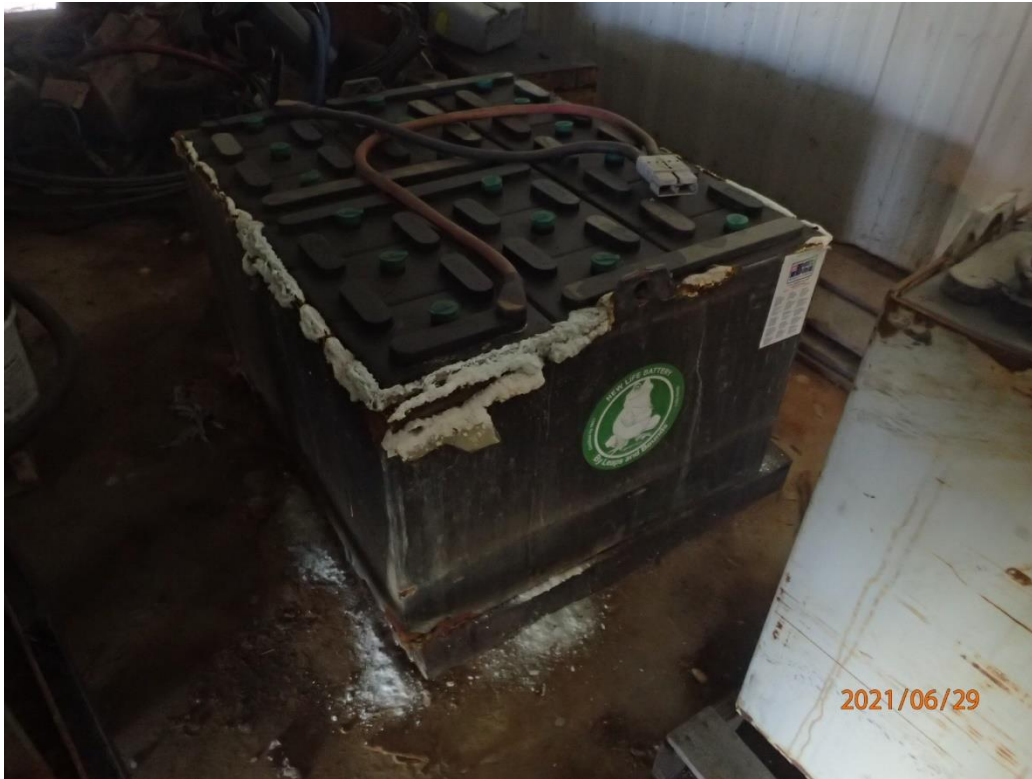
- One leaking forklift battery, not labeled or stored in a closed container (Photo #8).
- Three lead acid batteries in poor condition (not useable), not labeled or closed.

**Photo 8:** Leaking forklift battery, not labeled or properly closed in a container.

Pursuant to 25 S.C. Code Ann. Regs. R.61-79.273.13(a)(1) [40 CFR 273.13(a)(1)], a small quantity handler of universal waste must contain any universal waste battery that shows evidence of leakage, spillage, or damage that could cause leakage under reasonably foreseeable conditions in a container. The container must be closed, structurally sound, compatible with the contents of the battery, and must lack evidence of leakage, spillage, or damage that could cause leakage under reasonably foreseeable conditions.

Pursuant to 25 S.C. Code Ann. Regs. R.61-79.273.14(a) [40 CFR 273.14(a)], a small quantity handler of universal waste must label or mark the universal waste to identify the type of universal waste as specified below: Universal waste batteries (i.e., each battery), or a container in which the batteries are contained, must be labeled or marked clearly with any one of the following phrases: "Universal Waste -Battery(ies)," or "Waste Battery(ies)," or "Used Battery(ies);"

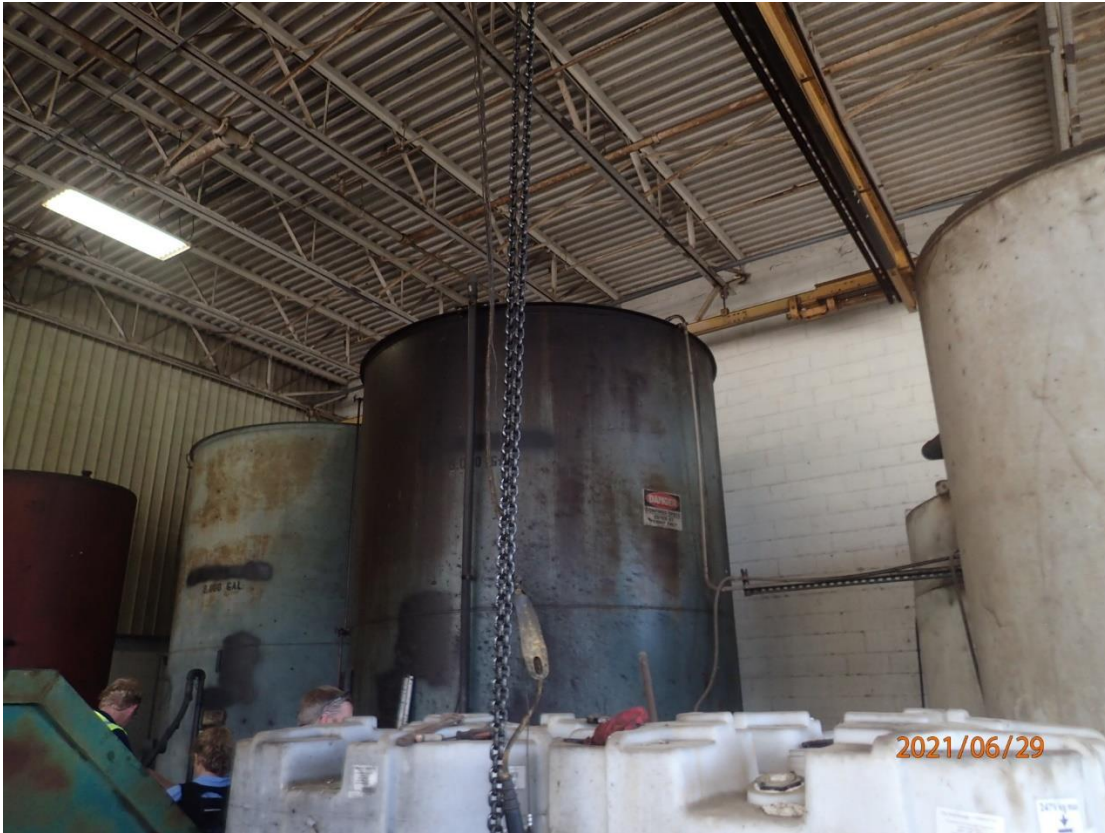
**Photo 9:** 8,000-gallon above ground storage tanks used to store used oil, not labeled “Used Oil”.

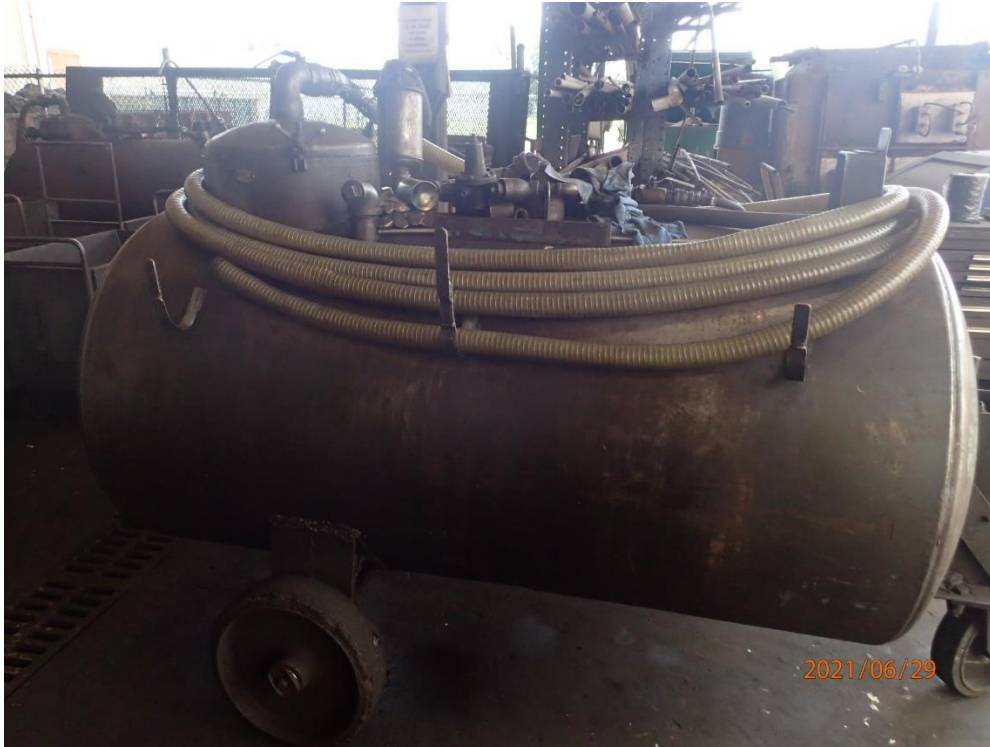
**Photo 10:** One (1) mobile used oil tank, not labeled “Used Oil”.

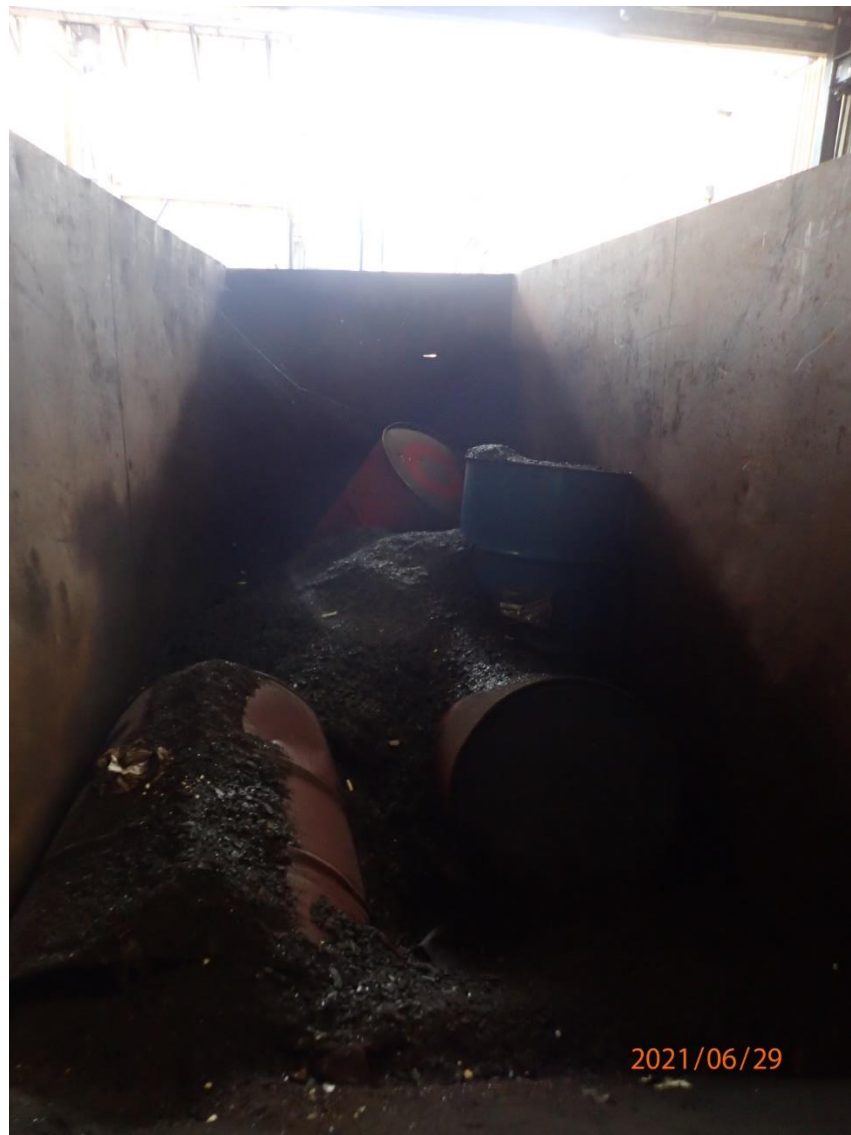
- One roll-off container with four (4) 55-gallon containers of unknown material, no labels. Facility personnel were not able to identify the material (Photo #11). A hazardous waste determination was requested at the end of the inspection and in a follow up email dated 07/02/2021.

**Photo 11:** One roll-off container with four (4) 55-gallon containers of unknown material, no labels. Facility personnel were not able to identify the material.

**Pursuant to 25 S.C. Code Ann. Regs. 61-79.262.11 [40 CFR 262.11] A person who generates a solid waste, as defined in 40 CFR 261.2, must make an accurate determination as to whether that waste is a hazardous waste in order to ensure wastes are properly managed according to applicable RCRA regulations.**

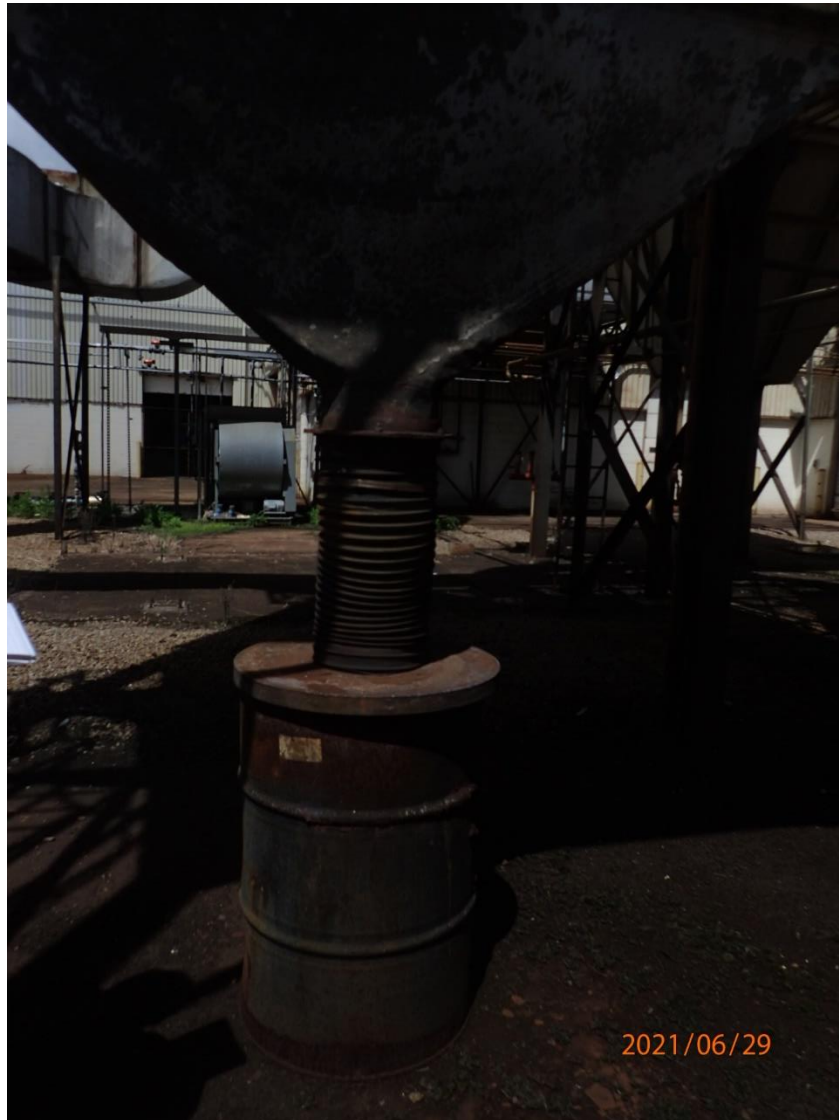
**Photo 12:** One of two 55-gallon containers attached to the baghouses. The container was not labeled.

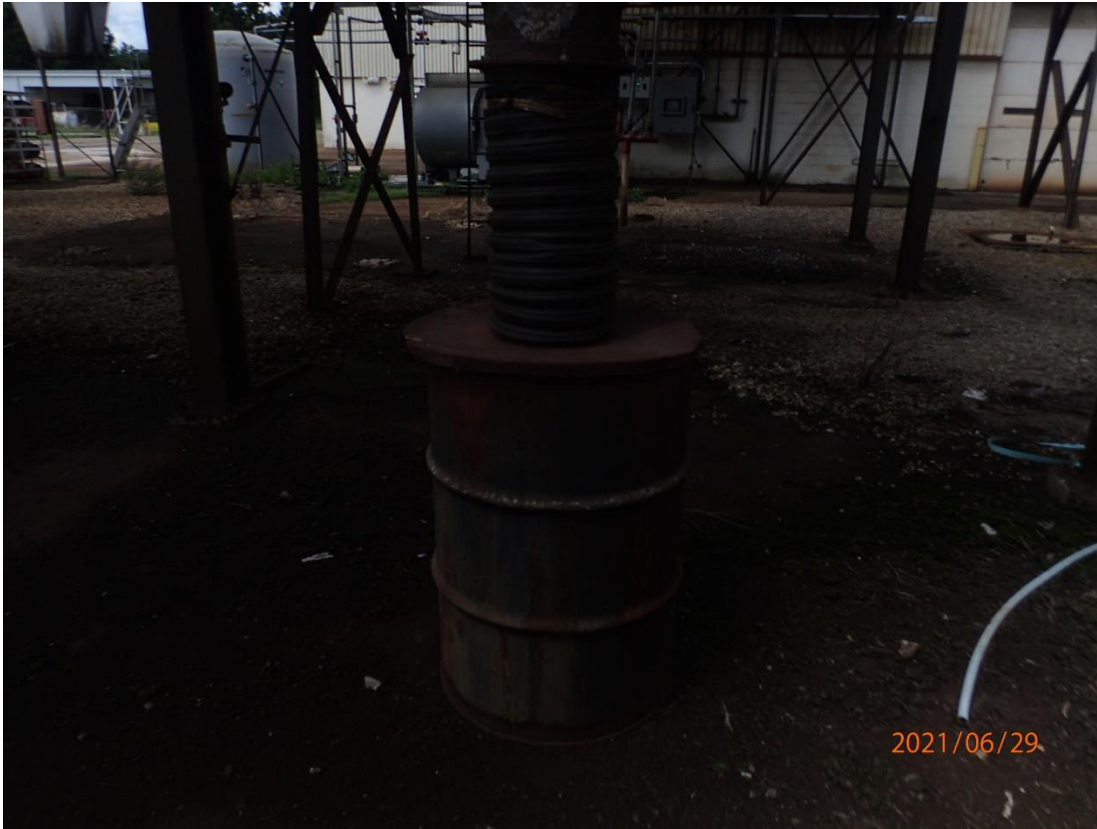
**Photo 13:** Second 55-gallon container attached to a baghouse. The container was not labeled.

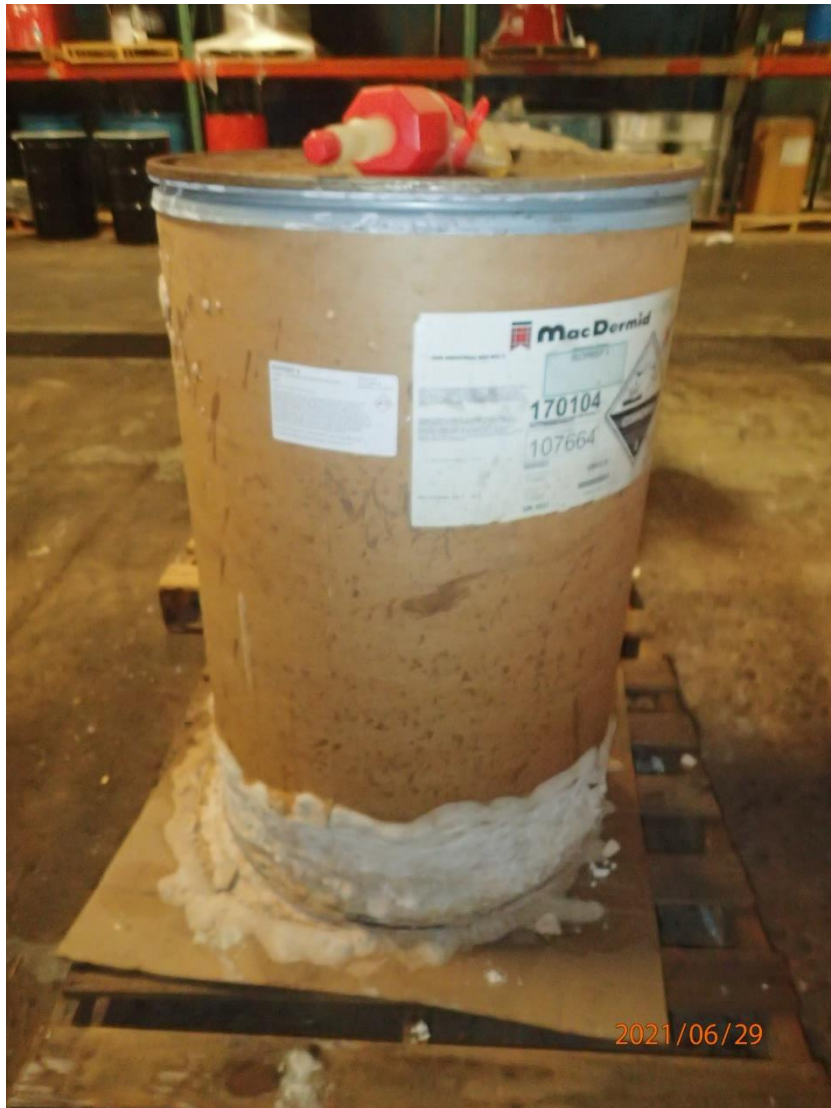
- One (1) 55-gallon fiber drum of Isoprep 3, was closed but appeared to show evidence of leaking around the bottom of the drum. The drum had a corrosive placard to indicate its hazard contents and a product expiration date of 11-20-19. (Photos #14 and #15).

**Photo 14:** One (1) 55-gallon fiber drum of Isoprep 3, closed but appeared to show evidence of leaking around the bottom of the drum. The drum had a corrosive placard to indicate its hazard contents and a product expiration date of 11-20-19.

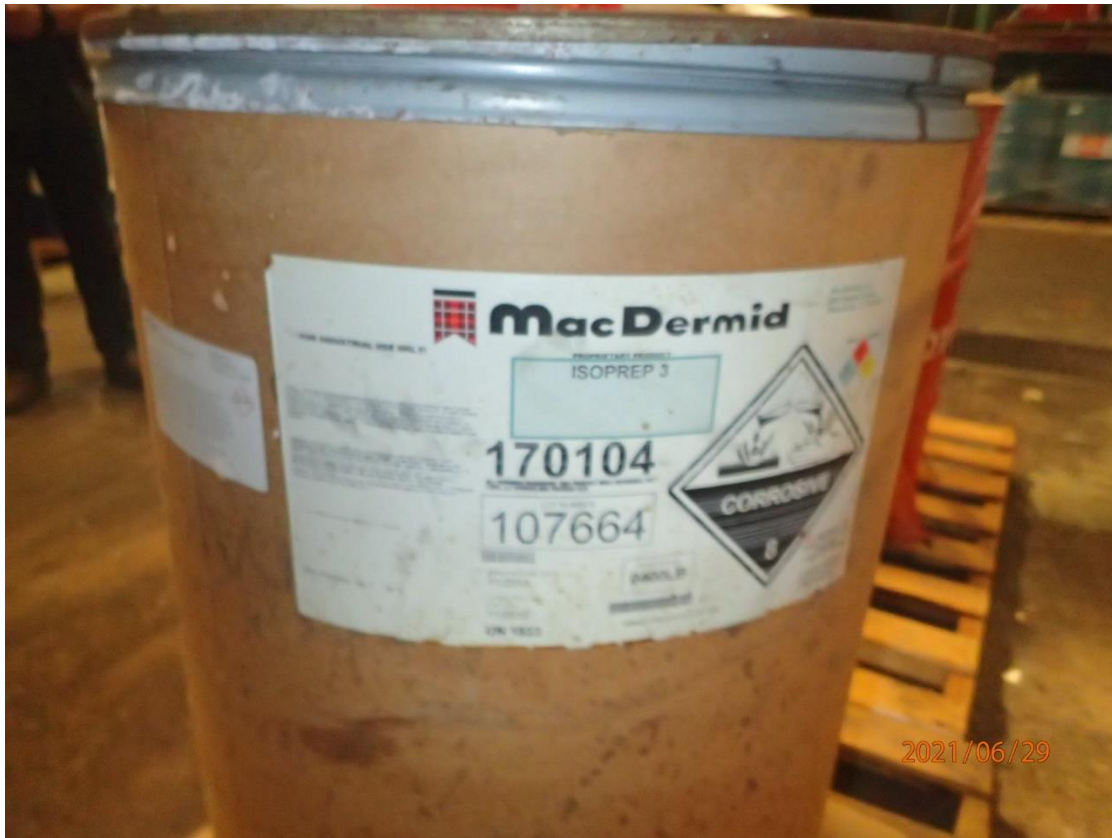
**Photo 15:** Close up of label for the One (1) 55-gallon fiber drum of Isoprep 3.

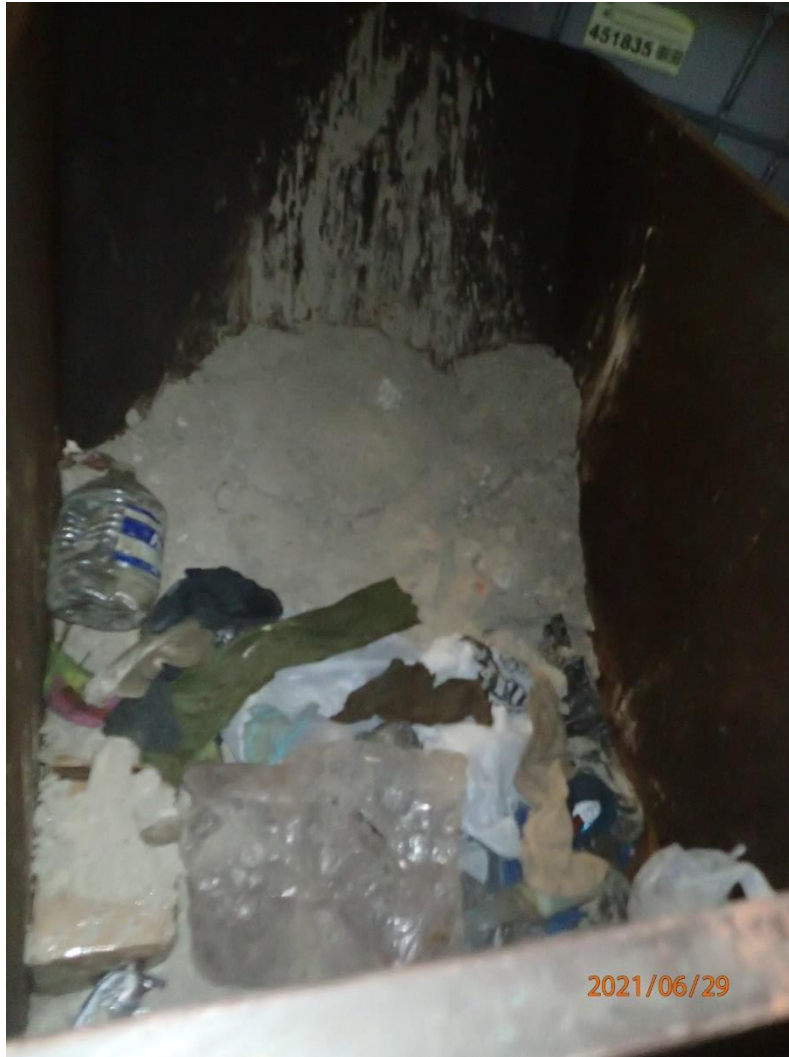
- One (1) roll-off container was observed with what appeared to be floor sweepings. No label was observed on the container. Facility personnel were unable to identify the contents in the roll-off container. (Photo #16) A waste determination was requested at the end of the inspection and in a follow up email dated 07/02/2021

**Photo 16:** Roll-off container was observed with what appeared to be floor sweepings. No label was observed on the container.

**Pursuant to 25 S.C. Code Ann. Regs. 61-79.262.11 [40 CFR 262.11] A person who generates a solid waste, as defined in 40 CFR 261.2, must make an accurate determination as to whether that waste is a hazardous waste in order to ensure wastes are properly managed according to applicable RCRA regulations.**

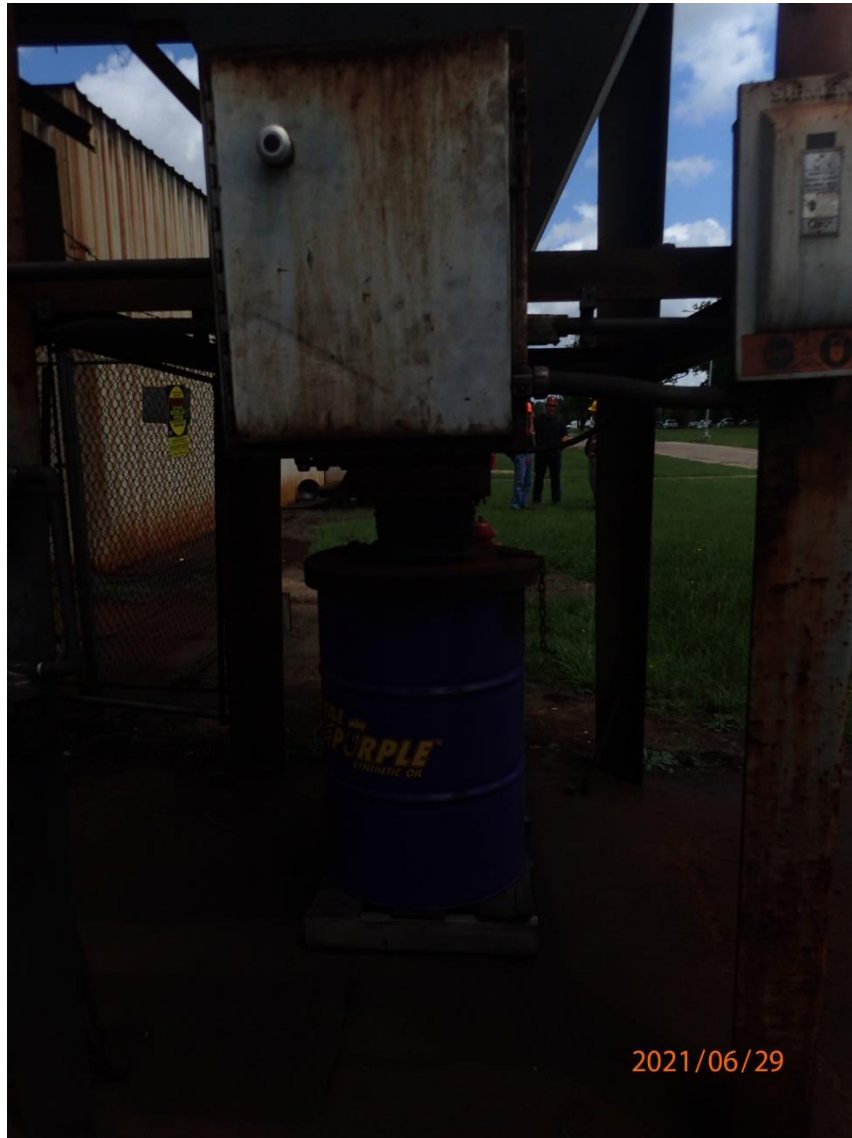
- One (1) 55-gallon drum connected to a baghouse, managed as non-hazardous waste.
- One (1) 55-gallon drum connected to a baghouse just outside of the Back Building, managed as non-hazardous waste. (Photo #17)

**Photo 17:** 55-gallon drum connected to a baghouse just outside of the Back Building, managed as non-hazardous waste
