INSPECTION REPORT

| Type of Inspection | Compliance Evaluation Inspection (CEI) | |
| Company Name | Alaska Railroad Corporation | |
| Facility/Site Physical Address | 327 W Ship Creek Ave | |

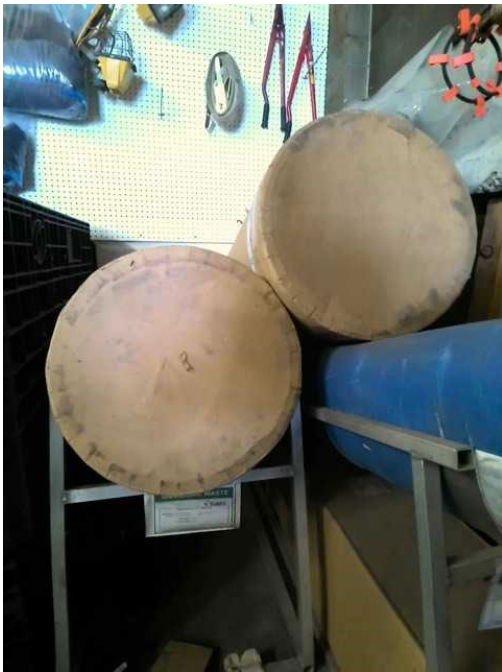
| Closed waste lamp container in CAA | | | IMG-20240709095350535073413.jpg |

| Waste lamp container after being closed. | | | |

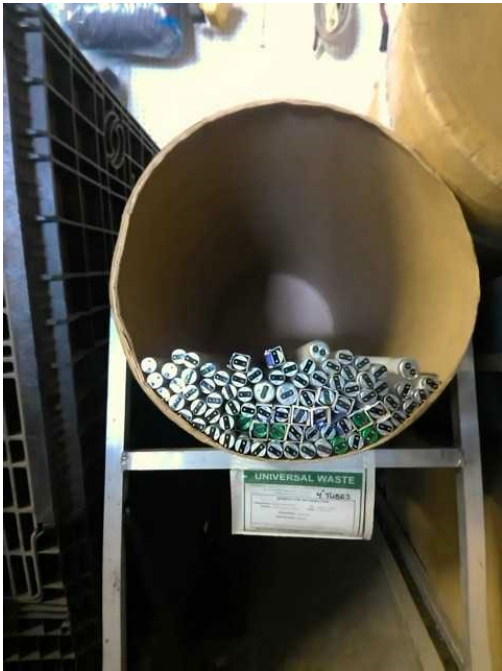
| Open waste lamp container in CAA | | | IMG-20240709093431343166406.jpg |

| Open waste lamp container with lamps inside and label affixed to stand, not container. | | | |

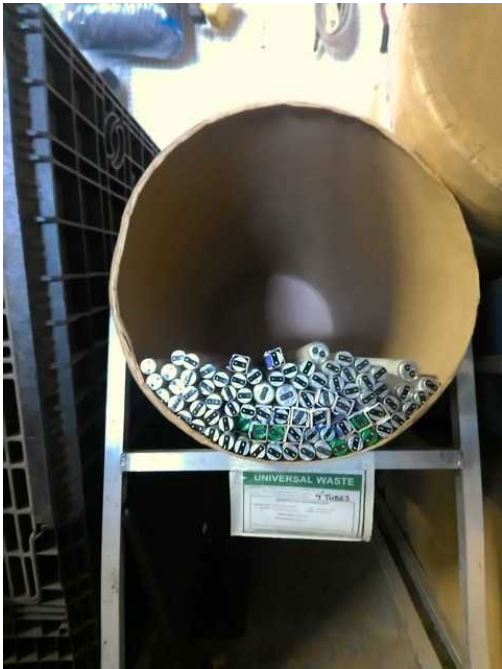
| Open waste lamp container in CAA | | | IMG-20240709093431343167507.jpg |

| Open waste lamp container with lamps inside and label affixed to stand, not container. | | | |

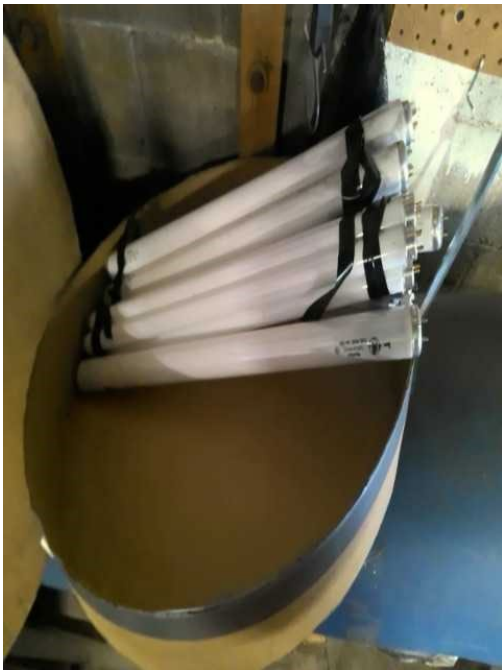
| Waste lamps not in container in CAA | | | IMG-20240709093543354348819.jpg |

| Waste lamps sitting in the lid of the waste lamp container, not properly contained. | | | |

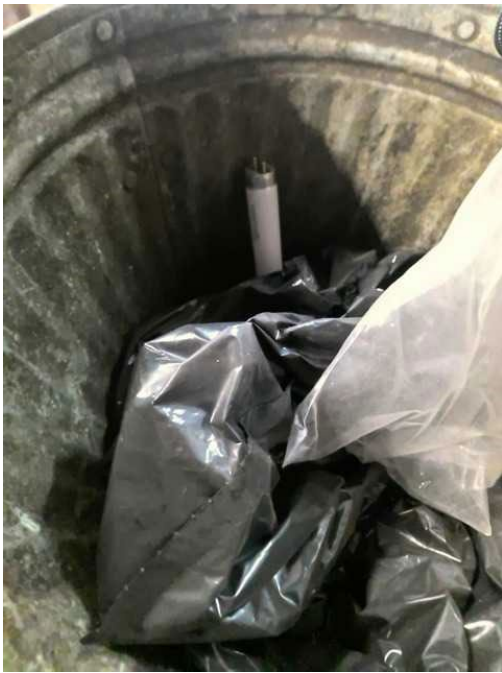
| Broken lamp in a trash can in CAA | | | IMG-20240709095022502269968.jpg |

At the time of the inspection, we observed one broken lamp in a trash can.

| Broken lamp in a trash can, not properly contained. | | | |

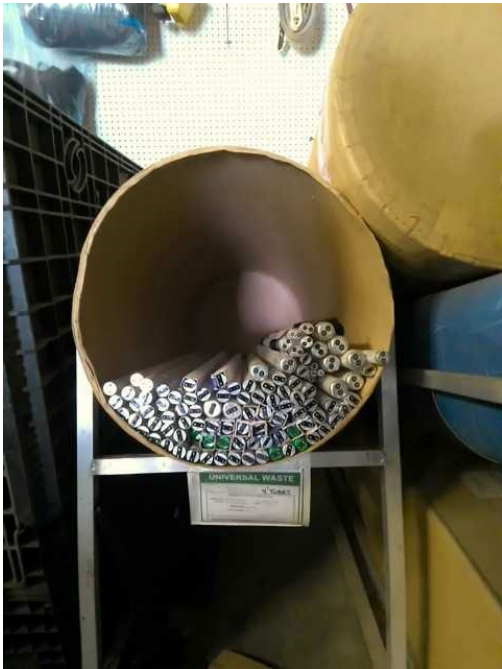
| Open waste lamp container in CAA | | | IMG-20240709095334533471072.jpg |

At the time of the inspection, we observed two containers of used lamps that were not closed. We also observed that the universal waste labels associated with these containers were attached to the container stands, instead of the containers themselves. Mr. Jones closed these containers during the inspection and made note that they are normally kept closed. He stated he would attach the labels to the containers.

| Open waste lamp container with lamps inside and lid sitting nearby. | | | |

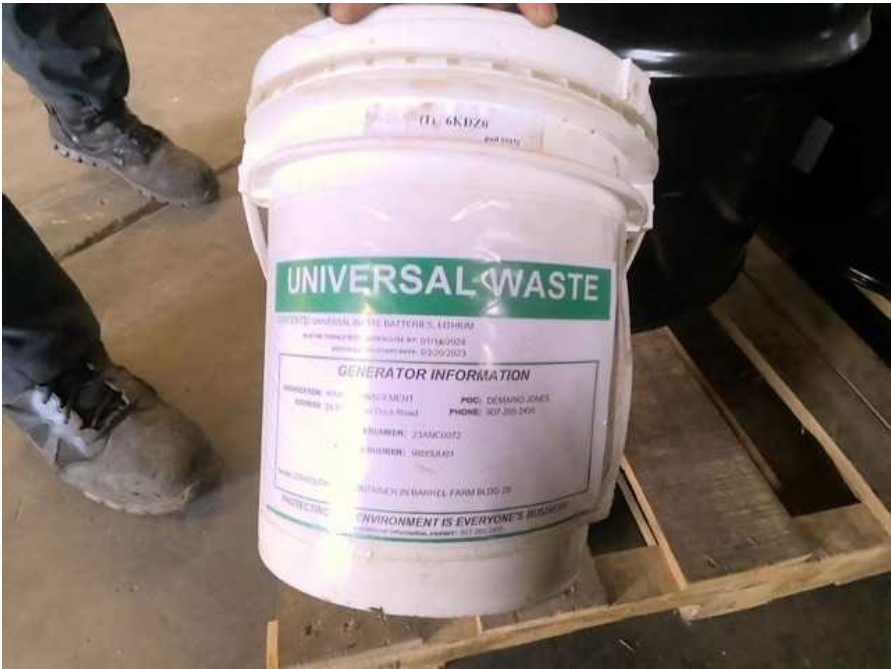
| Universal waste lithium batteries in CAA with accumulation over one year | | | IMG-202407091004064666326.jpg |

At the time of the inspection, we observed a container of NiCad batteries and a container of lithium batteries each with an accumulation start date of 3/20/23. This was over one year of accumulation at the time of the inspection. Mr. Jones reported that he believed these dates to be incorrect and he stated that the actual accumulation start dates were February 2024.

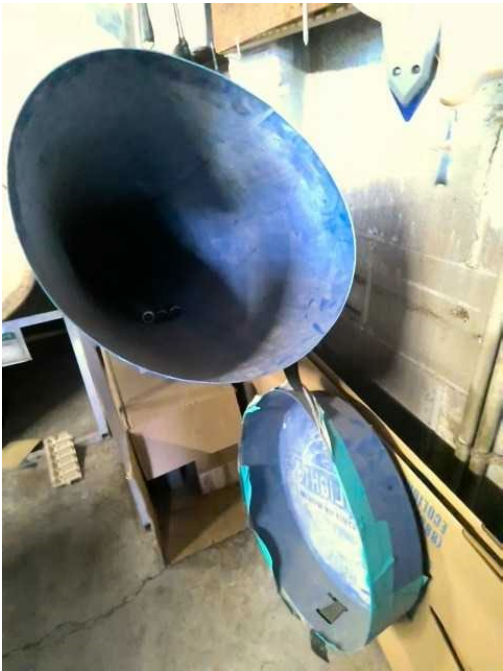
| Open waste lamp container in CAA | | | IMG-20240709095431543168403.jpg |

| Open waste lamp container with lamps inside and lid hanging off. | | | |

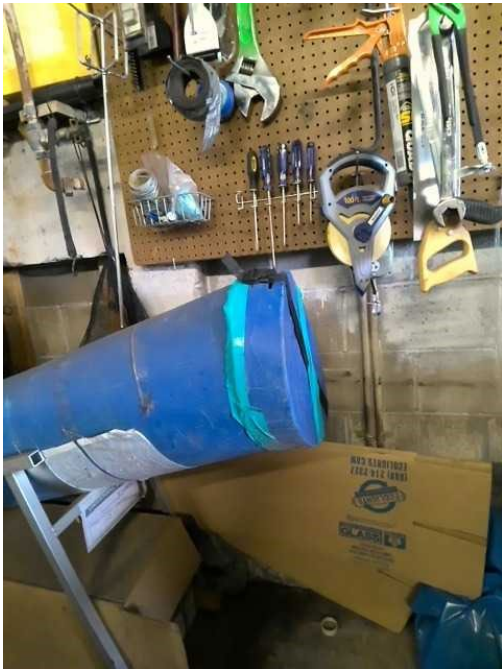
| Closed waste lamp container in CAA | | | IMG-20240709095449544994993.jpg |

| Waste lamp container with lamps inside, closed. | | | |

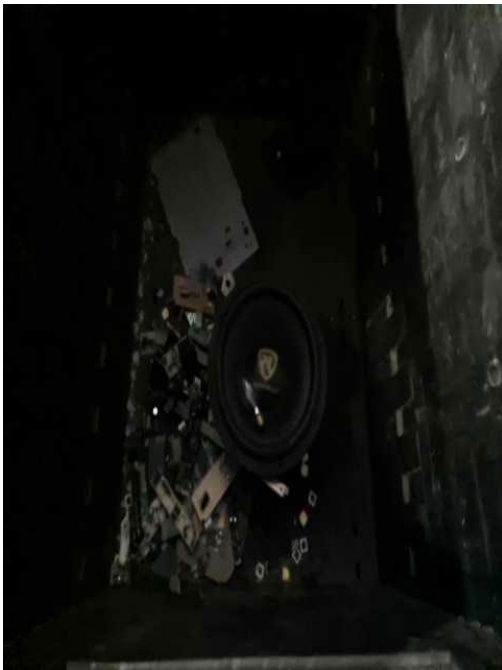
| Waste bulb in container of batteries in CAA | | | IMG-20240709095728572834723.jpg |

| Waste bulb in a container of batteries, not properly contained. | | | |

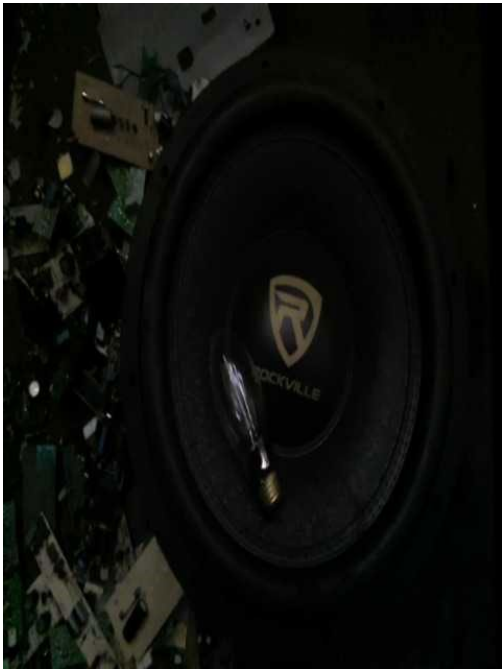
| Waste bulb in container of batteries in CAA | | | IMG-20240709095731573137486.jpg |

| Waste bulb in a container of batteries, not properly contained. | | | |

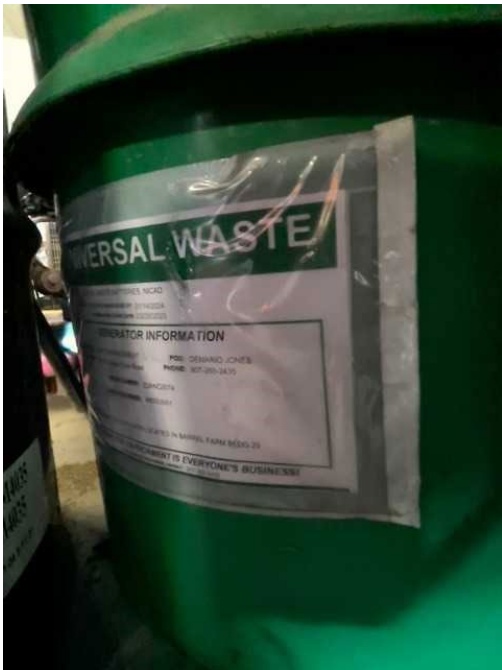
| Universal waste NiCad batteries in CAA with accumulation over one year | | | IMG-2024070910015115150328.jpg |

| Universal waste NiCad batteries accumulated for over one year. | | | |

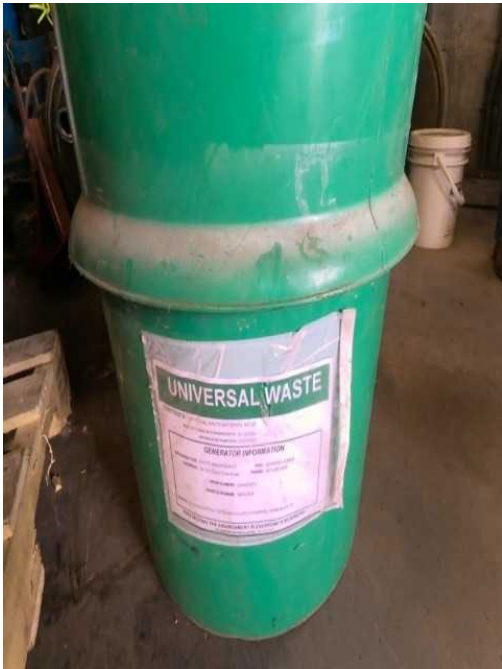
| Universal waste NiCad batteries in CAA with accumulation over one year | | | IMG-2024070910022922958057.jpg |

| Universal waste NiCad batteries accumulated for over one year. | | | |

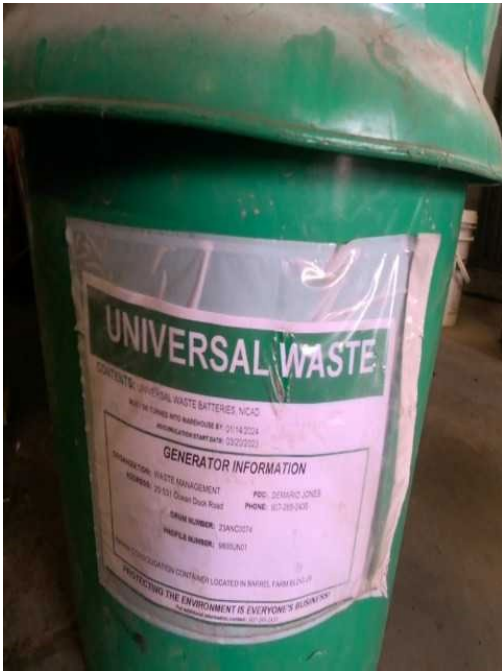
| Universal waste NiCad batteries in CAA with accumulation over one year | | | IMG-2024070910023523559299.jpg |

| Universal waste NiCad batteries accumulated for over one year. | | | |

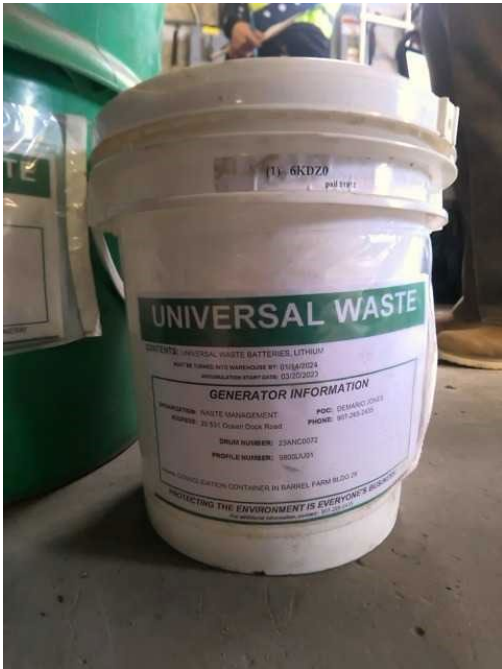
| Universal waste lithium batteries in CAA with accumulation over one year | | | IMG-2024070910044344361174.jpg |

| Universal waste lithium batteries accumulated for over one year. | | | |

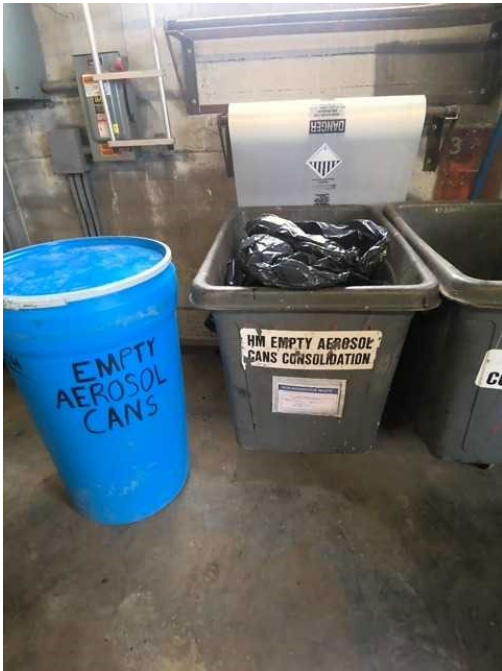
| Waste aerosol can accumulation in containers in CAA | | | IMG-2024070910091491473678.jpg |

| Waste aerosol can accumulation in CAA | | | |

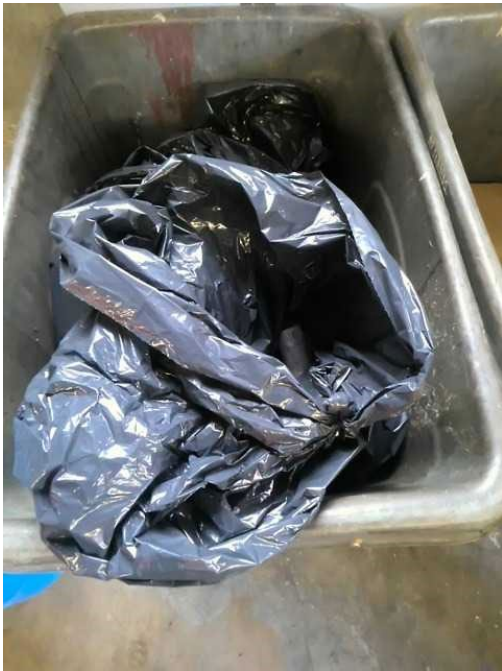
| Waste aerosol can accumulation in open container in CAA | | | IMG-2024070910092092089391.jpg |

At the time of the inspection, we observed waste aerosol cans in an open wheeling cart labeled as “non-hazardous”. This container was not labeled as “hazardous waste”, nor did it have a hazard indicator, or an accumulation start date. We also observed a blue container with waste aerosol cans that was closed and labeled “empty aerosol cans”. This container was not labeled as “hazardous waste”, nor did it have a hazard indicator, or an accumulation start date. Mr. Jones stated that the blue container is used to place waste aerosol cans into the wheeling cart and is not meant to accumulate waste aerosol cans.

| Waste aerosol cans in bag, in an open container labeled as “non-hazardous”. | | | |

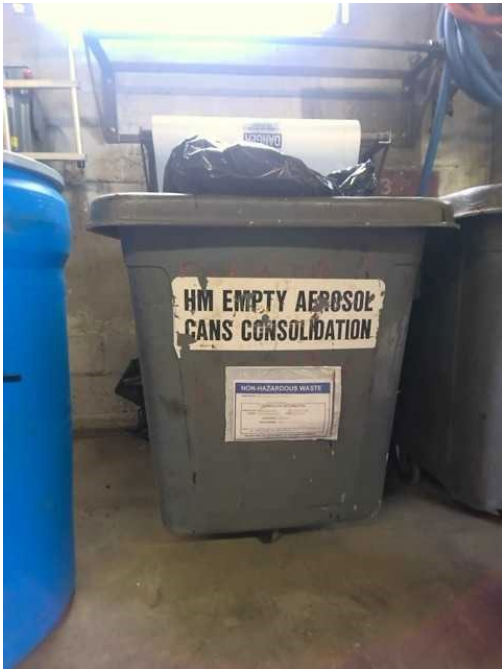
| Waste aerosol can accumulation in open container in CAA | | | IMG-20240709101220122055279.jpg |

| Waste aerosol cans in open container labeled “non-hazardous waste”. | | | |

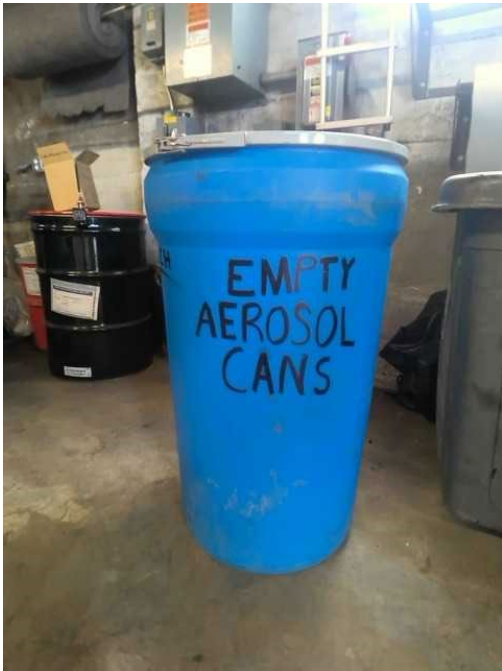
| Waste aerosol can accumulation in container in CAA | | | IMG-20240709101223122358898.jpg |

| Waste aerosol can accumulation in container labeled “empty aerosol cans”. | | | |

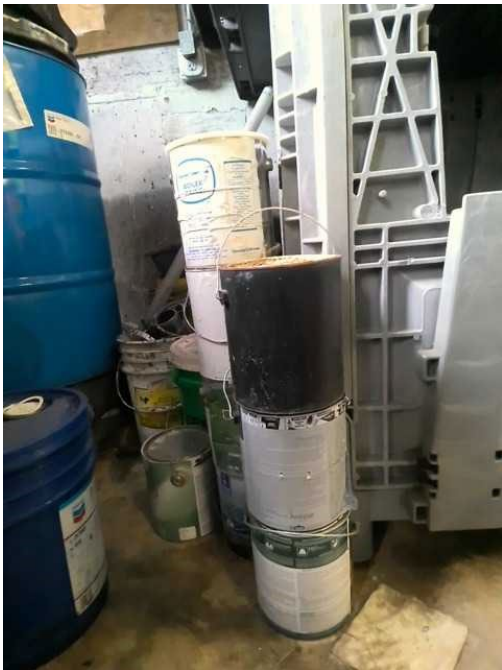
| Unknown containers in CAA | | | IMG-20240709101618161875285.jpg |

At the time of the inspection, we observed 10 containers stacked in a pile. These containers appeared to be waste paints based on the product label. We also observed two containers of lubricant and two containers of ‘black cement”. I asked Mr. Jones if these were waste. He stated that these materials arrived at the CAA two weeks ago and were waste, but he noted that he had yet to make a hazardous waste determination. We requested the waste determinations and safety data sheets (SDS) for these waste streams.

| Containers of unknown materials without hazardous waste determinations. | | | |

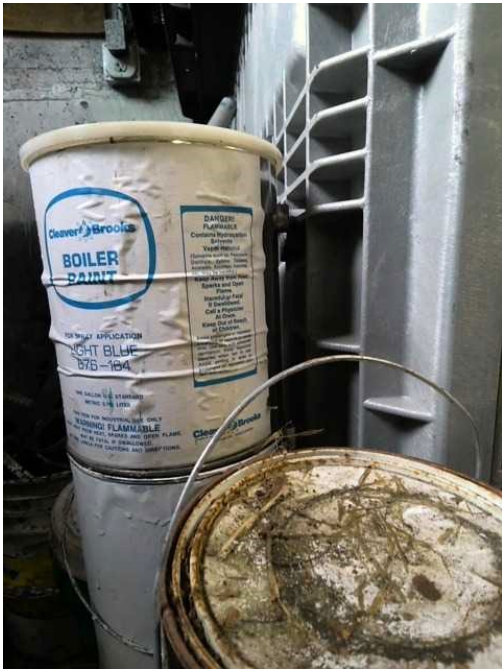
| Unknown containers in CAA | | | IMG-202407091016231623101017.jpg |

| Containers of unknown materials without hazardous waste determinations. | | | |

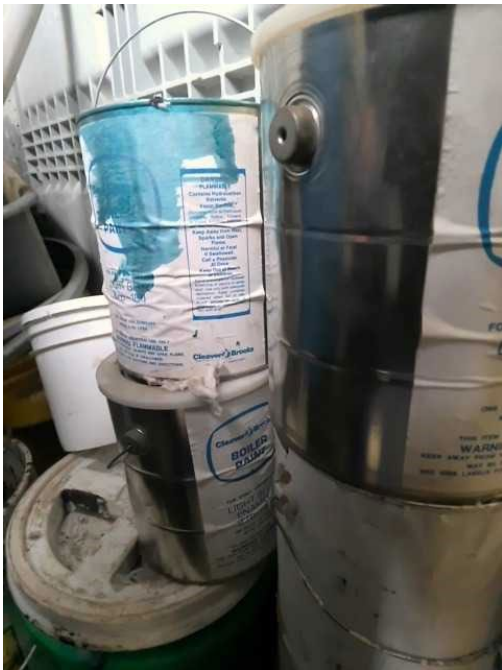
| Unknown containers in CAA | | | IMG-20240709101630163069358.jpg |

| Containers of unknown materials without hazardous waste determinations. | | | |

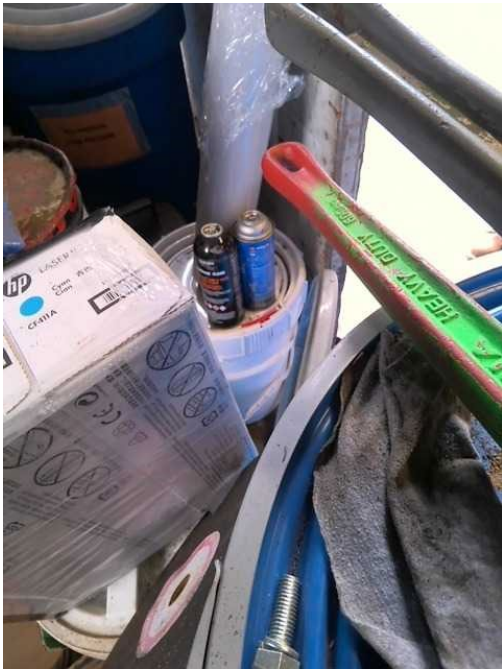
| Waste aerosol cans not contained in CAA | | | IMG-2024070910170717791964.jpg |

| Two waste aerosol cans not in appropriate container. | | | |

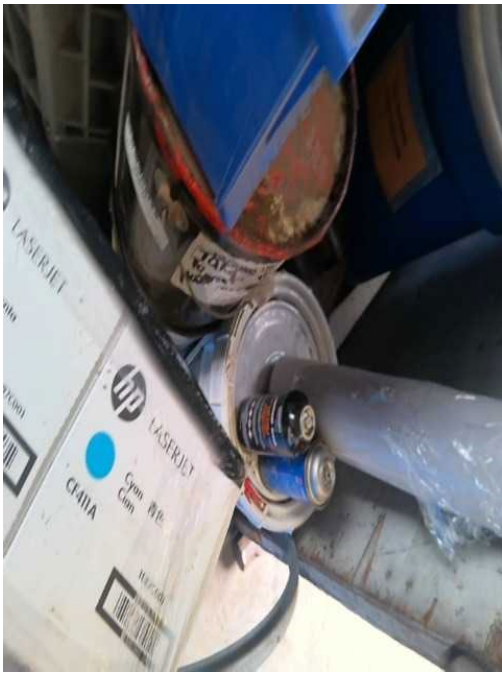
| Waste aerosol cans not contained in CAA | | | IMG-20240709101754175461182.jpg |

| Two waste aerosol cans not in appropriate container. | | | |

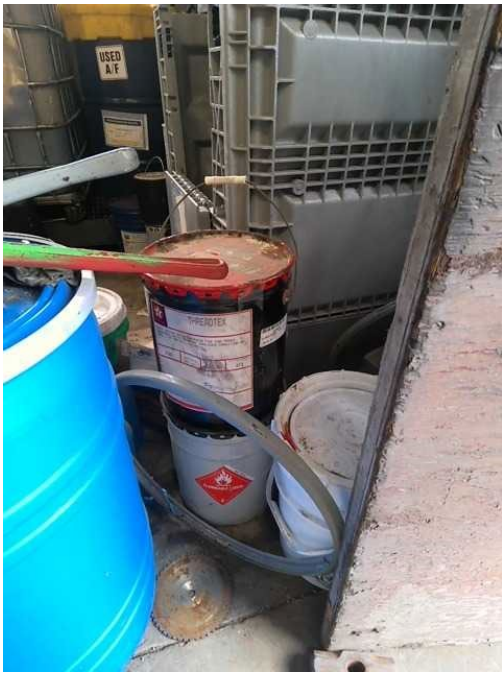
| Unknown containers in CAA | | | IMG-2024070910210321394717.jpg |

| Containers of unknown materials without hazardous waste determinations. | | | |

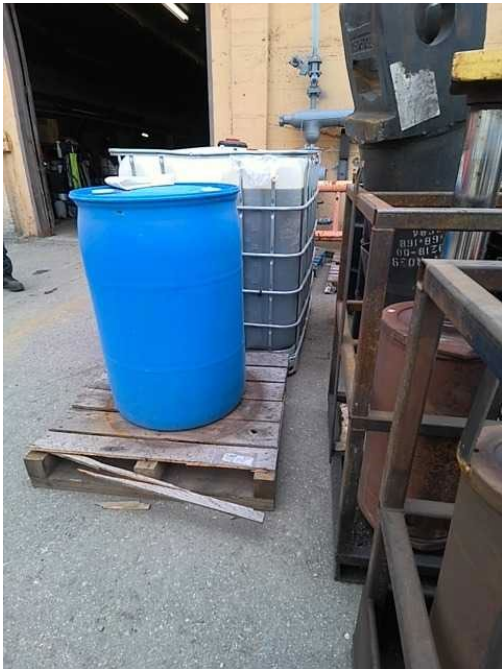
| Unknown containers outside of CAA | | | IMG-20240709103009309101190.jpg |

At the time of the inspection, we observed several miscellaneous containers of unknown materials outside of the CAA. This included a full 55-gallon container labeled "PF solvent used" and a tote labeled "bad", as well as an unlabeled blue container. Mr. Jones stated that he believed one of these containers to be a mix of oil and water and another to be a mix of diesel and water. He was unsure what the "PF solvent" was. Mr. Jones stated that he believed these materials to be wastes, but he noted that he had not yet made a hazardous waste determination. We requested the waste determinations and safety data sheets (SDS) for these waste streams.

| Unknown containers outside of CAA without hazardous waste determinations. | | | |

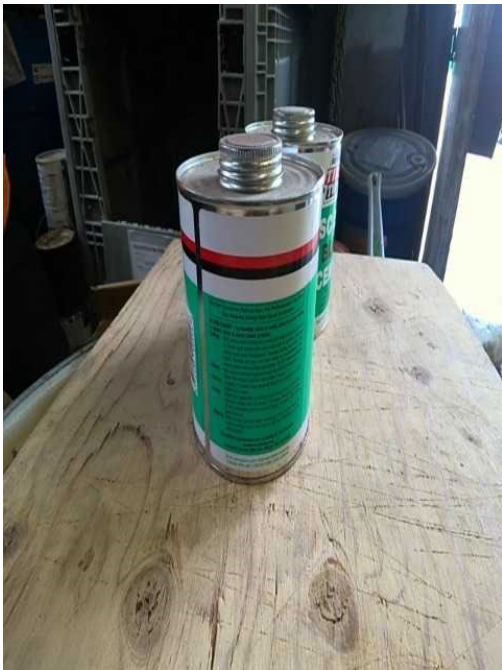
| "Black cement" containers in CAA | | | IMG-20240709102234223481031.jpg |

| Two containers of "black cement" in unknown materials pile without a hazardous waste determination. | | | |

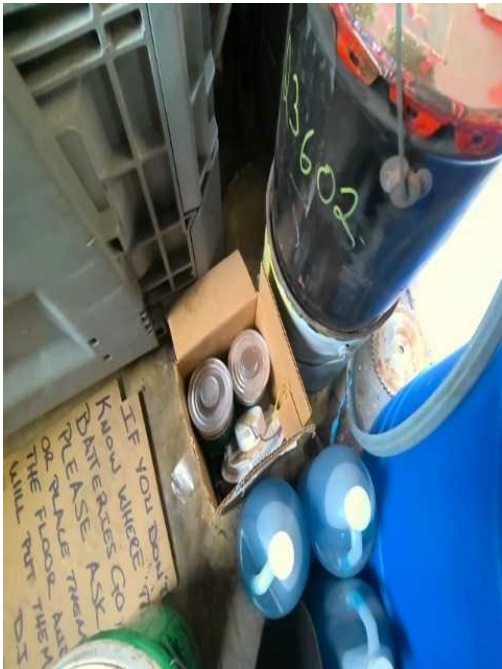
| Unknown containers in CAA | | | IMG-20240709102258225872482.jpg |

| Containers of unknown materials without hazardous waste determinations. | | | |

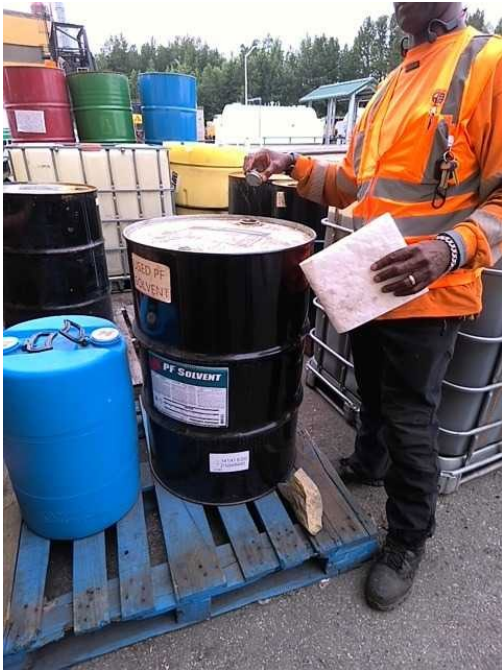
| Unknown containers outside of CAA | | | IMG-202407091026432643117435.jpg |

| Unknown containers outside of CAA without hazardous waste determinations. | | | |

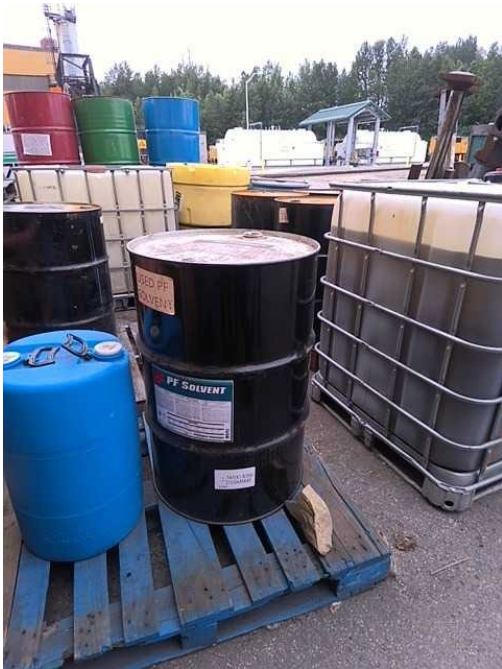
| Unknown containers outside of CAA | | | IMG-202407091026502650106465.jpg |

| Unknown containers outside of CAA without hazardous waste determinations. | | | |

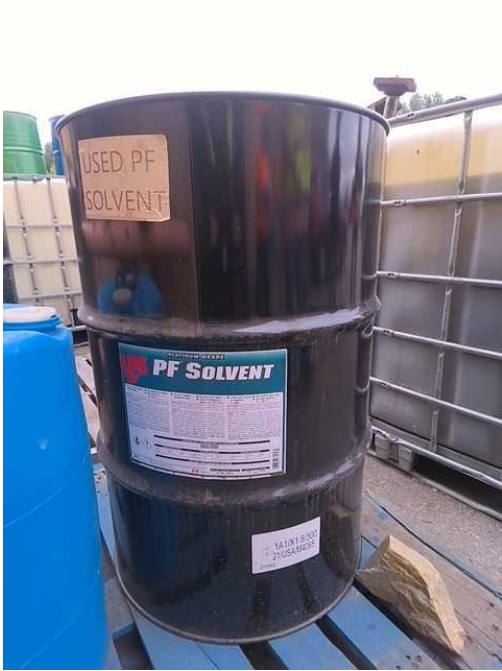
| Container of PF Solvent outside of CAA | | | IMG-20240709102653265376271.jpg |

| Container of PF Solvent outside of CAA without a hazardous waste determination. | | | |

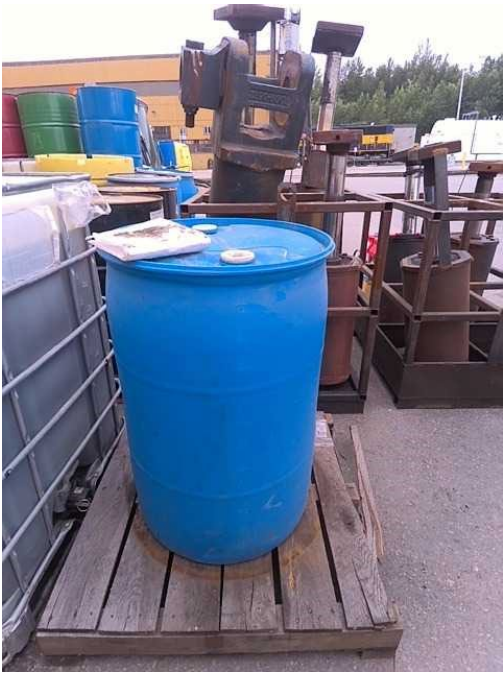
| Unknown container outside of CAA | | | IMG-20240709103002302101814.jpg |

| Unknown container outside of CAA without a hazardous waste determination. | | | |

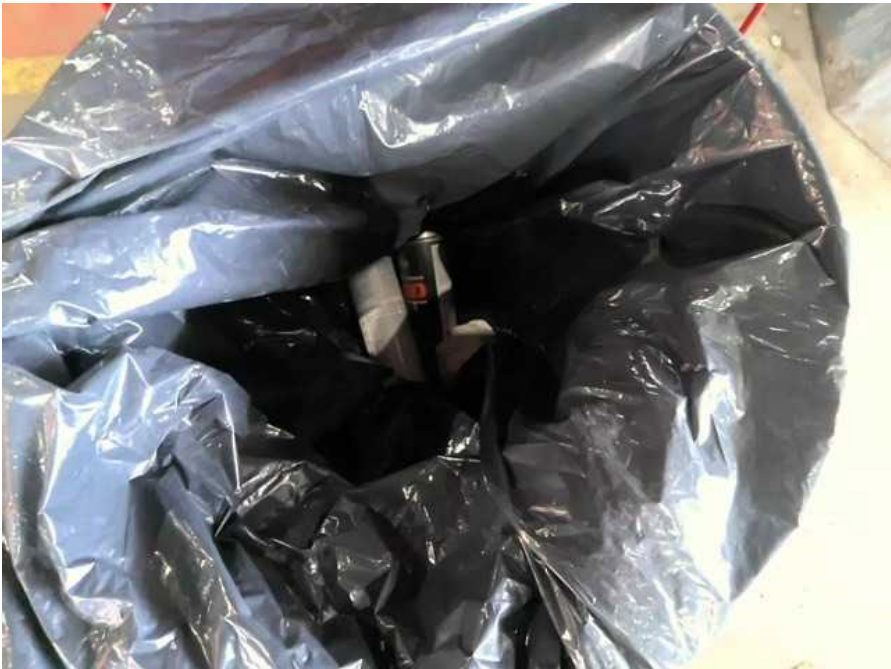
| Waste aerosol cans in container in CAA | | | IMG-20240709104810481081433.jpg |

| Waste aerosol cans in container in CAA. | | | |

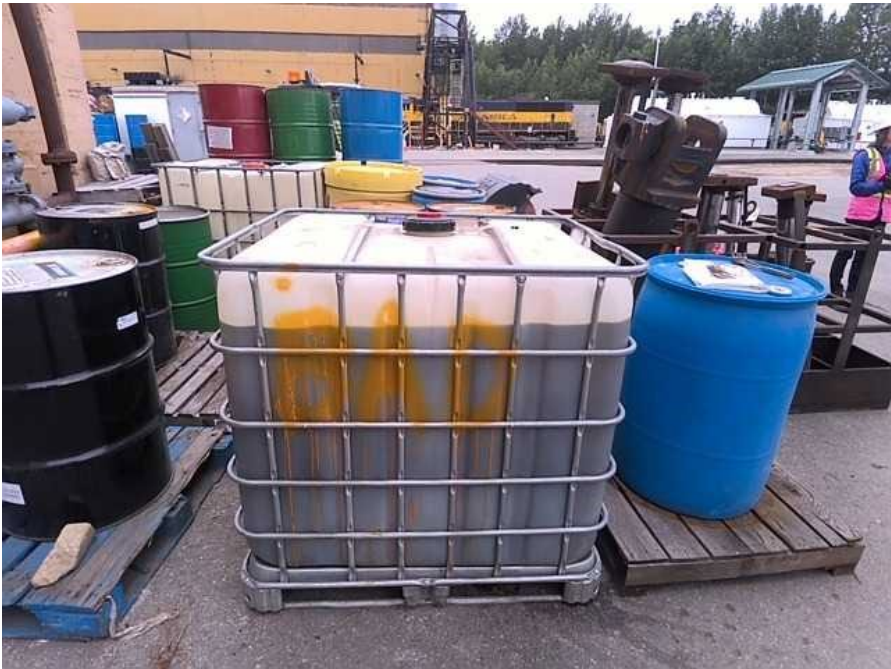
| Unknown container outside of CAA | | | IMG-202407091033343334118344.jpg |

| Unknown container outside of CAA labeled with word “BAD” without a hazardous waste determination. | | | |

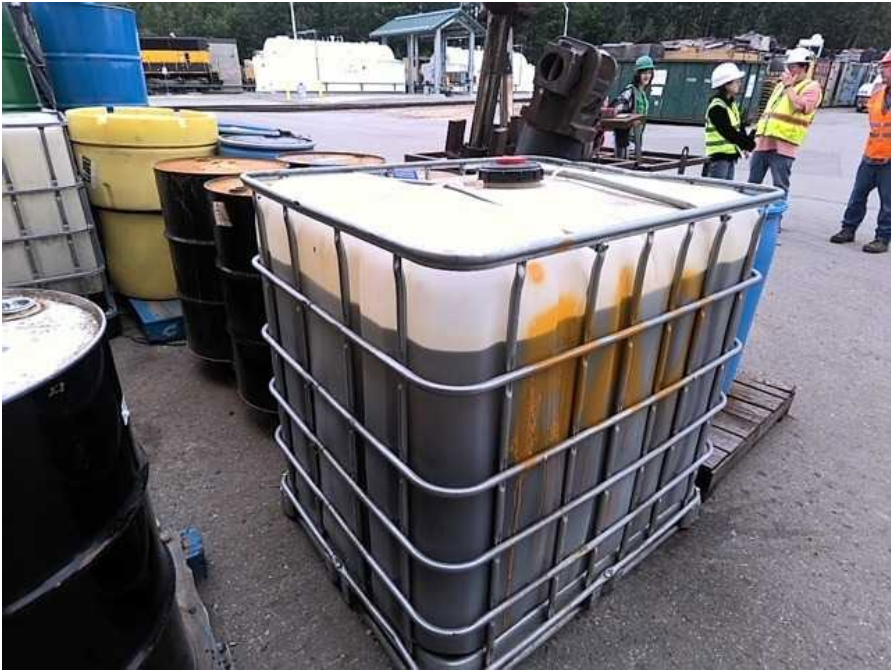
| Unknown container outside of CAA | | | IMG-202407091033373337120164.jpg |

| Unknown container outside of CAA labeled with word “BAD” without a hazardous waste determination. | | | |

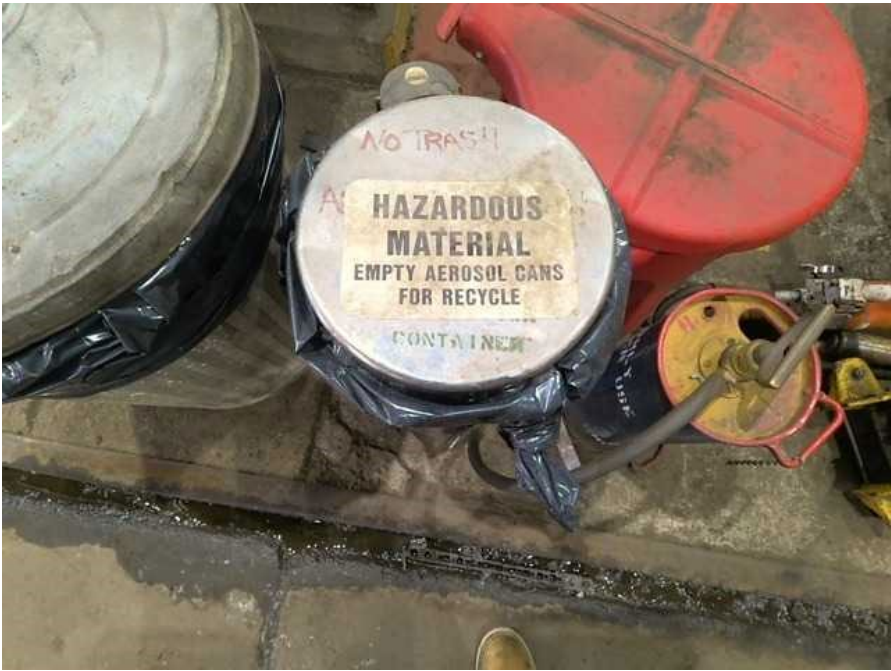
| Waste aerosol accumulation container in Car Shop SAA | | | IMG-20240709104024402497162.jpg |

At the time of the inspection, we observed a waste aerosol can in a container labeled "hazardous material". This container was closed but it was not labeled as "hazardous waste", nor did it have a hazard indicator.

| Waste aerosol accumulation container labeled “hazardous material”. | | | |

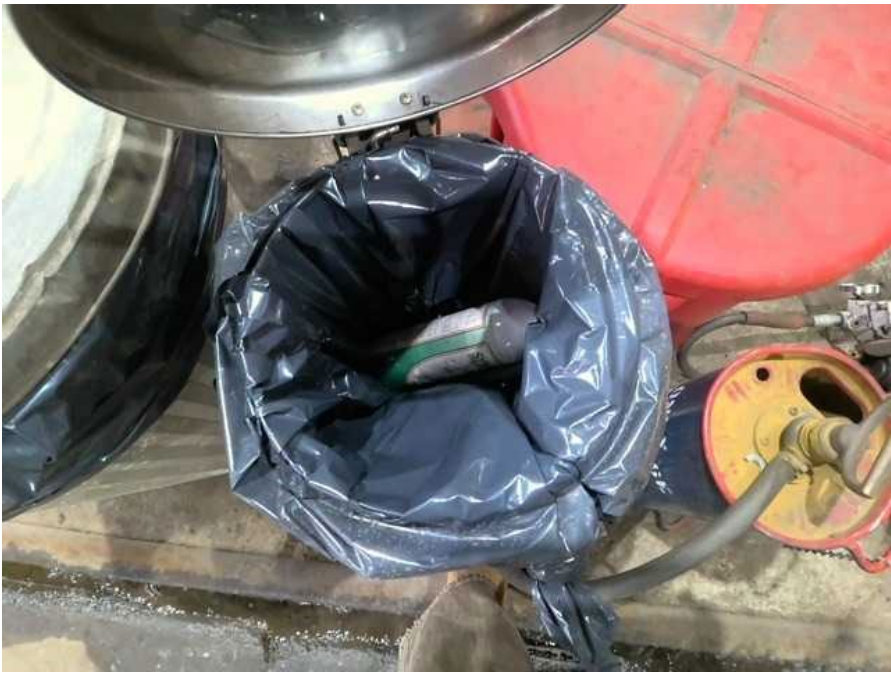
| Waste aerosol accumulation container in Car Shop SAA | | | IMG-20240709104031403193496.jpg |

| Waste aerosol accumulation container with a waste aerosol can present inside, labeled “hazardous material”. | | | |

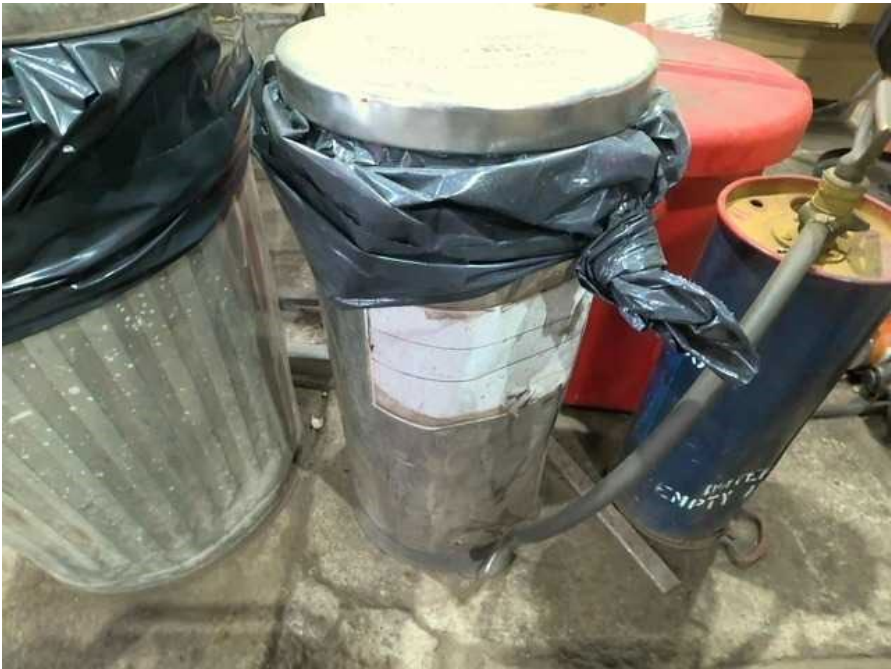
| Waste aerosol accumulation container in Car Shop SAA | | | IMG-20240709104036403689454.jpg |

| Waste aerosol accumulation container labeled “hazardous material”. | | | |

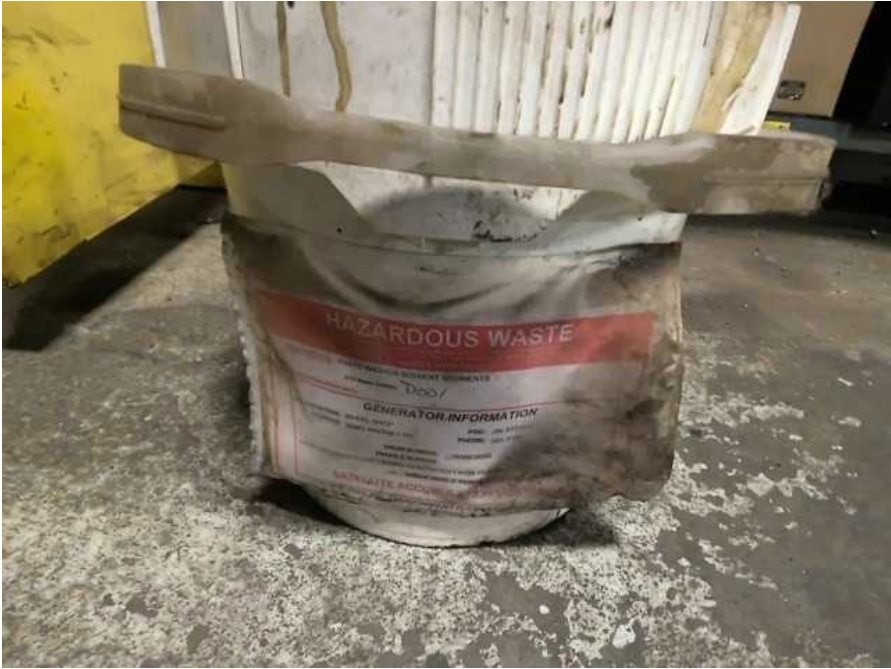
| Bucket of hazardous waste in Wheelhouse SAA | | | IMG-202407091100000092062.jpg |

At the time of the inspection, we observed a bucket and Mr. White told me it contained parts washer solvent sediment. This container was labeled with the words "hazardous waste" but was not marked with a hazard indicator. The log associated with this bucket stated that it had been onsite since 2/9/16.

| Bucket of hazardous waste without a hazard indicator. | | | |

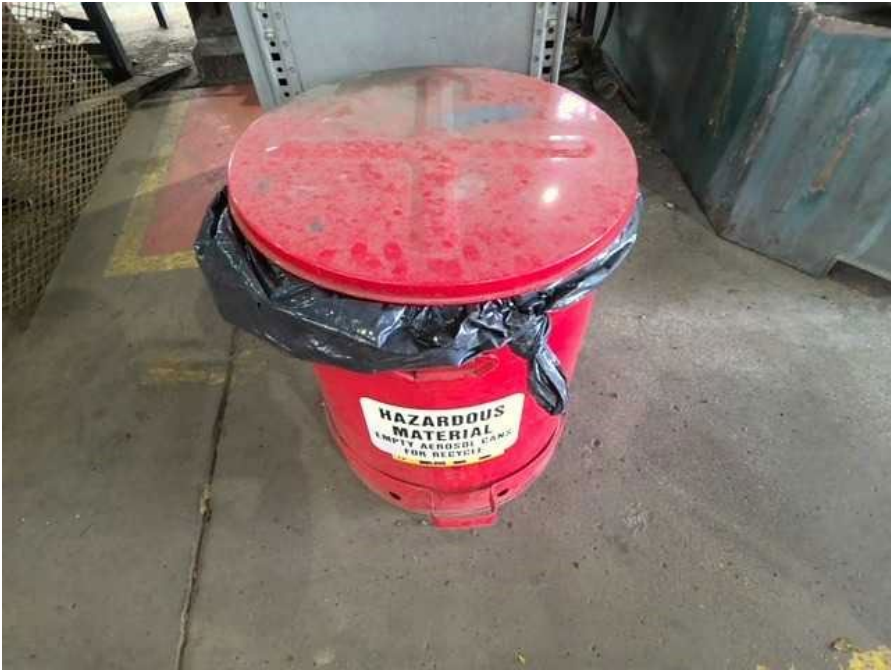
| Waste aerosol accumulation container in Car Shop SAA | | | IMG-20240709104813481388584.jpg |

| Waste aerosol accumulation container labeled “hazardous material”; however, no waste aerosol cans present in container at time of inspection. | | | |

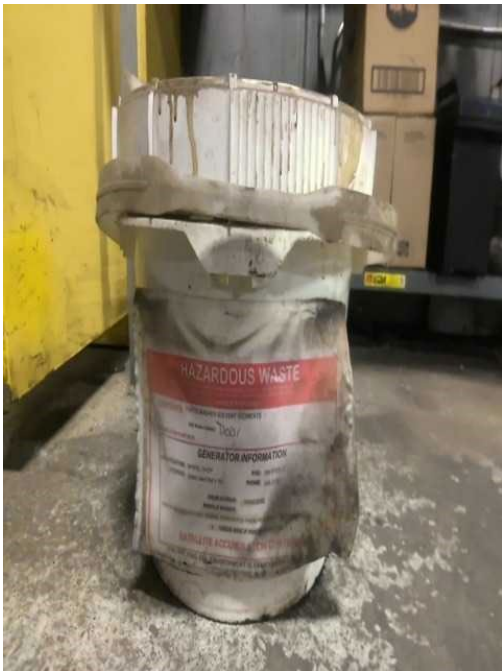
| Bucket of hazardous waste in Wheelhouse SAA | | | IMG-20240709105912591265309.jpg |

| Bucket of hazardous waste without a hazard indicator. | | | |

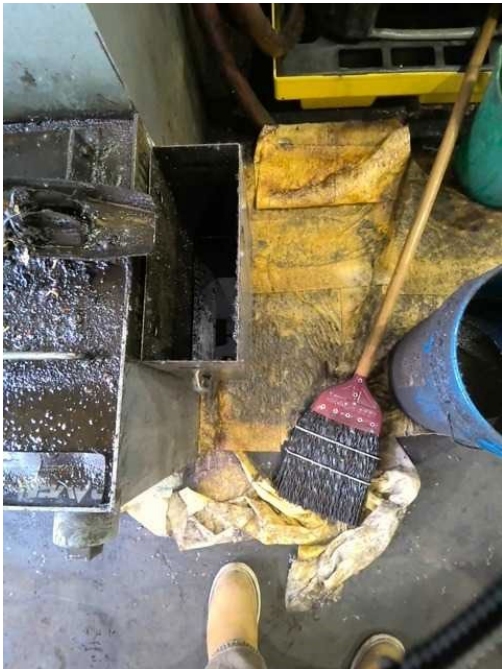
| Parts washer used oil collection container in General Repair Shop SAA | | | IMG-202407091112441244111583.jpg |

At the time of the inspection, we observed a parts washer with used oil in a collection container that was not labeled with the words "used oil". This machine was not running at the time of the inspection. Shop personnel reported that they take sludge and used oil from the parts washer, but they were unclear of where the sludge from this machine was sent. We requested additional information on this process, specifically where the sludge is sent for disposal.

| Used oil collection container on parts washer, not labeled "used oil". | | | |

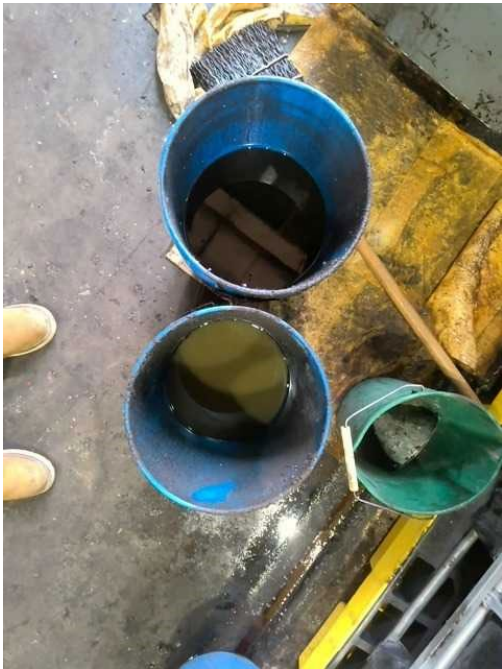
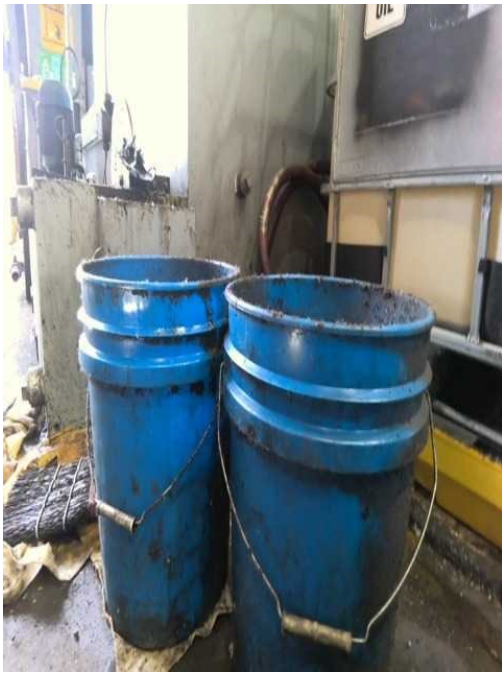
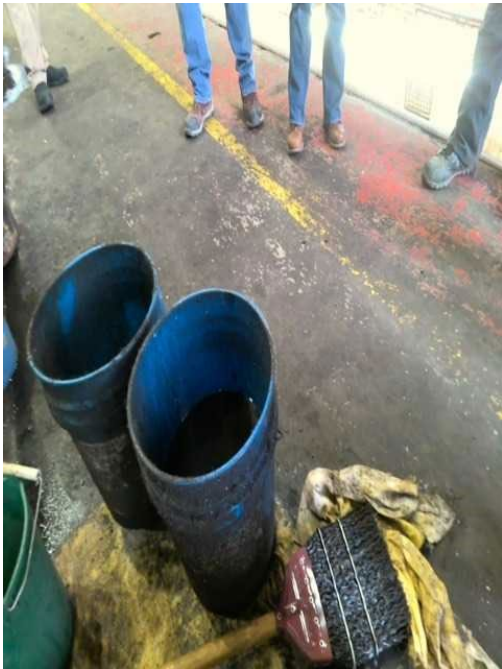
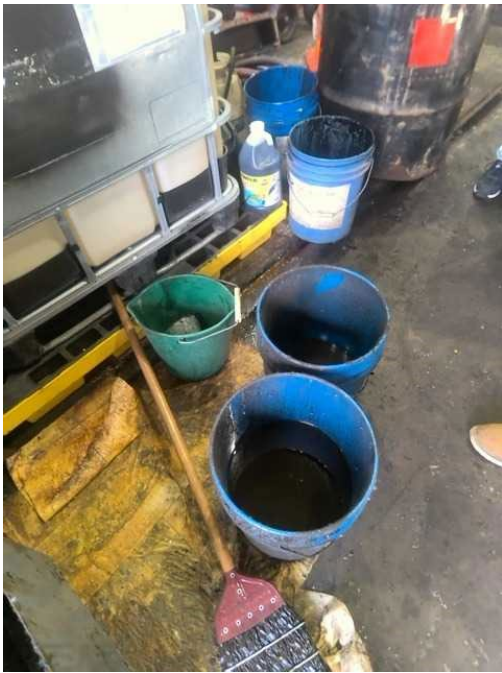
| Buckets of used oil in General Repair Shop SAA | | | IMG-2024070911083983999988.jpg |

At the time of the inspection, we observed two buckets and were told by Mr. Jones that they contained used oil but were not labeled with the words "used oil". We also observed two jugs and were told by Mr. Jones that they contained used oil but were not labeled with the words "used oil". Mr. Jones reported that these containers were likely waiting to be transferred to the main used oil container for storage.

| Two buckets of used oil, not labeled “used oil”. | | | |

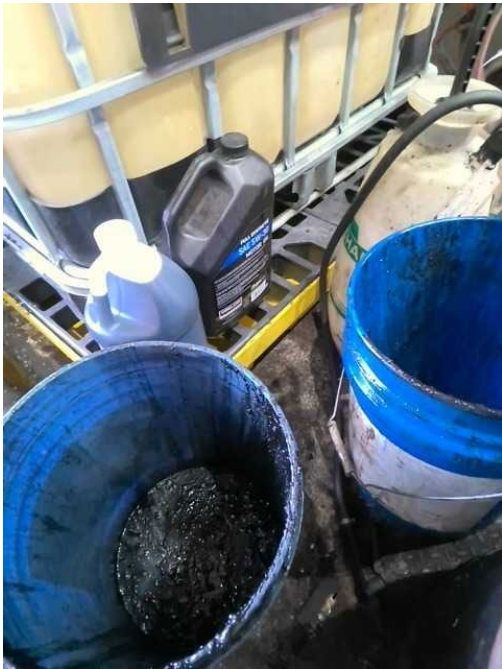
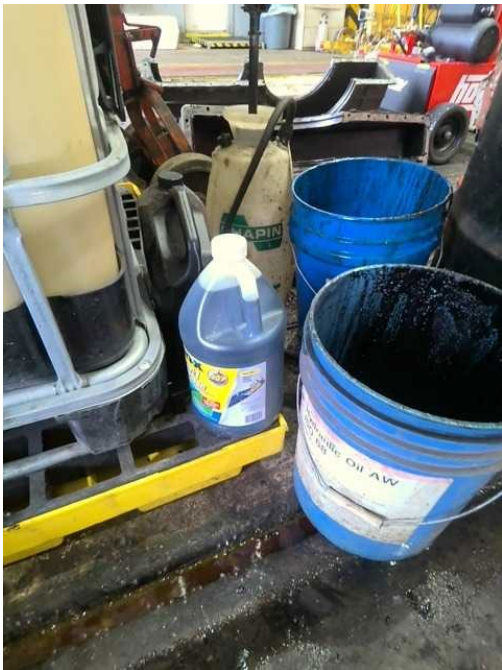
| Jugs of used oil in General Repair Shop SAA | | | IMG-2024070911111111191032.jpg |

| Two jugs of used oil, not labeled “used oil”. | | | |

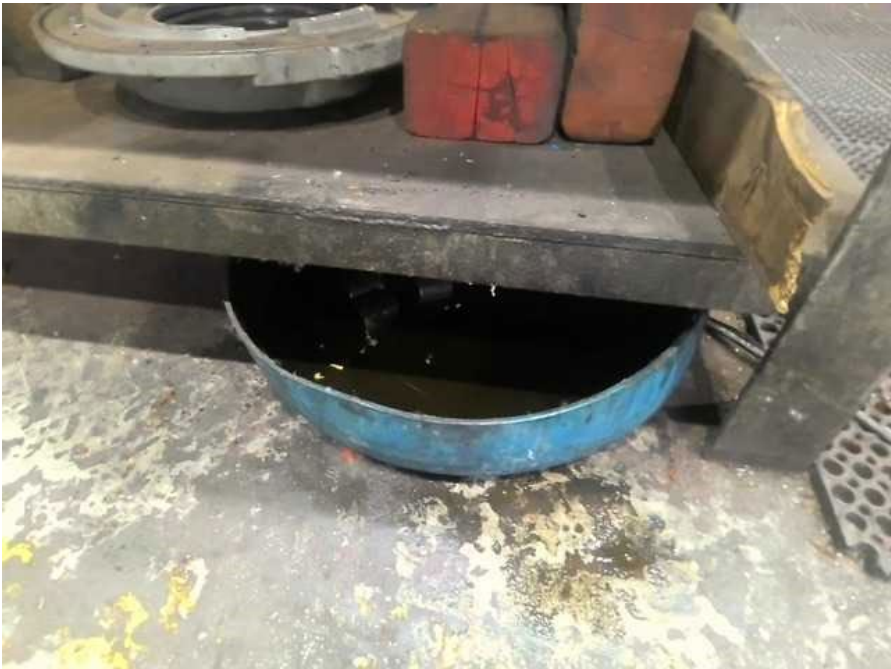
| Used oil drip pan in Electric Rewind Shop SAA | | | IMG-20240709113121312180696.jpg |

At the time of the inspection, we observed, and were told by Mr. White, that the two drip containers held used oil, but were not labeled with the words “used oil”.

| Drip pan of used oil, not labeled “used oil”. | | | |

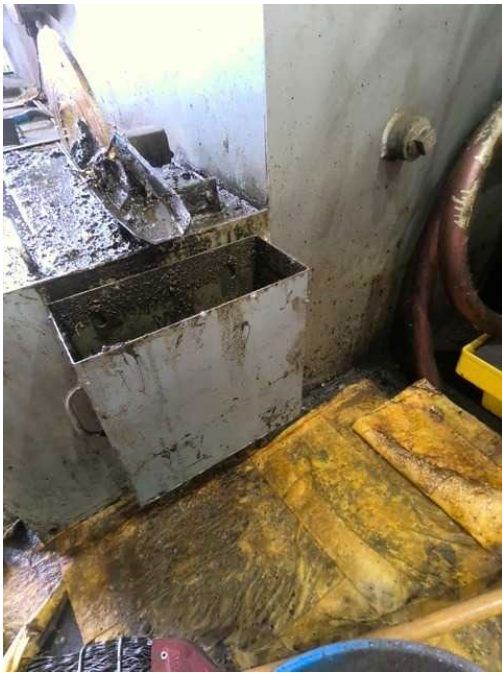
| Parts washer used oil collection container in General Repair Shop SAA | | | IMG-202407091112511251103717.jpg |

| Used oil collection container on parts washer, not labeled “used oil”. | | | |
