INSPECTION REPORT

| Type of Inspection | Compliance Evaluation Inspection (CEI) | |
| Company Name | Alaska Railroad Corporation | |
| Facility/Site Physical Address | 327 W Ship Creek Ave | |

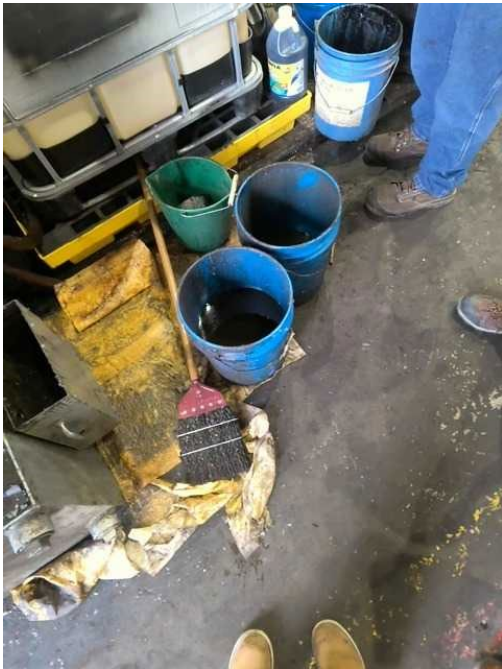
| Buckets of used oil in General Repair Shop SAA | | | IMG-202407091113161316100224.jpg |

| Two buckets of used oil, not labeled “used oil”. | | | |

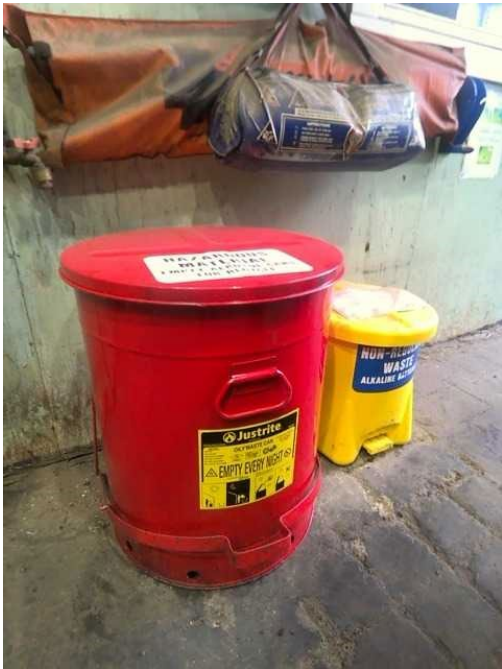
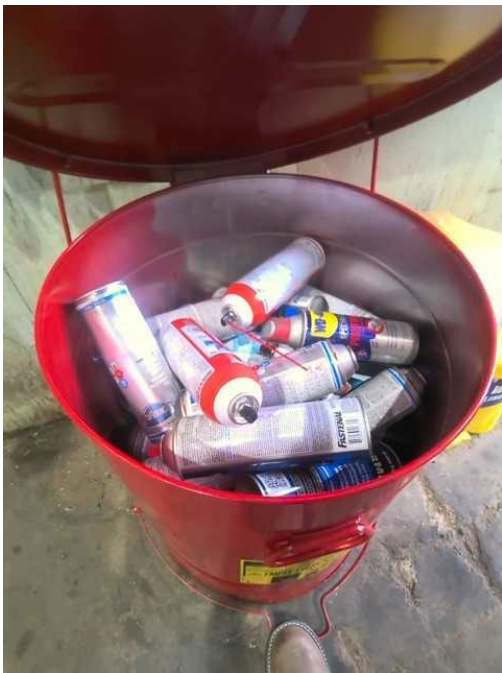
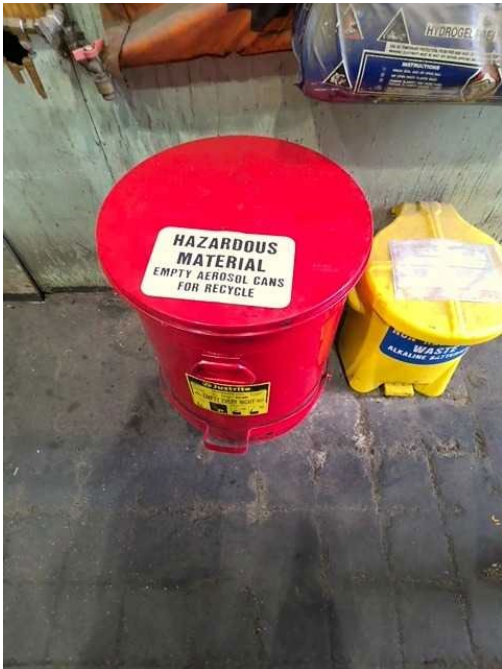
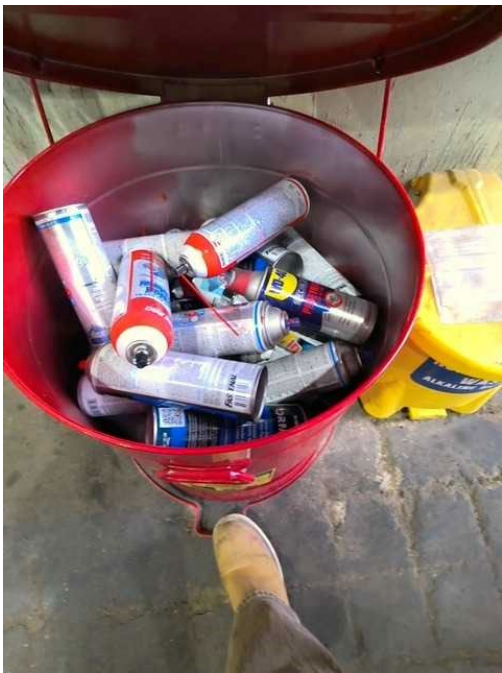
| Waste aerosol accumulation container in Electric Rewind Shop SAA | | | IMG-20240709111752175285018.jpg |

At the time of the inspection, we observed multiple waste aerosol cans in a container that was labeled “hazardous material”. This container was closed but it was not labeled as “hazardous waste”, nor did it have a hazard indicator. This container had a pre-made label stating that it was emptied daily. Upon inquiring about this, Mr. Jones confirmed that these containers are indeed emptied every 24-32 hours and that the amount present in this container represented an average accumulation over 24 hours for an SAA in the facility.

| Waste aerosol accumulation container labeled “hazardous material”. | | | |

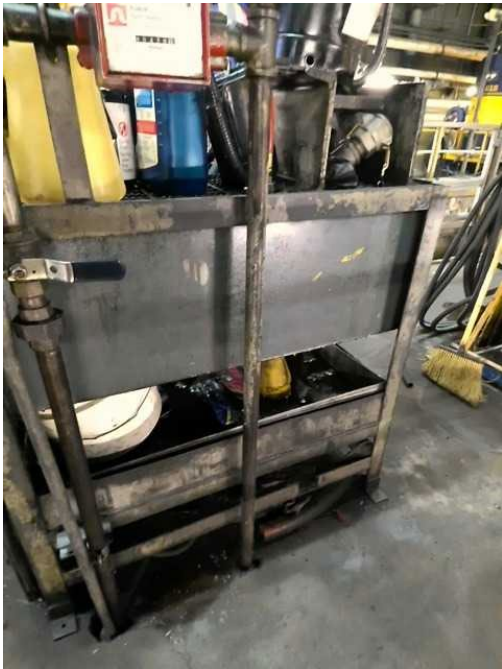
| Shelving unit with oily waste at bottom in Diesel Shop Center Aisle SAA | | | IMG-20240709113723372388463.jpg |

At the time of the inspection, we observed a shelving unit with a container of oily waste at the bottom. This container was not labeled with the words “used oil”.

| Shelving unit with oily waste at bottom, not labeled "used oil". | | | |

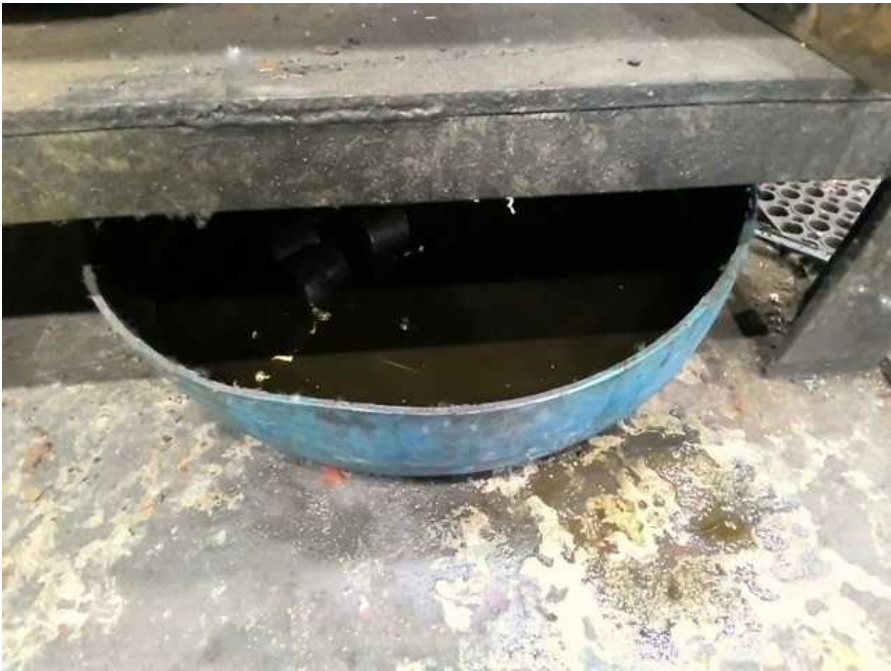
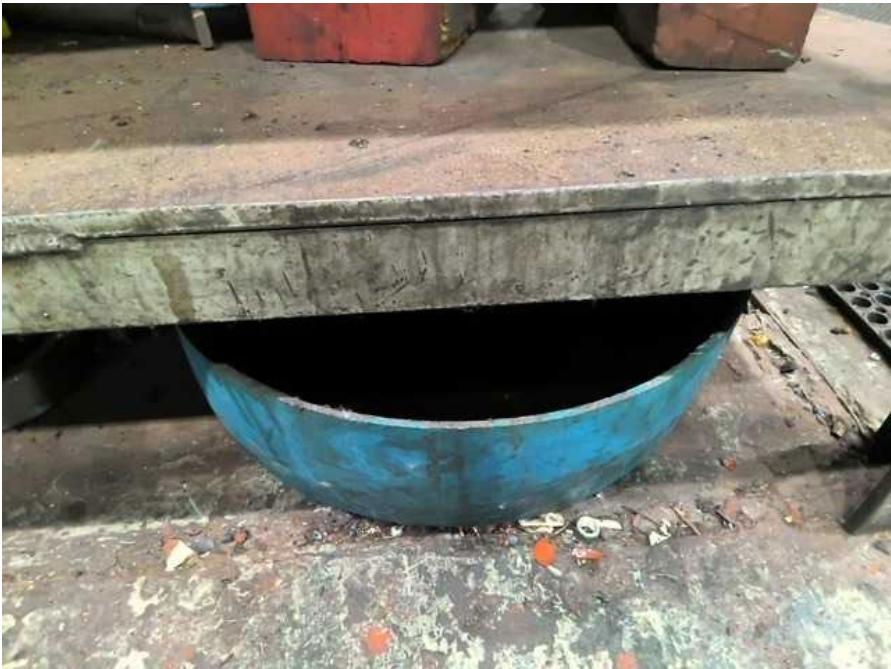
| Used oil drip pan in Electric Rewind Shop SAA | | | IMG-20240709113149314988767.jpg |

At the time of the inspection, we observed, and were told by Mr. White, that the two drip containers held used oil, but were not labeled with the words “used oil”.

| Drip pan of used oil, not labeled "used oil". | | | |

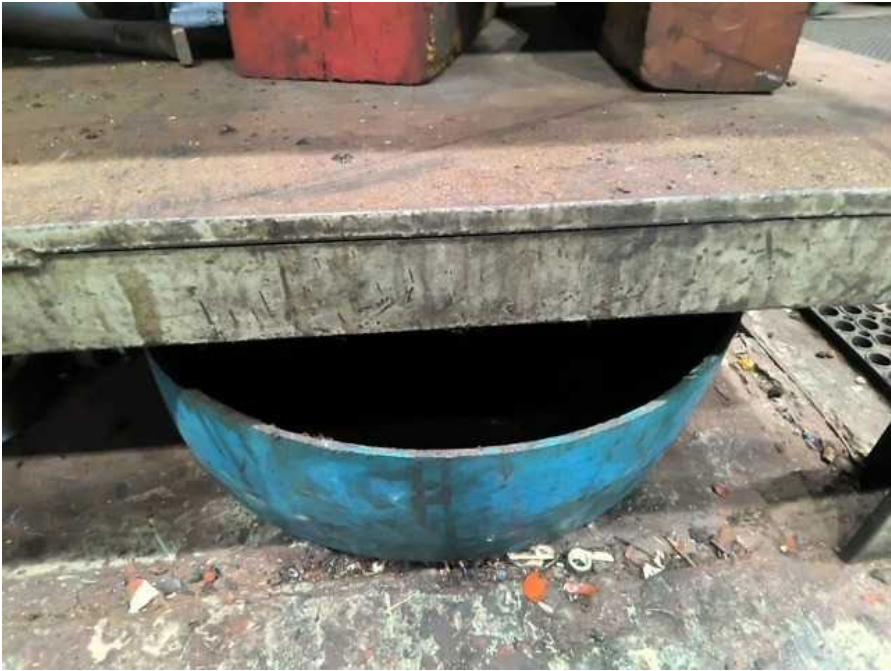
| Used oil drip pan in Electric Rewind Shop SAA | | | IMG-20240709113350335098142.jpg |

| Drip pan of used oil, not labeled “used oil”. | | | |

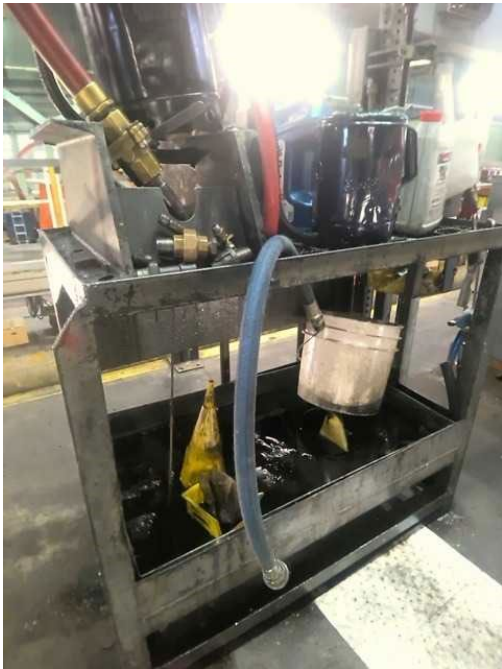
| Shelving unit with oily waste at bottom in Diesel Shop Center Aisle SAA | | | IMG-20240709113639363983050.jpg |

| Shelving unit with oily waste at bottom, not labeled “used oil”. | | | |

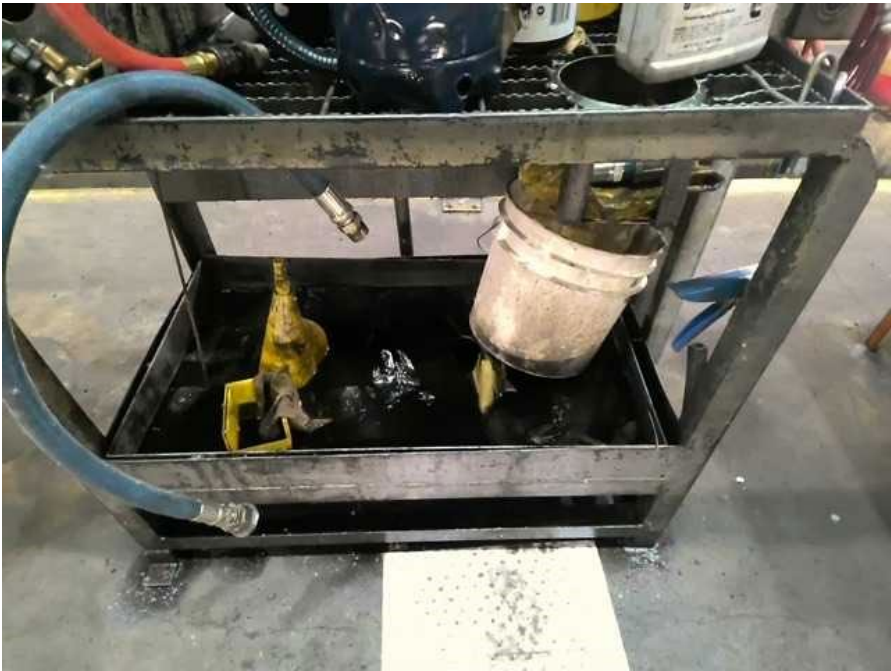
| Shelving unit with oily waste at bottom in Diesel Shop Center Aisle SAA | | | IMG-20240709113640364089811.jpg |

| Shelving unit with oily waste at bottom, not labeled “used oil”. | | | |

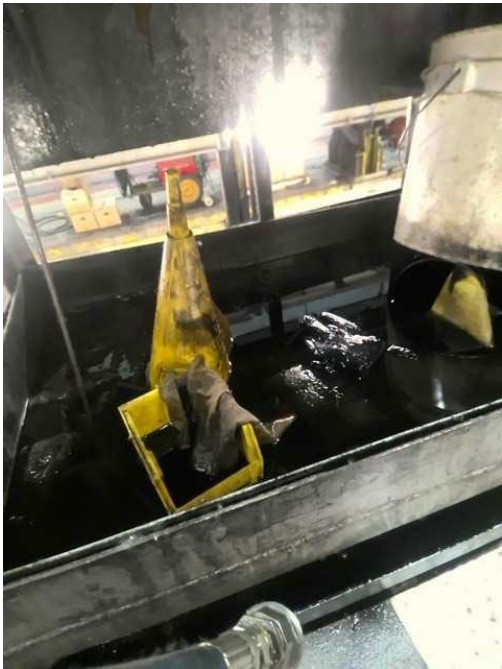
| Shelving unit with oily waste at bottom in Diesel Shop Center Aisle SAA | | | IMG-20240709113643364376899.jpg |

| Shelving unit with oily waste at bottom, not labeled “used oil”. | | | |

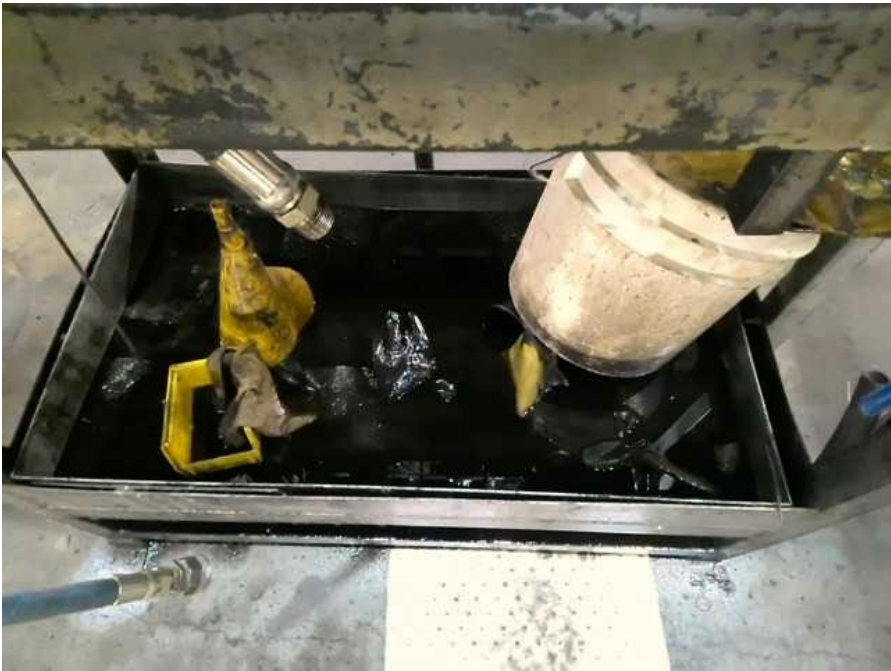
| Shelving unit with oily waste at bottom in Diesel Shop Center Aisle SAA | | | IMG-20240709113644364481298.jpg |

| Shelving unit with oily waste at bottom, not labeled “used oil”. | | | |

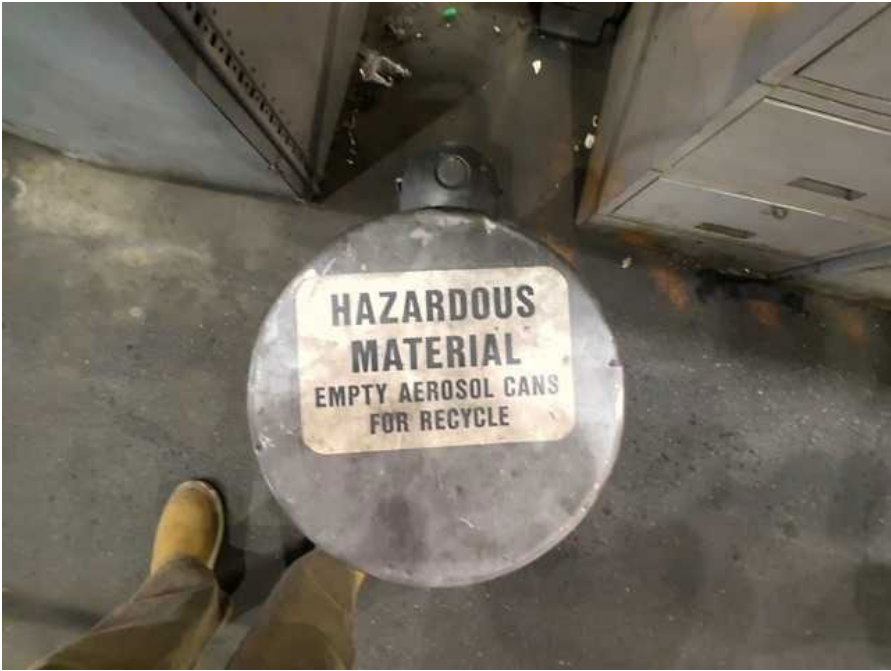
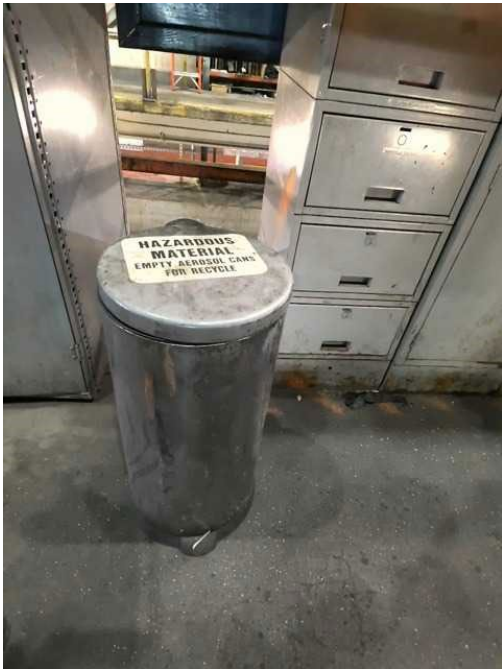
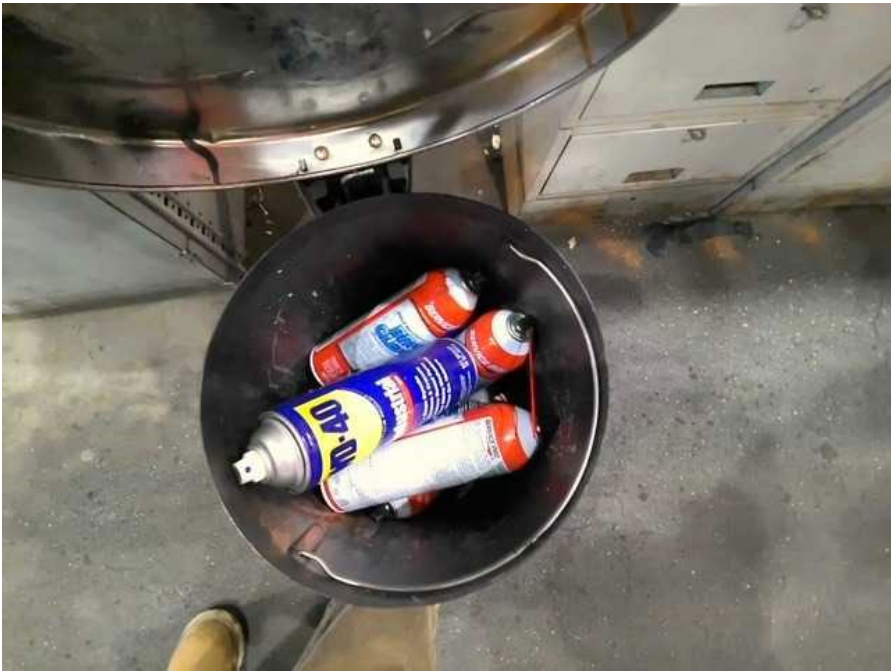
| Waste aerosol accumulation container in Diesel Shop Center Aisle SAA | | | IMG-2024070911380538563998.jpg |

At the time of the inspection, we observed waste aerosol cans in a container labeled “hazardous material”. This container was closed but it was not labeled as “hazardous waste”, nor did it have a hazard indicator.

| Waste aerosol accumulation container labeled as “hazardous material”. | | | |

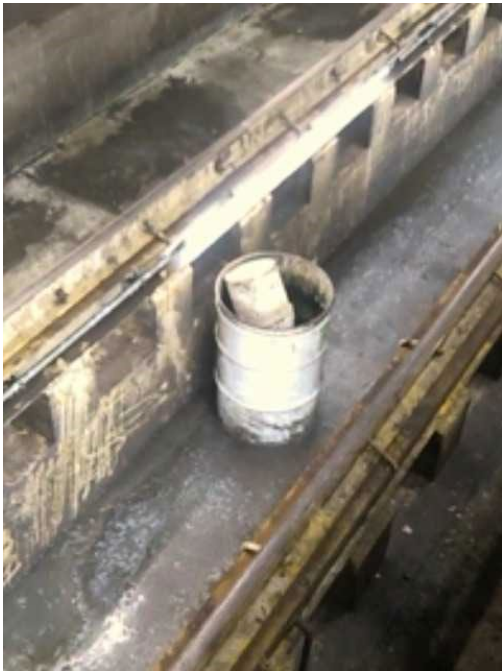
| Container of sludge, oil, and water in Diesel Shop<br>Center Aisle SAA | | | IMG-2024070911440044063979.jpg |

| Container of sludge, water, and oil, not labeled “used oil”. | | | |

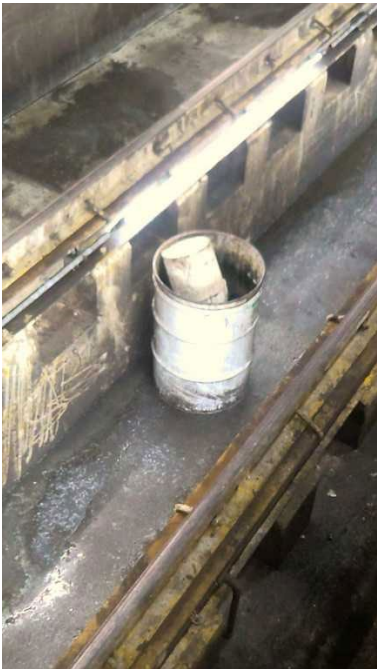
| Container of sludge, oil, and water in Diesel Shop Center Aisle SAA | | | IMG-20240709114406446857100.jpg |

| Container of sludge, water, and oil, not labeled “used oil”. | | | |

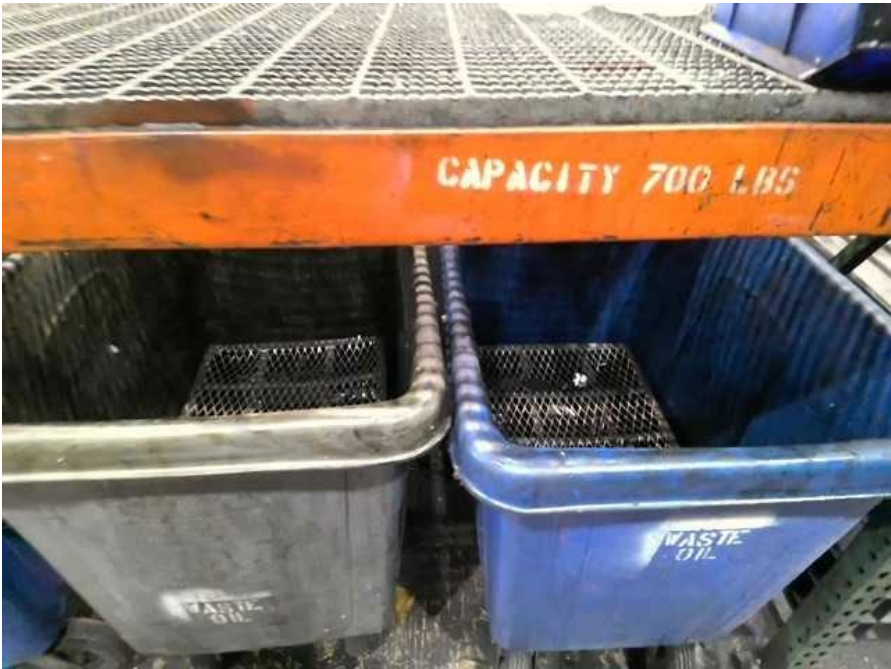
| Carts of used oil from oil filter crushing in Diesel Shop SAA | | | IMG-20240709115539553991931.jpg |

| Diesel Shop/ Oil Filter Crushing SAA | | | N/A |
| Carts used to remove used oil after oil filters are crushed, labeled “waste oil”. | | | |

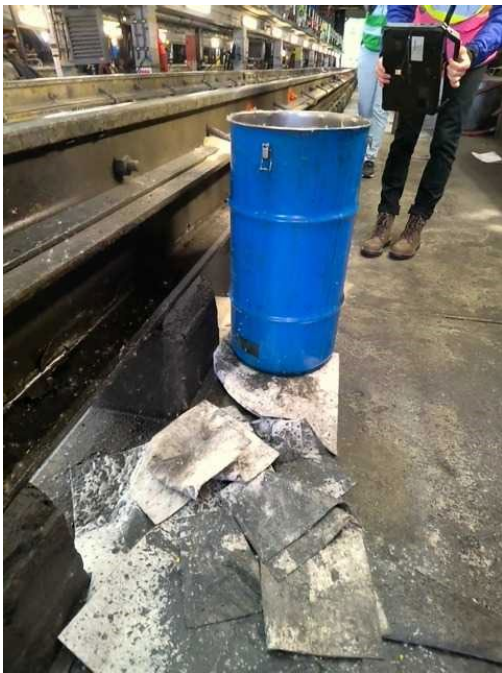
| Used oil container in Diesel Shop Center Aisle SAA | | | IMG-202407091146124612116236.jpg |

| Diesel Shop/ Center Aisle SAA | | | N/A |
| Used oil container, not labeled “used oil”. | | | |

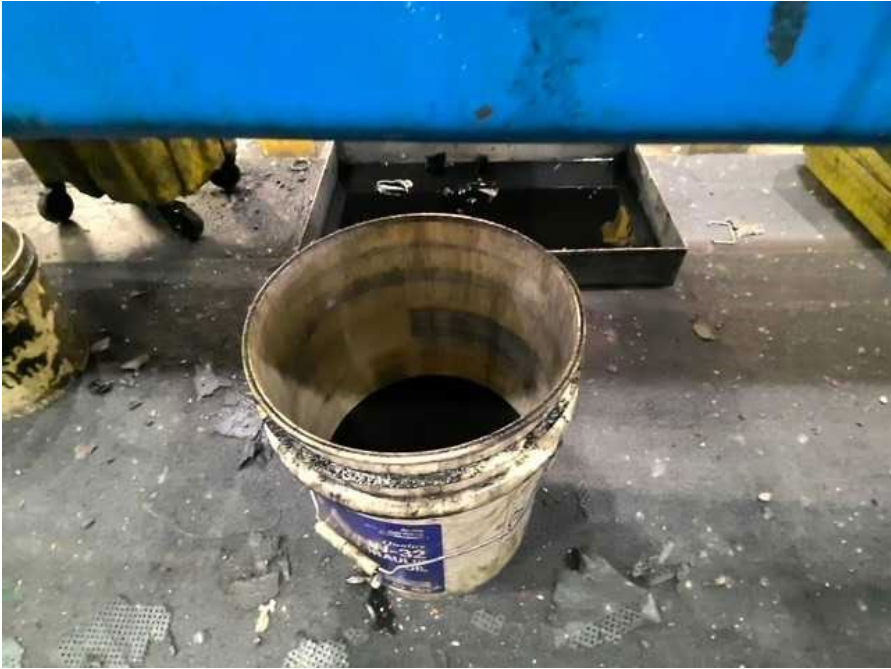
| Used oil collection container in Diesel Shop Oil Filter Crushing SAA | | | IMG-20240709115216521684351.jpg |

| Diesel Shop/ Oil Filter Crushing SAA | | | N/A |
| Container used to collect used oil when crushing used oil filters, not labeled “used oil”. | | | |

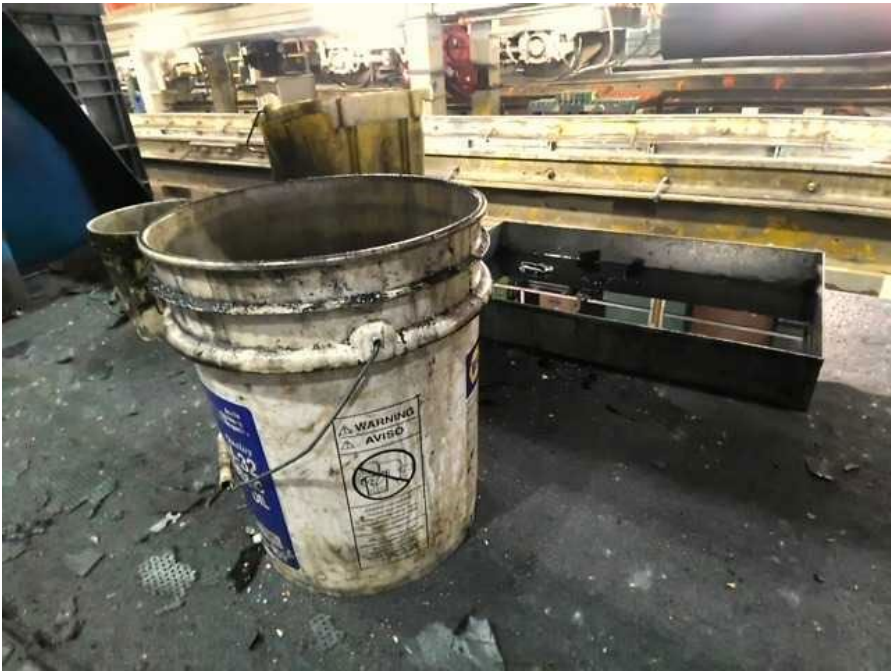
| Used oil collection container in Diesel Shop Oil Filter Crushing SAA | | | IMG-20240709115219521999265.jpg |

| Diesel Shop/ Oil Filter Crushing SAA | | | N/A |
| Container used to collect used oil when crushing used oil filters, not labeled “used oil”. | | | |

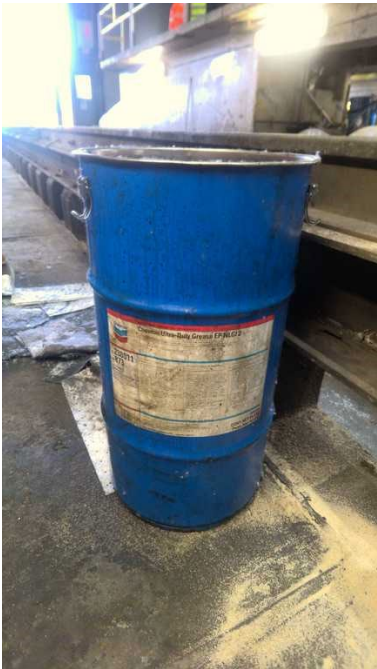
| Used oil container in Diesel Shop Center Aisle SAA | | | IMG-2024070911461046101424127.jpg |

| Diesel Shop/ Center Aisle SAA | | | N/A |
| Used oil container, not labeled “used oil”. | | | |

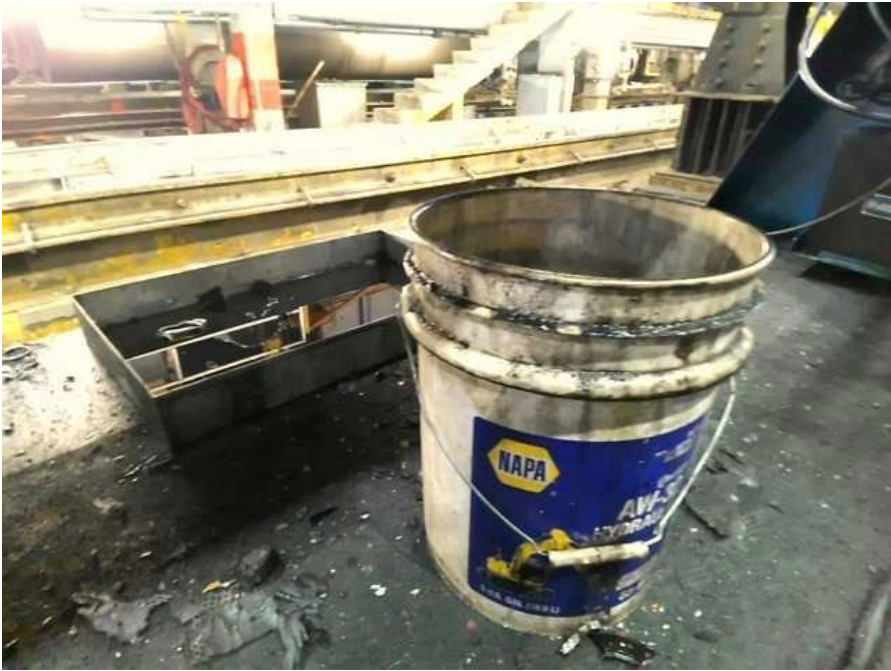
| Used oil collection container in Diesel Shop Oil Filter Crushing SAA | | | IMG-20240709115223522394047.jpg |

| Diesel Shop/ Oil Filter Crushing SAA | | | NA |
| Container used to collect used oil when crushing used oil filters, not labeled “used oil”. | | | |

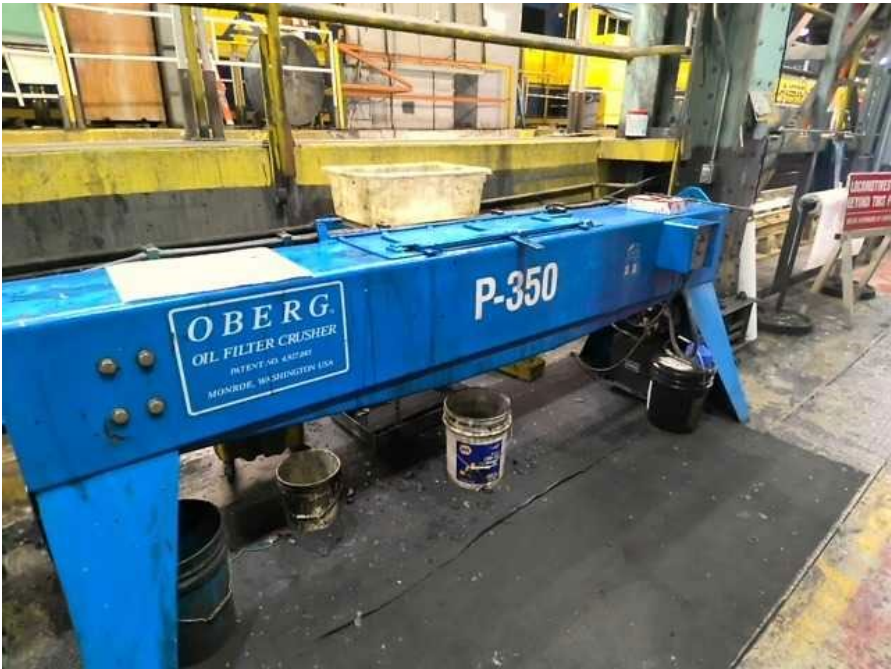
| Used oil filter crushing machine in Diesel Shop Oil Filter Crushing SAA | | | IMG-202407091152285228107485.jpg |

| Diesel Shop/ Oil Filter Crushing SAA | | | N/A |
| Machine used to crush used oil filters. | | | |

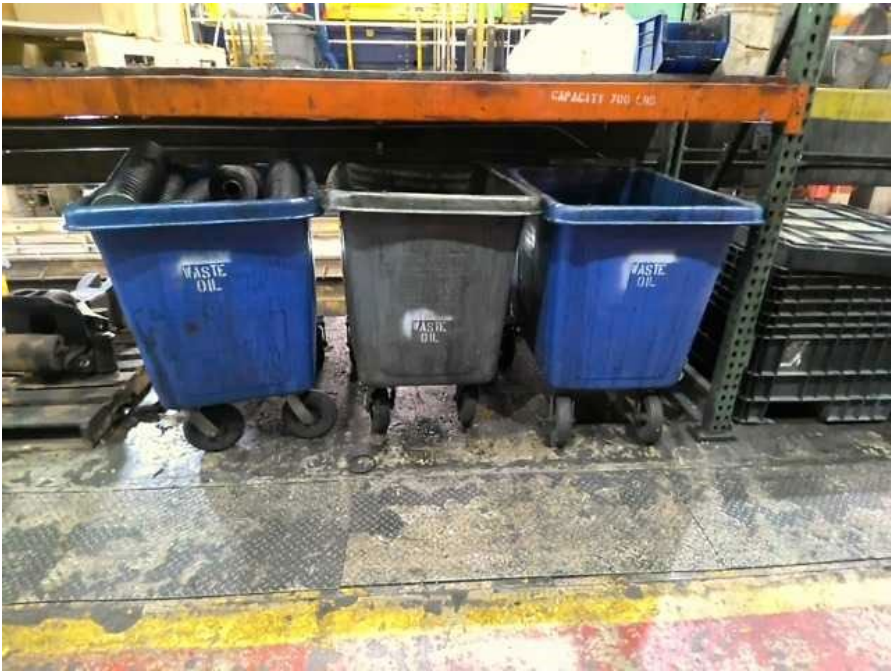
| Carts of used oil from oil filter crushing in Diesel Shop SAA | | | IMG-202407091155365536113918.jpg |

| Diesel Shop/ Oil Filter Crushing SAA | | | N/A |
| Carts used to drain oil filters and remove used oil after oil filters are crushed, labeled “waste oil”. | | | |

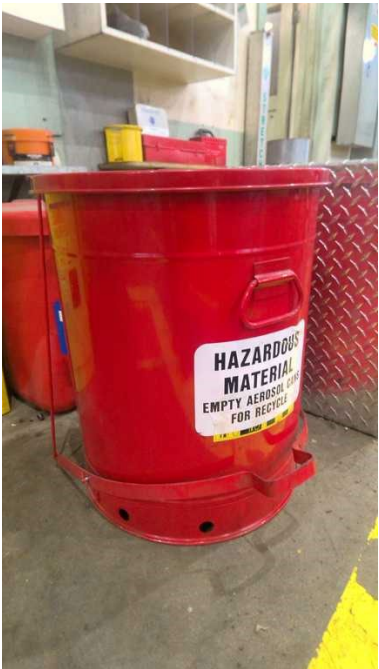
| Waste aerosol accumulation container in Heavy Equipment Shop SAA | | | IMG-202407091205145141072249.jpg |

| Heavy Equipment Shop/ SAA | | | N/A |
| Waste aerosol accumulation container labeled “hazardous material”. | | | |

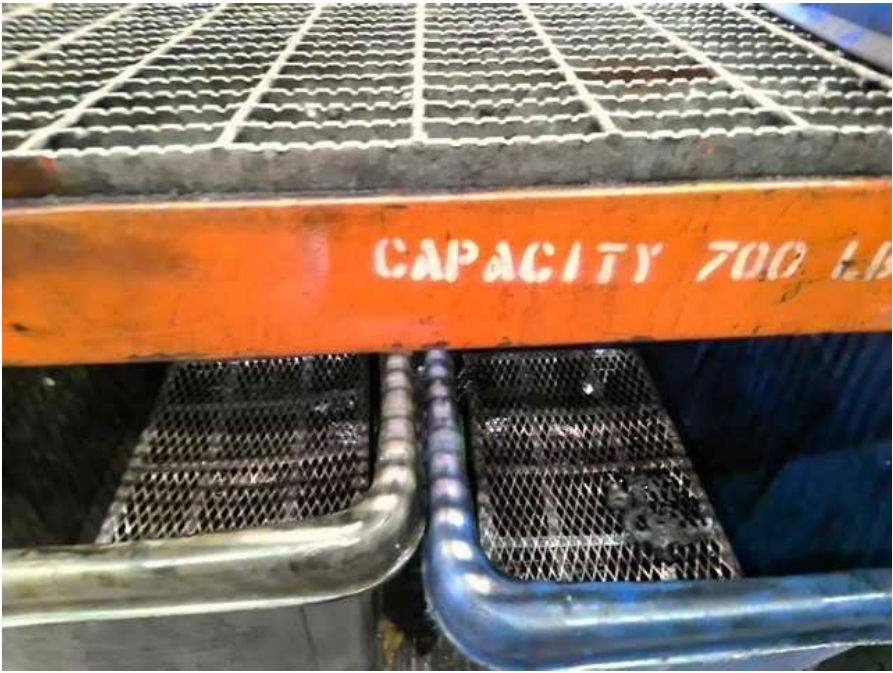
| Carts of used oil from oil filter crushing in Diesel Shop SAA | | | IMG-202407091155415541104019.jpg |

| Diesel Shop/ Oil Filter Crushing SAA | | | N/A |
| Carts used to remove used oil after oil filters are crushed, labeled “waste oil”. | | | |

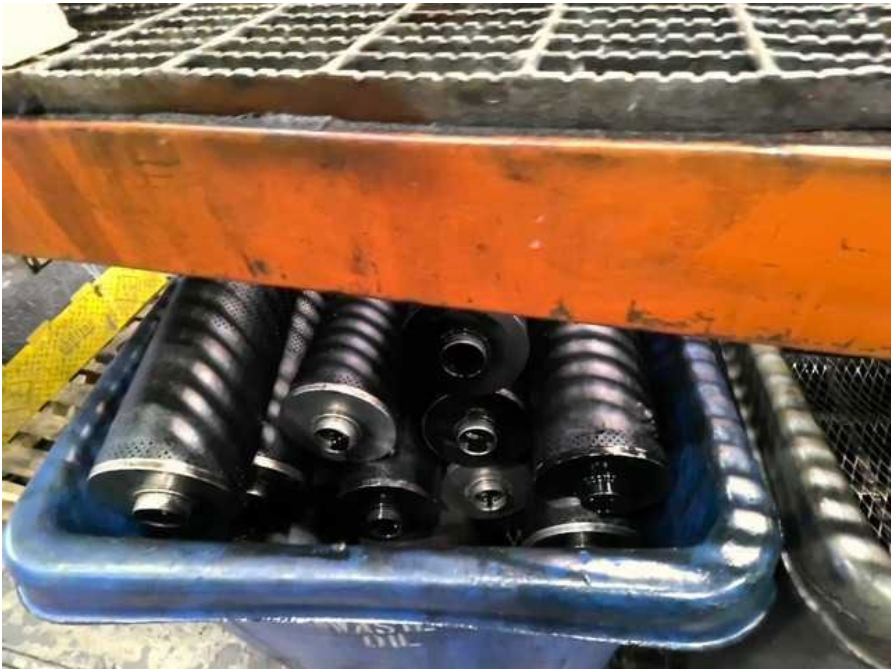
| Cart of used oil filters in Diesel Shop Oil Filter Crushing SAA | | | IMG-20240709115543554389953.jpg |

| Diesel Shop/ Oil Filter Crushing SAA | | | N/A |
| Cart of draining used oil filters, labeled “waste oil”. | | | |

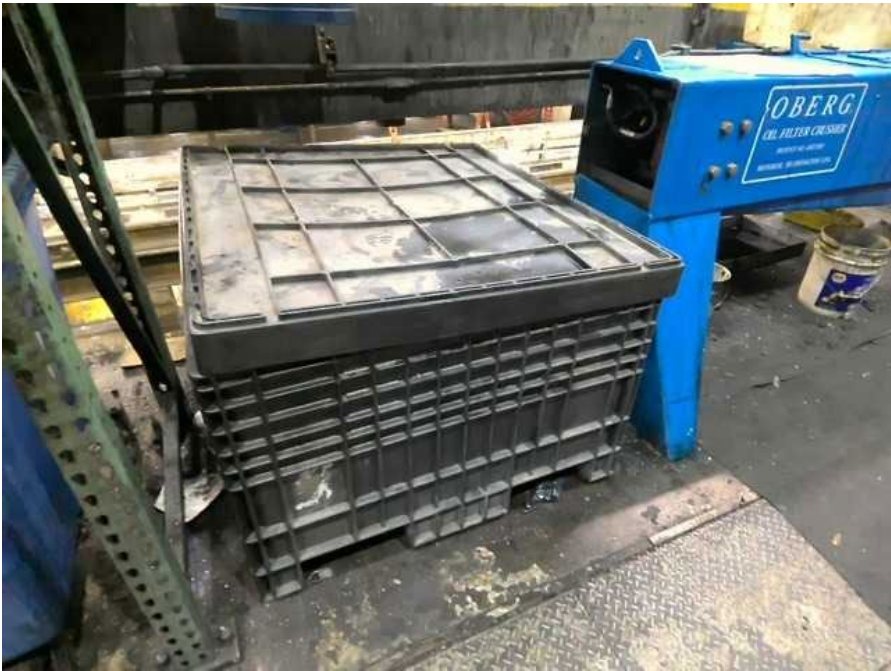
| Used oil filters in Diesel Shop Oil Filter Crushing SAA | | | IMG-202407091155475547105351.jpg |

| Diesel Shop/ Oil Filter Crushing SAA | | | N/A |
| Container of used oil filters. | | | |

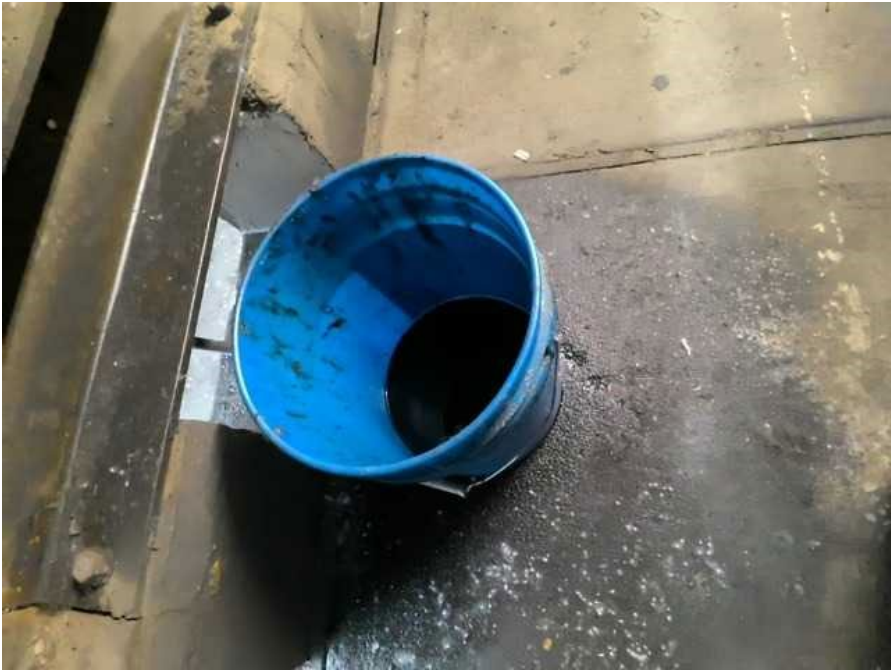
| Bucket of used oil in 5K Oil Tank SAA | | | IMG-2024070911580458480521.jpg |

| Bucket of used oil, not labeled “used oil”. | | | |

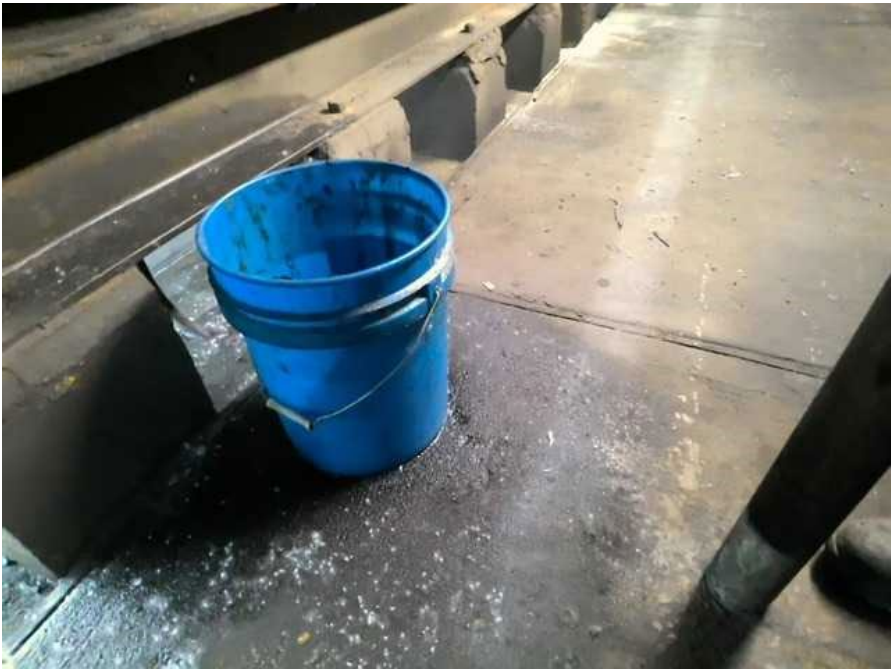
| Bucket of used oil in 5K Oil Tank SAA | | | IMG-2024070911580758780759.jpg |

| 5K Oil Tank/ SAA | | | N/A |

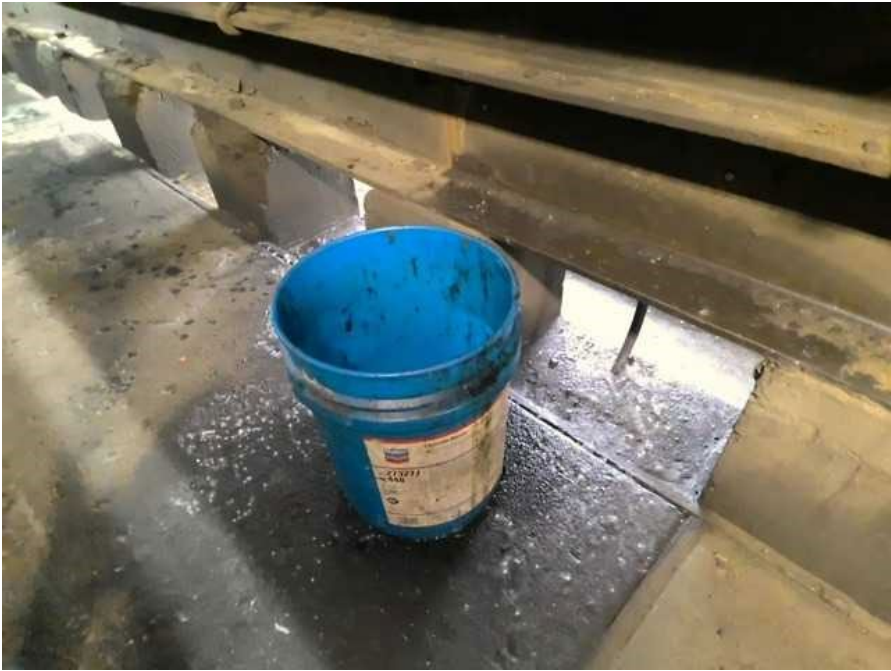
| Bucket of used oil in 5K Oil Tank SAA | | | IMG-20240709115812581279777.jpg |

| 5K Oil Tank/ SAA | | | N/A |
| Bucket of used oil, not labeled “used oil”. | | | |

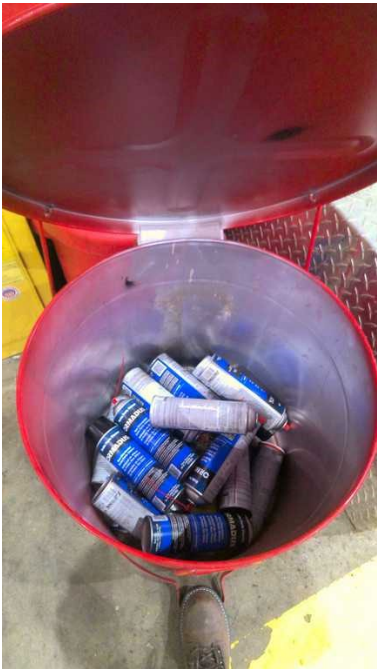
| Waste aerosol accumulation container in Heavy Equipment Shop SAA | | | IMG-202407091205225221284665.jpg |

| Waste aerosol accumulation container labeled “hazardous material”, with multiple waste aerosol cans inside. | | | |
