## **RCRA Inspection Report**

IGM Resins USA Inc.  
3300 Westinghouse Blvd.  
Charlotte, North Carolina 28273

November 9, 2022

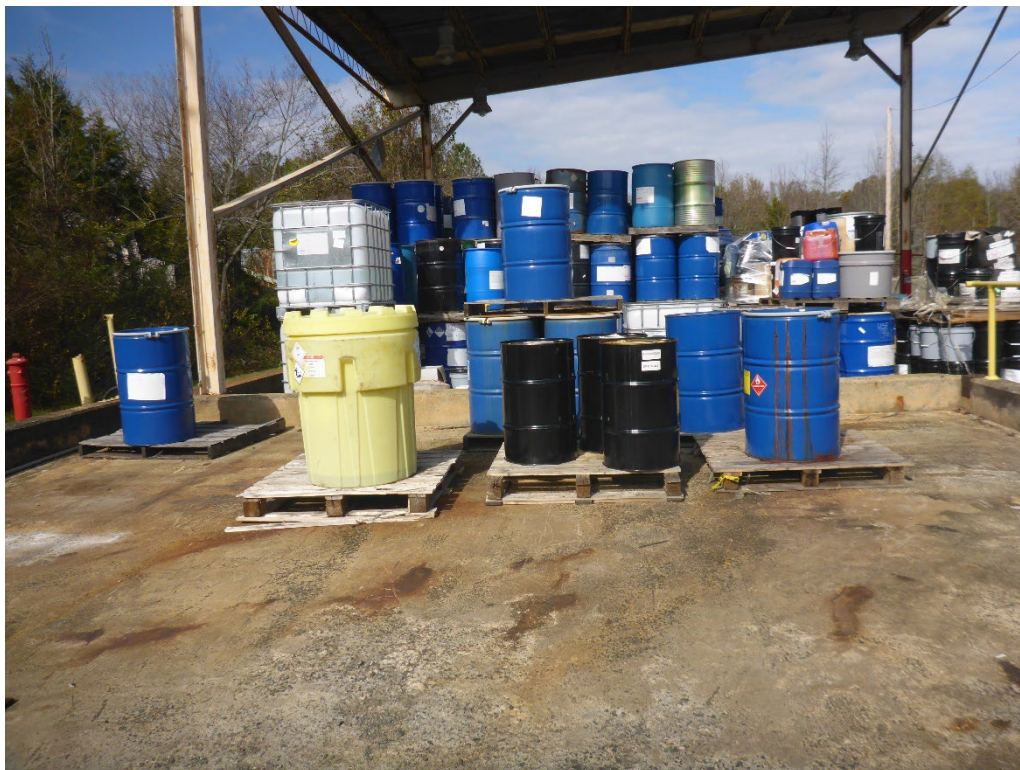
IGM manages hazardous waste (including ignitable waste) in a CAA on a curbed concrete pad in the facility yard (Photo 1). The area was identified with a sign which read "danger," "hazardous waste storage," and "no smoking," and the inspectors observed a spill kit and fire extinguishing equipment in an open shed next to the pad. According to Matthew Murray, personnel carry two-way radios for emergency communication when working in this area. However, the area does not appear to be equipped with an internal communications or alarm system capable of providing immediate emergency instruction to facility personnel.

The inspectors observed six pallets holding containers in the CAA. The pallets were arranged in four rows:

- Row 1 consisted of one pallet holding one 55-gallon container labeled nonhazardous waste photomer.
- Row 2 consisted of one pallet holding one overpack container identified with toxic and marine pollutant hazard pictograms. The container was not labeled as hazardous waste or marked with an accumulation start date.

- Row 3 consisted of three pallets. The first pallet held one 55-gallon drum labeled nonRCRA waste and was stacked above the second pallet, which held four 55-gallon drums. Each of the four drums was labeled nonhazardous and three were dated September 19, 2022. The third pallet held three 35-gallon drums of hazardous waste. Each 35-gallon drum was labeled hazardous waste flammable liquid (toluene, isopropanol), and identified as flammable and toxic. Each drum was marked with an accumulation start date of September 29, 2022, October 9, 2022, or October 21, 2022.

- Row 4 consisted of two pallets. The first pallet held one 55-gallon drum labeled nonhazardous waste and one 55-gallon drum labeled used oil. The last pallet held one 55-gallon drum labeled hazardous waste flammable liquid (toluene, isopropanol), identified as flammable and toxic, and marked with an accumulation start date of September 23, 2022. The inspectors observed evidence of dried material that had leaked or spilled down the outside of the drum.

**Photo 1:** Six pallets, which are arranged in four rows and not stacked, in the curbed concrete pad CAA in the facility yard. (Note that the stacked containers shown behind the CAA are in the Building 19 Covered Storage Pad.)

**Pursuant to 15A NCAC 13A .0107 [40 C.F.R. § 262.17(a)(1)(ii)], which is a condition of the LQG Permit Exemption, if a container holding hazardous waste is not in good condition, or if it begins to leak, the LQG must immediately transfer the hazardous waste from this container to a container that is in good condition, or immediately manage the waste in some other way that complies with the conditions for exemption of this section.**

In an email to the inspectors on November 18, 2022, Matthew Murray attached a photograph of the damaged drum inside the overpack container and explained that the drum contained a product material. According to Matthew Murray, the drum was placed into the overpack container when it was damaged by a forklift, and the material in the drum was used in a production batch after the inspection.

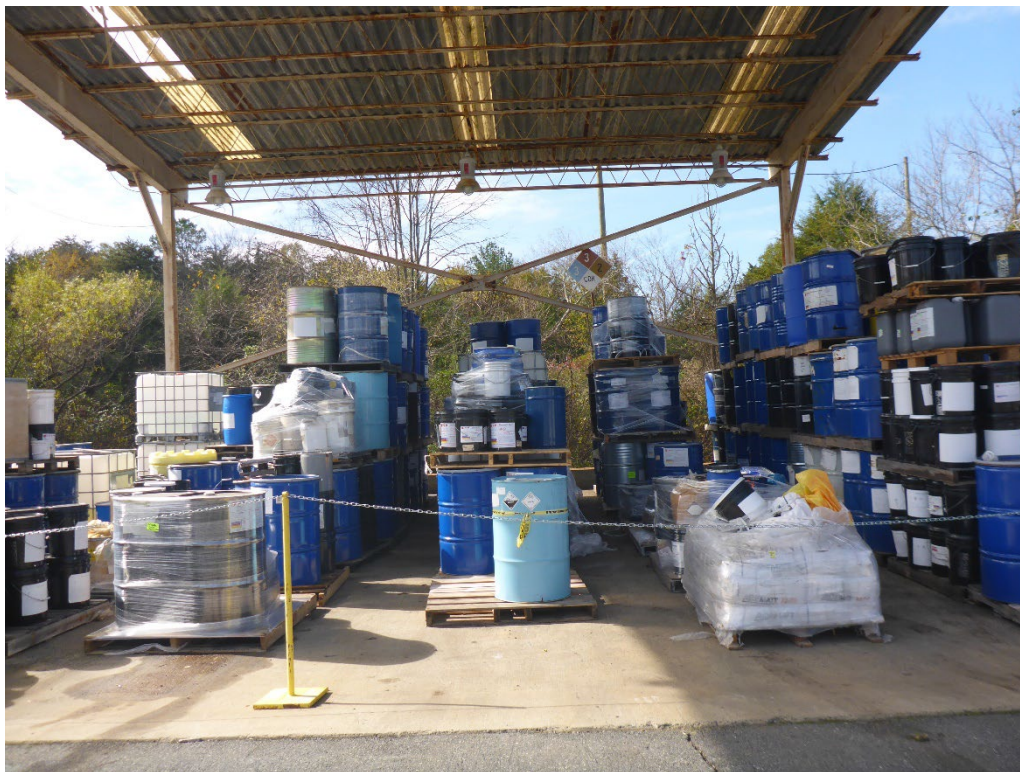
On a covered concrete pad next to the CAA, the inspectors observed six rows of pallets holding various containers ranging in size from less than 1-gallon to over 200-gallons (Photo 2). Matthew Murray explained that IGM converted to a new computer inventory system in 2020/2021, and that not all of the material onsite was entered into the new system. On October 18-20, 2022, IGM personnel conducted a full physical inventory of the contents of the warehouse, the Pilot Plant, and the outdoor storage area and recertified the levels of the contents inside the tanks. Any containers observed during the physical inventory that were not entered into the electronic inventory system were moved to this covered area or to the flammable storage area three weeks before the inspection.

The inspectors observed pallets stacked one to three pallets high and seven or eight pallets long in each row in this area:

Some containers were in poor condition, and the inspectors observed a large hole in one leaking two-liter container of 2-ethylhexyl acrylate. The inspectors also observed an unknown liquid on the pad which was evidence of leaking container(s) in the last row, but they were unable to identify which container(s) was responsible for the leaked/spilled material.

**Photo 2:** Six rows of pallets holding various containers ranging in size from less than 1-gallon to over 200-gallons observed in the Building 19 Covered Storage Pad next to the CAA. These containers were reportedly moved to this area on October 18-20, 2022 following a full physical inventory of the contents of the warehouse, the Pilot Plant, and the outdoor storage area. Any containers observed during the physical inventory that were not entered into the new electronic inventory system were moved to this covered area or to the Flammable Covered Storage Pad.

**Pursuant to 15A NCAC 13A .0107(a) [40 C.F.R. § 262.11], a person who generates a solid waste, as defined in 15A NCAC 13A .0106 [40 C.F.R. § 261.2], must use the steps articulated in 15A NCAC 13A .0107(a) [40 C.F.R. § 262.11] to make an accurate determination as to whether that waste is a hazardous waste in order to ensure wastes are properly managed according to applicable RCRA regulations.**
