## **RCRA Inspection Report**

Polychemie, Inc.  
Port Bienville Industrial Park, Road D  
Pearlington, Mississippi 39572

**COMPLIANCE EVALUATION Inspection**

**February 23 and 25, 2021**

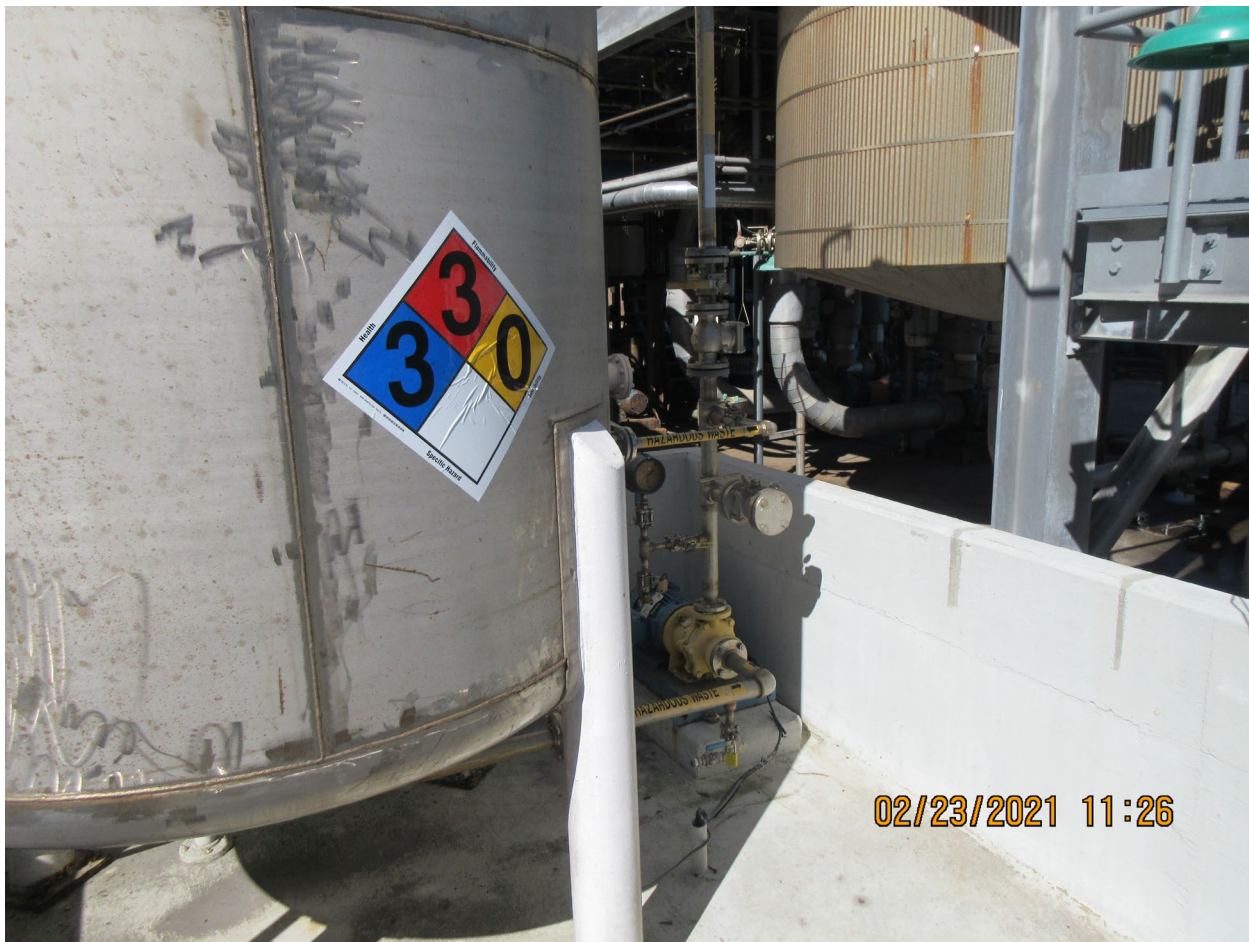
At the time of the inspection, the tanks secondary containment system for Tank-830 was observed to be sealed and free of any cracks and gaps (Photos 2, 3 & 4). The tank was observed to be closed at the time of the inspection. Facility personnel indicated that twelve pieces of ancillary equipment to the tank used to transfer the waste to outgoing tanker trucks were in service for greater than 300 hours per year. Pumps and valves which were part of this line were labeled and tagged at the time of the inspection (Photo 4).

Photo 4 – Ancillary equipment for Tank-830
