## RCRA Compliance Evaluation Inspection Report

Beckman Coulter Hialeah Facility  
740 W 83rd Street  
Hialeah, Florida 33014

7) **Purpose of Compliance Evaluation Inspection**

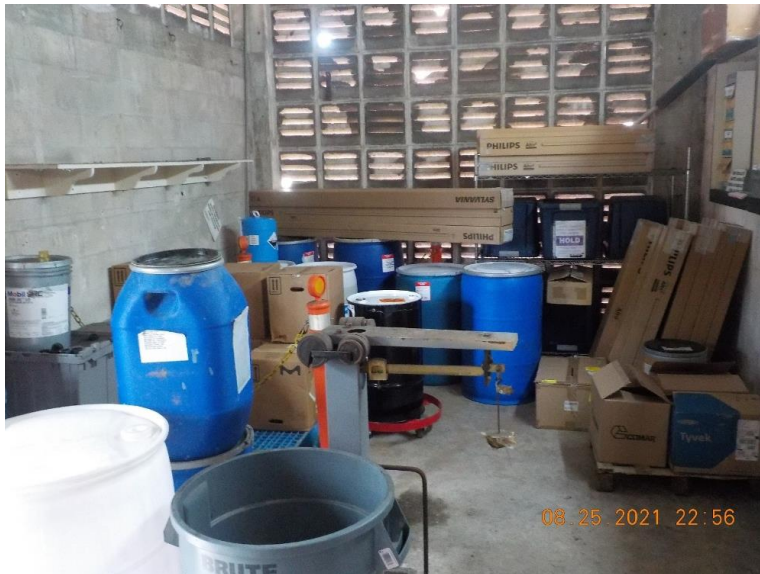
sq. ft. building forming west side of the campus. The building is comprised of a 90-day Central Accumulation Area (CAA), known as the “Waste Bunker,” the Plant Engineering Workshop, and the Receiving Area. The CAA is located on the southern side of Building 780 and has “No Smoking” and “Hazardous Waste” signage outside the door. Eye wash and safety showers were located directly outside of the CAA and were confirmed to be operable during the inspection. Spill kits and fire extinguishers were also located within the CAA. The following containers were stored in the Waste Bunker during the inspection (Photo #1):

- Seven empty 10-gallon containers; and
- Adequate aisle space was not observed in the CAA. The area was congested with containers and the inspector’s movement was obstructed to inspect all containers due to no aisle space.

Photo #1 – Central Accumulation Area (Waste Bunker).

On September 3, 2021, the facility informed the EPA and FDEP that all the waste stored in the Waste Bunker were shipped off to Veolia ES Technical Solutions, LLC in Beaumont, TX (TXD000838894) and Veolia ES Technical Solutions, LLC in Tallahassee, FL (FL0000207449). It appears that 2,310 lbs. of hazardous and 1,685 lbs. of non-hazardous wastes were shipped to Beaumont, Texas, designated facility (manifest number 001963040VES, shipping date 9/2/21) and 1,015 lbs. of universal wastes to Tallahassee, Florida, designated facility (manifest number ZZ00160261, shipping date 9/2/21).

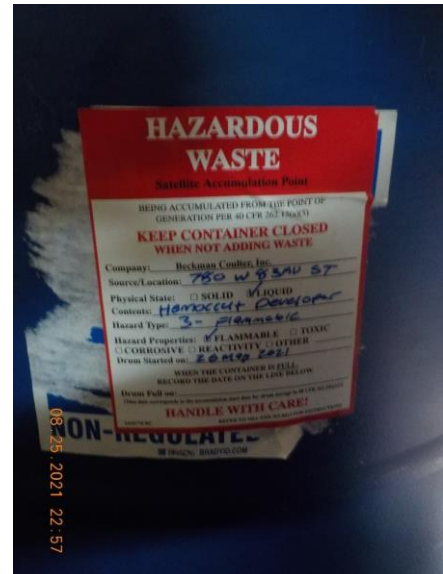
- One closed 55-gallon container of “Hazardous Waste Flammable” hemocult developer dated 5/26/21 (Photo #2). *The 55-gallon container has been in storage at the facility for greater than 90 days without a permit;*

Photo #2 – 55-gallon drum of hazardous waste dated 5/26/21.

**Pursuant to Fla. Admin. Code Ann. r. 62-730.160(1) [40 C.F.R. § 262.17], a LQG may accumulate hazardous waste on-site for 90 days or less without a permit or without having interim status, as required by Section 403.722 of the Florida Statutes, Fla. Stat. § 403.722 [Section 3005 of RCRA, 42 U.S.C. § 6925], provided that the generator complies with the conditions listed in Fla. Admin. Code Ann. r. 62-730.160(1) [40 C.F.R. § 262.17].** *The hemocult developer and the solvent contaminated rags containers have been in storage greater than 90 days without a permit.*

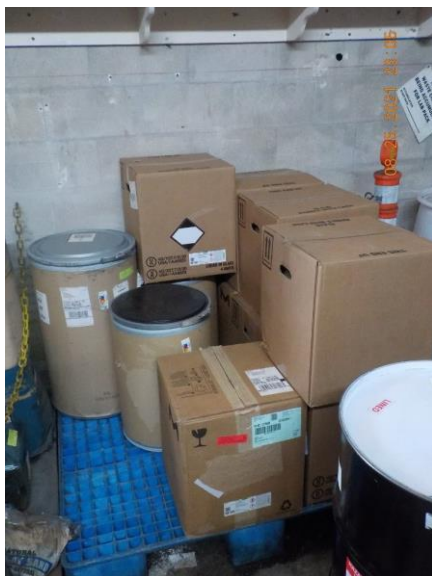
- Eight boxes of rejected dichloromethane (DCM), methylene chloride. These boxes were identified as non-hazardous; however, during the record review, it was determined that the wastes are considered discarded commercial chemical products with a U080 waste code, listed for toxicity. The boxes were not marked with the words “Hazardous Waste,” an indication of hazards of the contents, or an accumulation start date (Photo #3);

Photo #3 – Eight boxes of rejected DCM.

**Pursuant to Fla. Admin. Code Ann. r. 62-730.160(1) [40 C.F.R. § 262.17(a)(5)(i)(A-C)], which is a condition of the LQG Permit Exemption, a generator must mark or label its containers with the following: (A) the words “Hazardous Waste;” (B) an indication of the hazards of the contents (examples include, but are not limited to, the applicable hazardous waste characteristic(s) (i.e., ignitable, corrosive, reactive, toxic); hazard communication consistent with the Department of Transportation requirements at 49 C.F.R. part 172 subpart E (labeling) or subpart F (placarding); a hazard statement or pictogram consistent with the Occupational Safety and Health Administration Hazard Communication Standard at 29 C.F.R. 1910.1200; or a chemical hazard label consistent with the National Fire Protection Association code 704); and (C) the date upon which each period of accumulation begins clearly visible for inspection on each container.** *The corrosive sodium hydroxide solution, polymer/xylene/DCM/ethanol & chloroform, and DCM containers were not marked “Hazardous Waste” and an indication of the hazards of the contents. The rejected*

*laboratory filling, corrosive sodium hydroxide solution, polymer/xylene/DCM/ethanol & chloroform, and DCM containers were not marked with and an accumulation start date.*

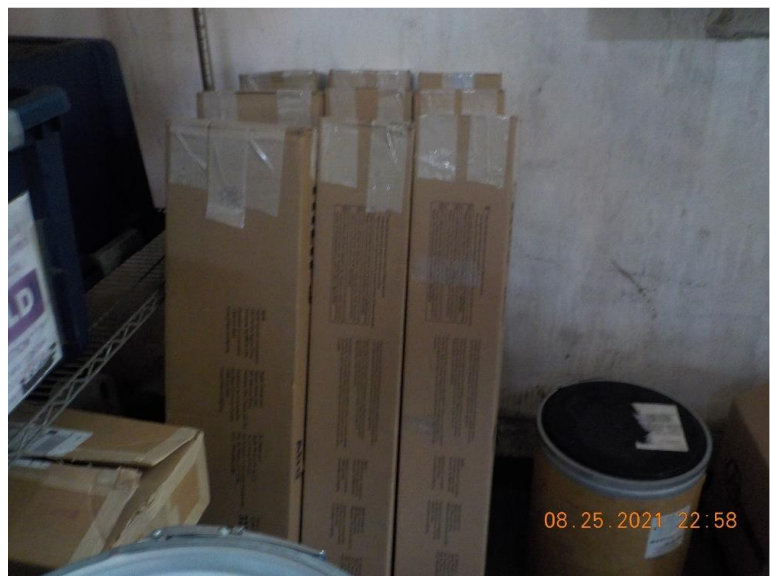
- One closed 80-liter container of non-hazardous sodium sulfate solution;
- One 55-gallon container marked “Used Oil;”
- Nineteen boxes of used universal waste lamp. The boxes were not marked “Universal Waste-Lamp(s),” or “Waste Lamp(s),” or “Used Lamps” and were not dated to demonstrate the length of time that the universal waste boxes have been accumulated from the date it became wastes or were received (Photo #4);

Photo #4 – Boxes of universal waste lamps.

**Pursuant to Fla. Admin. Code Ann. r. 62-730.185(1) [40 C.F.R. § 273.14(e)], a SQHUW must label or mark each lamp or container of lamps clearly with one of the following phrases: “Universal Waste-Lamp(s),” or “Waste Lamp(s),” or “Used Lamp(s).”** *The facility failed to label nineteen boxes of universal waste lamps.*

**Pursuant to Fla. Admin. Code Ann. r. 62-730.185(1) [40 C.F.R. § 273.15(a) and (c)], a SQHUW may accumulate universal waste no longer than one year and must be able to demonstrate the length of time that the universal waste has accumulated from the date that it became a waste or was received.** *The facility failed to mark the containers of universal waste with a date when universal waste became a waste.*

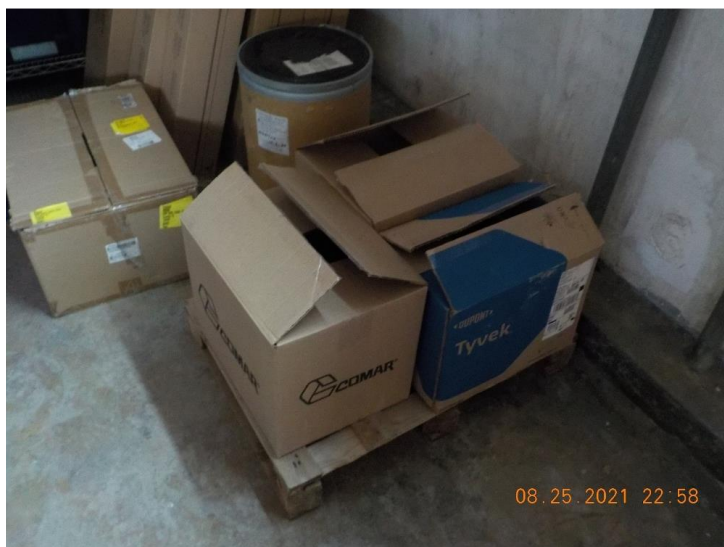
- One closed 1-gallon container of “Universal Waste” nickel cadmium batteries dated 10/6/20;
- Three boxes of spent sealed lead acid batteries. The boxes were not marked “Universal Waste - Battery(ies),” or “Waste Battery(ies),” or “Used Battery(ies)” and were not dated to demonstrate the length of time that the universal waste boxes have been accumulated from the date it became wastes or were received (Photo #5);

Photo # 5 - Boxes of spent lead acid batteries.

**Pursuant to Fla. Admin. Code Ann. r. 62-730.185(1) [40 C.F.R. § 273.14(a)], a small quantity handler of universal waste (SQHUW) must label or mark each battery or container of batteries clearly with one of the following phrases: “Universal Waste—Battery(ies),” or “Waste Battery(ies),” or “Used Battery(ies).”** *The facility failed to label three boxes of universal waste batteries.*

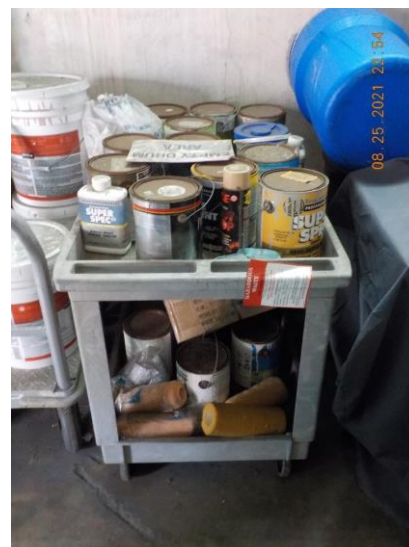
- One push-cart contained twenty 1-gallon containers of used paint and coating materials (Photo #6). The cart itself was labeled with the words “Hazardous Waste” however the contents on the label were “ink cartridge”. The inspectors instructed the facility to conduct a waste determination and ensure that the wastes are disposed of accordingly. In an email dated September 3, 2021, Mr. Beazer stated that the items were reviewed and determined not to be waste at this time. The paint and coating materials will be re-used, the area will be organized further, and additional appropriate labels will be added.

Photo #6 – Push-cart containing paint and coating containers.
