**Region 6 - Enforcement & Compliance Assurance Division**  
**INSPECTION REPORT**

| Inspection Date(s): | 03/05/2025 | |
| Company Name: | <b>Nevada Oil, LLC</b> | |
| Facility Name: | <b>Irma Nacatoch Unit SWD/EOR Tank Battery</b> | |

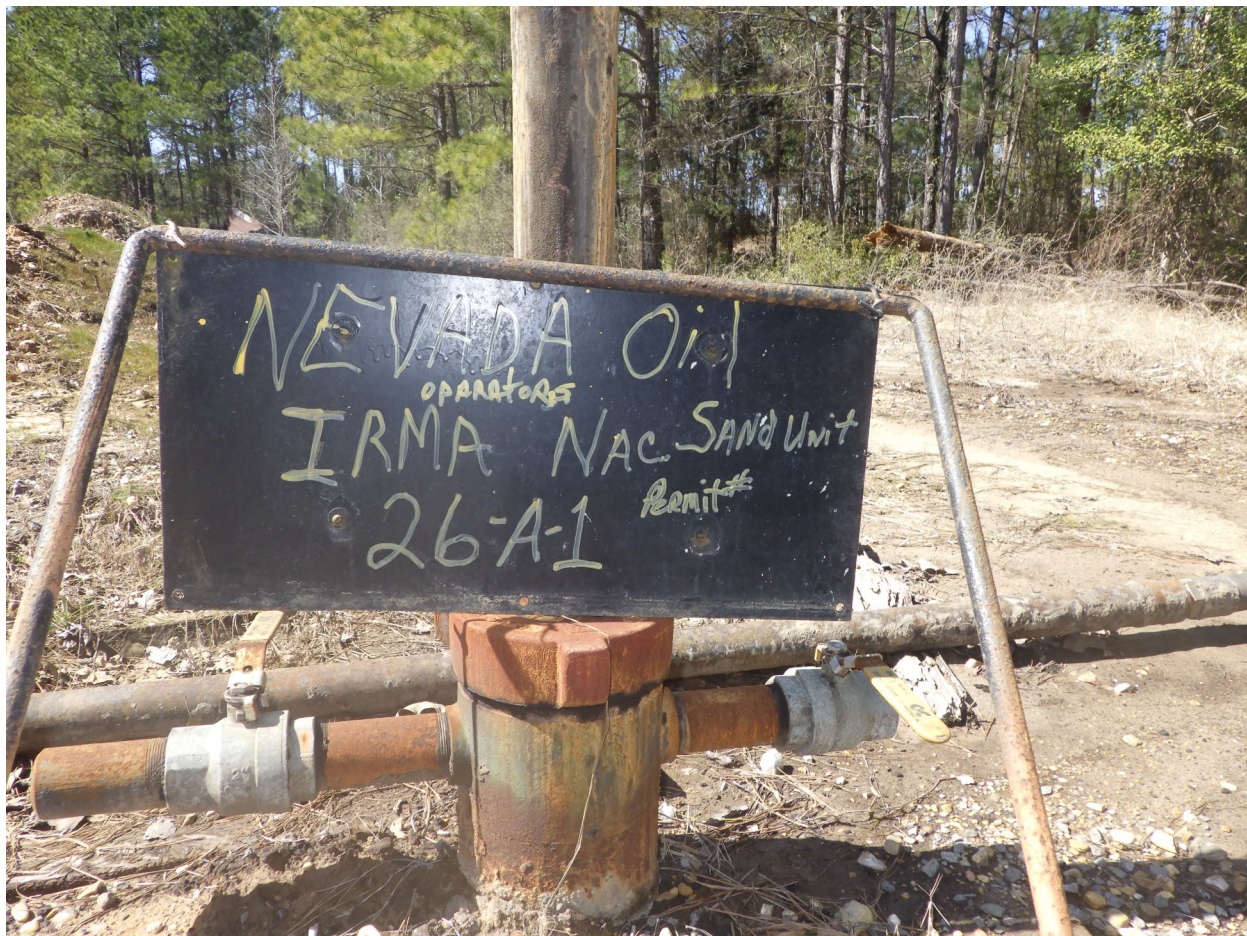
Photo No. 1

Description: Looking N, this photo shows the signage at the Irma Nacatoch (Sand) Unit SWD/EOR Tank Battery ("facility").

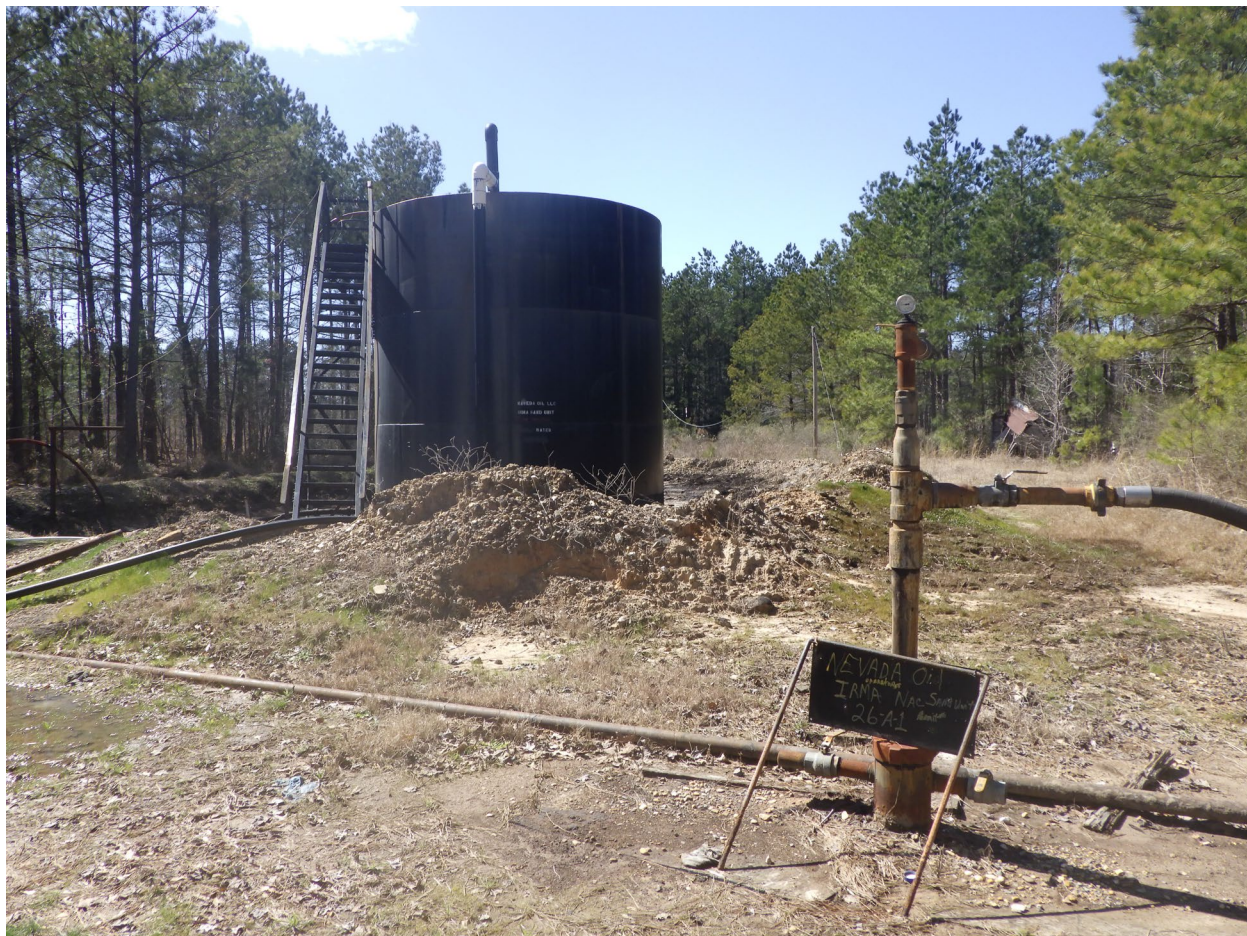
Photo No. 2

**Description:** Looking W, this photo shows an overview of the facility with a saltwater disposal (SWD) injection well or an enhanced oil recovery (EOR) well.

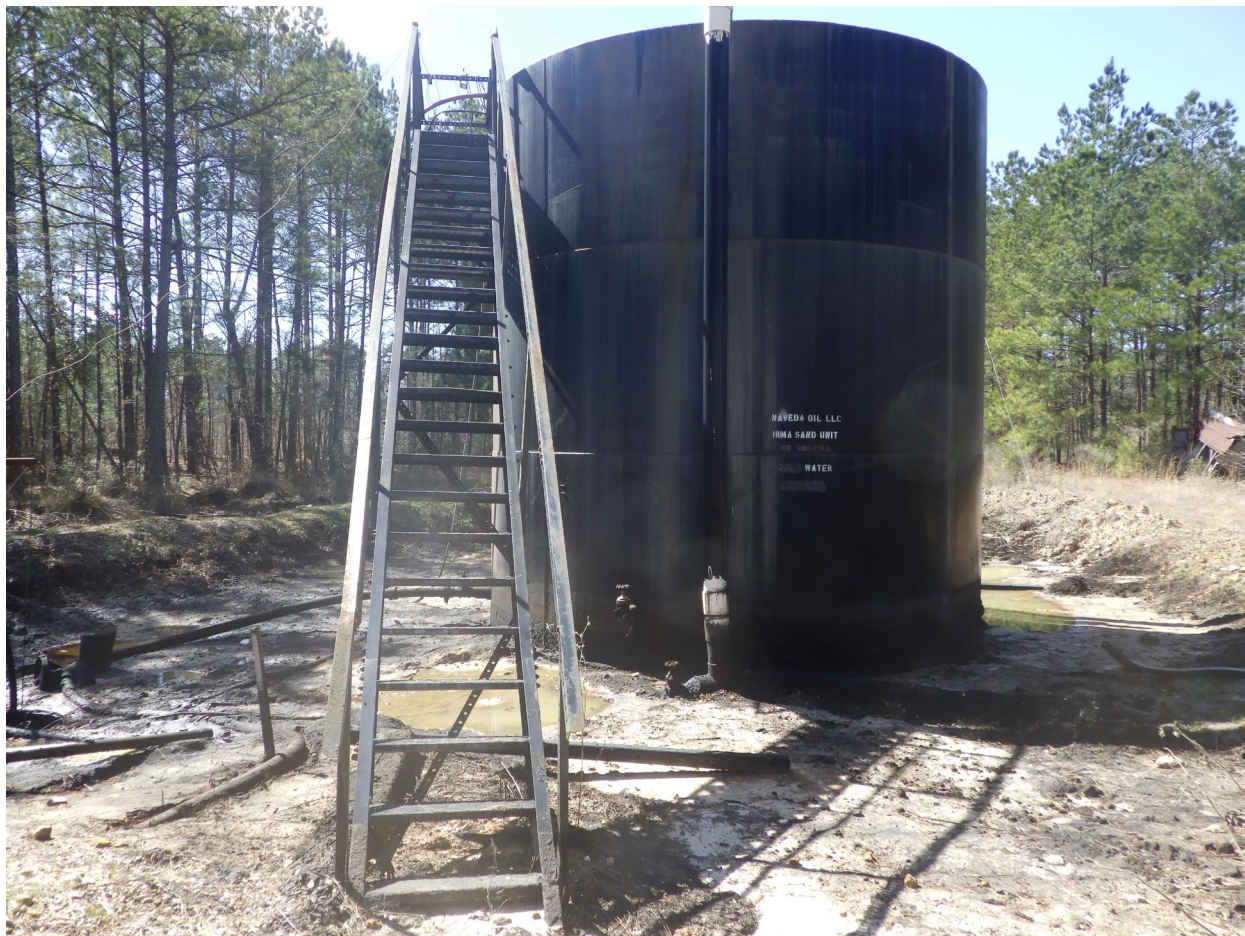
Photo No. 3

**Description:** Looking SSW, this photo shows the front view of the inside of the secondary containment.

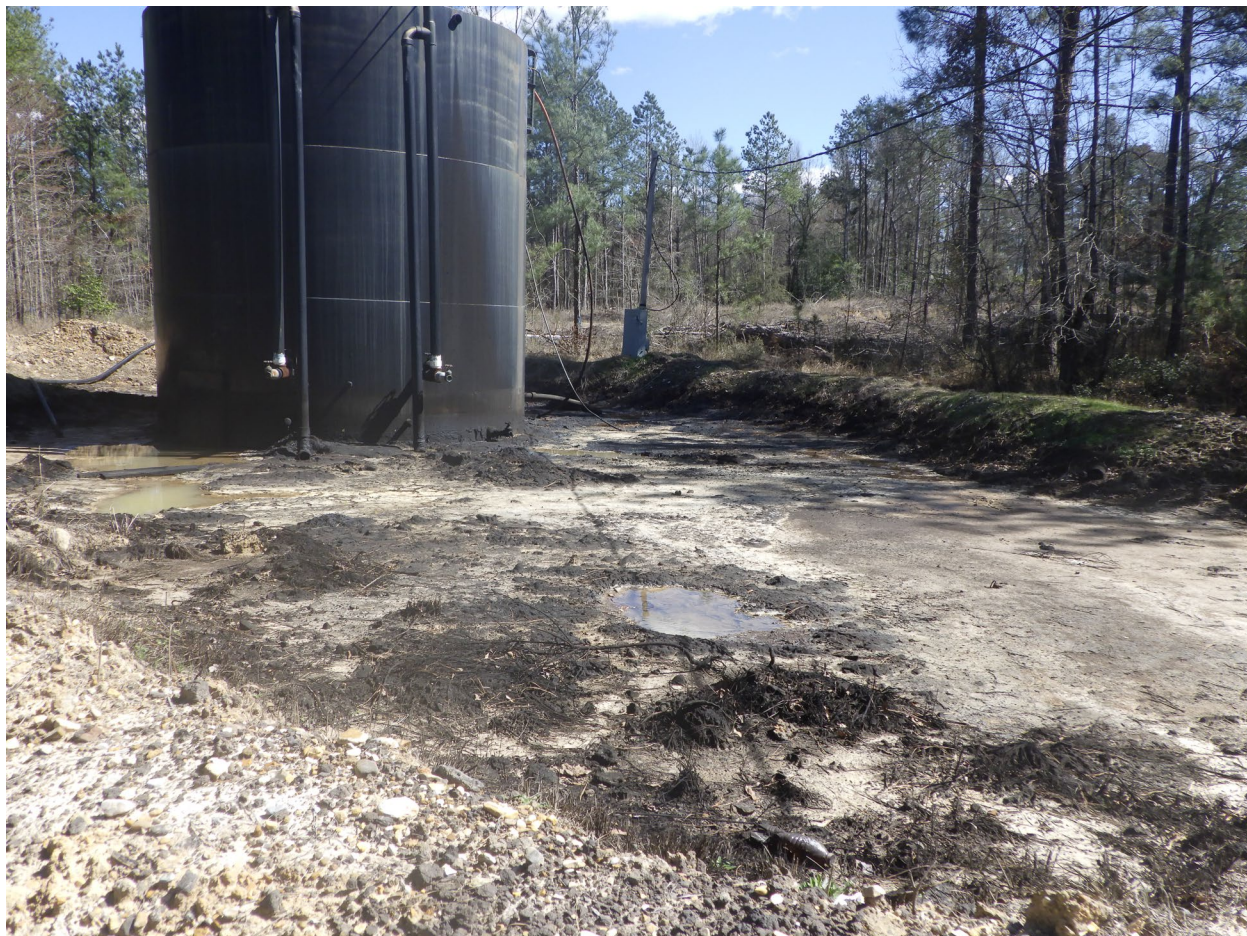
Photo No. 4

I observed loose crude oil and saltwater inside secondary containment, see Photos No. 4 through No. 7.

- Loose crude oil and saltwater inside secondary containment (Photos No. 4 through No. 7), and
- The motor and pump for the SWD/EOR well outside secondary containment with loose oil and saltwater saturating the ground (Photos No. 8 through No. 10).

**Description:** Looking ESE, this photo shows the back view of the inside of the secondary containment.

Inspector will conduct follow-up phone calls with the company representative(s) over the coming weeks and months to ensure areas of concern are properly addressed.

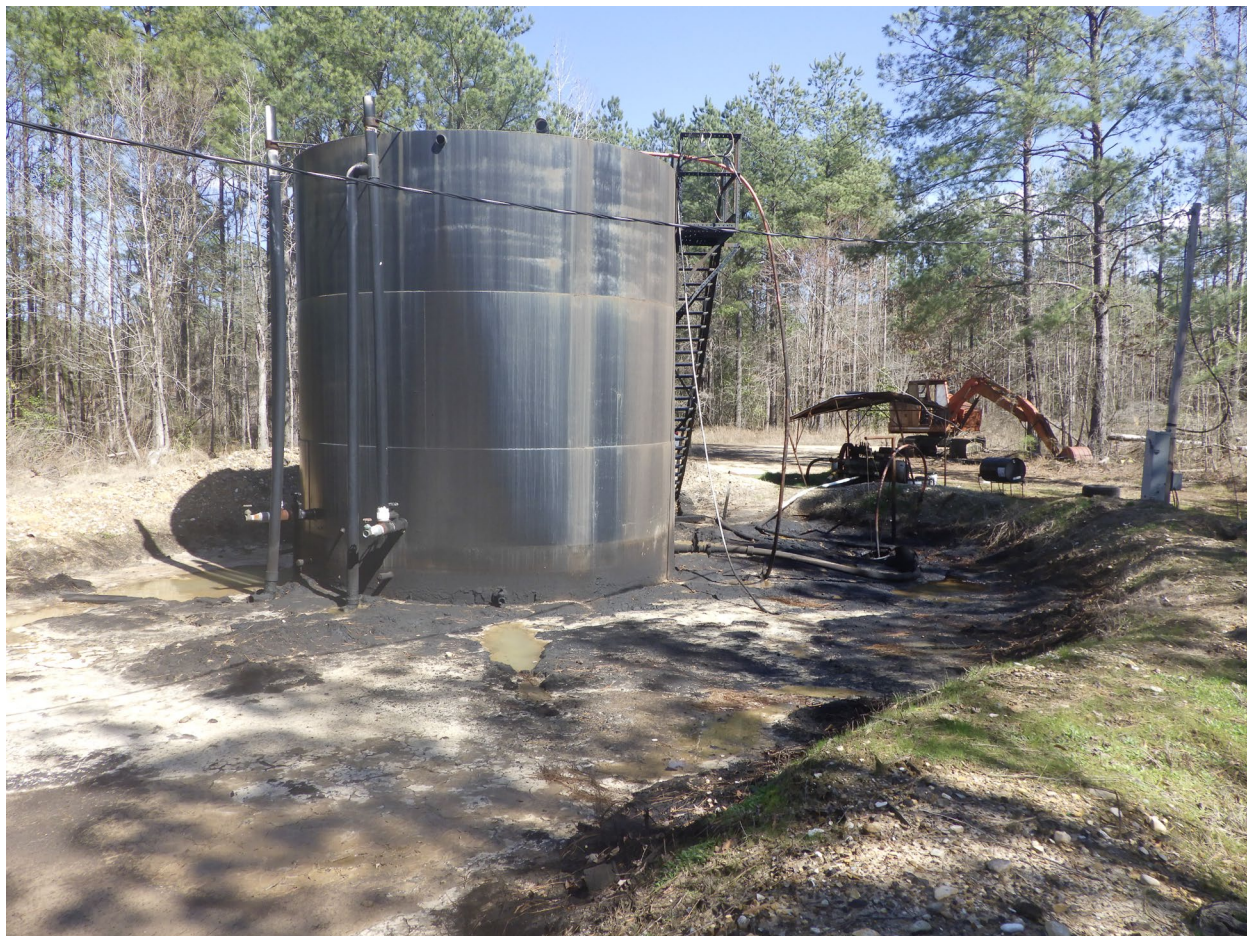
Photo No. 5

**Description:** Looking ENE, this photo shows loose crude oil and saltwater inside the secondary containment.

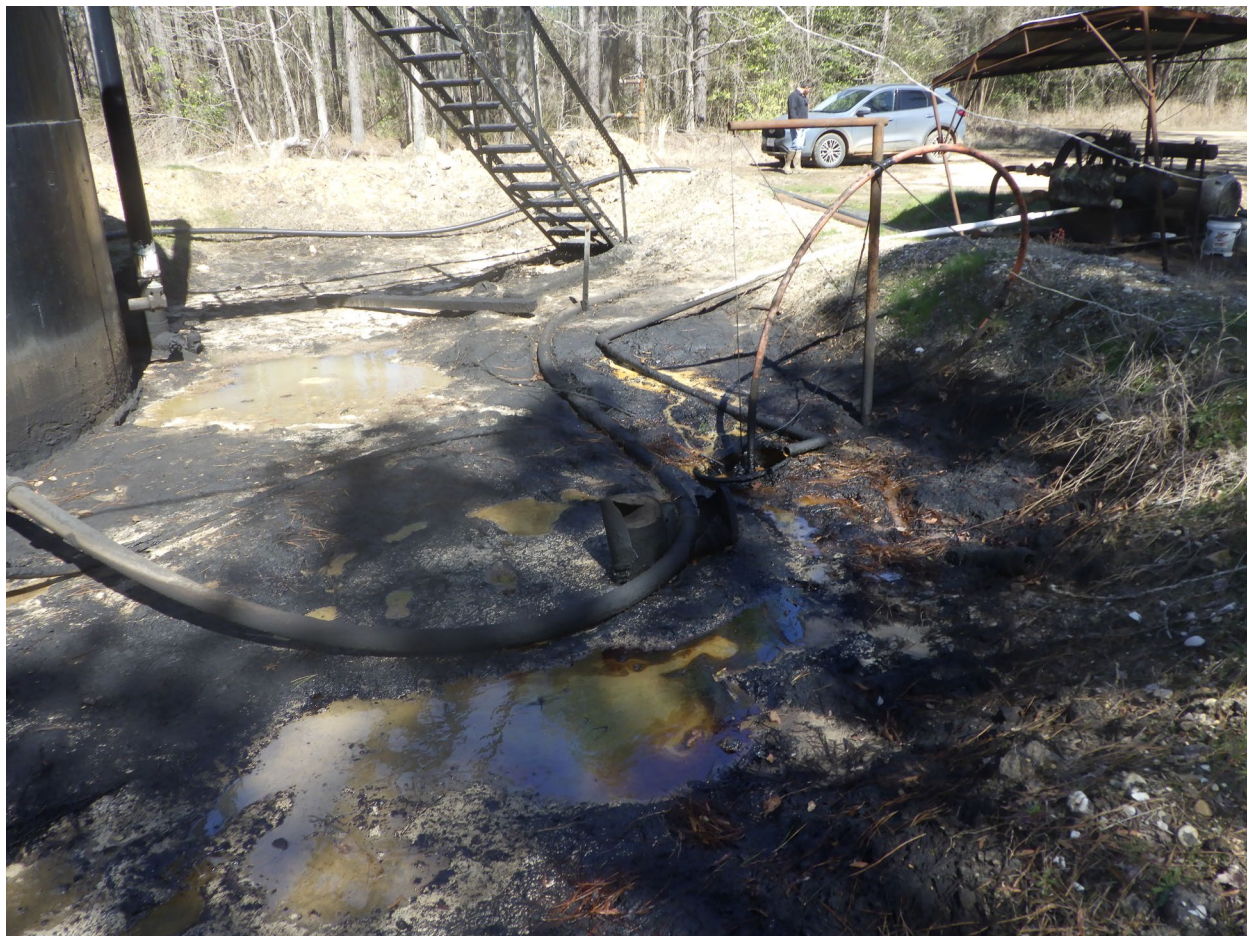
Photo No. 6

**Description:** Looking NE, this photo shows the sump area and pump for the secondary containment.

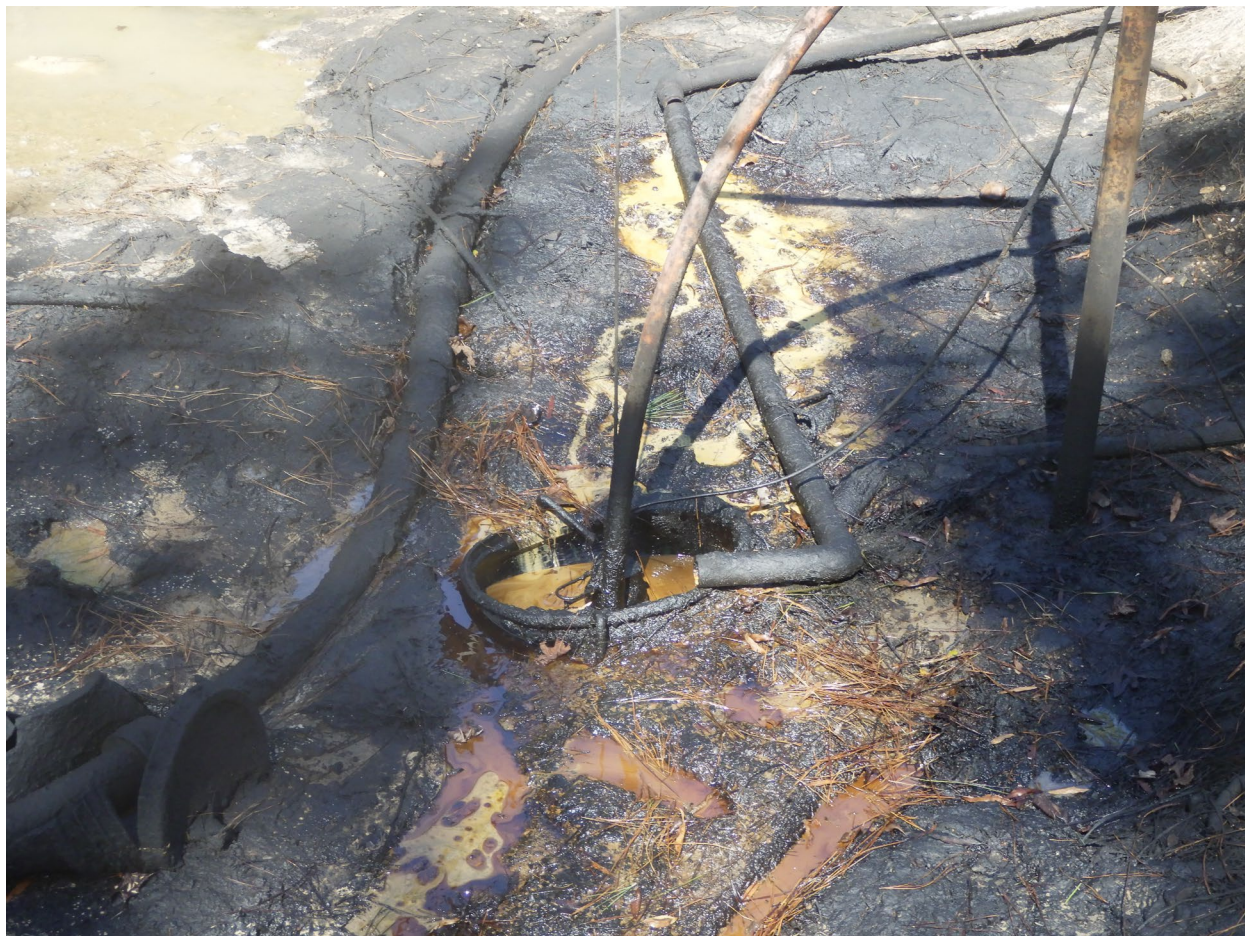
Photo No. 7

**Description:** Looking NNE, this photo shows a closeup of the sump and pump for secondary containment.

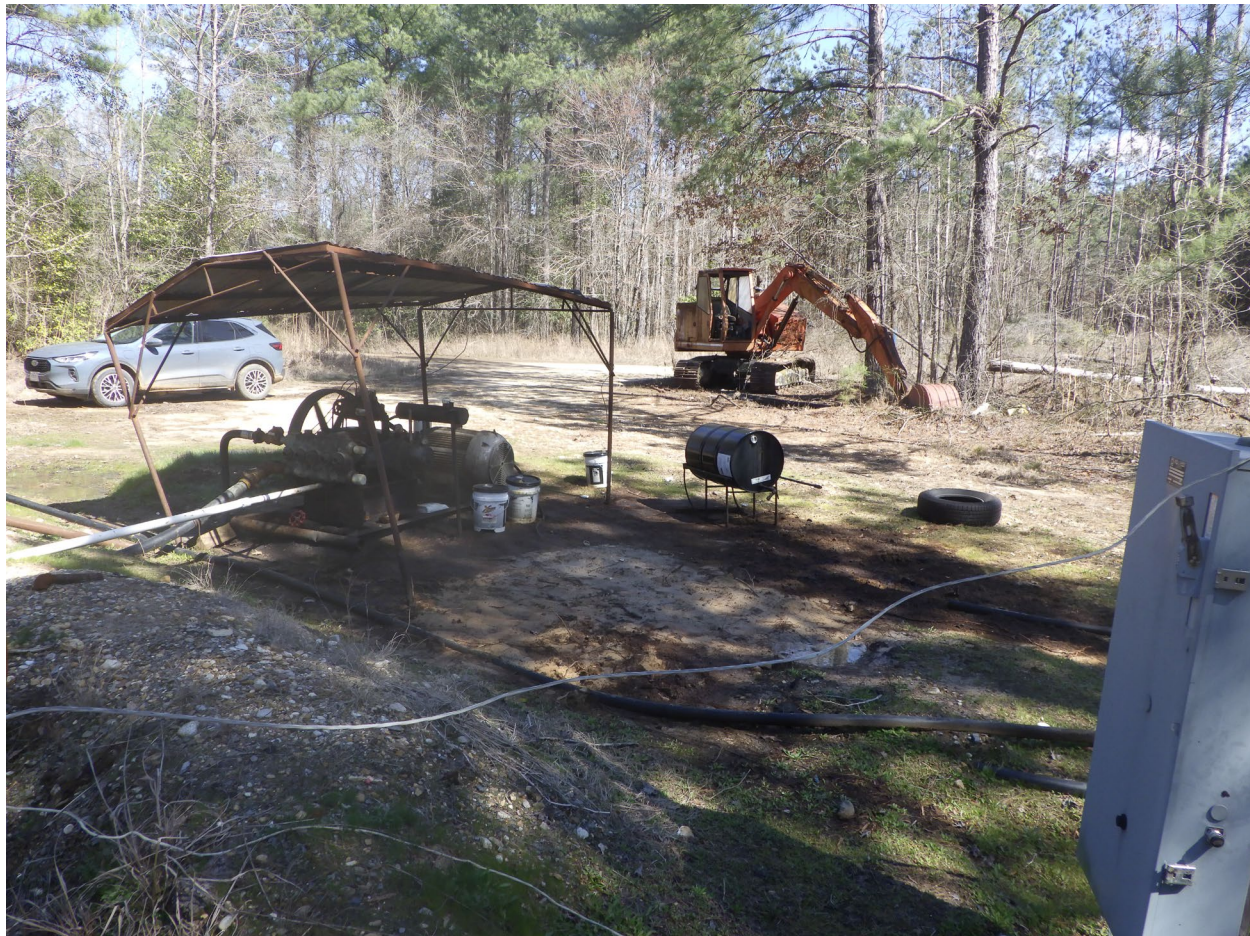
Photo No. 8

I observed the motor and pump for the SWD/EOR well outside secondary containment with loose and saltwater saturating the ground, see Photos No. 8 through No. 10.

**Description:** Looking ENE, this photo shows the SWD/EOR well motor and pump outside secondary containment with residual oil and saltwater staining.

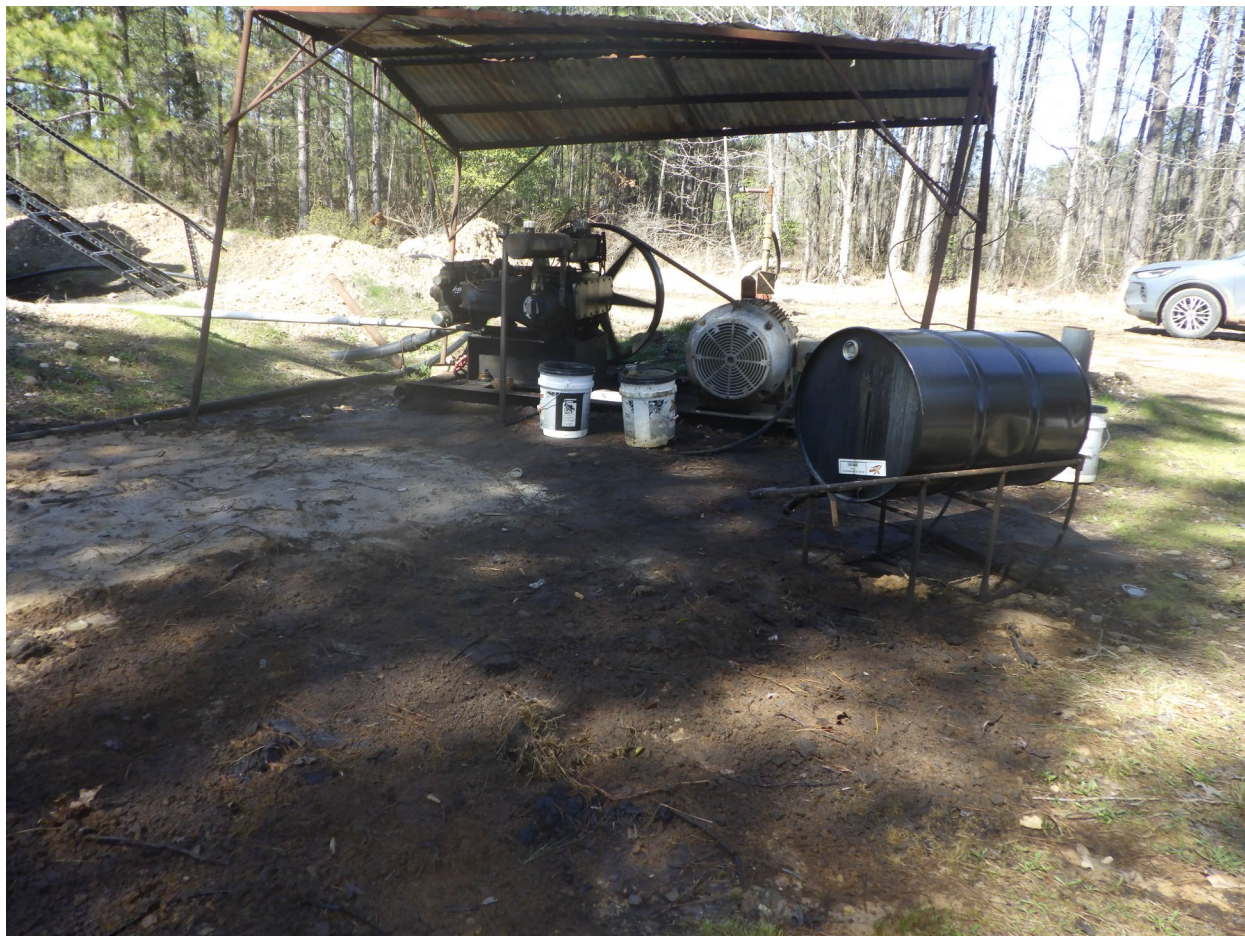
Photo No. 9

**Description:** Looking NNE, this photo shows an additional view of the SWD/EOR motor and pump and staining from Photo No. 8.

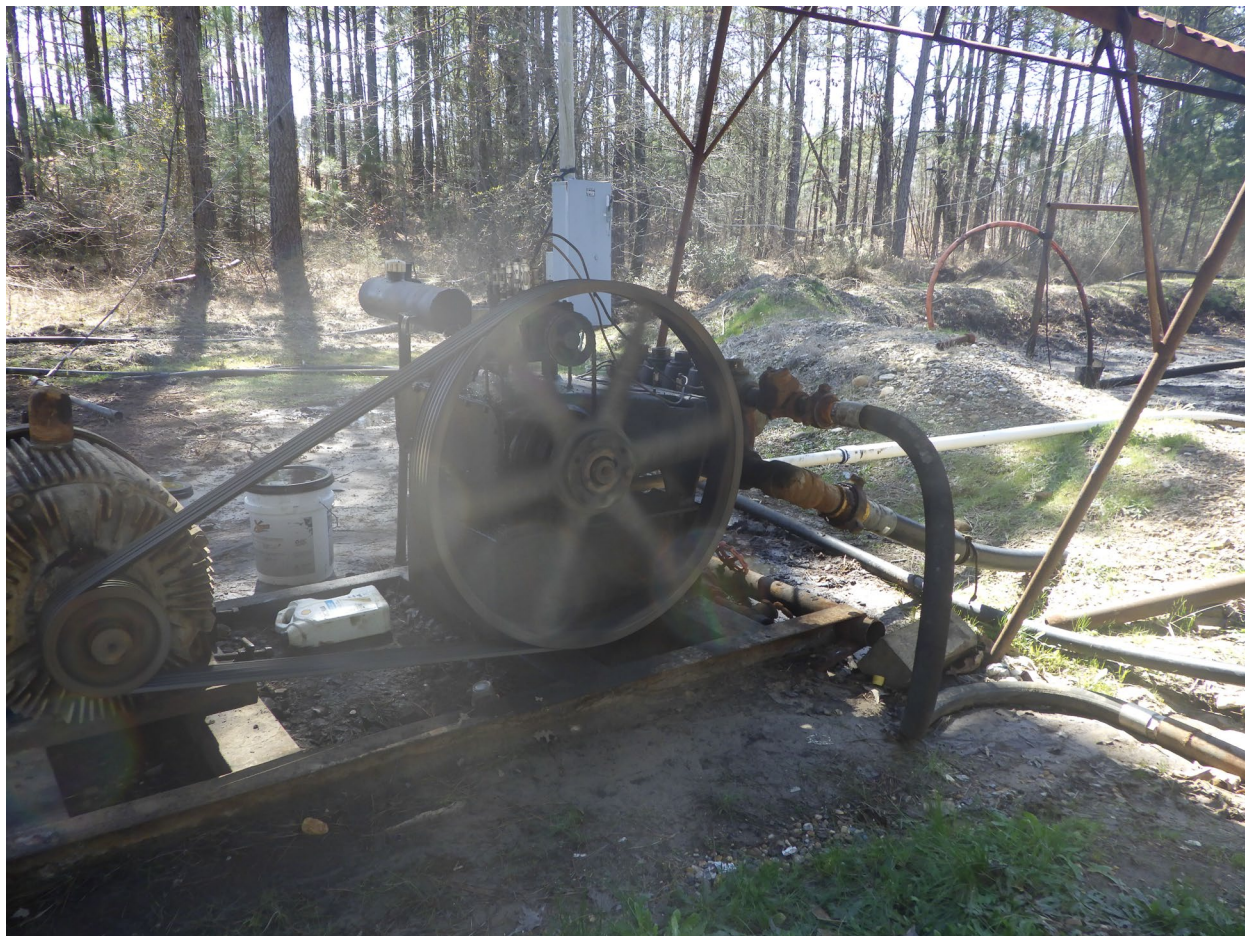
Photo No. 10

**Description:** Looking SW, this photo shows a closeup of the SWD/EOR motor and pump outside secondary containment and no guard over the motor belt.
