## **RCRA Inspection Report**

Arkema Inc.  
13755 Highway 43 North  
Axis, Alabama 36505

November 20, 2024, 10:10 AM

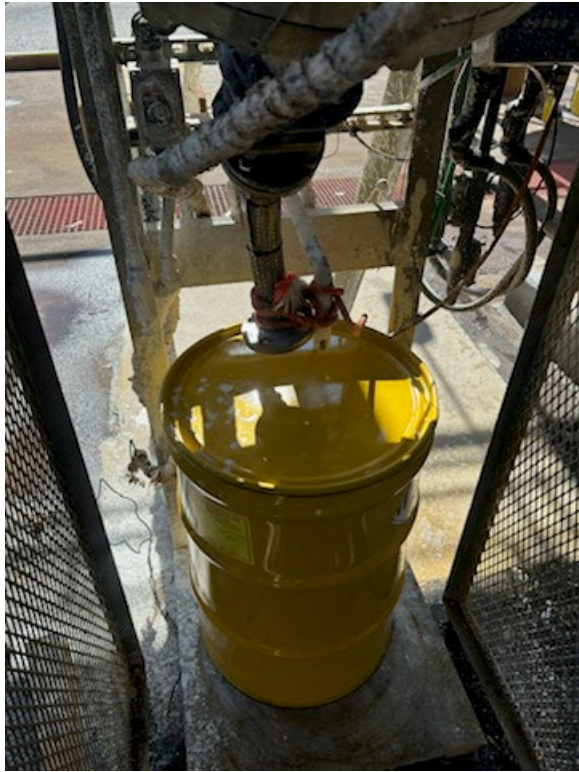
The inspectors observed one 55-gallon container in the PEKK/Distillation Area SAA (Photo 1). The drum was labeled with the words "Hazardous Waste," and it was identified with a Class 9 DOT hazard sticker. Because the DOT Class 9 label does not indicate any specific hazard associated with the waste, the EPA has determined that it is not appropriate to meet the RCRA indication of hazards labeling standard ([Frequent Questions About Implementing the Hazardous Waste Generator Improvements Final Rule | US EPA](#)). Pursuant to ADEM Admin. Code r. 335-14-2-.04(2)(a) [40 C.F.R. § 261.31(a)], F002 hazardous waste spent solvents are listed hazardous waste due to the hazard code associated with a toxic waste. The container was not marked with an indication that the contents are toxic, and the lid had not been secured to

close the container. In addition, the inspectors observed waste material on the outside of the 55-gallon container and on the pavement and equipment beneath the container. The inspectors also observed an approximately 2.5-foot piece of piping that was plugged with F002 hazardous waste on the pavement in this area (Photo 2). Facility personnel explained that the piping was removed yesterday, because they experienced an issue that caused the piping to become clogged with F002 hazardous waste.

**Photo 1:** One 55-gallon container in the PEKK Process Area SAA.

**Pursuant to ADEM Admin. Code r. 335-14-3-.01(5)(a)5. [40 C.F.R. § 265.15(a)(5)(ii)], which is a condition of the SAA Permit Exemption, a generator is required to mark or label its containers with an indication of the hazards of its contents.**

**Pursuant to ADEM Admin. Code r. 335-14-3-.01(5)(a)4. [40 C.F.R. § 265.15(a)(4)], which is a condition of the SAA Permit Exemption, a container holding hazardous waste must be closed at all times during accumulation, except: when adding, removing or consolidated waste; or when temporary venting of a container is necessary for the proper operation of equipment, or to prevent dangerous situations, such as build-up of extreme pressure.**

In an email dated November 20, 2024, Jonathan Allred provided Lanny Sasser, ADEM, and Laurie Benton DiGaetano, EPA, with photographs that he had taken on the day of the inspection. In addition to the photographs that were taken during the inspection tour of facility operations, Jonathan Allred also provided photographic evidence that the 55-gallon container in the PEKK/Distillation Area SAA had been identified with a DOT toxic hazard sticker (Photo D); that the lid on the container had been secured to close the container (Photo E); that the outside of the 55-gallon container and the pavement and equipment beneath the container had been cleaned to remove hazardous waste (Photo F); and that the 2.5-foot piece of piping had been cleaned to remove hazardous waste (Photo G).

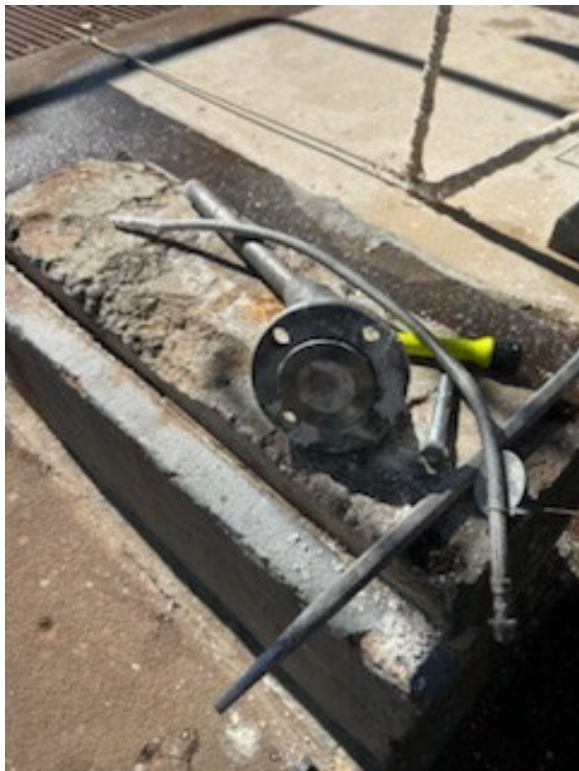
**Photo 2:** An approximately 2.5-foot piece of piping that is plugged with F002 hazardous waste on the pavement near the 55-gallon container in the PEKK Process Area SAA.

**Pursuant to ADEM Admin. Code r. 335-14-3-.01(7)(a)7. [40 C.F.R. § 262.17(a)(6)], which incorporates ADEM Admin. Code r. 335-14-3-.14(2) [40 C.F.R. § 262.251] and is a condition of the LQG Permit Exemption, a generator is required to maintain and operate its facility to minimize the possibility of a fire, explosion, or any unplanned sudden or non-sudden release of hazardous waste or hazardous waste constituents to air, soil, or surface water which could threaten human health or the environment.**

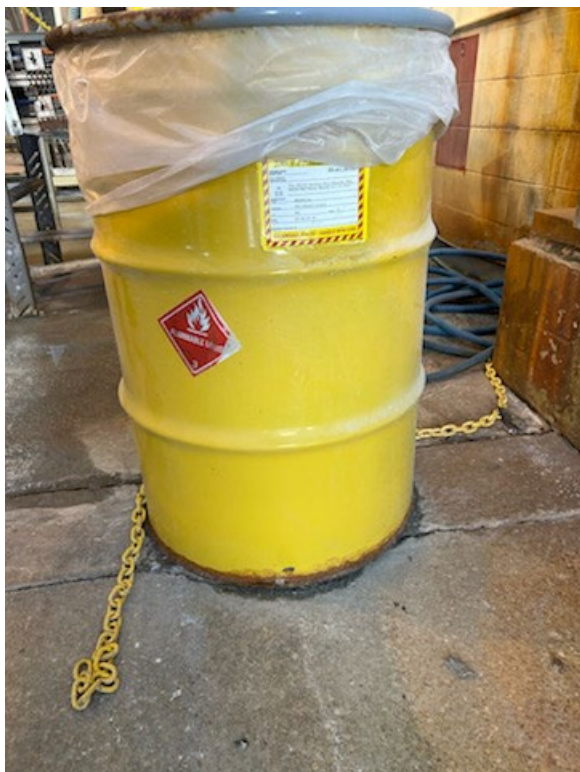
Arkema has identified two SAAs in the PA Process Area for managing D001, D035, F005 hazardous waste ink containers and wipes containing methyl ethyl ketone (MEK) and ethanol that is generated when packaging products for shipment. The inspectors observed one 55-gallon container in each SAA. The first container, which was located in the Phase 0 SAA, was closed; it was labeled with the words "Hazardous Waste;" and it was identified with a DOT flammable hazard sticker (Photo 3). The second container, which was located in the Phase 3 SAA, was also closed; it was labeled with the words "Hazardous Waste;" and it was identified with a DOT flammable hazard sticker. Pursuant to ADEM Admin. Code r. 335-14-2-.03(5)(b) [40 C.F.R. § 261.24(b)], D035 hazardous waste is a solid waste exhibiting the characteristic of

toxicity for MEK. Neither container was marked with an indication that its contents exhibit the hazardous waste characteristic of toxicity.

**Photo 3:** One 55-gallon container in the Phase 0 SAA at the PA Process Area.

**Pursuant to ADEM Admin. Code r. 335-14-3-.01(5)(a)5. [40 C.F.R. § 265.15(a)(5)(ii)], which is a condition of the SAA Permit Exemption, a generator is required to mark or label its containers with an indication of the hazards of its contents.**

In an email dated November 20, 2024, Jonathan Allred provided Lanny Sasser, ADEM, and Laurie Benton DiGaetano, EPA, with photographs that he had taken on the day of the inspection. In addition to the photographs that were taken during the inspection tour of facility operations, Jonathan Allred also provided photographic evidence that the 55-gallon container in the Phase 0 PA Process Area SAA had been marked with a DOT toxic hazard sticker (Photo H).

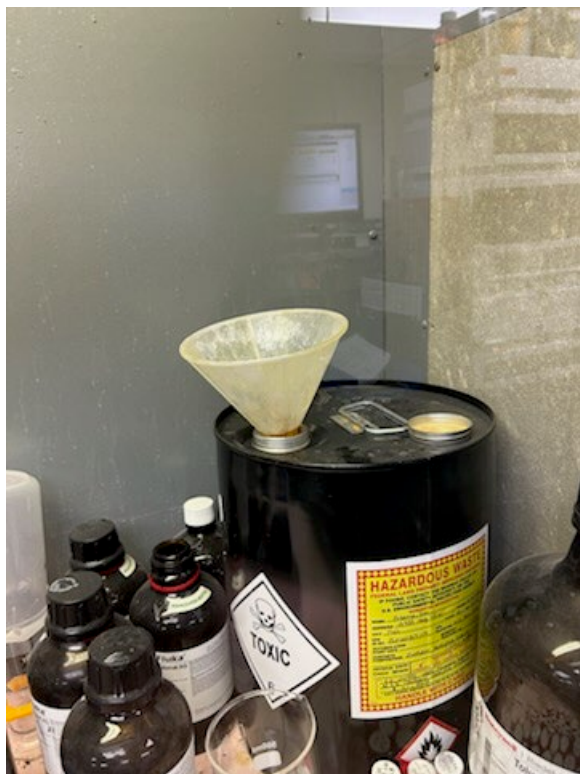
Arkema has identified SAAs in the laboratory for managing hazardous waste generated during the laboratory analysis procedures. The inspectors observed one 5-gallon container of D022 hazardous waste under fume hood EX-601-06 (Photo 4); and one 5-gallon container of HPLC hazardous waste and one 1-liter container of hazardous waste sulfuric acid/methanol mixture under fume hood EX-601-02. The 5-gallon container of D022 hazardous waste, which was open, was labeled with the words “Hazardous Waste” and identified with a DOT toxic hazard sticker. Facility personnel immediately closed the container. The 5-gallon container of HPLC hazardous waste, which was closed, was labeled with the words “Hazardous Waste,” and identified with DOT toxic and flammable hazard stickers. The 1-liter container of hazardous waste sulfuric acid/methanol mixture, which was closed, was labeled with the words “Hazardous Waste,” and identified with a DOT toxic hazard indicator. The 1-liter container was also marked with an indication that its contents exhibit the hazardous waste characteristics of ignitability, toxicity, and corrosivity.

**Photo 4:** One 5-gallon container of D022 hazardous waste under fume hood EX-601-06 in the Laboratory SAA.

**Pursuant to ADEM Admin. Code r. 335-14-3-.01(5)(a)4. [40 C.F.R. § 265.15(a)(4)], which is a condition of the SAA Permit Exemption, a container holding hazardous waste must be closed at all times during accumulation, except: when adding, removing or consolidated waste; or when temporary venting of a container is necessary for the proper operation of equipment, or to prevent dangerous situations, such as build-up of extreme pressure.**

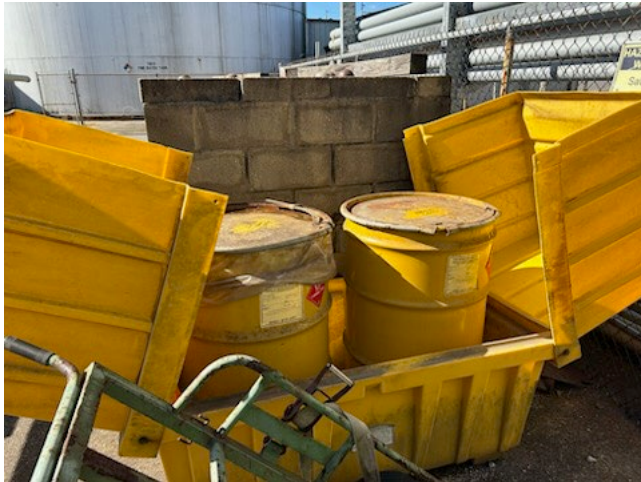
Arkema has identified one SAA in the Maintenance Area for managing hazardous waste aerosol cans and hazardous waste adhesives. The inspectors observed two 55-gallon containers inside a clam-shell-type storage unit at this SAA (Photo 5). Generators may manage more than one container in the same SAA, but the SAA Permit Exemption limits the total volume of waste accumulated in a SAA to be no more than 55-gallons. Although the total capacity of these containers exceeds the 55-gallon limit for a SAA, the volume of waste inside the containers appeared to be less than 55-gallons at the time of the inspection. The first drum was labeled as D001 hazardous waste adhesive containing flammable liquid, and it was identified with a DOT flammable hazard sticker. The second drum was labeled as D001, D035 hazardous waste aerosol cans, and it was identified with a DOT flammable hazard sticker. The second drum was

not marked with an indication that its contents also exhibit the hazardous waste characteristic of toxicity.

**Photo 5:** Two 55-gallon containers inside a clam-shell-type storage unit at the Maintenance Area SAA.

**Pursuant to ADEM Admin. Code r. 335-14-3-.01(5)(a)5. [40 C.F.R. § 265.15(a)(5)(ii)], which is a condition of the SAA Permit Exemption, a generator is required to mark or label its containers with an indication of the hazards of its contents.**

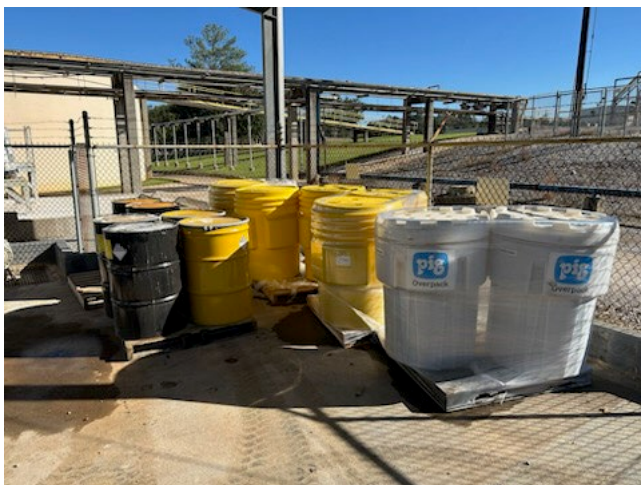
The inspectors observed six wooden pallets holding containers of hazardous waste in the CAA (Photo 7):

- Pallet 01 - two 55-gallon containers: one container of F002 hazardous waste solid, n.o.s. dichlorobenzene, was labeled with the words “Hazardous Waste,” marked with the EPA waste code F002, marked with an accumulation start date of November 11, 2024, and identified with a Class 9 DOT hazard sticker; and one container of F002 hazardous waste environmental hazardous substance orthodichlorobenzene, was labeled with the words “Hazardous Waste,” marked with an accumulation start date of November 11, 2024, and identified with a Class 9 DOT hazard sticker. The second container was not marked with the EPA waste code associated with its contents.

- Pallet 02 – four 55-gallon containers of F002 hazardous waste generated by the WFE: each container was labeled with the words “Hazardous Waste;” three of the four containers were marked with an accumulation start date of November 11, 2024; the fourth container was marked with an accumulation start date of November 14, 2024; each container was identified with a DOT Class 9 hazard sticker; and none of the containers were marked with the EPA hazardous waste number(s) associated with its contents.

- Pallet 03 – Two overpacks of D002, D003 hazardous waste Isophthaloyl chloride (ICL), which were shrink wrapped together: each container was labeled with the words “Hazardous Waste,” and marked with an accumulation start date of November 9, 2024. Pursuant to ADEM Admin. Code r. 335-14-2-.03(3)(b) and r. 335-14-2-.03(4)(b) [40 C.F.R. §§ 261.22(b) and 261.23(b)], a D002 hazardous waste is a solid waste exhibiting the characteristic of corrosivity and a D003 hazardous waste is a solid waste exhibiting the characteristic of reactivity, respectively. Neither container was marked with an indication that its contents exhibit the hazardous waste characteristics of corrosivity or reactivity, and neither container was marked with the EPA hazardous waste number(s) associated with its contents.

- Pallet 04 – Two overpacks of D002, D003 hazardous waste ICL: the first container was labeled with the words “Hazardous Waste,” and marked with an accumulation start date of November 11, 2024; and the second container was not labeled with the words “Hazardous Waste,” or marked with accumulation start date. Neither container was

marked with an indication that its contents exhibit the hazardous waste characteristics of corrosivity or reactivity, and neither container was marked with the EPA hazardous waste number(s) associated with its contents.

- Pallet 05 – Two overpacks, which shrink wrapped together: one container of D002 hazardous waste corrosive liquid (hydrochloric acid, terephthaloyl chloride) was labeled with the words “Hazardous Waste,” marked with an accumulation start date of November 9, 2024, and marked with the EPA hazardous waste number D002, but it was not marked with an indication of the hazards of its contents; one container of D002, D003 hazardous waste ICL was labeled with the words “Hazardous Waste” and marked with an accumulation start date of November 11, 2024, but it was not marked with an indication that its contents exhibit the hazardous waste characteristic of corrosivity or the hazardous waste characteristic of reactivity, or with the EPA hazardous waste number(s) associated with its contents.

- Pallet 06 – Two overpacks of D002, D003 hazardous waste ICL, which were shrink wrapped together: the first container was labeled with the words “Hazardous Waste” and marked with an accumulation start date of November 11, 2024; and the second container was not labeled with the words “Hazardous Waste” or marked with an accumulation start date. Neither container was marked with an indication that its contents exhibit the hazardous waste characteristics of corrosivity or reactivity, and neither container was marked with the EPA hazardous waste number(s) associated with its contents.

**Photo 7:** Six wooden pallets holding containers of hazardous waste in the CAA.

**Pursuant to ADEM Admin. Code r. 335-14-3-.01(7)(a)5.(i) [40 C.F.R. § 265.17(a)(5)(i)], which is a condition of the LQG Permit Exemption, a generator must mark or label its containers with the following: the words “Hazardous Waste”; an indication of the hazards of its contents; the date upon which each period of accumulation begins clearly visible for inspection on each container; and all appropriate EPA hazardous waste numbers associated with the hazardous waste.**

In an email dated November 20, 2024, Jonathan Allred provided Lanny Sasser, ADEM, and Laurie Benton DiGaetano, USEPA, with photographs that he had taken on the day of the inspection. In addition to the photographs that were taken during the inspection tour of facility operations, Jonathan Allred also provided photographic evidence that the unlabeled container on Pallet 04 had been labeled with the words “Hazardous Waste,” marked with an accumulation start date of October 1, 2024, marked with the EPA hazardous waste numbers D002 and D003, and marked with an indication that its contents exhibit the hazardous waste characteristic of corrosivity and the hazardous waste characteristic of reactivity (Photo A); that the container of F002 hazardous waste environmental hazardous substance orthodichlorobenzene on Pallet 01 had been marked with an indication that its contents are toxic (Photo B); and that DOT corrosive hazard stickers had been added to overpack containers on Pallets 04, 05, and 06 to indicate that the contents exhibit the hazardous waste characteristic of corrosivity (Photo C).

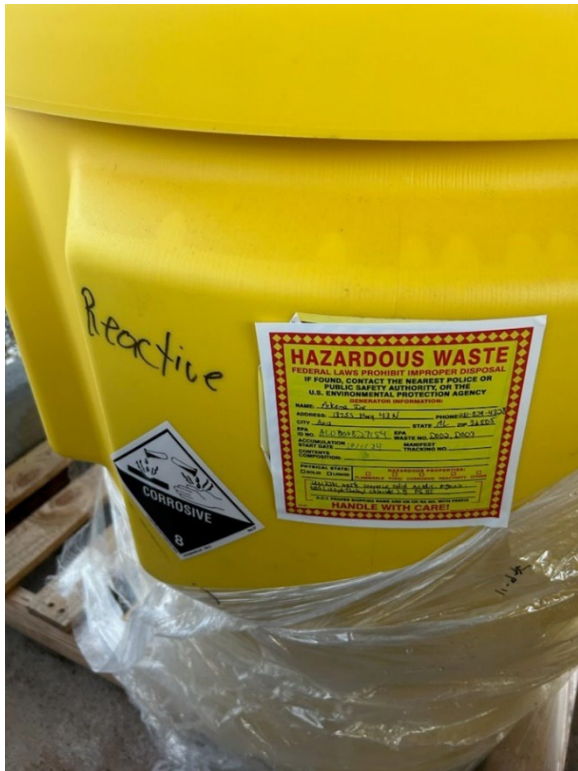
**Photo A:** Following the inspection tour of facility operations, the unlabeled container on Pallet 04 in the CAA was labeled with the words “Hazardous Waste,” marked with an accumulation start date of October 1, 2024, marked with the EPA hazardous waste numbers D002 and D003, and marked with an indication that its contents exhibit the hazardous waste characteristics of corrosivity and reactivity.

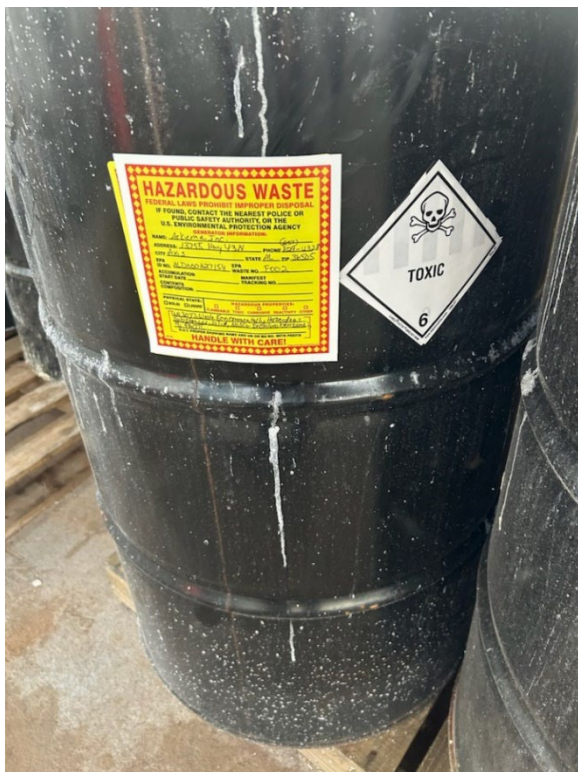
**Photo B:** Following the inspection tour of facility operations, a DOT toxic hazard sticker was added to the container of F002 hazardous waste environmental hazardous substance that was observed on Pallet 01 in the CAA.

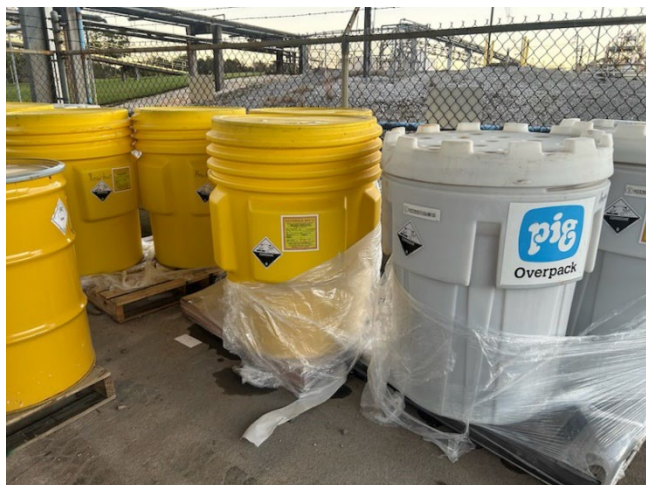
**Photo C:** Following the inspection tour of facility operations, DOT corrosive hazard stickers were added to overpack containers that were observed on Pallets 04, 05, and 06 in the CAA.

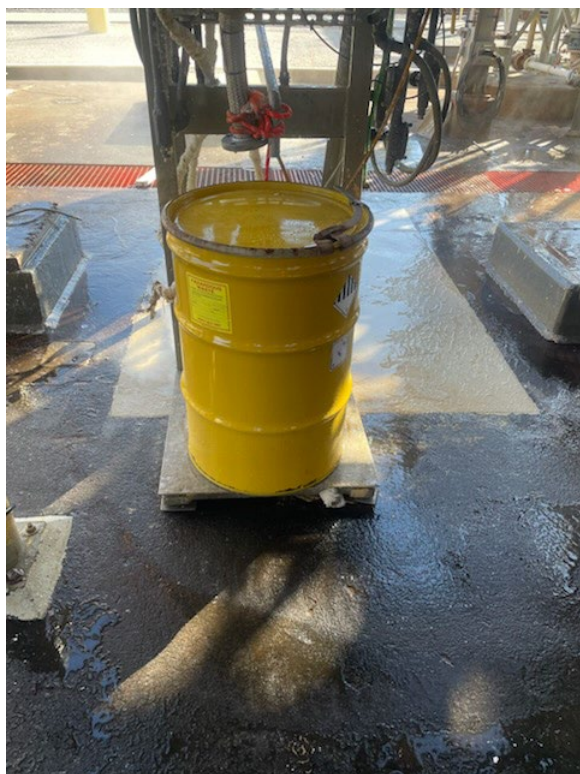
**Photo D:** Following the inspection tour of facility operations, the DOT toxic hazard sticker was added to the 55-gallon container in the Distillation Area SAA.

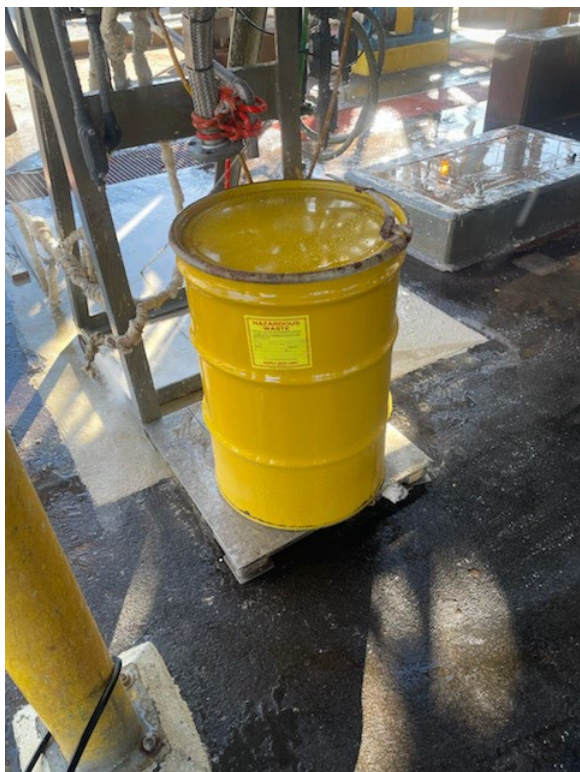
**Photo E:** Following the inspection tour of facility operations, the lid on the 55-gallon container in the Distillation Area SAA was secured to close the container.

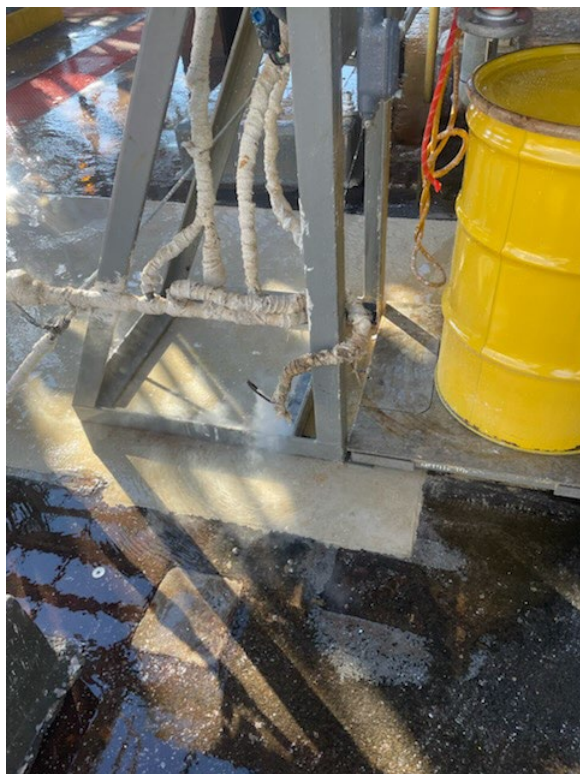
**Photo F:** Following the inspection tour of facility operations, the outside of the 55-gallon container in the Distillation Area SAA and the pavement and equipment below the container was cleaned to remove hazardous waste.

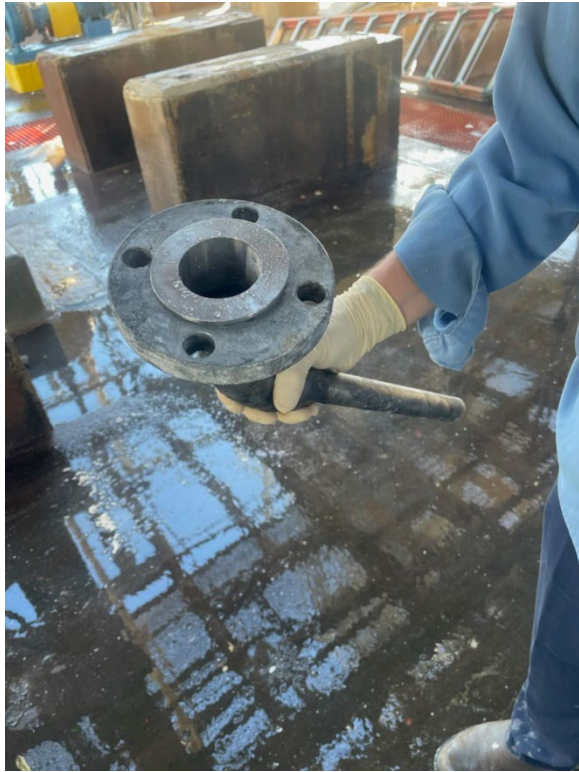
**Photo G:** Following the inspection tour of facility operations, the 2.5-foot piece of piping in the Distillation Area SAA was cleaned to remove hazardous waste.

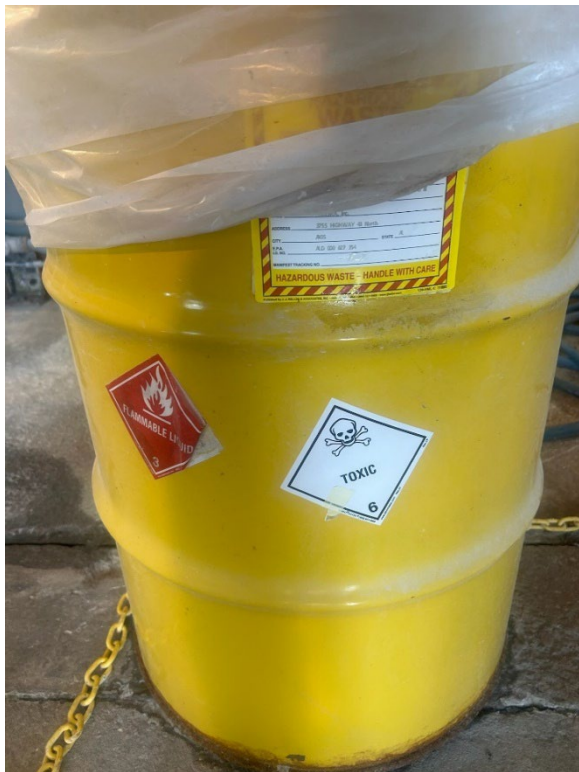
**Photo H:** Following the inspection tour of facility operations, a DOT toxic hazard sticker was added to the 55-gallon container in the Phase 0 PA Process Area SAA.
