## RCRA Compliance Branch INSPECTION REPORT

| <b>Facility or Site Name:</b> | Atlas Environmental Lab | |

### SECTION I – INTRODUCTION

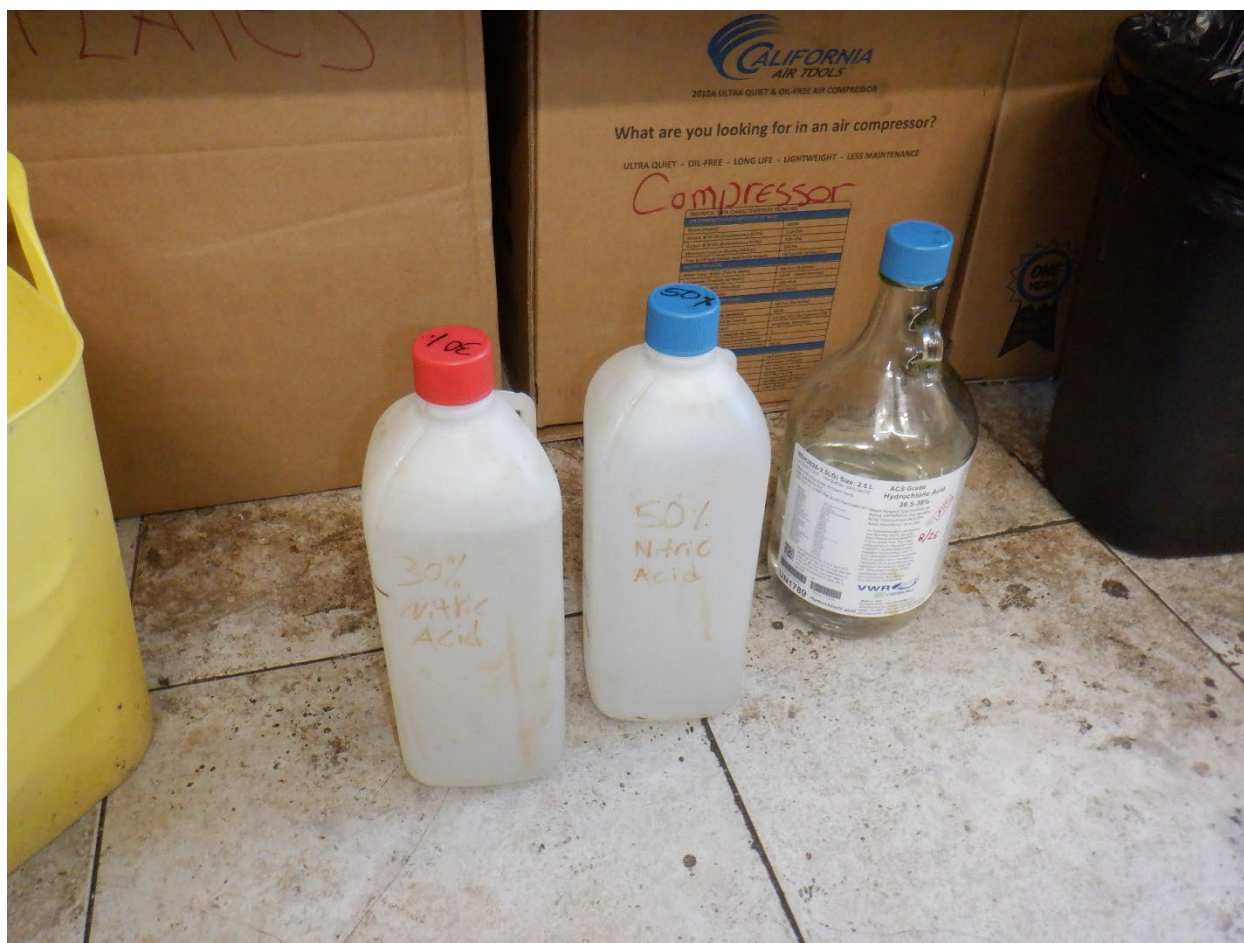
Mrs. Darvish explained that this area is used to conduct lead tests. The facility receives samples from its clients for the lead test and then use the machine to read the lead test results. At the time of the inspection, there were two machines that read the lead test results. The machines were connected to a pipe that was vented to the outside. In the lead acid prep area, there was also a fume hood that contained jars that were going to be tested for the lead test. On the floor nearby the fume hood there were three 1-liter bottles on the floor, as shown in figure 1. One bottle

contained 30% nitric acid, another bottle contained 50% nitric acid, and the last bottle contained Hydrochloric Acid. On the side of the fume hood there were two 1 quarter bottles of hydrogen peroxide and ethanol, as shown in figure 2.

(Figure 1: three 1-liter bottles on the floor of 30 % nitric acid, 50% nitric acid and Hydrochloric acid)

1. In case of an emergency, it would be recommended to have an emergency plan.
2. Recommended to take RCRA training on how to properly determine hazardous waste.
3. Bottles of different acids were stored closely adjacent to each other, and it is recommended that the acids be placed in separate secondary containment from each other.

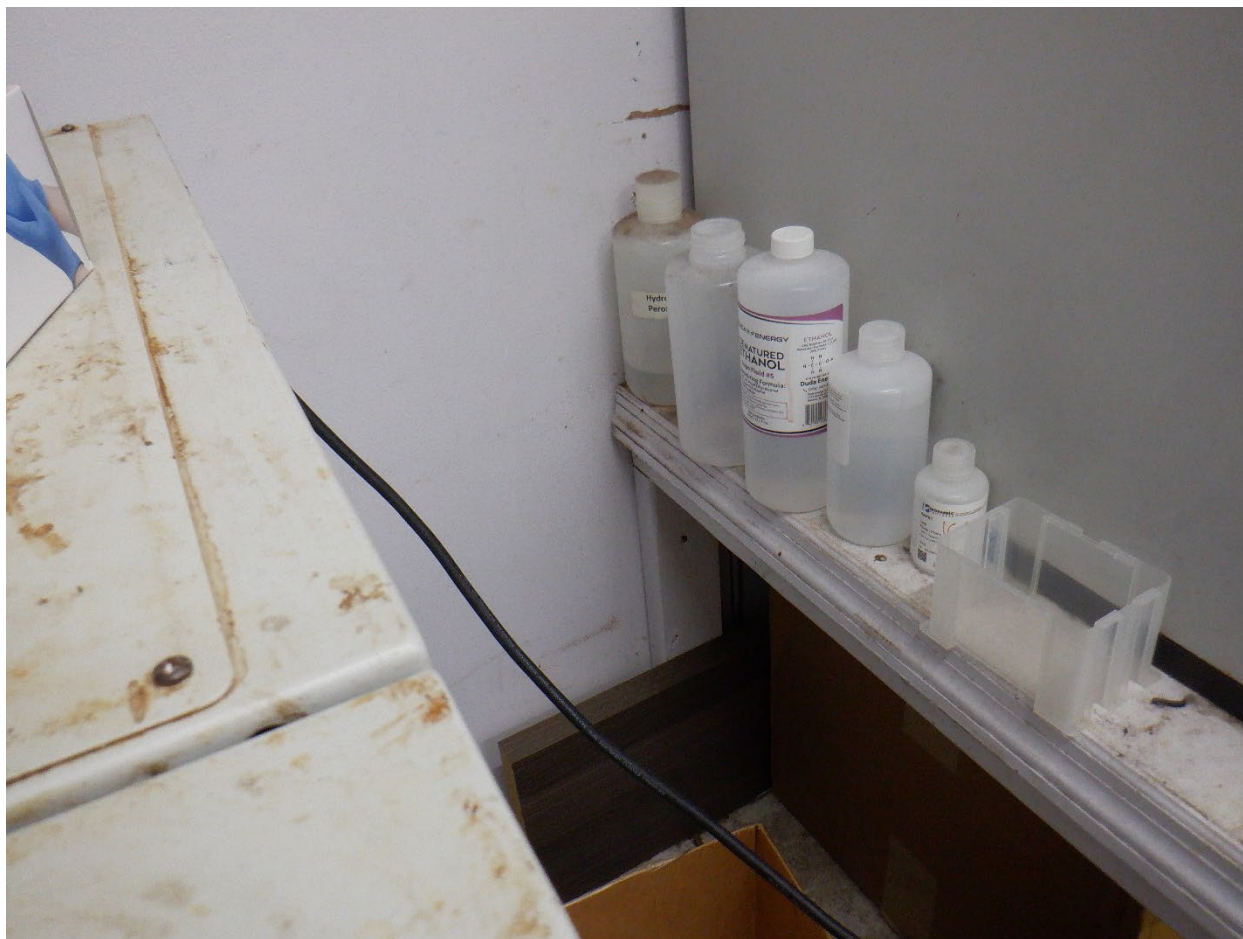
(Figure 2: three ½ liter bottles on the side of the fume hood floor of hydrogen peroxide, ethanol and two bottles that are not clear.)
