## **RCRA Inspection Report**

Noven Pharmaceuticals  
11960 SW 144<sup>th</sup> St  
Miami, FL 33186

EPA ID # FL0000545921  
NAICS # 325412 –  
Pharmaceutical Preparation  
Manufacturing

January 25, 2024

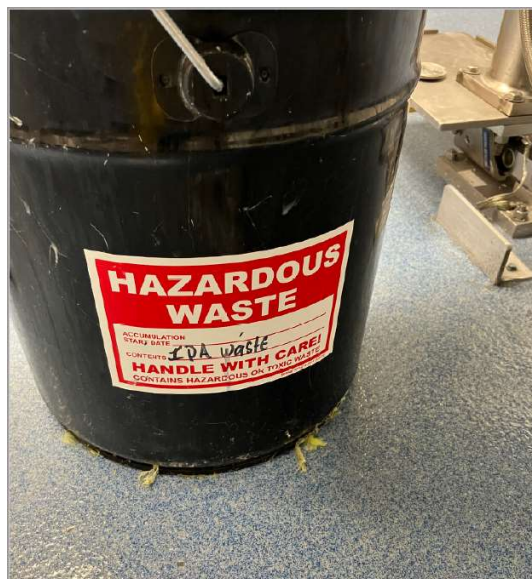
Blending Room – is used to blend the active ingredients. At the time of the inspection, Edwardo Cuevas was cleaning the blending machine, using isopropyl alcohol (IPA). The spent solvent was collected in a 5-gallon container labeled as "hazardous waste" and transferred to a 55-gallon container located in the Cleaning Room 105. The 5-gallon container was not labeled with the

indication of the hazard of the content. Photo #1. One 25-gallon container for solvent contaminated materials generated from the cleaning process was also observed in this room. The container was labeled as "Non-hazardous waste". However, an alcohol like odor came out from the container. Copy of the waste profile was received by email on February 9, 2024, therefore the waste qualifies for the excluded solvent contaminated wipes and the facility should label all corresponding waste containers with the words "Excluded solvent contaminated wipes". Photo #2.

Photo #1 -Bldg #2: Blending Room: A 5-gallon container not labeled with the indication of the hazard of the content.

**Pursuant to Fla. Admin. Code Ann. R. 62-730.160(1) [40 C.F.R. §262.15(a)(5)(ii)], which is a condition of the SAA permit exemption, a generator must mark or label its container with the following: (ii) an indication of the hazards of the contents (examples include, but are not limited to, the applicable hazardous waste characteristic(s) (i.e., ignitable, corrosive, reactive, toxic); hazard communication consistent with the Department of Transportation requirements at 49 CFR part 172 subpart E (labeling) or subpart F (placarding); a hazard statement or pictogram consistent with the Occupational Safety and Health Administration Hazard Communication Standard at 29 CFR 1910.1200; or a chemical hazard label consistent with the National Fire Protection Association code 704).**

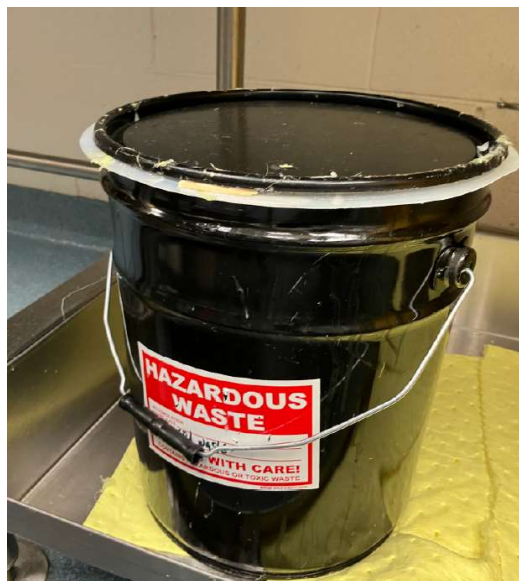
One closed (5)-gallon container (under the sink) with IPA waste, labeled as hazardous waste. The container was not marked with the indication of the hazards of the contents. Photo #3.

Photo #3 – Bldg #2: Cleaning Room: A 5-gallon container (under the sink) not labeled with the indication of the hazard of the content.

**Pursuant to Fla. Admin. Code Ann. R. 62-730.160(1) [40 C.F.R. §262.15(a)(5)(ii)], which is a condition of the SAA permit exemption, a generator must mark or label its container with the following: (ii) an indication of the hazards of the contents (examples include, but are not limited to, the applicable hazardous waste characteristic(s) (i.e., ignitable, corrosive, reactive, toxic); hazard communication consistent with the Department of Transportation requirements at 49 CFR part 172 subpart E (labeling) or subpart F (placarding); a hazard statement or pictogram consistent with the Occupational Safety and Health Administration Hazard Communication Standard at 29 CFR 1910.1200; or a chemical hazard label consistent**

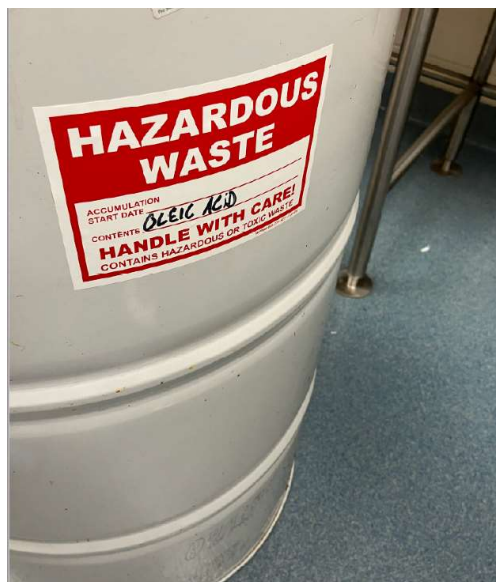
One closed (55)-gallon container with oleic acid (from the blending machine), labeled as hazardous waste. The container was not marked with the indication of the hazards of the contents. Photo #4.

Photo #4 – Bldg #2: Cleaning Room: A (55)-gallon container. The container was not marked with the indication of the hazard of the content.

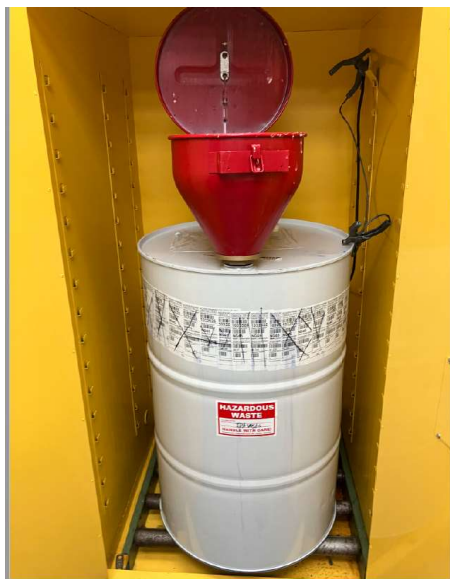
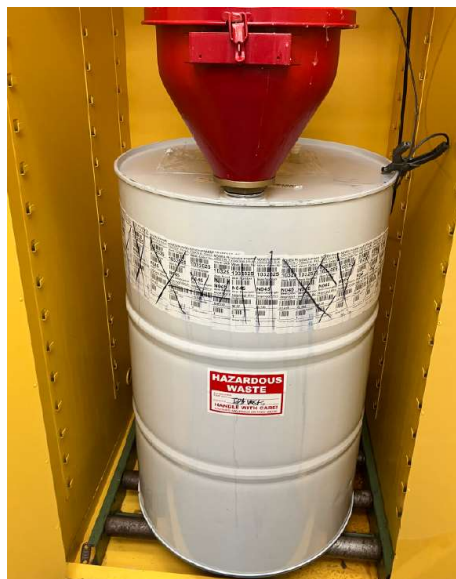
One (55)-gallon container with IPA waste, opened funnel, labeled as "hazardous waste". The container was not marked with the indication of the hazards of the contents. The container was closed at the time of the inspection. Photo #5.

Photo #5 – Bldg #2: Cleaning Room: A (55)-gallon container with IPA waste, opened funnel. The container was not marked with the indication of the hazard of the content.

**Pursuant to Fla. Admin. Code Ann. R. 62-730.160(1) [40 C.F.R. § 262.15(a)(4)], which is a condition of the SAA permit exemption, a container holding hazardous waste must be closed at all times during accumulation, except: (i) When adding, removing, or consolidating waste; or (ii) when temporary venting of a container is necessary.**

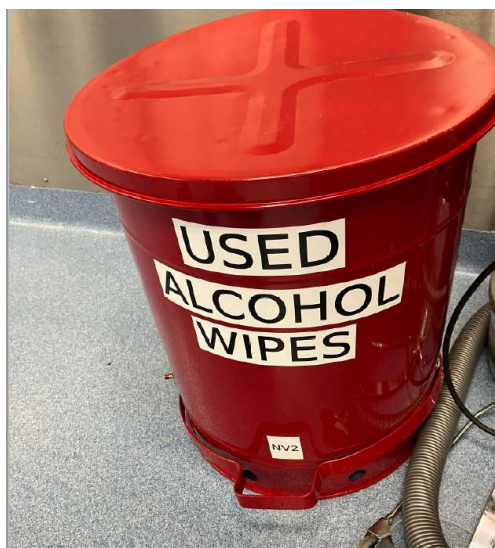
Room 123-Seal/Packing Station – The machine uses a laser to put the lab number and date. Machines are cleaned with IPA which generates alcohol contaminated wipes. One closed (15)-gallon container labeled with the words “Used Alcohol Wipes” was observed at the time of the inspection. The container was empty. Photo #6.

Photo #6 – Bldg. #2 Cleaning Room: A (10)-gallon container used to store “alcohol wipes”.

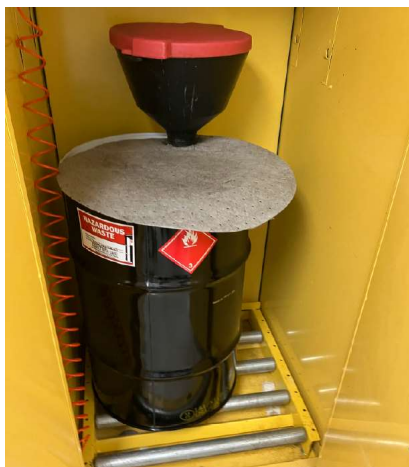
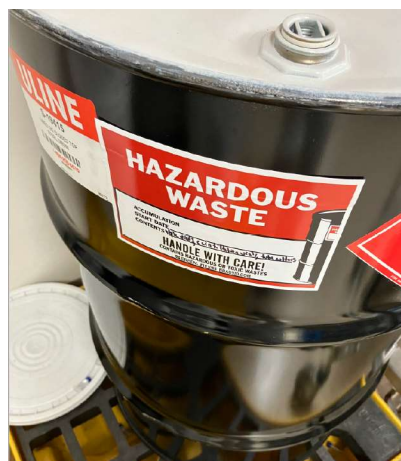
Photo #7 – Bldg. #2 QC Laboratory

Two (55)-gallon containers (one for liquid and one for solid) were observed closed, labeled as “hazardous waste”, and with the indication of the hazard of the content (flammable). Photo #7.

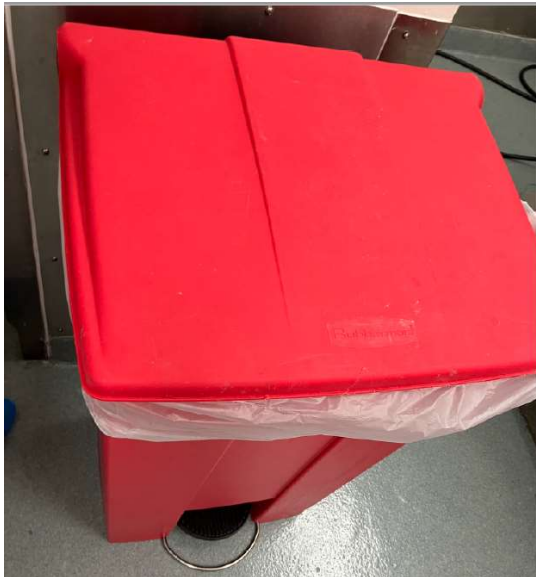
Blending Rooms – There are three blending rooms that follow the same process as Building #2 but for controlled substances. One closed (20)-gallon container with gloves/IPA waste was observed without label. Photo #11.

Photo #11 – Bldg. #3 Blending Room: A (20)-gallon

**Pursuant to Fla. Admin. Code Ann. R. 62-730.160(1) [40 C.F.R. §262.15(a)(5)(i)(ii)], which is a condition of the SAA permit exemption, a generator must mark or label its container with the following: (i) the words “Hazardous Waste”, and (ii) an indication of the hazards of the contents (examples include, but are not limited to, the applicable hazardous waste characteristic(s) (i.e., ignitable, corrosive, reactive, toxic); hazard communication consistent with the Department of Transportation requirements at 49 CFR part 172 subpart E (labeling) or subpart F (placarding); a hazard statement or pictogram consistent with the Occupational Safety and Health Administration Hazard Communication Standard at 29 CFR 1910.1200; or a chemical hazard label consistent with the National Fire Protection Association code 704).**

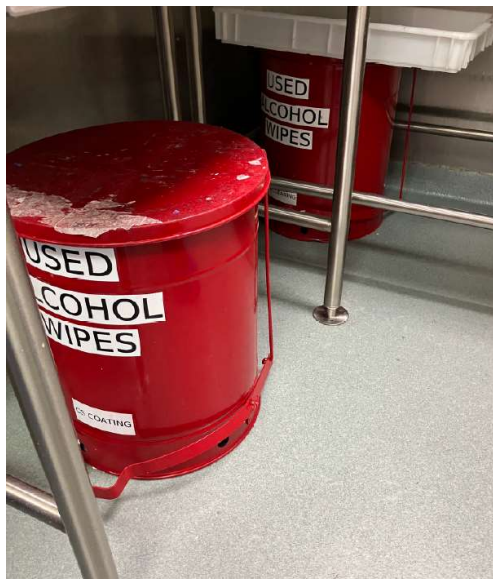
Two closed (15)-gallon containers labeled as “Used Alcohol Wipes”. Photo #12.

Photo #12 – Bldg. #3 Cleaning Room: Containers with alcohol wipes

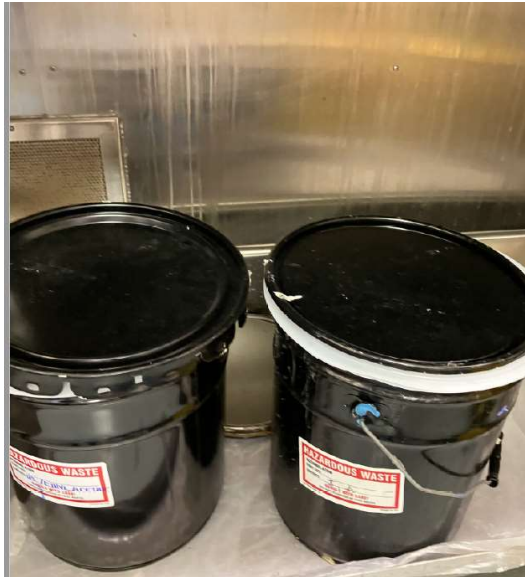
Two (5)-gallon containers with IPA ethyl acetate waste, labeled as “hazardous waste”. The container was not labeled with the indication of the hazards of the contents. Photo #13.

Photo #13 – Bldg. #3 Cleaning Room: Two (5)-gallon containers with IPA ethyl acetate waste

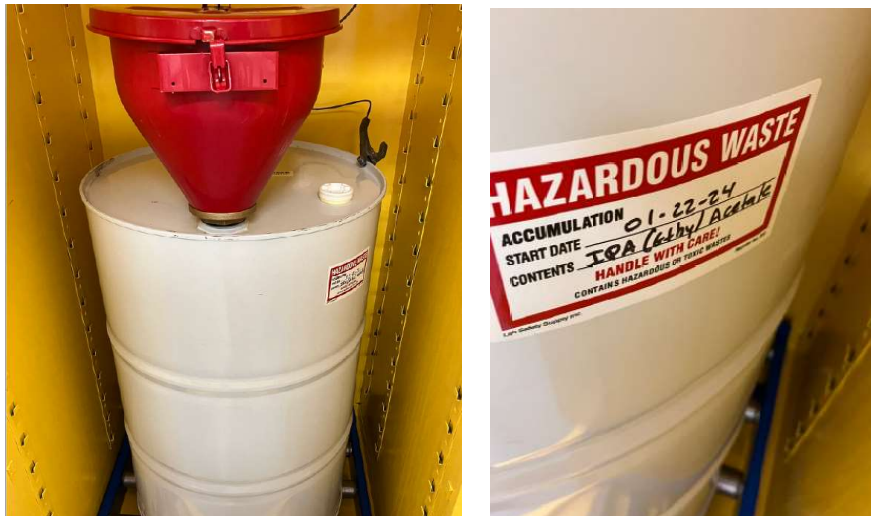
One (55)-gallon container with IPA ethyl acetate waste, with funnel, labeled as “hazardous waste”. The container was not labeled with the indications of the hazard of the contents. The container was dated January 22, 2024. Inspectors were informed that the drum was being relocated to the CAA by the end of the day. Photo #14.

Photo #14 – Bldg. #3 Cleaning Room: One (55)-gallon container with IPA ethyl acetate waste

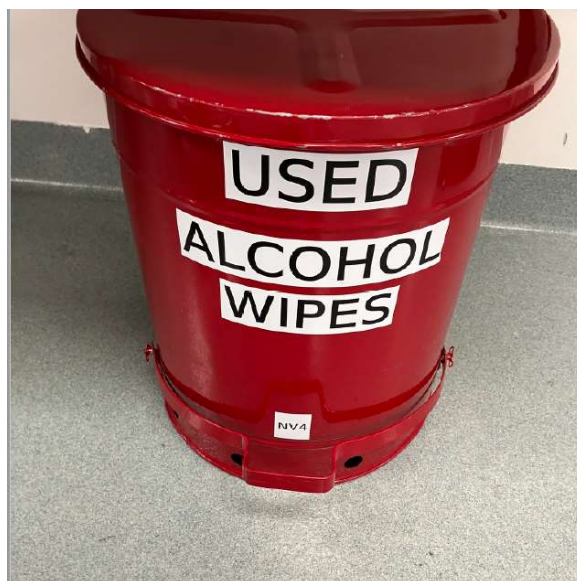
One closed (5)-gallon empty container used to store alcohol wipes. The container was not labeled with the words “hazardous waste” and not marked with the indication of the hazard of the content. Photo #15.

Photo #15 – Bldg. #3 Cleaning Room: Containers with alcohol wipes

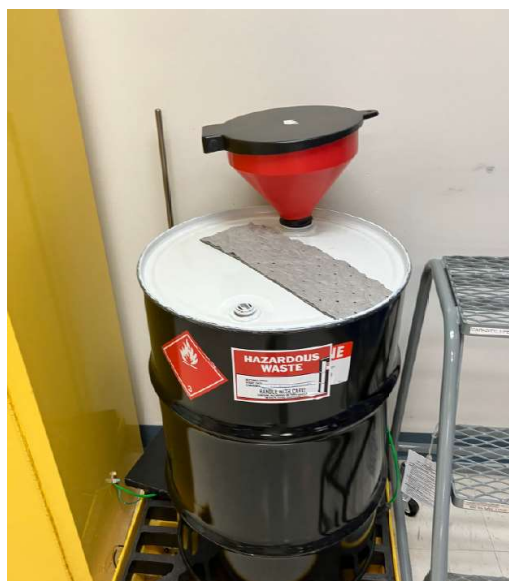
One (35)-gallon container with a funnel, used to store vials/tubes, was observed closed, labeled as “hazardous waste”, and with the indication of the hazards of the contents (flammable). Photo #16.

Photo #16 – Bldg. #3 QC Laboratory: A (35)-gallon container

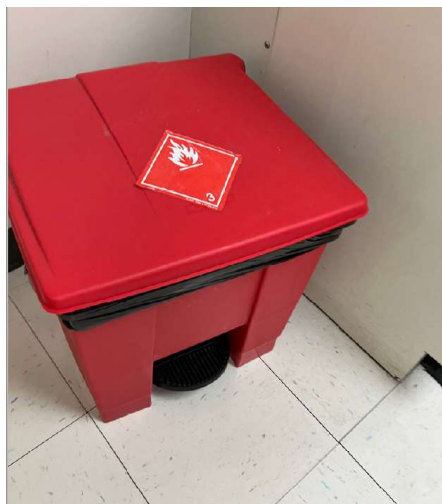
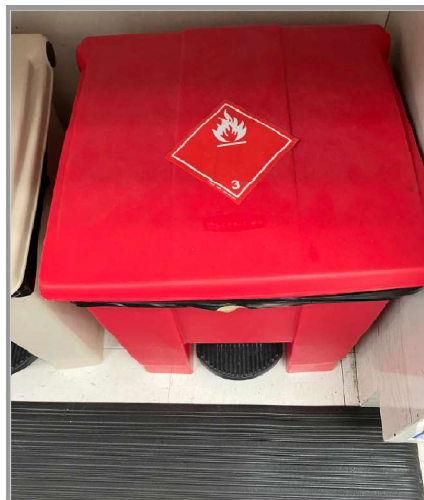
Photo #17 – Bldg. #3 QC Laboratory:

Several containers or bottles of different sizes (ranging from one liter to three gallons) were observed connected to the HPLC machines. Except for one container, these containers were closed, labeled with the words “hazardous waste” and with the indication of the hazards of the contents (flammable). Photo #17.

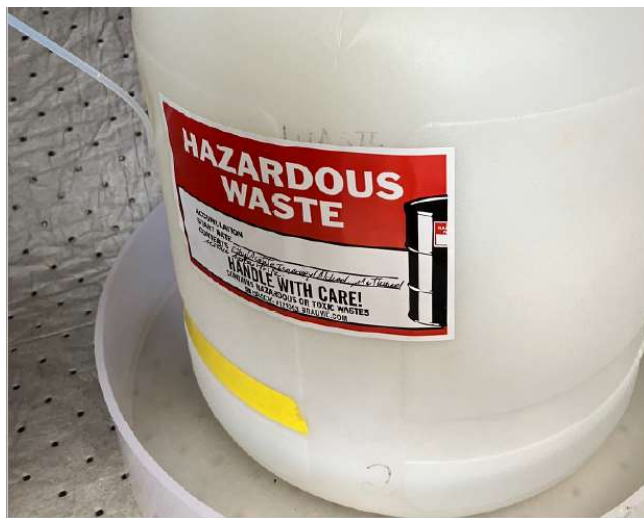
One (3)-gallon container labeled as methanol/acetone/ethyl acetate, etc. was not marked with the indication of the hazards of the contents. Photo #18.

Photo #18 – Bldg. #3 QC Laboratory: – A (3)-Gallon container

**Pursuant to Fla. Admin. Code Ann. R. 62-730.160(1) [40 C.F.R. §262.15(a)(5)(i)(ii)], which is a condition of the SAA permit exemption, a generator must mark or label its container with the following: (i) the words “Hazardous Waste”, and (ii) an indication of the hazards of the contents (examples include, but are not limited to, the applicable hazardous waste characteristic(s) (i.e., ignitable, corrosive, reactive, toxic); hazard communication consistent with the Department of Transportation requirements at 49 CFR part 172 subpart E (labeling) or subpart F (placarding); a hazard statement or pictogram consistent with the Occupational Safety and Health Administration Hazard Communication Standard at 29 CFR 1910.1200; or a chemical hazard label consistent with the National Fire Protection Association code 704).**

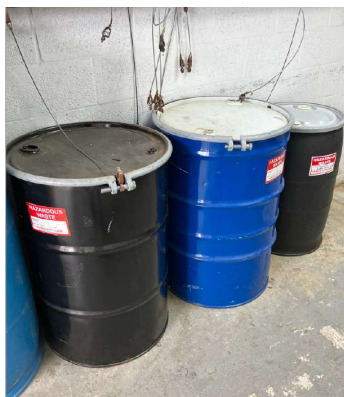
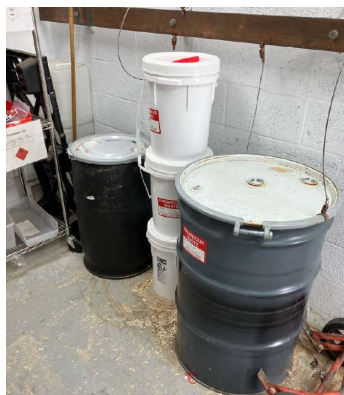
Photo #19 – Central Accumulation Area

The inspectors visited the 90 day CAA that is located behind Building #3. Christian Jinete, Inventory Control Analyst of Noven, joined the inspection team during the inspection. The area was identified with the words “Hazardous Waste Storage Area”, “Restricted Entry”, “No Smoking Sign”, land line phone, list of phone numbers, and the National Fire Protection Association code 704 at the entrance. The “No Smoking” label was faded, but it was replaced by a new one. There was adequate aisle space between sections. Eight (8) containers with hazardous waste material were observed in this area. The containers were observed closed, labeled with the words “hazardous waste”, and dated. The oldest accumulation start date was December 2023. However, these containers were not marked with the indication of the hazards of the contents. Photos #19 and #20.

**Pursuant to Fla. Admin. Code Ann. R. 62-730.160(1) [40 C.F.R. §262.15(a)(5)(ii)], which is a**

condition of the SAA permit exemption, a generator must mark or label its container with the following: (ii) an indication of the hazards of the contents (examples include, but are not limited to, the applicable hazardous waste characteristic(s) (i.e., ignitable, corrosive, reactive, toxic); hazard communication consistent with the Department of Transportation requirements at 49 CFR part 172 subpart E (labeling) or subpart F (placarding); a hazard statement or pictogram consistent with the Occupational Safety and Health Administration Hazard Communication Standard at 29 CFR 1910.1200; or a chemical hazard label consistent with the National Fire Protection Association code 704).

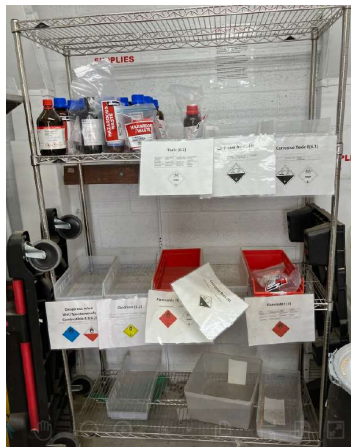
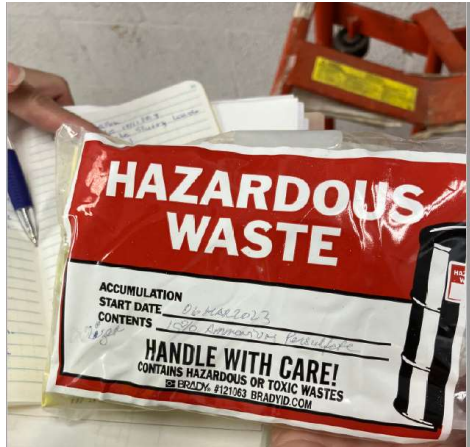
Lab Pack - Small bottles of different sizes were observed in separate bins, labeled with the words "hazardous waste", dated, and with the indication of the hazards of the contents. The oldest date accumulation start date was March 6, 2023. An email with a manifest (Lab Pack disposal) was received on February 13, 2024. Photos #21 and #22.

Photo #21 – Central Accumulation Area (Lab Pack)

**Pursuant to F.A.C. Chapter 62-730.160(1) [40 C.F.R. § 262.17(a)], which is a condition of the LQG Permit Exemption, a large quantity generator may accumulate hazardous waste on site without a permit or interim status, and without complying with the requirements of parts 124, 264 through 267, and 270 of this chapter, or the notification requirements of section 3010 of RCRA, provided the following condition for exemption is met: A large quantity generator accumulates hazardous waste on site for no more than 90 days, unless in compliance with the accumulation time limit extension or F006 accumulation conditions for exemption in paragraphs (b) through (e) of this section.**

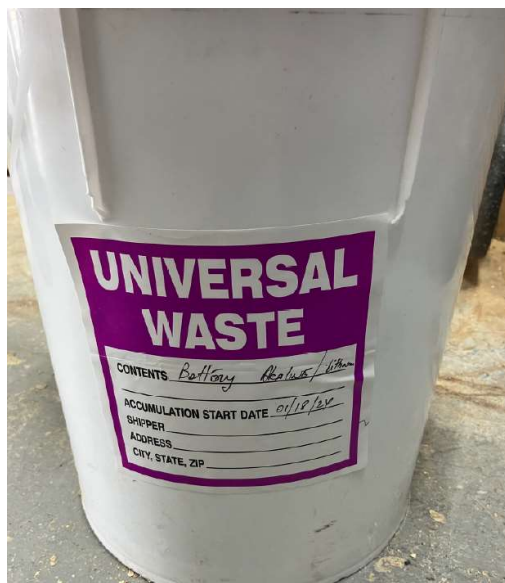
The facility generates universal waste batteries that are stored in the CAA. One closed (5)-gallon container with "universal waste" (batteries), dated January 18, 2024 was also observed at the time of the inspection. Photo #23.

Photo #23– Universal Waste Batteries
