## **RCRA Inspection Report**

U.S. Army Aviation Center of  
Excellence and Fort Novosel  
2218 6<sup>th</sup> Ave  
Fort Rucker, AL 36362

10:34 AM June 13, 2023

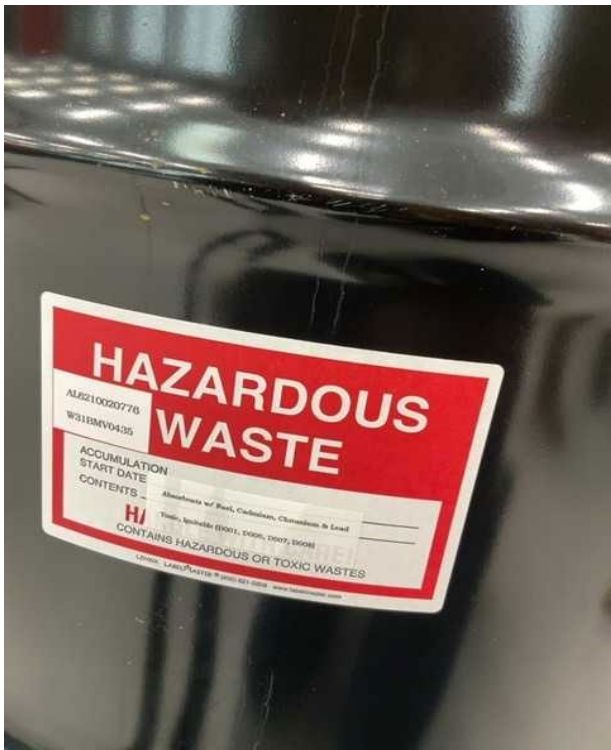
- One 55-gallon drum labeled “hazardous waste, absorbents with fuel, cadmium, chromium, lead, toxic, ignitable, D001, D006, D007, D008.” (Photo #1)
- One 55-gallon drum labeled “hazardous waste, solid paint waste, toxic, D006, D007, D035.” (Photo #2)

| | <p>Photo #1 – SAA container of absorbents with paint and fuel in the Aviation Maintenance Support Shop.</p> |

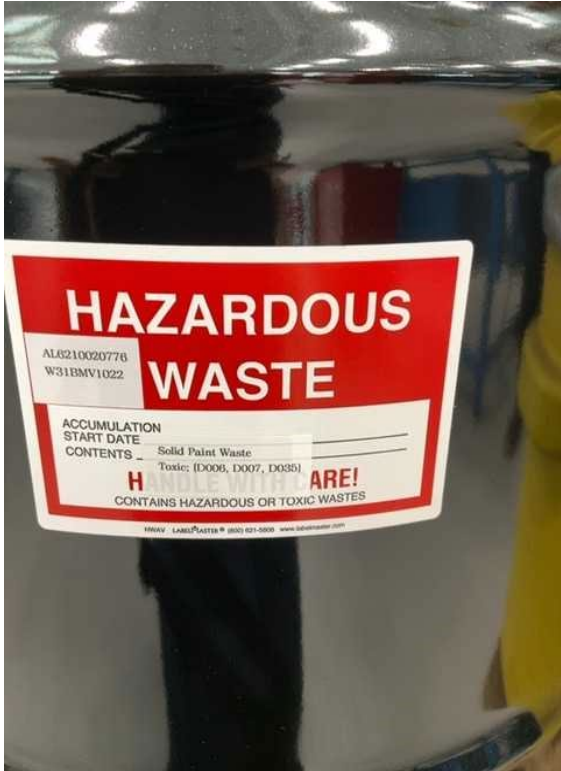
| | <p>Photo #1 – SAA container of solid paint waste in the Aviation Maintenance Support Shop.</p> |

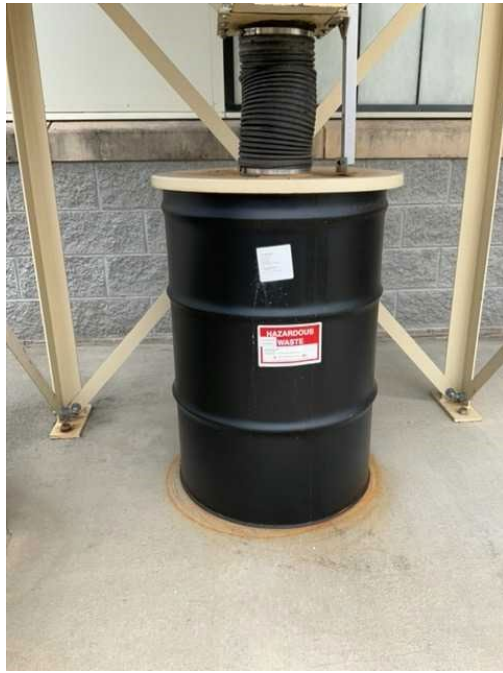
Parts are sand blasted with a plastic blast media in the Clean Shop for cleaning. Inspectors observed a 55-gallon drum connected to the bag house labeled “hazardous waste, blast media, toxic” (Photo #3).

Photo #3 – SAA container connected to the bag house in the Clean Shop.

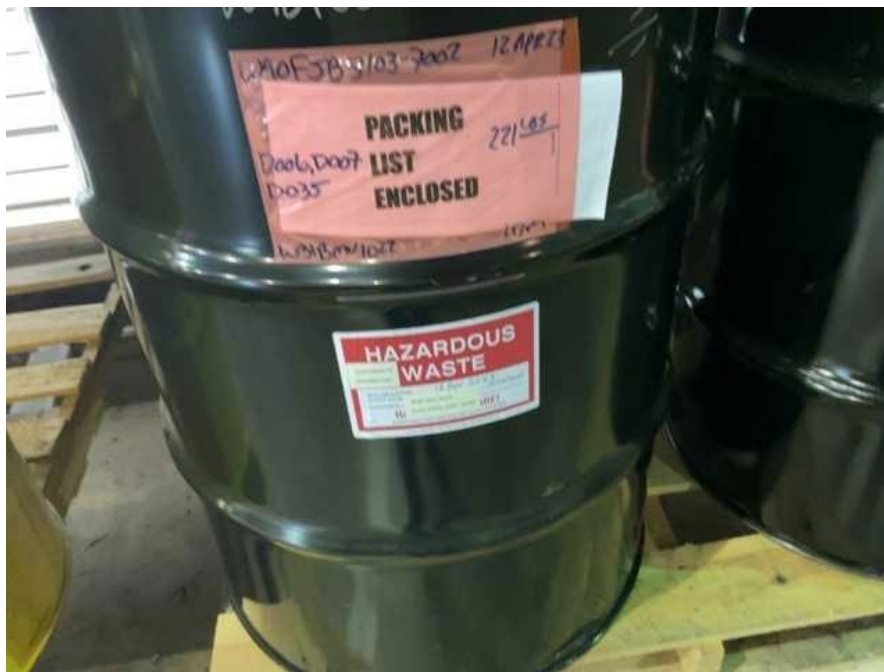
- Flammable Liquids (Photo #4):

- Five 5-gallon carboy containers labeled “hazardous waste, waste hydrocarbons, ignitable.”
- One 5-gallon drum labeled “hazardous waste, isopropyl alcohol, ignitable.”
- Two 10-gallon containers labeled “hazardous waste, waste liquid hydrocarbons, ignitable.”
- One 5-gallon container labeled “hazardous waste, carbon removing compound, corrosive.”
- One 55-gallon drum labeled “hazardous waste, paint thinner waste, toxic/ignitable.”
- One 55-gallon drum labeled “hazardous waste, alcohol, ignitable.”
- One 5-gallon drum labeled “hazardous waste, acetone, ignitable.”

- Two 5-gallon drums labeled “hazardous waste, waste liquid hydrocarbons, ignitable.”
- Three 5-gallon containers labeled “hazardous waste, naptha solvent, ignitable.”
- One 5-gallon drum labeled “hazardous waste, silicone/rubber, ignitable.”
- One 55-gallon drum labeled “hazardous waste, paint related material, toxic/ignitable.”
- One 30-gallon drum labeled “hazardous waste, naptha solvent, ignitable.”
- Sixteen 5-gallon containers labeled “hazardous waste, flammable liquid.”
- Two 10-gallon drums labeled “hazardous waste, flammable liquid.”
- Three 55-gallon drums labeled “hazardous waste, flammable liquid.”
- One 30-gallon drum labeled “hazardous waste, flammable liquid.”
- Three 55-gallon drums labeled “hazardous waste, flammable liquid.”

Photo #4 – Packing slip and hazardous waste label on waste containers in the Fort Novosel 90-day or loess accumulation area.

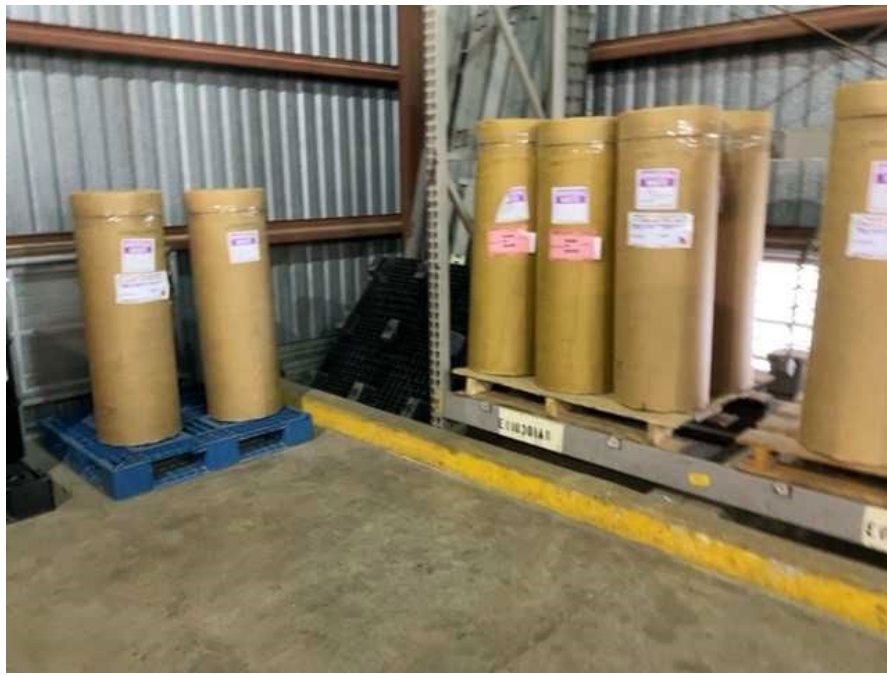
- Universal Waste (Photo #5):

- Two cardboard 4-foot cylinders labeled “universal waste fluorescent lamps.”
- Two 55-gallon drums labeled “universal waste, intact aerosol cans.”
- Thirteen 4-foot boxes labeled “universal waste fluorescent lamps.”
- One 5-gallon container us LED lamps.

Photo #5 – Universal Waste stored in 90-day or less accumulation area.

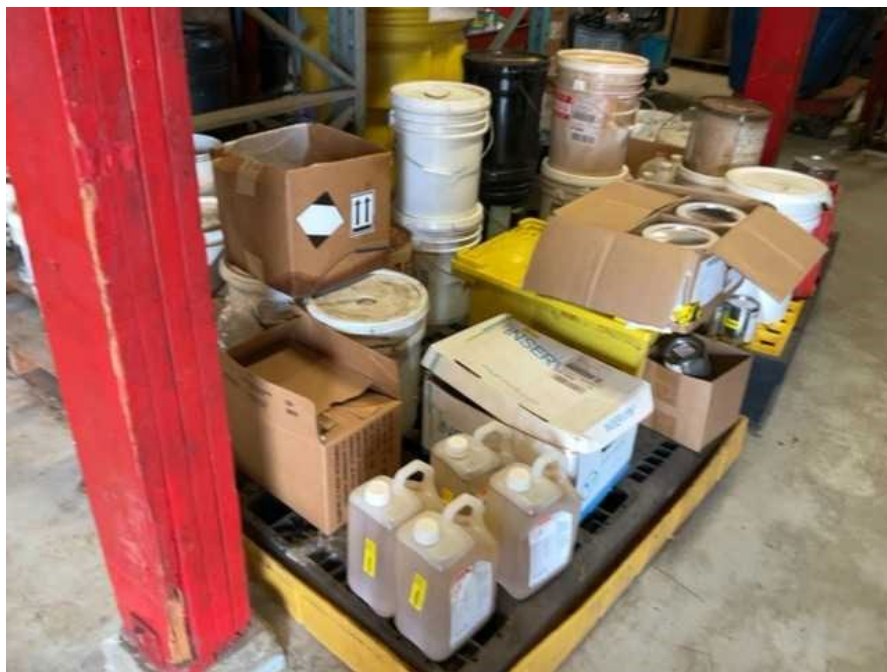
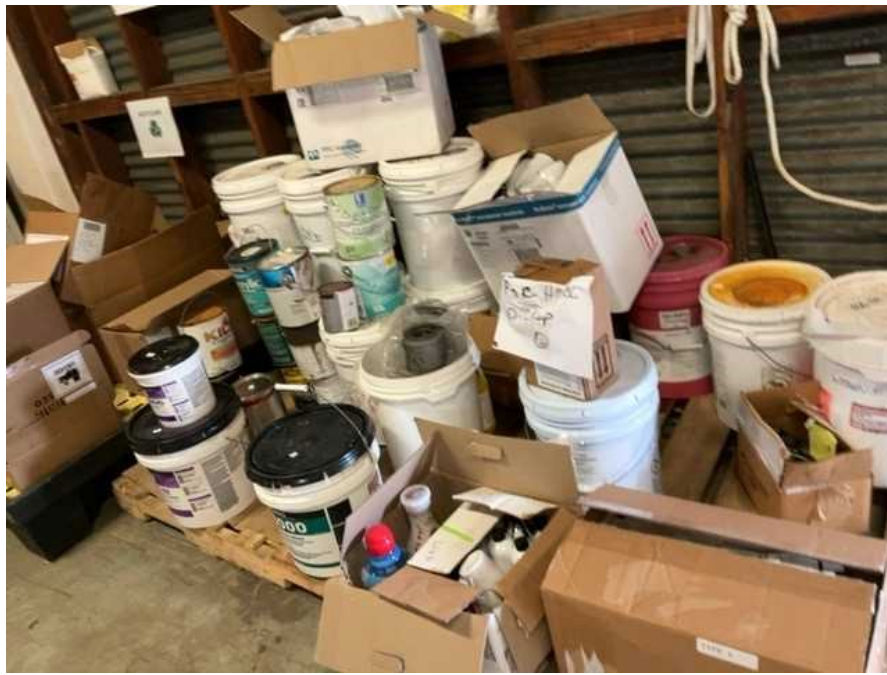
The pending analysis portion of the HMCC was located in a separate room from the CAA. In this area, inspectors observed carts and pallets of smaller chemicals, paint cans, and other product containers (Photos #6 and 7). Smaller containers are brought here by HMCC staff and are lab packed into 55-gallon SAA drums for consolidation of the same types of waste. These drums are dated and moved to the CAA when full.

Facility representatives informed inspectors that containers await analysis in this area for no more than a couple days. Inspectors informed HMCC staff that a waste determination must be conducted at the point of waste generation. Facility personnel stated that this area is the point of generation because not all material brought here will become a waste. HMCC staff conduct a visual inspection and determine if containers here can be reused depending on the condition of the container. Inspectors recommended facility representatives store containers in a confined area while awaiting a waste determination and label this area “Hazardous Waste Pending Analysis.”

Inspectors observed three 55-gallon drums and several 5-gallon drums consolidating smaller containers that had been determined to be hazardous waste. These containers were closed and labeled with the words “hazardous waste” and an indication of the hazards of the contents. Facility representatives informed inspectors that these containers are dated and moved to the CAA when full. Dan Patten stated that SAA containers remain in this area for less than a year. Following the inspection, inspectors informed facility representatives that the containers in this area exceed the 55-gallon accumulation limit for SAAs. These containers must be limited to 55-gallons cumulative or dated and managed as a CAA.

Photo #6 – Containers in the pending analysis portion of the CAA.

Photo #7 – Additional containers in the HMCC awaiting a waste determination.

**Pursuant to ADEM Admin. Code r. 335-14-3-.01(5)(a) [40 C.F.R. § 262.15(a)], a generator may accumulate as much as 55 gallons of non-acute hazardous waste in containers at or near any point of generation where wastes initially accumulate, which is under the control of the operator of the process generating the waste, without a permit or without having interim status, as required by Section 22-30-12(b) of the AHWMMA, Ala. Code § 22-30-12(b) [Section 3005 of RCRA, 42 U.S.C. § 6925], and without complying with ADEM Admin. Code r. 335-14-3-.01(6)(b) or 335-14-3-.01(7)(a) [40 C.F.R. § 262.16(b) or § 262.17(a)], except as required in ADEM Admin. Code r. 335-14-3-.01(5)(a)7. and 8. [40 C.F.R. § 262.15(a)(7) and (8)], provided that the generator complies with the satellite accumulation area conditions listed in ADEM Admin. Code r. 335-14-3-.01(5)(a) [40 C.F.R. § 262.15(a)] (hereinafter referred to as the “SAA Permit Exemption”).**

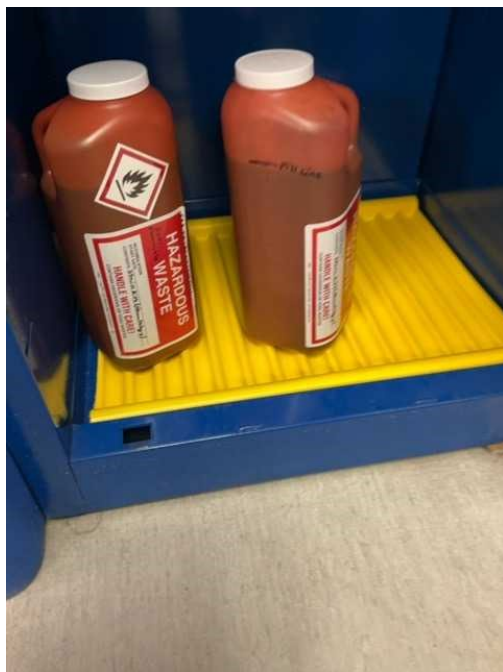
- One 3-gallon container labeled “hazardous waste, alkaline, corrosive.”
- Two 1-liter containers labeled “hazardous waste, stain, flammable” (Photo #8).

Photo #8 – SAA containers in the health clinic lab.

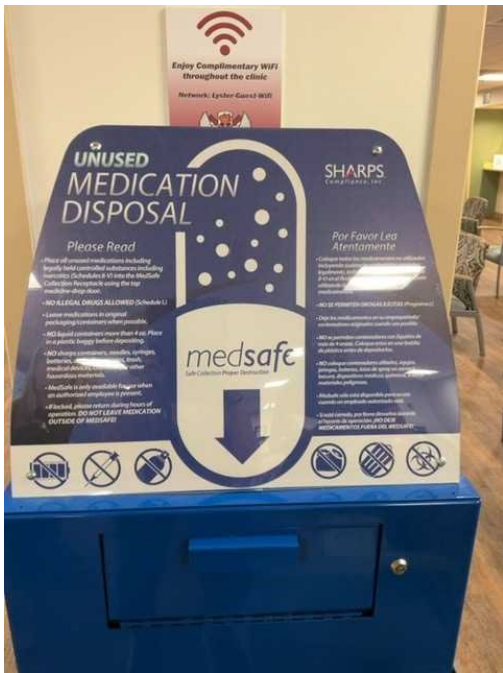
Inspectors met with Gordon Dahle, Inventory Management Specialist, in the pharmacy. Pharmacy personnel informed inspectors that waste is generated in the pharmacy when a pill is dropped, a pharmaceutical is damaged before reaching the customer, or a pharmaceutical expires. The pharmacy does not accept returns but has a locked drop box in the pharmacy waiting area for customers to drop off damaged or expired pharmaceuticals. This box is serviced by MedSafe and cannot be accessed by pharmacy personnel (Photo #9).

| | <p>Photo #9 – MedSafe container for customer household pharmaceutical disposal.</p> |

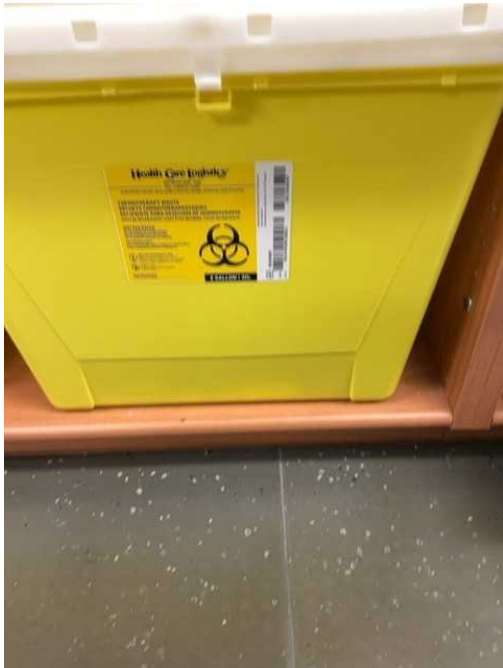
Most of the pharmaceutical waste generated by the facility is nonhazardous. Inspectors observed a binder labeled “NIOSH list of Hazardous Drugs in Healthcare Settings, 2020” which included descriptions of all pharmaceuticals sold in the pharmacy. Hazardous pharmaceuticals were highlighted in yellow. The facility representatives informed inspectors that nonhazardous waste pharmaceuticals are consolidated in a white container and disposed of by Pharma Logistics. Noncreditable hazardous waste pharmaceuticals are stored in a yellow bin labeled “chemo waste” and disposed of by Stericycle. Inspectors requested documentation of the three most recent shipments from Pharma Logistics, Stericycle, and the facility’s reverse distributor for potentially creditable hazardous waste pharmaceutical returns to the manufacturer, which pharmacy personnel were unable to identify at the time of the inspection. Inspectors also requested photo documentation of the yellow container labeled “hazardous waste pharmaceuticals.” (Photo #10)

| | <p>Photo # 10 – Container for hazardous waste pharmaceuticals. This container was not labeled with the words “hazardous waste pharmaceuticals”</p> |

**Pursuant to ADEM Admin. Code r. 335-14-7-.16(2)(e) [40 CFR 266.502(e)] a healthcare facility must label or clearly mark each container of non-creditable hazardous waste pharmaceuticals with the phrase “Hazardous Waste Pharmaceuticals.”**
