**Region 6 Compliance Assurance and Enforcement Division  
INSPECTION REPORT**

| Inspection Date(s): | 08/15/2018 | | |
| Company Name: | <b>City of Roswell</b> | | |
| Facility Name: | <b>Roswell Wastewater Treatment Plant</b> | | |

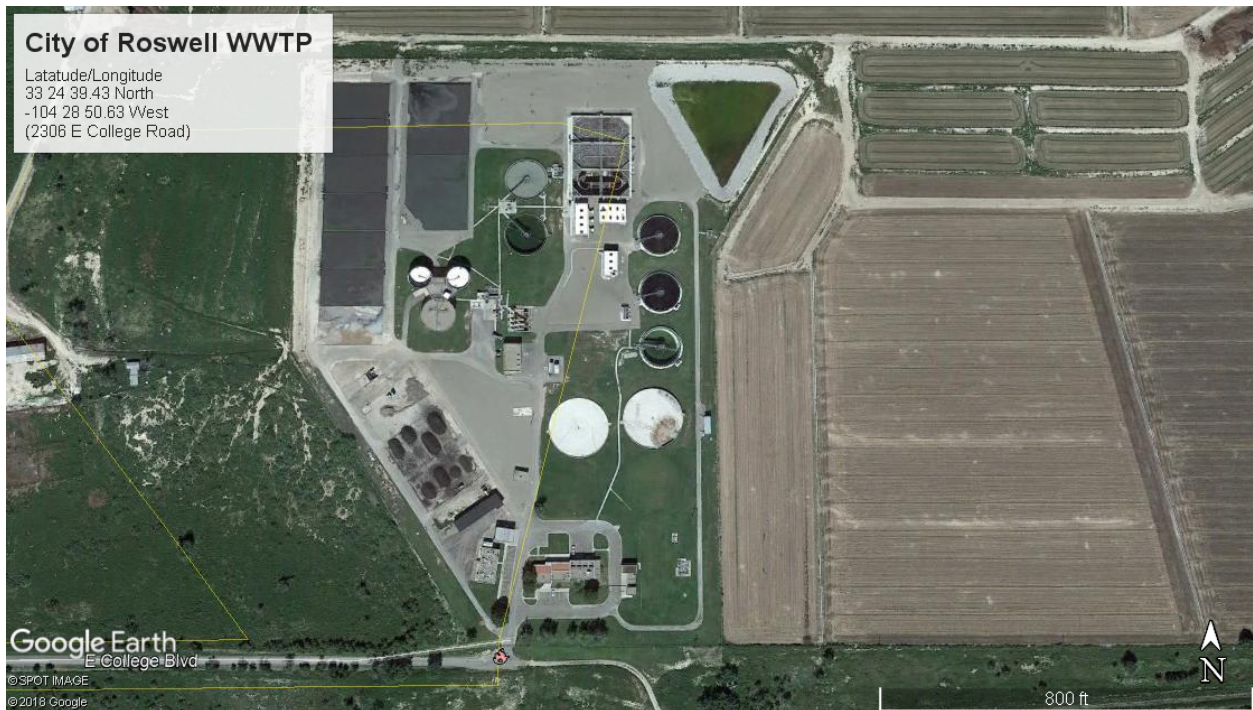
**Aerial Image #1:** Overall view of the City of Roswell’s Wastewater Treatment Plant. Aerial from Google Earth maps.

The WWTP is a major discharger with a design flow of 7.0 million gallons per day (MGD) and average daily flow of approximately 3.4 MGD. The facility is located at 2306 E. College Road, Roswell, Chavez County, New Mexico (depicted in Aerial Image #1 below). The WWTP facility serves a population of approximately 48,600 (2014 US Census) residents. The WWTP is operated by staff within the Public Works Department and consists of 9 full-time equivalent (FTE) positions, exclusive of administrative support during the hours of 7:00 AM to 3:30 PM seven (7) days during the regular work week and 7:00 AM to 9:00 AM on the weekends. On-call staff is available on an as needed basis.
