## **RCRA Inspection Report**

Brenntag Mid-south, Inc. TND084060086  
317 Wauhatchie Pike  
Chattanooga, Hamilton County, Tennessee 37419

May 24, 2023

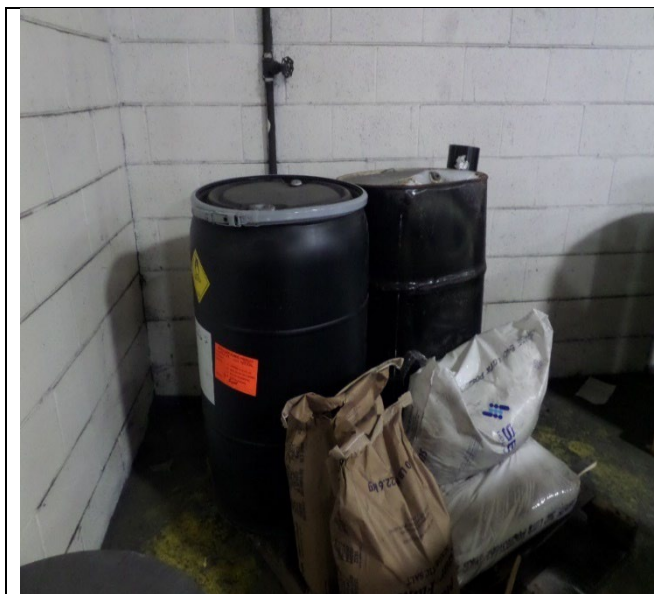
Non-Conforming Product Area. Inspectors observed container of ammonium persulfate with an oxidizing hazardous indicator and with an orange label 4/21/22. Inspectors also observed a dented container of unknown material and bags of dry material. Photograph 1 taken at 10:05 a.m.

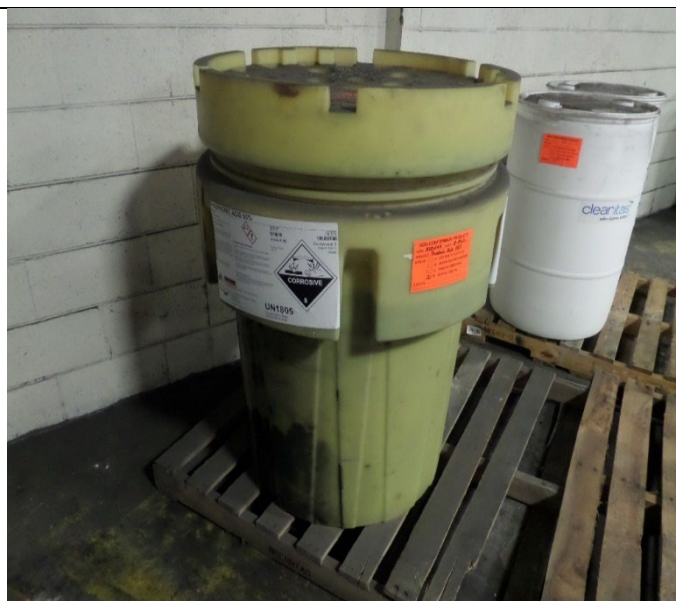
Non-Conforming Product Area. Inspectors observed container of phosphoric acid 85% in an overpack with an orange label 8/29/22. Photograph 2 taken at 10:08 a.m.

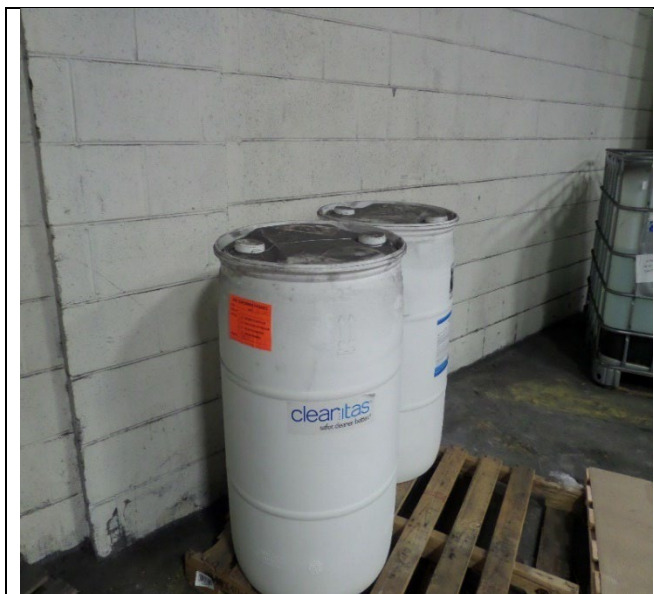
Non-Conforming Product Area. Inspectors observed two containers of Clearitas 820. Orange label with date 11/11/20. Photograph 3 taken at 10:08 a.m.

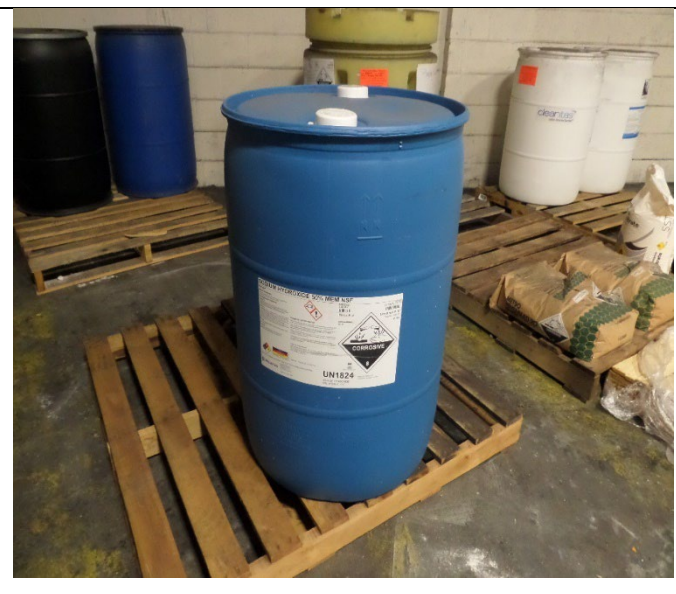
Non-Conforming Product Area. Inspectors observed container of sodium hydroxide, 50% not marked with an orange label. Observed bags of dry material. Photograph 4 taken at 10:08 a.m.

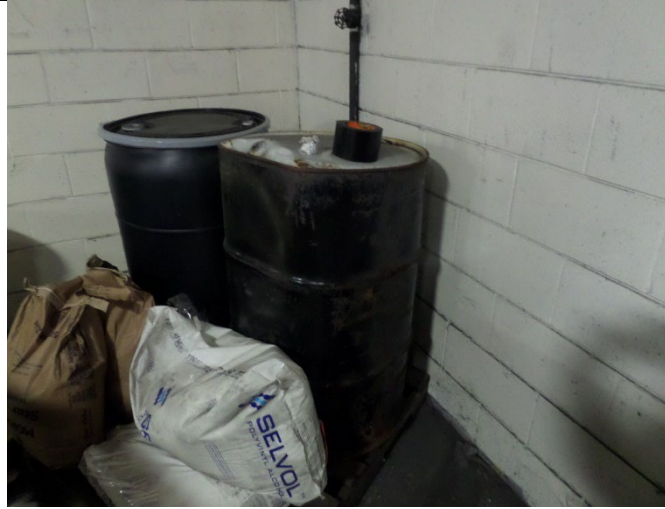
Non-Conforming Product Area. Inspectors observed a dented container of unknown material with no labels or markings next to container of ammonium persulfate. Observed bags of dry material. Photograph 5 taken at 10:08 a.m.

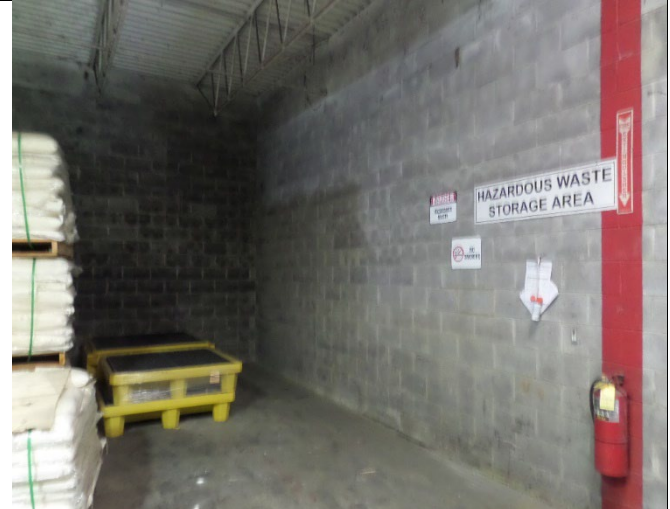
The CAA is constructed of cinder block walls and a concrete floor. The inspectors observed a sign on the wall with the words “hazardous waste storage area” (Photograph 6). The inspectors observed spill, emergency and communication equipment. Inspectors did not observe hazardous waste in the CAA at the time of the inspection. Brenntag representatives indicate the facility accumulates approximately 12-16 containers of hazardous waste in the CAA for shipment.

Central Accumulation Area (CAA). Inspectors observed containers of waste were not stored in the CAA at the time of the inspection. Observed sign on wall with words "hazardous waste storage area". Photograph 6 taken at 10:37 a.m.

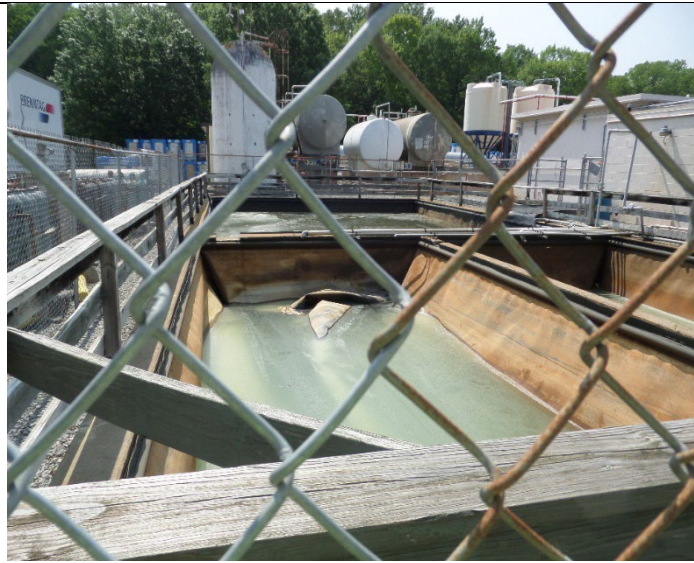
Acid Wastewater Treatment (Lower). Inspectors observed three lined concrete units to treat acidic wastewater. Effluent is discharged to the POTW. Photograph 7 taken at 11:28 a.m.

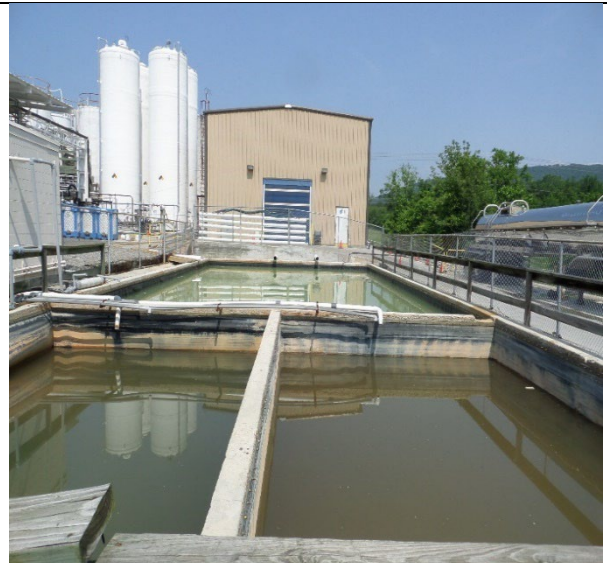
Caustic Wastewater Treatment (Upper). Inspectors observed three lined concrete units to treat caustic wastewater. Effluent is discharged to the POTW. Photograph 8 taken at 11:28 a.m.

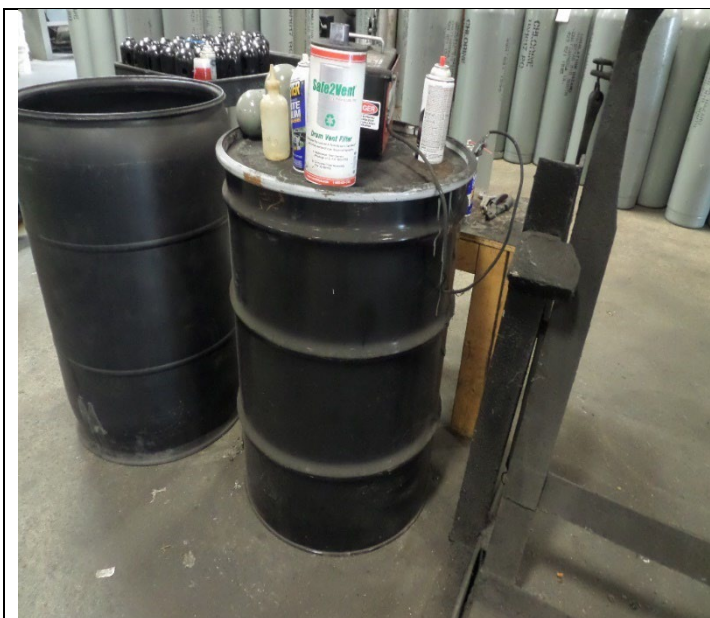
Inspectors observed one 55-gallon SAA container with an aerosol can puncturing unit accumulating aerosol can residue (waste paint and solvent). The container was closed and in good condition. The container was not marked or labeled with the words “hazardous waste” and not marked or labeled with a hazard indicator (Photographs 9 and 10). Brenntag representatives labeled the container with the words “hazardous waste” and marked the container with hazard indicators (Photograph 11).

Chlorine Packaging. Inspectors observed a 55-gallon SAA container of spent solvent from aerosol puncturing. Observed not marked or labeled with the words hazardous waste and not marked or labeled with a hazard indicator. Brenntag representatives labeled the container. Photograph 9 taken at 11:37 a.m.

**Pursuant to Tenn. Comp. R. & Regs. 0400-12-01-.03(1)(f)1.(v)(I&II) [40 C.F.R. § 262.15(a)(5)(i&ii)], which is a condition of the SAA Permit Exemption, a generator is required to mark or label its containers (i) with the words “Hazardous Waste” and (ii) a generator must mark or label its containers with an indication of the hazards of the contents (examples include, but are not limited to, the applicable hazardous waste characteristic(s) (i.e., ignitable, corrosive, reactive, toxic); hazard communication consistent with the Department of Transportation requirements at 49 CFR part 172 subpart E (labeling) or subpart F (placarding); a hazard statement or pictogram consistent with the Occupational Safety and Health Administration Hazard Communication Standard at 29 CFR 1910.1200; or a chemical hazard label consistent with the National Fire Protection Association code 704).**

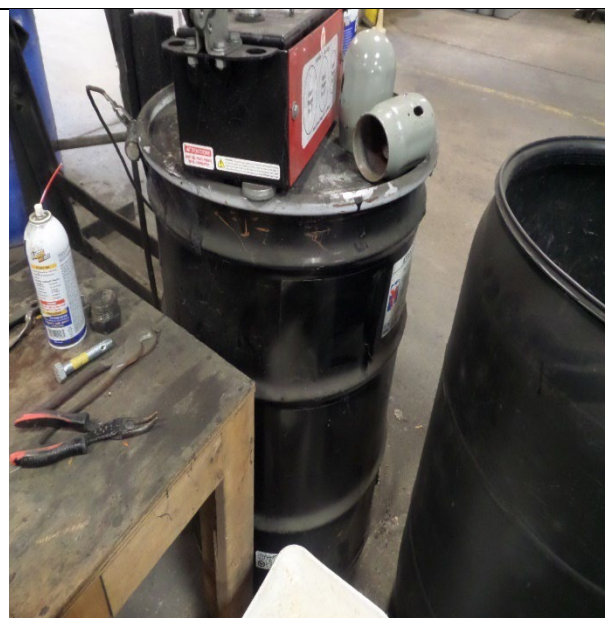
Chlorine Packaging. Inspectors observed a 55-gallon SAA container of spent solvent from aerosol puncturing. Observed not marked or labeled with the words hazardous waste and not marked or labeled with a hazard indicator. Brenntag representatives labeled the container. Photograph 10 taken at 11:37 a.m.

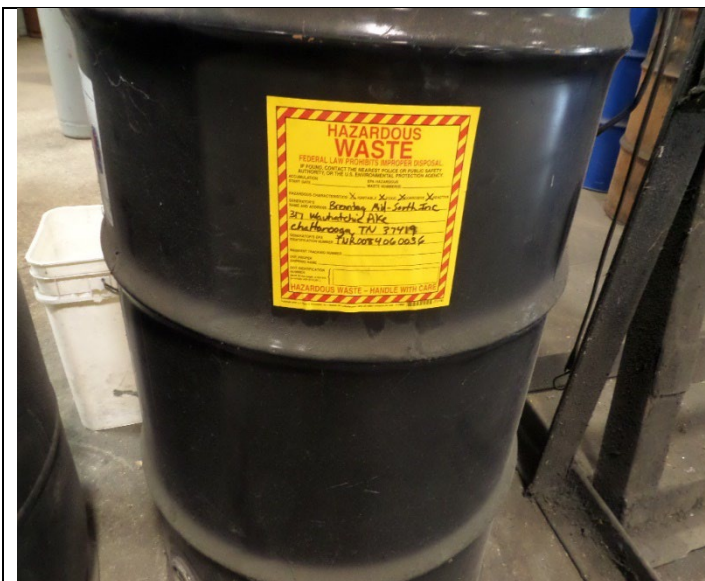
Chlorine Packaging. Inspectors observed a 55-gallon SAA unlabeled container of spent solvent from aerosol puncturing. Brenntag representatives labeled the container. Photograph 11 taken at 11:47 a.m.

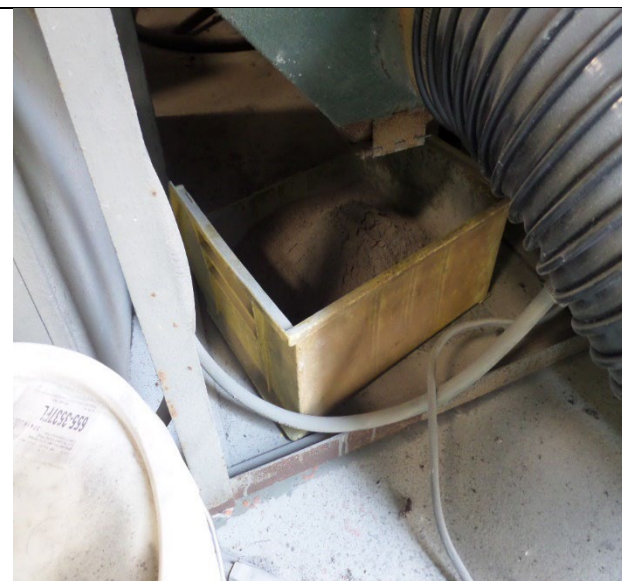
Inspectors observed a small plastic tray accumulating blast media under the blast cabinet and one 10-gallon container accumulating blast media next to the blast cabinet. The containers were not closed and not marked or labeled (Photographs 12 and 13). Brenntag representatives indicated a waste determination had not been performed on the blast media.

Chlorine Packaging. Blast Cabinet Area. Inspectors observed spent blast media in a small plastic tray and on the floor under the blast cabinet. Observed the blast cabinet was not operating and the container was open. Photograph 12 taken at 11:52 a.m.

**Pursuant to Tenn. Comp. R. & Regs. 0400-12-01-.03(1)(b) [40 C.F.R. § 262.11], a person who generates a solid waste, as defined in TN Rule 0400-12-01-.02(1)(b) [40 C.F.R. § 261.2], must use the steps articulated in TN Rule 0400-12-01-.03(1)(b) [40 C.F.R. § 262.11] to make an accurate determination as to whether that waste is a hazardous waste in order to ensure wastes are properly managed according to applicable RCRA regulations.**

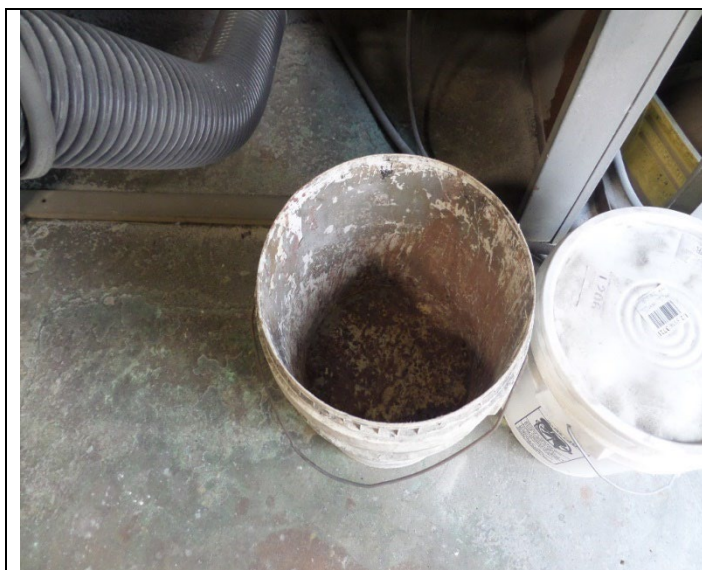
Chlorine Packaging. Blast Cabinet Area. Inspectors observed spent blast media in a 10-gallon container next to blast cabinet. Observed the blast cabinet was not operating and the container was open. Photograph 13 taken at 11:53 a.m.

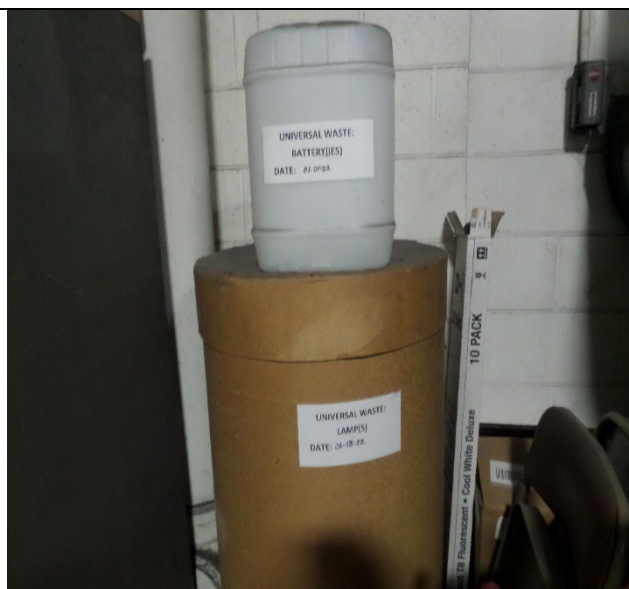
Universal waste batteries and lamps are accumulated in a designated area near the laboratory’s sample retention area. The inspectors observed a sign on the wall with the words “universal waste storage area”. The inspectors observed one 5-gallon container of universal waste batteries marked with the date January 5, 2022 and one container of four-foot universal waste lamps marked with the date January 18, 2022. The containers were closed, in good condition, and labeled with the words “universal waste” (Photograph 14).

Main Warehouse/Universal Waste Accumulation Area. The inspectors observed a container of waste batteries dated 1/5/22 and a container of waste four-foot lamps dated 1/18/22. Photograph 14 taken at 12:17 p.m.

**Pursuant to Tenn. Comp. R. & Regs. 0400-12-01-.12(2)(d)4.(i)(I) [40 C.F.R. § 273.15(a)], a SQHUW may accumulate universal waste for no longer than one year from the date the universal waste is generated, or received from another handler, unless the requirements of paragraph (b) of this section are met.**

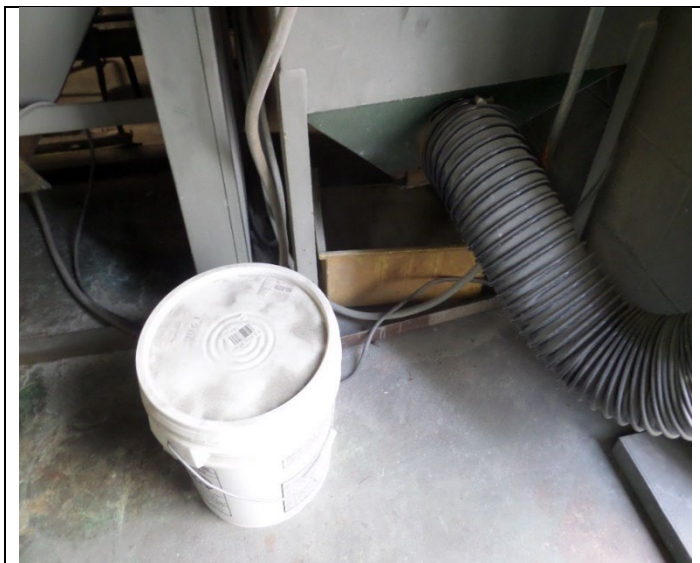
Chlorine Packaging. Blast Cabinet Area. Inspectors returned to this area and blast media from the plastic tray was transferred to the 10-gallon container and the container closed. Photograph 15 taken at 3:36 p.m.

The inspectors returned to this area in the afternoon after the record review. Brenntag representatives transferred the blast media from the tray to the 10-gallon container, closed and marked the container with the words “hazardous waste pending analysis” (Photograph 15).
