Clean Water Act Section 404: Site Visit/Case Development

| Site Name | Chelkas Chassidim Cemetery | Start Date | October 5, 2021 |

Map with GPS Points and Photolog

CWA 404 Inspection
Chelkas Chassidim Cemetery
Brick Church Road
New Hempstead, Rockland County, NY

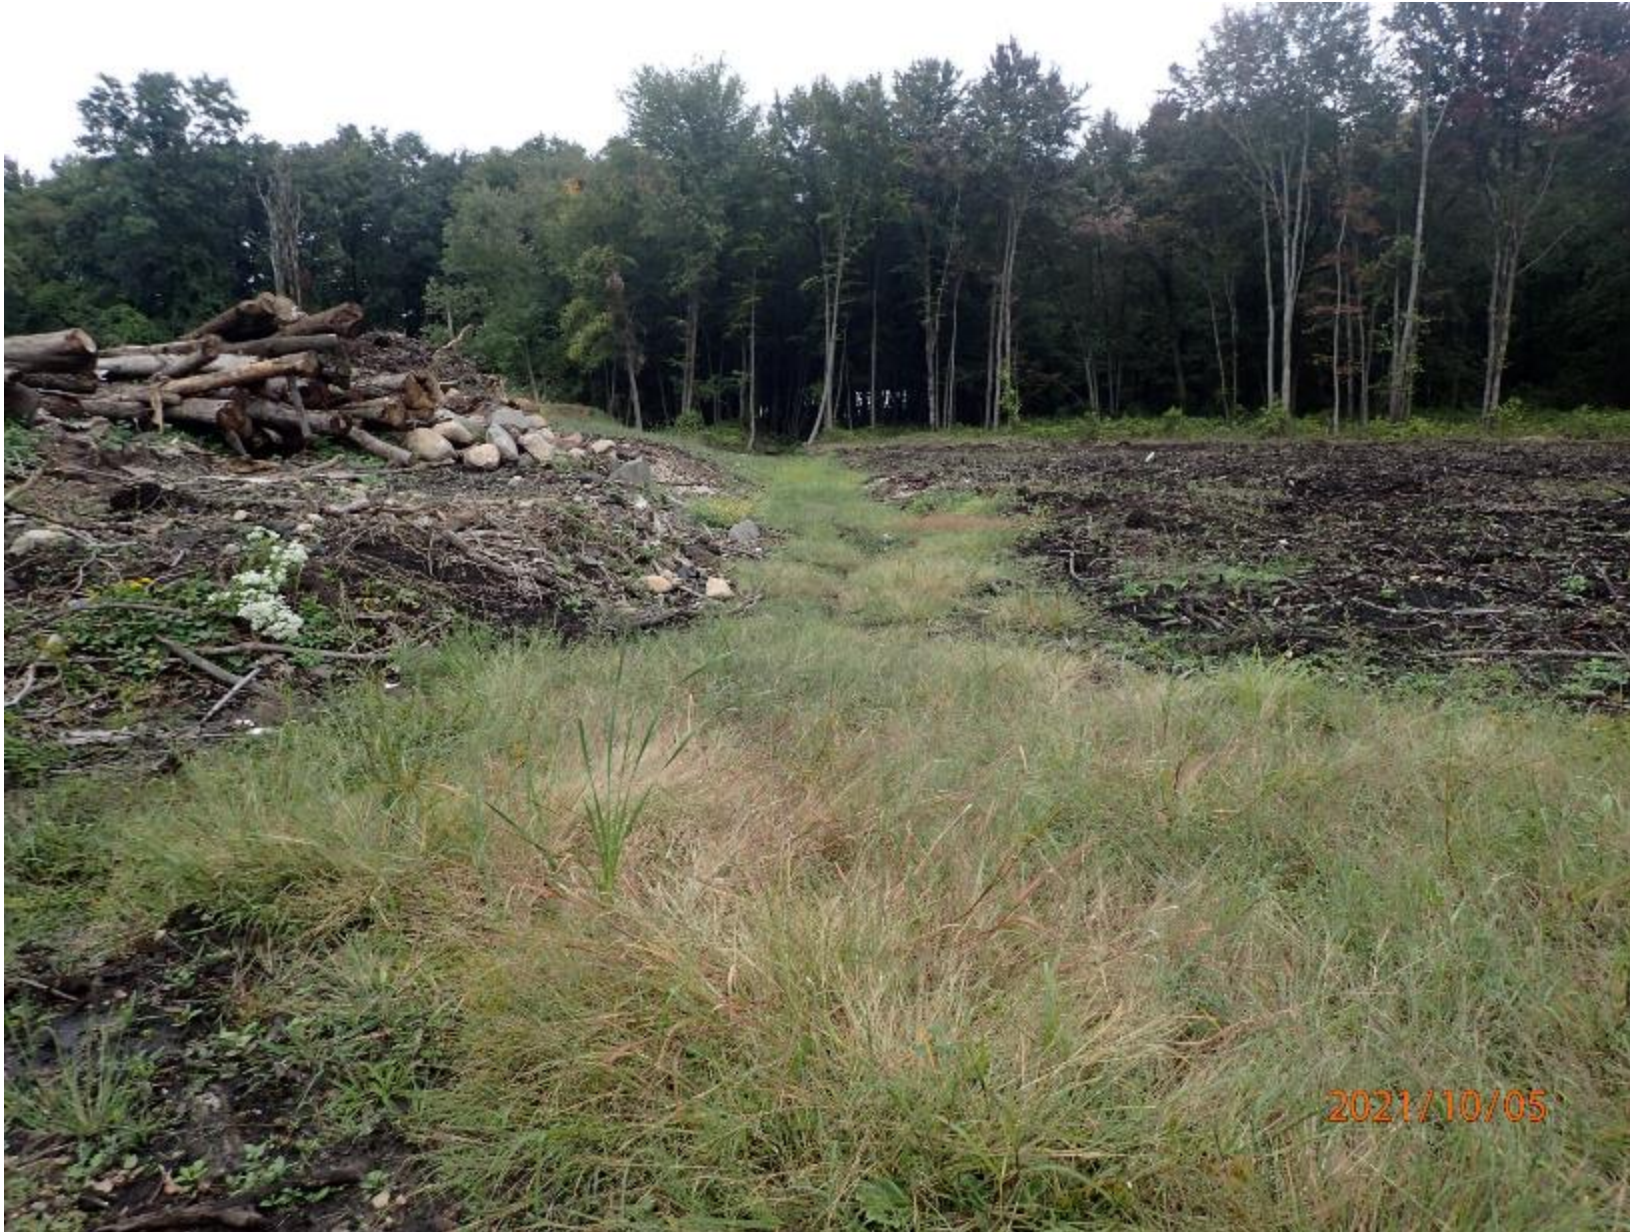
Date: 10/05/2021
Time: 1:48 PM
Photographer: SSA
Photo ID: 1 – PA050144

(1/3) Panorama of disturbance, which included tree and vegetation clearing, grubbing, and grading

Ditch/stream in center of photo

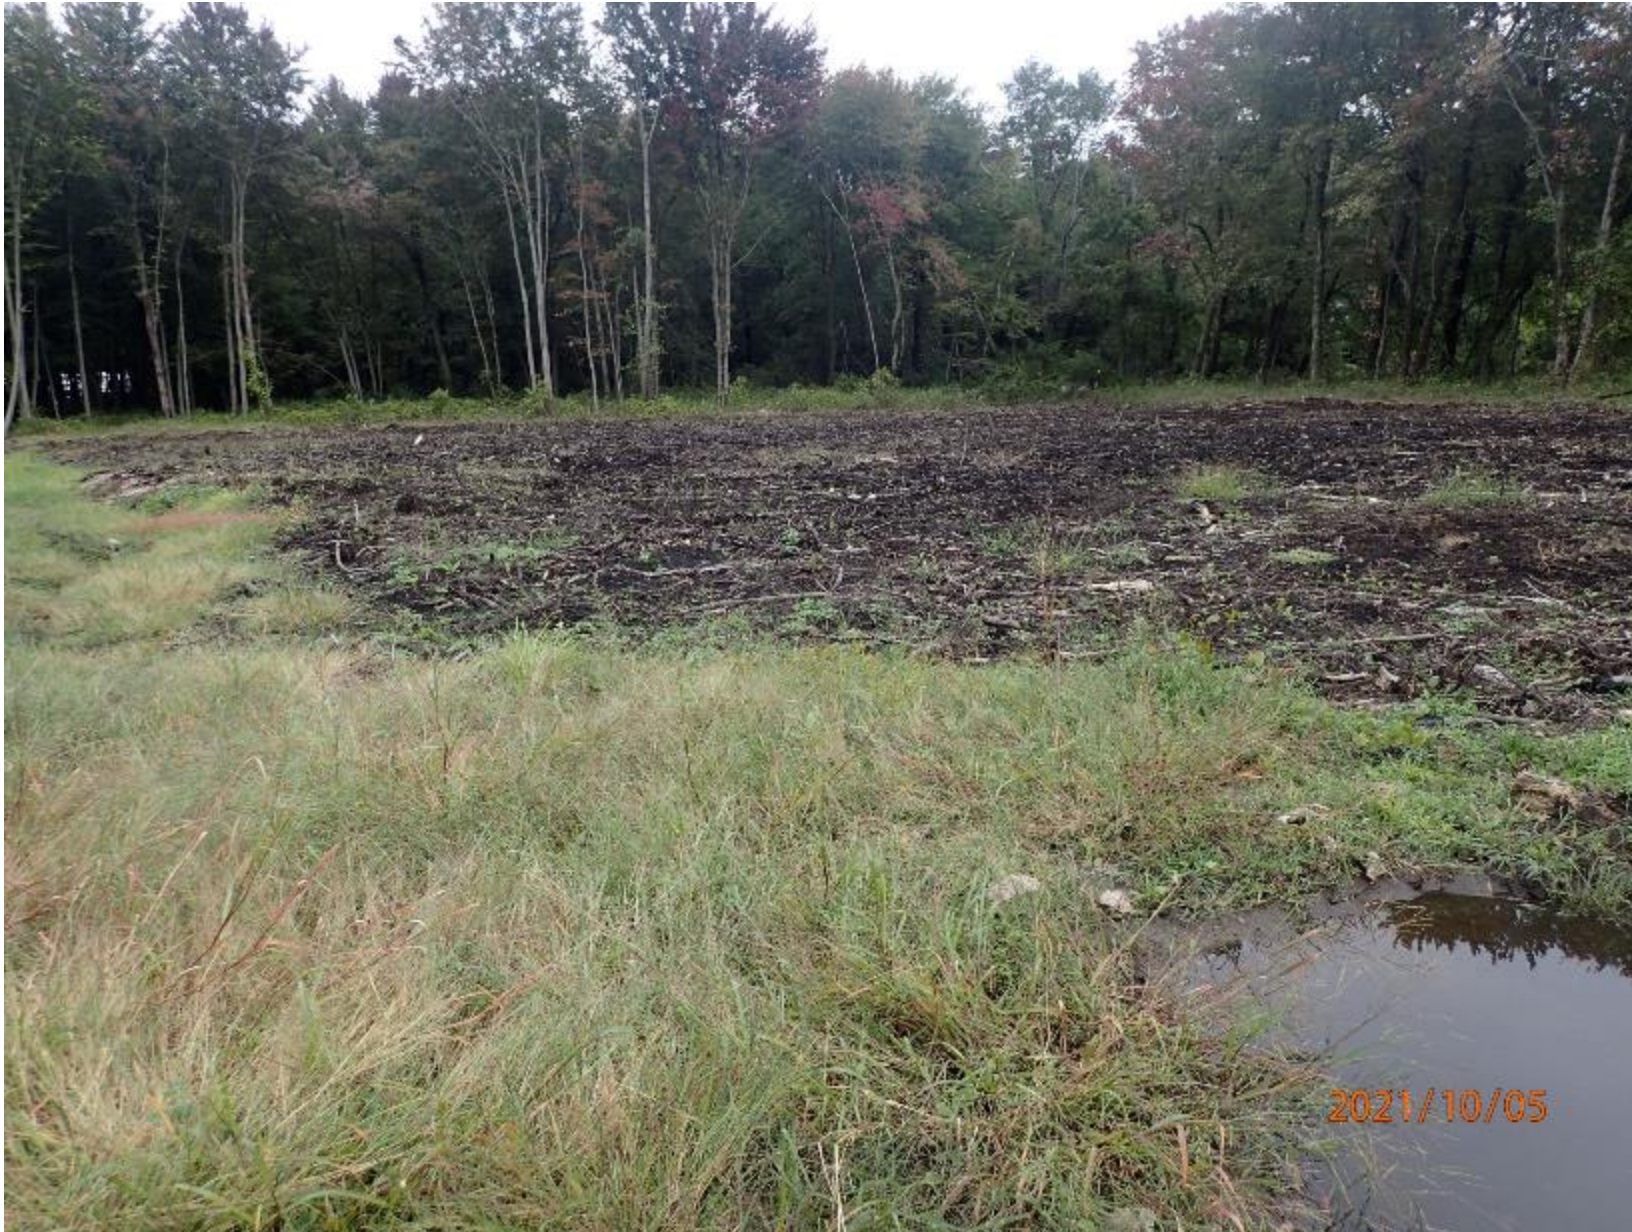
Date: 10/05/2021
Time: 1:49 PM
Photographer: SSA
Photo ID: 2 – PA050145

(2/3) Panorama of disturbance, which included tree and vegetation clearing, grubbing, and grading

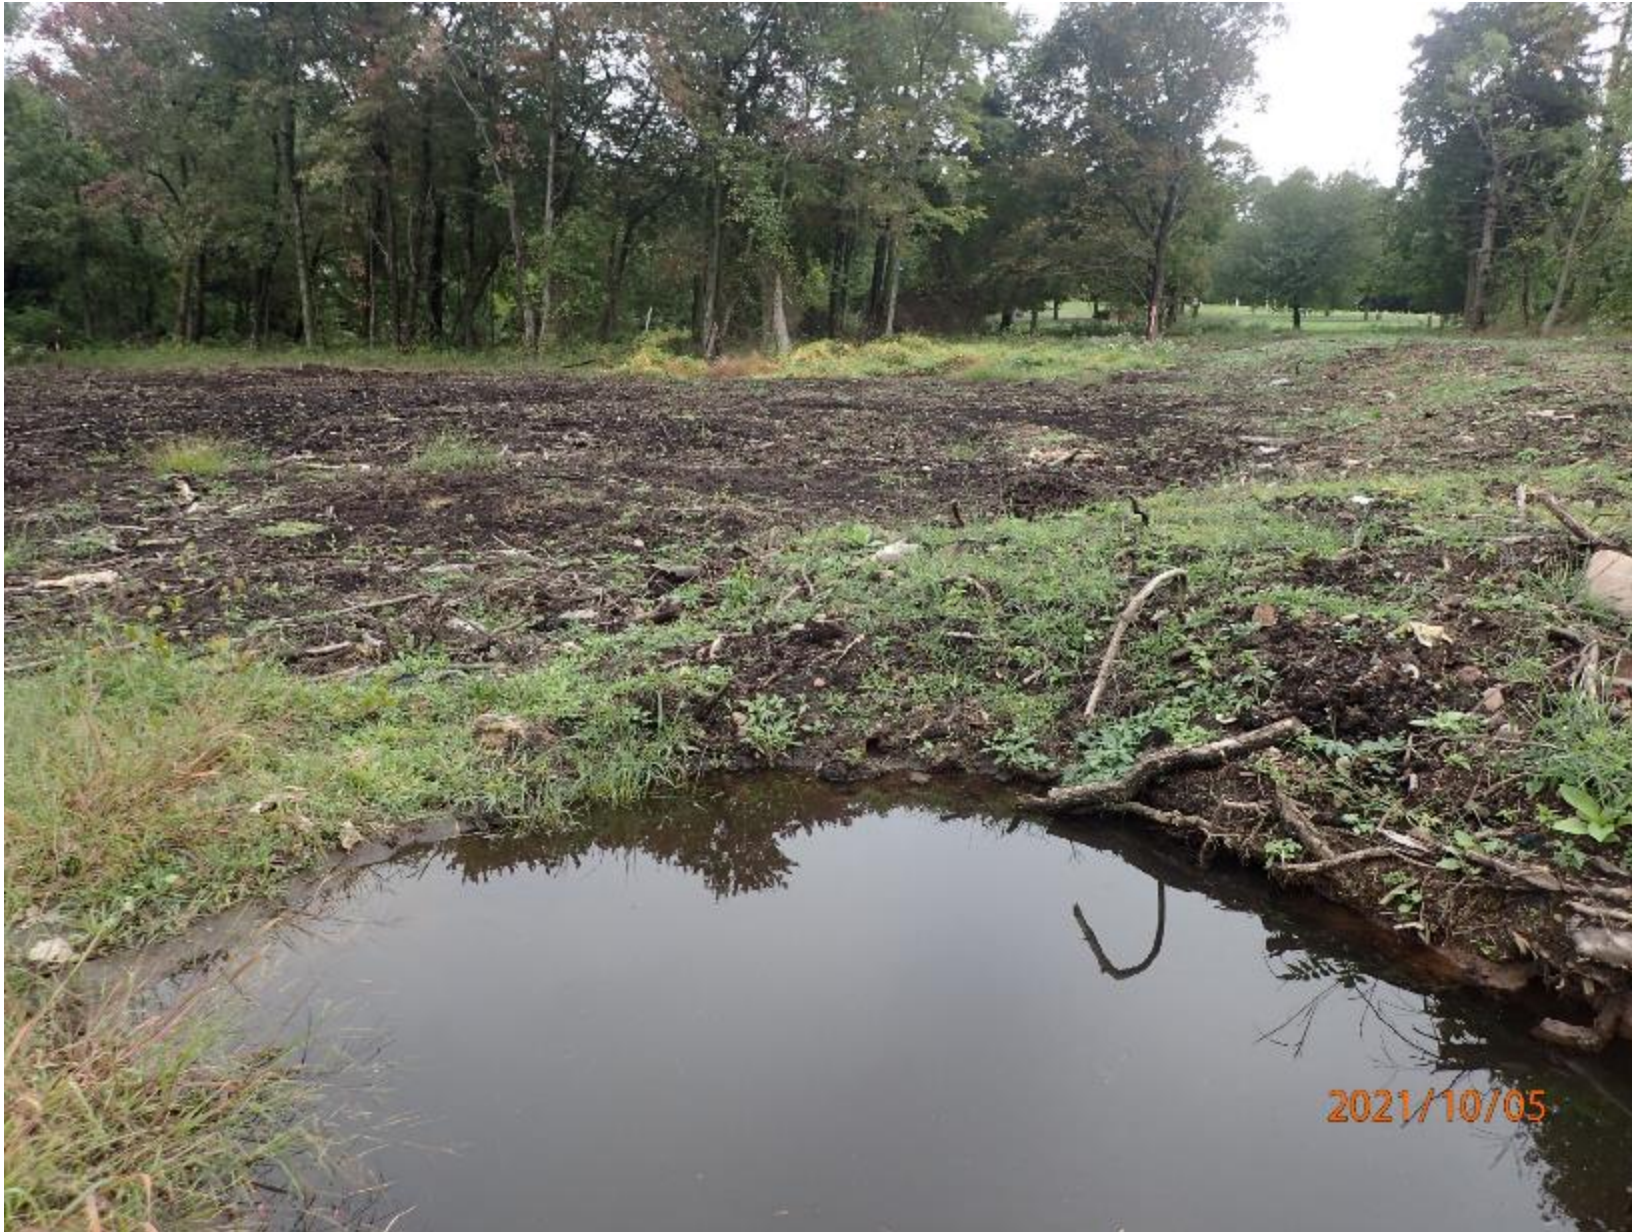
Date: 10/05/2021
Time: 1:49 PM
Photographer: SSA
Photo ID: 3 – PA050146

(3/3) Panorama of disturbance, which included tree and vegetation clearing, grubbing, and grading

Small pre-existing pit in foreground

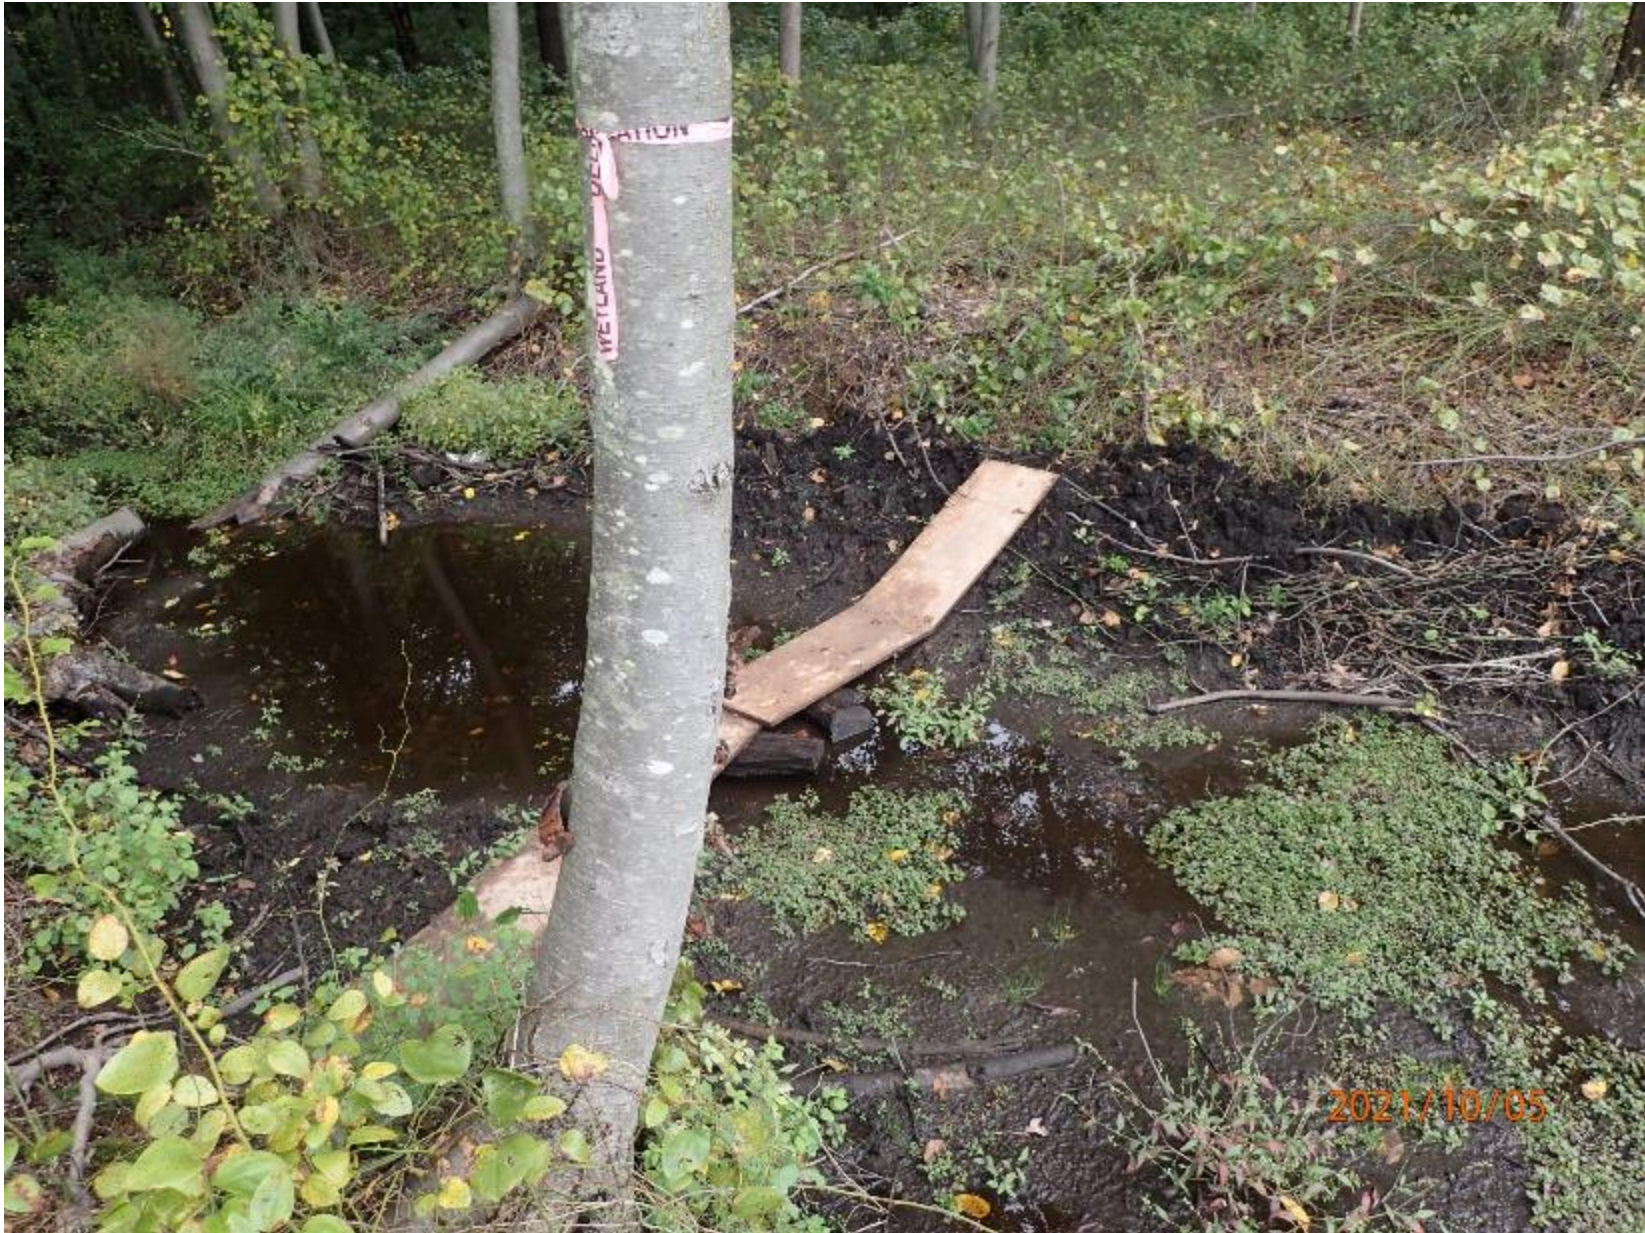
Date: 10/05/2021
Time: 1:59 PM
Photographer: SSA
Photo ID: 4 – PA050147

Description:
Wetland delineation flagging
tape hanging on tree

Located on ditch/stream at
northern property boundary
(Labeled "K")

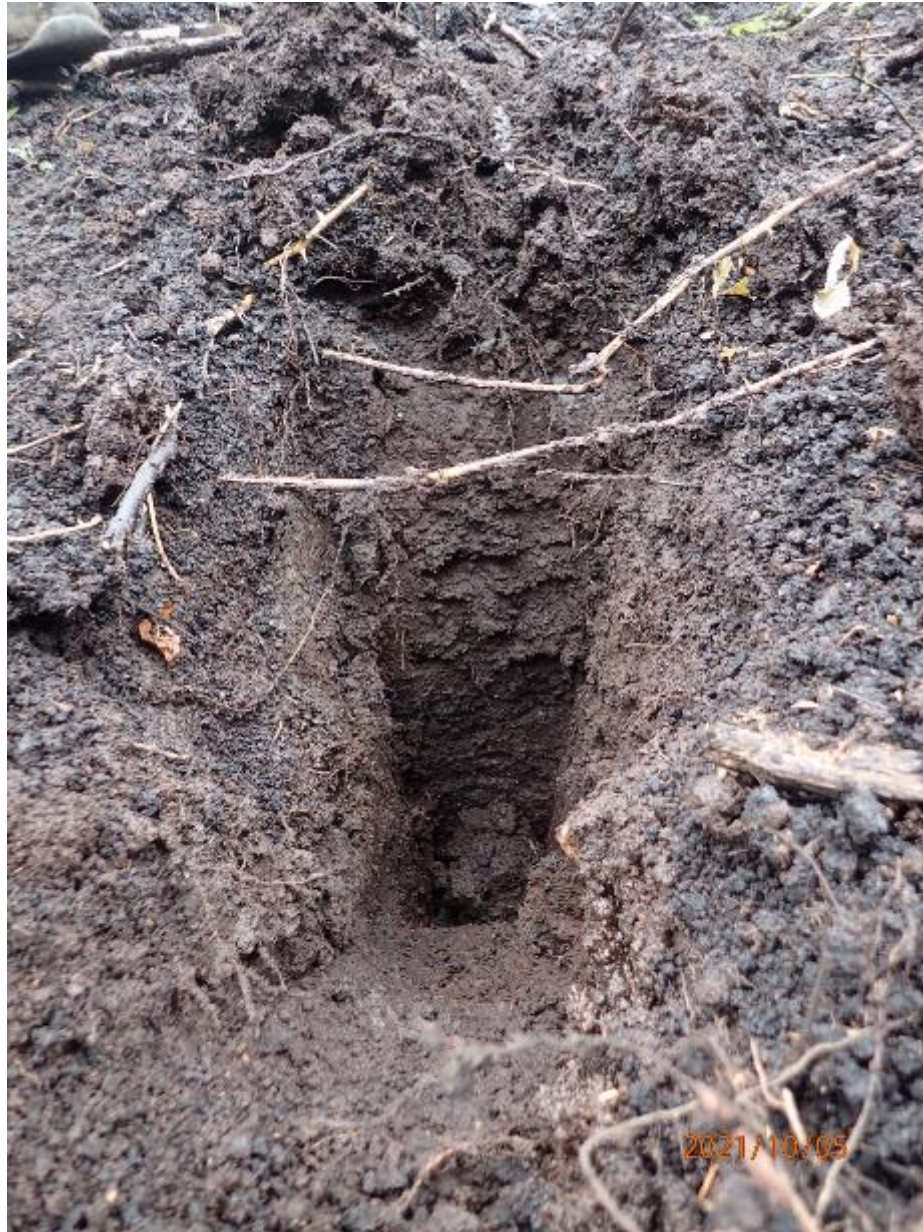
Date: 10/05/2021
Time: 2:29 PM
Photographer: SSA
Photo ID: 5 – PA050148

Description:
Soil Pit “SS1”

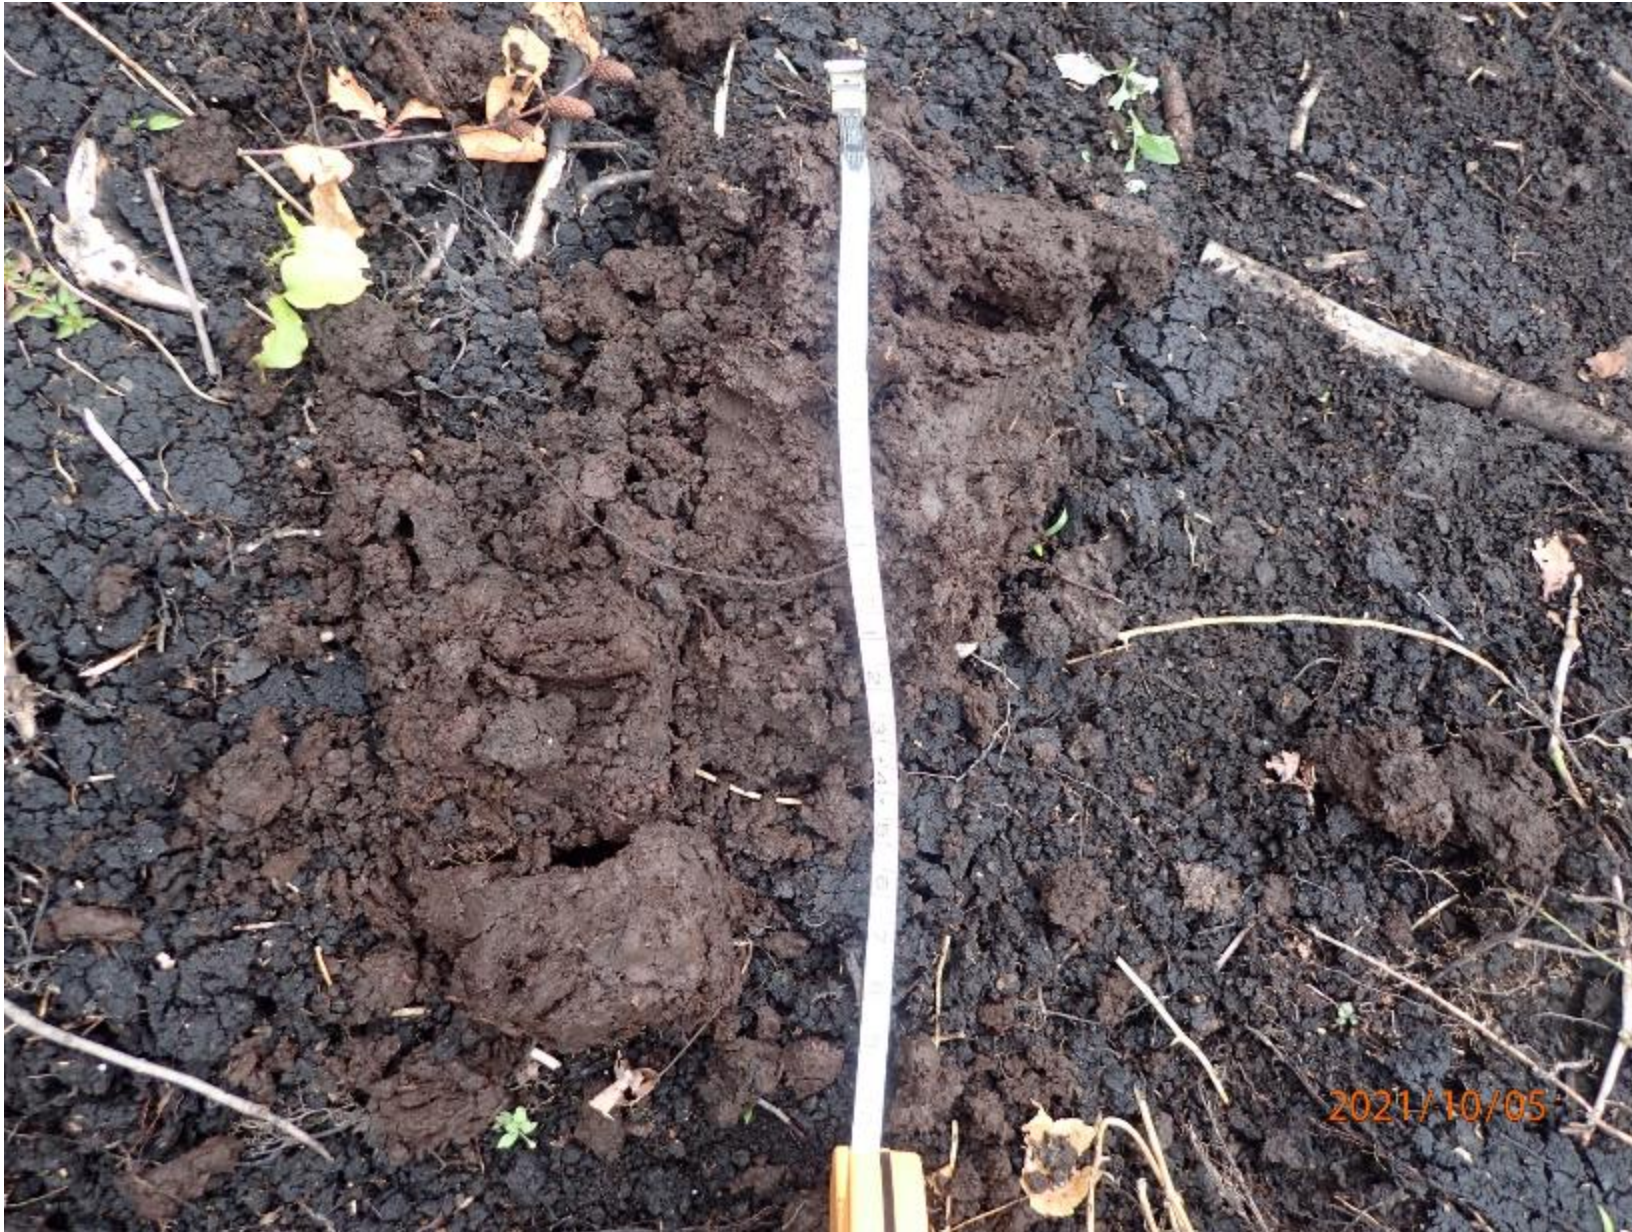
Date: 10/05/2021
Time: 2:31 PM
Photographer: SSA
Photo ID: 6 – PA050149

Description:
Soil profile from soil pit “SS1”

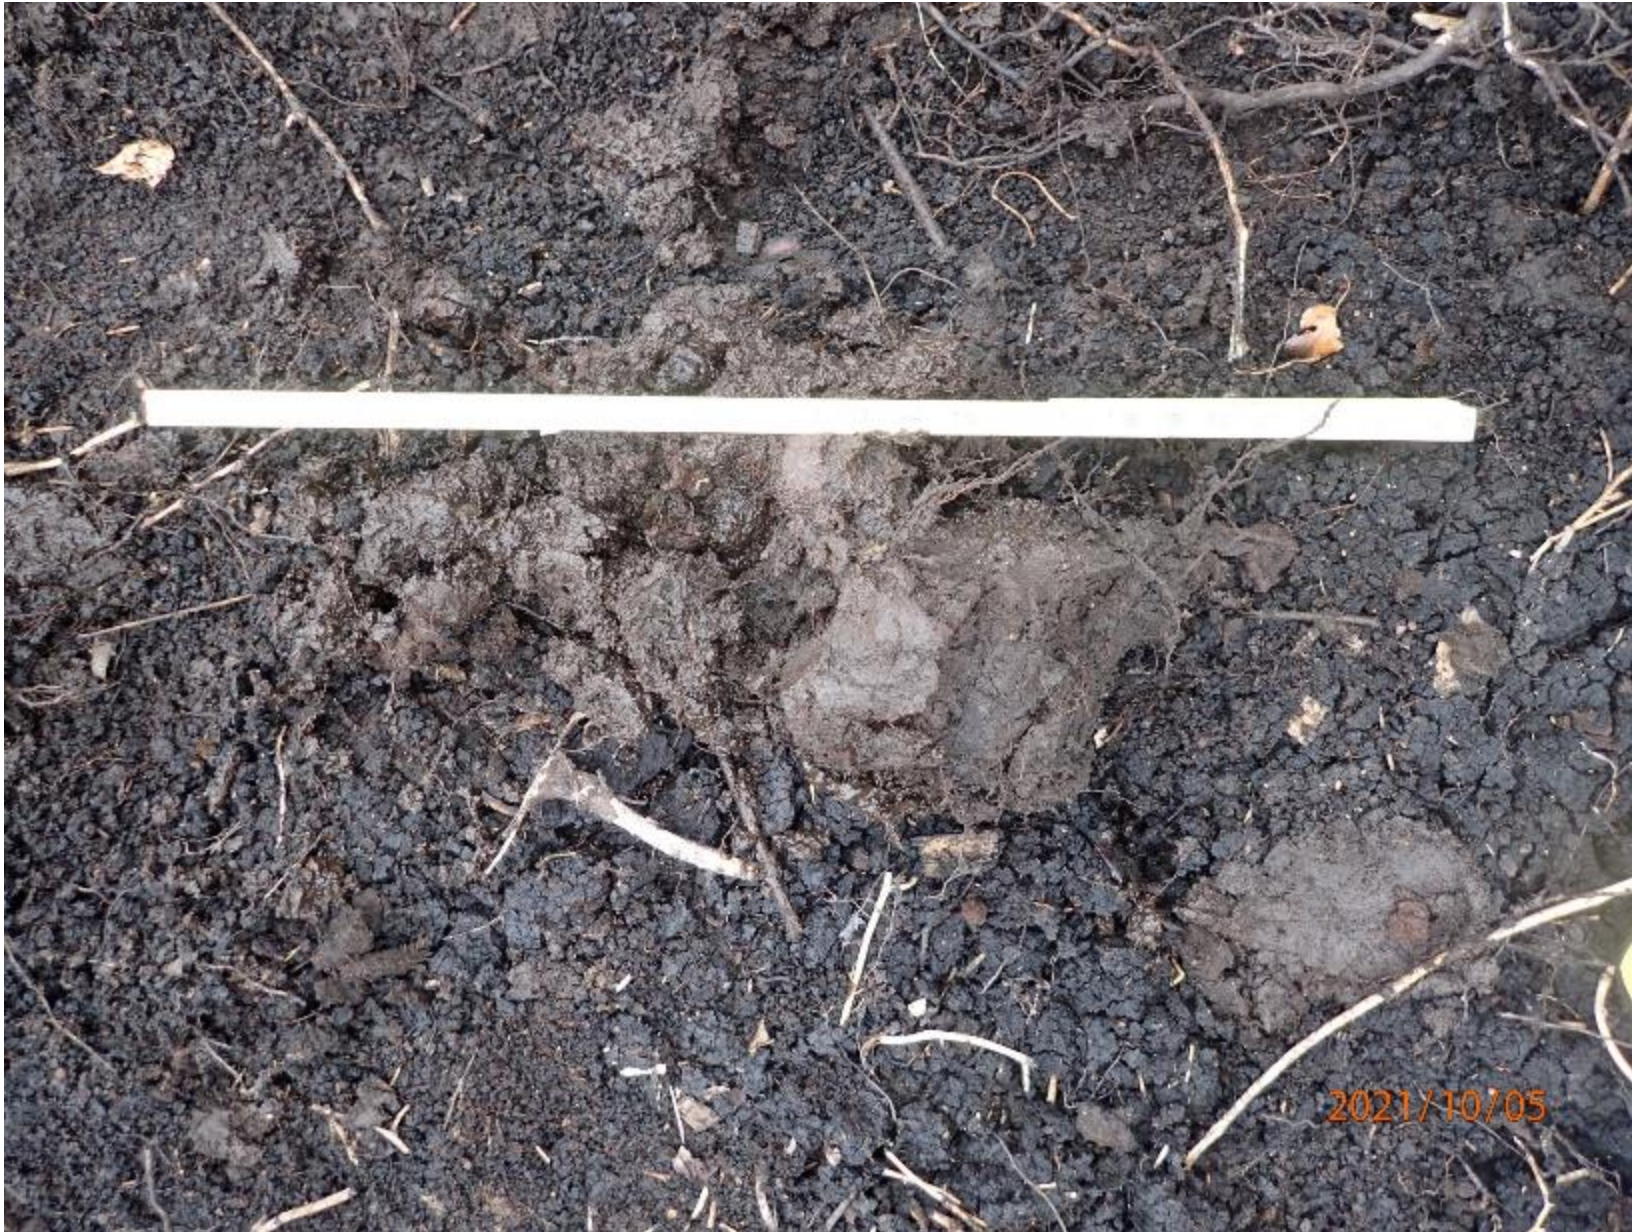
Date: 10/05/2021
Time: 2:40 PM
Photographer: SSA
Photo ID: 7 – PA050150

Description:
Soil profile from soil pit “SS2”

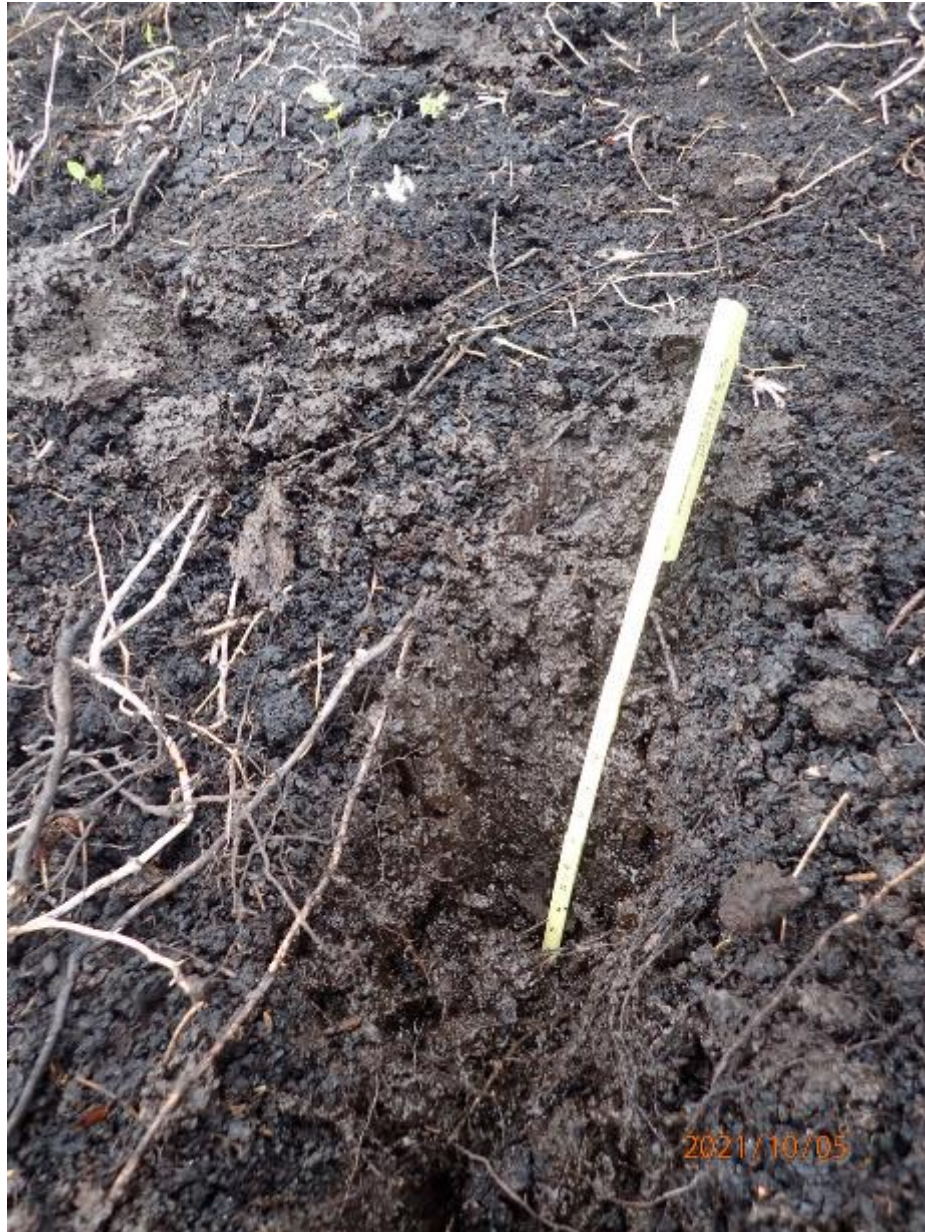
Date: 10/05/2021
Time: 2:43 PM
Photographer: SSA
Photo ID: 8 – PA050151

Description:
Soil Pit “SS2”

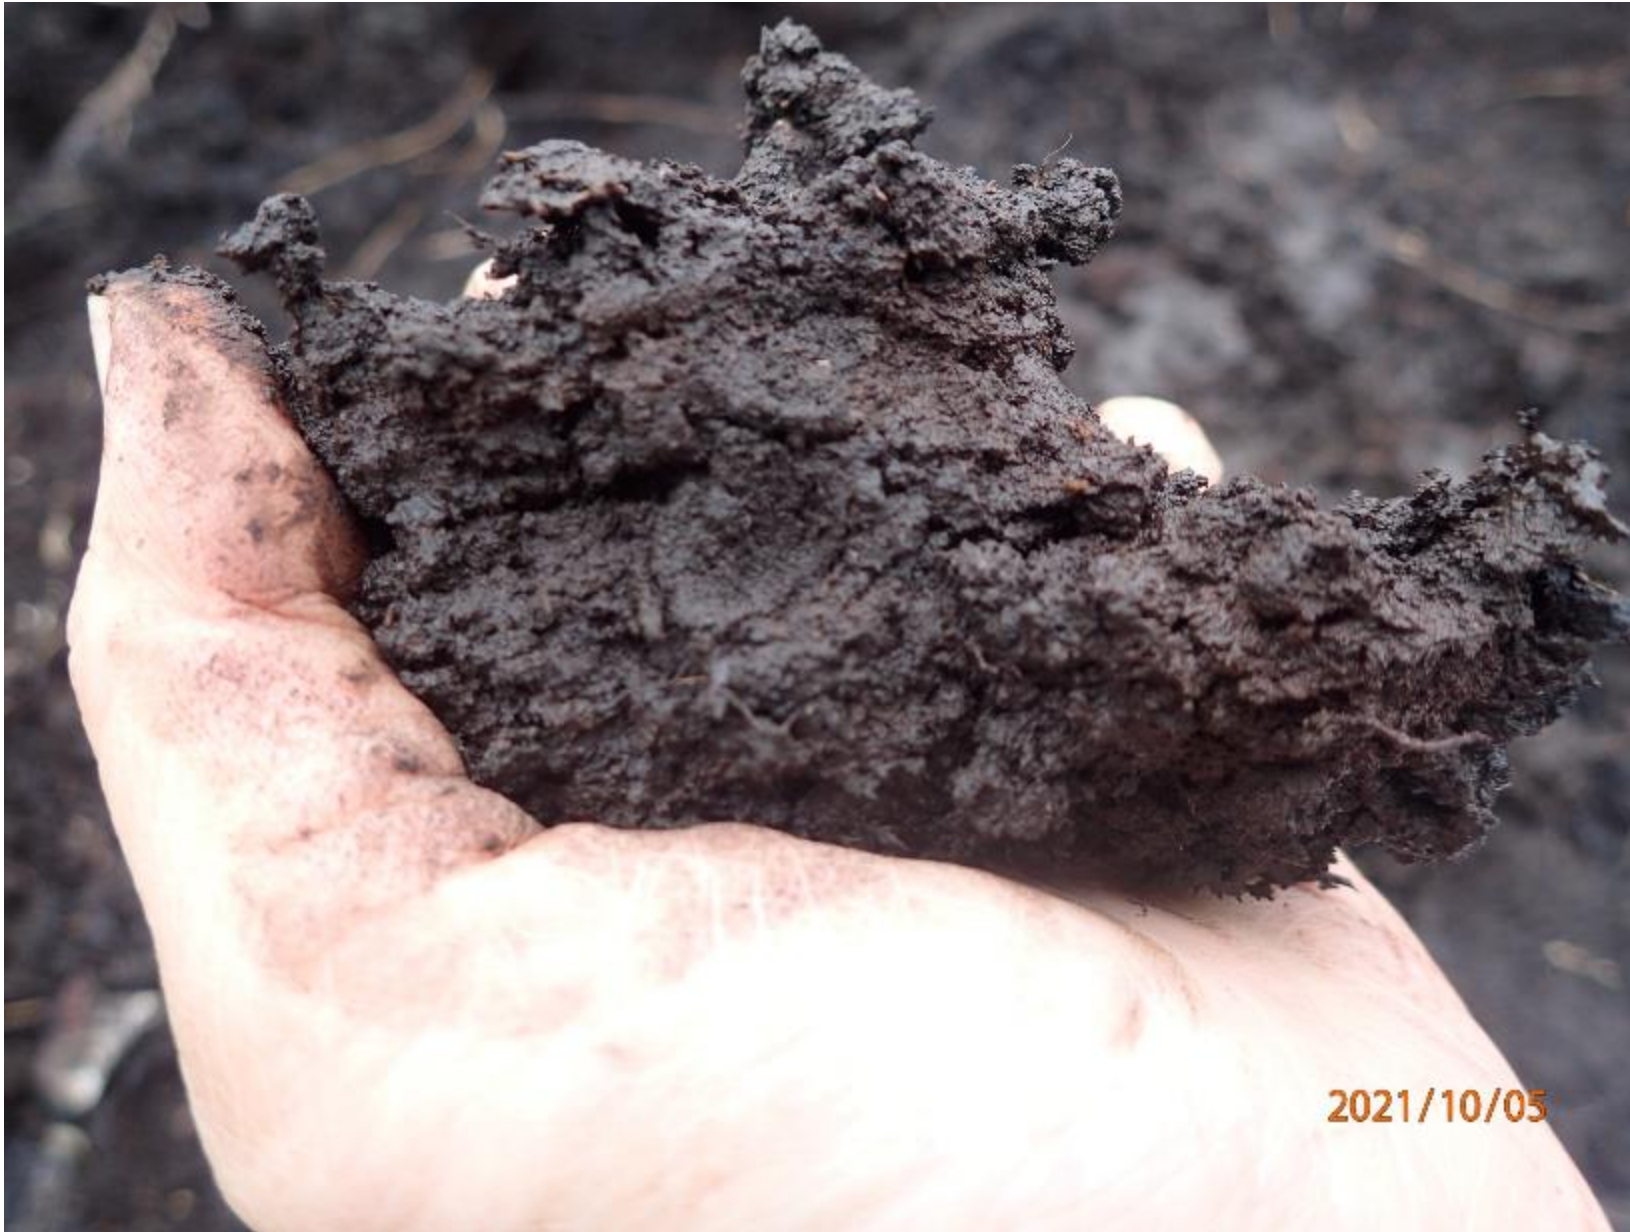
Date: 10/05/2021
Time: 2:45 PM
Photographer: SSA
Photo ID: 9 – PA050152

Soil from soil pit "SS2" showing faint redox features

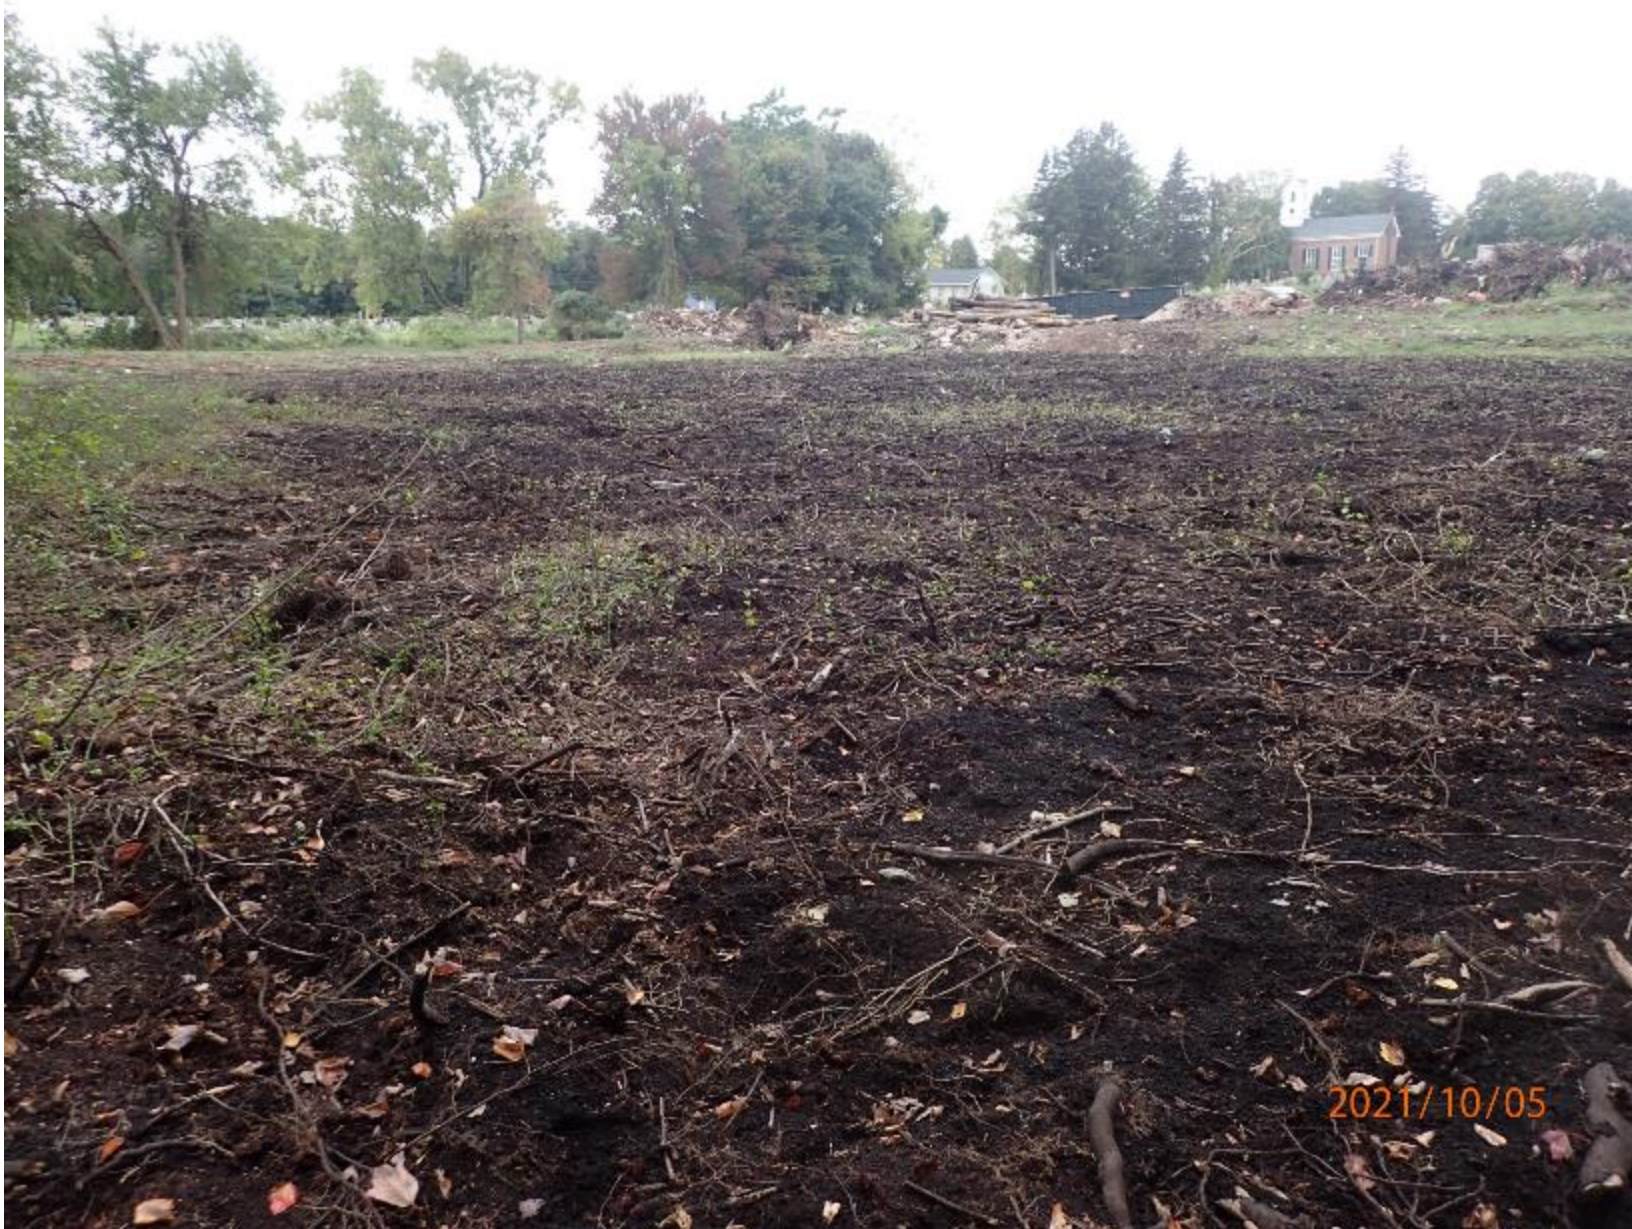
Date: 10/05/2021
Time: 3:00 PM
Photographer: SSA
Photo ID: 10 – PA050153

Photo taken of disturbance from
NE Limit of Disturbance; photo
facing southwest

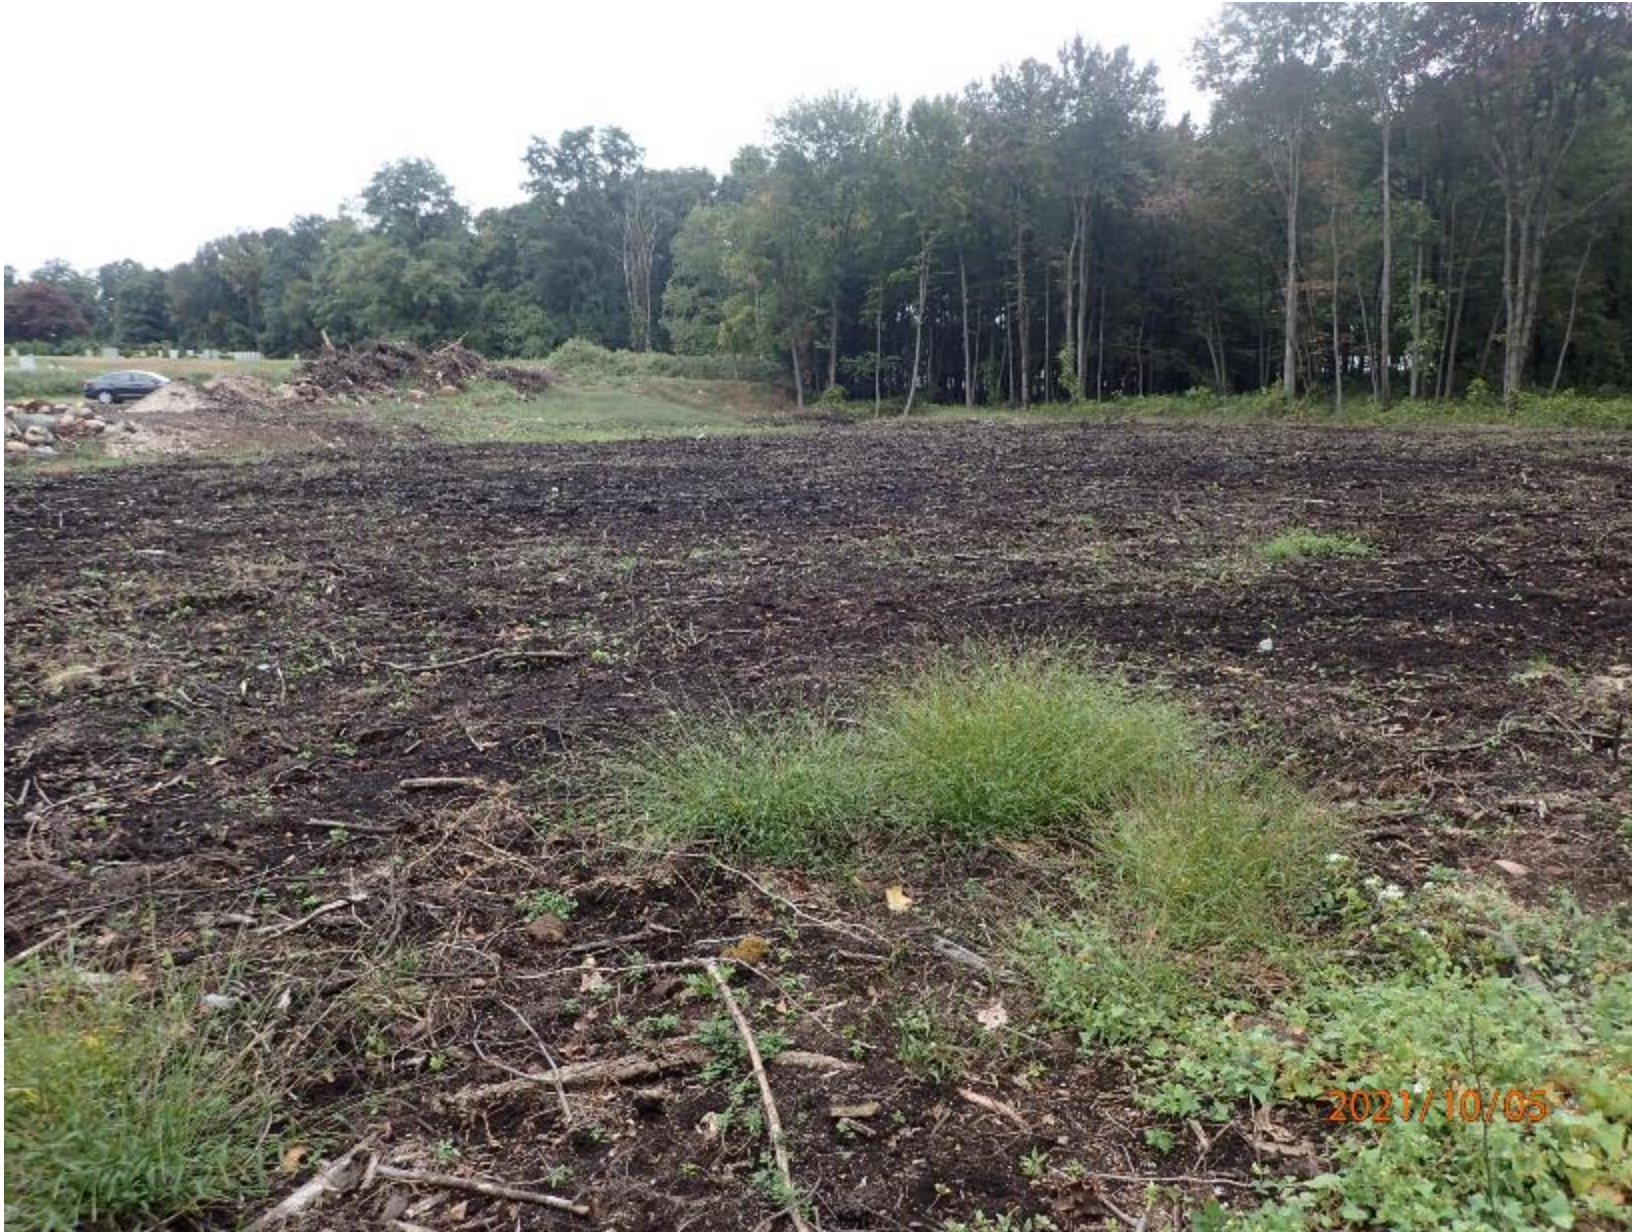
Date: 10/05/2021
Time: 3:02 PM
Photographer: SSA
Photo ID: 11 – PA050154

Photo taken of disturbance from SE Limit of Disturbance; photo facing northwest

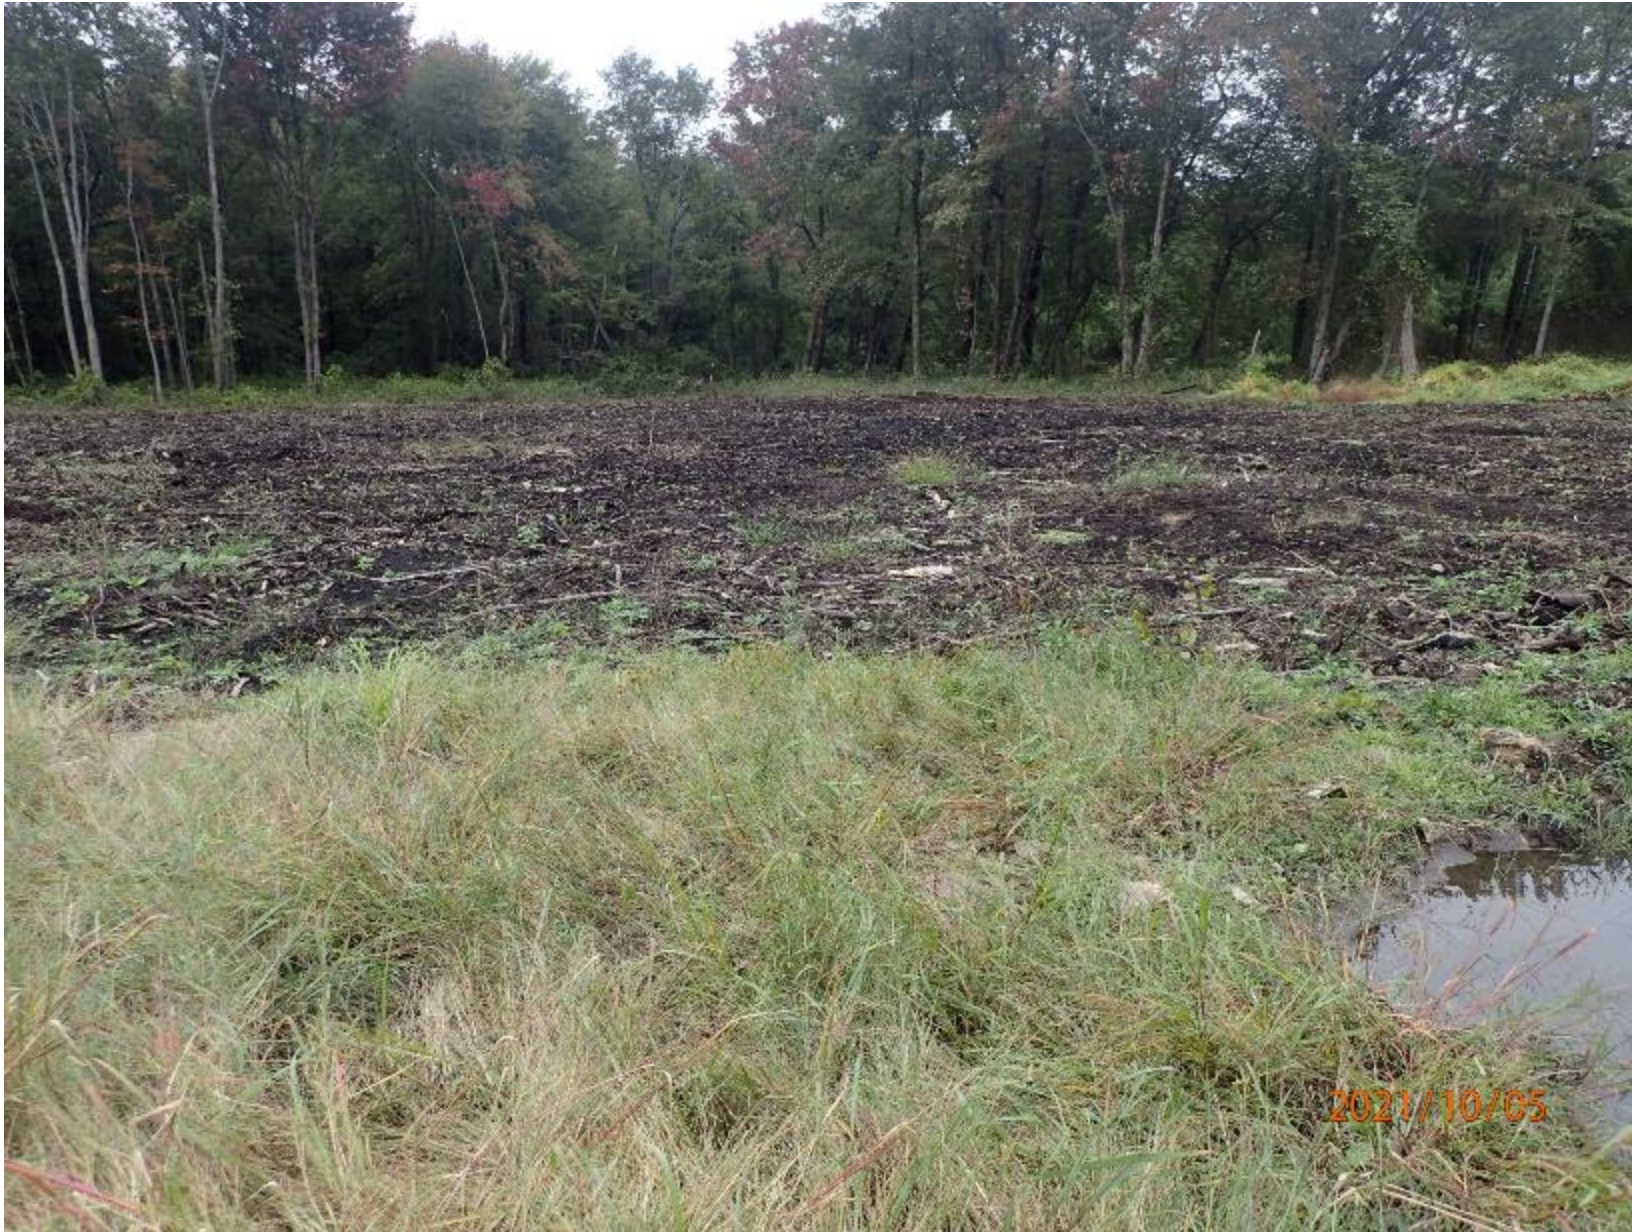
Date: 10/05/2021
Time: 3:09 PM
Photographer: SSA
Photo ID: 12 – PA050155

Photo taken of disturbance from SW Limit of Disturbance; photo facing northeast
